# MAITLAND GAOL CONSERVATION MANAGEMENT PLAN

Eric Martin & Associates

Maitland City Council

**FINAL DRAFT**  
ISSUE 4  
22207  
28 July 2023

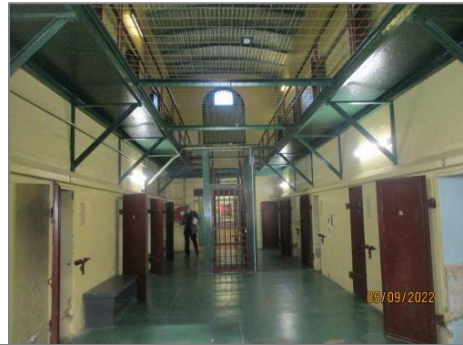
**Building 17 Yards**

Four separate yards built during the 1991 upgrade of facilities at the Gaol.

**Condition: Reasonable**

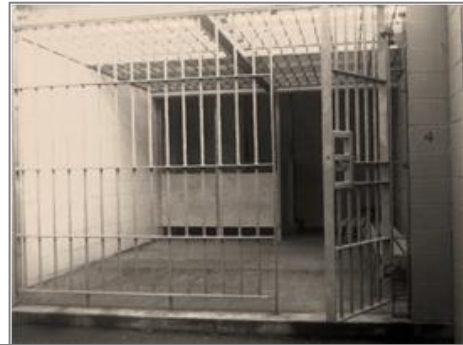
**Building 18 5 Wing Maximum Security Building**

This is a relatively modern single storey cell block comprising 22 cells with individual yards.

**Condition: Reasonable**

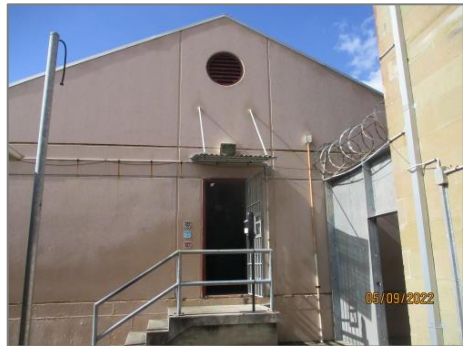
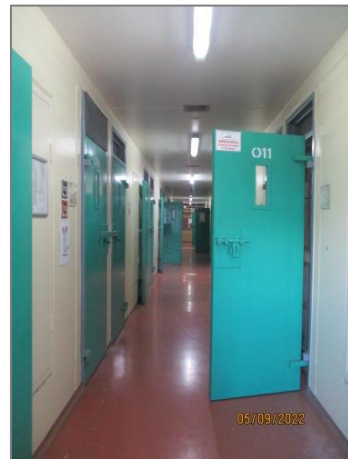
### Building 19 Gymnasium and Education Building

The former maintenance workshop is a two storey sandstone (Ravensfield) gabled. It has open arcading to the ground floor facing the courtyard, with early grilles surviving in each arch.

The lower level contains a smaller central room used as an office with original joinery and ripple iron ceiling. The larger rooms either side are currently used as a gym (originally a tin smith) and a locker room (originally a carpenter).

**Condition: The building was not assessed as it was not available for access.**

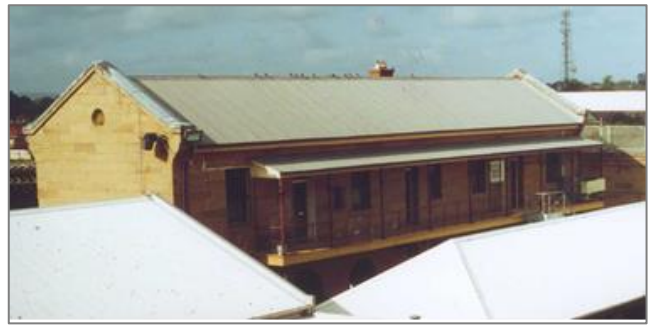
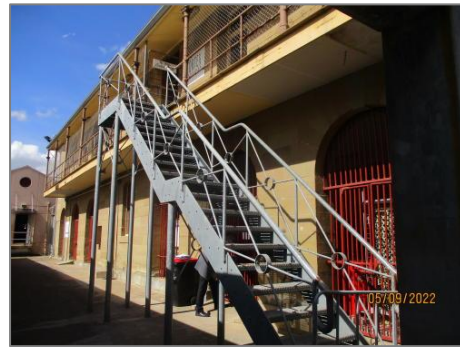
### Building 20 Visits Centre

A handsome shed with chamfered, bracketed timber posts supporting Kingpost trusses. Corrugated zincalume has replaced the original corrugated iron as the hipped roof. To the west the shed is separated from the yard by two sandstone steps along the length of the shed

**Condition: Reasonable**

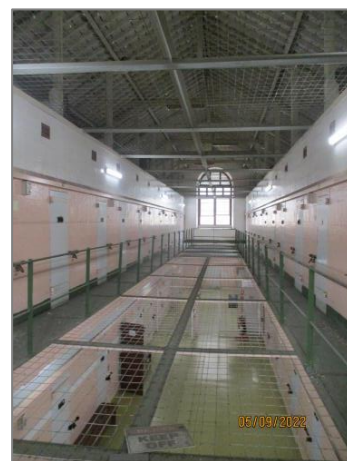
**Figure 12 Interior of A Wing**

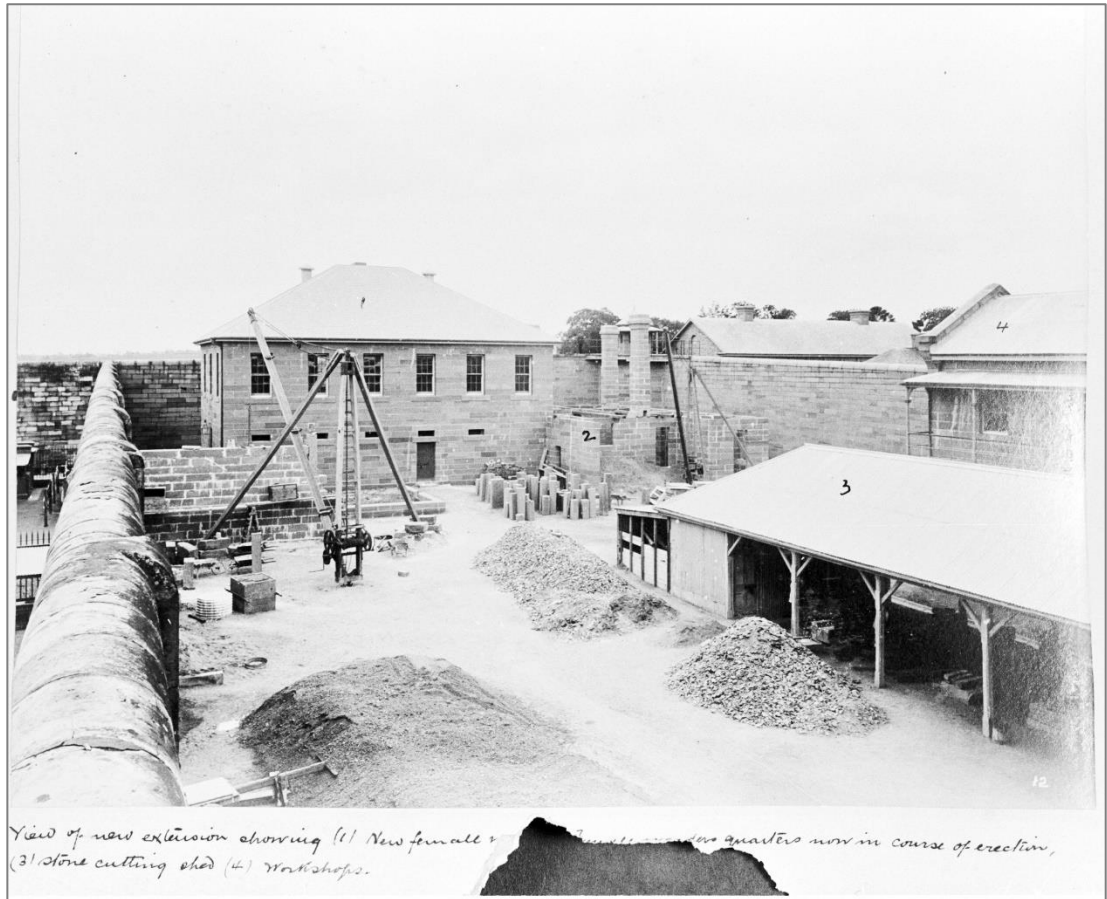
**Figure 17 Eastern Extension 1: Female Wing; 2: Female warders' quarters in course of erection; 3: stone cutting shed; 4: workshops, c. 1897.**

The Eastern Extension was planned and replanned a number of times, one scheme semi-completed before being radically changed. The primary example of *this* is that 'C wing', originally intended, and built, to have cells on the ground floor and a hospital, attendant's room and work-room on the upper level was modified to provide cells on two levels. To achieve this, windows on the upper level were blocked in, the staircase relocated and galleries added. The fate of the near completed female warder's quarters (re unroofed structure is not known. However from earlier plans it seems that two isolation cells were erected in their place. A wall dividing the Eastern Extension into two equal lots was under construction c.1897 (Figure 17).

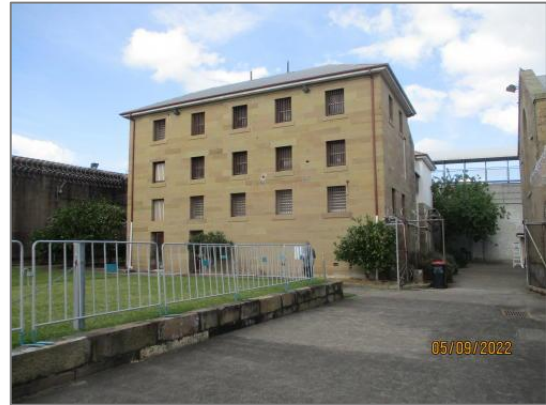
**Figure 22 Kitchen Block. Kitchen block with cells above.**

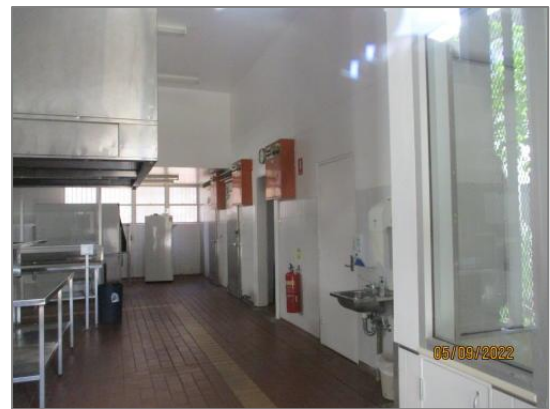
**Figure 23 Kitchen Interior – Ground floor**

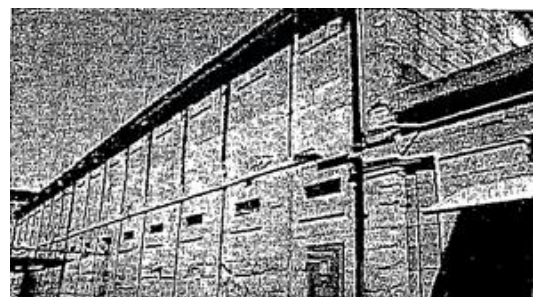
Also of interest is the change in condition and type of stone on the exterior of 'A wing' (north-west elevation). Reading the fabric misleadingly suggests that a smaller building was built prior to the current building on the site, and then later extended to the north-east and a second storey added (refer Figure 24). The stone of the 'earlier' building, being in such poor condition, suggesting that it was built of (inferior) East Maitland stone<sup>50</sup>. That an earlier, shorter building preceded the current building, at first appears to be confirmed by the 1850 sketch plan of the gaol by James Cox.

**Figure 24: Northwest elevation of A Wing showing difference in stone condition.**

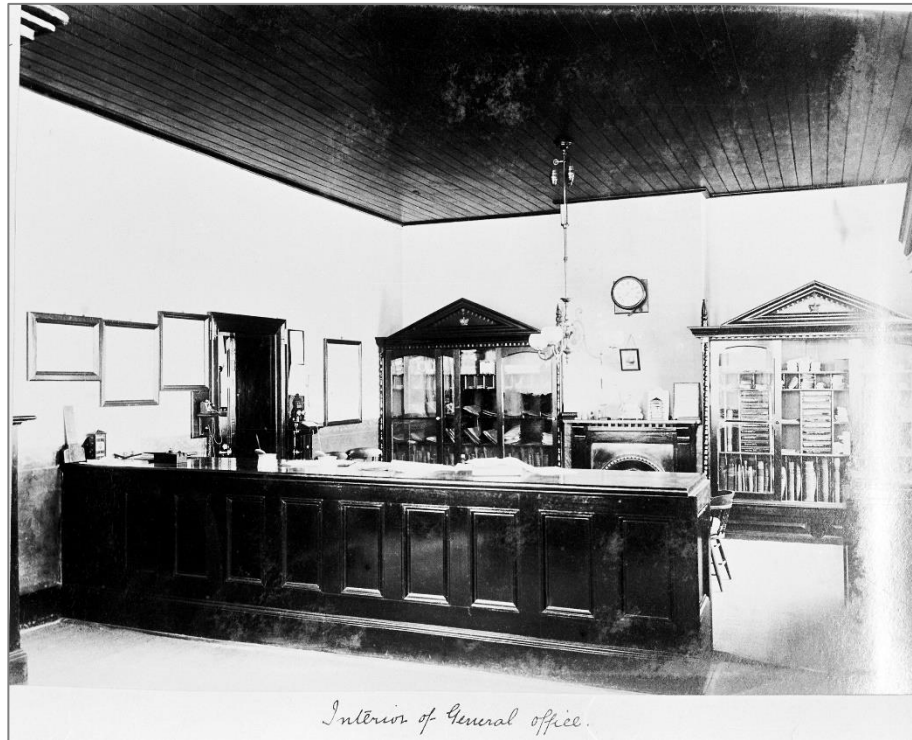
**Figure 29 General Office Interior n.d. c.1870.**

The history and use of the former chapel is described in section 2.8 of this report. The exterior of the building is largely intact in form. The interior, while appearing significantly modified, retains the original form of two completely separate ground floor areas, currently the hospital/dispensary and general offices. The upper level, while partitioned in recent years, still reads as the large open space of the former chapel. The western stair now demolished (part of the dispensary below) and the southern stair providing the main access to the upper level (Figure 28) indicates the modern partition walls dotted and demolished stair by a cross). A large opening has been introduced in the centre of the northeastern wall to connect the upper level to a raised 'demountable' building, which in turn connects to the ground via a modern steel stair. These changes have taken place in recent decades and are generally of a low standard. While most are detrimental to the building. They are largely reversible (Figure 29).

Historic photographs indicate that the chapel and general office were spaces of a high quality (Figure 29).

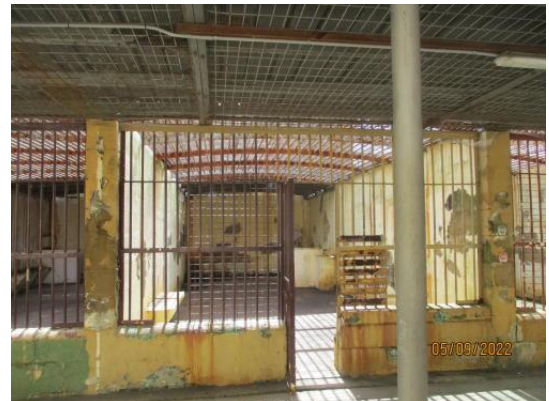
Figure 34 Interior of a typical yard

The special yards are a significant part of the early design of the gaol and remain so despite early 20th century modifications, and recent<sup>55</sup> demolition of half of the complex. By comparing early and recent site plans it appears that the yards have been modified twice.

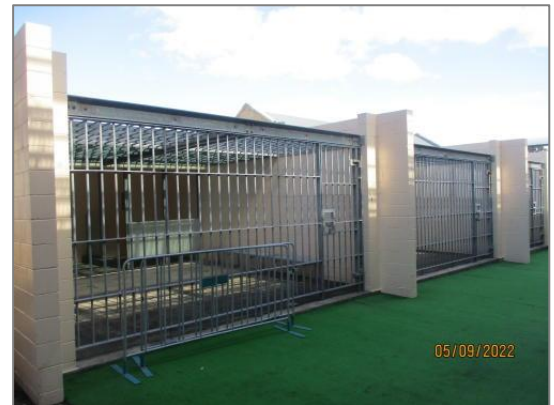
**Figure 36 View of the Eastern Extension. Shows the new Yards in the foreground and the cell block behind.**

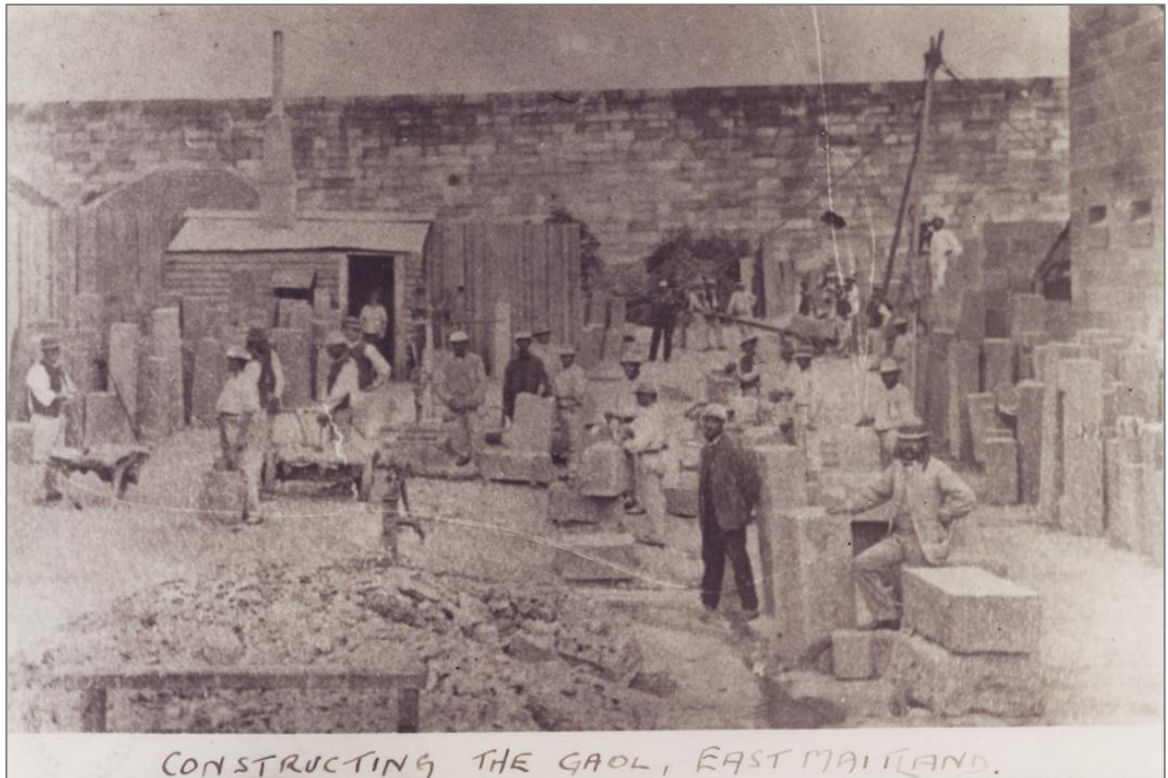
**Figure 39: Constructing the Gaol**

The walls of the gaol display evidence of changes to the Gaol over the years. The most noticeable alteration to the walls is that the stone has been rendered almost entirely on the inside and the outside. This detracts from the visual quality of the Gaol, however, it is evident from photographs dating back to 1899 that the walls even then were suffering from the effects of weathering. As noted above it is possible that the walls were constructed of East Maitland stone, before it was found to be inferior and Ravensfield stone subsequently used for the second phase of construction.

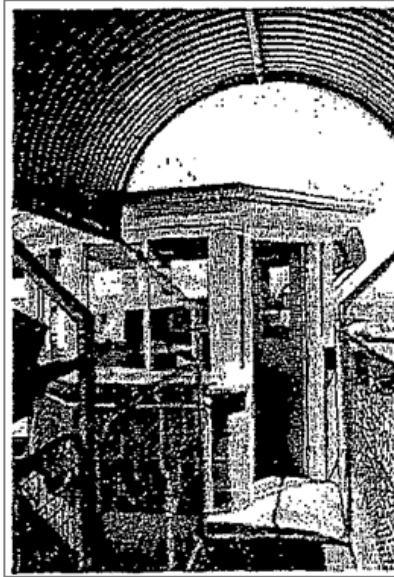
**Figure 41** Detail photograph of the same tower as in Figure 40 East tower of central gaol.

The concrete block towers lead to modern catwalks, built in the 1980s, with mesh floors and curved roofs attached to the top of the walls (Figure 41). The 19th century photographs indicate that the original towers were of stone construction and that the walkways originally extended as far as the flat coping stones of the walls (i.e., providing the walking surface), and had iron handrails. The remainder of the wall copings are curved. The original catwalks were extended by an earlier of the current design. This earlier catwalk was also perched over the walls, with a timber floor deck and had no roof.

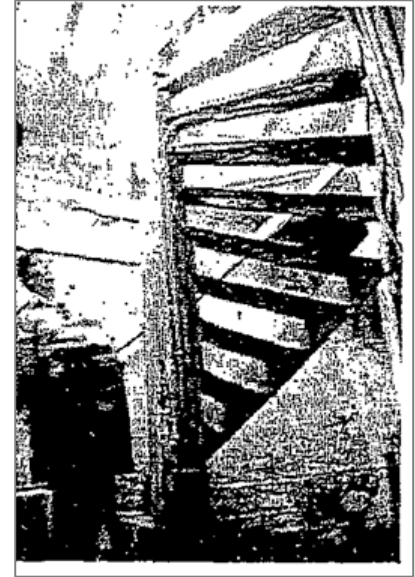
**Figure 42** Interior photograph of the early timber stair inside a triangular tower.

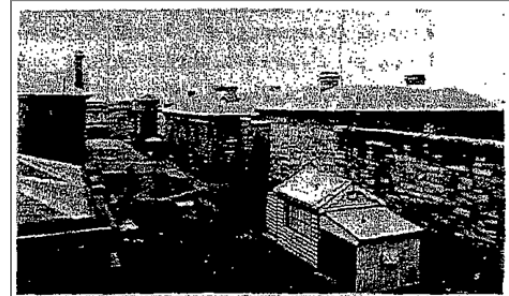
**Figure 48. A small garden (centre) is visible beside the Entry Gate and at the back of the Lieutenant Governor's Quarters, c1897.**

An early photograph, c.1897 (Figure 48) shows a small square of shrubs just inside and to the west of the main entry gate of the Gaol. They appear to be ornamentals, or possibly tall herbs. Today, however, there is nothing of landscape interest within the Gaol itself. Instead, one has to go beyond the Gaol walls to identify such elements.

A subsequent plan c1885 (Figure 50) shows the spatial outline of the two garden yards but no layout or planting information. It indicates a feature in the centre of the garden yard of the Governor's Residence, which would appear from the photograph, dated c.1897, to be a well and a water pump in the centre. Note that the garden yard had already been paved over, the only planting being ivy which half covers the back wall. At the time of writing nothing further is known about these gardens from the documentation.

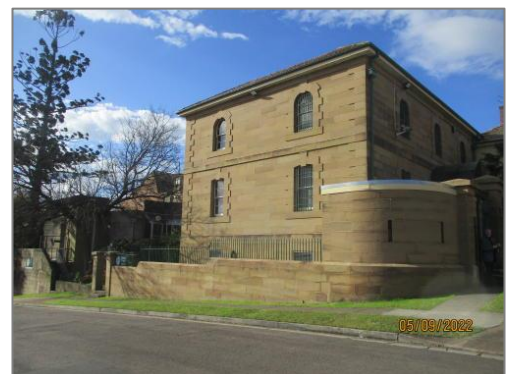
**Figure 54 The c1890 Hoop Pine near the former Deputy Governor's Residence, west of the main entrance to the Gaol.**

The most obvious early plantings are the very tall Hoop Pines (*Araucaria cunninghamii*) which were planted as boundary and entry markers to the Gaol.

As these did not appear in the early photographs, it is assumed that they were not original plantings, but put in a little later, perhaps towards the turn of the century. Although, the one now remaining at the front entrance (there could have been a pair, originally) appears to be in good health, the other two remaining ones are in a poor state; the hoop pine in front of the former Police Station is unfortunately senescent and the Lindesay Street tree was struck by lightning a few years ago and is dead from 4 metres up Their location is shown on a 1990 Survey Plan.<sup>72</sup>

As the only remaining early plantings of the whole site, they have a moderate to high degree of heritage significance, as they reflect the late Victorian taste for monumental, sculptural plantings, especially for use as markers of important sites. A more precise estimate of their degree of significance could be determined, if supporting documentation was available.

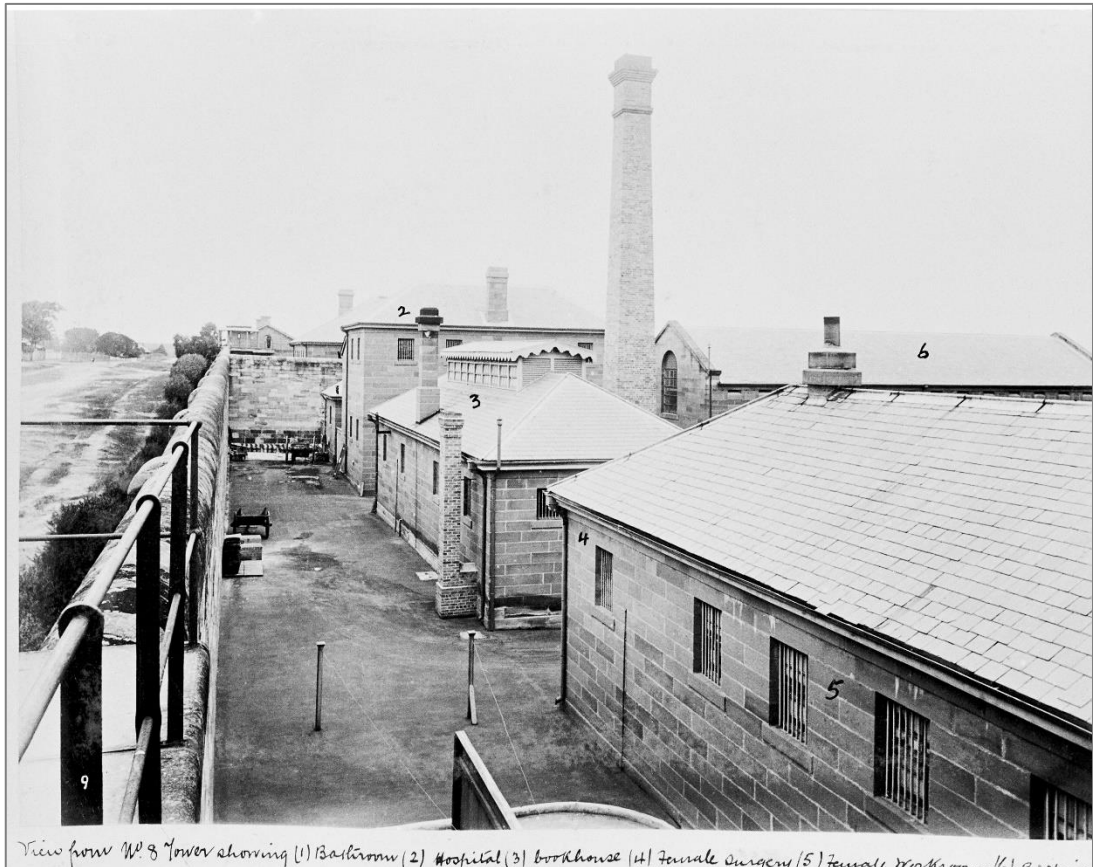
**Figure 58 View from North Tower looking towards Asset No's 013 and 009. This photograph clearly shows the two buildings: the Cookhouse (3) and the Female Surgery/Workroom buildings (4) that were demolished to provide an open area. The Bathroom and Hospital (2) have been modified to create the present Kitchen Block.**

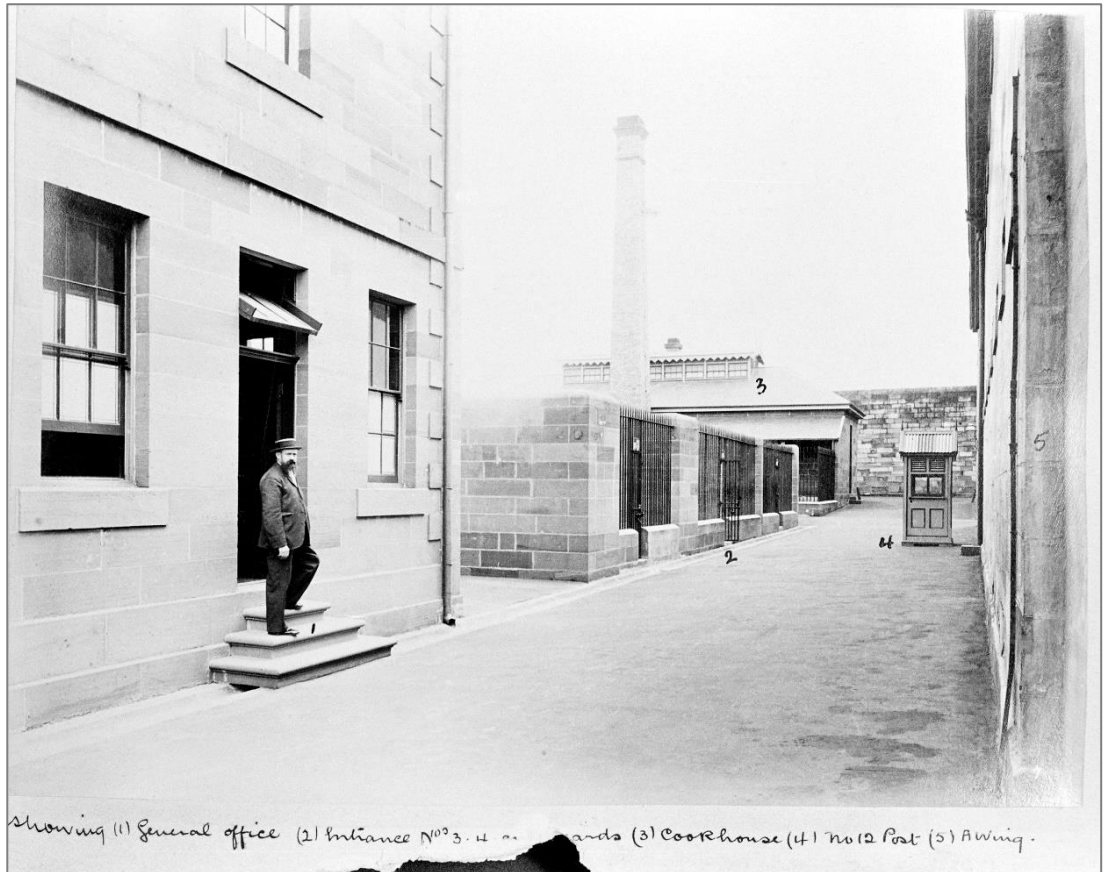
**Figure 59 View looking north-east between Asset No's 005 and 009. This photograph shows an early configuration of the special yards, with the Cookhouse in the background. The wall of the closest yard in the c1897 photograph has been blocked in and an opening created on the north-western side. An infill wall at the end of this space and lightweight shelter-type structures built over this space detract from the appreciation of this area.**

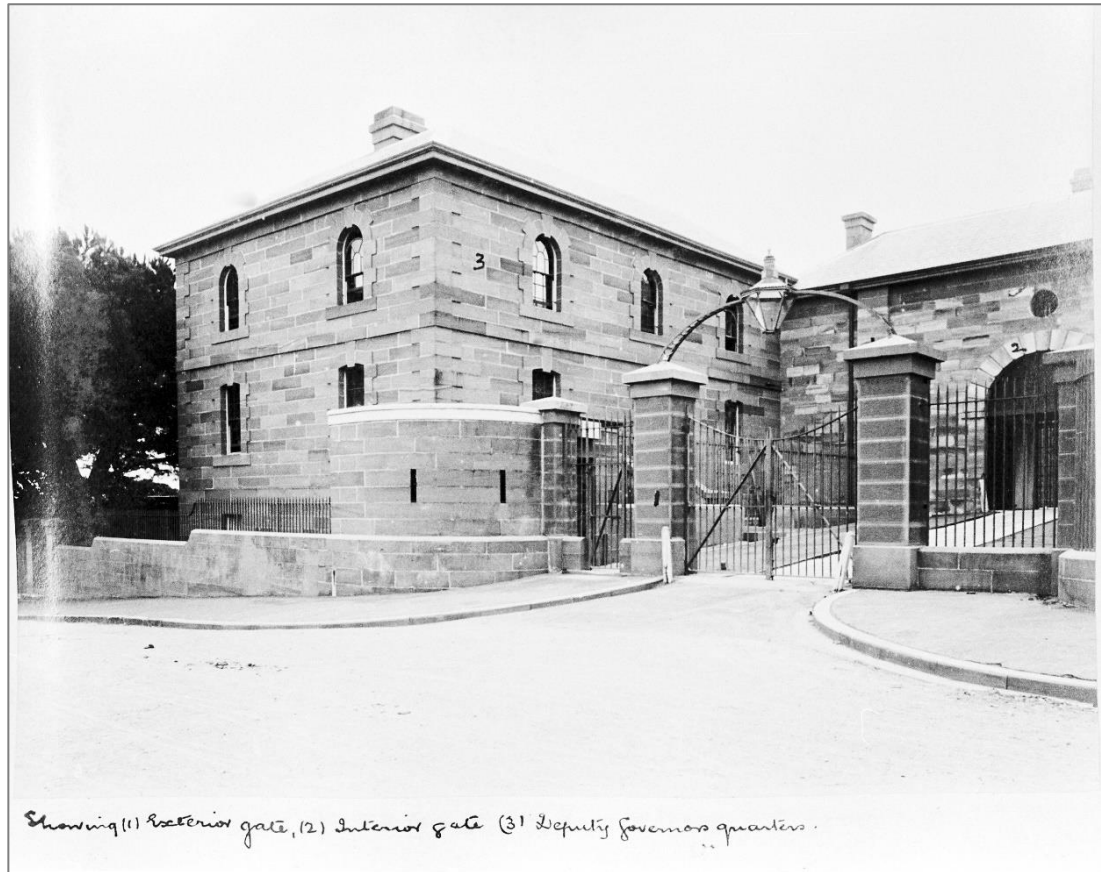
**Figure 64 View looking towards main entry of the gaol complex from John Street. Note the original gateposts with lamp over and current cage canopy concealing main arch of entrance way. The central building has been rendered on the street façade.**

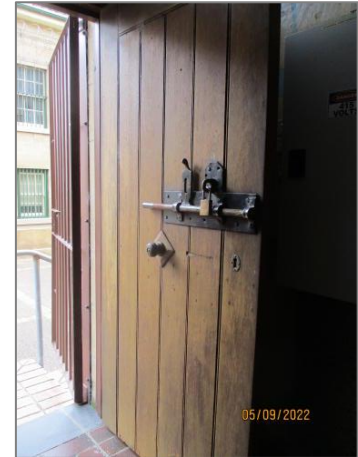
**Figure 69 Typical cell door bolt and lock. This lock is one of the more recent Abloy Lock types.**

Significant 'fixed' items that should be retained include: original and heritage iron and steel gates; cell doors and all hardware; cell grill doors; signage; and graffiti dating from the operating period as a correctional institution. A representative selection of cell furniture, electrical service control panels in cells, machinery, locks and other loose items should be retained. Artwork (i.e., paintings) should be retained but could be relocated.

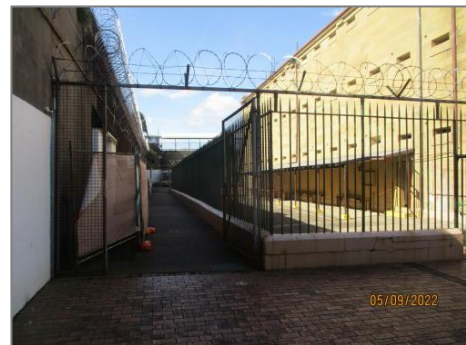
**Figure 71 Typical security fences etc. (Eastern Extension)**

In summary, it is recommended that some of these elements remain. It is desirable that the fabric which is retained relates to a particular precinct in terms of security and operation of the Gaol, such as the maximum security area of the Eastern Extension.

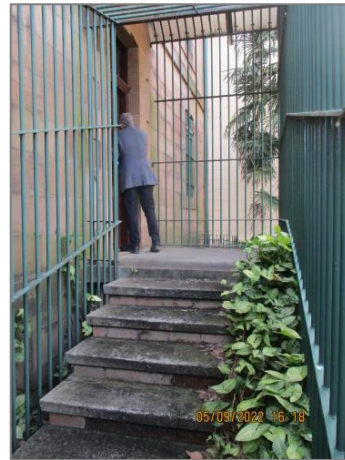
**Figure 72 Detail of modern stair and security bars to Asset No. 002.**

Archival recording should take place before and after removal, and should only be undertaken if removal is followed by positive action to repair any damage to significant fabric and the overall result is to regain lost significance. These elements include the 'pergola' type structures built between 'A wing' and the Special Yards, and entry structures (including paving, security cages and ramps) to both Asset Nos 002 and 003 (refer Figure 72).

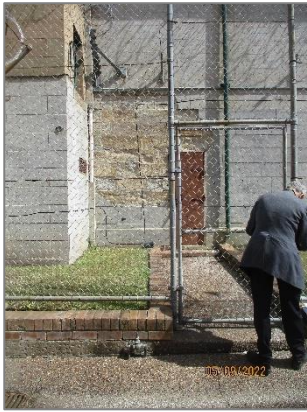
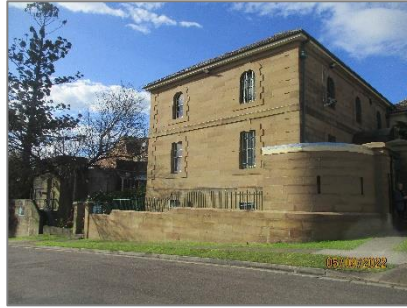
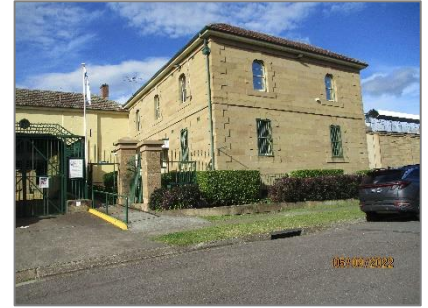
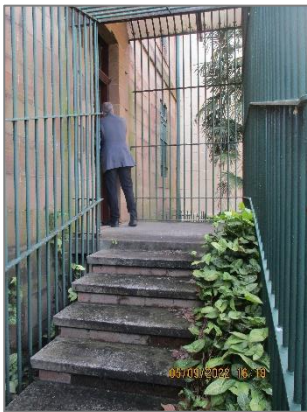
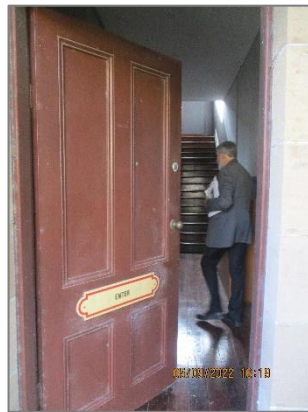
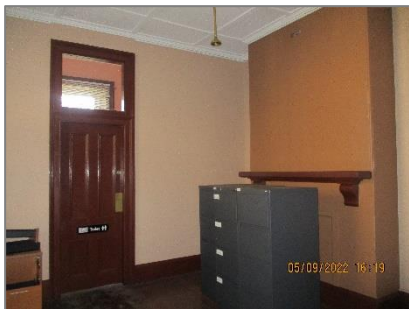
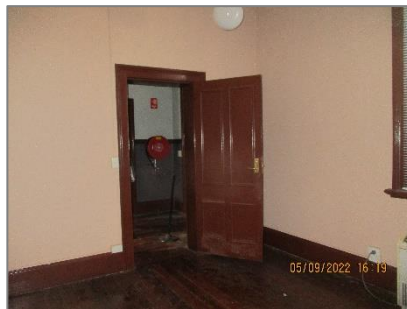
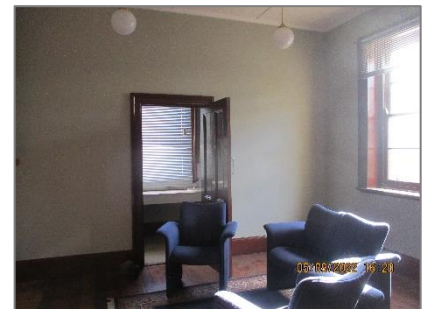
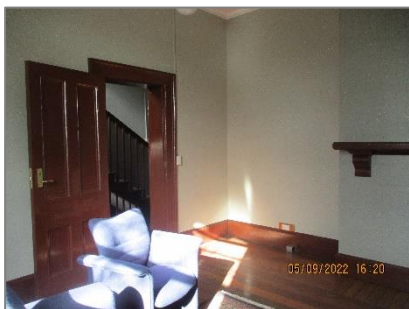
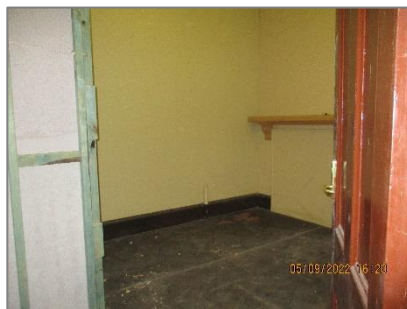
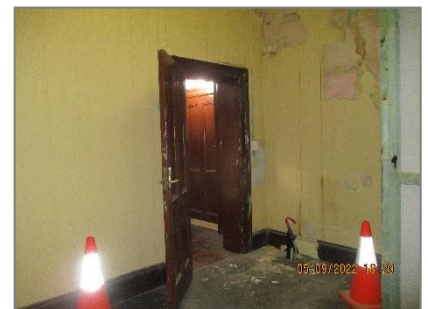
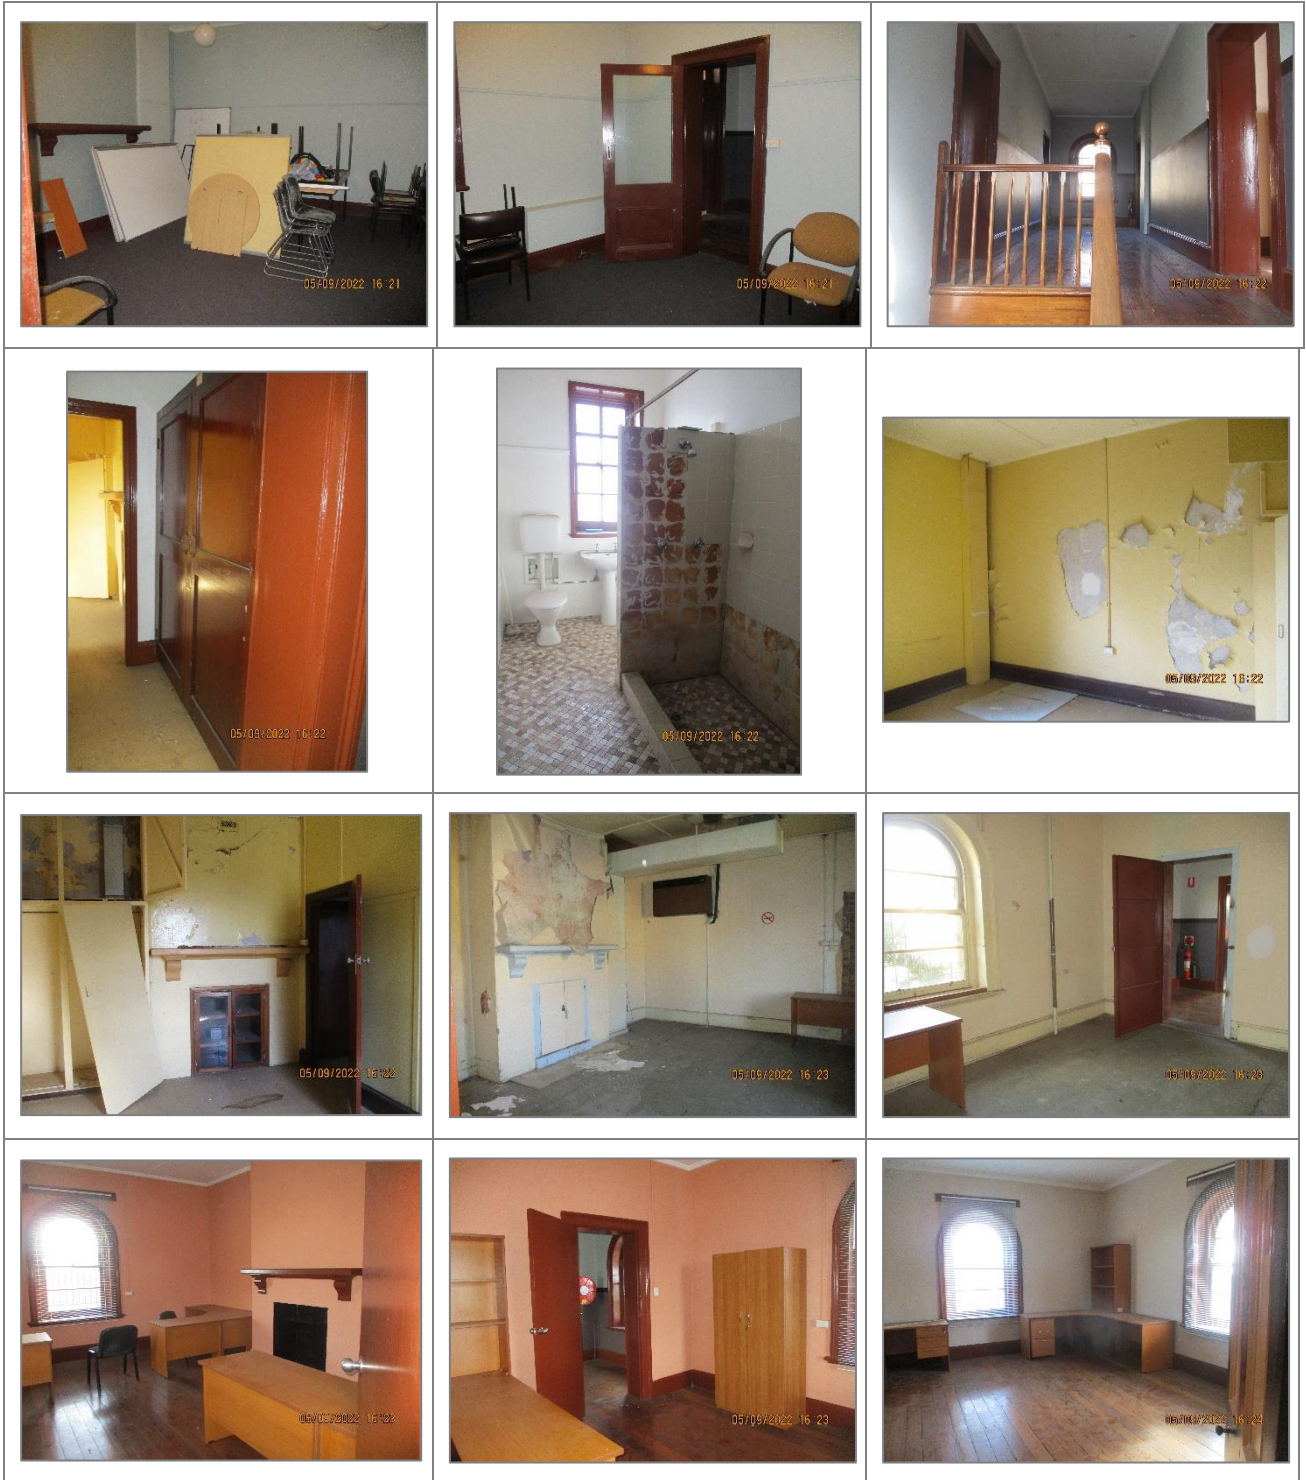
<b>Asset No: 3</b>	<b>BUILDING NAME:</b> <span style="float: right;"><b>Governor's House</b></span>
<b>Location:</b> E

**Description:**  
 Three-storey building, including basement, ashlar sandstone with heavily rusticated arched windows and corners, this building projects forward from the compound wall to form a three-sided court with its twin the lieutenant governor's house and the gatehouse. The chimney has been demolished.

<b>Comment:</b> Original layout and some fittings remain.	<b>Condition: Reasonable except for the basement which has rising damp and water ponding in the light well.</b>
--	---

Investigate source of rising damp and seek to halt damage if ongoing. Repair stone as necessary.

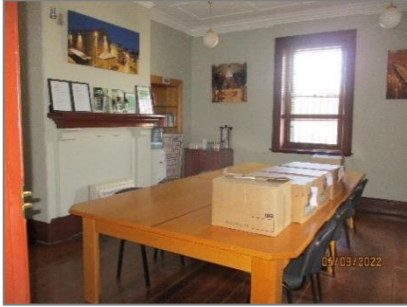
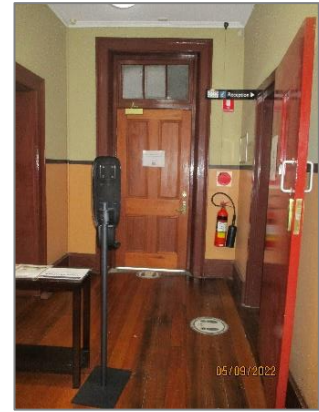
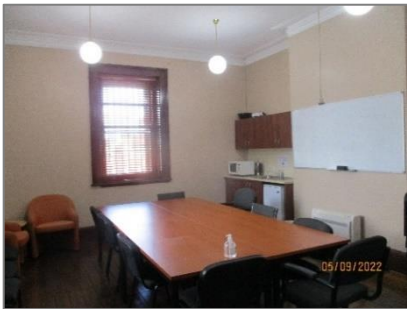
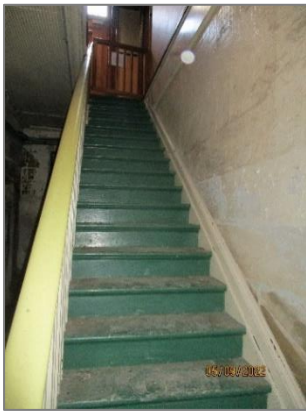
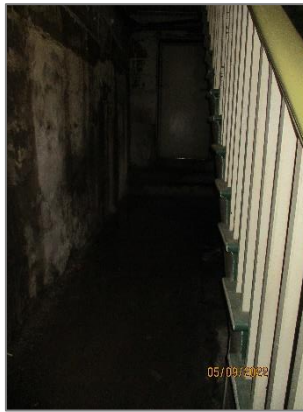
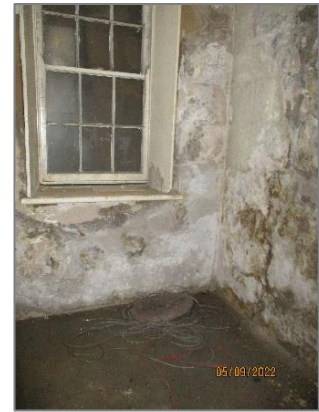
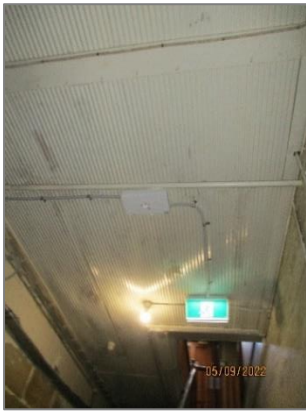
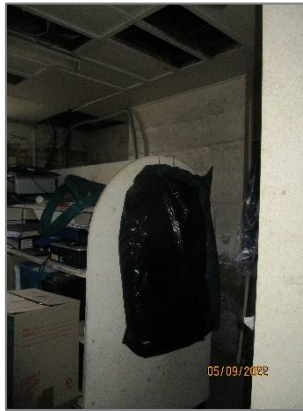
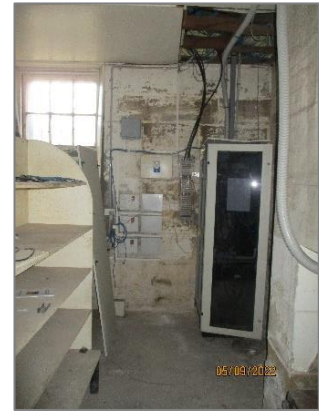
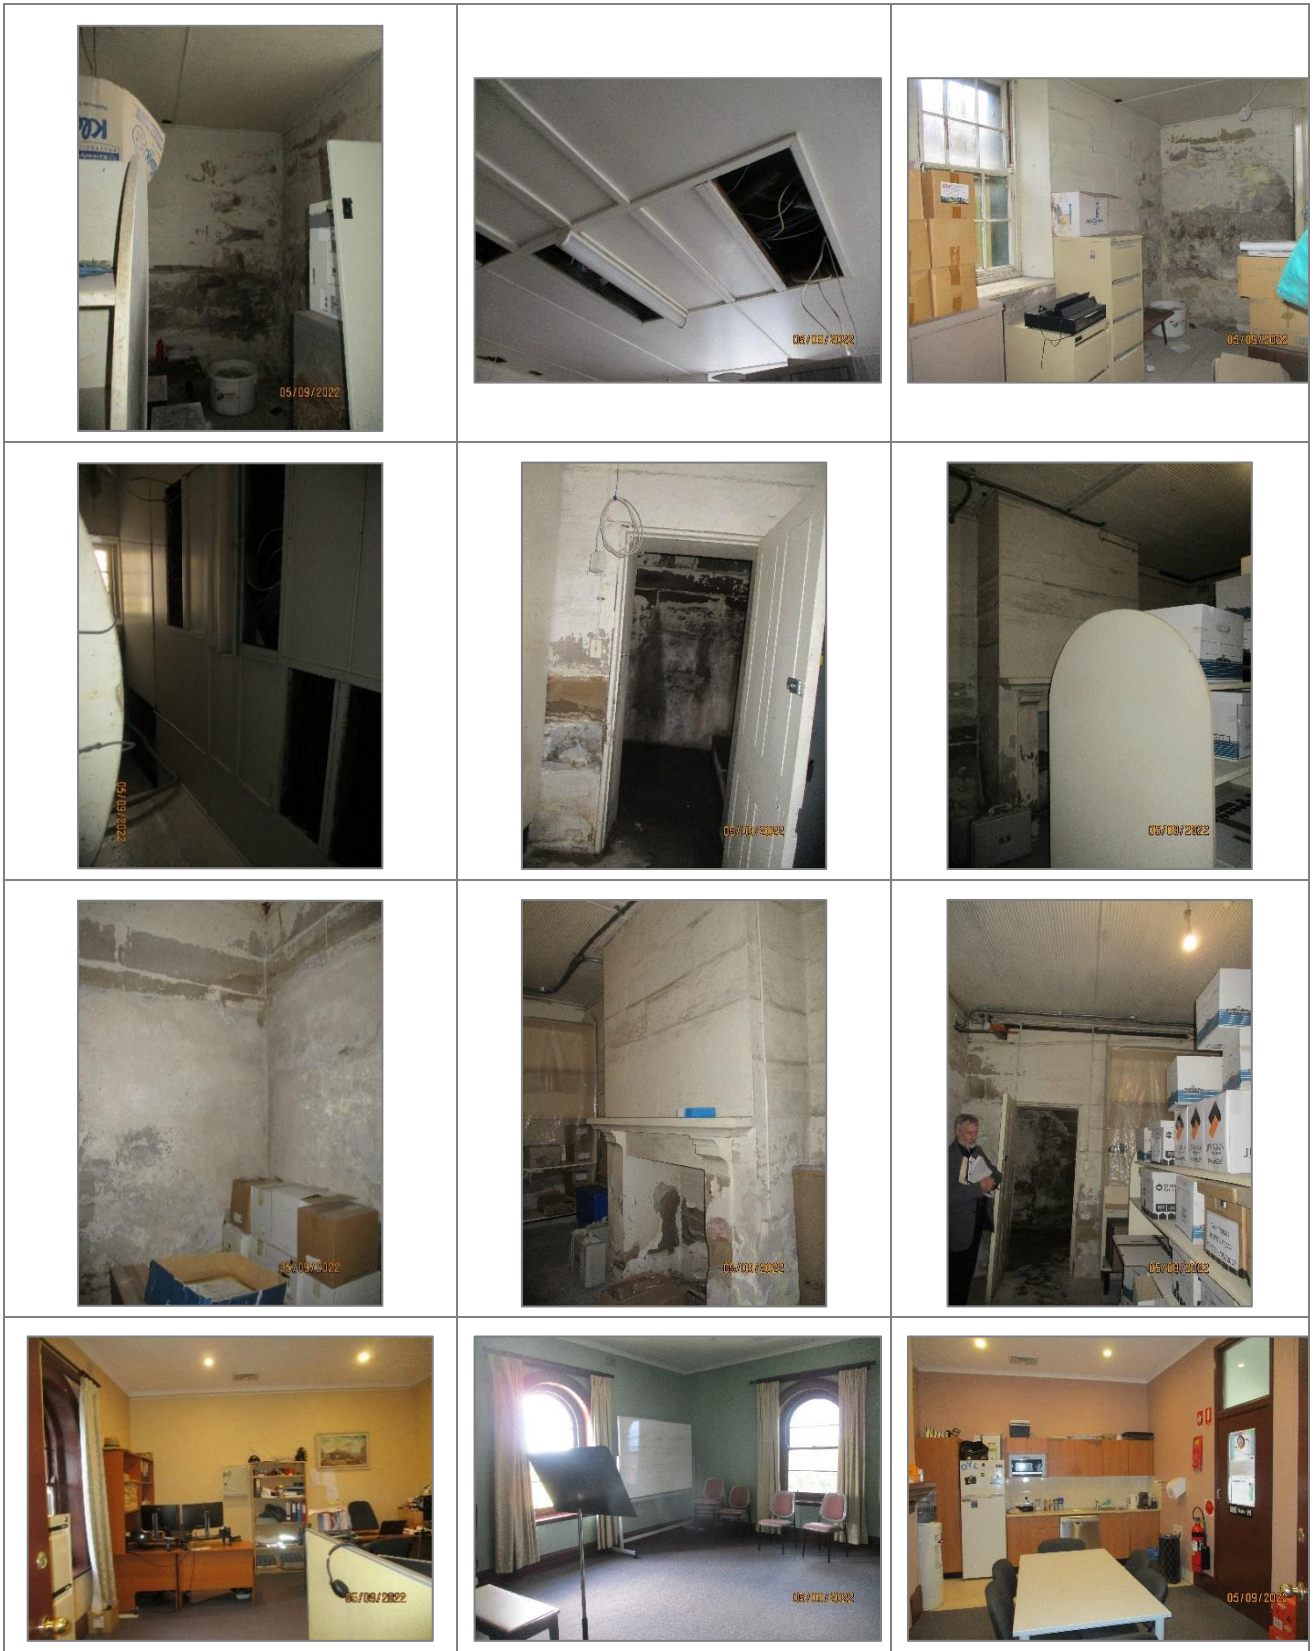
<b>Asset No: 4</b>	<b>BUILDING NAME: Sentry Post (Gatehouse)</b>
<b>Location: D</b> (southeast corner)

<b>Uses: Not defined.</b>	<b>Significance Rating: High</b>
<b>Comment: Original layout.</b>	<b>Condition: Reasonable</b>

Element	Significance	Recommendation
Floor	High, except vinyl which is of little significance	Return floor to original floor under the vinyl.
Walls	High.	Repainting possible in original colours.

Element	Significance	Recommendation
<b>Ceiling</b>	Little	Retain existing FC ceiling, however, investigate the original ceiling and if details exist about it reinstate original details.
<b>Window</b>	Moderate significance to the small windows and little significance to the larger window.	Retain existing unless the original details of the windows can be found, when reconstruction to the original details is preferred.
<b>Door/Gates</b>	High	Retain and repaint in existing or original colours.

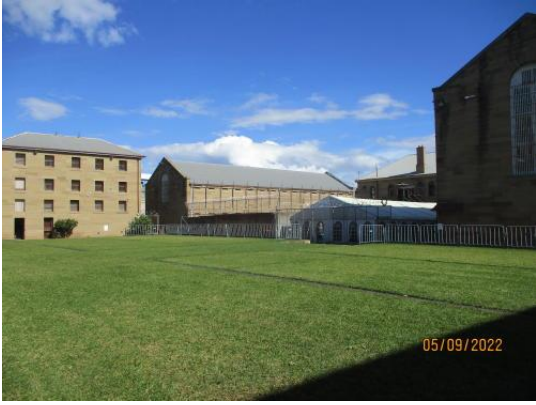
<b>Description:</b> This is the site of the demolished female wing and cook house.		
<b>Building Images:</b>		
<b>EXTERIOR</b>

<b>Significance:</b>		
Potential archaeological evidence and remains of footings.		
<b>Uses: Open Space</b>	<b>Significance Rating: Little</b>	
<b>Comment:</b> No surface indication of previous structure.	<b>Condition: Good</b>	
<b>Conservation Strategy:</b> Retain as open space. Do not excavate area unless essential and then adopt an Unanticipated Finds Protocol.

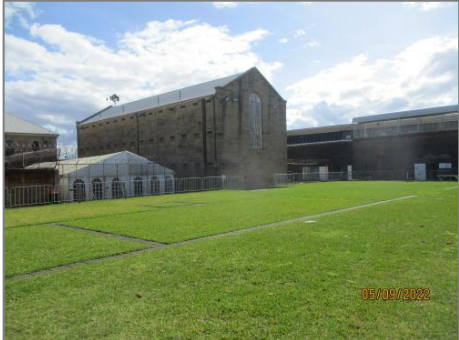
<p><b>Description:</b> This is the site of the demolished female wing and cook house.</p>		
<p><b>Building Images:</b></p>		
<p><b>EXTERIOR</b></p>

<p><b>Significance:</b></p>		
<p>Potential archaeological evidence remains of footings.</p>		
<p><b>Uses: open space</b></p>	<p><b>Significance Rating: little</b></p>	
<p><b>Comment:</b> No surface indication of previous structure.</p>	<p><b>Condition: Quite good</b></p>	
<p><b>Conservation Strategy:</b> Retain as open space. Do not excavate area unless essential and then adopt an Unanticipated Finds Protocol.</p>

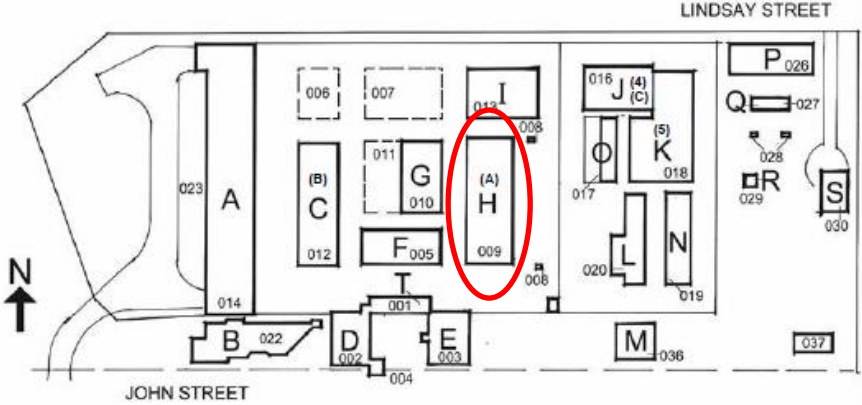
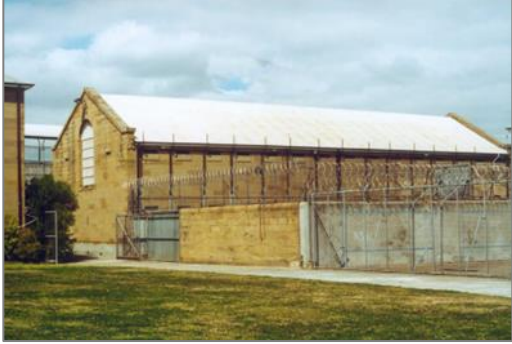
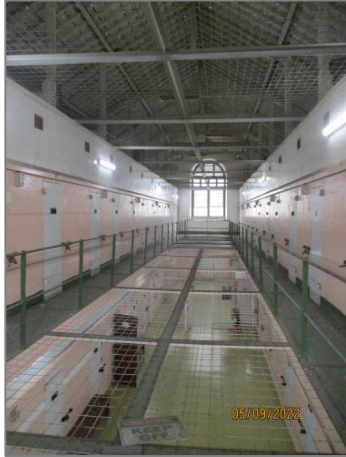
<p><b>Asset No: 9</b></p>	<p><b>BUILDING NAME: A Wing</b></p>	
<p><b>Location: H</b></p>

<p><b>Description:</b> A two-storey building built with large 12' x 8' cells and with the cells on the upper levels accessed by the gallery. Most cells were subdivided doubling the number of cells in the wing.</p>		
<p><b>Building Images:</b> (further photographs attached).</p>		
<p><b>EXTERIOR</b></p>

<p><b>Significance:</b> This is the oldest building within the compound and along with the external wall, represents the original Gaol of the 1840s. It is a heritage significant building and is similar in style to B Wing. It is only two levels but is operated in exactly the same way as B Wing. There are three exits from the building at ground level. The front of the wing is used for storage and as a staff room and facility for tour guides.</p>		
<p><b>Uses:</b></p> <ul style="list-style-type: none"> <li>• Tours and interpretations</li> <li>• Small events and functions</li> </ul>	<p><b>Significance Rating: High</b></p>
