# MAITLAND GAOL CONSERVATION MANAGEMENT PLAN

Eric Martin & Associates

Maitland City Council

**FINAL DRAFT**  
ISSUE 4  
22207  
28 July 2023

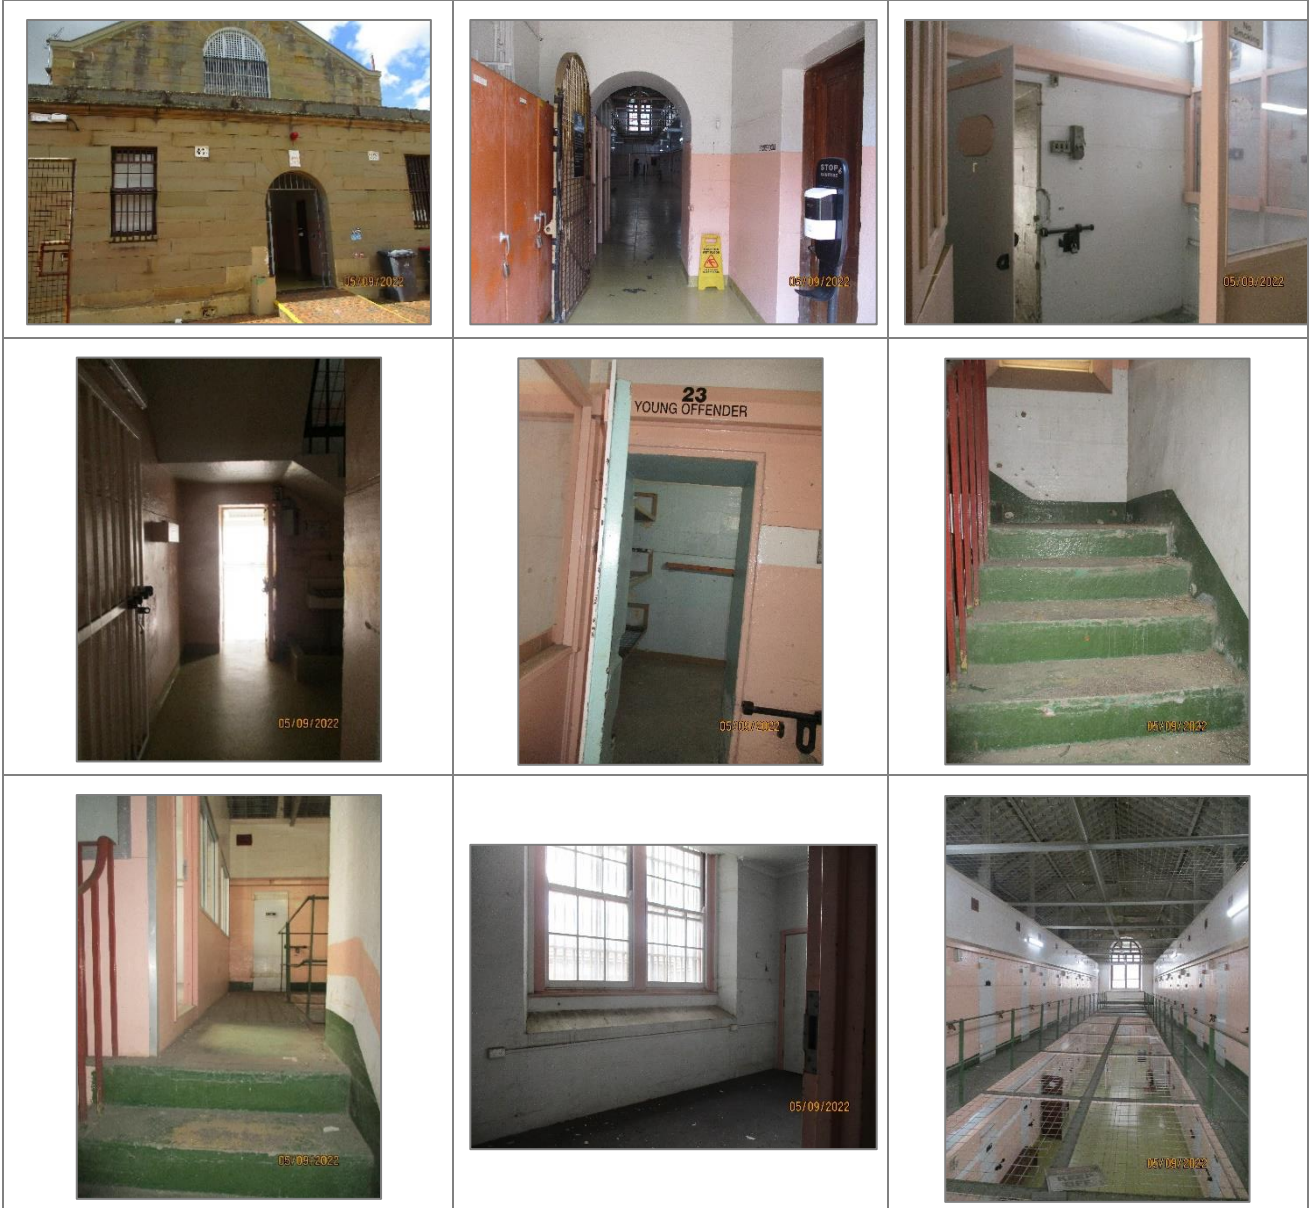
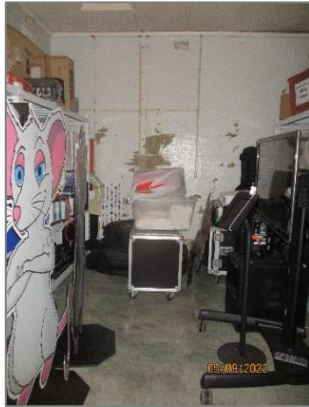
<b>Comment:</b>					<b>Condition: Quite Good</b>		
The only surviving example of the Inspectors Gaols by Mortimer Lewis. There have been some changes to a number of cells and other elements added.							
<b>Conservation Strategy:</b>							
The existing cell layout should be retained.							
For tours, retention of existing elements is an important part of the interpretation even elements that are relatively recent. For functions the only space suitable is the central area on the ground floor. The conservation strategy is to retain as much as possible as is and only, undertake essential maintenance where required.							
Retain the existing galleried layout. This block is of considerable significance and proposed changes to accommodate a new use need to be carefully balanced against loss of significance for the Gaol.							
Retain at least one pair of single cells on each level intact with existing fittings and furnishings as an example of the divided cell plan (see note below).

Element	Significance	Recommendation
<b>Floor</b>	Moderate significance; East store of little significance.	Retain painted concrete. Repainting is possible but must be in existing colours eg beige to the beige area only. Unpainted section near control post to remain unpainted. Retain existing vinyl in the east storeroom or remove it back to bare concrete. The west storeroom floor to be repainted in green when essential.
<b>Skirting</b>	Moderate significance.	Retain existing painted skirting. Repainting in existing colours for maintenance purposes is possible.
<b>Walls</b>	High, except: <ul style="list-style-type: none"> <li>Room at south end first floor in central space, which is of little significance.</li> <li>Divider in the middle of the ground floor central space which is of little significance.</li> </ul>	Retain existing walls as they are. Minimal patch repainting of areas where walls have deteriorated (i.e. where paint has flaked off at ground level) in existing colours can be undertaken. Retain evidence of signage including Perspex nameplates and other graffiti exactly as they are (no repainting). Ventilators should be retained as is despite the fact some are missing and damaged. Retain as is.

<b>Fittings in West Store</b>	Little	Preferable to remove including splash backs.
<b>Element</b>	<b>Significance</b>	<b>Recommendation</b>
<b>Fittings: Railings cage and gates to upper levels</b>	High	Retain existing as is.

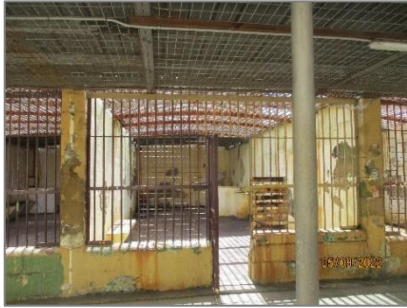
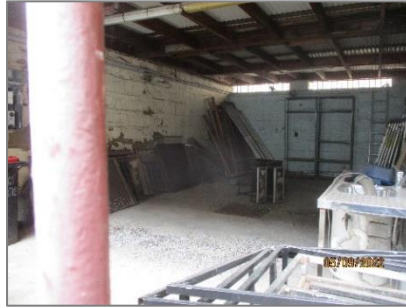
**Building 10**

<b>Comment:</b> The yards have been modified from original layout.	<b>Condition: Quite Good</b>
---	------------------------------

Element	Significance	Recommendation
Floor	Moderate significance	Retain as is.
Walls	Moderate significance	Retain as is. Original finish appears to be sandstone and the removal of the paint may occur by natural or artificial means. Repainting of the walls should not happen.
Ceiling	Moderate significance	Retain existing. Repainting in existing colours to preserve the metal.
Door/Gates	Moderate significance	Retain. Repaint in original colours as required to preserve them.
Fittings	Moderate significance	Retain existing fittings.
Cover over the yard between G and H	Little	Remove cover unless considered essential for proposed future use.

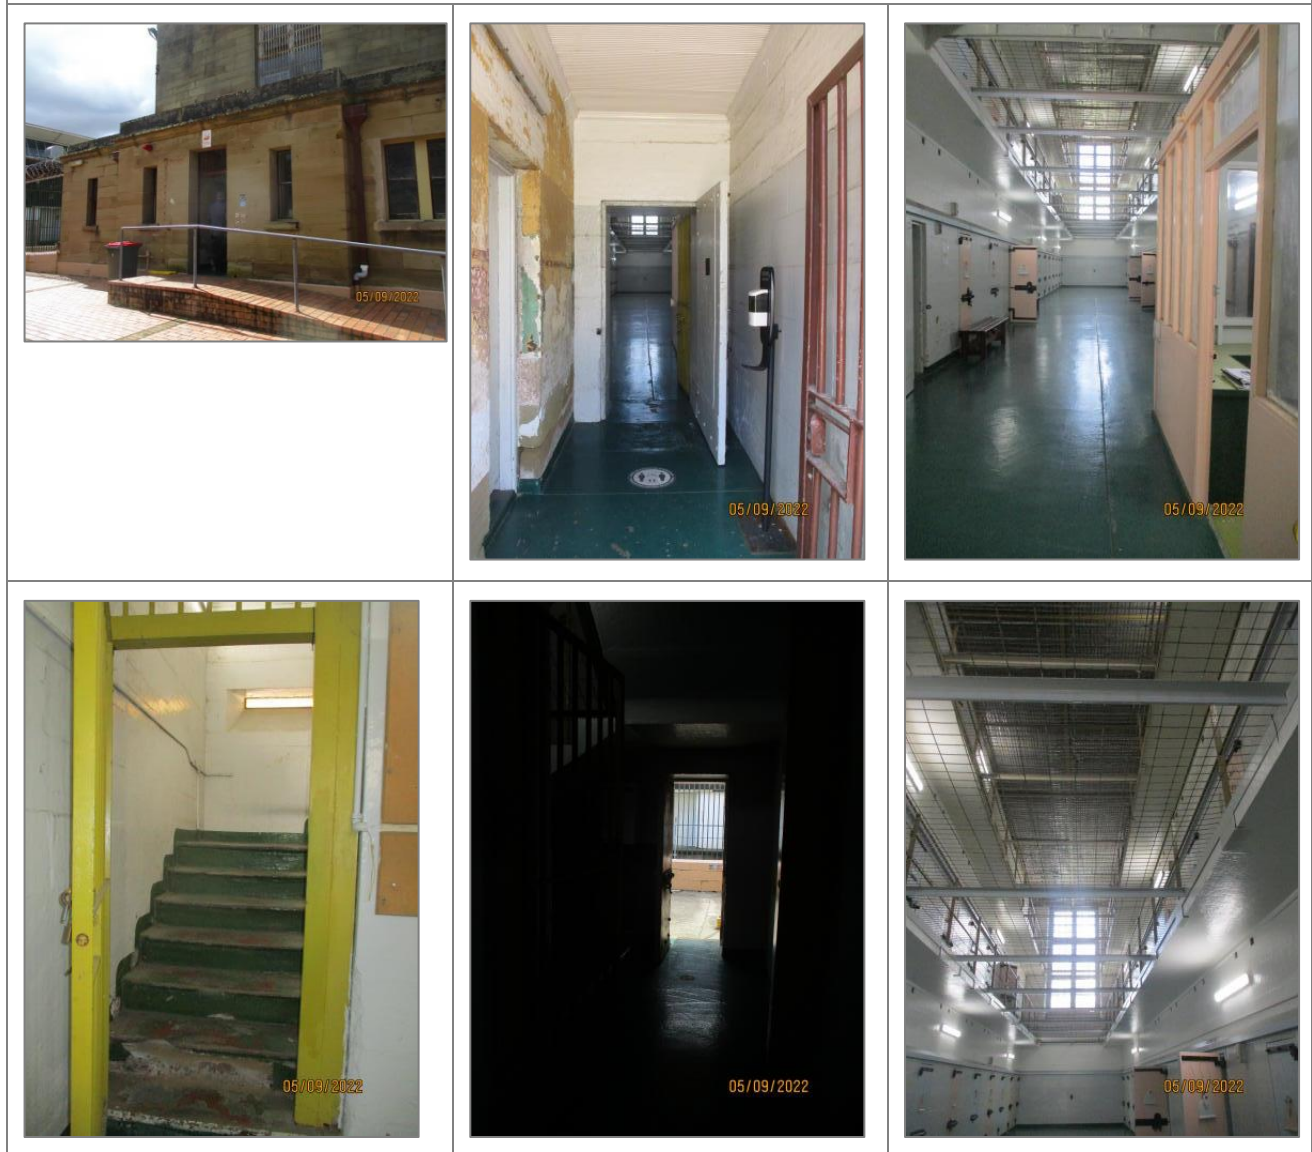
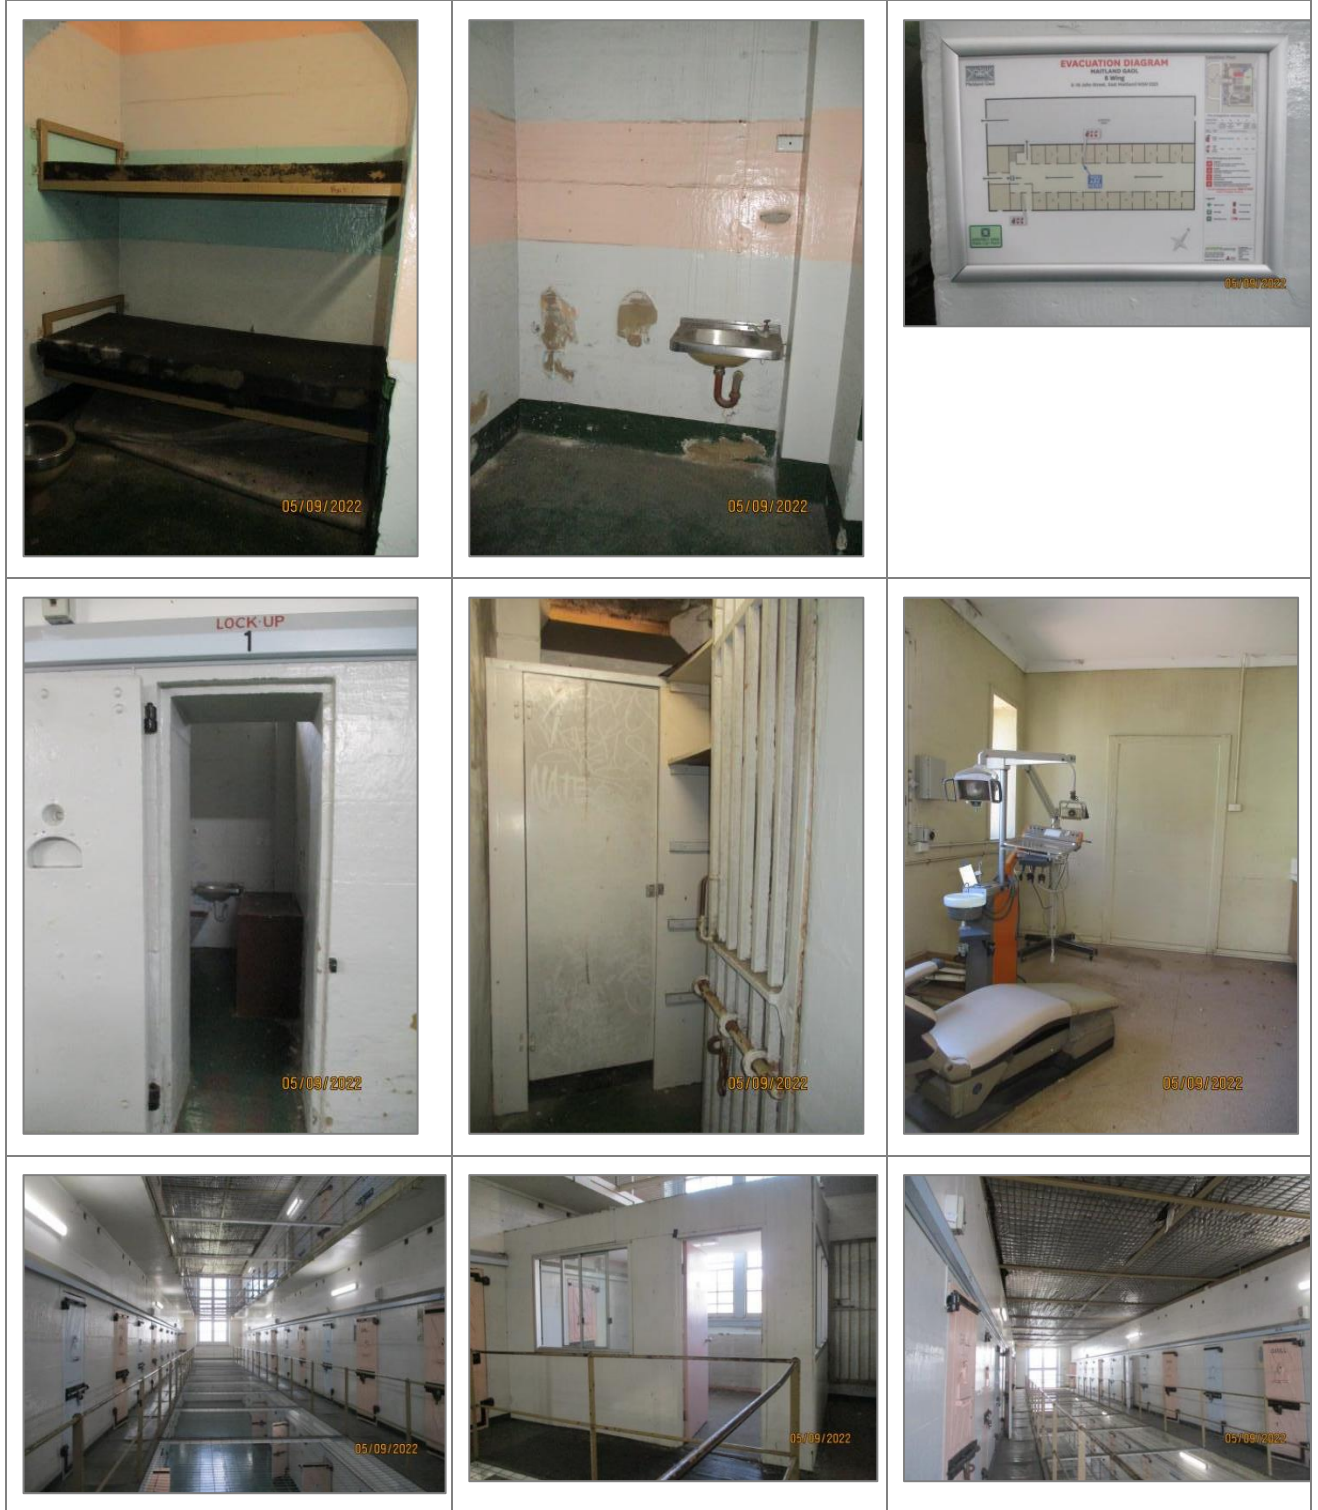
<p><b>Uses:</b></p> <ul style="list-style-type: none"> <li>• Tours and interpretations</li> <li>• Small events and functions</li> </ul>	<p><b>Significance Rating: High</b></p>
<p><b>Comment:</b></p> <p>Cells were originally all single but now most are doubles.</p> <p>It is one of two surviving examples of “inspectors Gaols” but has had a few changes such as offices, mesh, toilet fittings and staff escape route.</p>	<p><b>Condition: Quite Good</b></p>

Element	Significance	Recommendation
<b>Floor</b>	Moderate significance	Retain painted concrete. Repainting is possible but must be the existing green colour. Retain existing vinyl in dentist's room.
<b>Skirting</b>	Moderate significance	Retain existing painted skirting. Repainting in existing colour for maintenance purposes is possible. Retain existing skirtings in dentist's room. Repaint in existing colours as required for essential maintenance.
<b>Walls</b>	High except office walls which are moderate. Minimal patching.	Retain existing walls as they are. Repainting of areas where walls have deteriorated (ie where paint has flaked off at ground level) in existing colours can be undertaken. Retain evidence of signage and other graffiti exactly as they are (no repainting). Repainting of walls in dentist's room in existing colours is possible.
<b>Ceiling</b>	High, except the two south rooms which are of little significance.	Retain existing as is. Repainting of dentist's ceiling in existing colours is possible.

<b>Door/Gates</b>	High, except door to dentist's room which is of little significance.	Retain as they are including paint colours. Repainting is considered unnecessary. Repainting the dentist's door for maintenance purposes is possible.
<b>Lighting</b>	Little	Retain existing or replace with similar.
<b>Stairs</b>	High	Retain as is.
<b>Fittings Within Cells</b>	Moderate	Retain as they currently exist. Temporary removal of loose items for cleaning and maintenance etc. is acceptable provided they are replaced. Temporary removal of fixed elements, if essential, is possible if no damage to any original fabric occurs and replacement using existing original fixings is guaranteed. If the fixings are not original the fixed elements can be removed, if essential, provided no change to the fabric occurs. New fixings can be used to refix the fittings.

Element	Significance	Recommendation
Fittings in Dentist's Room	Moderate	Retain as is.
Fittings: Railings, cage and gates to upper levels	High	Retain as is.

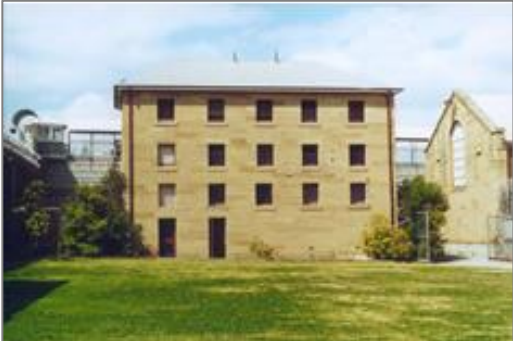
<p><b>Asset No: 13</b></p>	<p><b>BUILDING NAME: Kitchen</b></p>	
<p><b>Location: I</b></p>	 	
<p><b>Description:</b> This is a four-storey sandstone building with kitchen at lower level and cells above.</p>		
<p><b>Building Images:</b> (further photographs attached).</p>		
<p><b>EXTERIOR</b></p>

<p><b>Uses:</b></p> <ul style="list-style-type: none"> <li>• Interpretation</li> <li>• Food Packaging and processing</li> <li>• Small group training and overnight accommodation.</li> </ul>	<p><b>Significance Rating: Moderate</b></p>	
<p><b>Comment:</b></p>	<p><b>Condition: Reasonable</b></p>	
<p>Initially two buildings which were linked at ground and first floors</p>

Element	Significance	Recommendation
<b>Floor</b>	Moderate to upper floors, little to ground floor.	Retain or change ground floor. Retain existing upper floor including paint colour Repaint in existing colour as required.
<b>Skirting</b>	Moderate to upper floors, little to ground floor.	Retain or change ground floor. Retain painted skirtings. Repainting as required for maintenance purposes in existing colours.
<b>Walls</b>	External Walls to original buildings and cell walls of moderate significance, others little.	Retain external walls and original walls to east building. Other walls can be altered as desired. Retain existing paint and graffiti in all cells. Central space of first floor can be repainted in existing colours.
<b>Cornice</b>	Little	Retain or change.
<b>Ceiling</b>	Moderate to upper floors, little to ground floor.	Retain or change ground floor. Retain painted concrete. Repainting in existing colours for maintenance purposes as required.

Element	Significance	Recommendation
<b>Door/Gates</b>	Moderate to cells, little elsewhere.	Doors can be altered as desired but no new external doors to be provided. Retain existing, cell doors only repainting in existing colours if required for essential maintenance. Other doors can be retained or altered.
<b>Architrave</b>	Little	Retain or change.
<b>Lighting</b>	Little	Retain existing or replace with something similar.
<b>Fittings (general)</b>	Little to ground floor. Moderate to other floors.	Retain or change to ground floor. Retain existing on upper floors, repainting in existing colours if required for essential maintenance.
<b>Fittings (menu boards, knife cupboards)</b>	Moderate	Retain in area, even if area is altered for interpretation purposes.

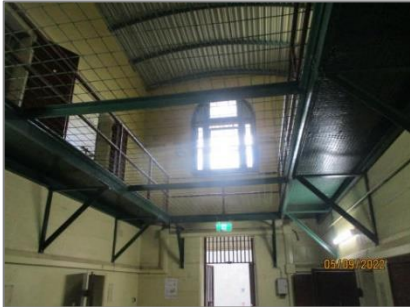
**Description:**  
 'C-wing' is a two-storey ashlar block building comprising 24 cells. Corrugated metal roofing has replaced the original slate. The upper-level external window openings have been modified to high level barred openings (cells were not originally intended for the upper level). The roof is a queen post truss with battens for slates which were the original roof covering.

<p><b>Comment:</b></p>	<p><b>Condition: Reasonable</b></p>
------------------------	-------------------------------------

Element	Significance	Recommendation
Floor	Moderate significance	Retain painted concrete. Repainting is possible, using existing colours.
Walls	High	Retain existing walls as they are. Repainting of areas where walls have deteriorated in existing colour can be undertaken but work to be restricted to patch painting. Retain evidence of signage and other graffiti exactly as they are.
Ceiling	High, except ceiling over central space which is of moderate significance.	Retain existing as is.
Window	High	Retain existing as is. Bird proofing openings with bird wire or expanded mesh to match existing to be maintained.

Element	Significance	Recommendation
Door/Gates	High	Retain as they are including paint colours. Repainting is considered unnecessary.
Lighting	Little	Retain existing or replace with similar.
Stairs	High	Retain as is.
Fittings Within Cells	Moderate	Retain as they currently exist. Temporary removal of loose items for cleaning and maintenance etc. is acceptable provided they are replaced. Temporary removal of fixed elements, if essential, is possible if no damage to any original fabric occurs and replacement using existing original fixings is guaranteed. If the fixings are not original the fixed elements can be removed, if essential provided no change to the fabric occurs. New fixings can be used to refix the fittings.
Fittings: railings, mesh ceiling	High for railings. Moderate for mesh ceiling.	Retain as is.

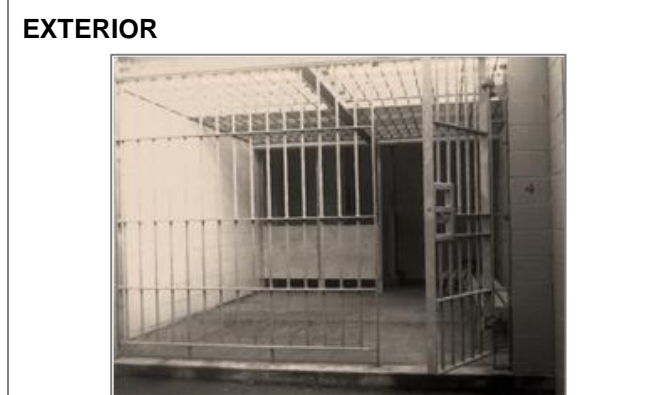
**Description:**  
Four separate yards built during the 1991 upgrade of facilities at the Gaol.

<b>Comment:</b> Constructed during 1991 upgrade.	<b>Condition: Reasonable</b>
---	------------------------------

<b>Recommendations:</b>		
<b>Element</b>	<b>Significance</b>	<b>Recommendation</b>
<b>Whole Building</b>	Little	Retain or alter as required. They are not really suitable for accommodation without alteration.
<b>Whole Building</b>	Little	Retain or alter as required. They are not really suitable for accommodation without alteration.

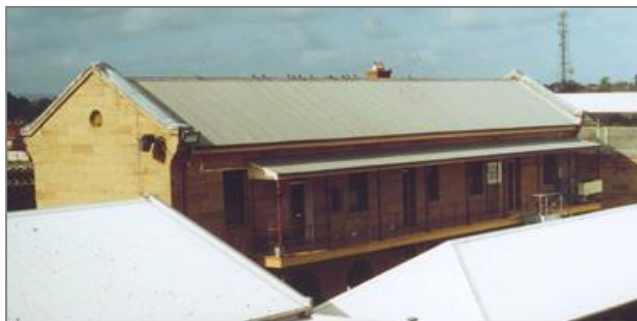
**EXTERIOR**

<b>Uses:</b>		<b>Significance Rating: High</b>					
<ul style="list-style-type: none"> <li>• Interpretation</li> <li>• Mobile retail</li> </ul>							
<b>Comment:</b>		<b>Condition:</b>					
<p>Note: this information has been taken from the previous report as internal access was not possible.</p> <p>Balcony has been shortened and stair relocated.</p> <p>Modern services installed in many areas.</p>		<p>The building was not assessed as it was not available for access.</p>					
<b>Conservation Strategy:</b>							
<p>Retain the building with original walls but consider opening up the whole of the first floor. Improve presentation of grilles and consider reconstructing original ceiling.</p> <p>Seek a compatible use for the former workshops which retains the significant configuration of rooms and original fabric providing evidence of early use of the building (i.e. forge). The modern interior walls and infill walls to the arched colonnade (ground level) may be removed.</p> <p>Consider reconstructing the missing length of the balcony and access stair to the upper level in original form and location. Original roofing and cast iron columns (and flooring pending further investigation) should be retained. Replace missing column brackets, and timber flooring to the balcony.</p> <p>Remove air-conditioning ducts from upper level and condenser unit on balcony.</p> <p>Replace modern ceilings on both levels with metal profile similar to original.</p> <p>Preserve the wall murals on the upper level.</p>

<b>Recommendations:</b>		
<b>Element</b>	<b>Significance</b>	<b>Recommendation</b>
<b>Floor</b>	Structure high, except for northern room upper level. Finishes - little	Retain existing structure. Vinyl and carpet floor finishes can be replaced if necessary. Removing finishes and exposing original timber floors is preferred. If interpretation is proposed for the upstairs room then removal of the higher floor at the northern end should occur. Retention and exposure of concrete floors at ground level is preferred.
<b>Skirting</b>	Moderate significance	Retain existing skirtings. Repainting is possible in existing colours.
<b>Walls</b>	High, except for the internal partitions at the northern end of the upper floor.	Retain existing. Repainting to be only undertaken for essential touch up (such as around doorway on upper level northern end) and essential maintenance. Internal walls at northern end can be removed if the upper level is to be open for interpretation. The artwork upstairs to be conserved in situ including conservation work required to all paintings to ensure their ongoing preservation. (Conservation advice should be obtained). The graffiti downstairs to be retained as is. If it is considered offensive then an interpretative panel for the room to be placed in front of it.

<b>Cornice</b>	Little, except for the cornice to the two central rooms downstairs which are of moderate significance.	Replace cornice with original details. Retain existing cornice in the two central rooms downstairs.
<b>Ceiling</b>	Little, except for the two central rooms on the lower level which are high.	Replace ceilings with original details, except for the existing ceilings in the two central rooms downstairs, which should be retained.
<b>Window</b>	High	Retain. Repainting in existing or original colours for essential maintenance purposes only.
<b>Door/Gates</b>	External doors high, except the two infill panels behind the grille doors on the ground floor northern end which are of little significance. Internal doors - little.	External doors to be retained. Repaint as required in existing or original colours for essential maintenance. Grilled doors on the ground floor: if a door is required clear glaze the back of the grilles, and if a door is not required clear glaze the whole opening in frameless glass. Internal doors can be removed if the upper area is to be opened up for interpretation.

<b>Lighting</b>	Little	Replace the lighting with original details or unobtrusive lighting.
<b>Reveals</b>	High	Retain. Repainting in existing or original colours for essential maintenance purposes only.

<b>Mechanical duct work</b>	Intrusive	Remove the ductwork
<b>Plumbing on ground floor</b>	Little	Retain if required for new uses otherwise remove.
<b>Hoist</b>	Little	Remove and reinstate the floor (refer also BCA issues: access below).
<b>External Stair</b>	Little	Retain or reconstruct original details.
<b>Balcony</b>	Moderate	Retain or reconstruct original length and details.

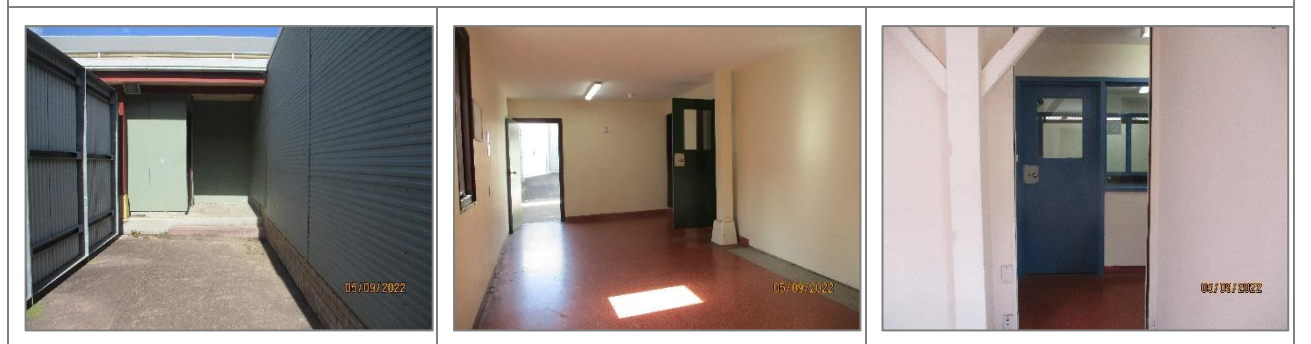
<b>Description:</b>
A handsome shed with chamfered, bracketed timber posts supporting Kingpost trusses. Corrugated zincalume has replaced the original corrugated iron as the hipped roof. To the west the shed is separated from the yard by two sandstone steps along the length of the shed.

<b>Comment:</b>	<b>Condition: Reasonable</b>
A demountable shed constructed under the original stone cutter's shelter shed which dates from the 1860's.

Element	Significance	Recommendation
<b>Whole Building</b>	High for the Stone Cutter's Shelter Shed. Little for the rest.	Retain the original structure, repainting in existing or original colours. Retain or alter as desired, including removal, but not in any way that affects the original stone cutter's shelter shed. No extensions to be permitted.

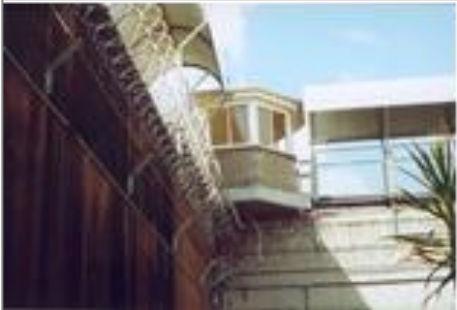
<b>Description:</b> <p>The perimeter wall of the first compound is rendered sandstone with semi-circular coping. Quadrant capped buttresses were placed on the exterior to keep the interior face of the wall flush and difficult to climb. Access to the three watch towers was from the exterior of the compound.</p>		
<b>Building Images:</b> (further photographs attached).		
<b>EXTERIOR</b>

<b>Significance:</b>		
<p>A very important component of the Gaol and the main visible element around and within the complex.</p>		
<b>Uses:</b> <ul style="list-style-type: none"> <li>• Gaol walls.</li> <li>• Guard Posts are unused.</li> </ul>	<b>Significance Rating:</b> <ul style="list-style-type: none"> <li>• Walls - High</li> <li>• Guard - Posts little</li> </ul>	
<b>Comment:</b>	<b>Condition: Reasonable</b>	
<p>Walls are part of the original gaol, the Guard Posts were initially open structures and were rebuilt in the 1991 upgrade.</p> <p>Access to Tower 1 is supported as per 2022 proposal.</p>

<b>Conservation Strategy:</b> <p>Retain walls and guard posts as is.</p> <p>Maintain the rendered finish of the walls of the central walled complex and the Ravensfield finish of the eastern extension.</p>

Element	Significance	Recommendation
Floor	Little	Retain Existing.
Walls	High for Gaol; little for guard posts.	Retain existing. Maintain exterior of guard posts by repainting as necessary.
Ceiling	Little	Retain existing.
Window	Little	Retain existing, repainting for maintenance purposes.
Door/Gates	Moderate	Retain existing.
Lighting	Little	Retain existing.
Stairs	Moderate	Retain timber stair including aluminium nosing.
Guard Post Fittings	Little	Retain existing.

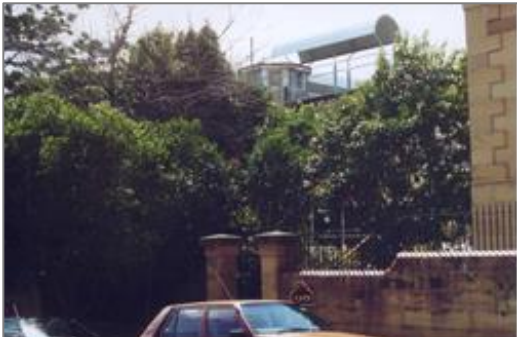
<b>Description:</b> A modern addition for the work centre and accessed externally.		
<b>Building Images:</b> (further photographs attached).		
<b>EXTERIOR</b>

<b>Comment:</b>	<b>Condition: Reasonable; café not inspected internally.</b>	
Part of the evolution of the gaol but conceals original gaol wall and has a detrimental effect on Asset 2.		
<b>Conservation Strategy:</b> Retain the building while it can be effectively used otherwise demolition should be considered. Remove link to Asset 2.

Element	Significance	Recommendation
<b>Upper Level</b>	Little	The building can altered internally as desired or demolished. Any external change to be minimised and only permitted if it has no greater impact on the setting of the original gaol than existing. The link to Asset 2 to be removed and the original stonewall around light well reinstated. This will require female toilets to be installed within the building.
<b>Lower Level</b>	Little	The squash court can be reused for video presentations or otherwise, however, access will need to be resolved. Internally, there are no areas of significance so changes as deemed necessary can occur.

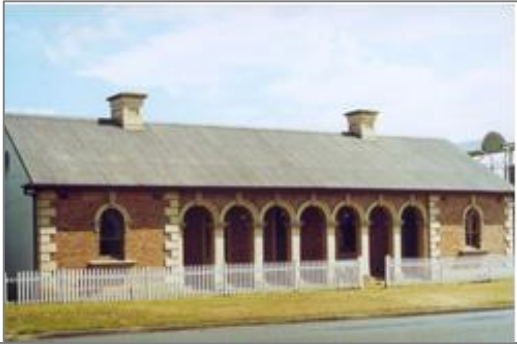
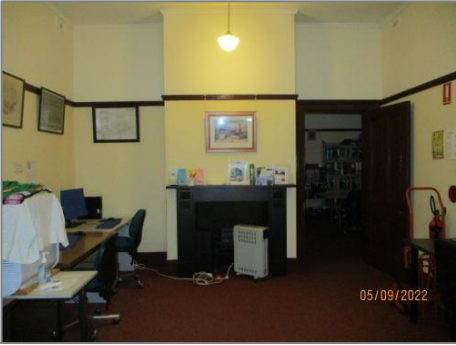
<p><b>Description:</b></p> <p>A single storey building with a central portico on each long elevation and a simple gable roof. Sandstone arcade columns support sandstone Roman arches with accentuated keystones. Sandstone is also used for quoins and the arched heads to the pavilion windows. A timber picket fence separates the building from Lindsay Street.</p>		
<p><b>Building Images:</b> (further photographs attached).</p>		
<p><b>EXTERIOR</b></p>

<b>Comment:</b>					<b>Condition: Reasonable</b>		
Largely unmodified except timber shingles and some ceilings replaced.							
<b>Conservation Strategy:</b>							
<p>The building should not be altered. There is a good opportunity to enhance the significance by reconstructing original ceilings and painting in the original colour scheme. Modern elements should not be permitted to be permanently installed.</p> <p>A compatible new use for the former Mounted Police Barracks should be sought and it should be conserved as a significant element of the Barracks group.</p> <p>The Barracks building should be restored, and introduction of modern elements restricted.</p>							
<b>Significance of Elements:</b>							
Asset No	Name of Building	Architectural Form	Internal Configuration	Original Fabric	Element	Level of Significance	Tolerance
026	Training (former Mounted Police Barracks)	B	B	B	Original	B	L
<b>Recommendations:</b>

Element	Significance	Recommendation					
Floor	High, except the coverings are of little significance.	Retain the original flooring system. Carpet can be replaced. Exposure of timber floorboards preferred.					
Skirting	High	Retain. Repaint in original or existing colours.					
Walls	High	Maintain the render. Repaint in original or existing colours.					
Picture Rail	Moderate significance.	Investigate the authenticity of the picture rail, because it is not original, and if no picture rail existed originally, remove it. Otherwise retain existing picture rail.					
Cornice	West and southeast rooms high, the other rooms little.	Retain original cornices. Repaint in original or existing colours. Other existing cornices can be retained but is preferable to reinstate original cornices with original colours.					
Ceiling	West and southeast rooms high, the other rooms little.	Retain original ceilings. Repaint in original or existing colours. Other existing ceilings can be retained but is preferable to reinstate original ceilings with original colours.

<b>Fireplaces</b>	High	Retain all.
<b>Curtains</b>	Intrusive	Remove and replace with window coverings, which are more appropriate.
<b>Cupboard</b>	Moderate	Retain and paint in original colours.

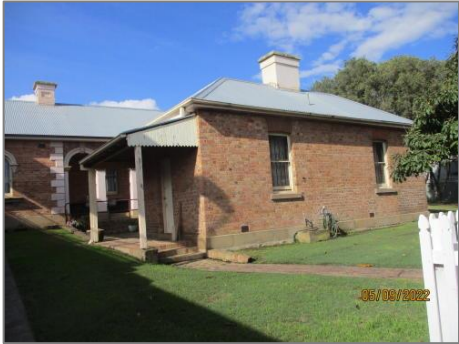
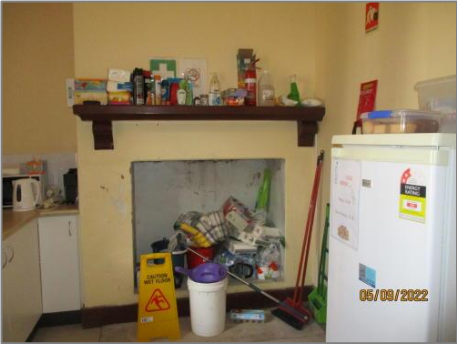
<p><b>Description:</b> Single storey small building with a verandah at the sole door. A central chimney suggests that there were originally two rooms. Ravensfield sandstone has been used for the plinth/footing.</p>		
<p><b>Building Images:</b> (further photographs attached).</p>		
<p><b>EXTERIOR</b></p>

<p><b>Uses:</b></p> <ul style="list-style-type: none"> <li>• Undefined</li> </ul>	<p><b>Significance Rating: High</b></p>	
<p><b>Comment:</b> Once located in a walled enclosure with the toilets.</p>	<p><b>Condition: Reasonable</b></p>

Element	Significance	Recommendation
<b>Floor</b>	High, except for toilet which is of little significance Floor coverings are of little significance.	Retain original timber floors, although restumping of the western half is required. Removal of floor finishes back to original timber floor finishes preferred. New floor finishes can be applied if desired.
<b>Skirting</b>	High, except for the toilet.	Retain original and if toilet is removed, reinstate original skirting. Repaint in original colours preferred, although existing is acceptable.
<b>Walls</b>	High, except for the wall to the toilet which is of little significance.	Preferable to remove the toilet wall, but this can remain if toilet remains. Retain other walls. Repaint in original or existing colours.
<b>Cornice</b>	West end room moderate significance. East end room of high significance.	Retain original cornice, repaint in original colours preferred or existing colours acceptable. The cornice in the west room to be replaced with original cornice on the perimeter walls and painted original colours.

<b>Ceiling</b>	High	Retain. Repaint in original or existing colours.
<b>Window</b>	High	Retain. Repaint in original or existing colours.
<b>Door/Gates</b>	High, except door to toilet which is of little significance.	Retain existing. Repaint in original or existing colours. The toilet doors can be repainted any colour.
<b>Lighting</b>	Intrusive	Replace with something more appropriate.
<b>Fireplaces</b>	High	Fireplace to the east end to be retained.
<b>Bathroom Fittings</b>	Little	Removal preferred. Can be retained if toilet required.
<b>Kitchen Bench incl. Splashback</b>	Intrusive	Remove.

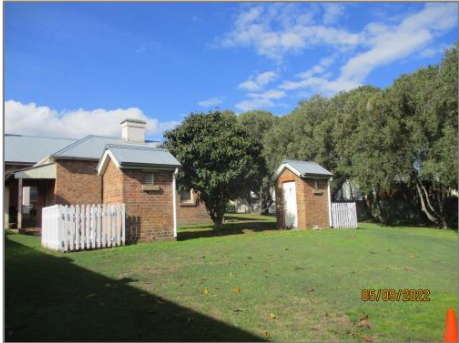
<b>Description:</b> Small simple brick structures.		
<b>Building Images:</b> (further photographs attached).		
<b>EXTERIOR</b>

<b>Significance:</b>		
Utilitarian structures illustrative of the time.		
<b>Uses:</b> <ul style="list-style-type: none"> <li>No proposed use.</li> </ul>	<b>Significance Rating: Moderate</b>	
<b>Comment:</b> Original wall removed but toilets are intact.	<b>Condition: Reasonable</b>	
<b>Conservation Strategy:</b> Conserve the building as is as part of the Barracks Group.

Recommendations:		
Element	Significance	Recommendation
Whole Building	Moderate	Conserve the building exactly as it currently exists.

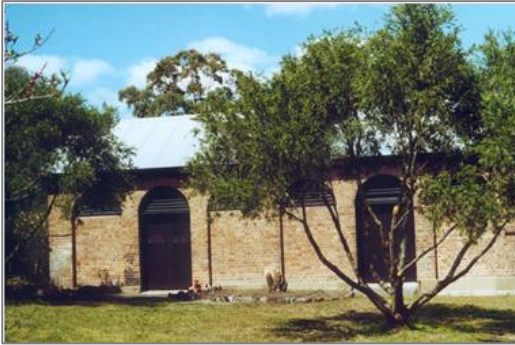
<p><b>Description:</b></p> <p>A single storey face brick shed. Of the five arched openings to the original stable four have been bricked in up to the arches which have been louvred. Two circular louvred openings vent the interior under the ridge. On the Lindsay St elevation there is evidence of either a large opening having been blocked in or of an arched structure having been removed.</p>		
<p><b>Building Images:</b> (further photographs attached).</p>		
<p><b>EXTERIOR</b></p>

<p><b>Uses:</b></p> <ul style="list-style-type: none"> <li>• Interpretation</li> </ul>	<p><b>Significance Rating: High</b></p>	
<p><b>Comment/Condition:</b></p> <p>Most original arches are bricked up.</p>

Element	Significance	Recommendation
<b>Floor</b>	Moderate, except for the toilet which is of little significance.	Retain existing concrete, although some investigation as to the existence of cobblestones below the concrete would be desirable. If cobblestones are found then the situation should be reassessed and if feasible the cobblestones exposed. Remove toilet floor.
<b>Walls</b>	High, except for centre divide and toilet walls which are intrusive.	Retain existing perimeter walls and wall between annex and stables. Repainting possible in any colour. Centre and toilet walls can be removed if desired.
<b>Ceiling</b>	High	Retain original shingle battens.
<b>Window</b>	High	Retain existing louvres and openings in party wall. Repaint in original colours where necessary.
<b>Door/Gates</b>	Moderate	Retain existing doors (the northwest door is older than the other two, but does not appear original) Repaint in original or existing colours.

<b>Lighting</b>	Intrusive	Replace with something more sympathetic.
<b>Chain Wire Enclosure</b>	Little	Remove or retain.

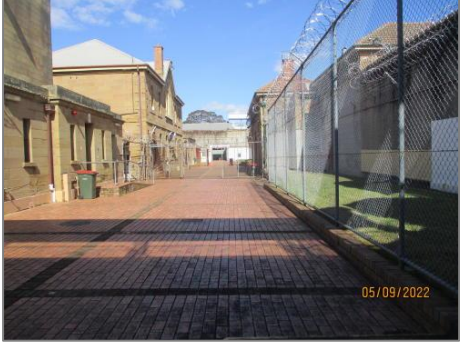
<p><b>Description:</b></p> <p>This covers the external spaces within the Gaol and includes details related to access for people with disabilities as well as heritage conservation issues.</p>		
<p><b>Building Images:</b> (further photographs attached).</p>		
<p><b>EXTERIOR</b></p>

<p><b>Significance:</b></p>		
<p>Many details have changed and generally pavements have little significance; fences and gates are of moderate significance; and there are some intrusive elements.</p>		
<p><b>Uses:</b></p>	<p><b>Significance: varies</b></p>	
<p><b>Comment:</b></p>	<p><b>Condition: Quite good</b></p>	
<p>A collection of items and details that have evolved with time.</p>		
<p><b>Conservation Strategy:</b></p> <p>Conserve where possible.</p>		
<p><b>Significance of Elements:</b></p> <p>Refer comments in recommendations below.</p>

Issue	Recommendation
1. Inside the main gate there is a gate stop in the centre which protrudes above the surface about 50mm with masking tape highlighted around it.	Paint the gate stop in contrasting colour (yellow).

2. A heavy steel grate inside the main gate has 25mm gaps and 200mm long.	Add solid (checker plate) cover over main access route at least 2m wide.
3. Pavement beyond the Entry consists of bitumen, exposed aggregate with brick bands or brickwork with gatic covers over service trenches and pits set flush with the surface. Gradings are generally fairly flat except where otherwise noted. Access to the buildings is usually through steps and ramps, which are commented on with the particular buildings.	No action

4. There are some step-ups in areas where former Sentry Boxes were located and these are not highlighted as potential hazards.	Paint perimeter edge (50mm) in contrasting colour (yellow).

5. The south access into the Exercise Yard of Asset 12 has a 50mm step down into the brick pavement, a worn threshold and an access gate 610mm wide and another step down internally of 20 mm. The gate is normally open.	Widening the gate is not supported particularly as the area can be appreciated from outside it. The step needs identification at edge (50mm) in contrasting colour (yellow).

9. The shelter on Asset 12 is rated as being of high significance. It has steel posts and roof battens are in poor condition in areas and roof sheeting is lifting.	The shelter on Asset 12 should have the timber posts reconstructed to original details. Roof sheeting can be replaced with corrugated metal and battens replaced as necessary retaining all sound existing material and only replacing deteriorated material.

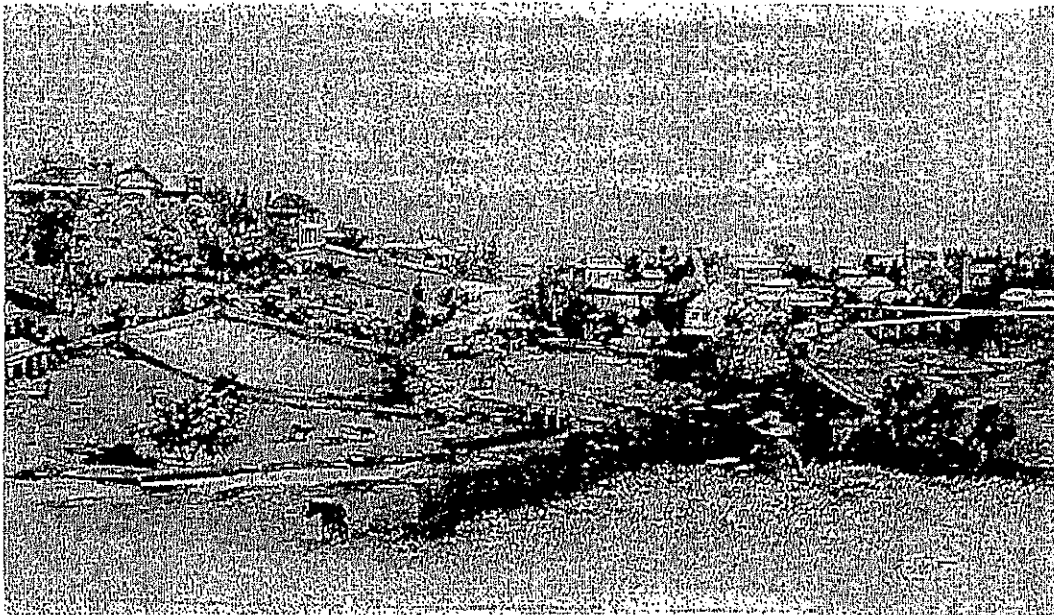
Figure 2-8 East Maitland, from the Picturesque Atlas of Australasia, 1888

Although the 1829 Plan of the Town of Maitland (fig 2-2) indicates the concept of the future town, an undated map, (fig 2-5) showing the planned boundaries, with farmhouses on some grants and a scatter of buildings at the junction of the Newcastle to West Maitland and Morpeth roads, is more indicative of the extent of settlement in 1829.<sup>5</sup> The development of the town is charted in the following photographs (Figs. 2-6 to 2-8).

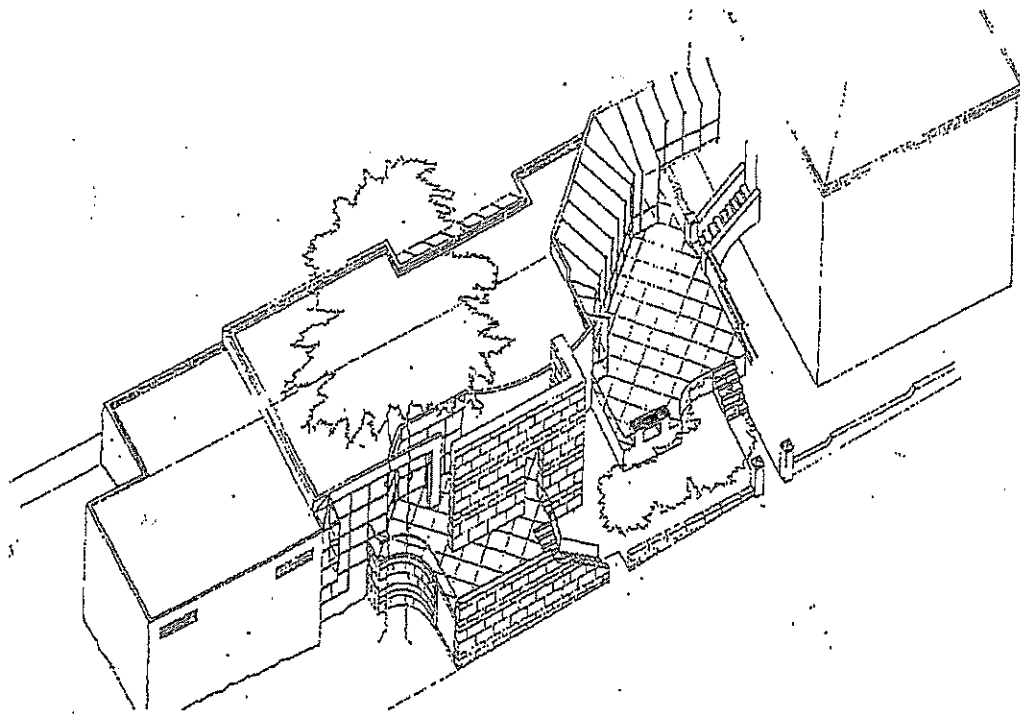
Fig. 2-17 Officers' Amenities Extension, Axonometric 7/3/80, (DPW&S Plan Room No. PC 321/192)
