BUSHFIRE ASSESSMENT REPORT

**PROPOSED 3 DWELLING DEVELOPMENT
AND 3 LOT SUBDIVISION**

**LOT 231 DP 1269483
32 Lilac Avenue, Lochinvar**

Date: **24/10/2023**

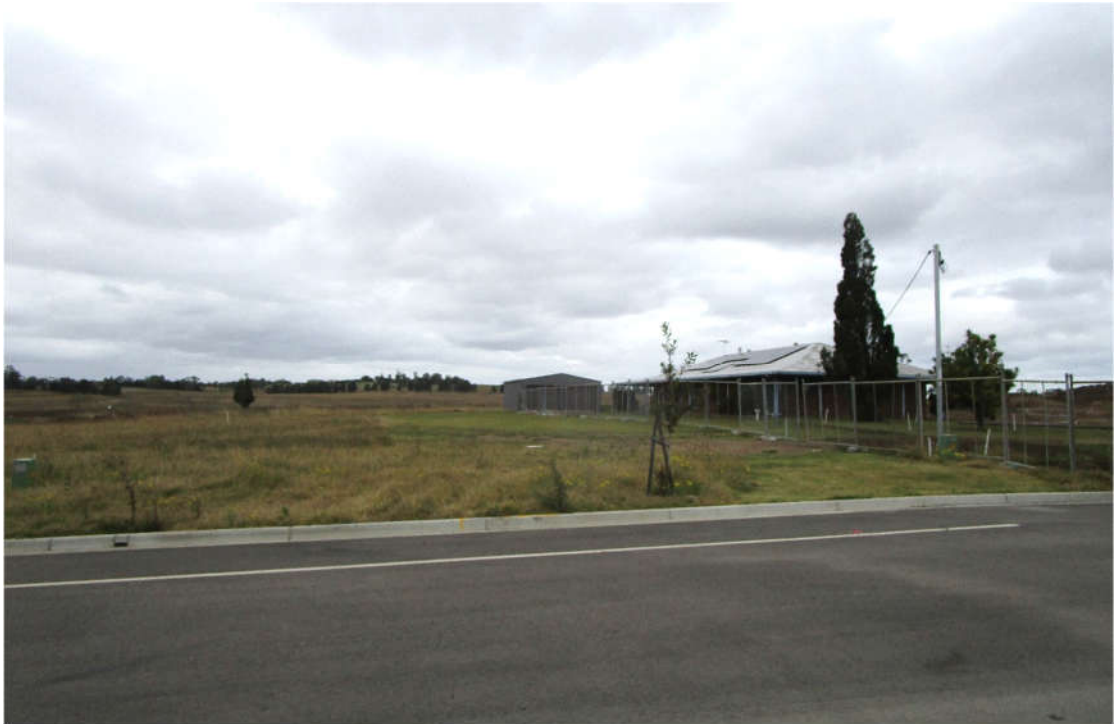
PHOTOGRAPH 1 – SOUTHERN NEIGHBOURING PROPERTY AND DWELLING

View of the southern neighbouring property and dwelling looking east from Lilac Avenue. The site is surrounded by cleared residential properties and future subdivision civil works.

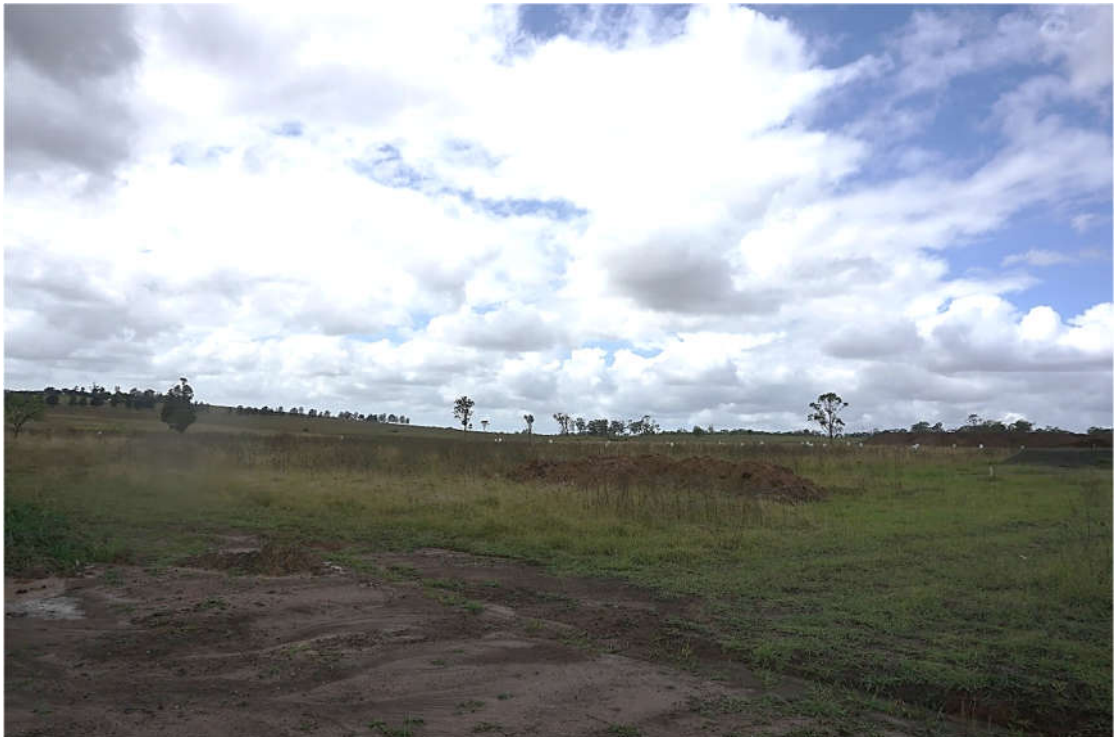
PHOTOGRAPH 2 – EASTERN GRASS AND SUBDIVISION WORKS

View of future subdivision stages and grass located east of the site. The grass shows signs of past slashing however was more than 10 centimetres in length at time of site visit. Lot markers extend through the grass a significant distance to the east.

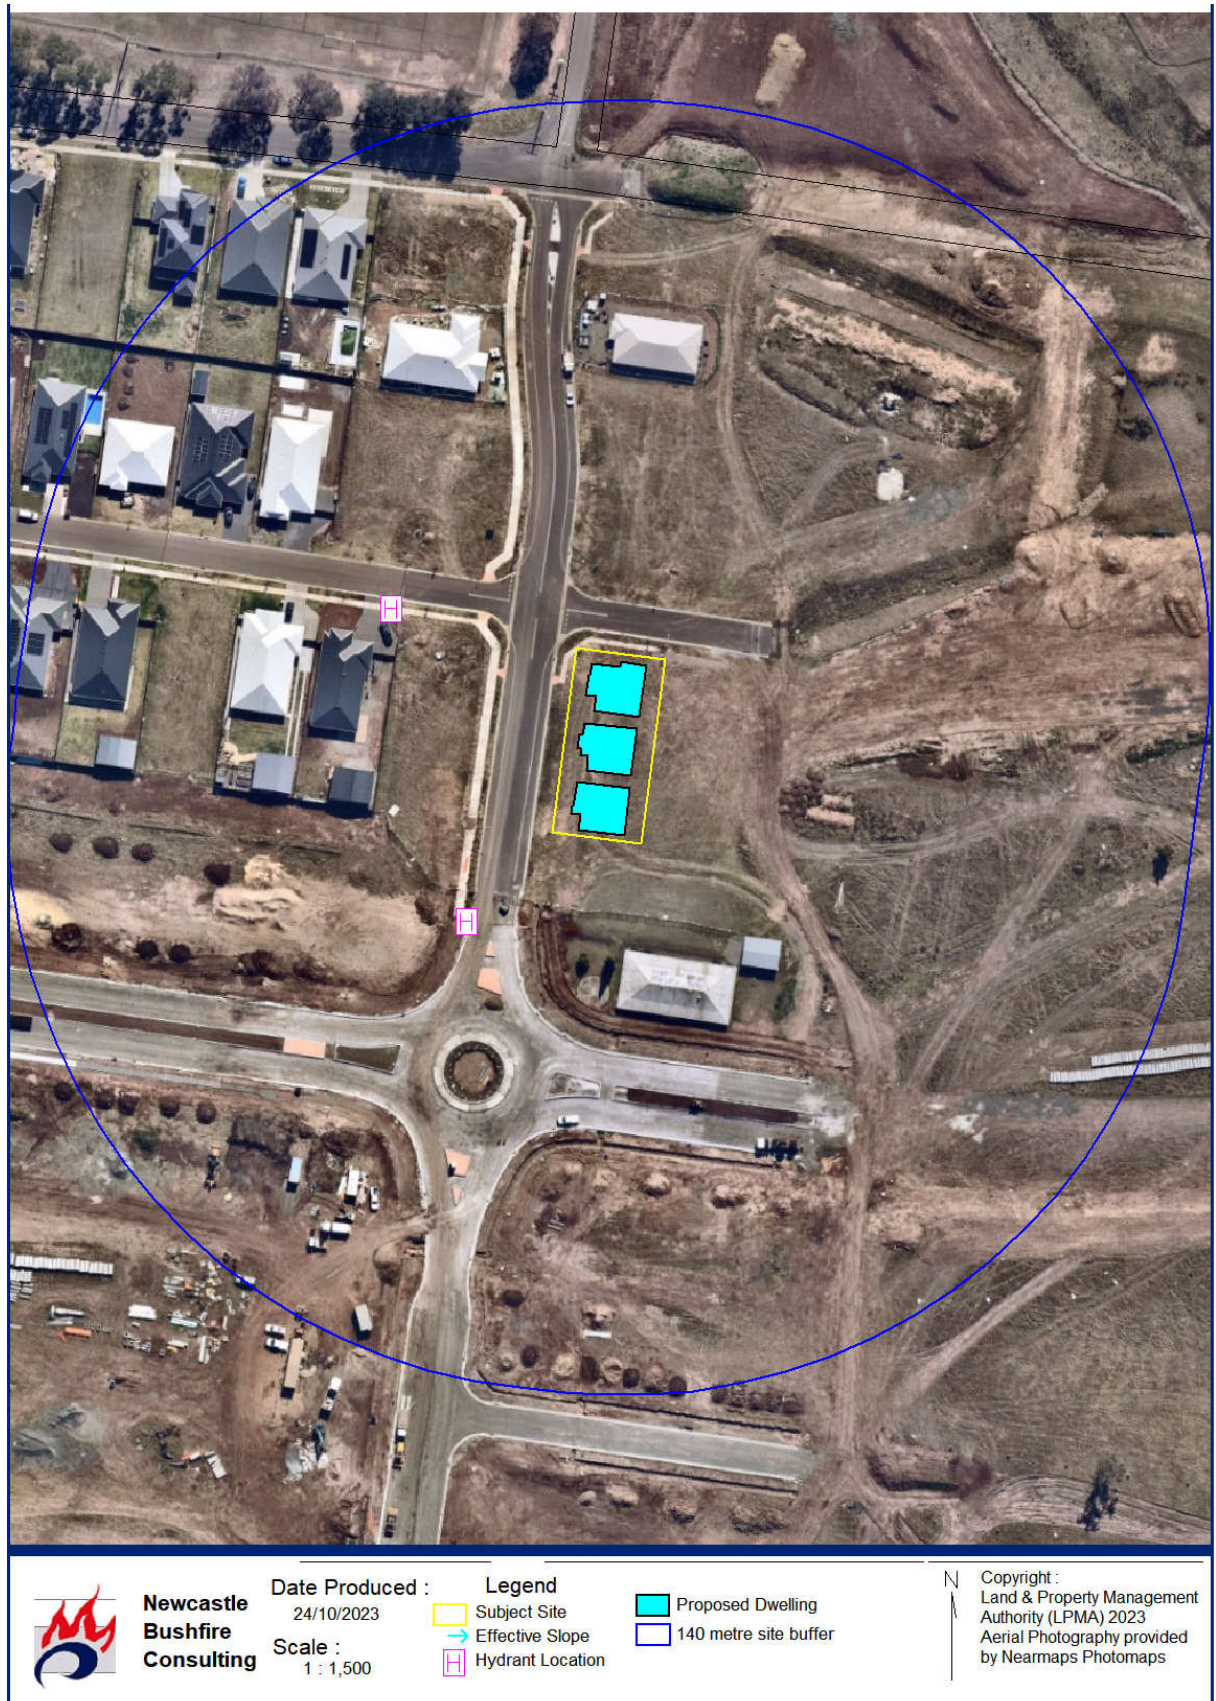
FIGURE 1 – SITE CONSTRAINTS MAP

Primary Vegetation Structures have been identified in Figure 1 – Site Constraints Map and separation distances shown in Table 2 – Bushfire Attack Assessment.

Effective slopes have been identified in Figure 1 – Site Constraints Map and slope ranges are shown in Table 2 – Bushfire Threat Assessment.

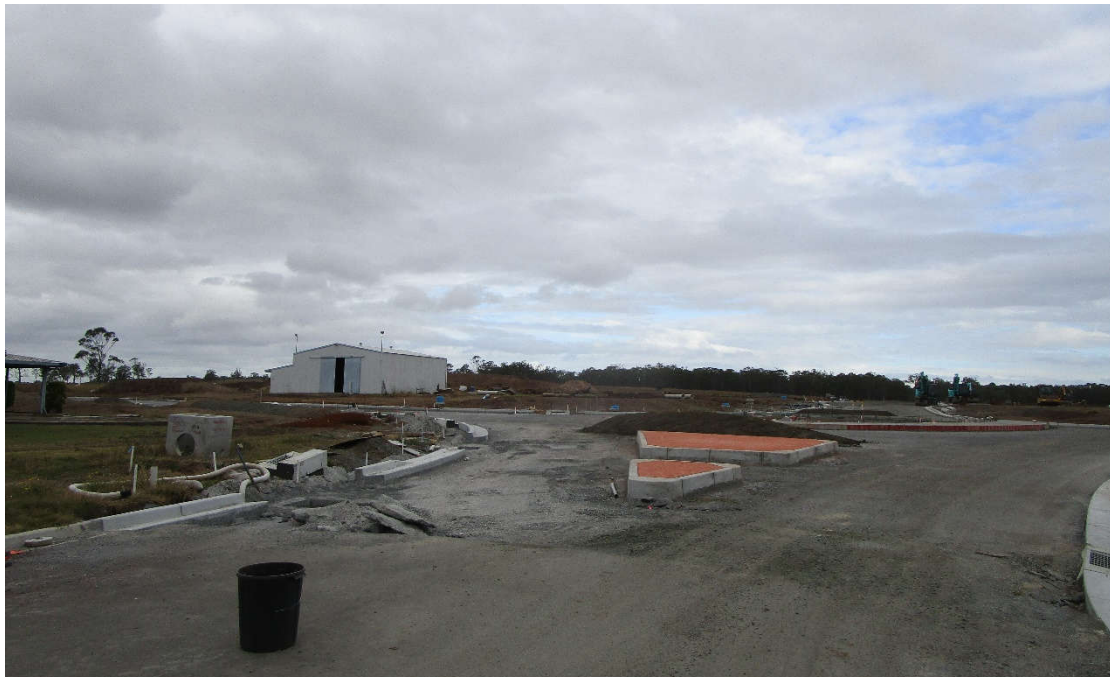
PHOTOGRAPH 3 – SOUTHERN CIVIL WORKS

View of subdivision civil works located south of the site. The land has been cleared to exposed mineral earth.

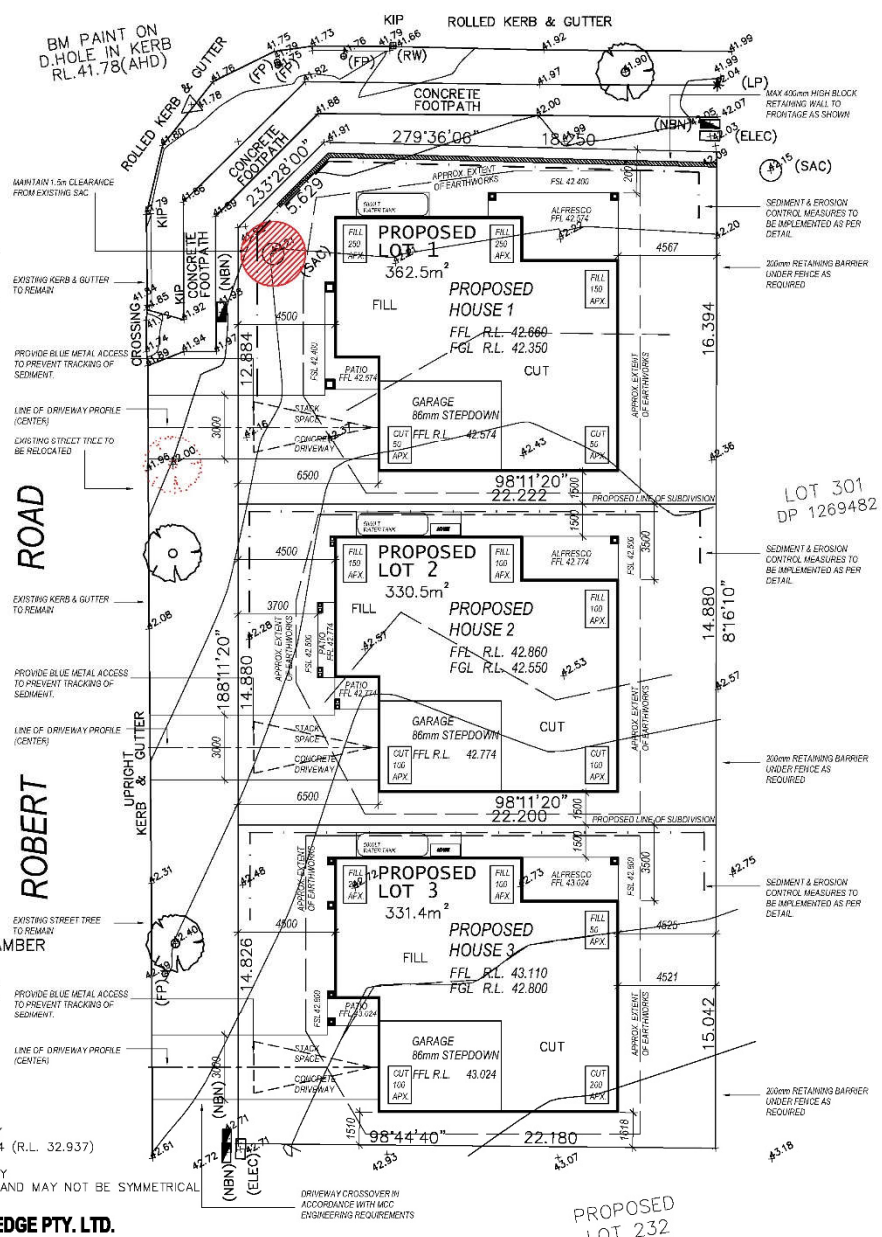
FIGURE 4 – SUBDIVISION PLAN

The land is zoned R1: General Residential and is comprised of a single allotment 1024.4 square metres in size. The proposed development includes a 3 lot subdivision and 3 freestanding dwellings.
