Contamination and Preliminary Waste Classification Assessment

Max McMahon Oval,
Rutherford NSW

NEW22P-0130-AA
12 August 2022

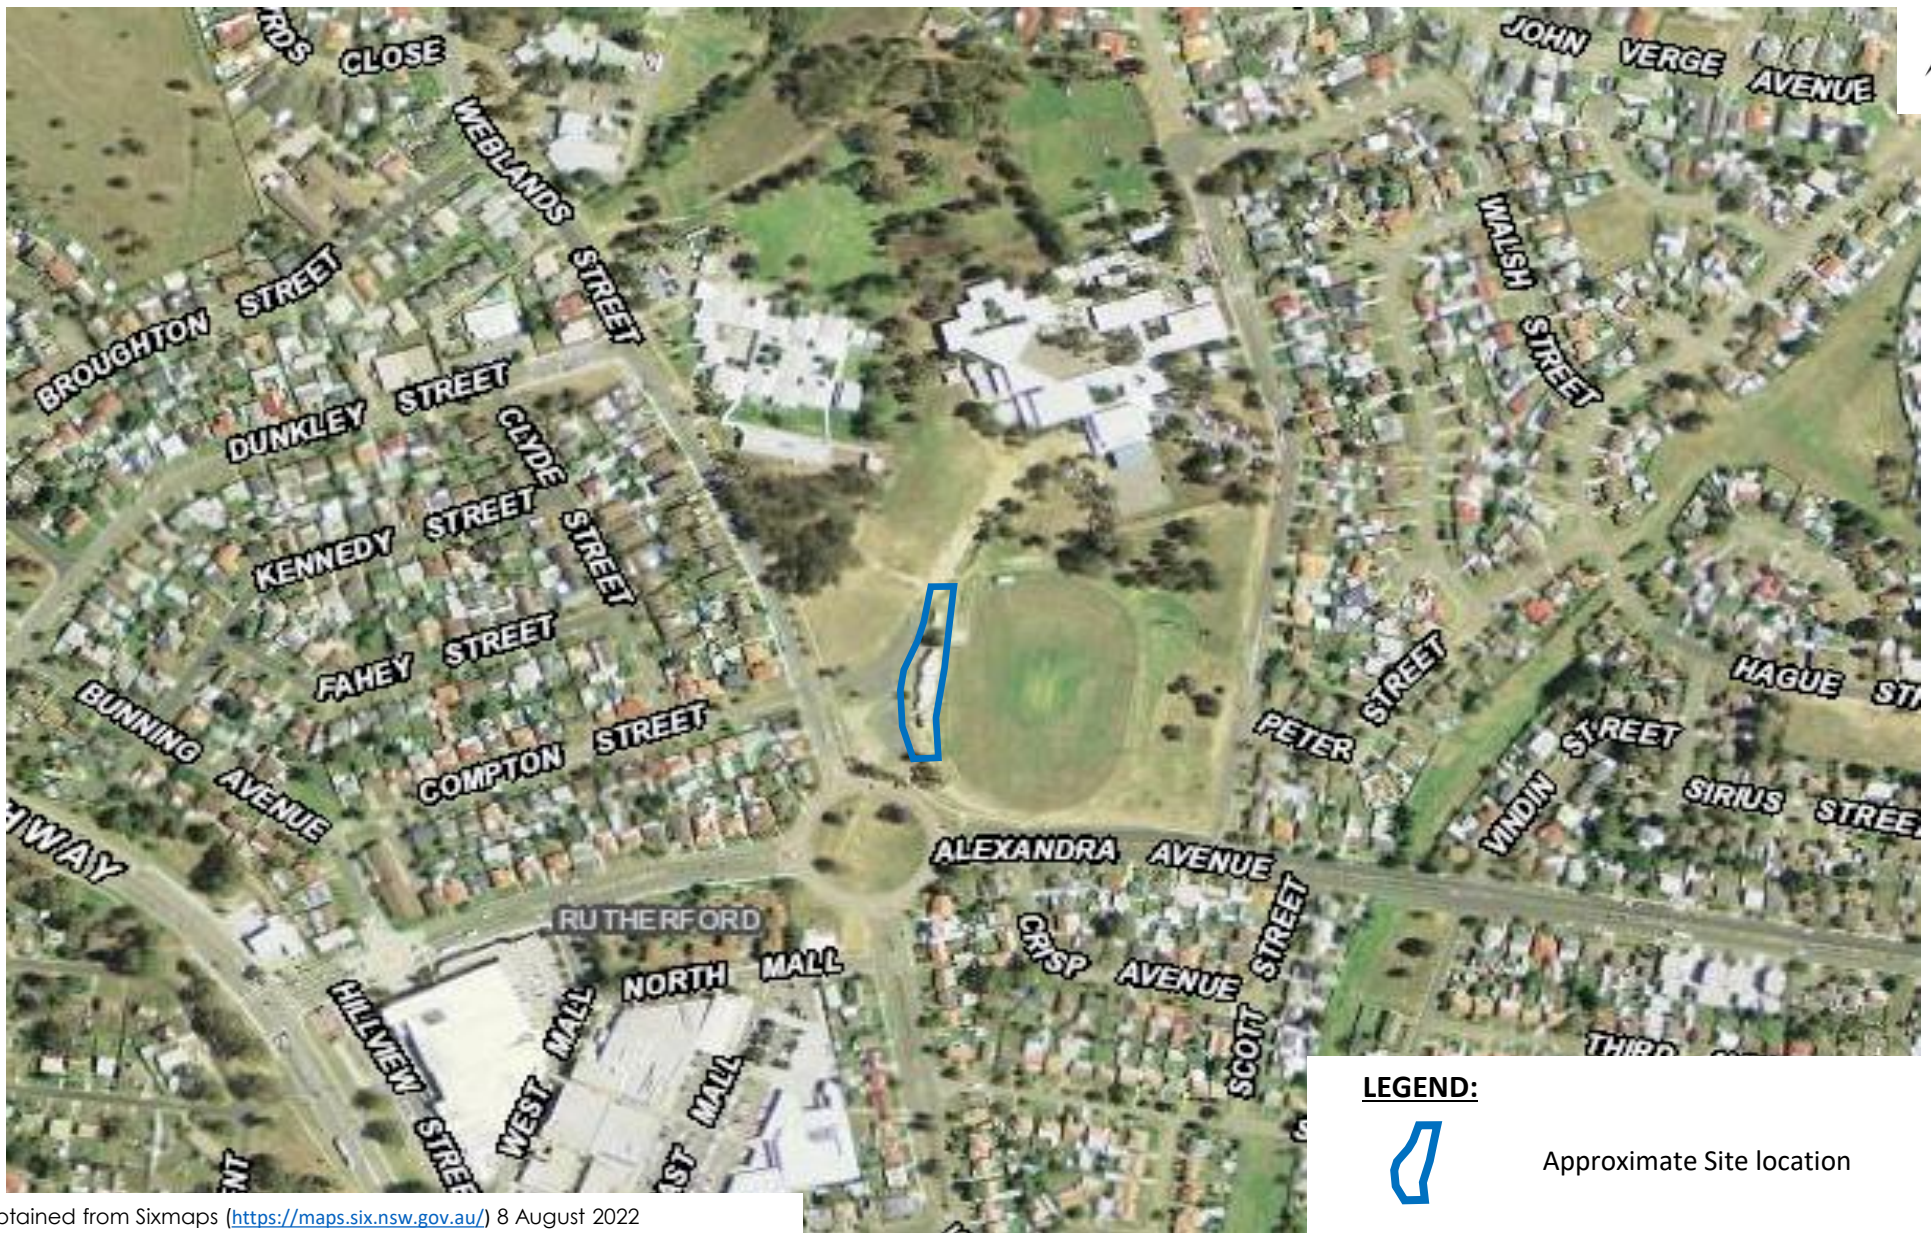
Client:	EJE ARCHITECTURE PTY LTD	Drawing No:	FIGURE 1
Project:	PROPOSED AMENITIES UPGRADE	Project No:	NEW22P-0130-AA
Location:	MAX MCMAHON OVAL, RUTHERFORD	Scale:	N.T.S
Title:	SITE LOCATION	Date:	8/08/2022

Image obtained from Sixmaps (<https://maps.six.nsw.gov.au/>) 8 August 2022

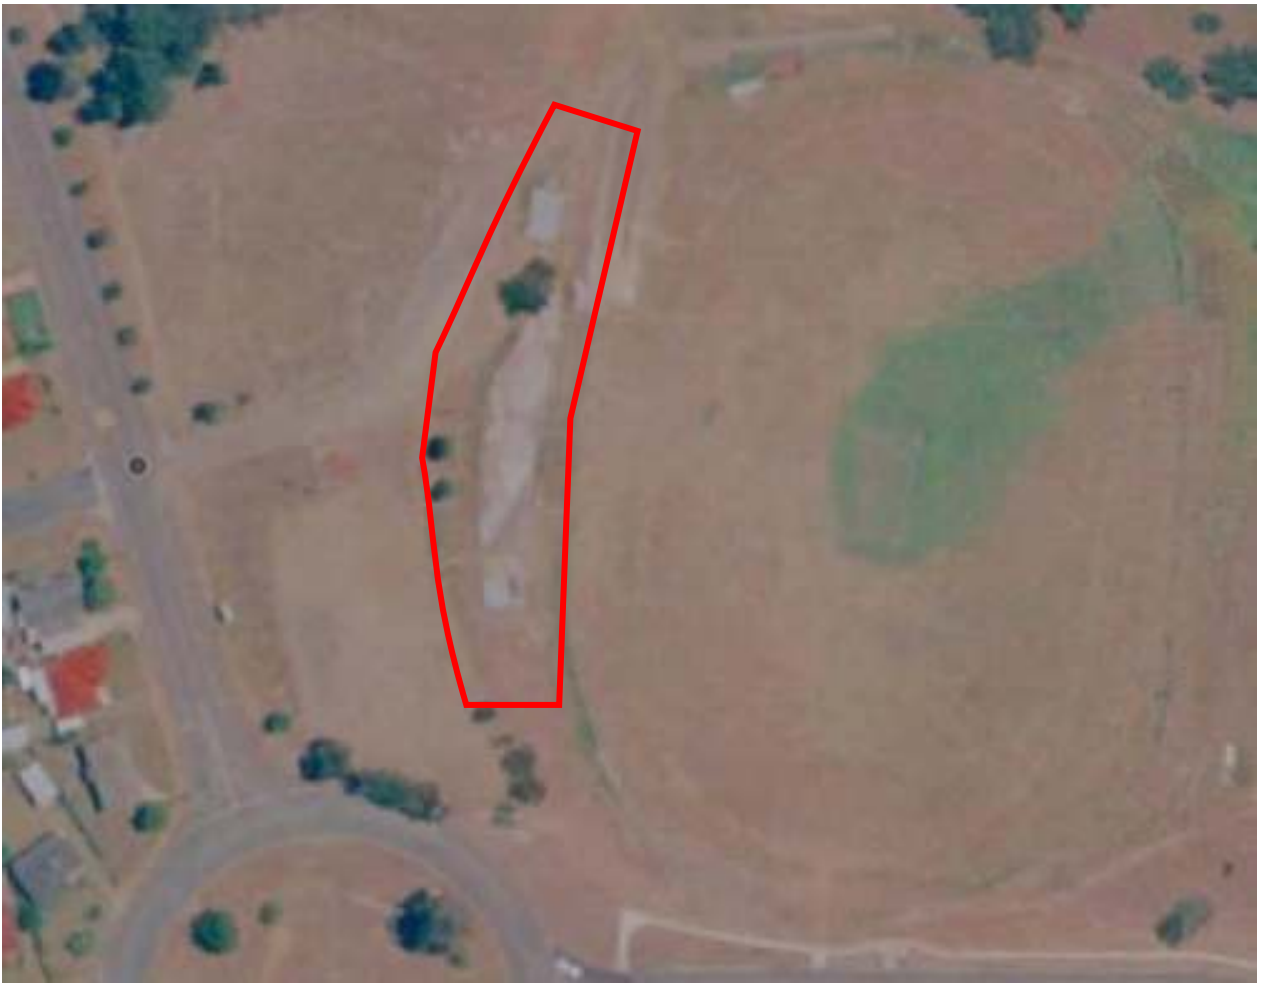
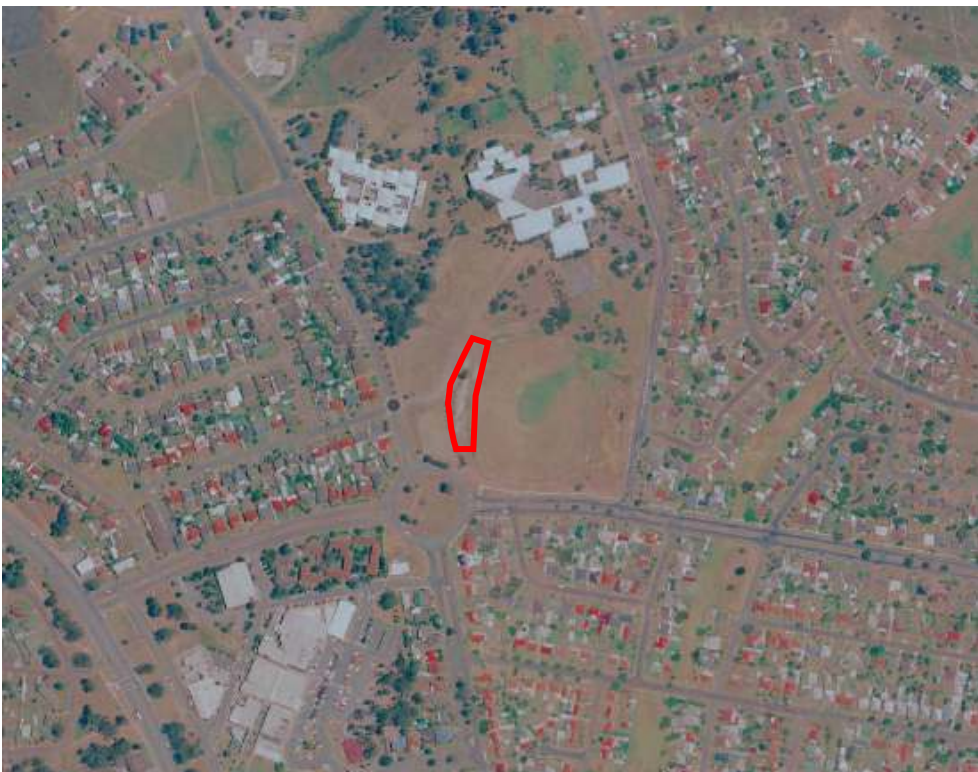
2001	The site is similar to the previous photograph.	The surrounding area appears similar to the previous aerial photograph.
2010	The site is similar to the previous photograph.	The surrounding area appears similar to the previous aerial photograph.
2022	The structure located in the northern portion has had a change of roof colour, possibly rust affected.	A large building, possibly a school has been developed to the north-west. The remaining surrounding area appears similar to the previous aerial photograph.
