EFFLUENT MANAGEMENT PLAN

FARLEY LIFESTYLE RESORT

WASTEWATER TREATMENT SYSTEM (WWTS)

EFFLUENT MANAGEMENT PLAN (EMP)

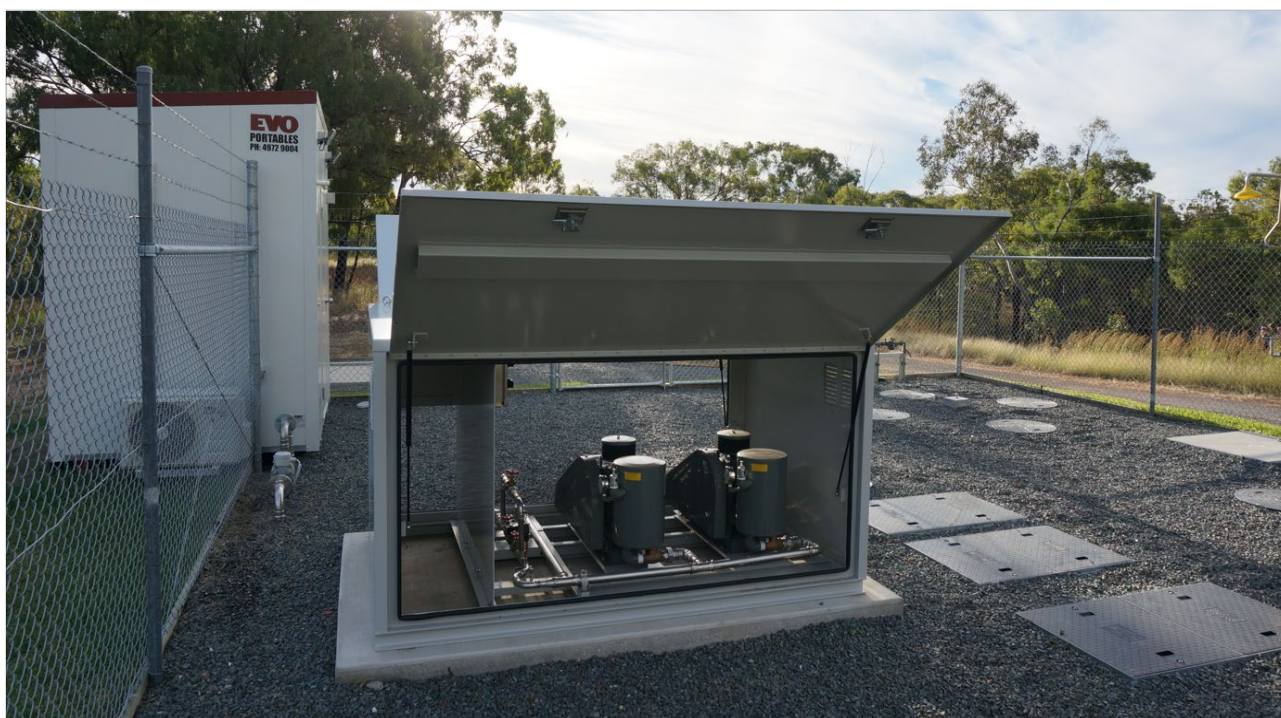
Figure 9.4 – 40kL Kubota WWTP for Water Utility - Plant room, electrical box, and monitoring unit (foreground) site office (background)

Operational monitoring refers to the day-to-day function of the WWTS and includes the monitoring of mechanical function. A telemetry system is integrated into the wastewater system to monitor the function of the WWTS and provide real time notification of events which allows immediate response. Real time monitoring includes; daily flow, operational levels, power supply and pump operation, with all parameters automatically logged and actioned by the True Water Customer Resource Management (CRM) system.

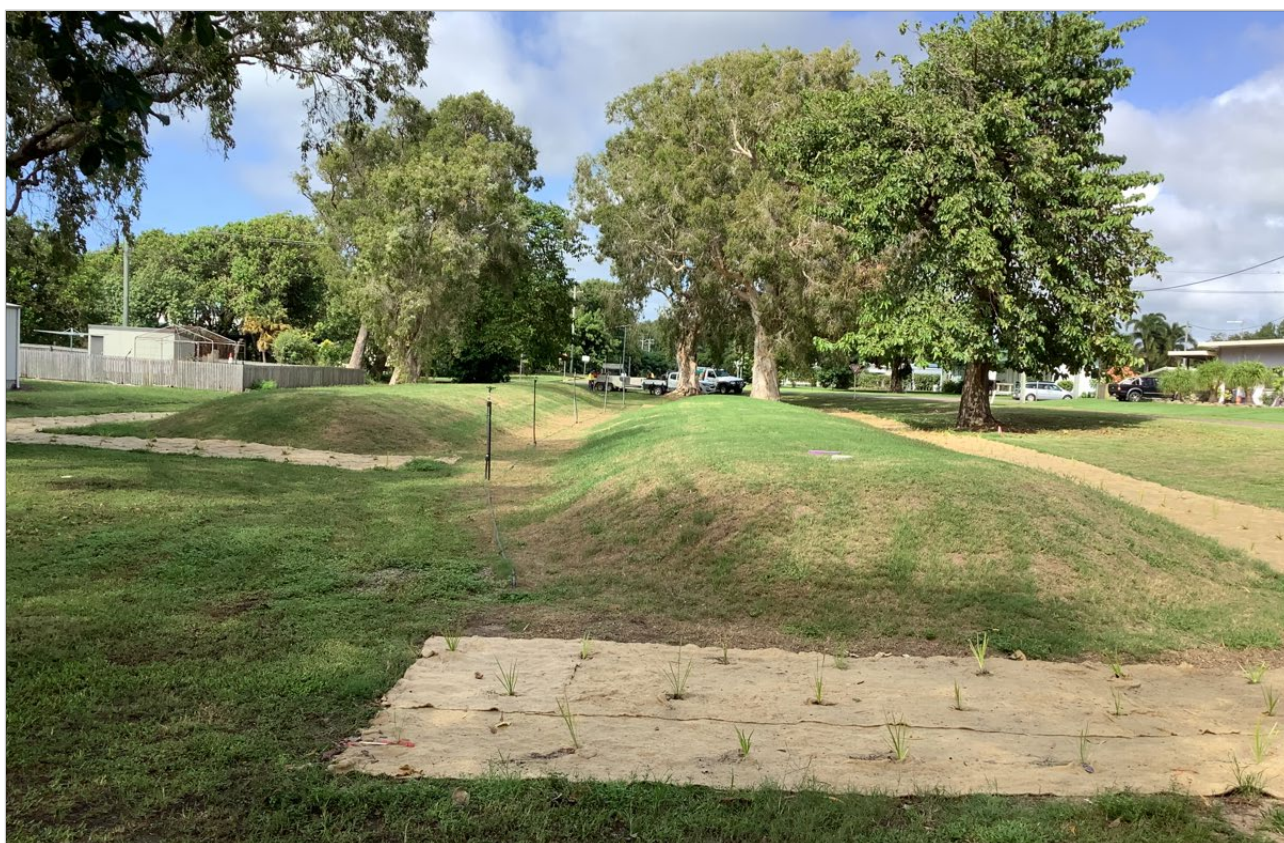
Figure 10.3 – Two newly commissioned Engineered Mounds at a Council owned Caravan Park

A vegetative screen shall be established around each mound to aid in the evapotranspiration of moisture and to maximise nutrient uptake and prevent nutrient migration. The screen will be 1-2 metres wide and will be located around the Engineered Mounds. Species will be selected considering moisture and nutrient uptake capacity, deep root penetration and root density. The vegetative screen will consist of select native species such as Lomandra.

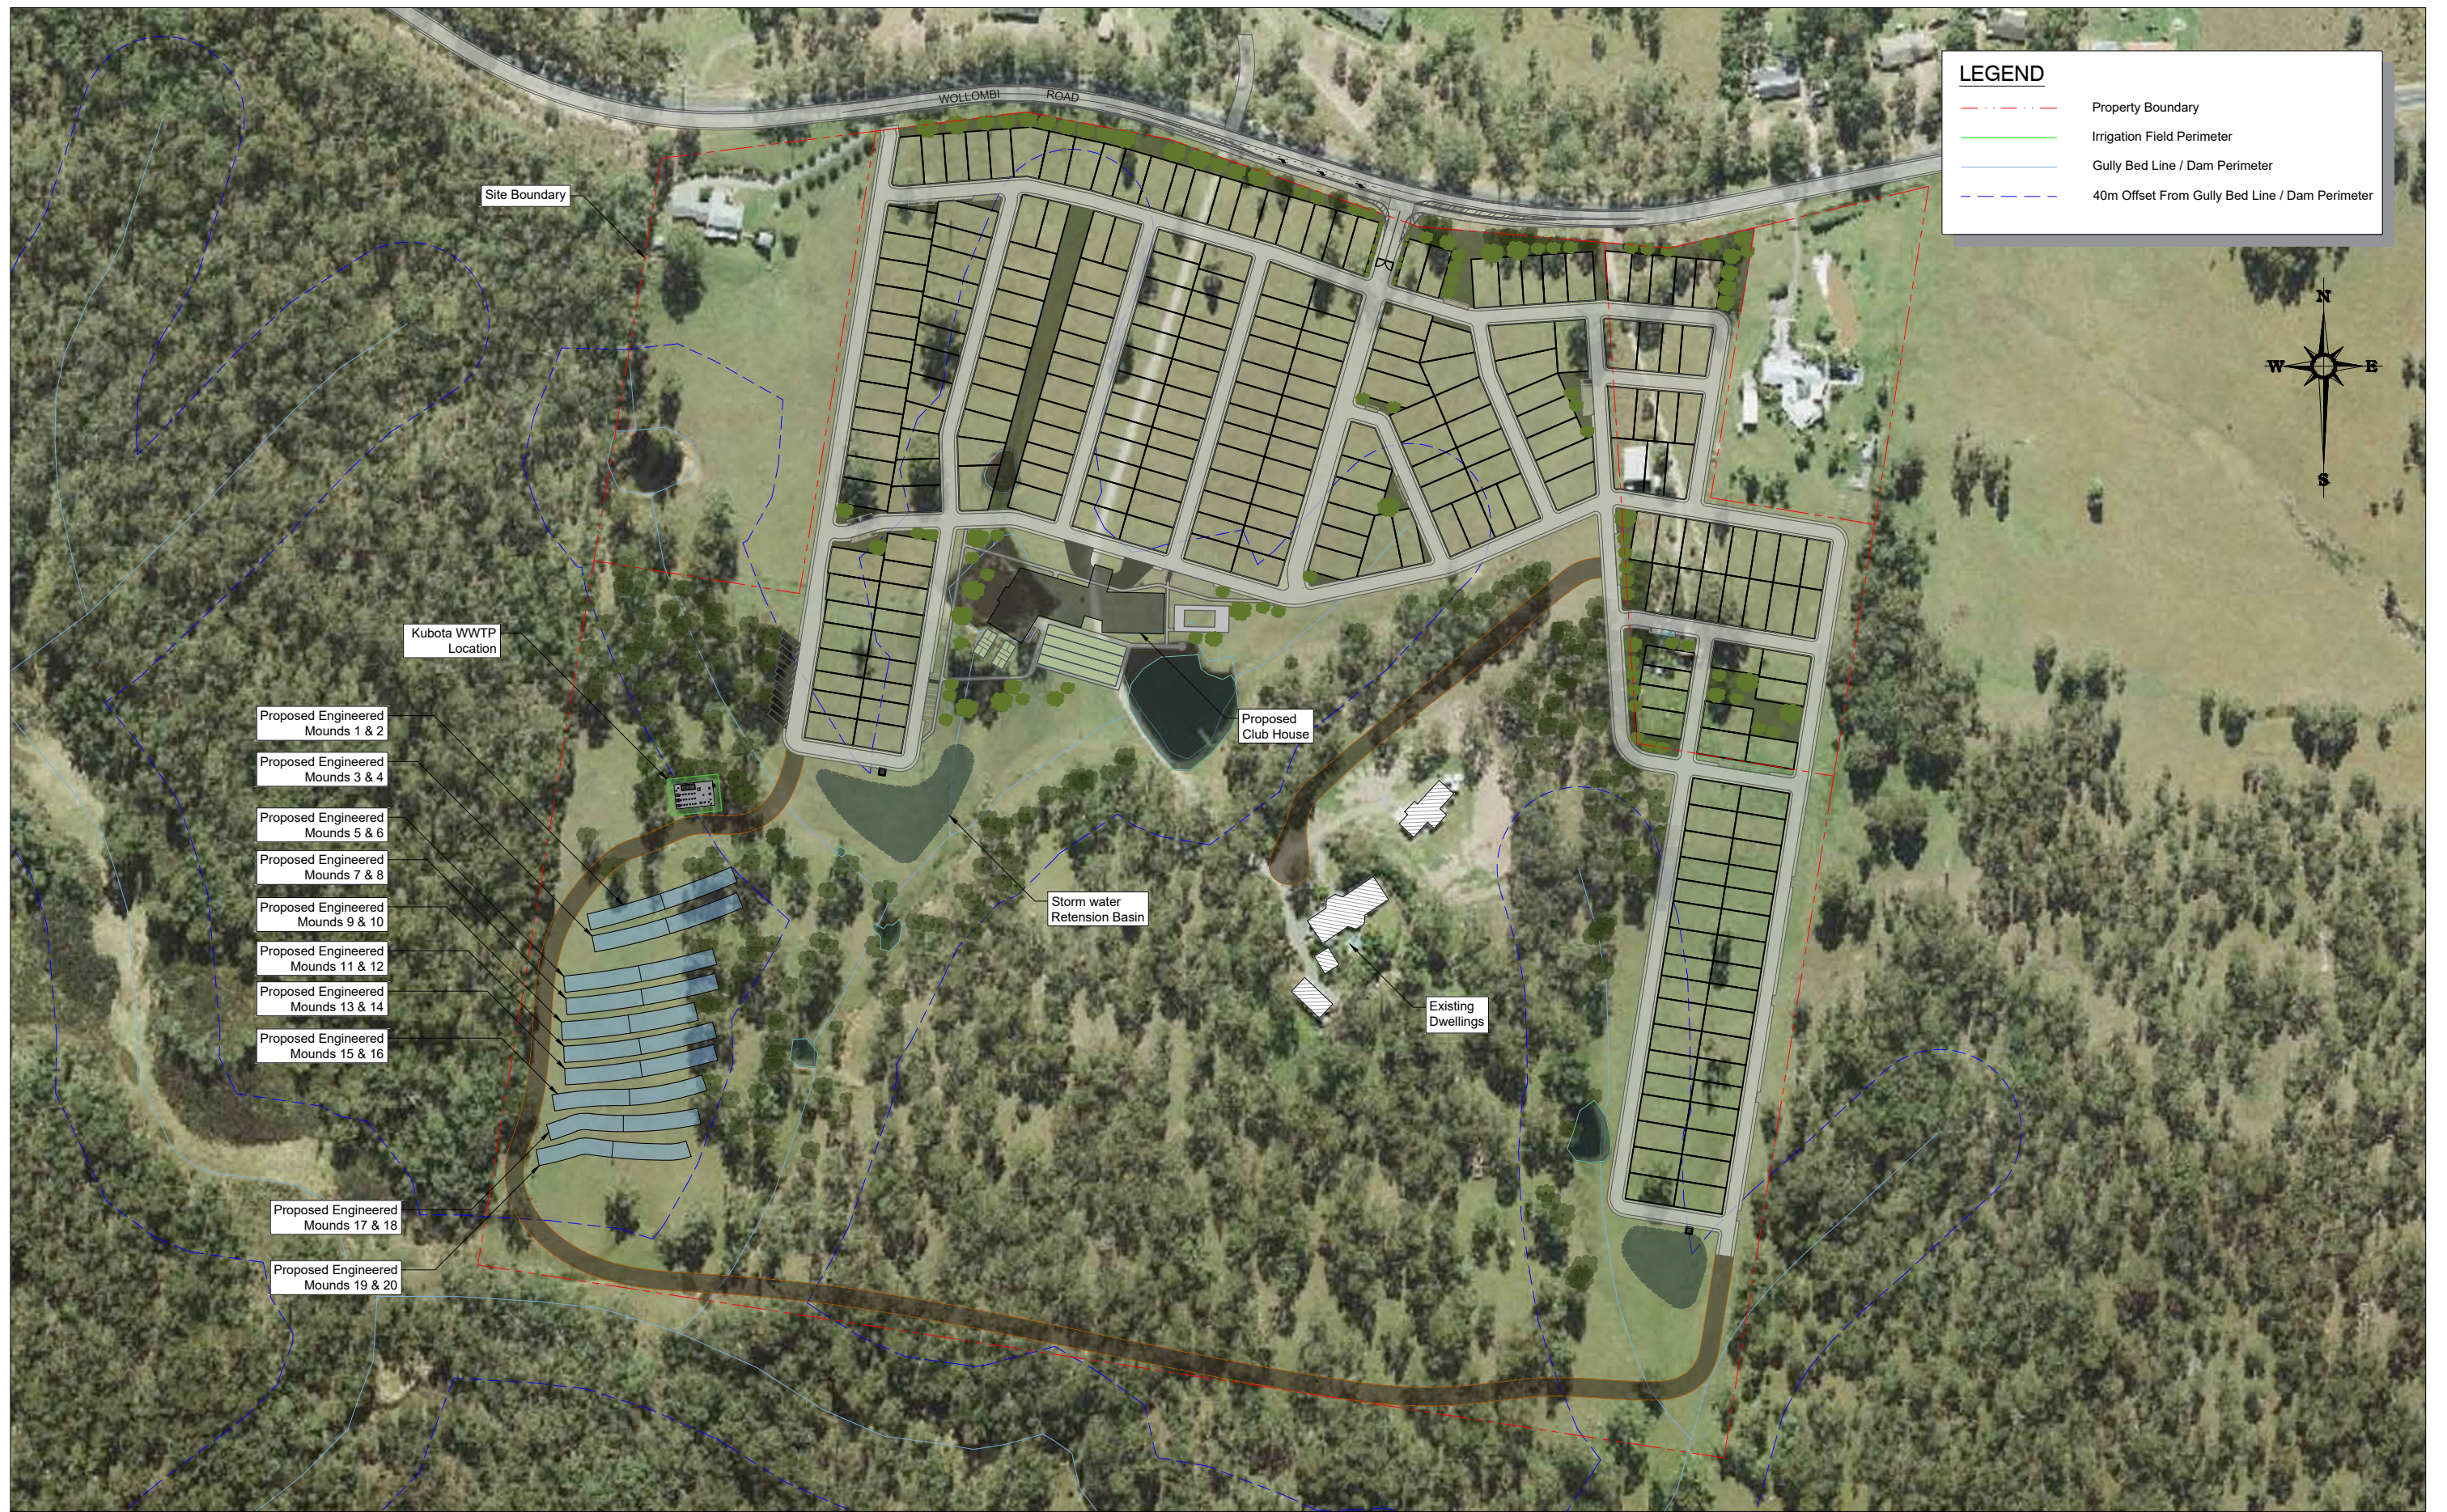
JOB STATUS	CONCEPT
DRAWING TITLE	SITE PLAN - INDICATIVE LAYOUT
DRAWING NO.	FLR-WWTP-H-0005
REV.	D

- Proposed Engineered Mounds 1 & 2
- Proposed Engineered Mounds 3 & 4
- Proposed Engineered Mounds 5 & 6
- Proposed Engineered Mounds 7 & 8
- Proposed Engineered Mounds 9 & 10
- Proposed Engineered Mounds 11 & 12
- Proposed Engineered Mounds 13 & 14
- Proposed Engineered Mounds 15 & 16

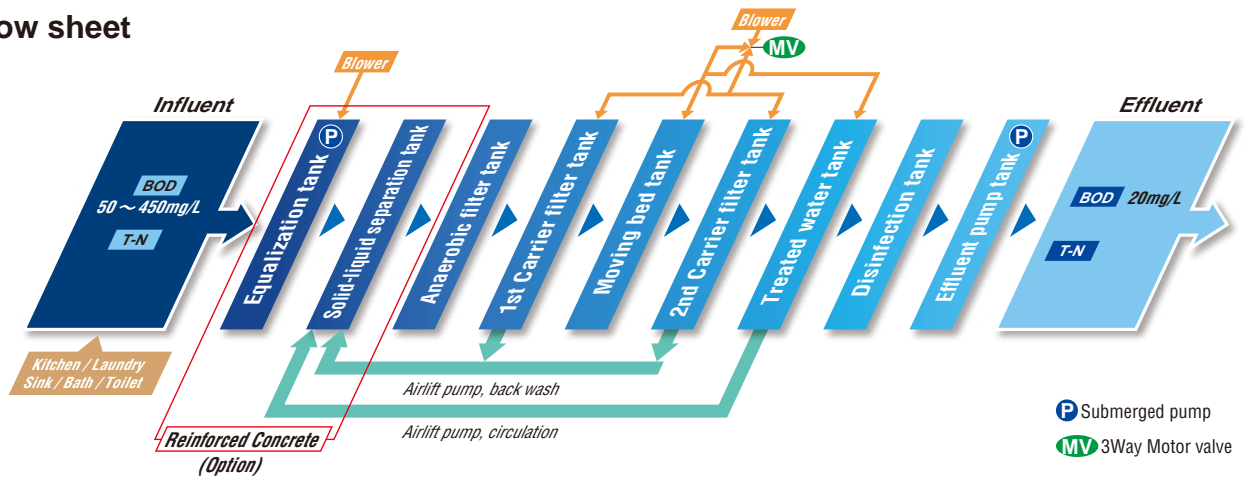
■ Flow sheet

■ Specifications (BOD 200mg/L→20mg/L, T-N 80mg/L→20mg/L, influent 12 hrs/day)

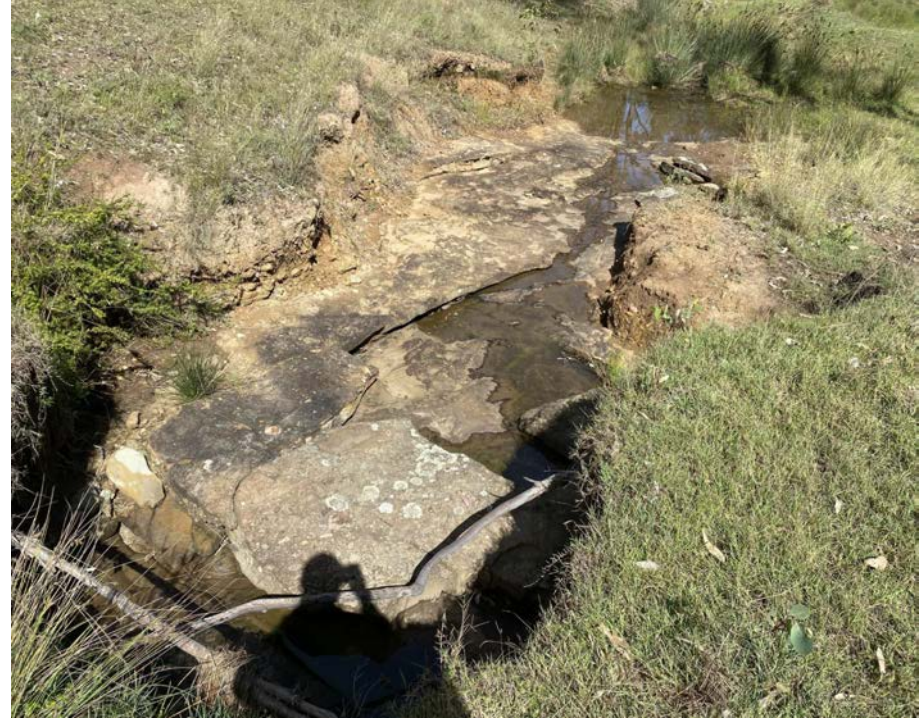
View of rock in creek near BH7
