MCS

Block B Upgrade

ARBORICULTURE IMPACT ASSESSMENT

12 OCTOBER 2023

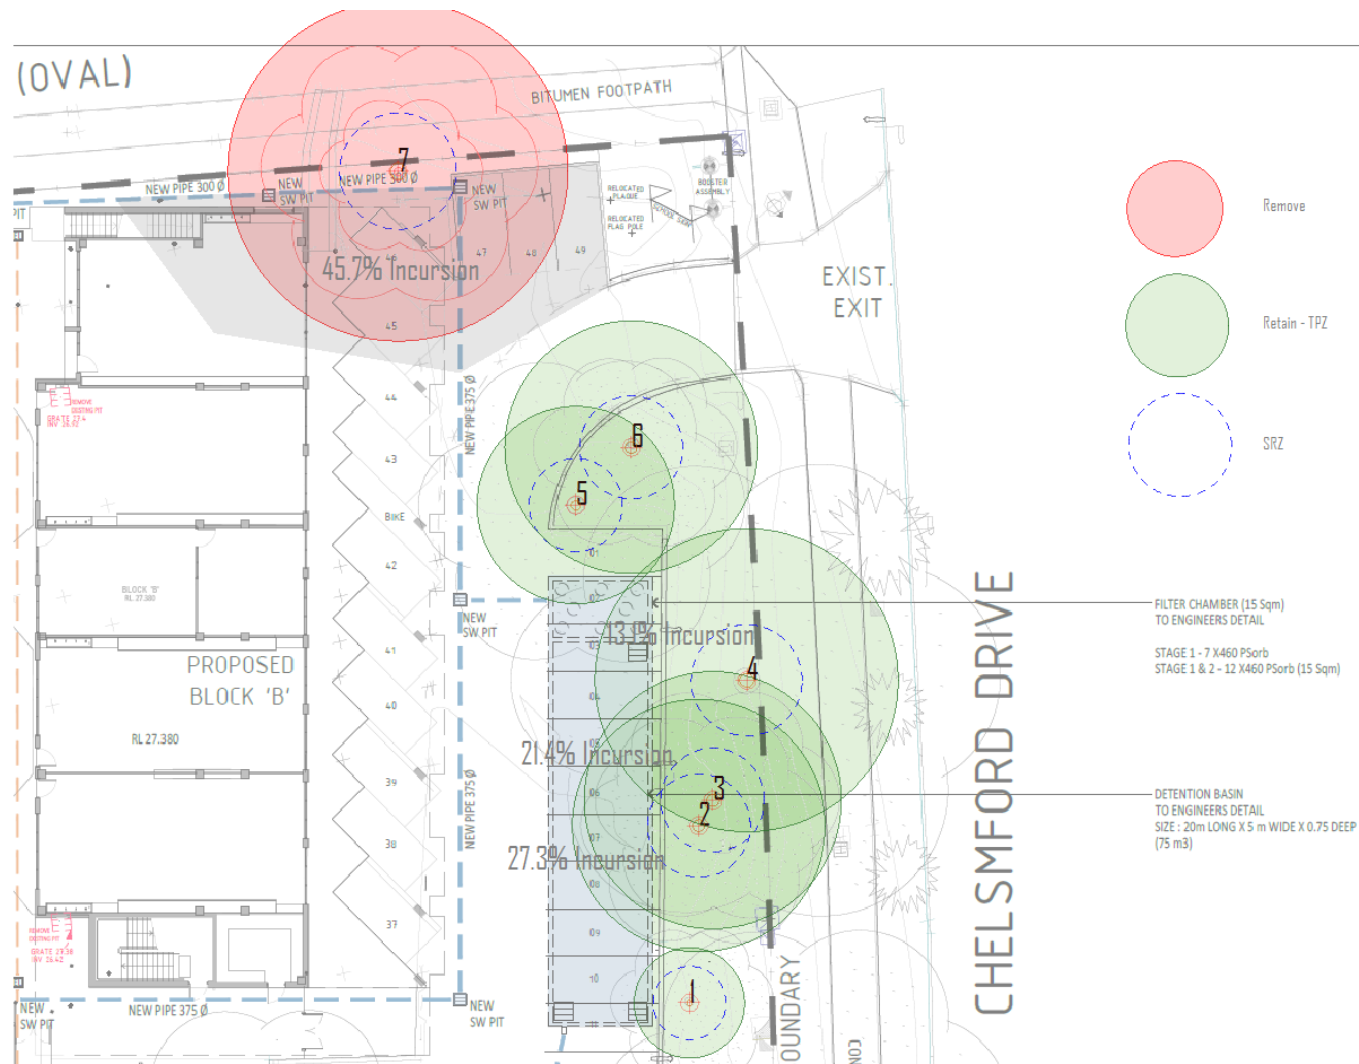
Figure 1 – Tree map showing TPZ and SRZ circles around trees and all major incursions (more 10%).

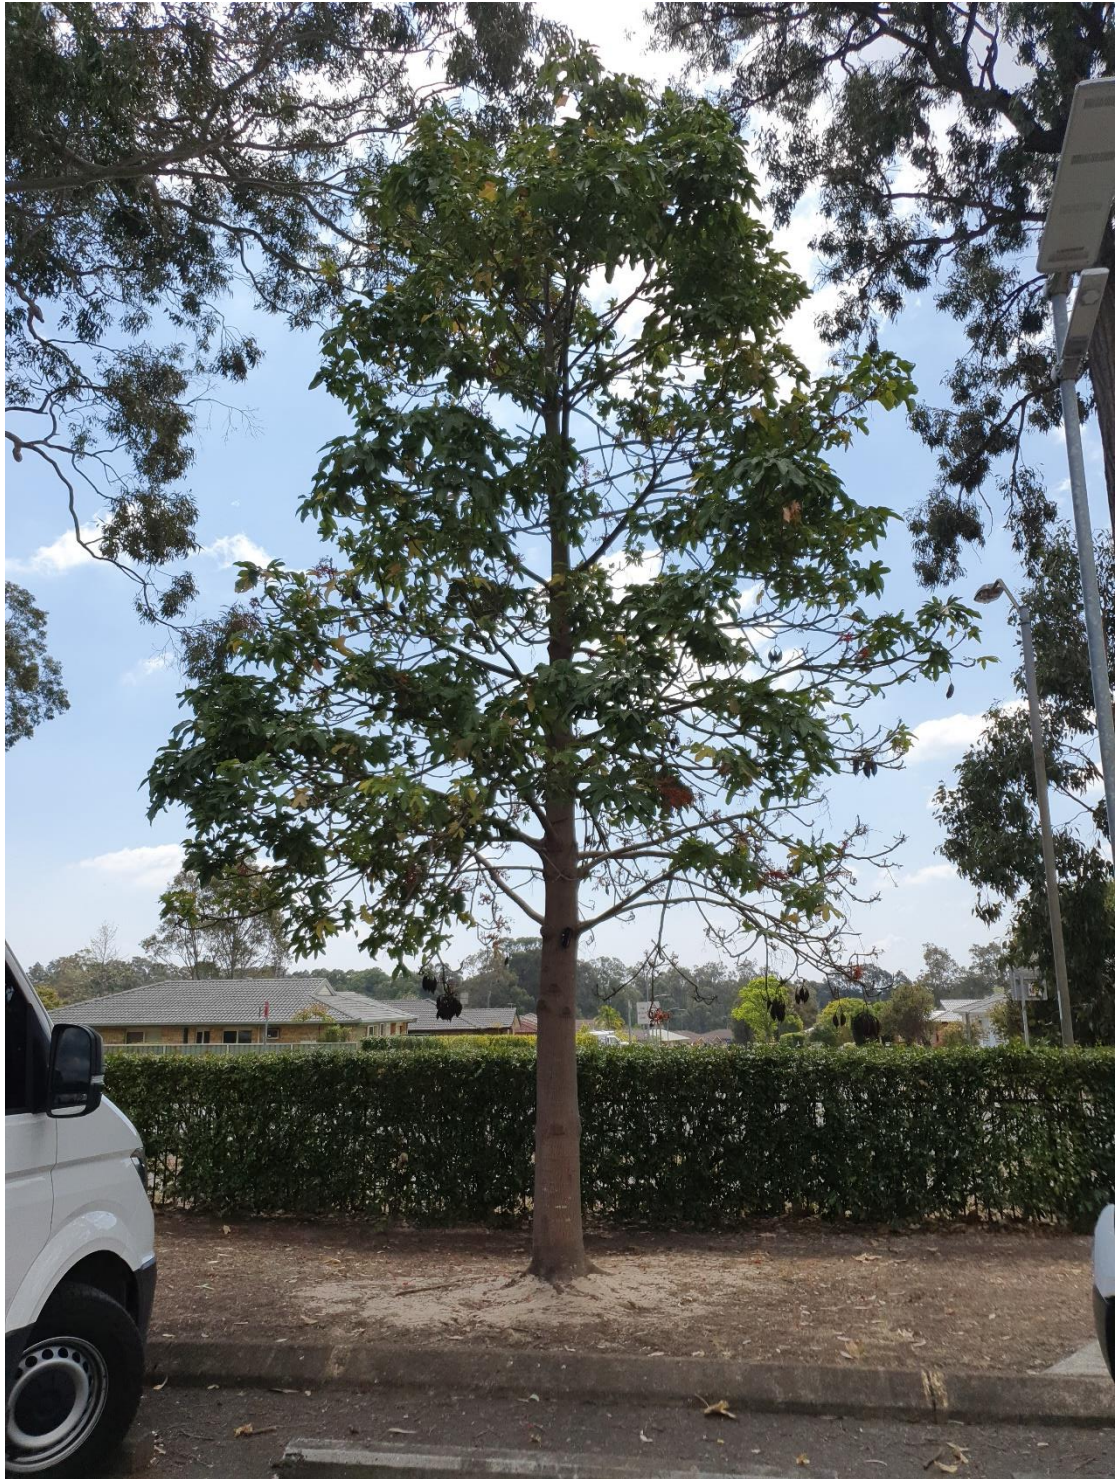
| Tree ID | Species | Common Name | Height m | Canopy Spread m | DBH mm | DRC mm | Condition | Landscape Significance | Sustainability | Retention Value | SRZ radius | TPZ radius | Outcome | Comments |
|---|---|---|---|---|---|---|---|---|---|---|---|---|---|--|
| 1 | <i>Brachychiton acerifolius</i> | Illawarra flame tree | 6 | 4 | 240 | 270 | Excellent | Greater 40 years | Moderate - 4 | Moderate | 1.91 | 2.88 | Retain | Less than 10% encroachment. No management activities required. |

Figure 2 - Tree 1, Retain

6.1.1. Minimal impacts on feeder roots on the outside of the TPZ with excavations to encroach very close to structural root zone. Tree will require no special management activities.

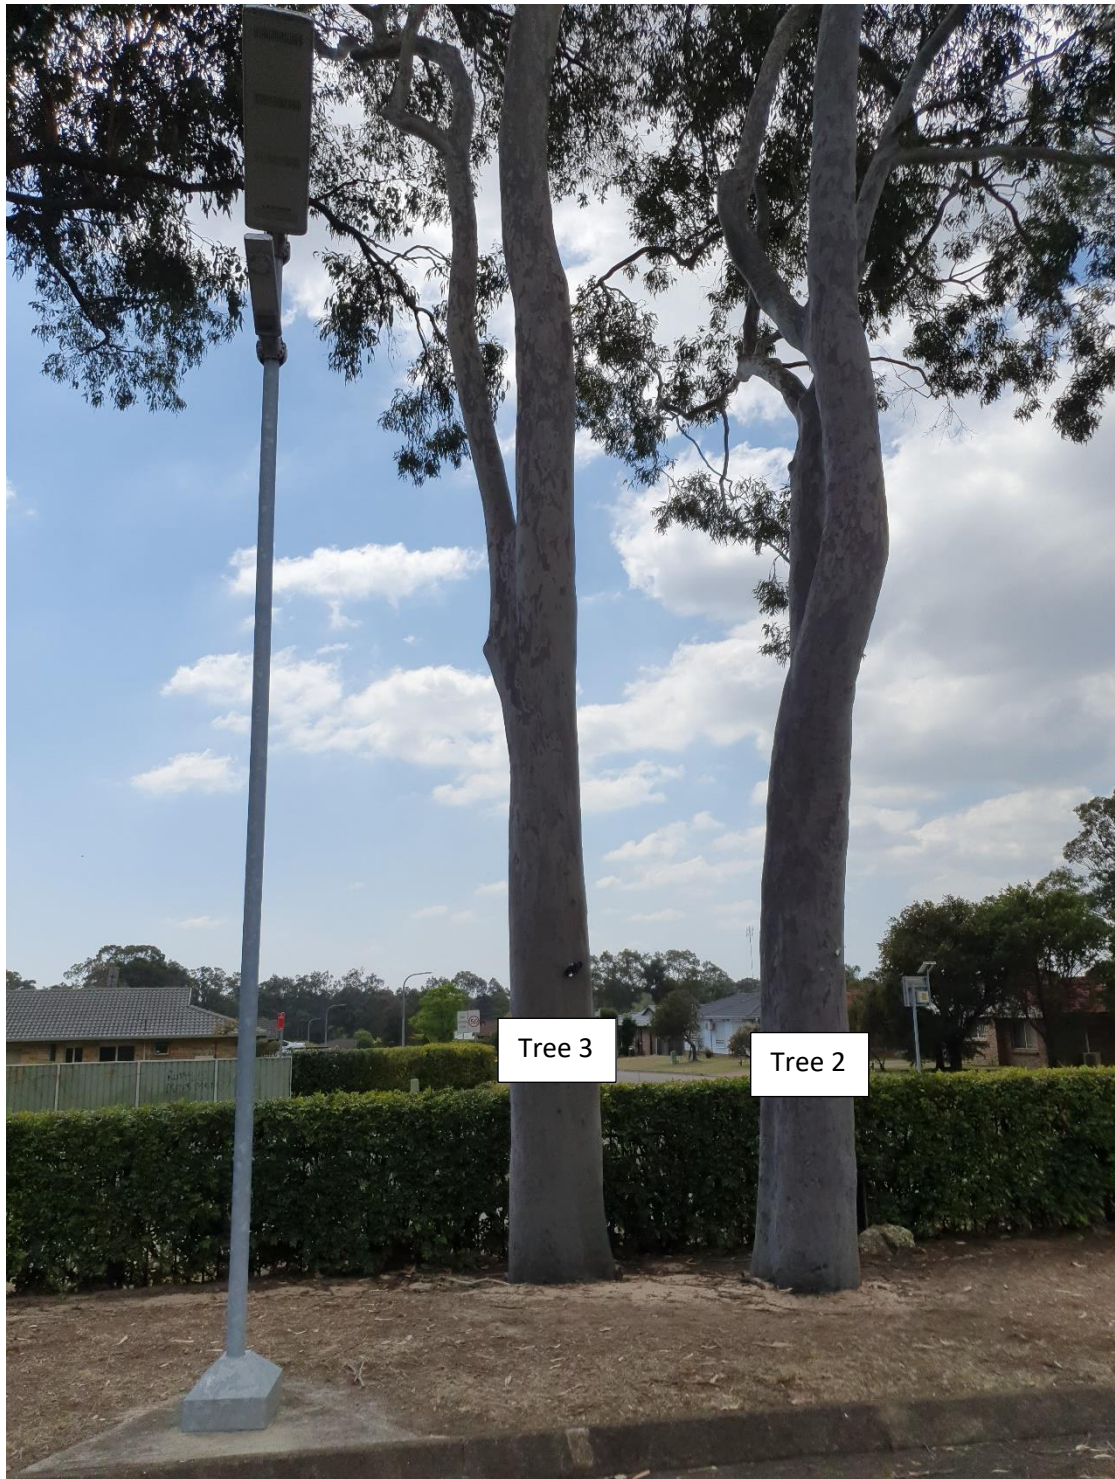
| Tree ID | Species | Common Name | Height m | Canopy Spread m | DBH mm | DRC mm | Condition | Landscape Significance | Sustainability | Retention Value | SRZ radius | TPZ radius | Outcome | Comments |
|---|---|---|---|---|---|---|---|---|---|---|---|---|---|--|
| 2 | <i>Corymbia maculata</i> | Spotted Gum | 18 | 9 | 550 | 610 | Good | Greater 40 years | High - 3 | High | 2.69 | 6.6 | Retain with supervision | 27.3% encroachment into TPZ. Arborist to supervise digging of detention pit as per AS4970. |
| 3 | <i>Corymbia maculata</i> | Spotted Gum | 19 | 10 | 560 | 620 | Good | Greater 40 years | High - 3 | High | 2.71 | 6.72 | Retain with supervision | 21.4% encroachment into TPZ. Arborist to supervise digging of detention pit as per AS4970. |

Figure 3 - Tree 2 and 3, Retain with arborist supervision during detention basin excavation as per AS4970.

6.2.1. Excavations for the proposed detention basin will encroach into the SRZ of this tree. Extreme care must be taken to avoid destabilisation. Excavation in this area should be supervised by an AQF5 arborist with extensive experience in root investigations to determine if the tree remains stable and viable once the extent of excavations has been achieved.

6.3.1. Excavations for the proposed detention basin will encroach into the SRZ of this tree. Extreme care must be taken to avoid destabilisation. Excavation in this area should be supervised by an AQF5 arborist with extensive experience in root investigations to determine if the tree remains stable and viable once the extent of excavations has been achieved.

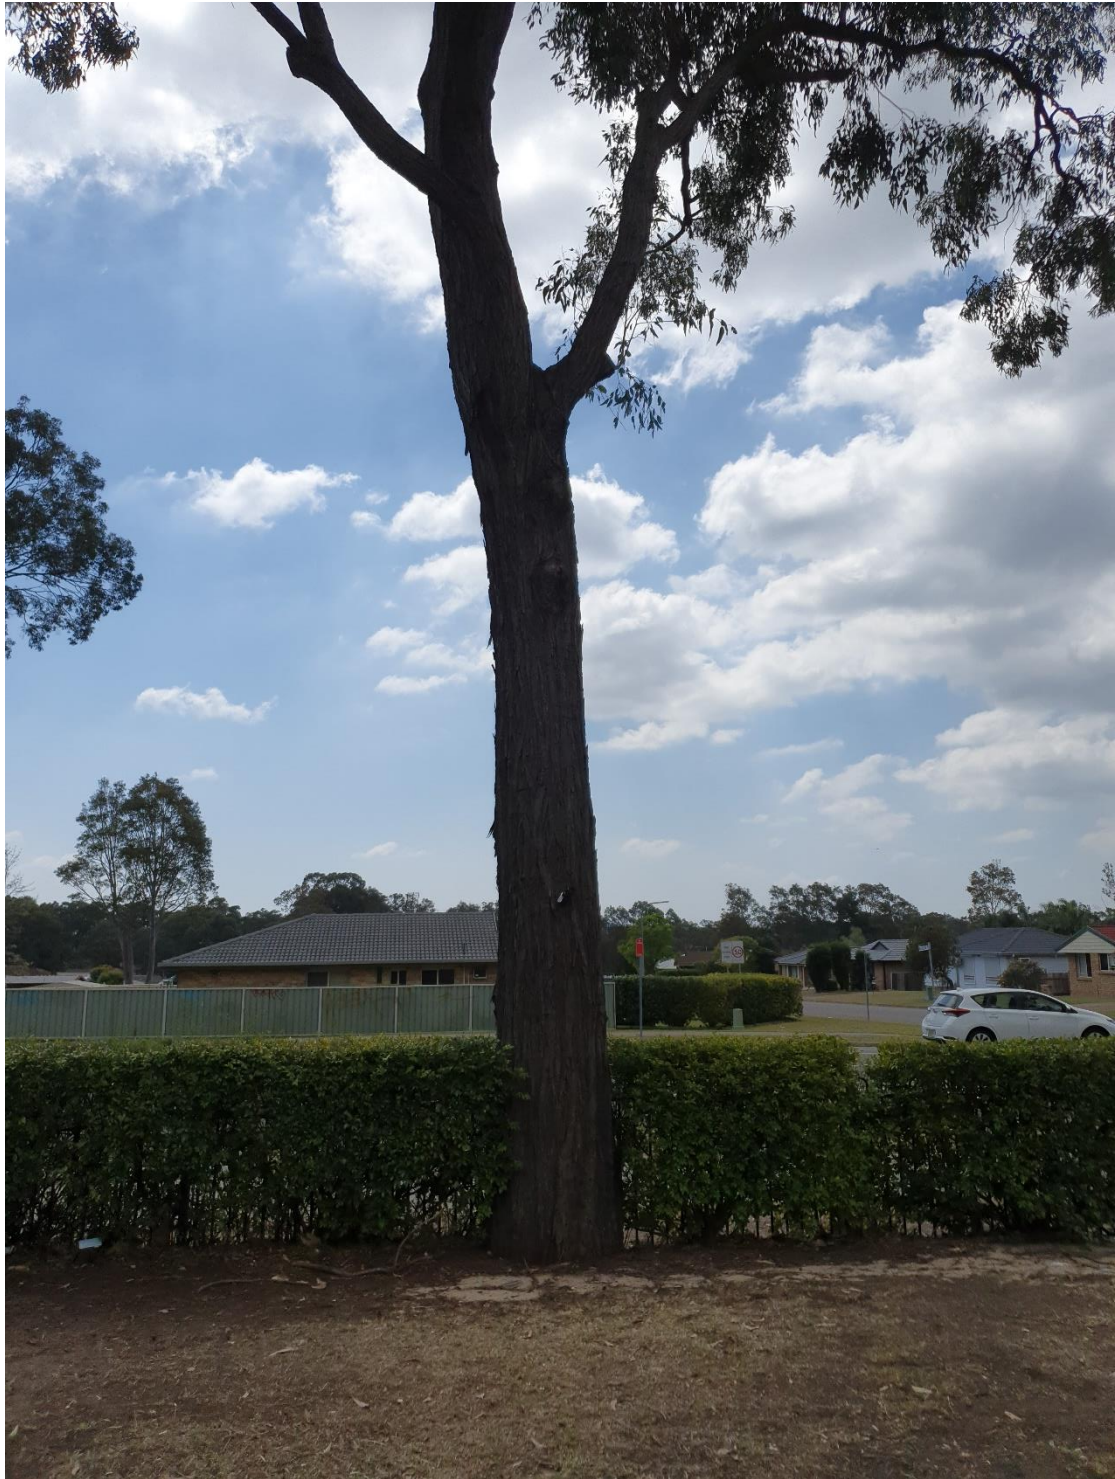
| Tree ID | Species | Common Name | Height m | Canopy Spread m | DBH mm | DRC mm | Condition | Landscape Significance | Sustainability | Retention Value | SRZ radius | TPZ radius | Outcome | Comments |
|---|---|---|---|---|---|---|---|---|---|---|---|---|---|--|
| 4 | <i>Eucalyptus paniculata</i> | Grey Ironbark | 18 | 14 | 660 | 730 | Excellent | Greater 40 years | High - 3 | High | 2.9 | 7.92 | Retain with supervision | 13.1% encroachment into TPZ. Arborist to supervise digging of detention pit as per AS4970. |

Figure 4 - Tree 4, Retain with arborist supervision during detention basin excavation as per AS4970.

6.4.1. TPZ for this tree will be encroached by over 10% so excavation inside the TPZ must be monitored by an AQF5 arborist as with trees 2 and 3. However it is expected that no structural roots will be located inside the excavation area.

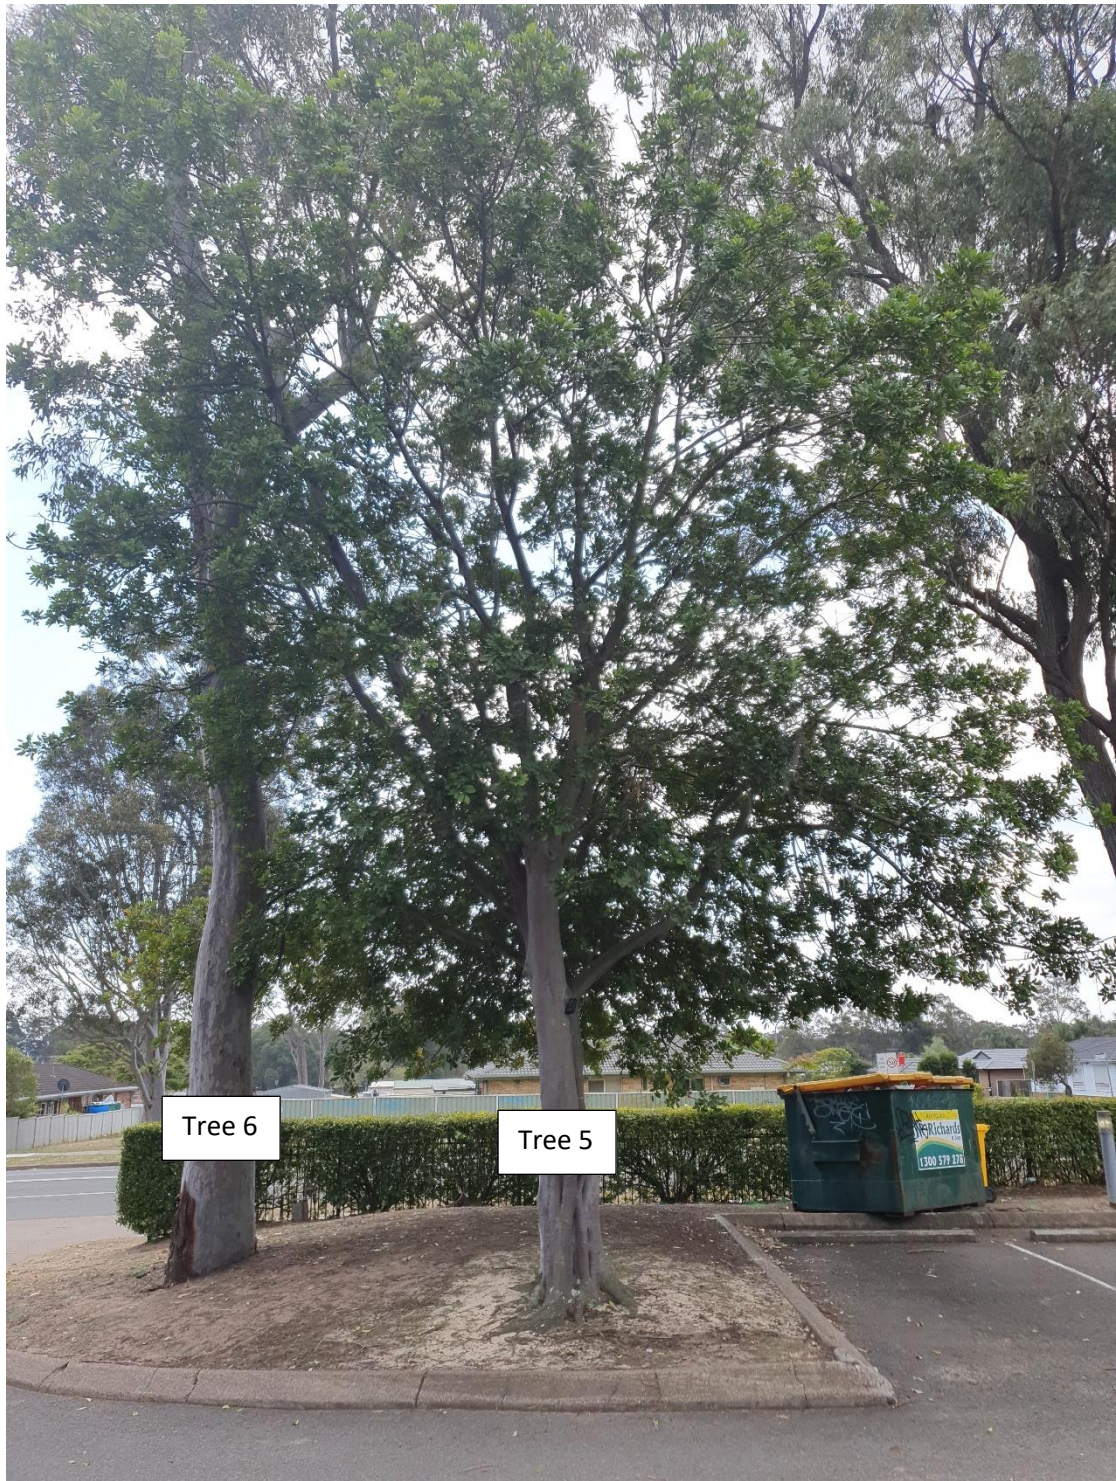
| Tree ID | Species | Common Name | Height m | Canopy Spread m | DBH mm | DRC mm | Condition | Landscape Significance | Sustainability | Retention Value | SRZ radius | TPZ radius | Outcome | Comments |
|---|---|---|---|---|---|---|---|---|---|---|---|---|---|--|
| 5 | <i>Cupaniopsis anacardioides</i> | Tuckeroo | 7 | 5 | 430 | 480 | Good | Greater 40 years | Moderate - 4 | Moderate | 2.43 | 5.16 | Retain | Less than 10% encroachment. No management activities required. |
| 6 | <i>Corymbia maculata</i> | Spotted Gum | 19 | 10 | 550 | 610 | Poor | 5 - 15 years | Moderate - 4 | Low | 2.69 | 6.6 | Retain | Less than 10% encroachment. No management activities required. |

Figure 5 - Tree 5 and 6, Retain.

6.5.1. Tree will require no special management activities.

6.6.1. Tree will require no special management activities.

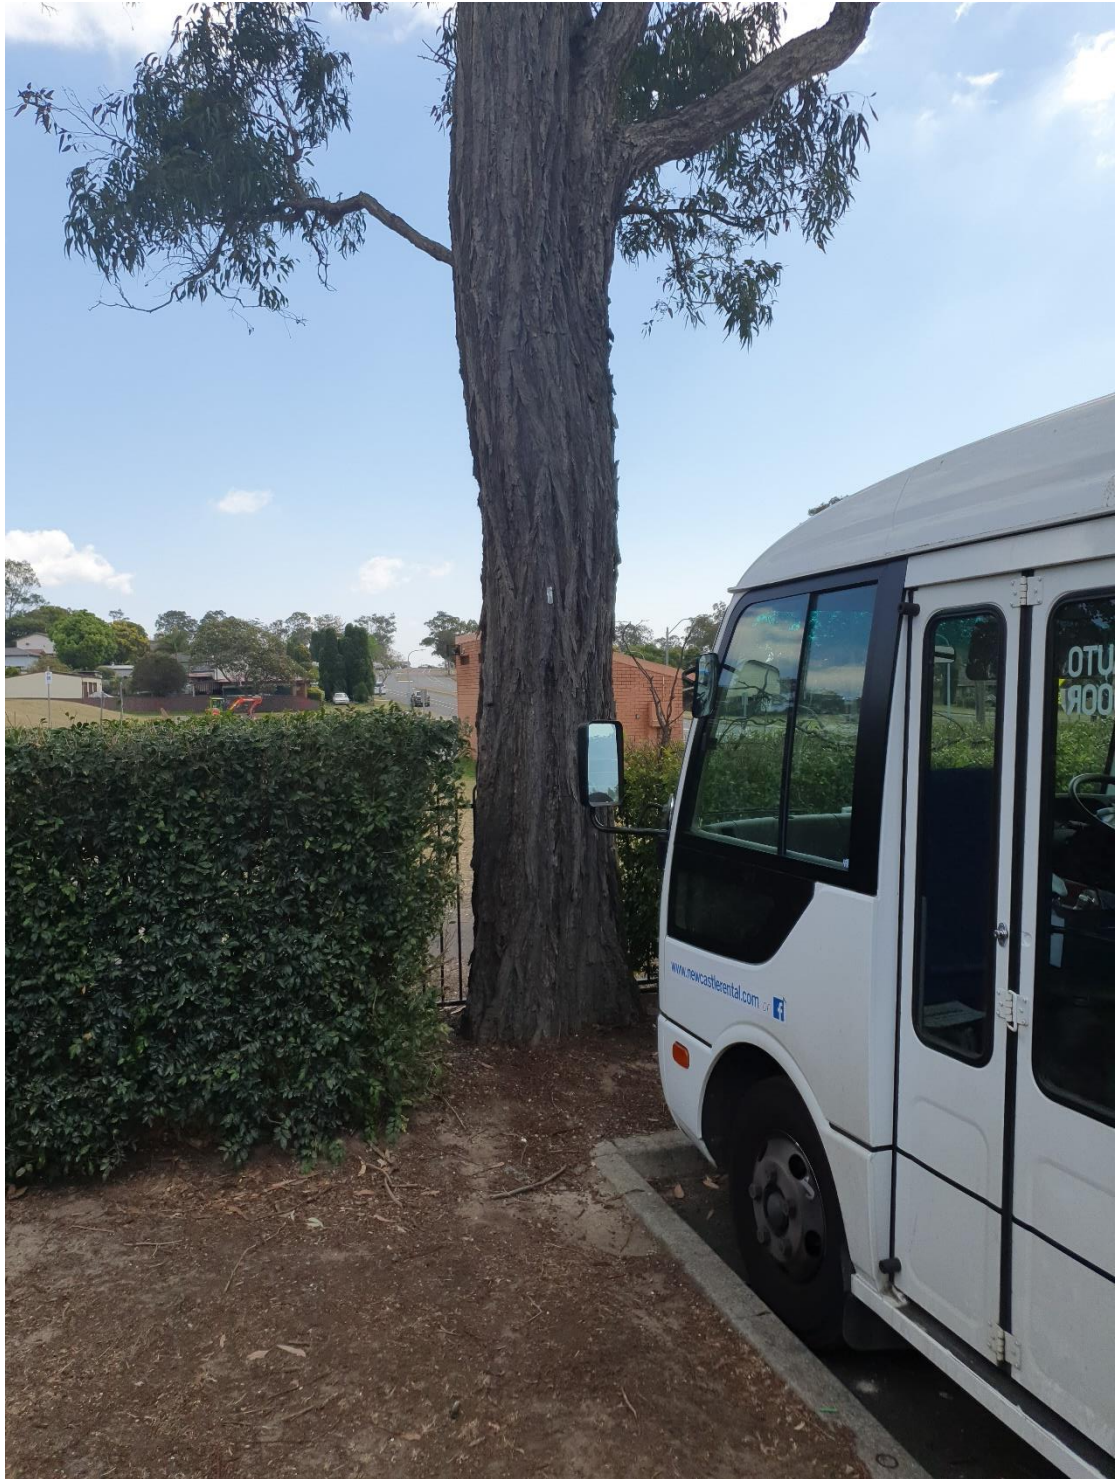
| Tree ID | Species | Common Name | Height m | Canopy Spread m | DBH mm | DRC mm | Condition | Landscape Significance | Sustainability | Retention Value | SRZ radius | TPZ radius | Outcome | Comments |
|---|---|---|---|---|---|---|---|---|---|---|---|---|---|--|
| 7 | <i>Eucalyptus paniculata</i> | Grey Ironbark | 21 | 11 | 740 | 820 | Excellent | Greater 40 years | High - 3 | High | 3.04 | 8.88 | Remove | A 45.7% encroachment of the TPZ will occur with trenching well inside the SRZ. Removal required. |

Figure 6 - Tree 7, Remove prior to construction.

6.7.1. Removal of this tree is required as the encroachment of the carpark upgrade, corner of building and in particular the new 300mm water pipe will be disturbing 45.7% of the root area of this tree, including well into the SRZ.

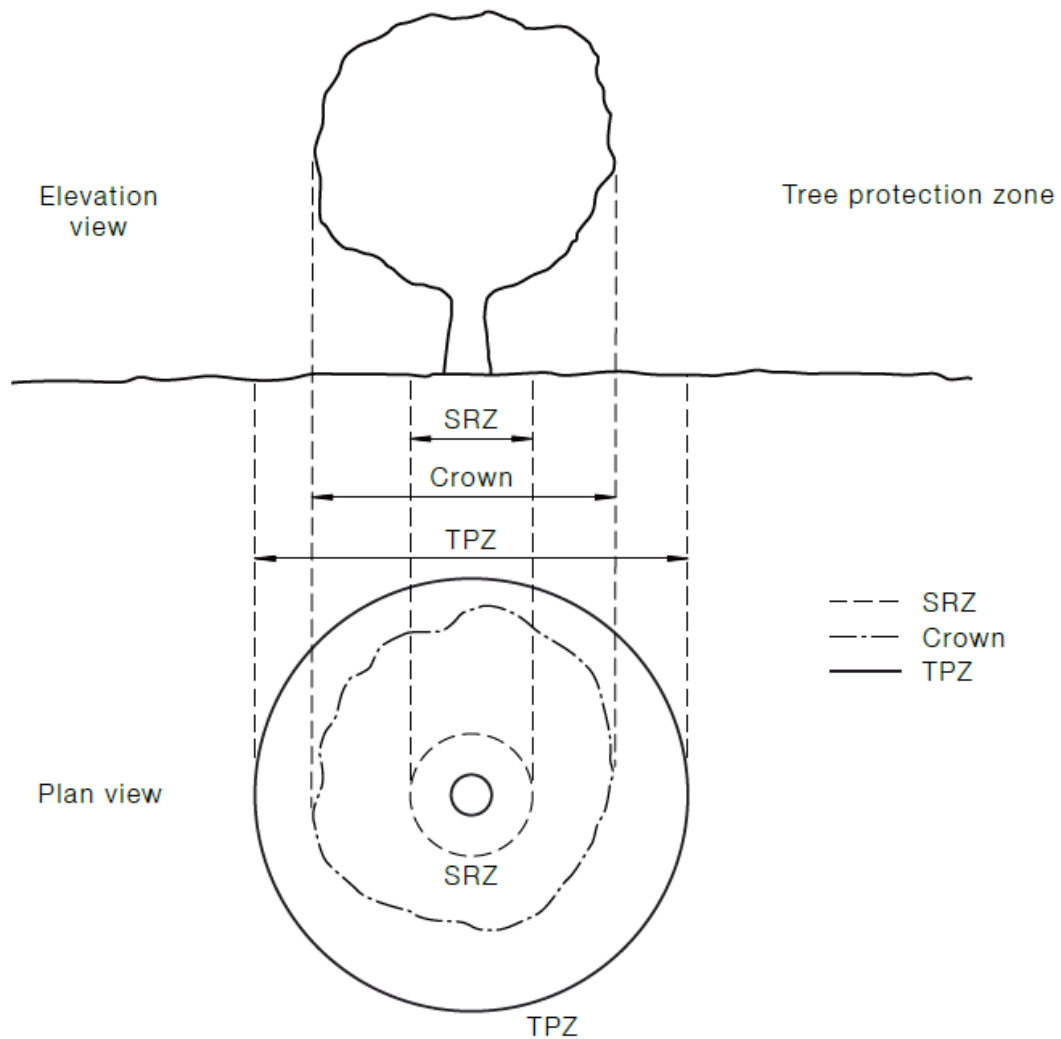
There are many factors that affect the size of the SRZ (e.g. tree height, crown area, soil type, soil moisture). The SRZ may also be influenced by natural or built structures, such as rocks and footings. An indicative SRZ radius can be determined from the trunk diameter

Where D = trunk diameter, in m, measured above the root buttress

NOTE: The SRZ for trees with trunk diameters less than 0.15 m will be 1.5 m

Figure 7 - TPZ and SRZ Diagram

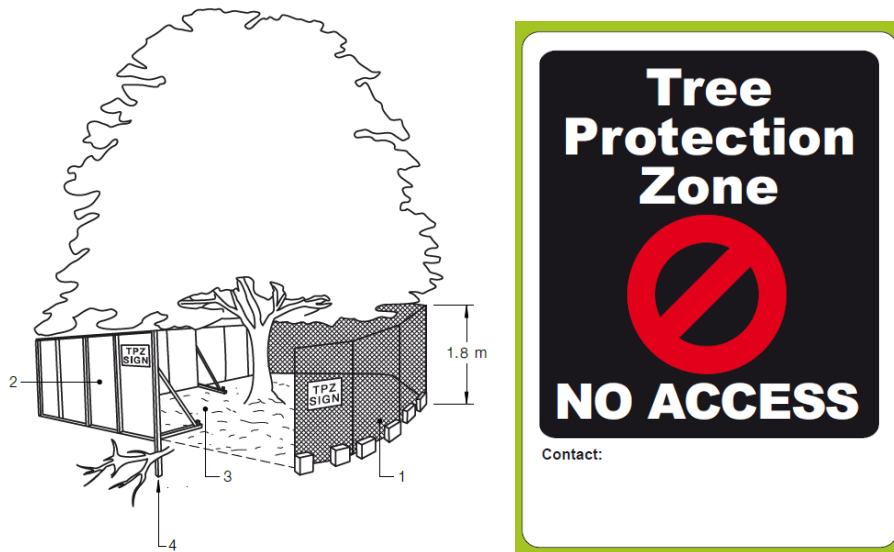
Signs identifying the TPZ should be placed around the edge of the TPZ and be visible from within the development site (see image below).

Figure 8 - Tree Protection Zone fencing example and example of a sign format

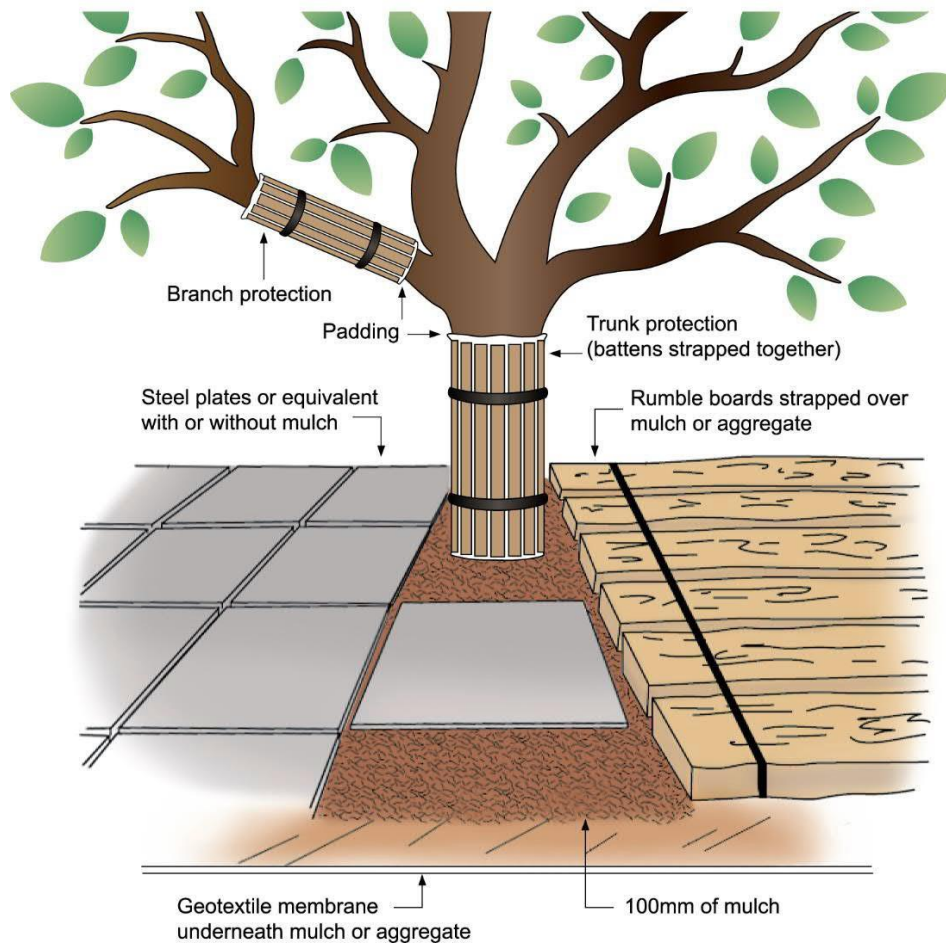
Where necessary, install protection to the trunk and branches of trees as shown below. The materials and positioning of protection are to be specified by the project arborist. A minimum height of 2 m is recommended.

Figure 9 - Tree Protection Measures if fencing cannot be maintained or must be removed
