Project Number: HN000682-A

# ABORIGINAL HERITAGE DUE DILIGENCE ASSESSMENT REPORT – WINDELLA

FINAL 8 / 11 / 2023

**REPORT TO: MAVID DEVELOPMENT**

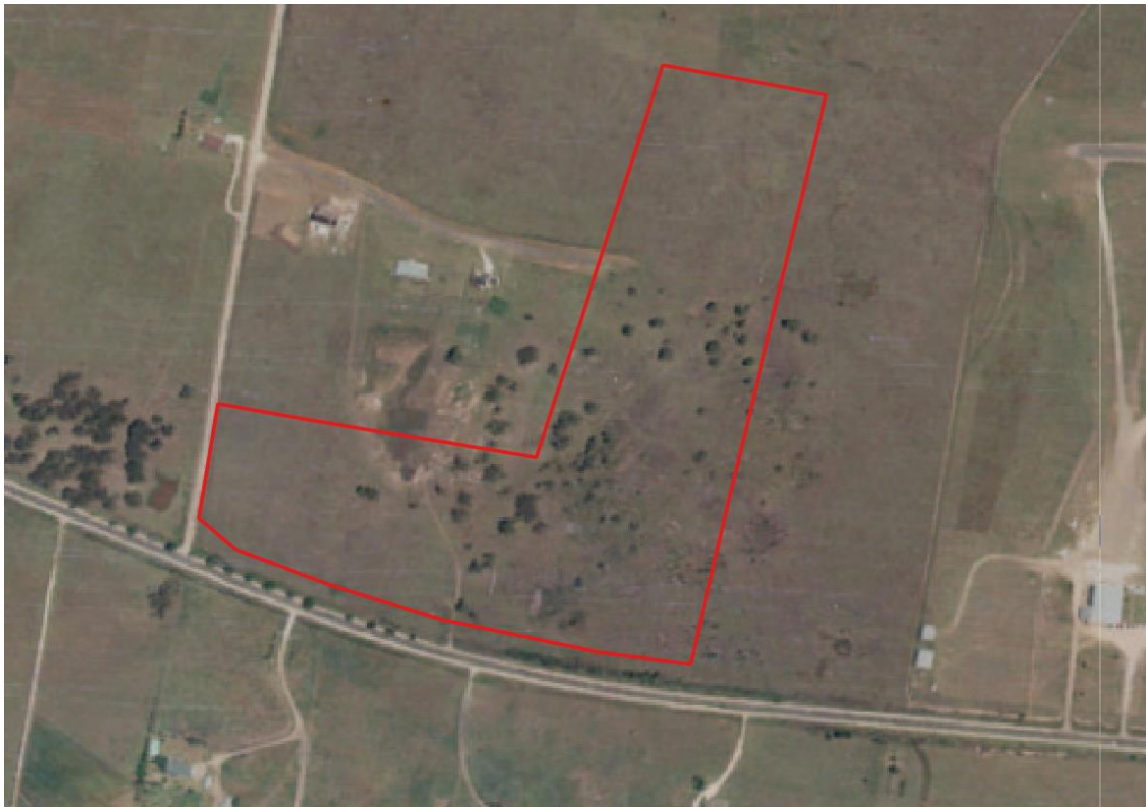
A historical aerial from 1976 shows that the Project Area had been mostly cleared, with only a scattering of trees remaining (Figure 4). In the central western section of the Project Area there appears to be a dam or excavation area, with an unsealed track leading from there to the New England Highway. In a 1983 aerial, vegetation in the central section of the Project Area has begun growing back, and the dam/excavated area has been infilled, although evidence of tracks remains (Figure 5). The 1987 aerial shows more unsealed tracks passing through the area, with two tracks in the southern section, leading to small cleared areas that have ground disturbance, and one in the northern section, leading to an outbuilding on a neighbouring lot (Figure 6). Aerials from 1993 show several buildings (most likely residential buildings) in the south-west of the Project Area, with a track leading to them (Figure 7). There are also some buildings in the central northern section with a track leading off Denton Close. The majority of the vegetation in the Project Area has been cleared and a dam is located in the south-eastern corner, and near the centre of the southern boundary. A 1998 aerial shows some additional ground disturbance around the buildings in the south-west section of the Project Area, and there are additional outbuildings in the central northern section (Figure 8). In 2012, there is evidence of disturbance near the southern boundary and in the south-west corner near the creek, most likely associated with a sewer line that appears to have been installed (Figure 9). Currently, land within the Project Area is being used as rural residential lots.

Figure 4. The Project Area in 1976. (Source: NSW Government Historical Imagery).

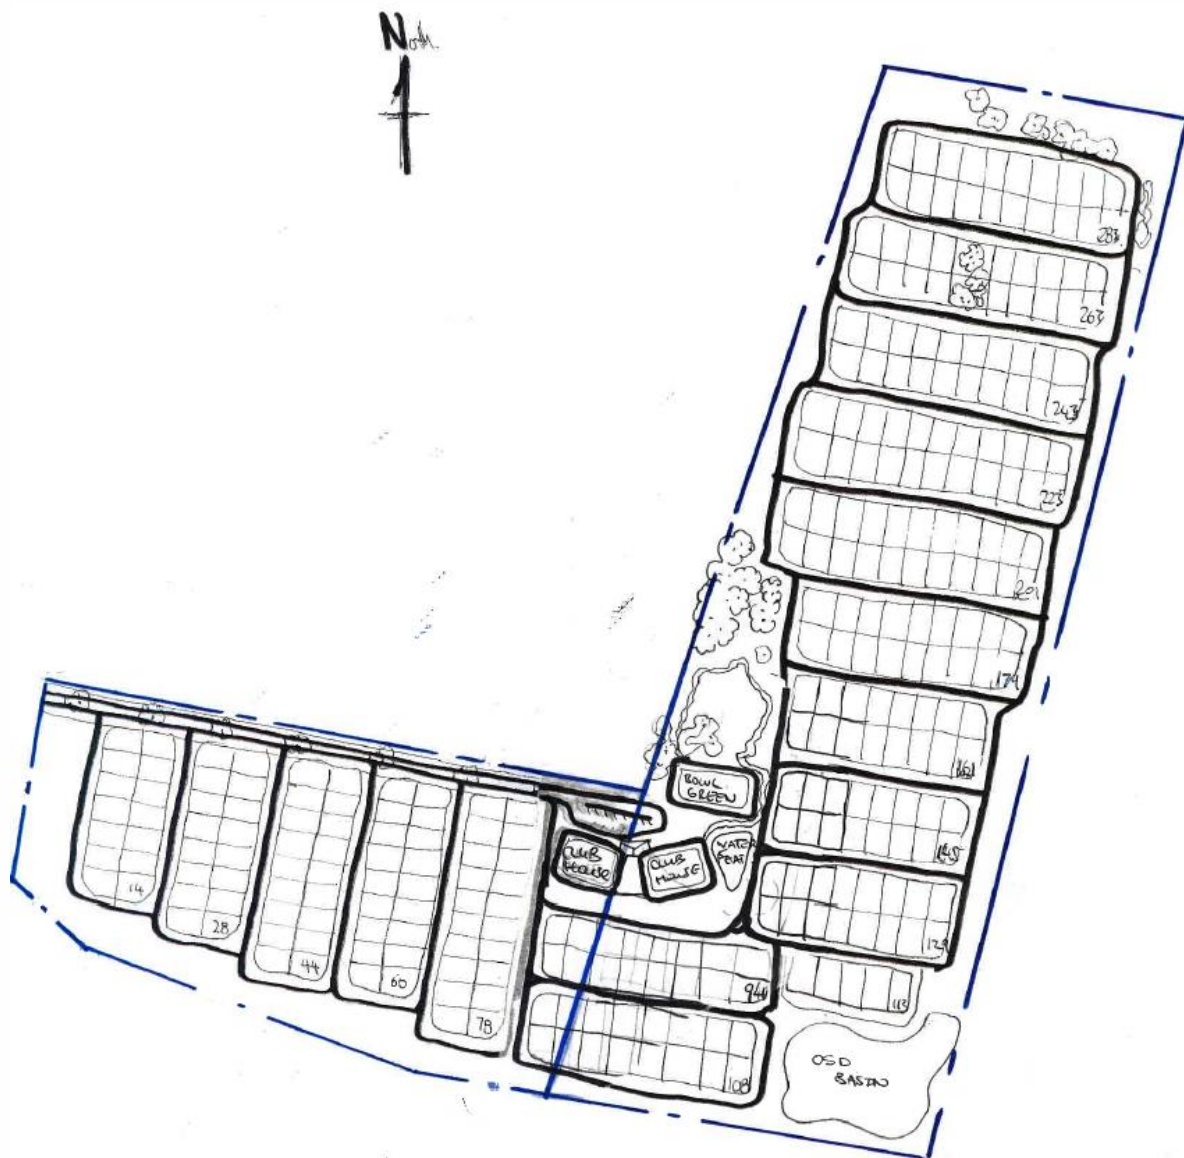
12

The Project Area is proposed for a staged development, as shown in Figure 12-Figure 13. The Stage 1 proposal is for 78 lots, a clubhouse, shared lawn and temporary detention basin, with Stage 2 including over 200 additional lots, an extension of the clubhouse, water feature, bowling green and a larger detention basin. The development will involve clearing of vegetation and cut and fill to prepare the Project Area. It will require the installation of below and above ground services including water and sewer, telecommunications and electricity, the formation of roads and access ways to the lots, followed by construction of individual buildings on the lots.

**STAGE 2**  
**200 Lots (total 280)**  
**CLUBHOUSE EXTENSION**  
**NEW FACILITIES**  
**MAIN BASIN**  
**BROADER ROAD UPGRADE.**

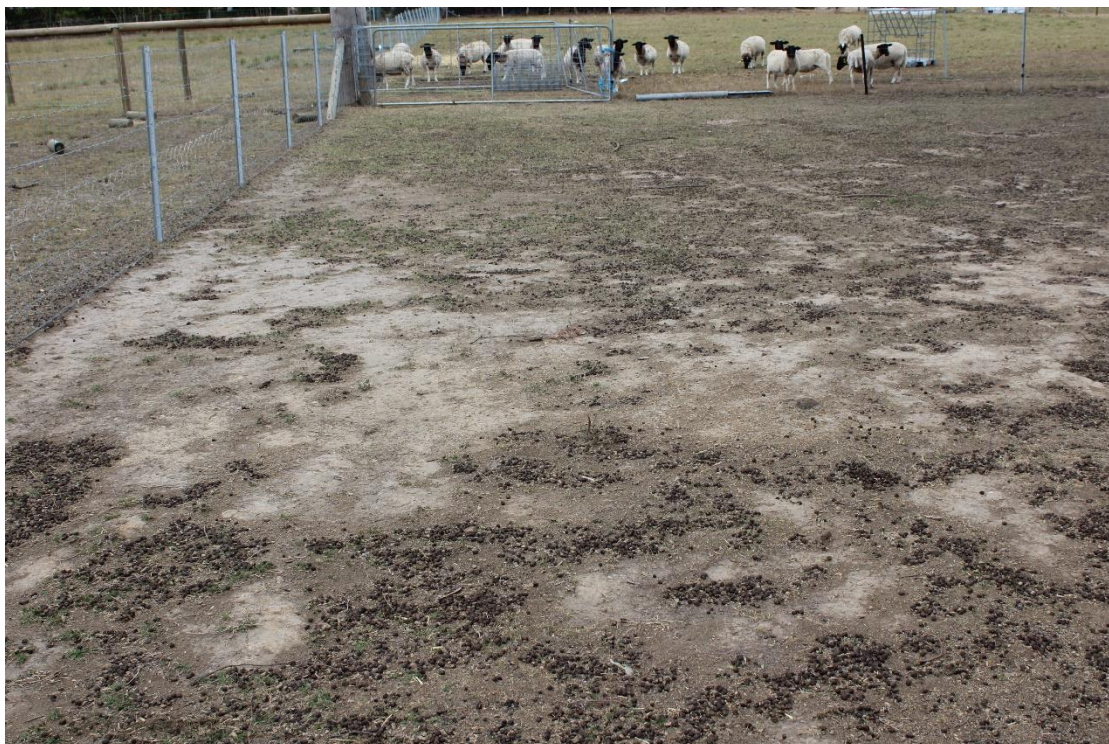
*Plate 1. Example of good ground surface exposures resulting from animal grazing. (Source: Heritage Now 2023)*

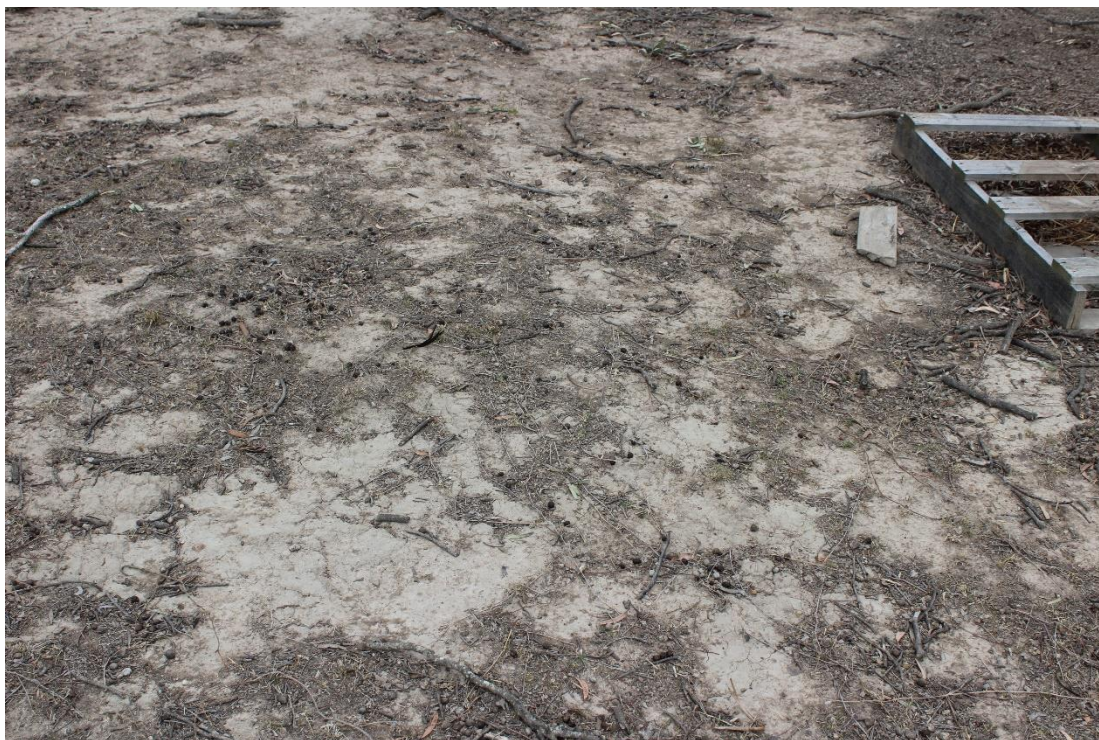
*Plate 2. Example of erosion to basal clay. (Source: Heritage Now 2023)*

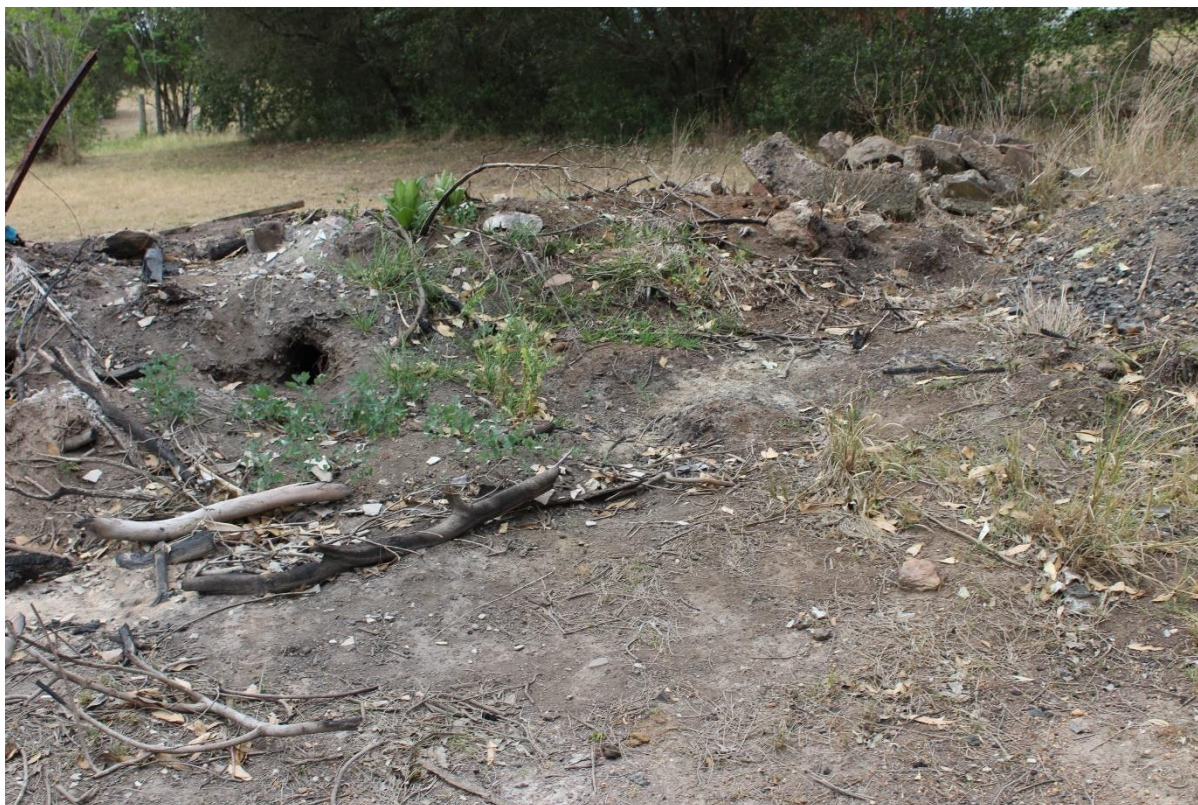
*Plate 3. Example of excavated topsoil pile. (Source: Heritage Now 2023)*

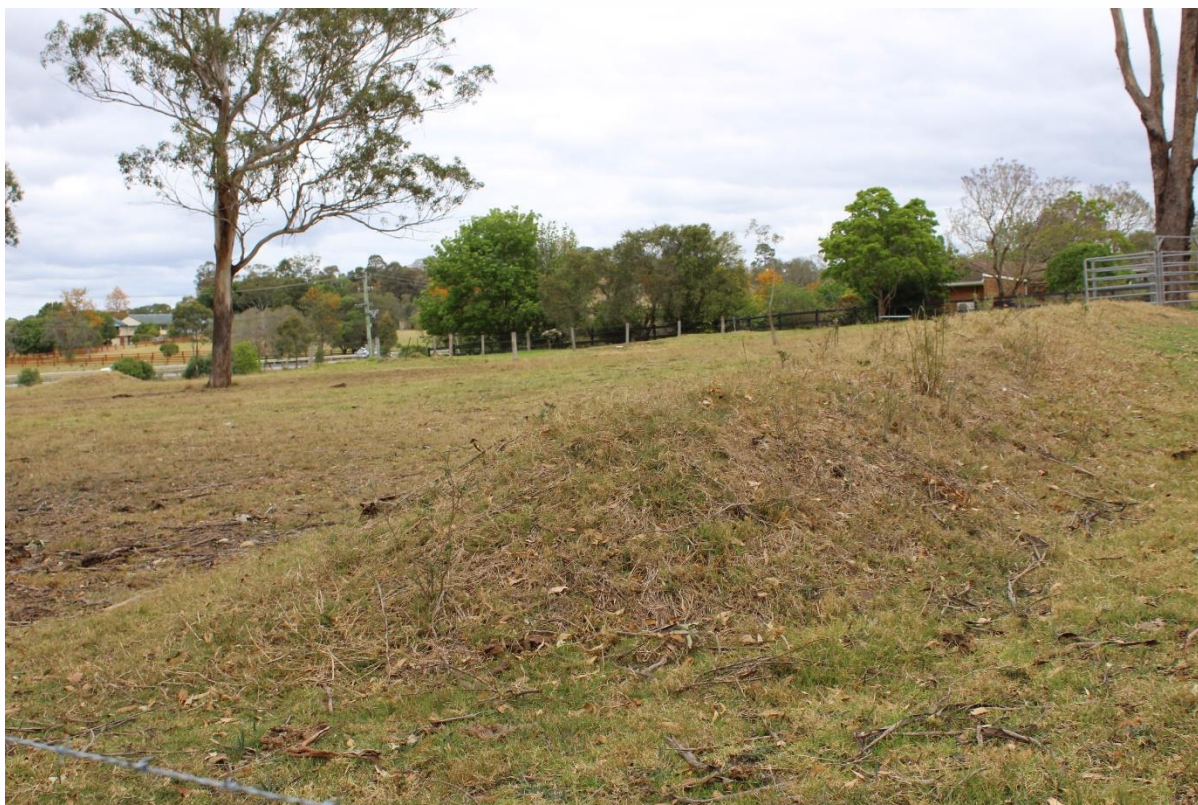
*Plate 4. Example of soil disturbance/mounding resulting from construction of dams, buildings and other rural activities. (Source: Heritage Now 2023)*

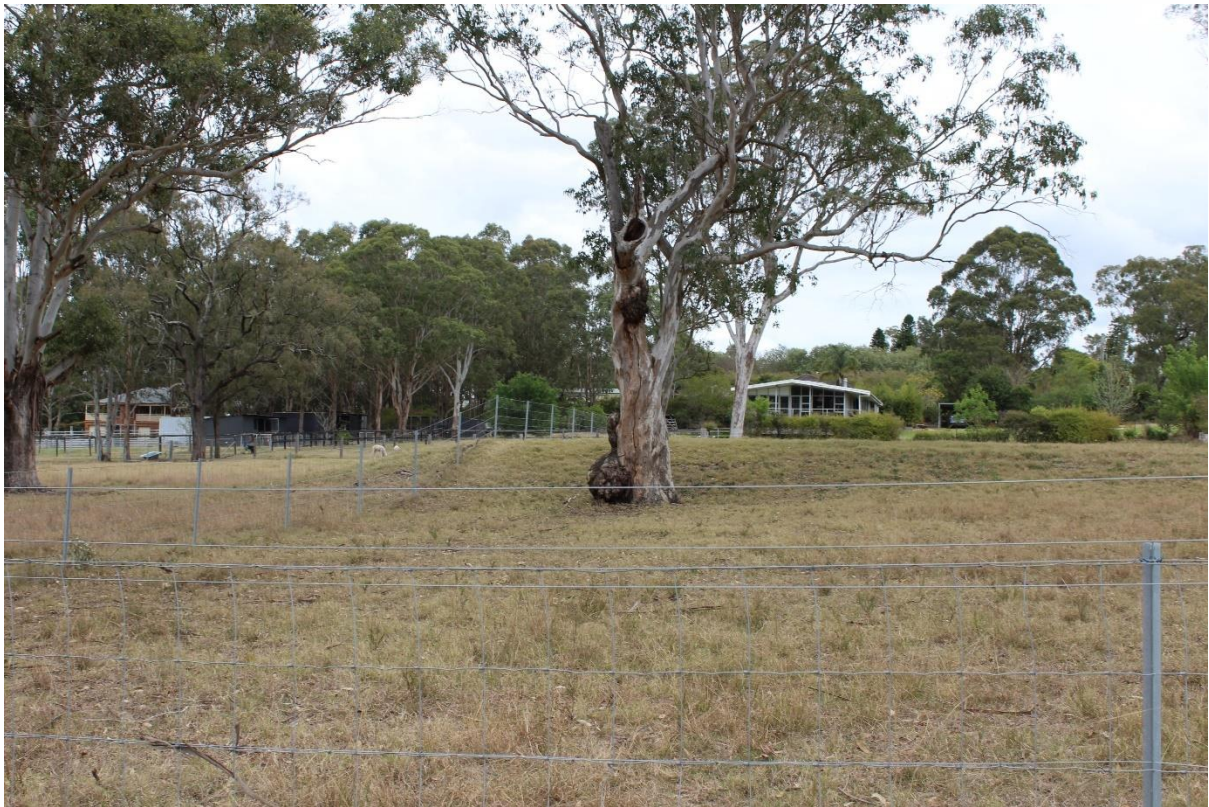
*Plate 5. Example of soil disturbance/mounding resulting from rural activities, including former horse arena. (Source: Heritage Now 2023)*

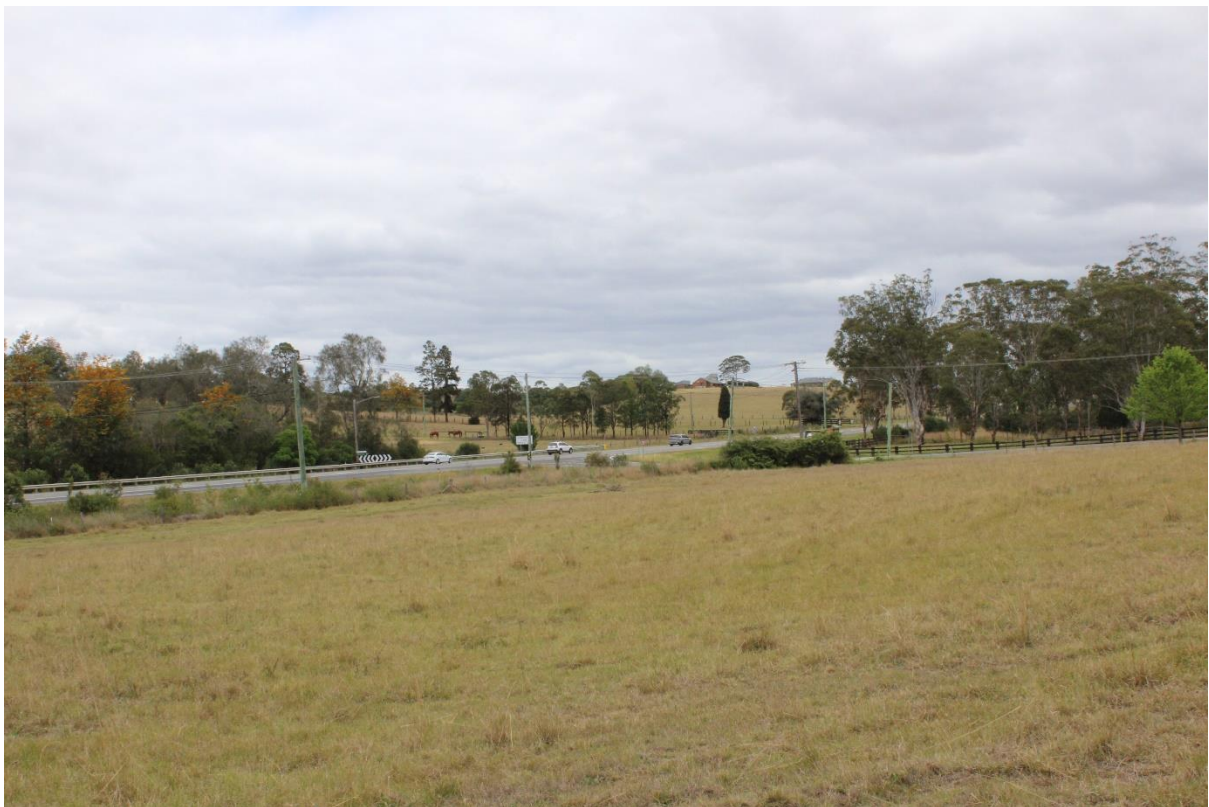
*Plate 6. View of the south-western section of the Project Area near the creek line, showing vegetation cover. (Source: Heritage Now 2023)*

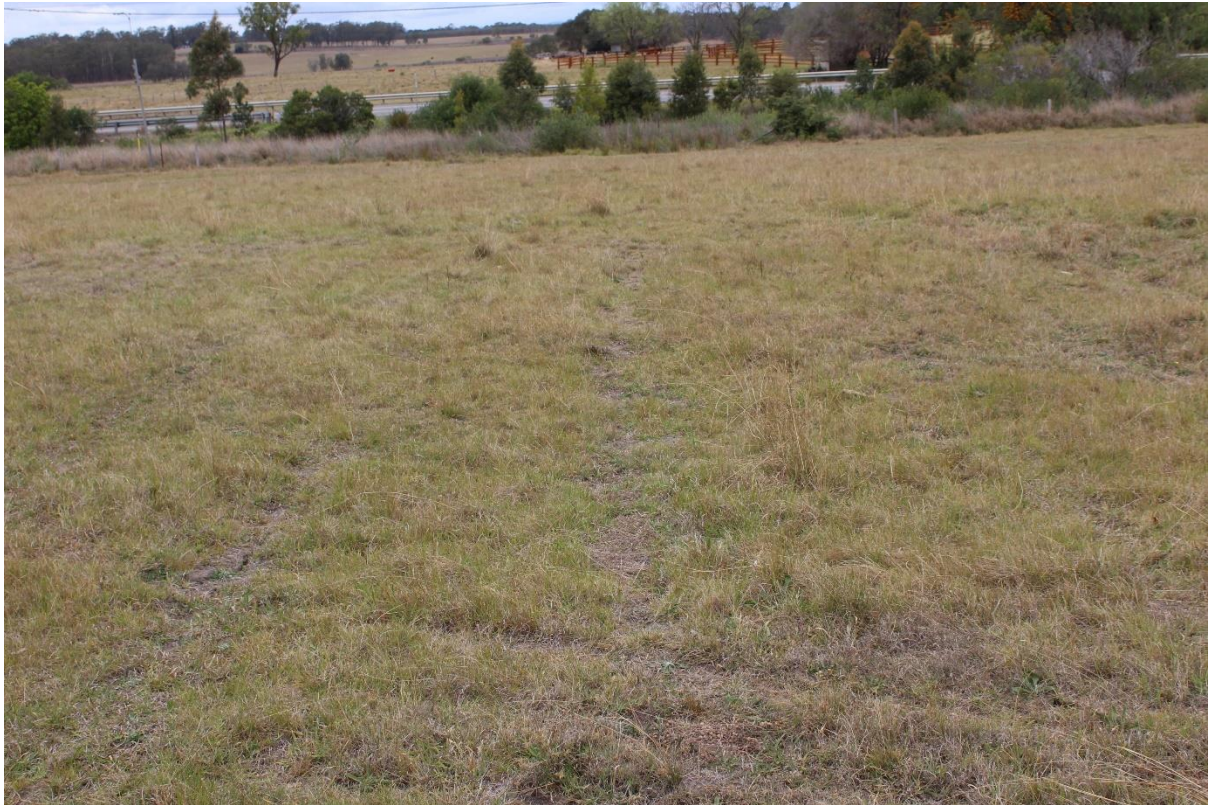
*Plate 7. Evidence of disturbance from vehicles in the south-western section of the Project Area. (Source: Heritage Now 2023)*

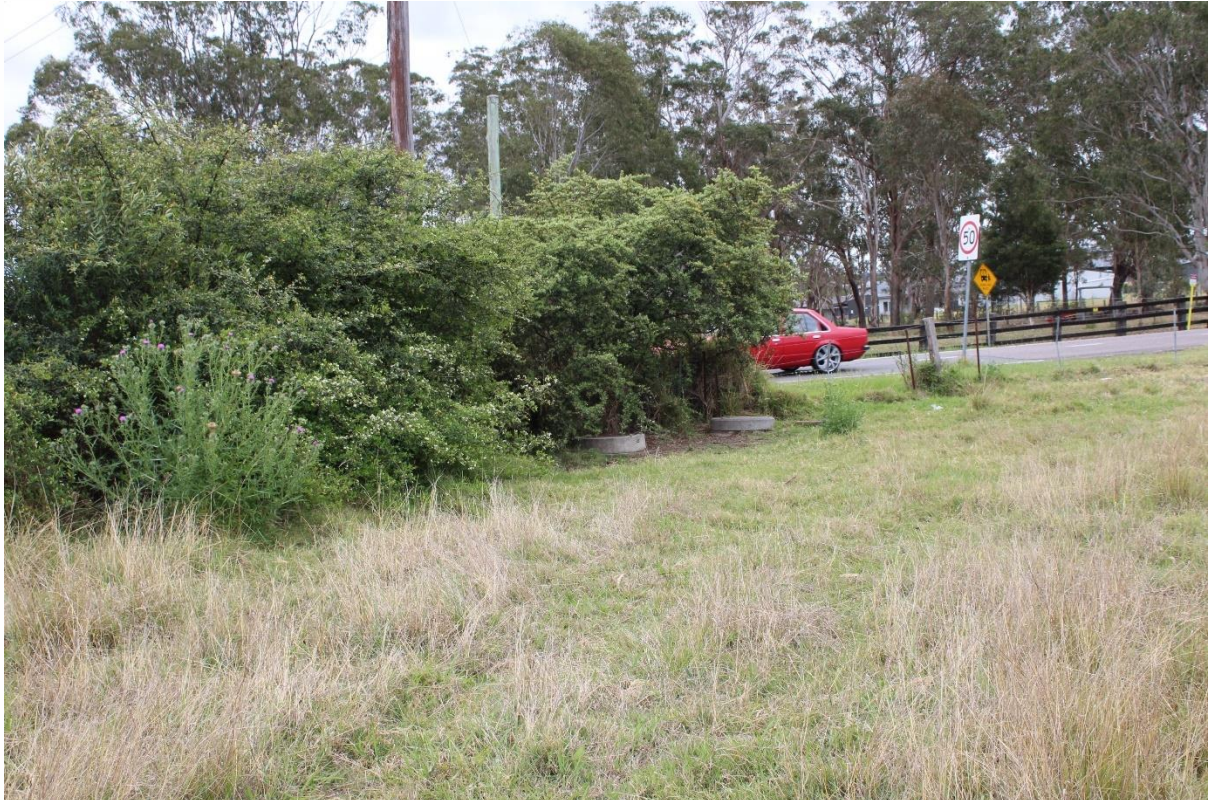
*Plate 8. Evidence of sewer infrastructure in the south-western section of the Project Area near the creek line. (Source: Heritage Now 2023)*

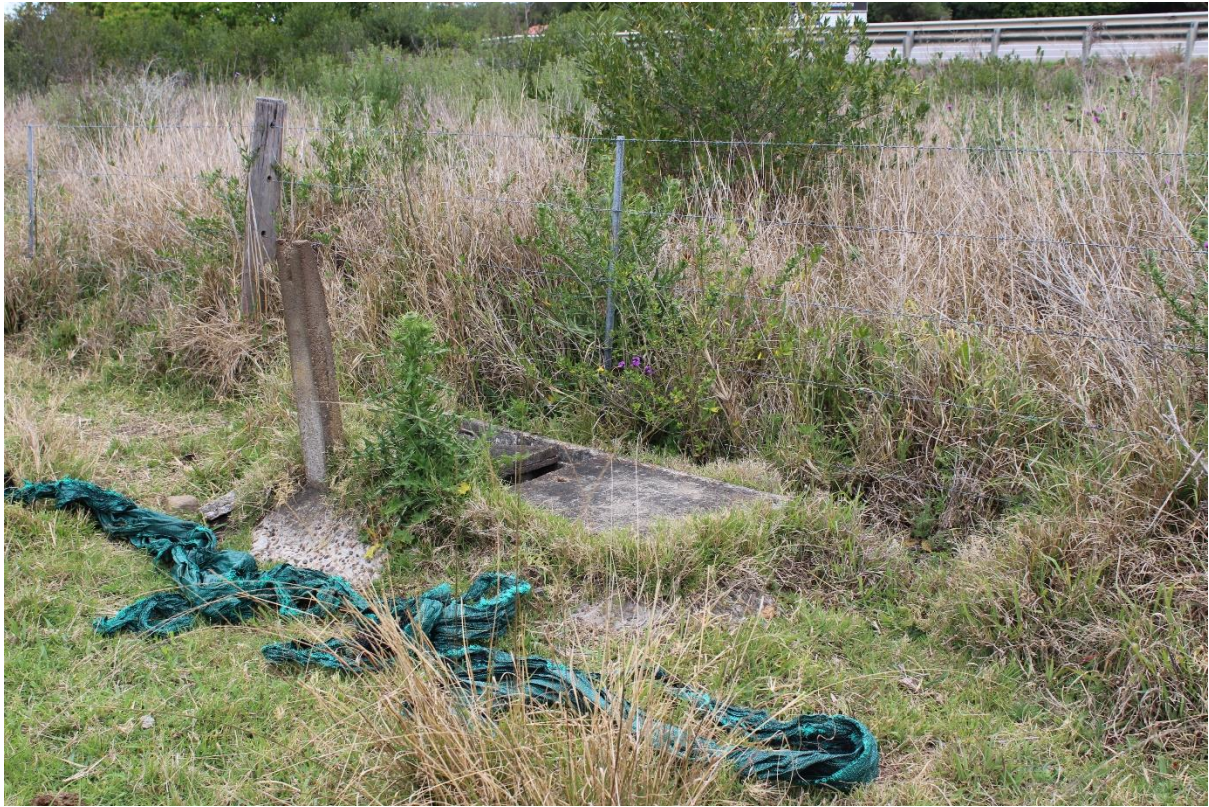
*Plate 9. Evidence of water infrastructure along the southern boundary of the Project Area. (Source: Heritage Now 2023)*
