29 January 2024

Mr Craig Parson
Civil Design Engineer
Infrastructure and Works
Maitland City Council

**Re: Statement of Heritage Impact & Archaeological Assessment
Scobies Lane Realignment, Oakhampton.**

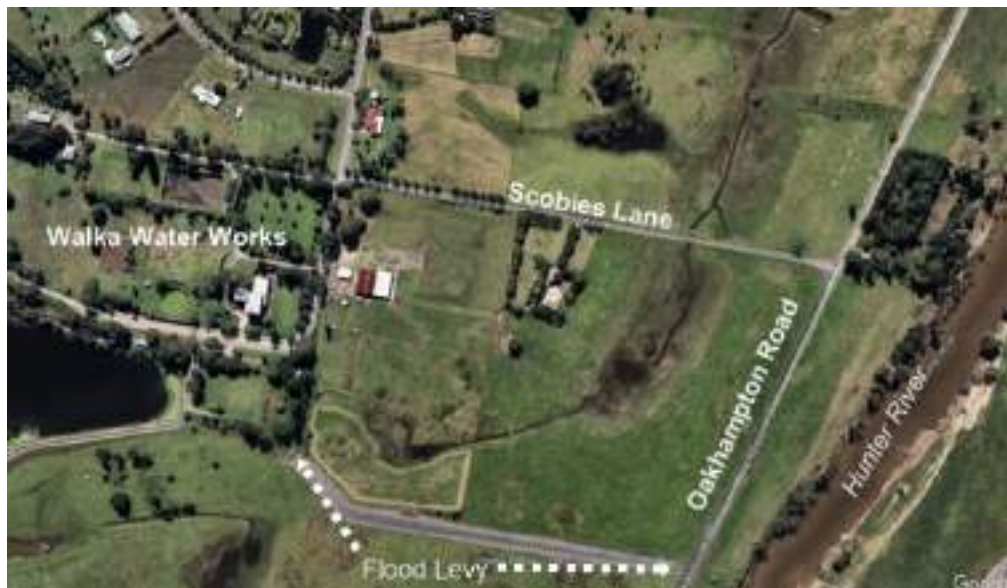
Figure 2 – Aerial view of project site showing the current alignment of Scobies Lane, surrounding features and rural development, including the existing flood levy extending from Oakhampton Road. Source: Google Earth.

A site location plan showing the study site in relation to the city of Maitland is provided in **Figure 1**. An aerial view of the site and surrounding development is shown in **Figure 2**.

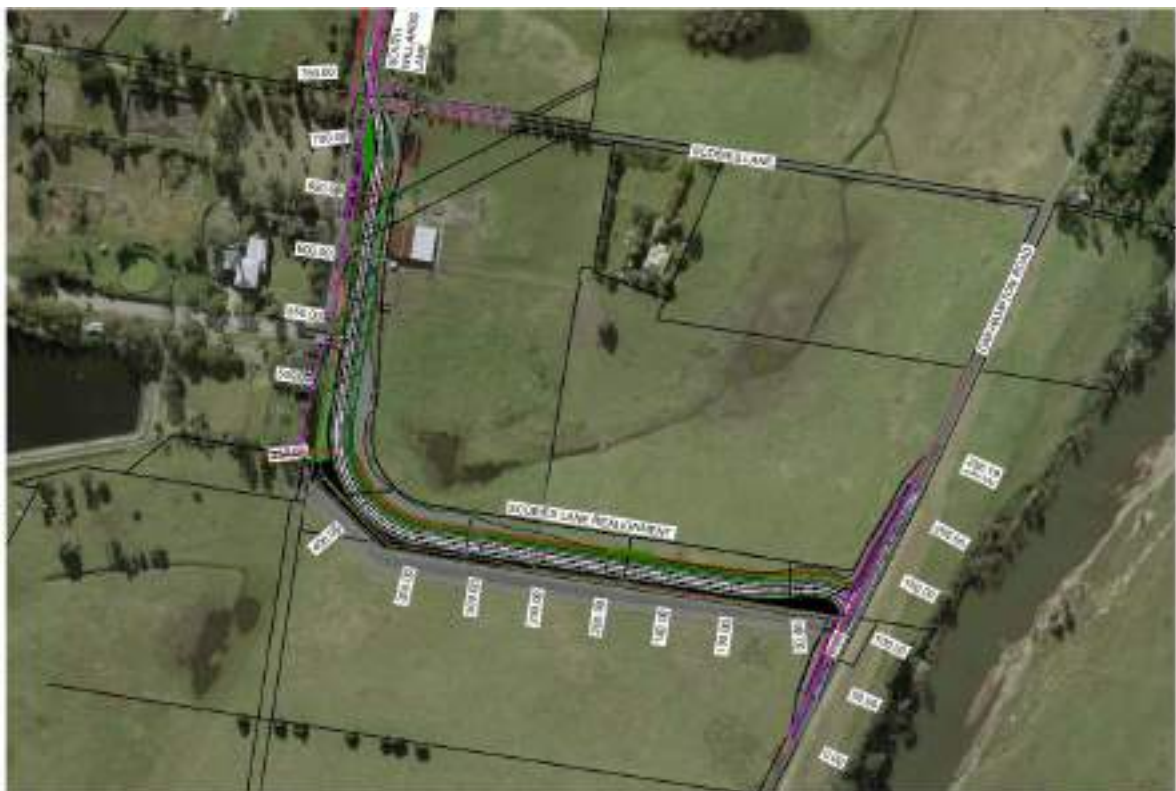
Figure 3 – Plan of proposed stage 1 project works. Source: MCC

Maitland City Council is proposing the realignment of Scobies Lane, Oakhampton to reduce the risk of isolation during a flood event for the residents of neighbouring Oakhampton Heights. A plan showing the design of the proposed realignment is provided in **Figure 3**.

The project would be carried out in stages. Stage 1 for this project is planned to commence in February 2024 and is scheduled to be completed by 30 June 2024. Stage 1 would include construction of an embankment adjacent to the flood control levy, and the formation of an access track which, during this stage of works, would only be used for access during flood events. Future stages of works would involve the completion of the road pavement along the embankment, and the closure of the existing alignment of Scobies Lane.

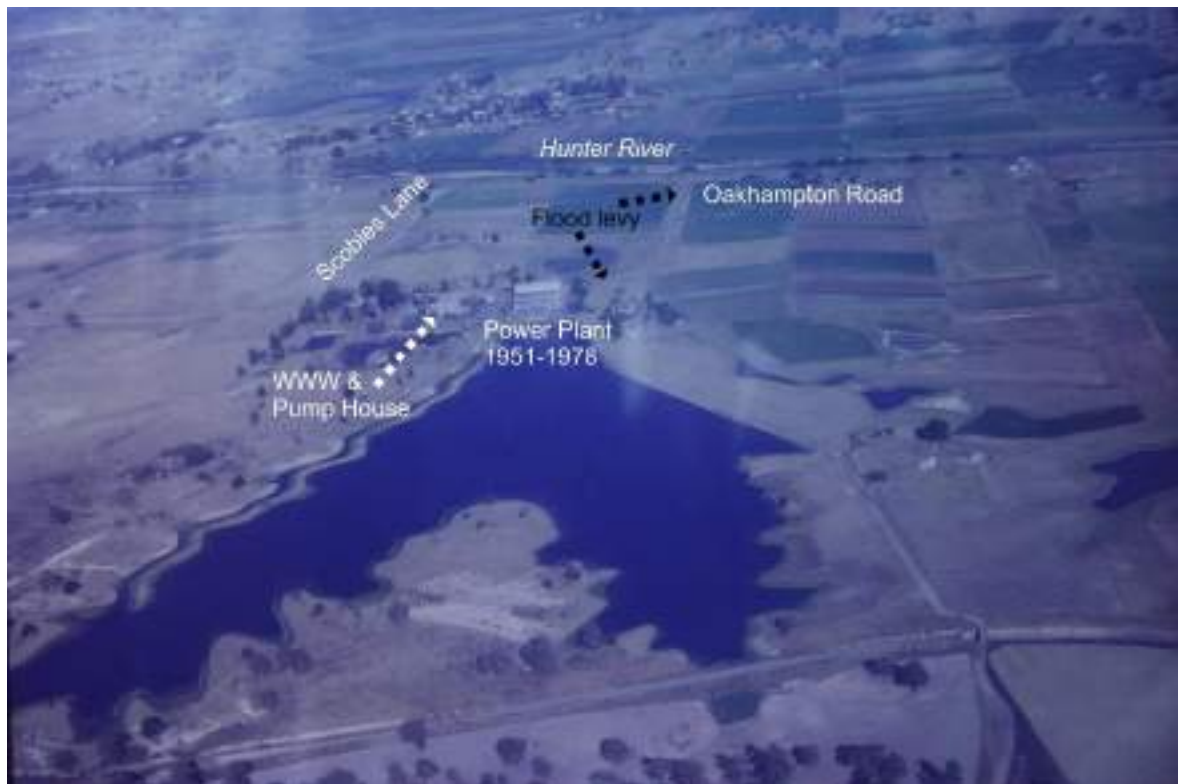
Figure 7 – Aerial view of The Walka Water Works pre 1978 [the date the power plant was dismantled] –looking east to Oakhampton Road and the Hunter River. Source: Picture Maitland

An aerial view of the site prior to the dismantling of the power station in 1978 is shown in **Figure 7**. This image demonstrates the use of surrounding land for farming, with little observable development across the proposed project site, and the presence of the flood levy.

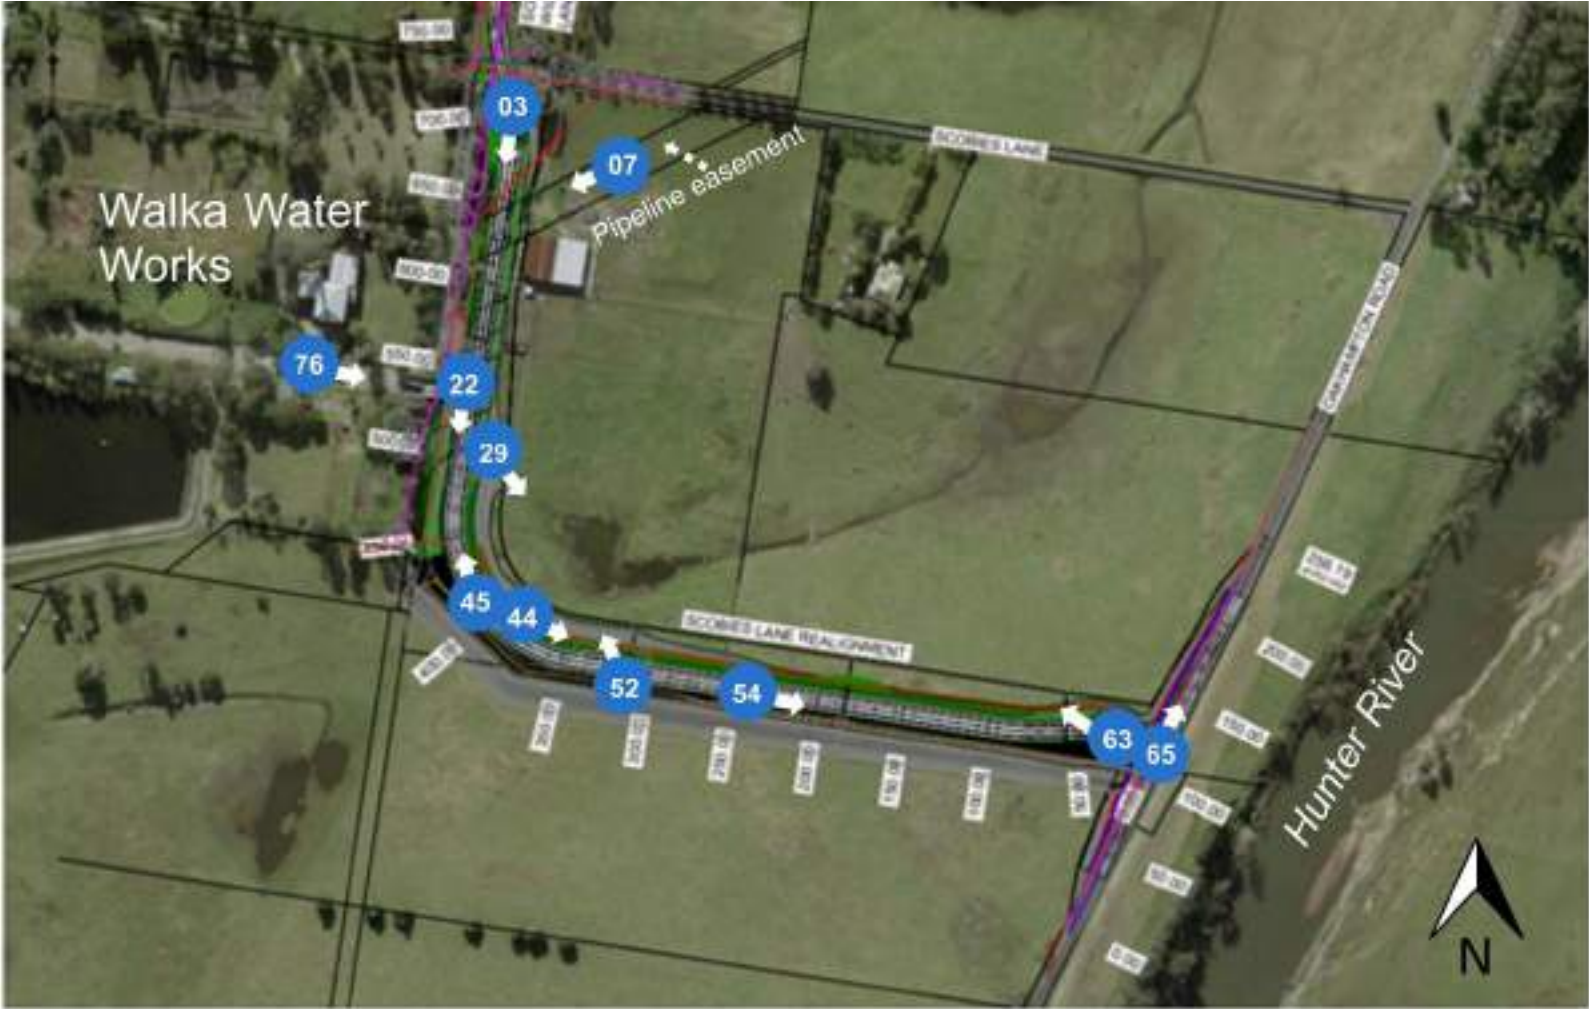
Figure 8 –Proposed Stage 1 works with images showing location and orientation of views. Image numbers align with the full photograph log Appendix 1.

Site inspection images were provided by MCC. A selection of images is provided below (**Figure 8** to **Figure 19**) and the full photographic log prepared by MCC is attached as **Appendix 1**. Commentary below, within the image captions, provides additional detail on site context. For brevity, Walka Water Works has been abbreviated to WWW within the captions.

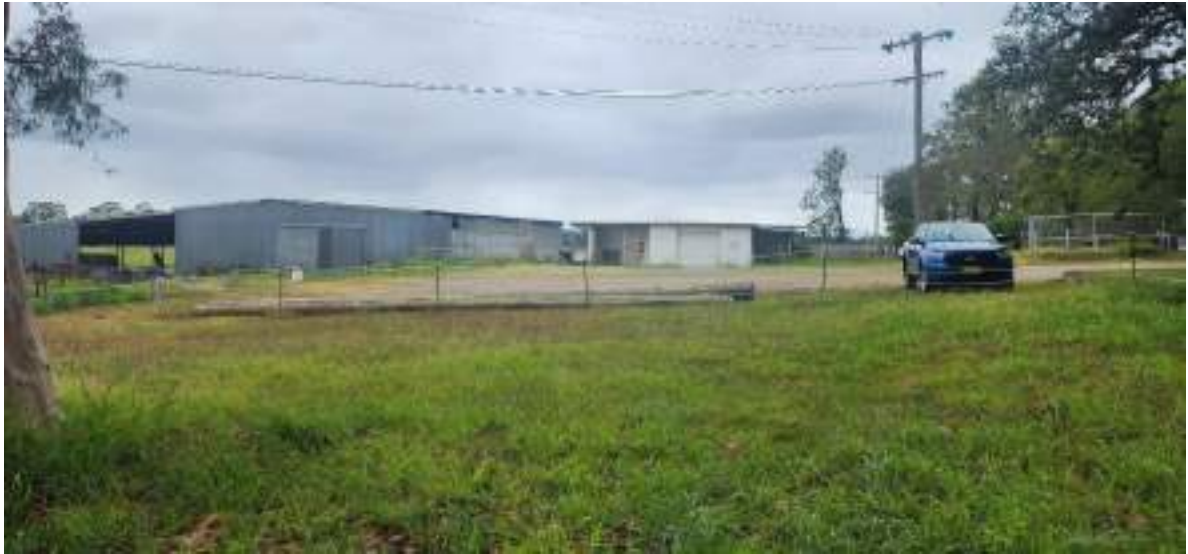
Figure 9 – (refer Figure 9 Image 03). Looking south along proposed line of re-alignment from the current Scobies Lane. The white building (former dairy building) is currently being demolished as it is within the proposed new alignment.

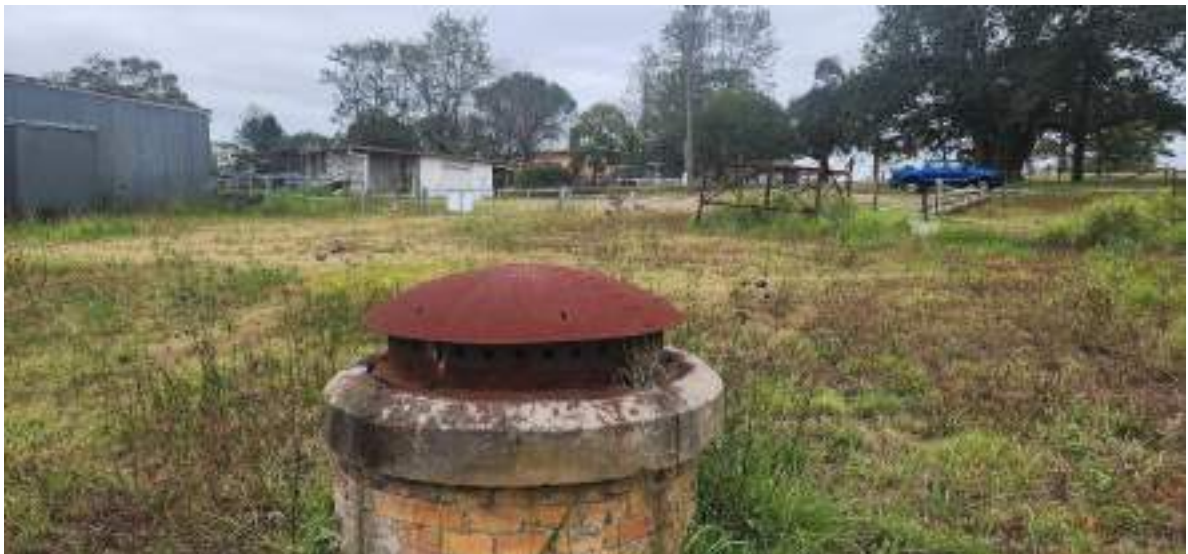
Figure 10 – (refer Figure 9 Image 07). Located within the Hunter Water easement, and located outside the area of projects works, this structure appears to be a remnant of the former intake pipeline to the Walka Water Works. Possibly an air vent and/or inspection portal. Further investigation is required to identify purpose and provenance. The presence of this remnant may provide an indication that some associated remnant works remain underground. MCC is in the process of acquiring the easement from Hunter Water. Historical records mention an inspection man hole with rickety iron ladder located east of the pump house.

Of note to the current study, it appears that the intake and outlet pipes could be inspected via a man hole with rickety iron ladder located immediately east of the pump house¹². There is potential for the structure identified within the intake pipe easement (refer Figure 10) to also be an inspection portal.

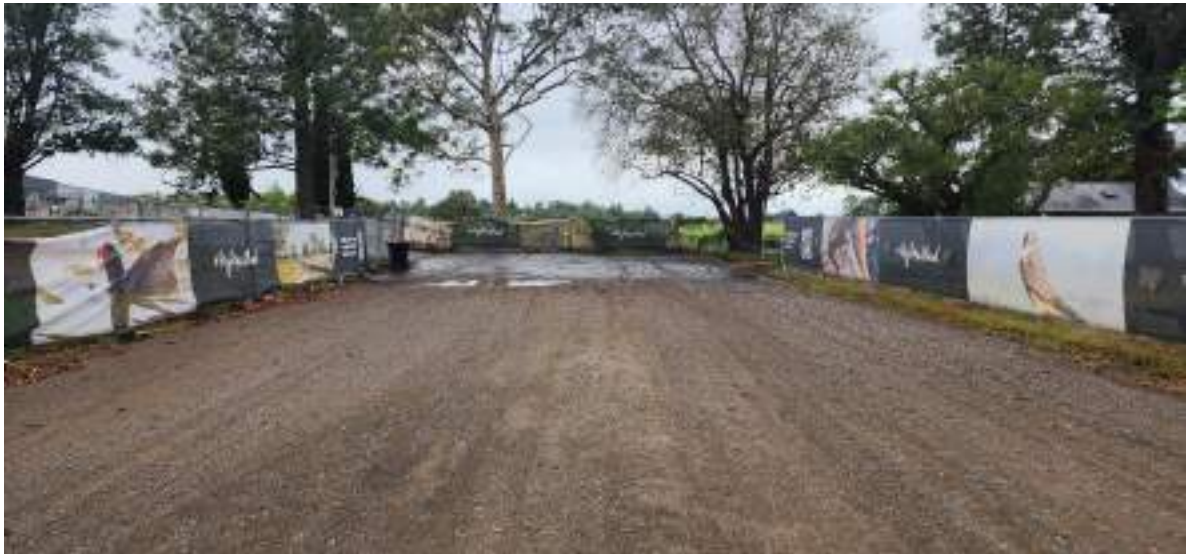
Figure 11 – (refer Figure 9 Image 76). Looking east along WWW internal road to the location of the proposed new alignment beyond the fencing.

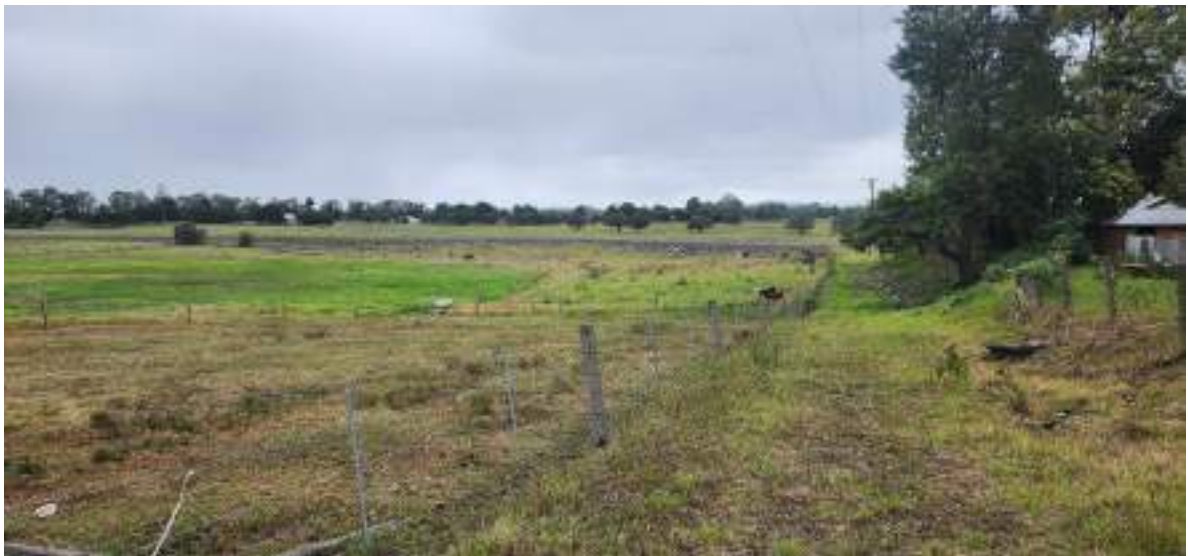
Figure 12 – (refer Figure 9 Image 22). Looking south along the proposed alignment of the proposed embankment with gabion structure of the existing flood levy visible in the distance.

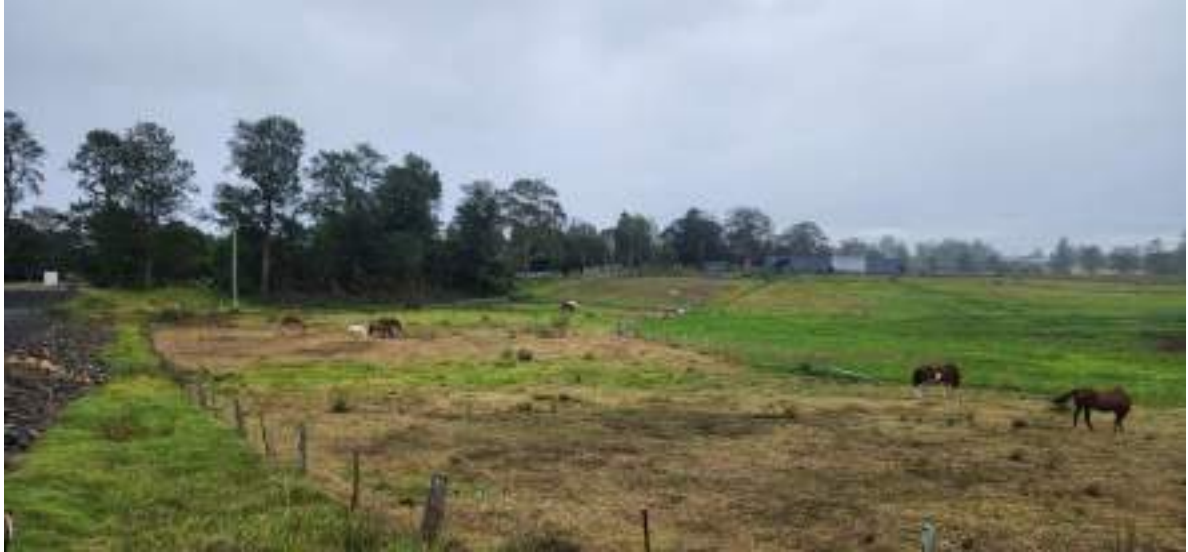
Figure 13 - (refer Figure 9 Image 45). Looking north-west from the existing flood levy along the proposed line of embankment for the Scobies Lane realignment. The WWW pumphouse is difficult to see but is just beyond the tree line.

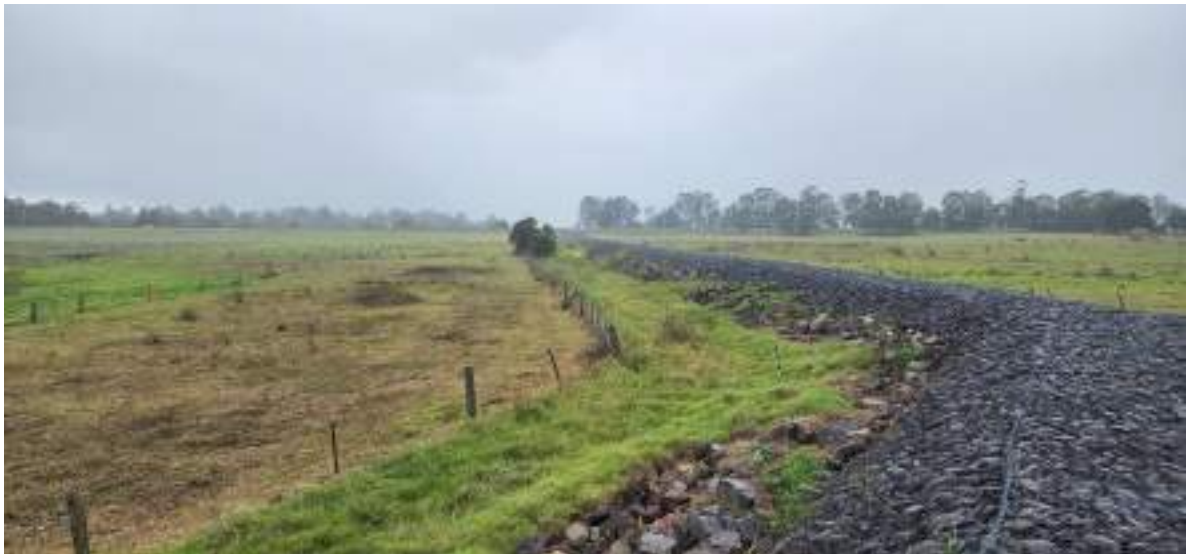
Figure 14 – (refer Figure 9 Image 44). Looking east to Oakhampton Road along line of existing levy bank.

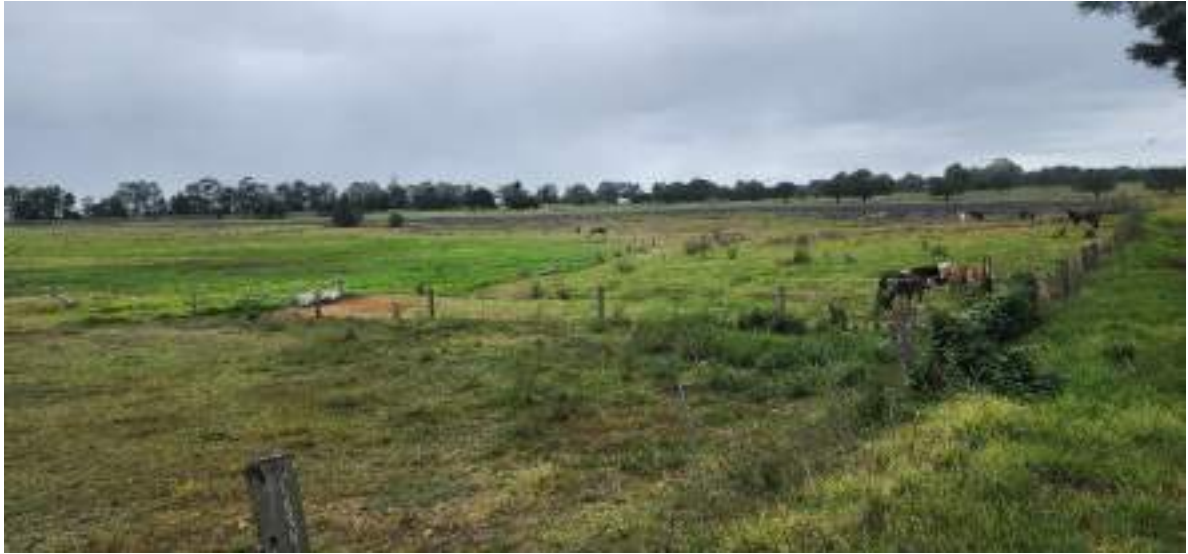
Figure 15 - (refer Figure 9 Image 29). Context view of the low-lying land adjacent to the WWW site looking south-east with the existing flood levy middle distance.

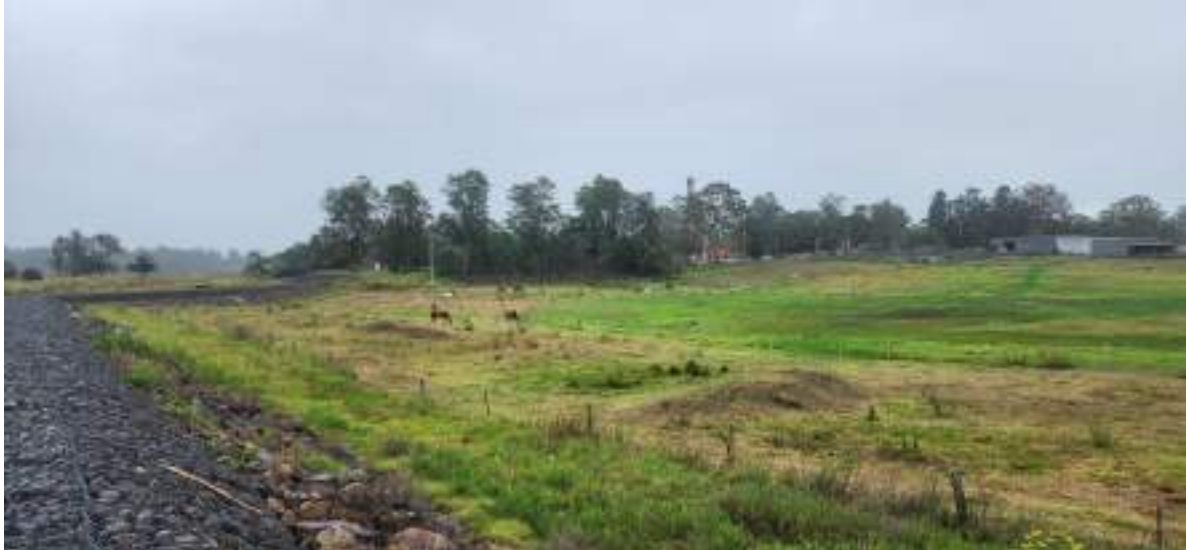
Figure 16 - (refer Figure 9 Image 52). Looking north-west from flood levy to proposed new Scobies Land roadway adjacent following the existing flood levy and along the eastern boundary of the WWW site (along tree line) with the WWW chimney stack visible beyond tree centre right of view.

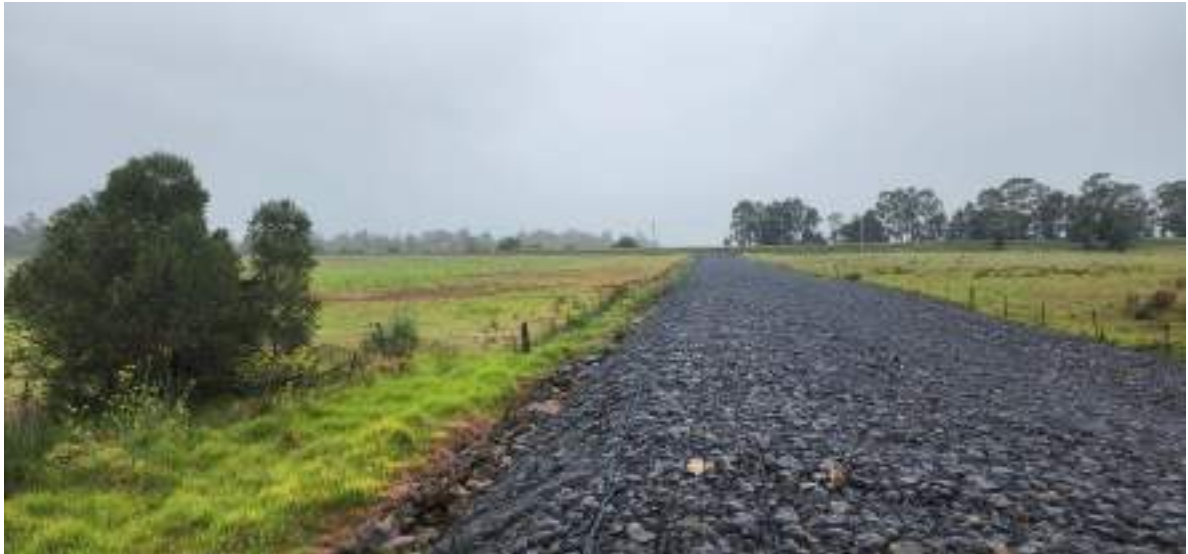
Figure 17 - (refer Figure 9 Image 54). Looking east along the flood levy to the Oakhampton Road. The proposed new roadway would lie to the left of the levy.

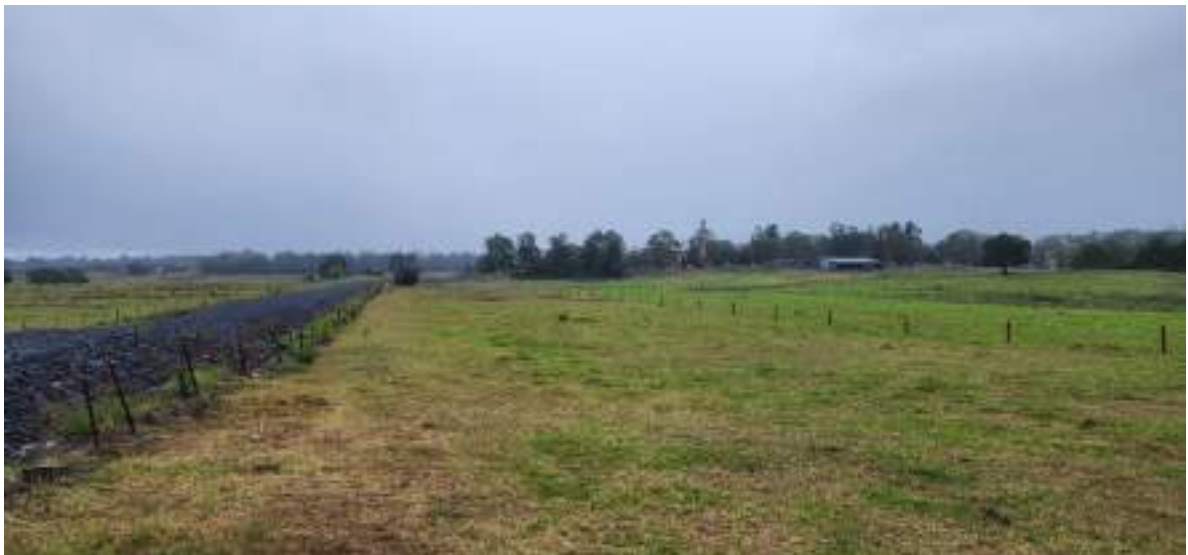
Figure 18 - (refer Figure 9 Image 63). Looking west from Oakhampton Road along line of proposed embankment to the right of the flood levy . The chimney stack of the WWW is just visible centre right of view.

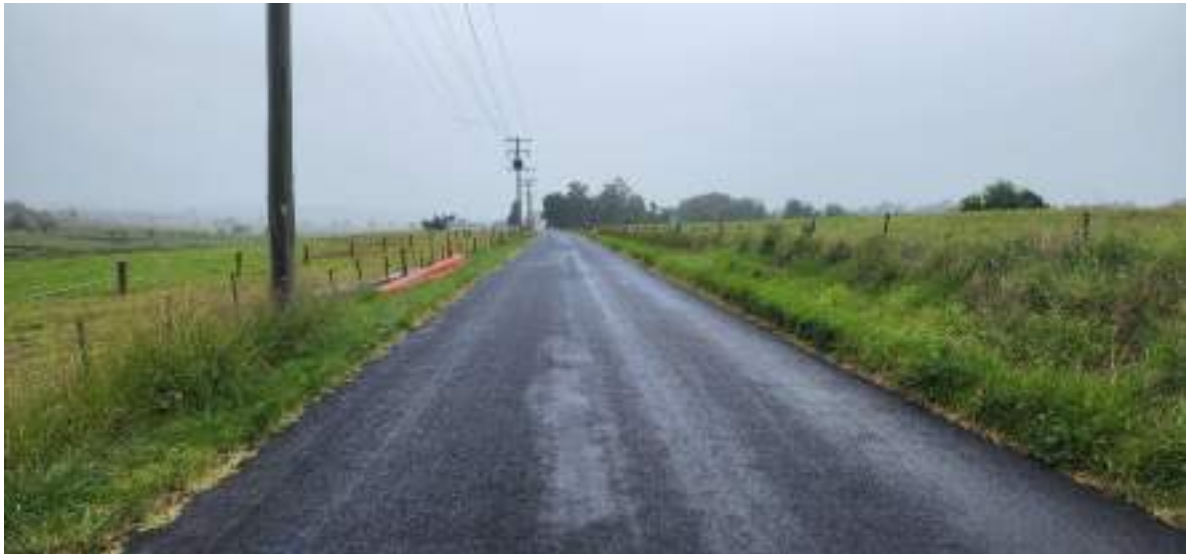
Figure 19 - (refer Figure 9 Image 65). Looking north along Oakhampton Road showing the rural context of the area, at the intersection of the proposed new intersection with Scobies Lane.

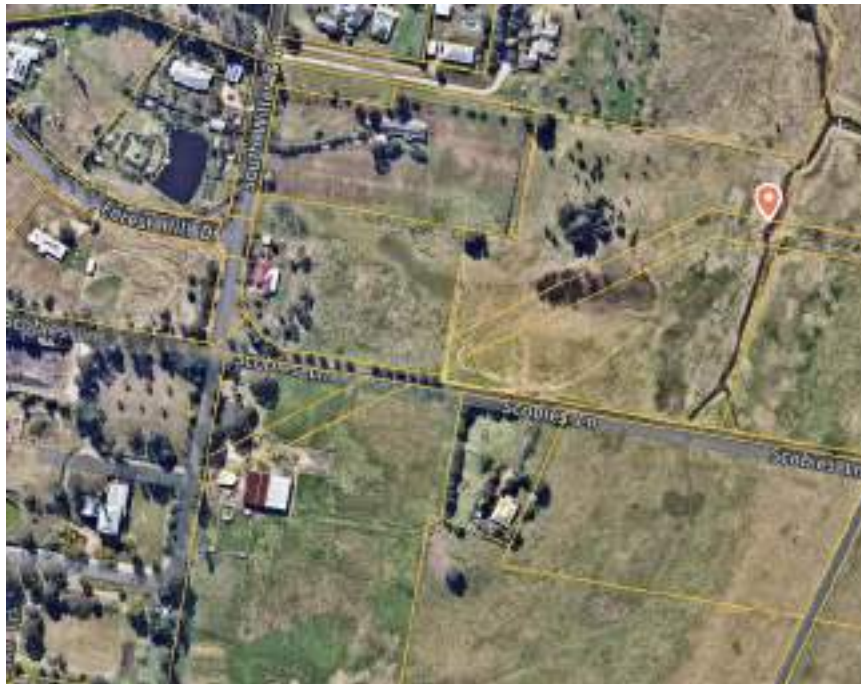
Figure 23 – Location of exposed pipework (orange pin) across a drainage line located to the north of the current alignment of Scobies Lane, and well beyond any risk of impact by the proposed Stage 1 works. The easement created for the line of the intake pipes is still clearly defined on cadastral plans. The extent of the presence of remnant pipework within the ground of the easement is not currently known.

In response to reports from the public of leaking pipework, Hunter Water advised MCC of the presence of exposed pipework across a drainage line north of Scobies Lane Oakhampton (**Figure 23**). It was recognised that the line had been long abandoned, and it was correctly identified as the remnants of the suction main that pumped water from the Hunter River to the Walka Water Works.

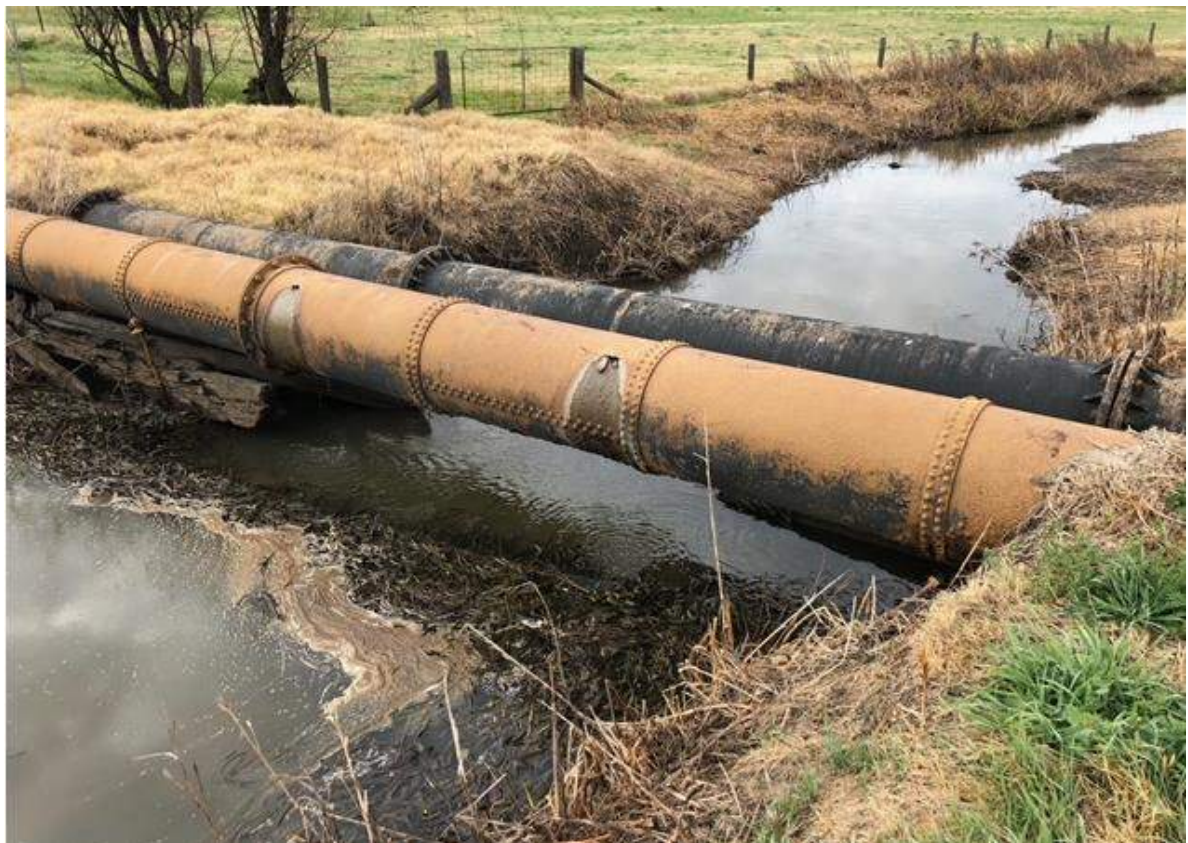
Figure 24 – Detail of the reported leaking pipes showing two different types of pipe manufacture, cast iron and rivetted steel. Source: Hunter Water.

Information available to substantiate the provenance of the pipes is contained in various sources referenced during the current study. While this does not provide a comprehensive investigation or an assessment, historical resources appear to substantiate the physical evidence by location and the characteristics of the exposed pipes.

Pumps located in the main pump house at the north-eastern end of the reservoir drew water from the Hunter River through a suction main 5'5" in diameter which was housed in a tunnel on account of the raised level of the ground between the pumps and the Hunter River. The suction pipe within the river was protected by a strainer and could be raised or lowered to suit the water level. Usually, the water from the Hunter was sufficiently clear to be pumped directly into the settling tank. On occasions when the water was too muddy it was pumped from the river to an outlet at the western end of the reservoir and from an intake at the eastern end to the settling tank¹¹.

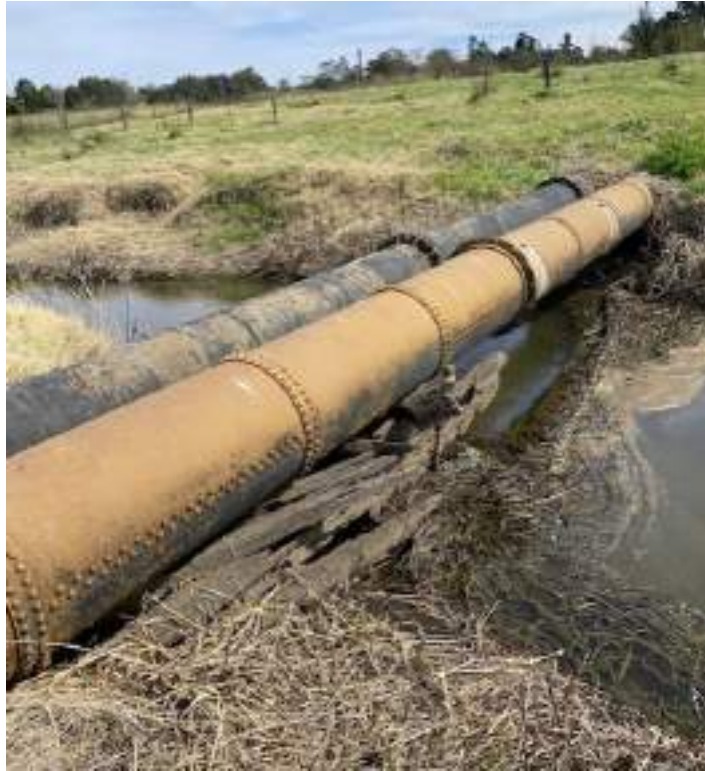
Figure 25 – Alternative view of the pipes where the timber supports appear to be rotted and failing. Source: Hunter Water.

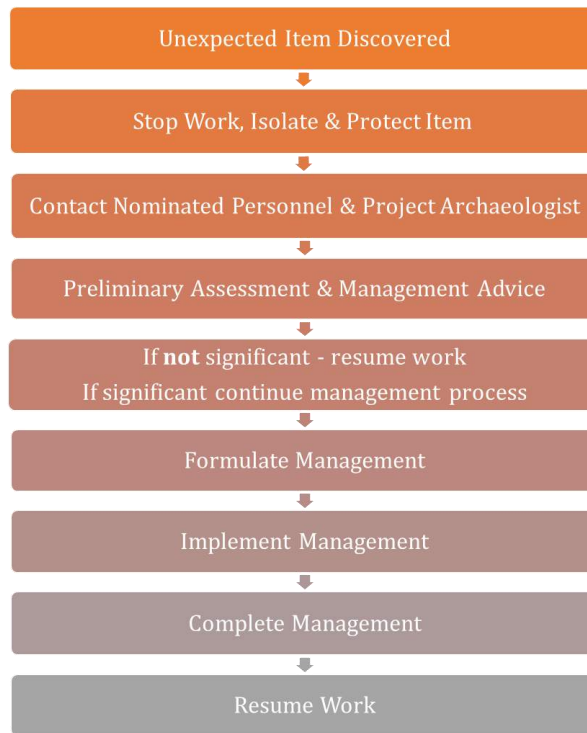
A flow chart showing the procedure to follow for unexpected finds is presented graphically below. This procedure should be included in site inductions and in briefings for all site personnel.

A suitably qualified specialist/archaeologist should be retained in an on-call during project works to provide an assessment and guide management should unexpected heritage or archaeological items be discovered or suspected.
