Geotechnical Investigation Report - Scobies Lane, Oakhampton Heights

MCC 2023/24 Capital Works Program

304100979-005

Prepared for
Maitland City Council

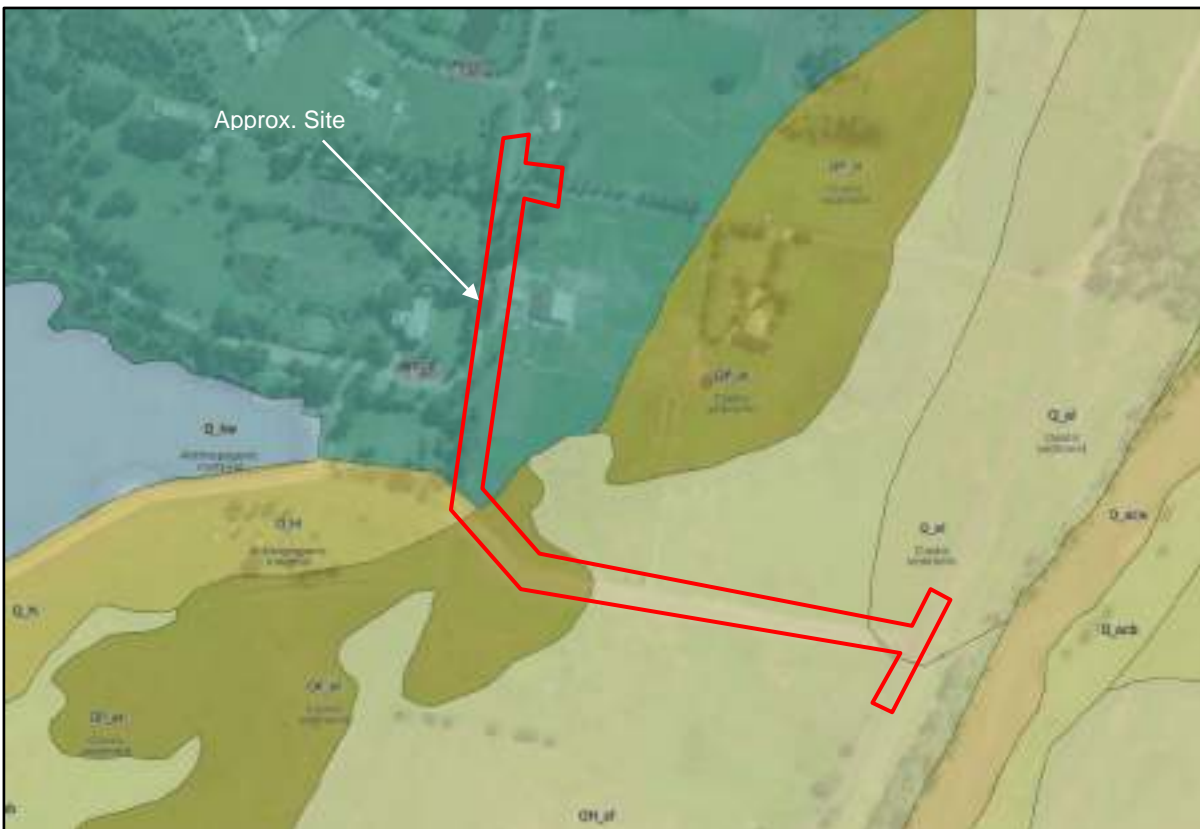
Figure 2-2 NSW Seamless Geology extract (site denoted by red outline)

Approximate Ch. 450 to 820m of the proposed flood access road is underlain by the *Mulbring Siltstone* (Pmtm) formation of the Maitland Group, known to comprise predominantly siltstone and claystone rocks and soils formed from decomposition of these rocks.

The approximate site bounds are shown overlaid onto the regional geology extract in Figure 2-2 below.

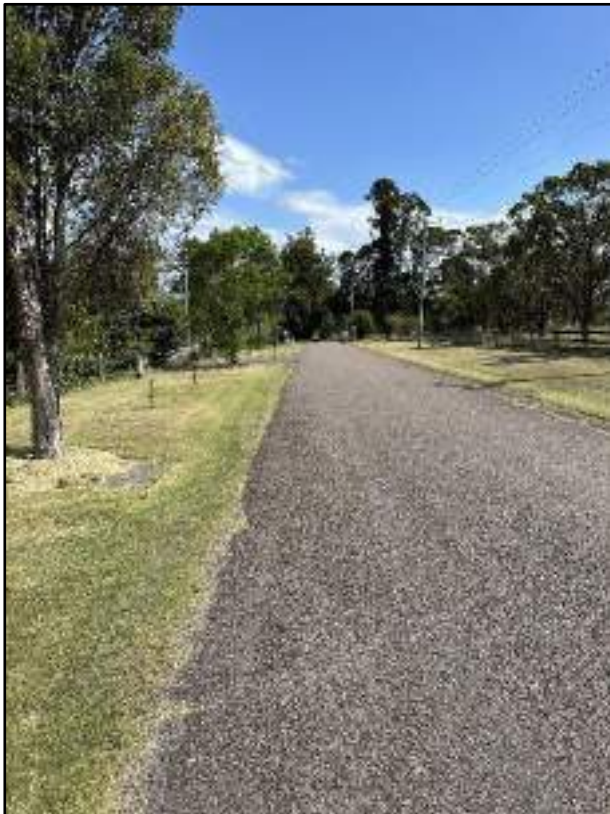
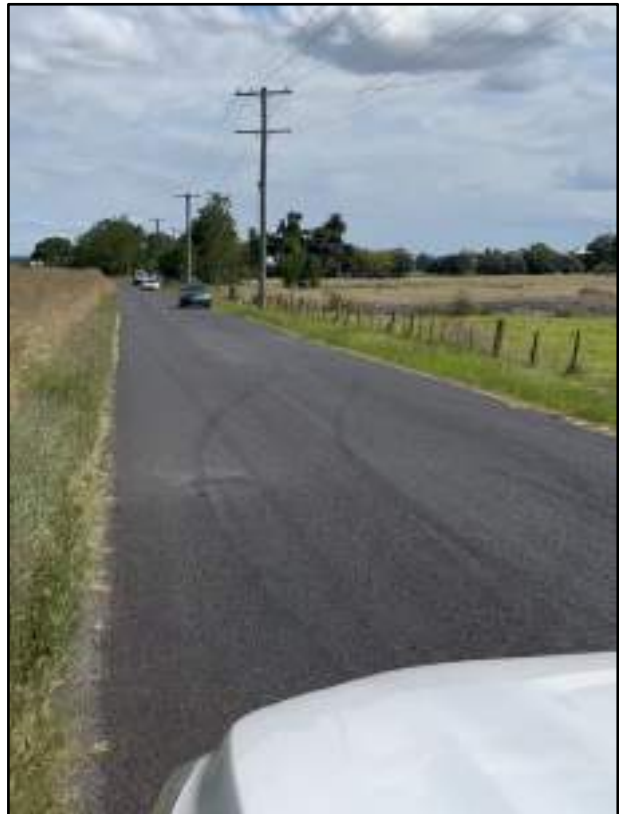
Figure 3-2 S Willards Lane general view, looking south

Road Section	Existing Surface Condition	Pavement Condition / Defect Description
S Willards Lane	Reasonable	Existing S Willards Lane pavement section comprised a spray seal wearing course, and concrete gutter along the NB shoulder only. No significant surface defects were identified along the section of road, outside of edge defects along the SB shoulder associated with the lack of drainage infrastructure / edge support.
Scobies Lane	Poor	Existing Scobies Lane pavement section (Ch. 0 to 82m) comprised a spray seal wearing course with no kerb and gutter along both sides. Observed defects comprised the following: <ul style="list-style-type: none"> ▪ Significant seal edge breaking along the EB lane shoulder, with former patchwork evident. ▪ Patched potholes within both travel lanes. ▪ Minor rutting and seal flushing along the existing wheel paths.
Oakhampton Road	Reasonable	Existing Oakhampton Rd pavement section (Ch. 0 to 600m) comprised a spray seal wearing course with no kerb and gutter along both sides. Observed defects comprised the following: <ul style="list-style-type: none"> ▪ Minor isolated potholes observed along the alignment, with patchwork undertaken. ▪ Patched potholes within both travel lanes. ▪ Minor rutting along the existing wheel paths. ▪ No significant edge breaking was observed.

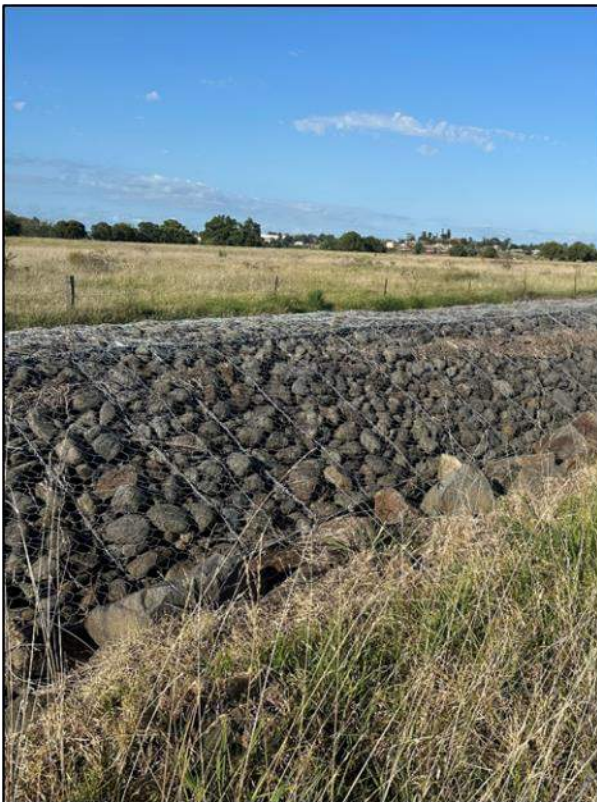
Figure 3-5 Flood control levee, looking east

- > Flood control levee constructed from rock fill extending east-west, parallel to the proposed alignment, extending from Oakhampton to the former Walka Waterworks pumping station. Rockfill levee noted to comprise:
 - Reno mattress lining, with cable and concrete post tie-down support.
 - Rockfill consisted of rounded, cobble to boulder sized material.
 - Embankment height predominantly from 0.5 to 1.5m, with heights in excess of 2m where levee spans the existing gullies.
 - Batter angles to the flood levee were generally in the order of 2H:1V on the northern side, and approx. 5H:1V on the southern side.
- > Existing small diameter culvert identified below the rockfill levee at approximately Ch. 180 of the proposed alignment, with culvert noted to be partially blocked by rockfill.

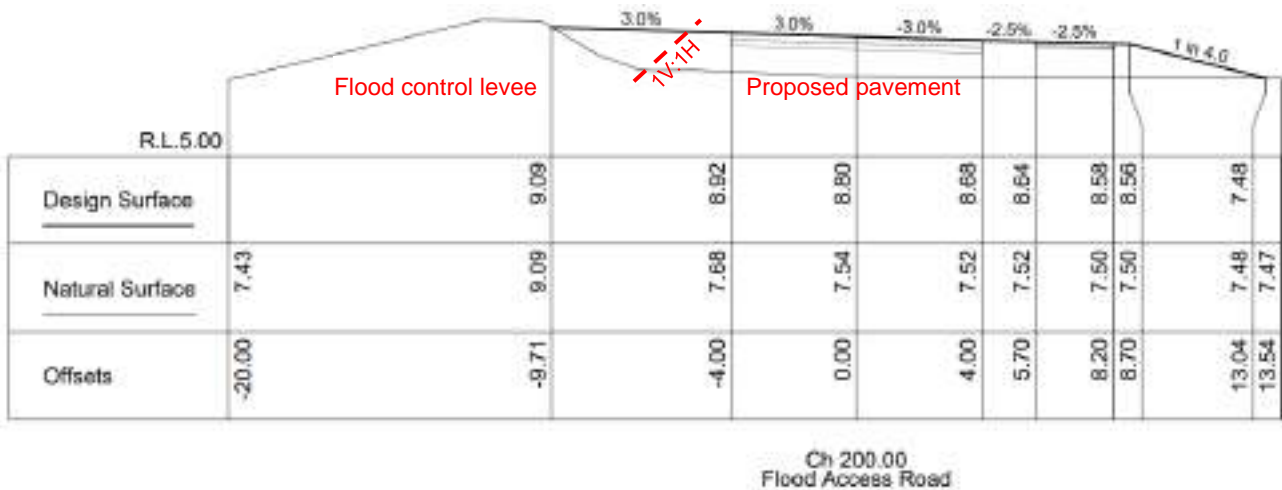
Figure 6-1 Flood access road design plan extract

- > The pavement shall not be located closer than 1V:1H zone from the toe of existing flood control levee (denoted by dashed red line in Figure 6-1 below), which may result in widening of the proposed embankment shown in the current design.

- > Removal of any uncontrolled filling and surface vegetation within the existing levee footprint is required prior to embankment construction, including adjustment of / reinstating roughly placed boulder size rock fill within the existing Zone 3A to ensure it is a suitable embankment foundation.
- > Geofabric is recommended to be placed over the existing flood control levy surface (predominantly rock fill and reno mattresses) prior to fill placement.
- > Existing culvert pipes beneath the levee require extension underneath the proposed fill embankment.

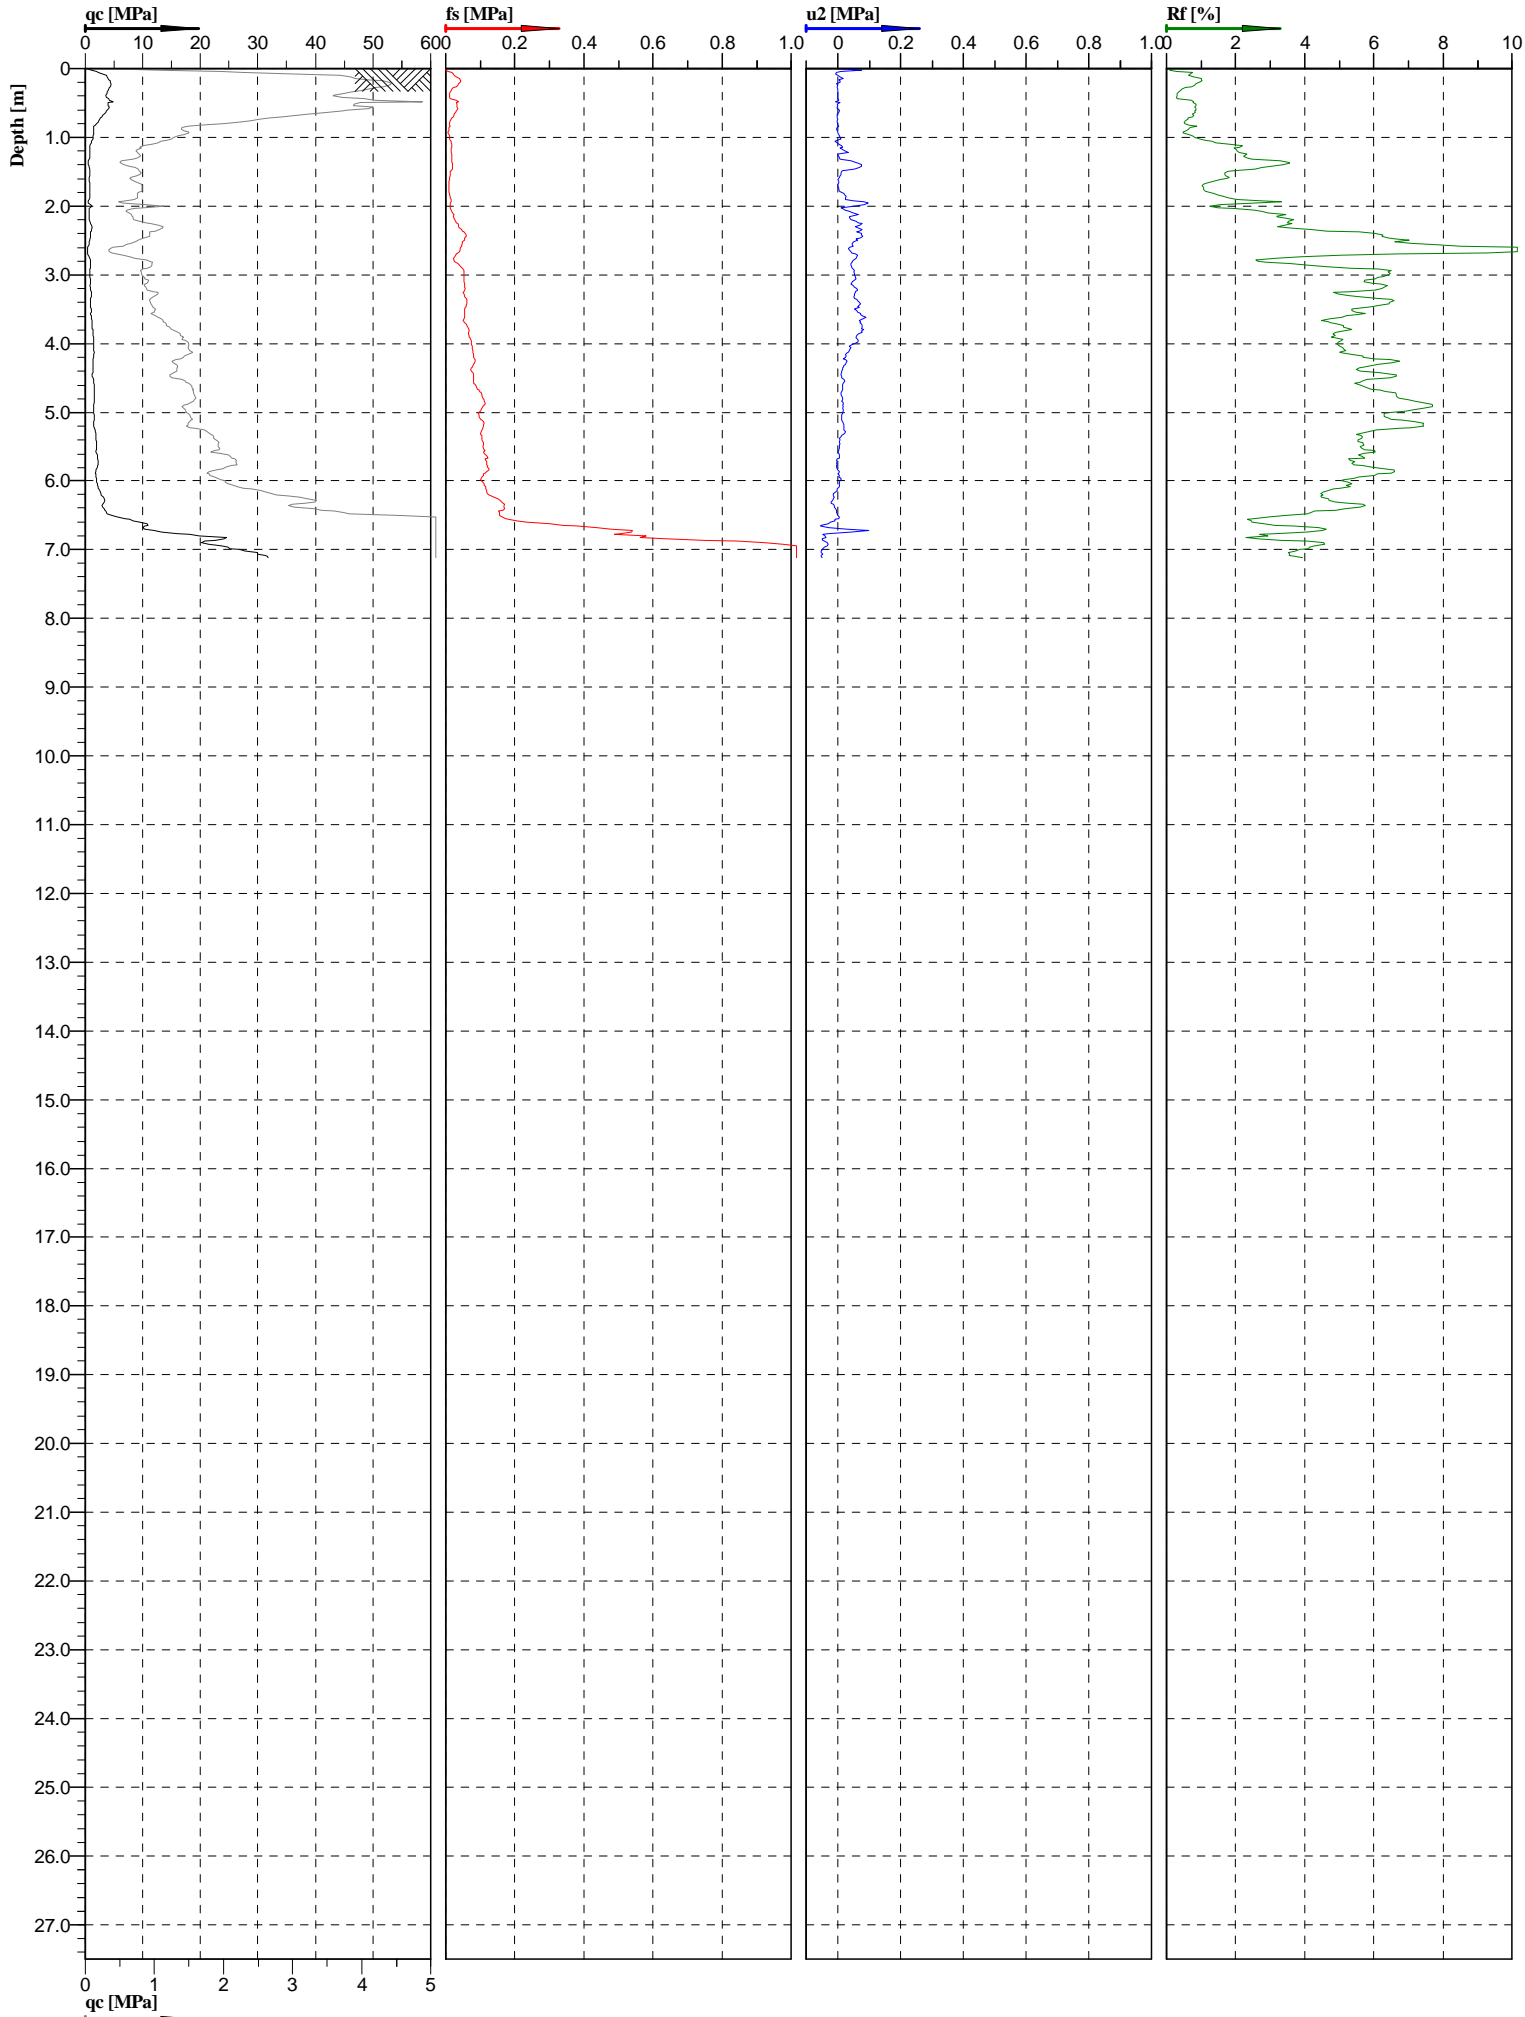
Location: South Willards Lane, Oakhampton	Position: X: 0.00 m, Y: 0.00 m	Ground level: 0.00	Test no: CPT05
Project ID: 304100979	Client: Stantec	Date: 8/02/2023	Scale: 1 : 110
Project: Geotechnical Investigation		Page: 1/1	Fig:
		File: CPT05.cpt

Cone No: 4254
 Tip area [cm²]: 10
 Sleeve area [cm²]: 150

Subsurface conditions along the proposed flood access road have been summarised below based on encountered materials within boreholes (BH01-BH07) and interpreted material composition from CPT's (CPT01-CPT05) using the CPT-based soil behaviour type classification system (*Robertson, 2010*). Detailed engineering logs and CPT results are attached within Appendix B.

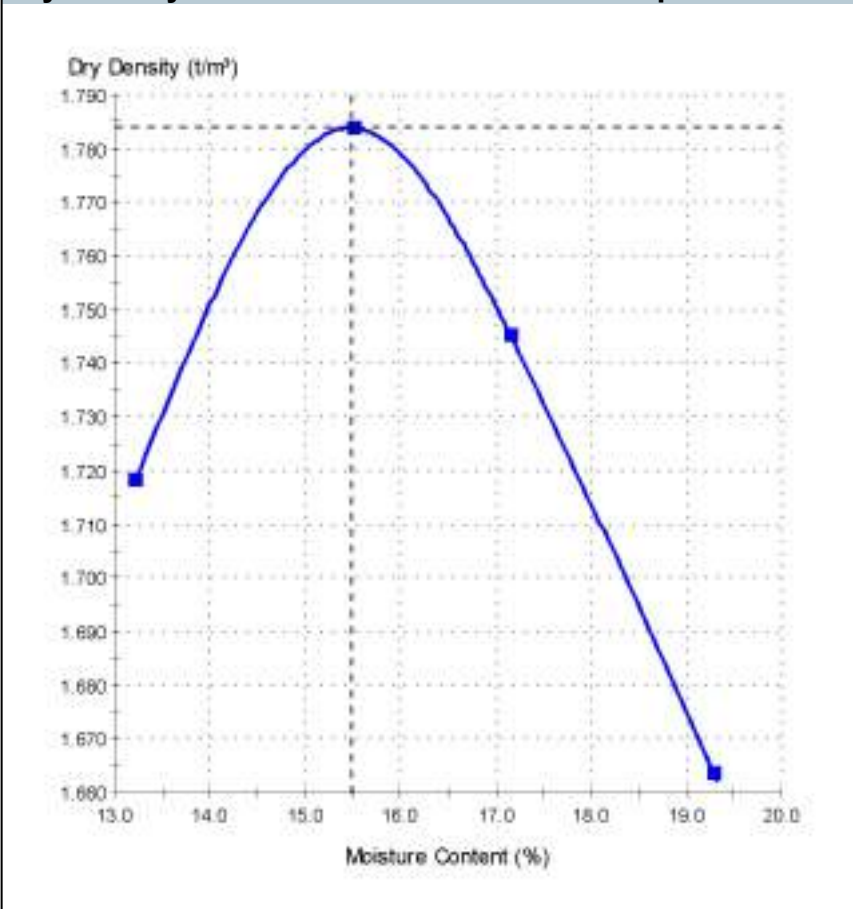
Dry Density - Moisture Content Relationship

Sample ID: NEWC22S-10766 Sampling Method: Submitted by client*
Date Sampled: 6/12/2022 Material: Existing Ground
Date Submitted: 13/12/2022 Source: On-Site
Date Tested: 31/01/2023 Specification: No Specification
Project Location: Various Locations
Sample Location: Scoobies Lane, NSW, TB02 - 0.5 - 1.0m

AS 1289.5.1.1
Standard MDD (t/m³): 1.78
Standard OMC (%): 15.5
Retained Sieve (mm): 19.0
Oversize Material (%): 5
Curing Time (h): 72
LL Method: Visual / Tactile

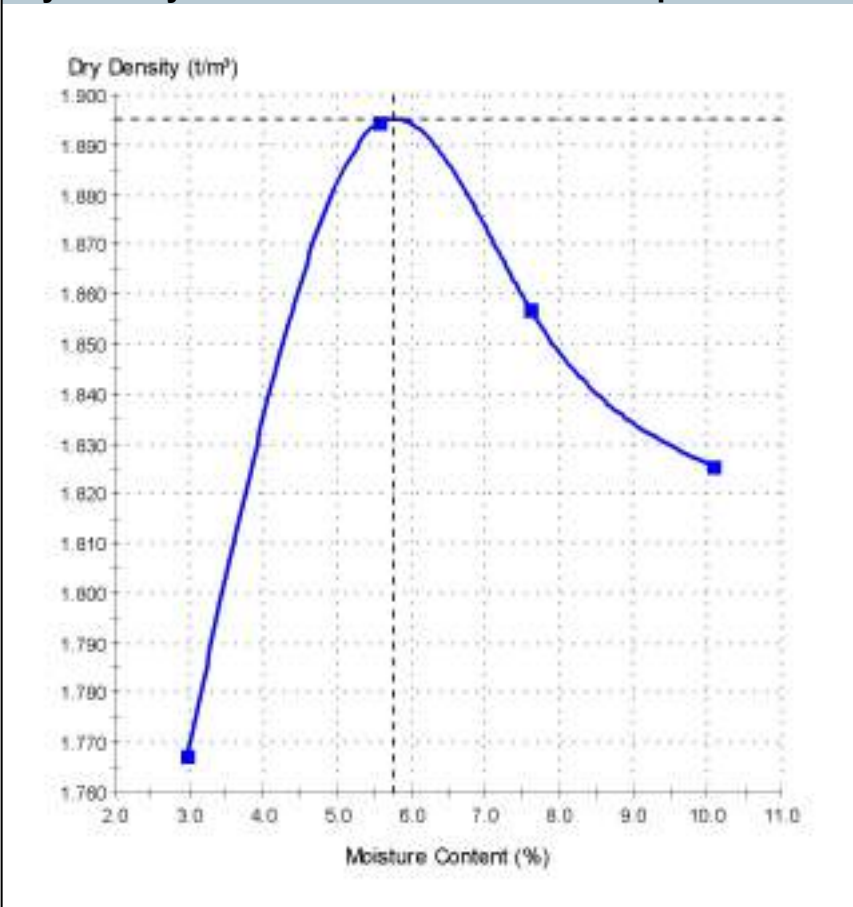
Dry Density - Moisture Content Relationship

Sample ID:	NEWC22S-10767	Sampling Method:	Submitted by client*
Date Sampled:	6/12/2022	Material:	Existing Ground
Date Submitted:	13/12/2022	Source:	On-Site
Date Tested:	31/01/2023	Specification:	No Specification
Project Location:	Various Locations		
Sample Location:	Scoobies Lane, NSW, TB04 - 0.7 - 1.0m

AS 1289.5.1.1
Standard MDD (t/m³):	1.90
Standard OMC (%):	6.0
Retained Sieve (mm):	19.0
Oversize Material (%):	2
Curing Time (h):	25
LL Method:	Visual / Tactile
