FOUNDATION
EARTH
SCIENCES

PRELIMINARY ACID SULPHATE SOIL ASSESSMENT
(PASSA)

39-41 Fairfax Street, Rutherford NSW

Greentree Projects

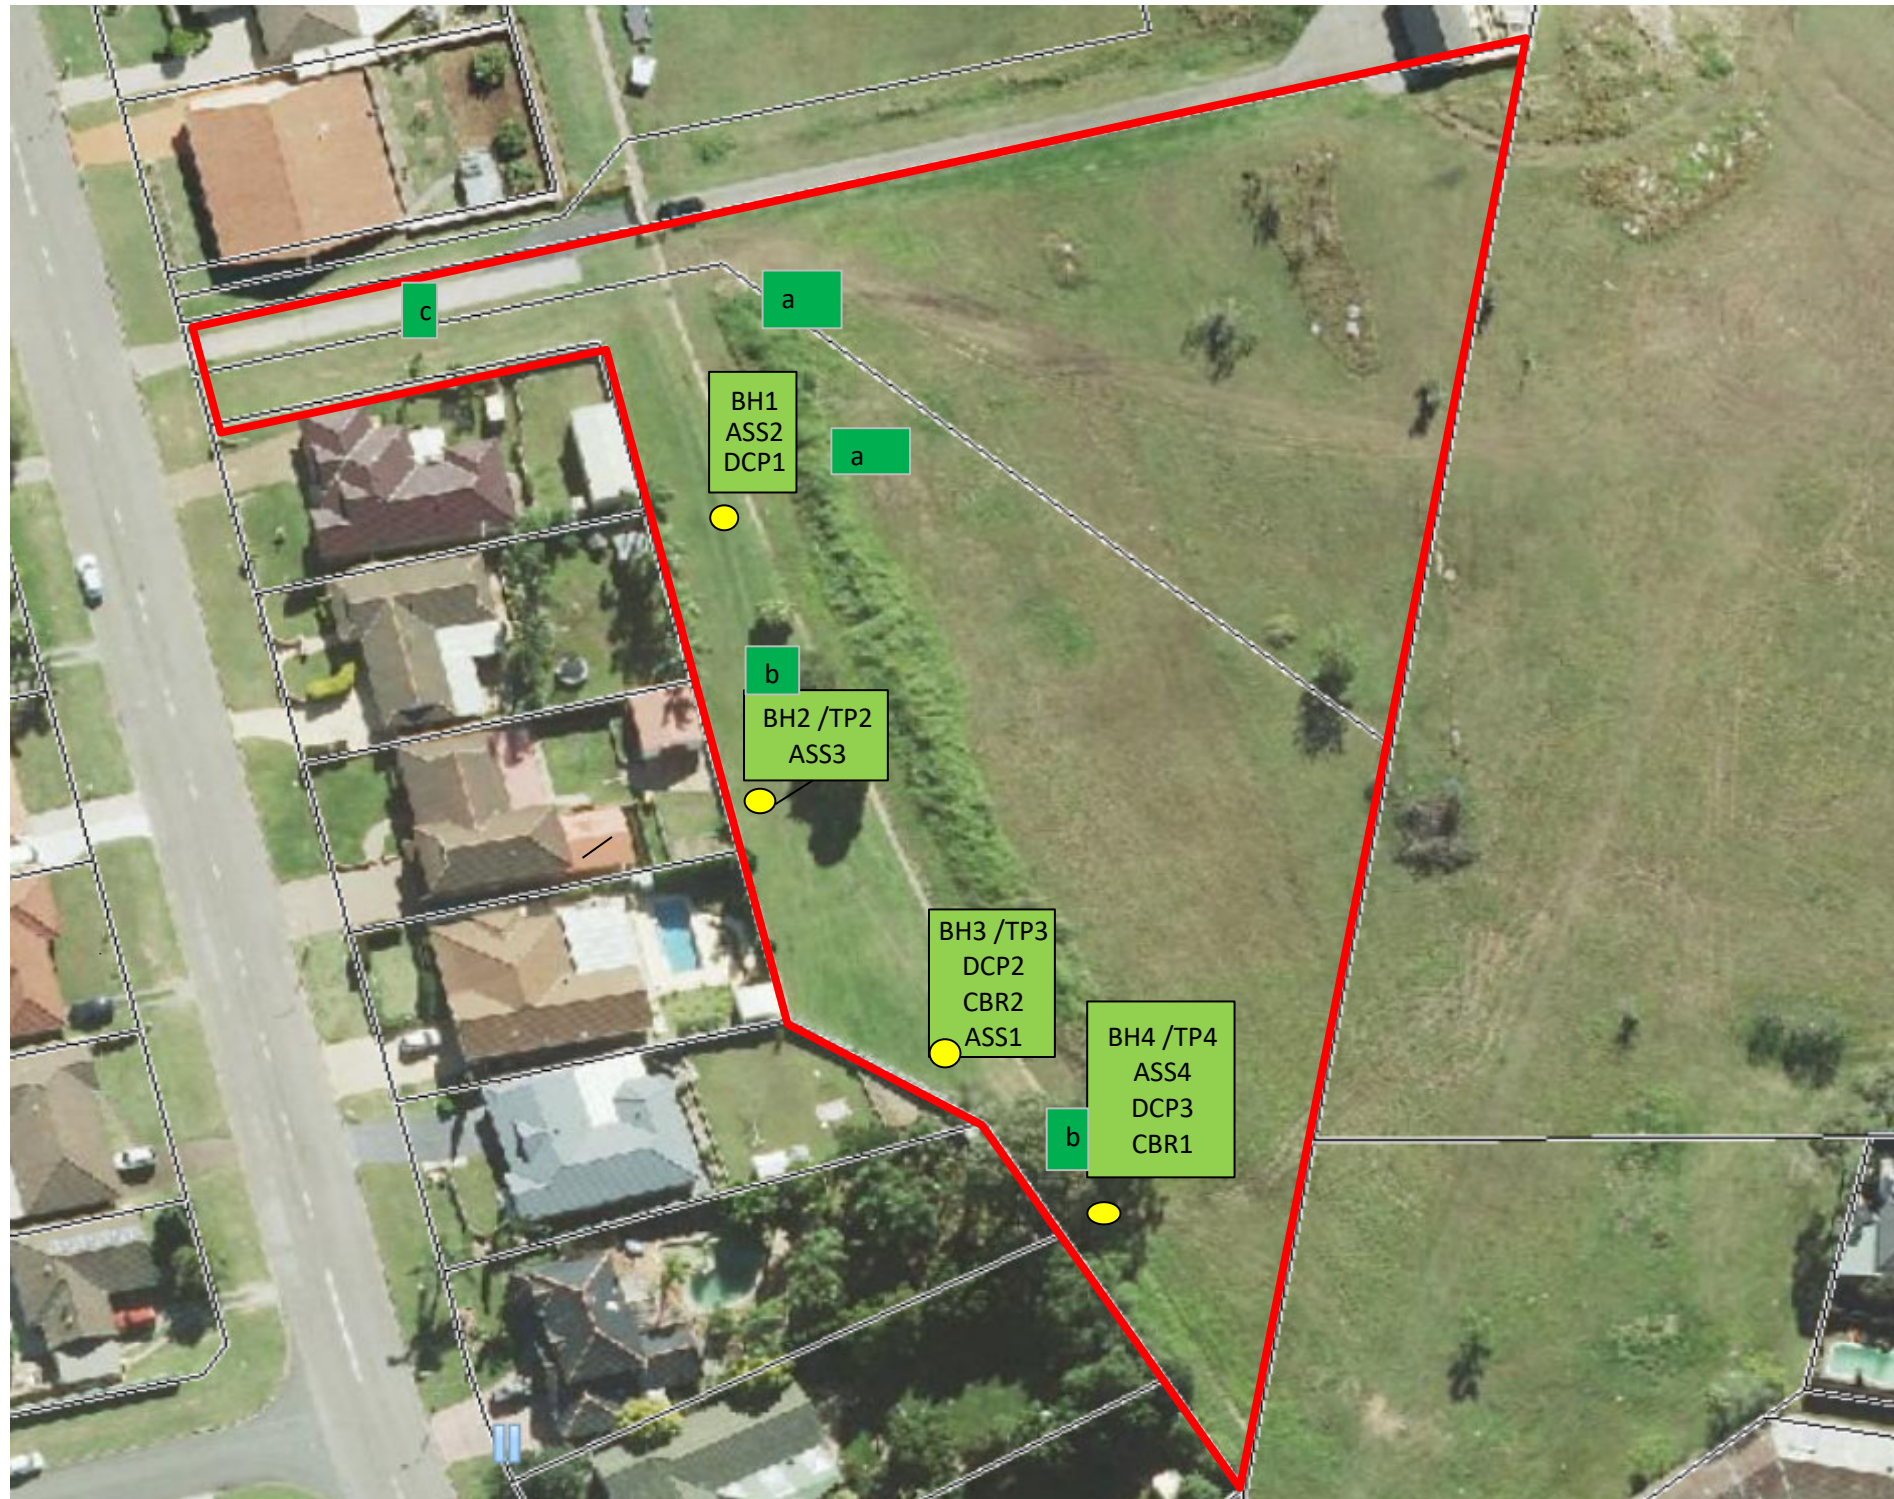
FIGURE 2: SITE FEATURES & BOREHOLE LOCATION PLAN

Feature No	Details
a	Fences
b	Tree
c	Driveway

Key	
Site Location	
Borehole Location

A soil sampling and analysis program was used to consolidate the nature and degree of Acid Sulphate Soils present in the surface and subsurface geology. Samples were collected from four (4) boreholes within the site. The borehole locations are presented in **Figure 2 – Site Features and Borehole Location Plan**.
