Report on
Preliminary Site Investigation (Contamination)

Due Diligence Assessment - September 2021
Lots 19-23 DP746311
Bungaree Street, Maitland

Prepared for
Eagers Automotive Limited

Project 18412.01
March 2024

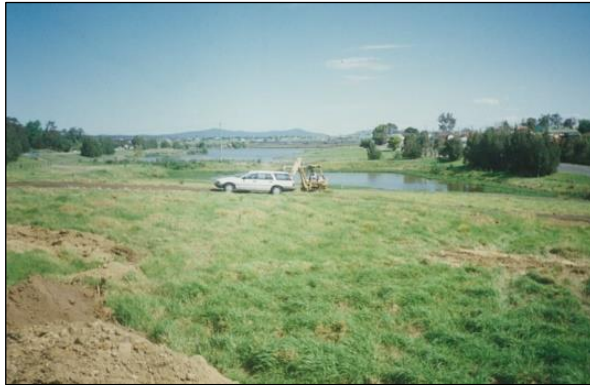
Figure 1: Central and southern portion of the site and existing surface water body (1995)

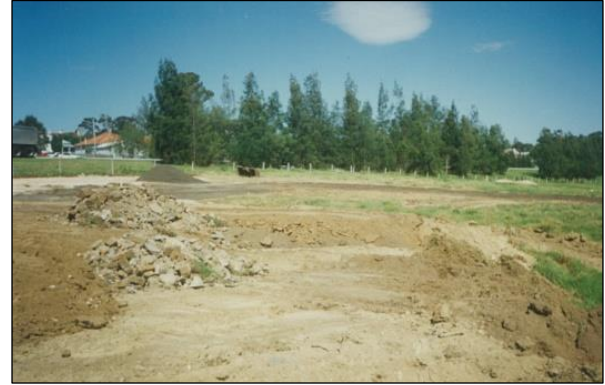
Figure 2: Stripped surface soils in the northern / north-eastern part of the site (1995)

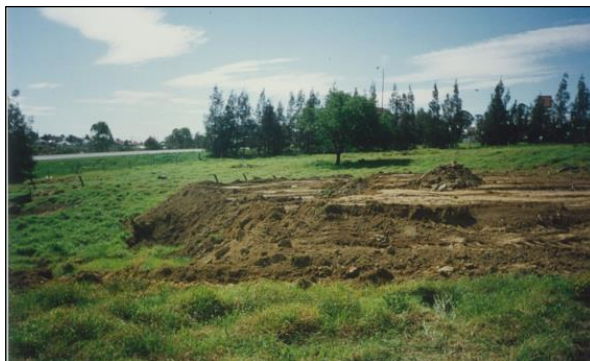
Figure 3: Stockpiles soils (approx central and southern portion of the site) (1995)

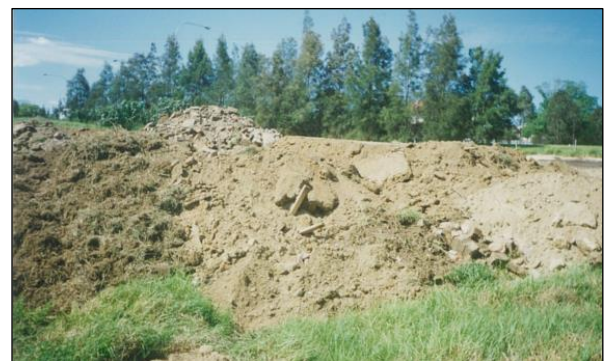
Figure 4: Stockpiled soils in central / northern part of site including anthropogenic materials (1995)

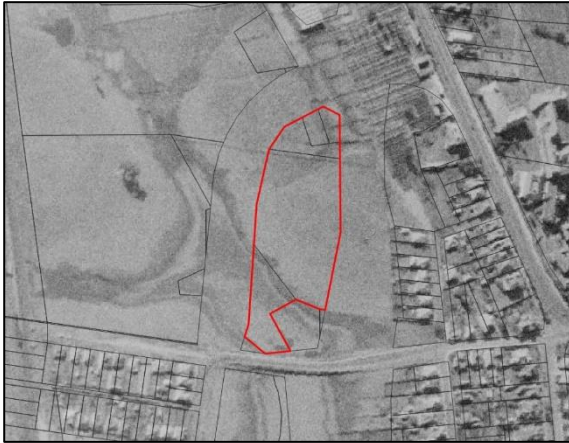
Figure 5: 1954 aerial

Year Quality Figure	Site	Surrounding Land Use
1954 B&W Figure 5	The site appears to be mostly grassed / cleared land. The southern portion of the site (Lot 23) is a part of Telarah Lagoon. The northern corner of the site may be part of the development to the north-east (possible cattle sales yard).	No development immediately adjacent sites with exception of residential developments to the east and a development to the north-east (possible cattle sales yard). Majority of developments in the vicinity of the site appear to be residential. Ledsam Street is present along the southern boundary of the site, probably unsealed. A railway is present approximately 250 m west of the site.
1977 Colour Figure 6	Similar to 1954 aerial (grassed, undeveloped). Telarah Lagoon contains water (brown in colour). Several trees in northern part of site. Possible fencing (east-west) in northern part of site.	Similar to 1954 aerial.

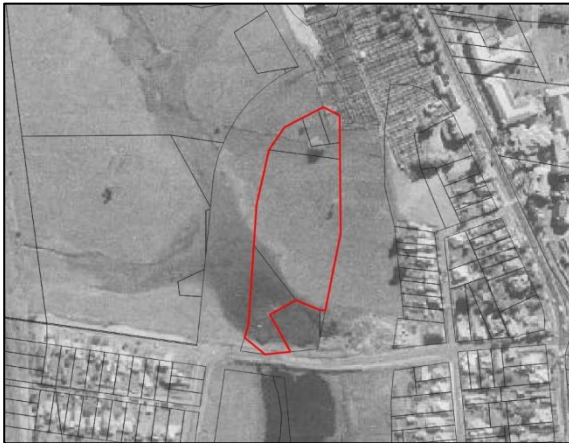
Figure 7: 1984 aerial

1984 B&W Figure 7	Similar to 1977 aerial.	Similar to 1977 aerial.
1986 B&W	Similar to 1984 aerial. Contours present on the aerial which indicate the site ranges from approximately RL 4 m AHD (southern boundary / Telarah Lagoon) to RL 14 m AHD (northern boundary)	Similar to 1984 aerial.
1993 Colour Figure 8	Tree rows are present along the northern and eastern boundary of the site.	Significant infrastructure development is present to the immediate north, east and west of the site comprising construction of New England Highway, Bungaree Street, and a large roundabout to the immediate north of the site (previously possible cattle yard).
2001 Colour Figure 9	Significant development at the site. Developments comprise a building in the centre of lot 22 (current main warehouse / workshop), a building in along the boundary between Lot 21/22 (current showroom / office) and construction of pavements and carparks throughout Lots 19 – 22.	Similar to 1993 aerial.

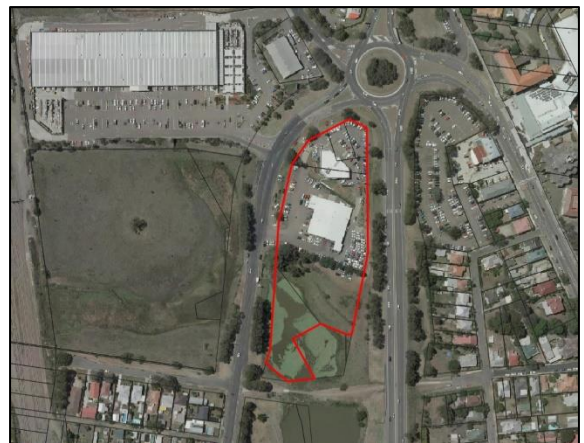
Figure 10: 2007 aerial

2007 Colour Figure 10	Similar to 2001 aerial.	Large structure present to the north-west of the site with surrounding pavements.
2010 Colour Figure 11	Further development at the site. Developments comprise construction of a building and surrounding pavements/carparks in the southern portion of lot 22, extensions to the west and southern edges of the building in lot 21/22.	Similar to 2007 aerial.
23 April 2021 Colour	Similar to 2010 aerial.	Similar to 2010 aerial.

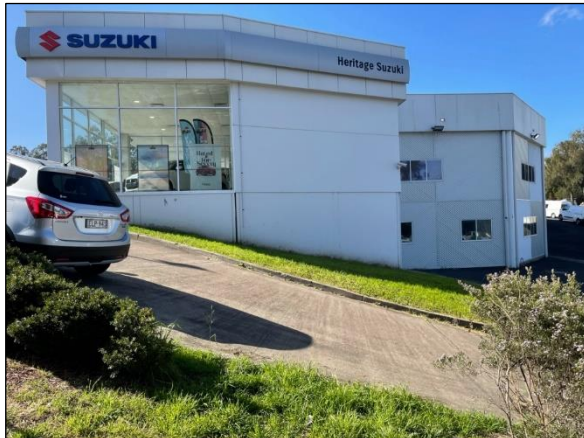
- A showroom, offices and amenities building was located in the northern portion of the site, south of sales yard (Figure 12). The floors were typically tile over the suspended concrete slab. The south-western portion of the building was two storey, comprising administration offices;

Figure 12: Showroom in the northern portion of the site, looking east.

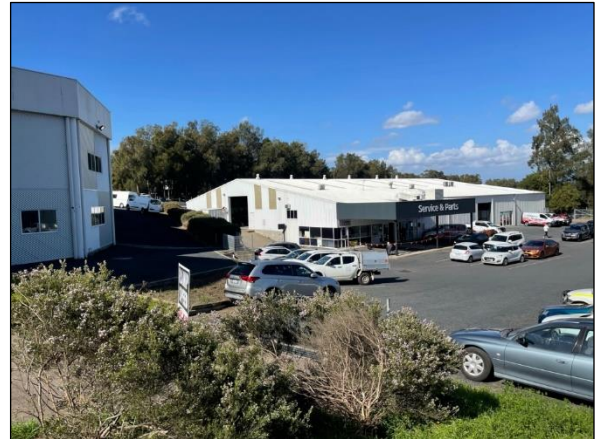
- A servicing, and repairs warehouse was located in the central portion of the site (Figure 13). The main part of the building (servicing) was elevated above the western side (new parts storage, office and retail area). The main workshop building was an open warehouse with concrete floors with minor falls to direct and surface water runoff to internal drains. The drains are directed to the GPT upgradient of the surface water sediment dam. Vehicle hoists were present. No in-ground inspection pits were observed;

Figure 13: Warehouse in the central portion of the site, looking south-east.

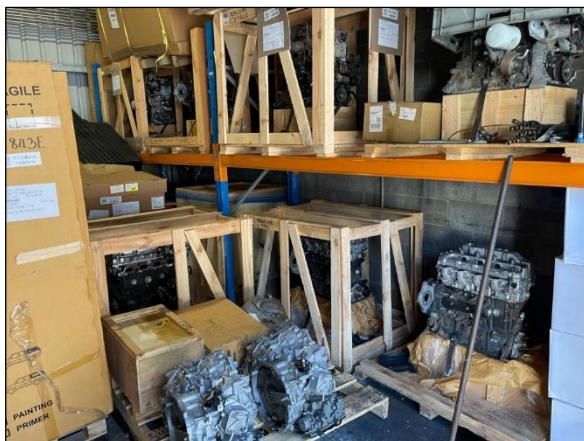
- The concrete floored oil store on the south-eastern corner of the workshop building and included an in-ground concrete oil collection sump (open pit with surface grate) (Figure 16 and Figure 17). Motor oils were stored in 160 L drums and wall / above ground mounted metal containers. Smaller quantities of oils, hydrocarbon, coolants were also stored e.g. 20 L plastic container. An intermediate bulk container (IBC) was within the store for collection of waste oils for collection and off-site disposal (Figure 17). Hydrocarbon staining of the adjacent concrete outside the collection sump was mostly minor, with some thick built up on the northern side of the store at the location of an oil rag collection recycling bin. The concrete surface was generally in good condition (i.e. no obvious cracks or significant gaps in concrete joints). Several motors / engineer parts (new) were also stored in the vicinity;

Figure 16: Engine storage within warehouse.

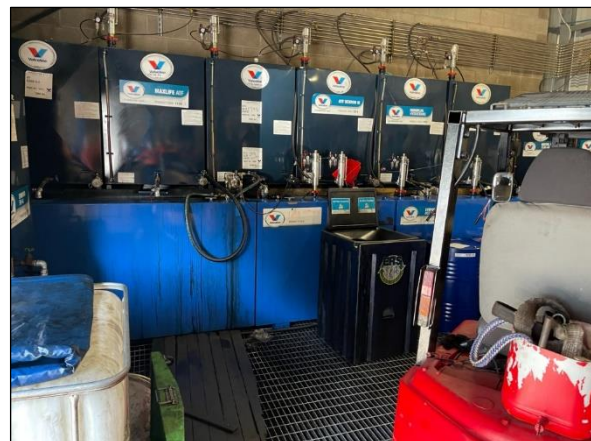
Figure 17: Oil storage within warehouse.

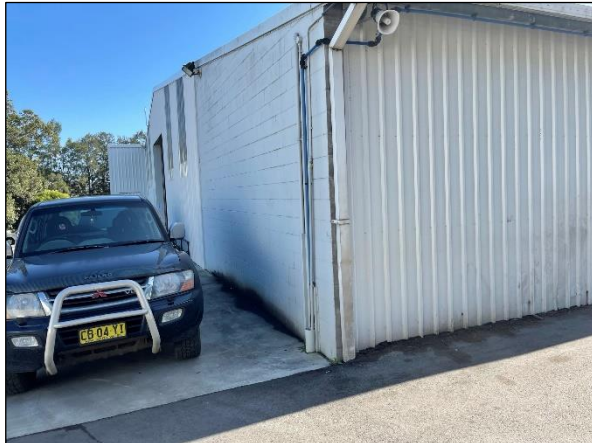
- Hydrocarbon (oil/grease) staining and seepage was observed on the exterior areas to the oil store (i.e. southern-eastern corner of main servicing building) (Figure 18 and Figure 19). The staining was most obvious on the southern side, and extended along the concrete and up the cement block wall. A minor gap was observed in one of the masonry brick (Figure 19)). On the eastern side, the staining appeared to have seeped between the concrete floor and metal wall on to the adjacent asphalt pavement;

Figure 18: Staining on asphalt surface and masonry side wall of oil store

Impact to soil was not identified downgradient of the waste oil tank / former wash bay at Bore 104, however, observations indicated hydrocarbon/oil staining at the surface of the building perimeter. Residual impacts to soils are likely to be present, however, such impacts may be localised rather than widespread. The possible presence or the extent of such impacts has not been determined.

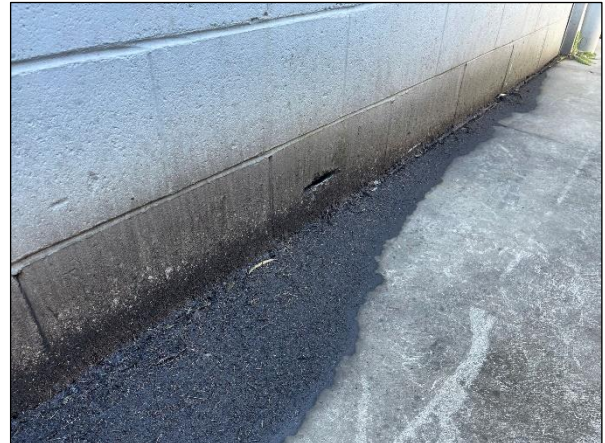
Figure 19: Staining on surface and masonry side wall of oil store

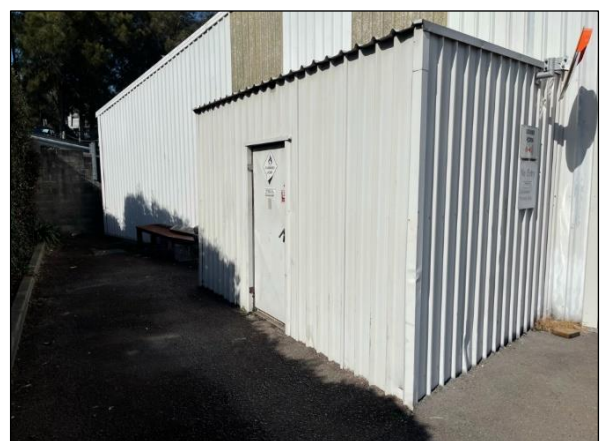
- A former flammable liquids store, adjoining the warehouse on the northern side was present however, was being used for storage of general tools and equipment rather than hazardous goods (Figure 21).

Figure 21: Former flammable liquids storage, northern side of warehouse

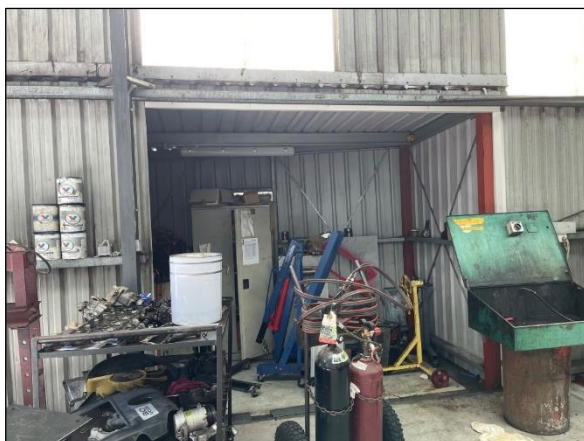
Figure 22: Former flammable liquids storage, northern side of warehouse

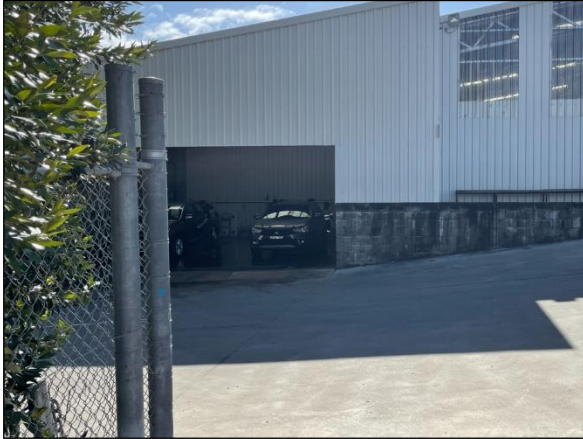
- Concrete floored vehicle wash bay, adjoining the warehouse on the southern side (Figure 24). The drains are directed to the GPT upgradient of the surface water dam;

Figure 24: Wash bay attached to warehouse, looking north.

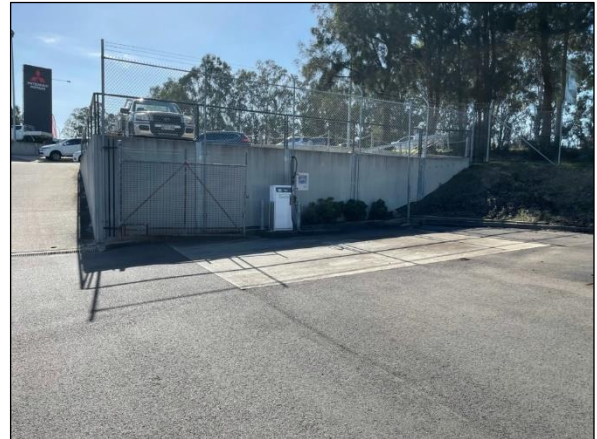
- One petrol underground fuel storage tank (UST), one fuel bowser and an electronic card reader and fuel vent pipe (active) were located to the east and upgradient of the warehouse (Figure 25). Minor surface staining was apparent to the surface concrete. No groundwater wells were located in the vicinity;

Figure 25: Bowser and UST location, looking north-east.

- Review / audit of the current UST loss monitoring procedures, leak detection of UPSS system, record keeping and environmental management of the area with reference to regulatory and statutory requirements. This should include installation of a third groundwater monitoring well and biannual groundwater monitoring to align with NSW EPA *Underground Petroleum Storage Systems Regulation* (NSW EPA, 2020b).
- Removal of the UST and associated infrastructure, if proposed, should be undertaken with reference to NSW EPA (2014c) *Technical Note: Investigation of Service Station Sites*;
- Improvement of existing environmental controls including clean up of localised hydrocarbon spills within the waste oil store to minimise the potential for migration / overflows and surface water run-off.

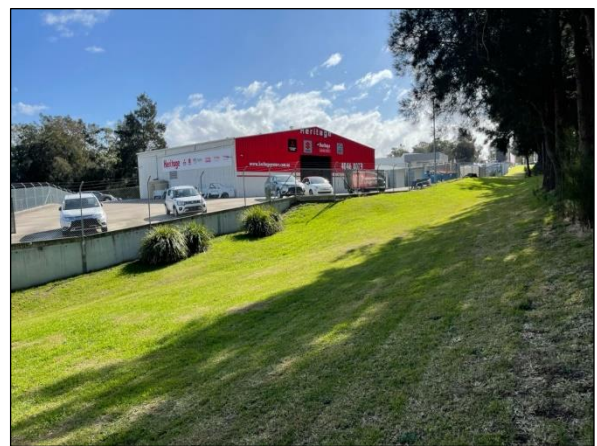
- Detailing workshop in the southern portion of the site (Figure 26 and Figure 27). The floor was painted concrete and was observed to be wearing in trafficked areas. There were no obvious indicators of gross spills or staining on the surface. The drains are directed to the GPT upgradient of the surface water dam. Vehicle hoists were present. No in-ground inspection pits were observed.

Figure 27: Detailing workshop in the southern portion of the site, looking north-west.

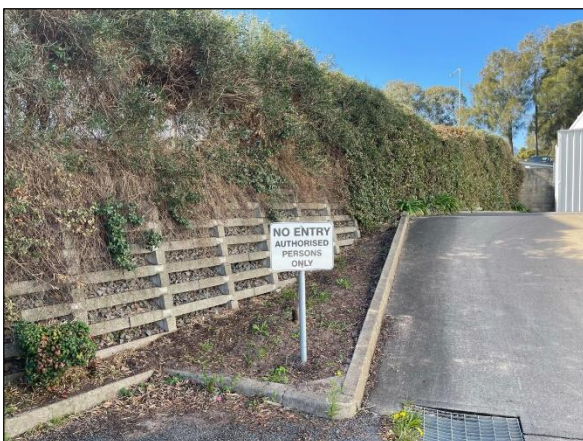
Figure 28: Retaining wall, between workshop and showroom, looking east. Backfilled with natural gravels (blue metal gravel)

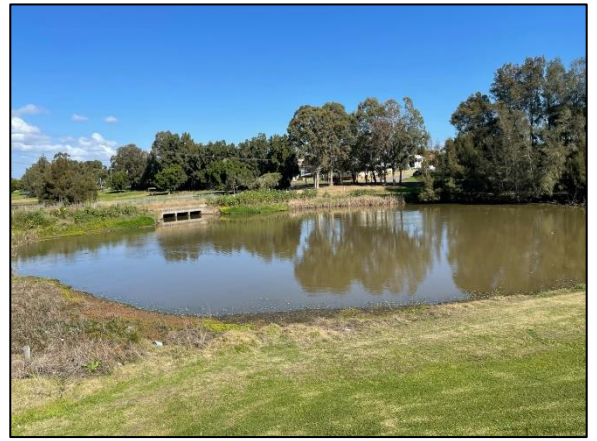
- There was a surface water lagoon in the southern portion of the site (Figure 29). The surface water body was slightly turbid brown with no obvious indicators of gross contamination (staining / slicks / algal growth). Surface water was not flowing at the time. Refer Section 10.2 for field screening of surface water;

Figure 29: Lagoon in the southern portion of the site, looking south.

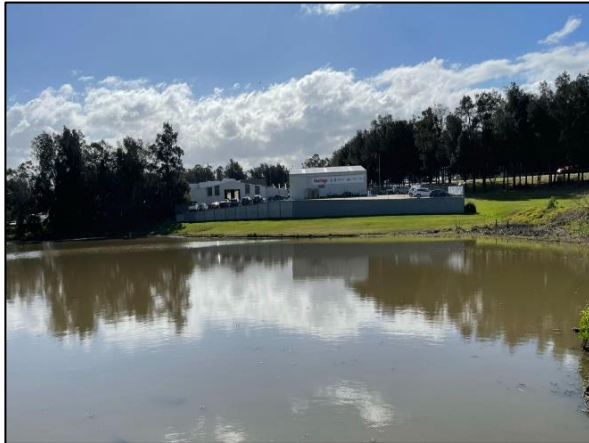
Figure 30: Above grade fill platform in the southern portion of the site, looking north.

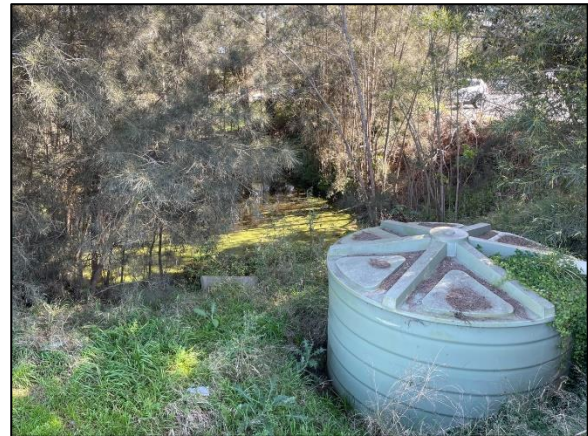
Figure 31: Water storage tank adjacent to the sediment dam (background), south of main developed area, looking west. Receives surface water runoff from main site (rainwater etc). Discharge from dam to surface water body
