Report on
Preliminary Site Investigation (Contamination)

Proposed Community Centre
Whitewater Park, Heritage Drive, Chisholm

Prepared for
Maitland City Council

Project 221538.00
July 2023

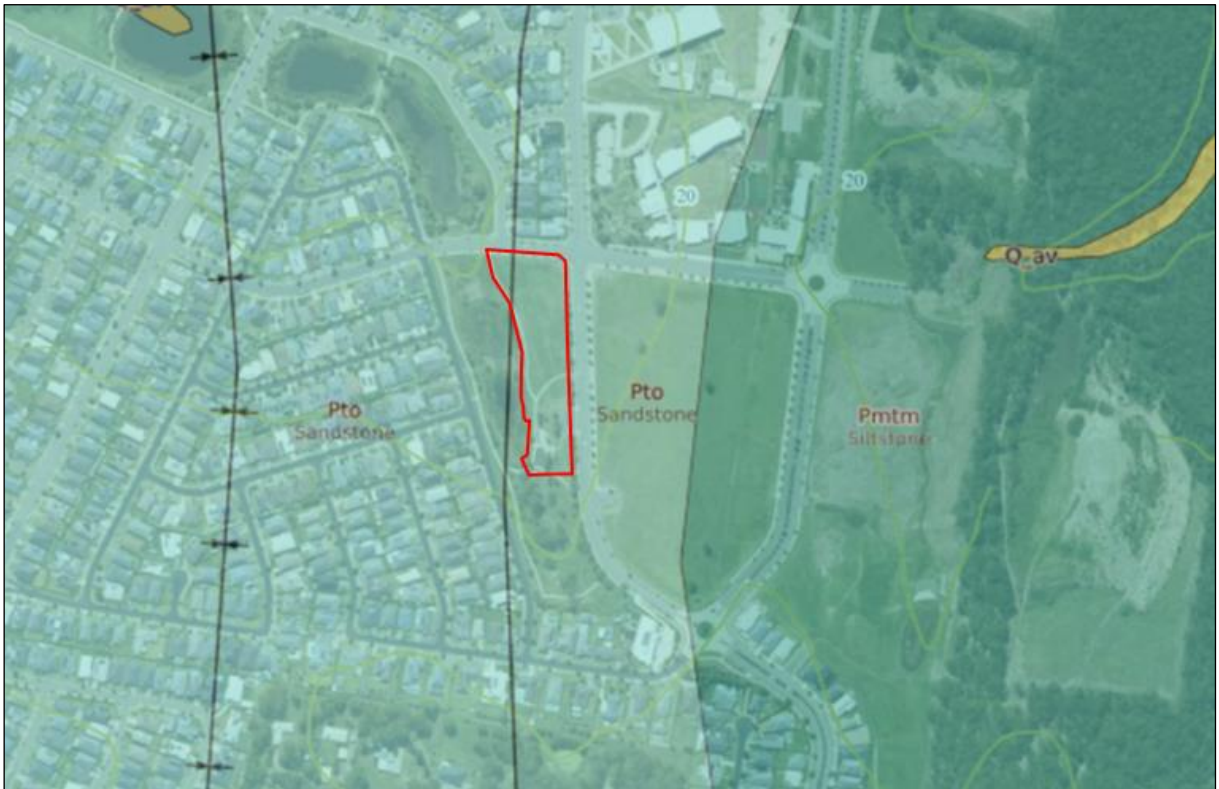
Figure 2: Site (red) shown on the NSW Seamless Geology map

Geology	The NSW Seamless Geology map indicates that the site is underlain by the Tomago Coal Measures of Lopingian age. The dominant lithology is of very fine- to medium-grained sandstone. Laminated to carbonaceous shale and mudstone, siltstone, coal with sporadic interbeds of carbonaceous shale, claystone, sideritic bands, rare pebble para-conglomerate may also be present.
Acid Sulfate Soils	The NSW acid sulfate soils (ASS) risk mapping indicates that the site is not mapped within an area of mapped risk. This is consistent with the mapped residual soils which by definition are not ASS. The closest areas of high risk are approximately 500 m to the north-west of the site in lower lying areas which are mapped as alluvial soils.
Surface Water	An unnamed water course watercourse/gully is located immediately to the west of the investigation site and through Lot 720 D.P. 1210544 and passes under Tigerhawk Drive via a culvert. The water course collects runoff from the site and adjacent urban development and flows north-west via a series of detention basins towards low-lying areas and ultimately reaches Four Mile Creek (freshwater environment) approximately 1.2 km from the site.

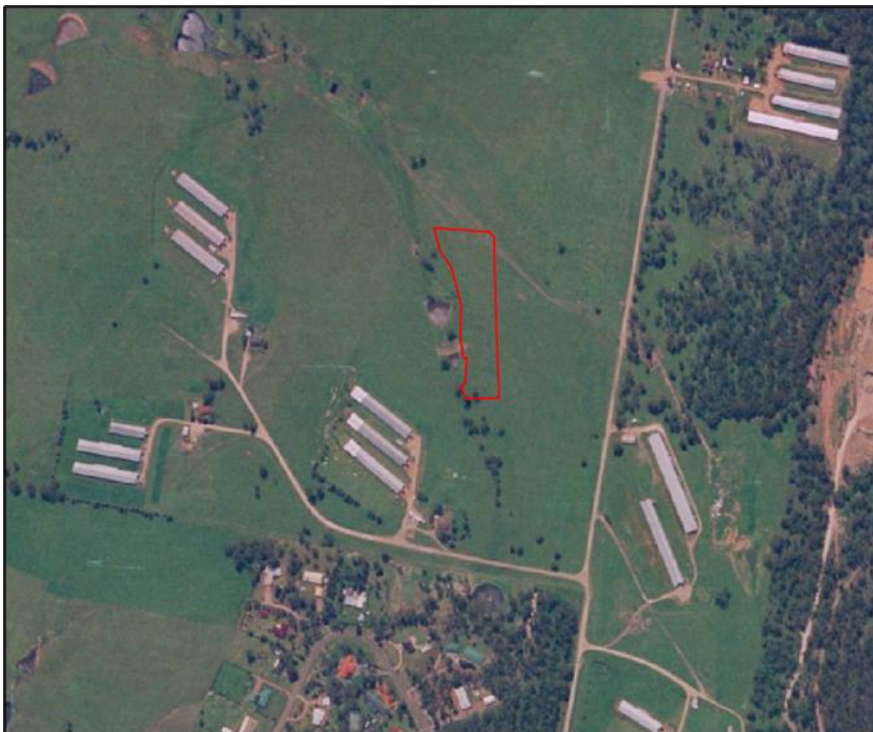
Figure 4: Approximate location of current site area (red) within former greater agricultural/poultry farm area (1998 aerial photo)

The approximate extent of the current site location, overlain on the 1998 historical aerial photo shows the greater agricultural and poultry farming activities on the site, is shown in Figure 4 below.

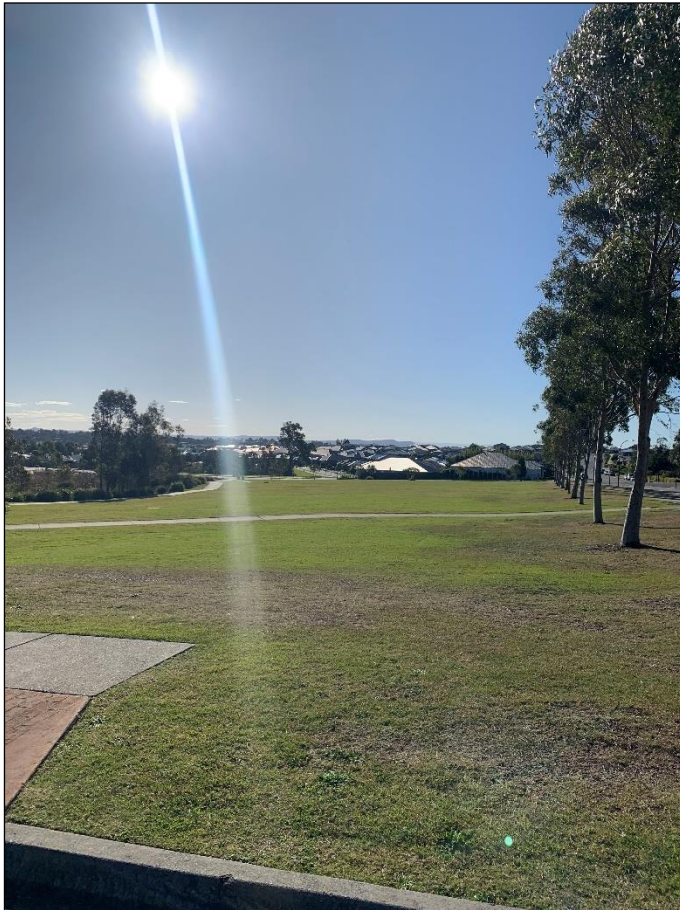
Figure 5: Central and northern portion of the site, looking north from existing car park

- The site is known as Whitewater Park;
- The majority of the central and northern portions of the site comprised open grassed areas (Figure 5);
- Possible cut/fill in the northern portion of the site (Figure 6);
- Existing concrete path in the western portion of the site (Figure 7);
- Existing vegetation and surface water body immediately west of the current site area (Figure 7 and Figure 8);
- Localised drainage feature in the north-western portion of the site (Figure 9);
- Existing asphalt car park and constructed playground in the southern portion of the site, including possible cut/fill in the vicinity of the car park (Figure 10);
- Exposed soils beneath trees in the south-eastern and eastern portion of the site (Figures 11 and 12), generally comprising clayey soils and gravel, with some minor anthropogenic inclusions;

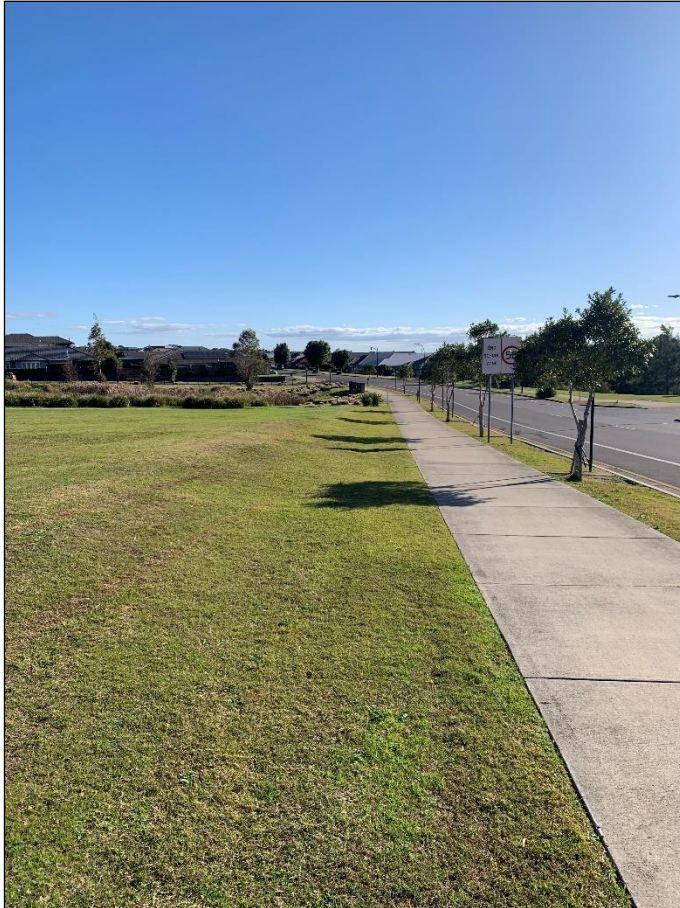
Figure 6: Northern site boundary, with indications of cut/fill and change of level within the site

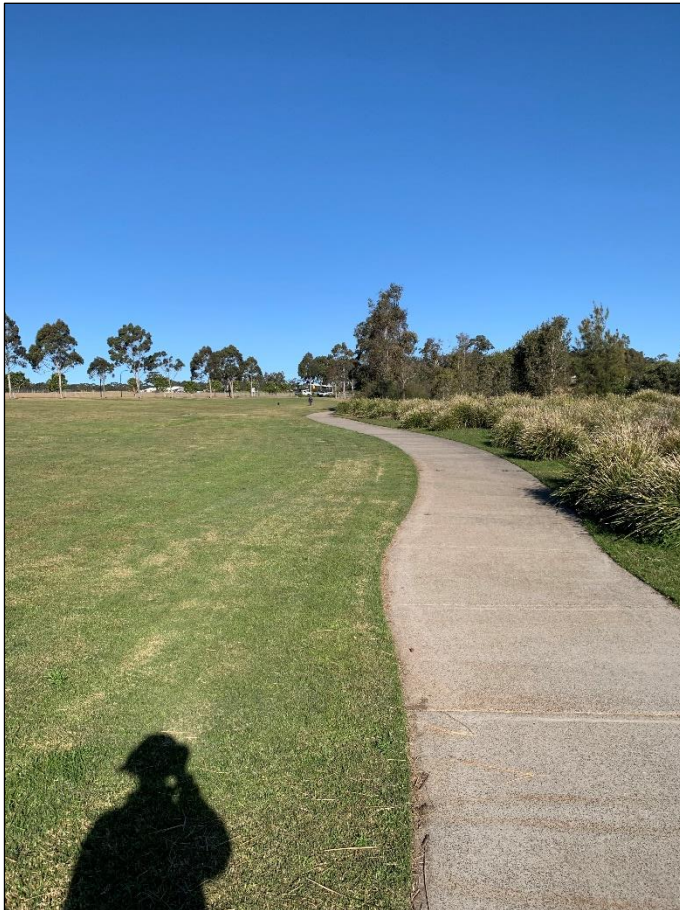
Figure 7: Existing concrete path in the western portion of the site (looking south) and planted vegetation immediately west of the western site boundary

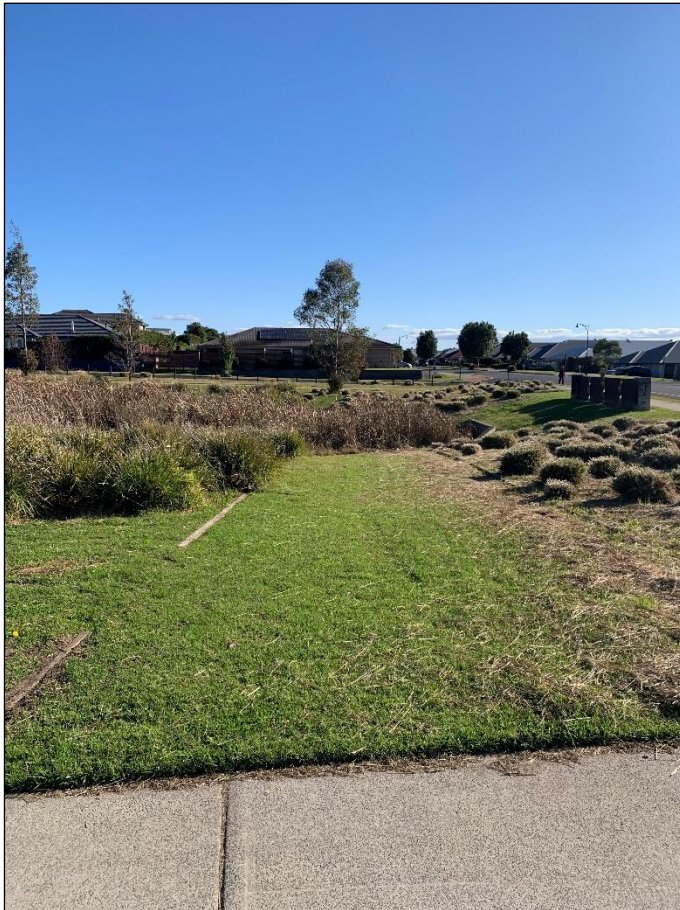
Figure 8: Water body (detention basin) immediately west of the site, looking west

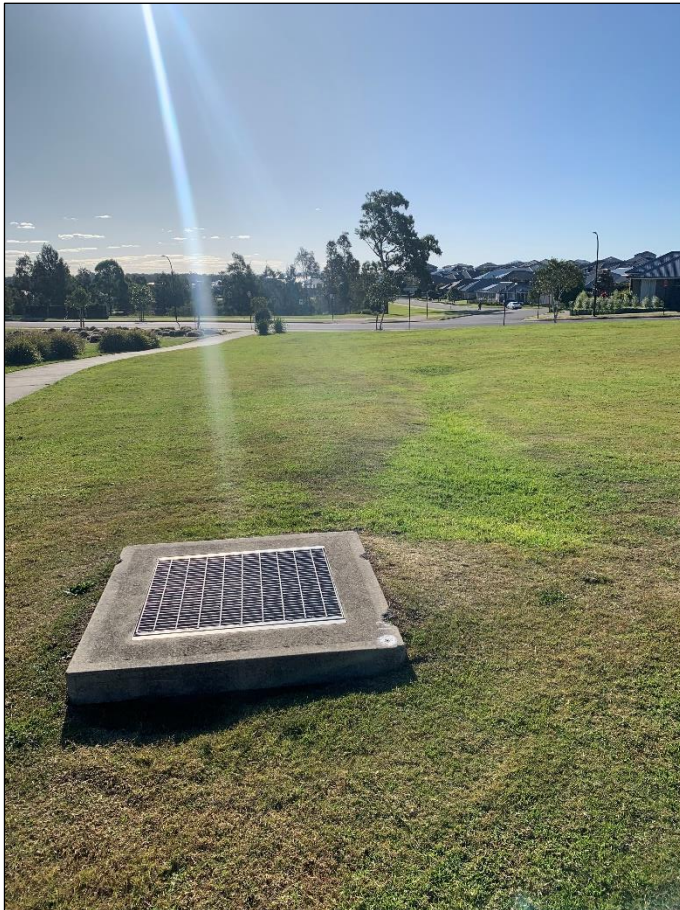
Figure 9: Localised drainage feature in the north-western portion of the site, looking north

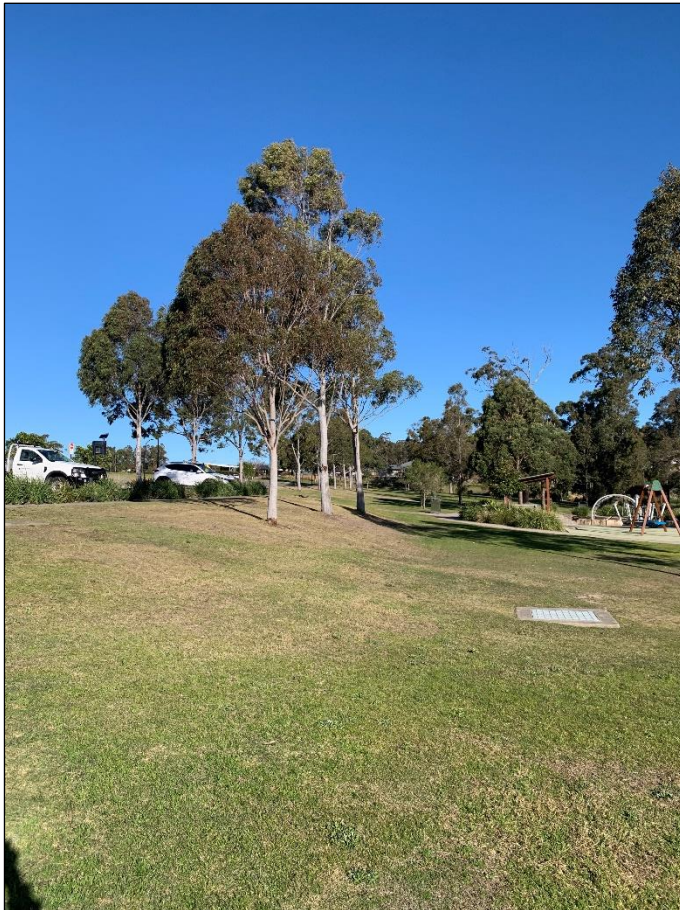
Figure 10: Car park and playground in the southern portion of the site, looking south, including possible cut and fill associated with the car park

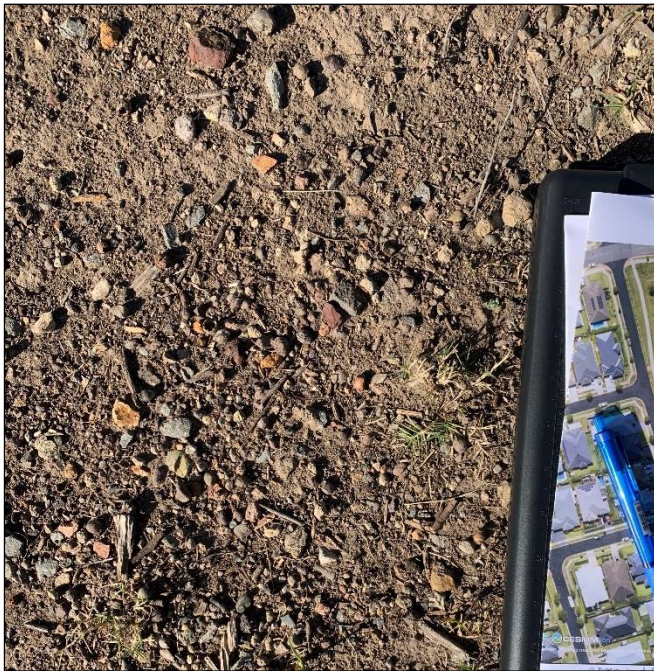
Figure 11: Exposed soil in the south-eastern and eastern portion of the site, generally comprising clayey soils and gravels.

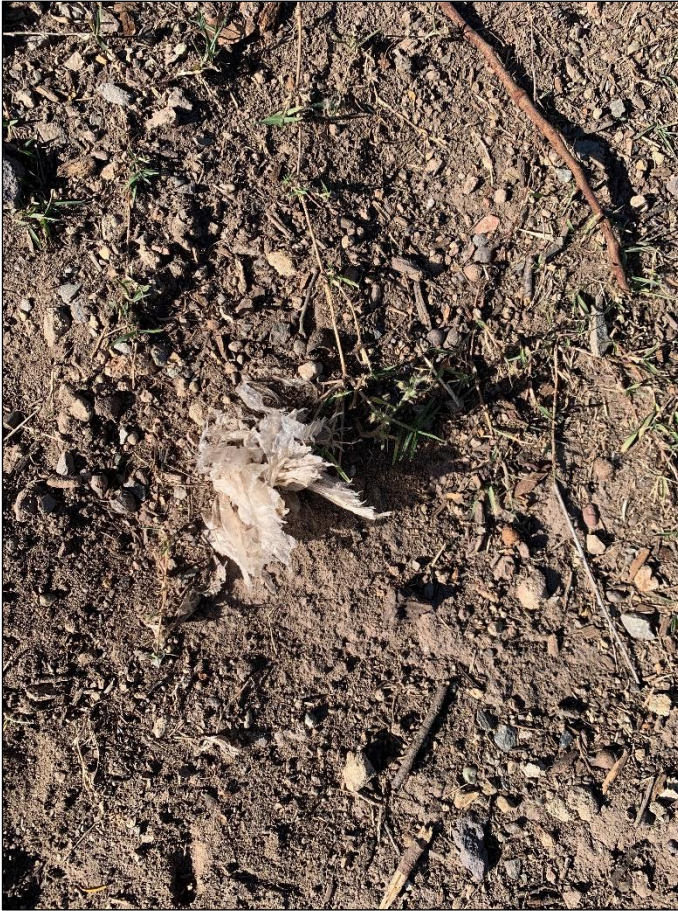
Figure 12: Exposed soil in the south-eastern and eastern portion of the site, generally comprising clayey soils and gravels, with some minor anthropogenic materials (e.g. plastic sheeting).

Asbestos has not been detected by observation or by laboratory analysis on the surface of the site. Building demolition materials, such as plastic sheeting, were, however, observed at the surface, and these are considered as indicative of the possible presence of hazardous building materials (HBM), including asbestos.

It is recommended that subsurface investigation, laboratory testing and reporting is undertaken to assess the possible presence and implications (if any) associated with the identified potential sources of contamination within the site. This work should be conducted with reference to NSW EPA (2020) and NEPC (2013) and assess requirements for remediation and validation. It is anticipated that the sampling and testing would comprise targeted and systematic soil sampling and testing to confirm the contamination status of soils and localised fill. In addition to the proposed assessment, additional testing would be required if on-site soils are proposed for use in the community garden to confirm suitability for use. Alternatively, appropriate imported soils could be used for community garden purposes. Subsequent investigation should be conducted with reference to a site-specific Sampling, Analysis and Quality Plan.

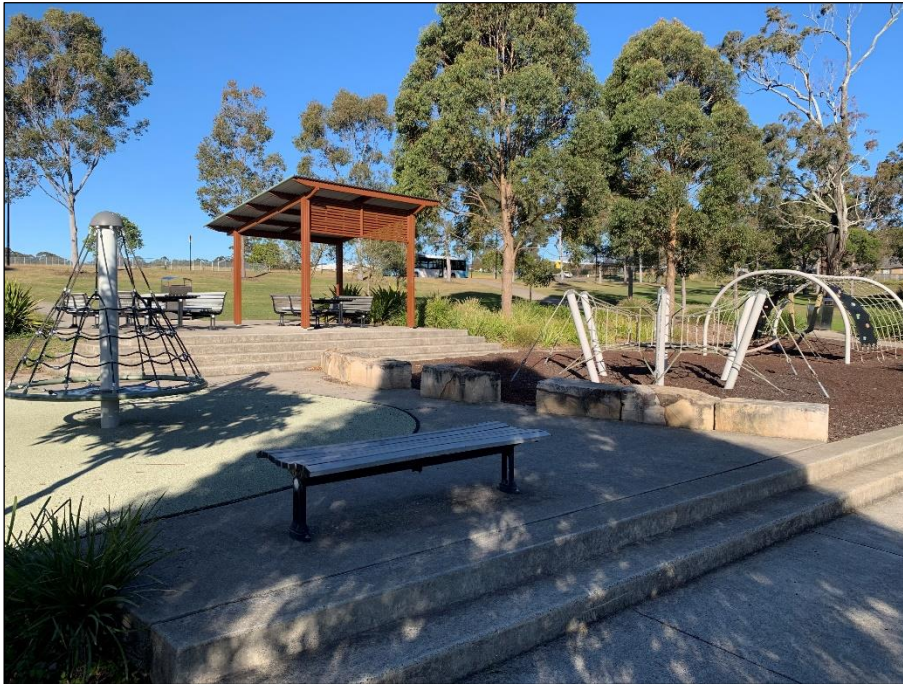
- Playground and picnic area in the southern portion of the site, including several level changes suggesting possible cut and fill, plus imported materials (woodchip) in the playground area (Figure 13).

Figure 13: Picnic and playground area in the southern portion of the site, including several level changes.
