Remediation Action Plan

Proposed Multi Purpose Centre
All Saints College Maitland, Crn Hunter and Odd
Streets, Horseshoe Bend

Prepared for
SHAC

Project 81916.07
November 2022

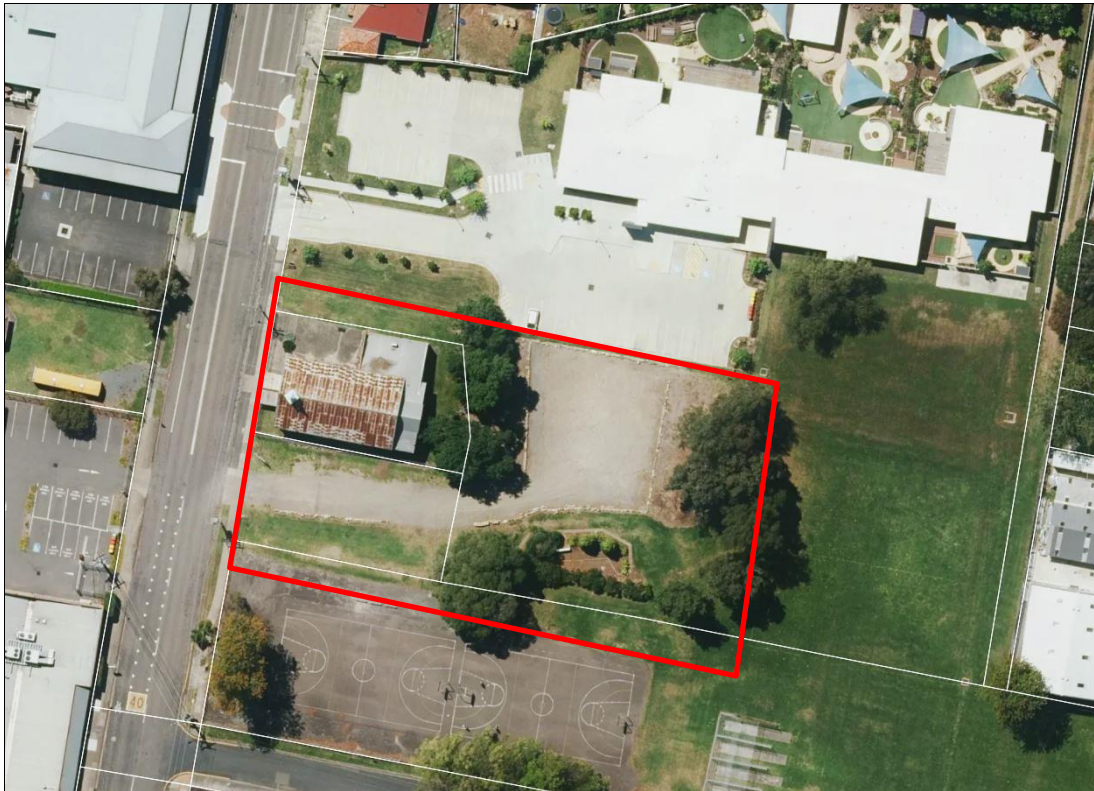
Figure 1: Current site layout and approximate site boundary in red (MetroMap 9/10/2021).

The site is currently occupied by a gravel hardstand driveway and carpark, along with a building structure (St Paul's hall) in the north western portion and surrounding grassed areas and gardens along the southern and eastern boundaries and a grassed area in the far north western corner. The site layout is shown on Drawing 1, Appendix A and Figure 1 above.

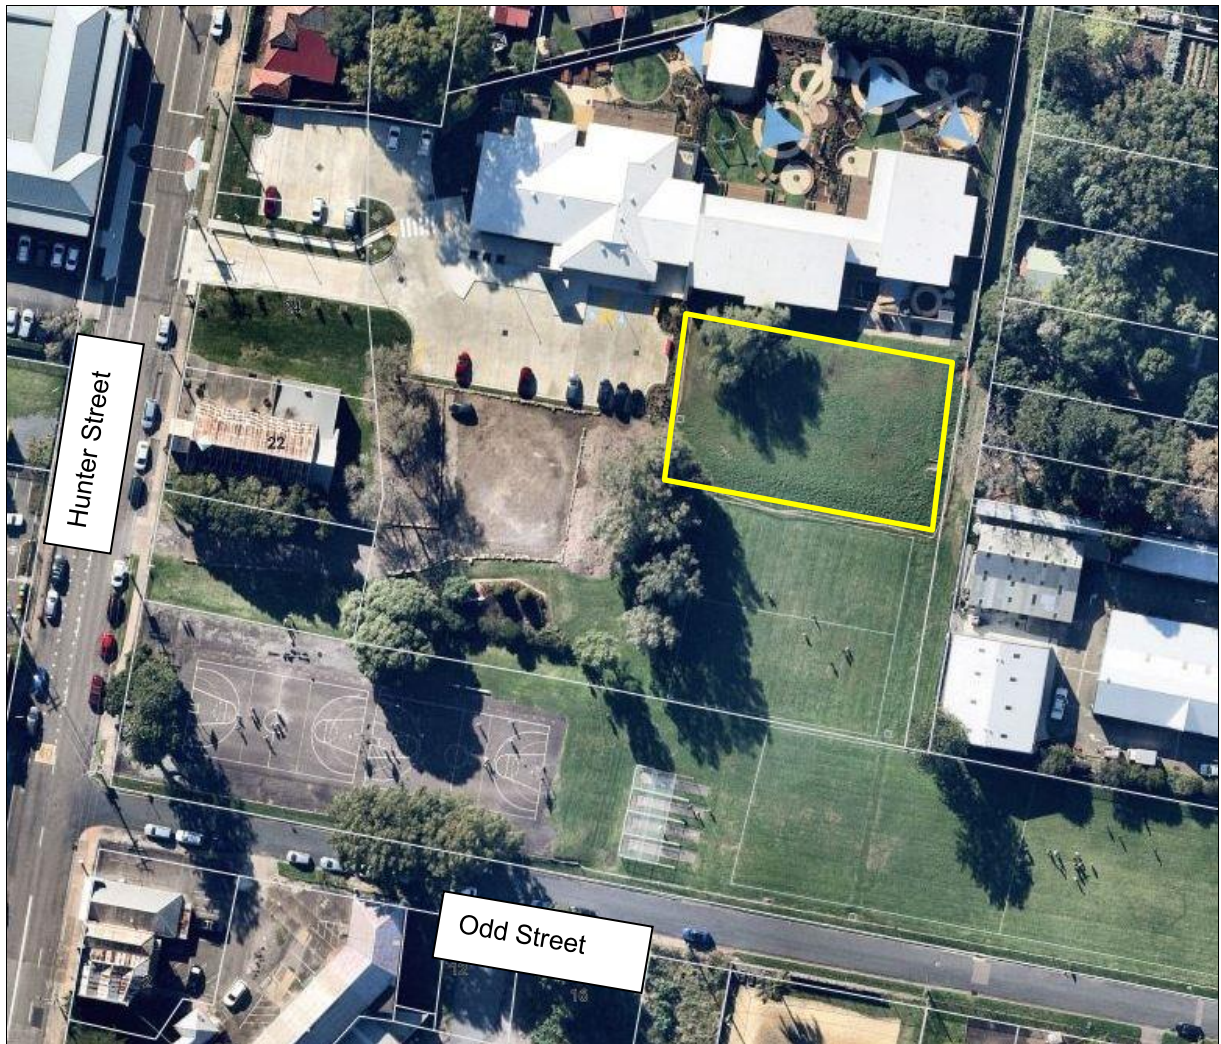
Figure 2: Outlined area of initial previous ACM testing (yellow).

In June 2020 asbestos testing was also conducted on placed fill directly to the north east of the site. The fill originated from stormwater infrastructure excavations conducted on the subject site. The assessment was targeted to the area of obvious fill in the southern extent of the fill embankment (Figure 2). The results indicated that the four fragments analysed contained asbestos (email dated 17 June 2020).
