BUSHFIRE ASSESSMENT
PROPOSED TYRE RECYCLING FACILITY

LOT 3005 DP 1040568
9 Burlington Place, Rutherford

Date: **6/6/2024**
Prepared for: **Rutherford Tyre Recyclers Pty Ltd**

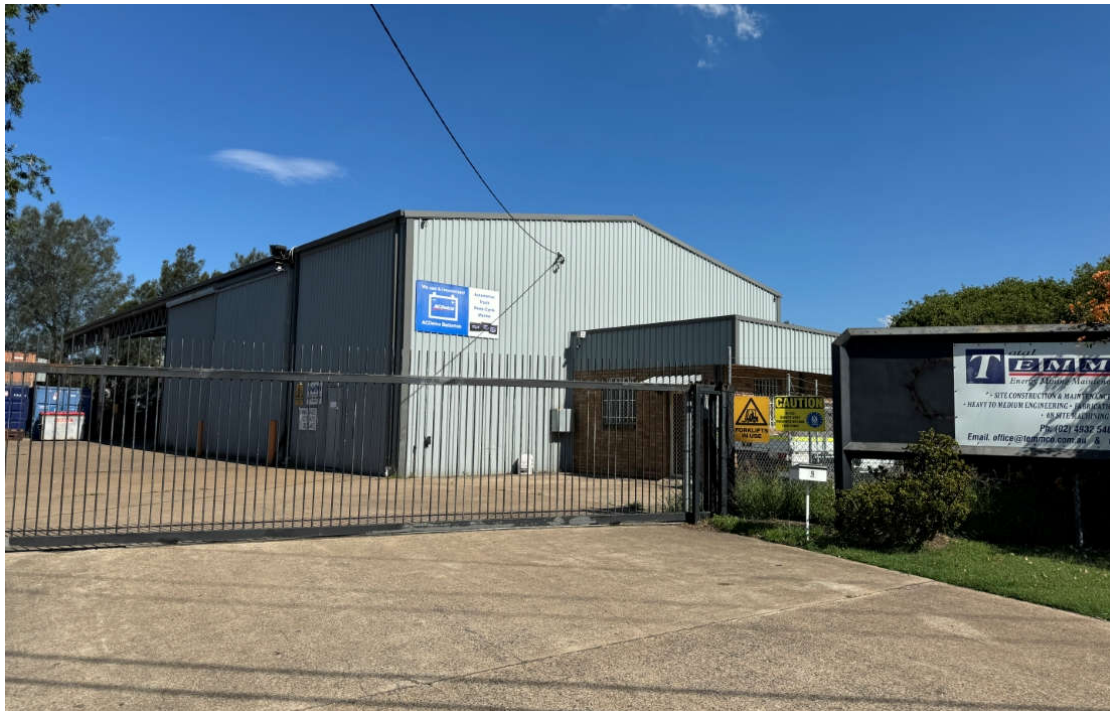
PHOTO 1 - SITE PHOTO LOOKING EAST

View of the subject site looking east. Established industrial/commercial development surrounds the site.

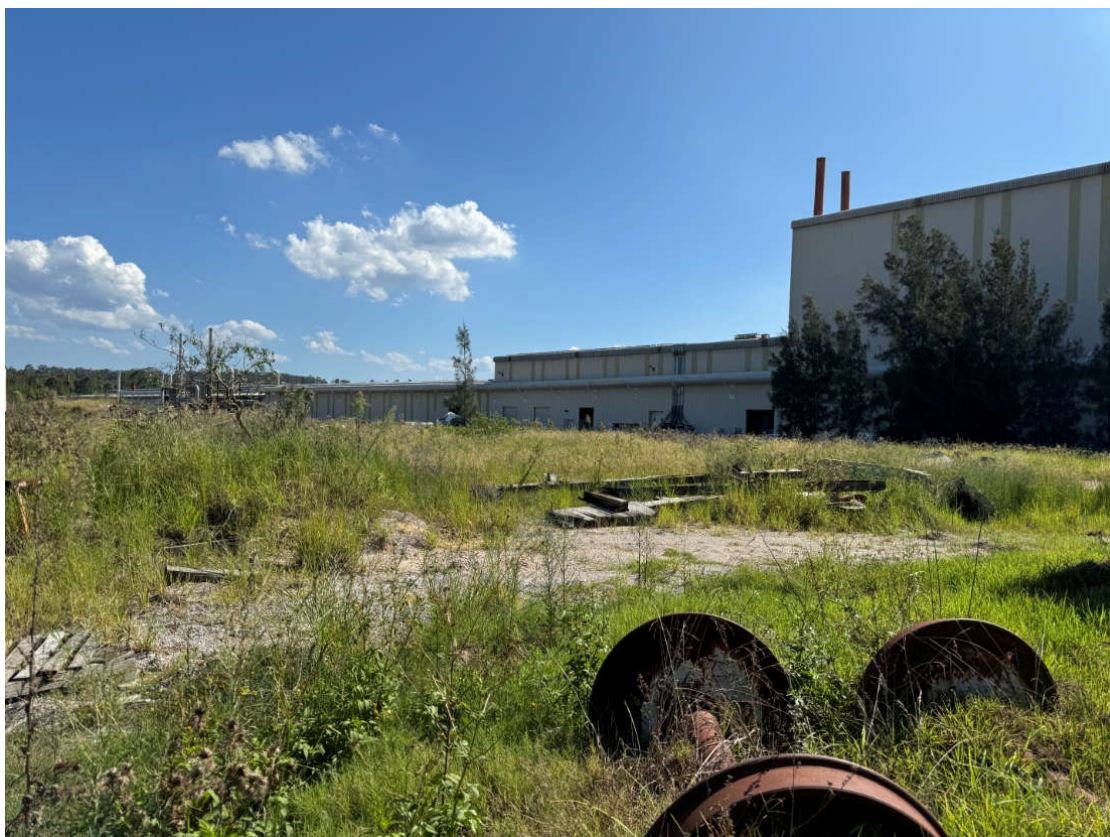
PHOTO 2 - SOUTHWESTERN GRASSLAND

View of grassland located more than 100 metres south of the site. The grassland is punctuated by storage of industrial equipment and access trails.

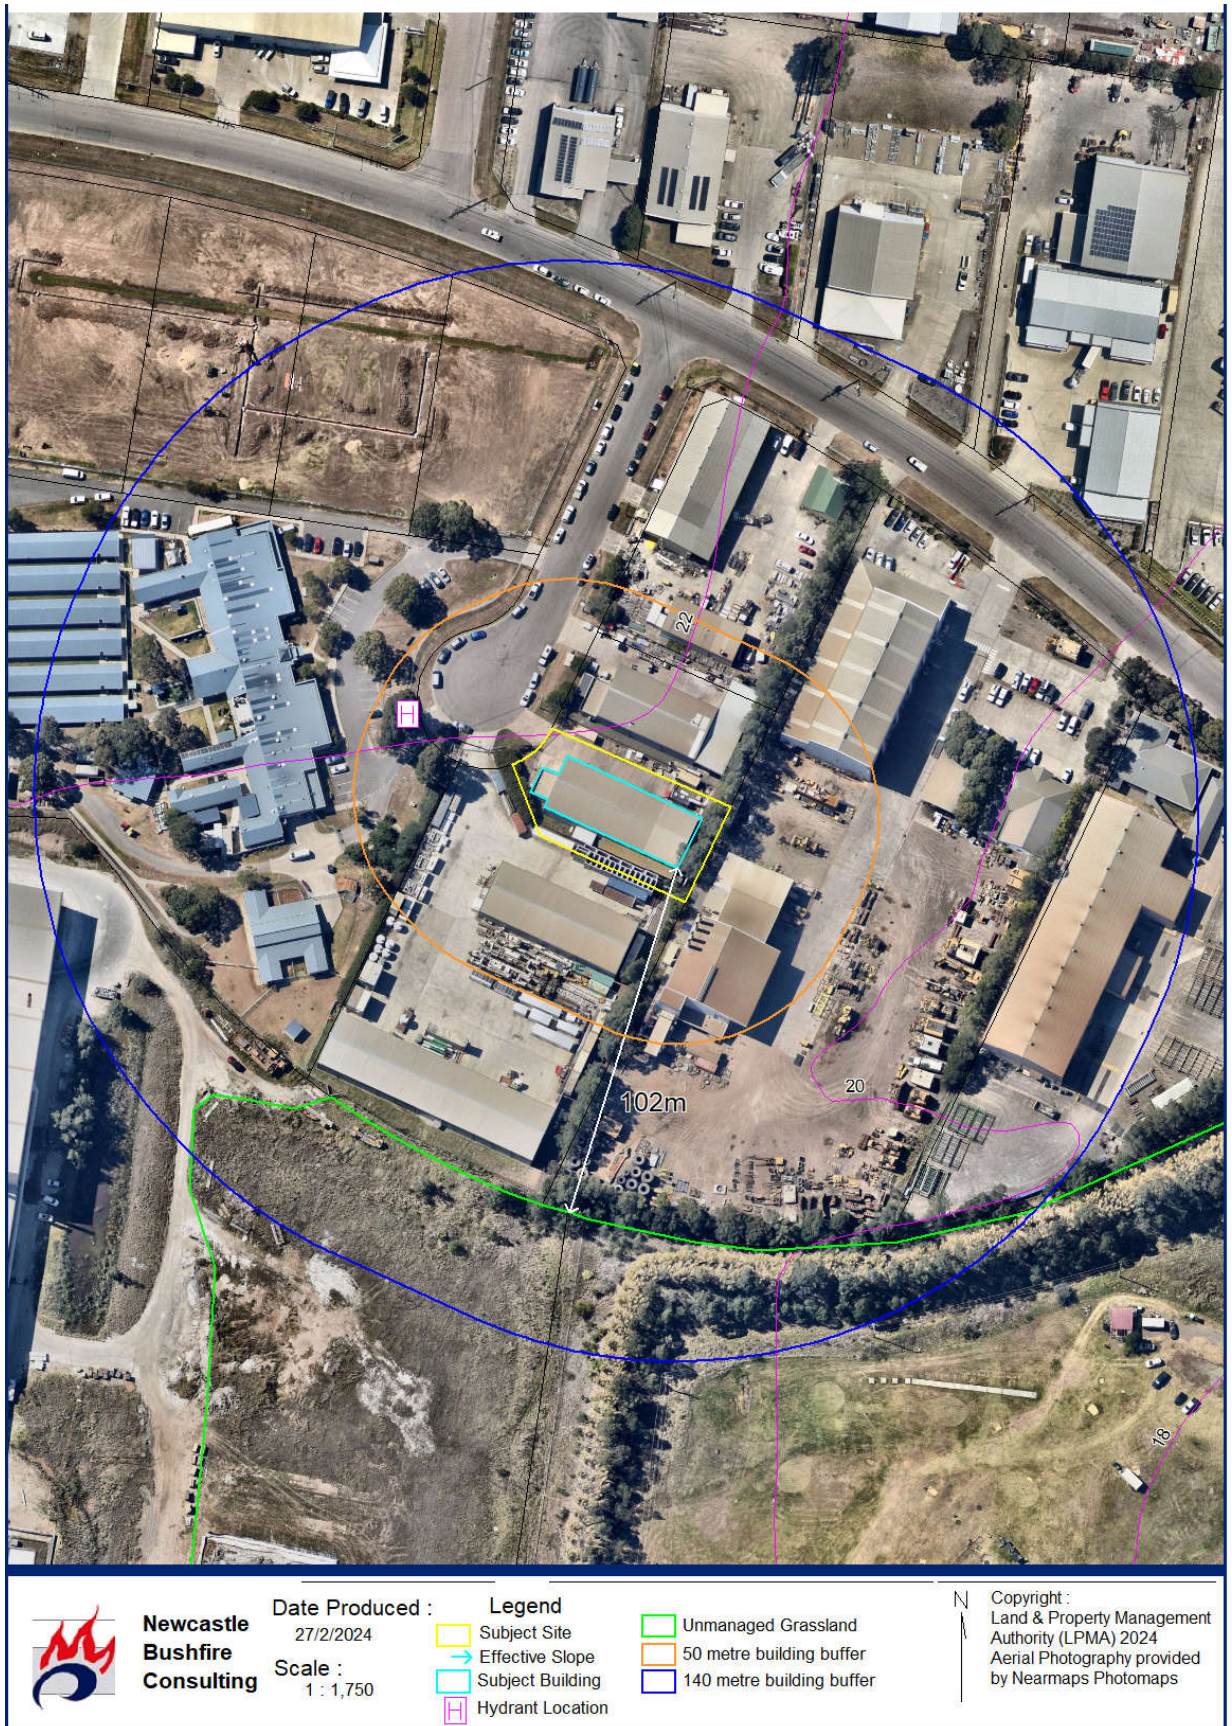
FIGURE 1 – SITE CONSTRAINTS MAP

Primary vegetation structures have been identified in Figure 1 – Site Constraints Map and separation distances shown in Table 2 – Bushfire Attack Assessment.

Effective Slopes have been identified in Figure 1 – Site Constraints Map and slope ranges are shown in Table 2 – Bushfire Threat Assessment.

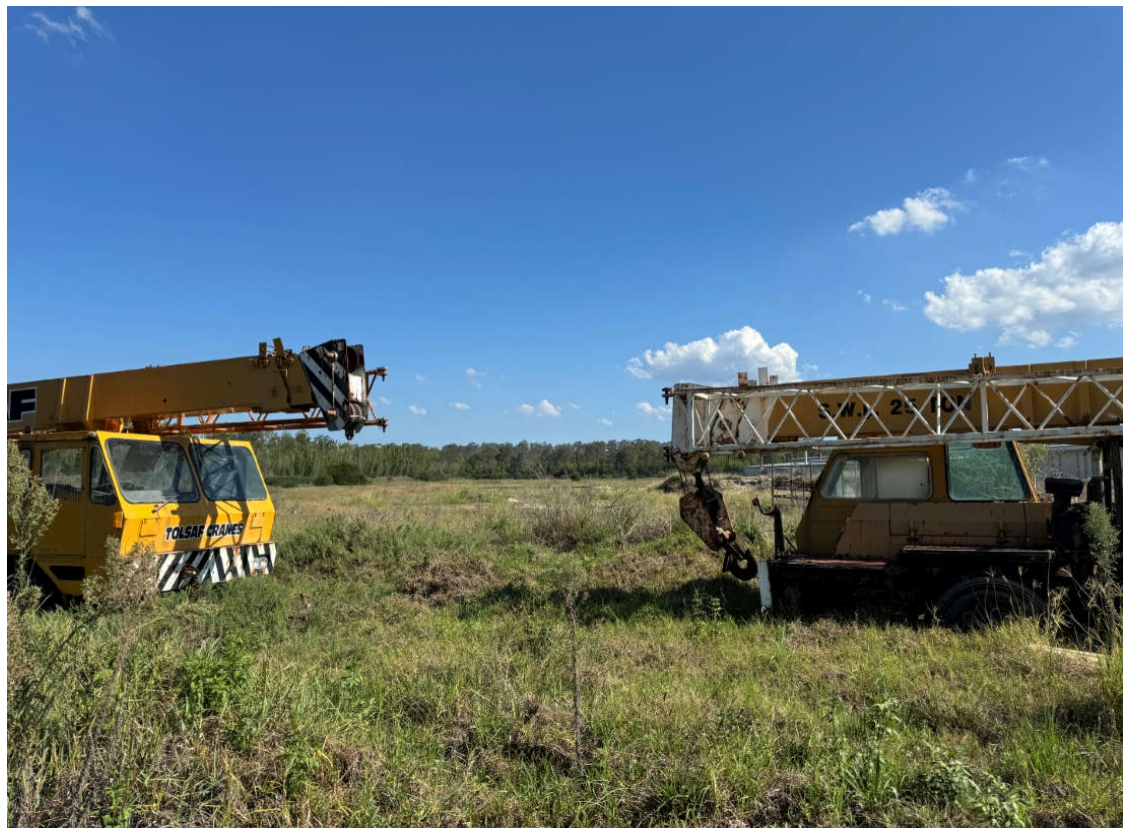
PHOTO 3 - SOUTHERN GRASSLAND

View of grassland located more than 100 metres south of the site. The grassland is punctuated by storage of industrial equipment and access trails.
