**Report on Preliminary Geotechnical Site
Investigation**

Proposed Manufactured Home Estate

27-31 Metford Road, Tenambit NSW

Project 225276.00

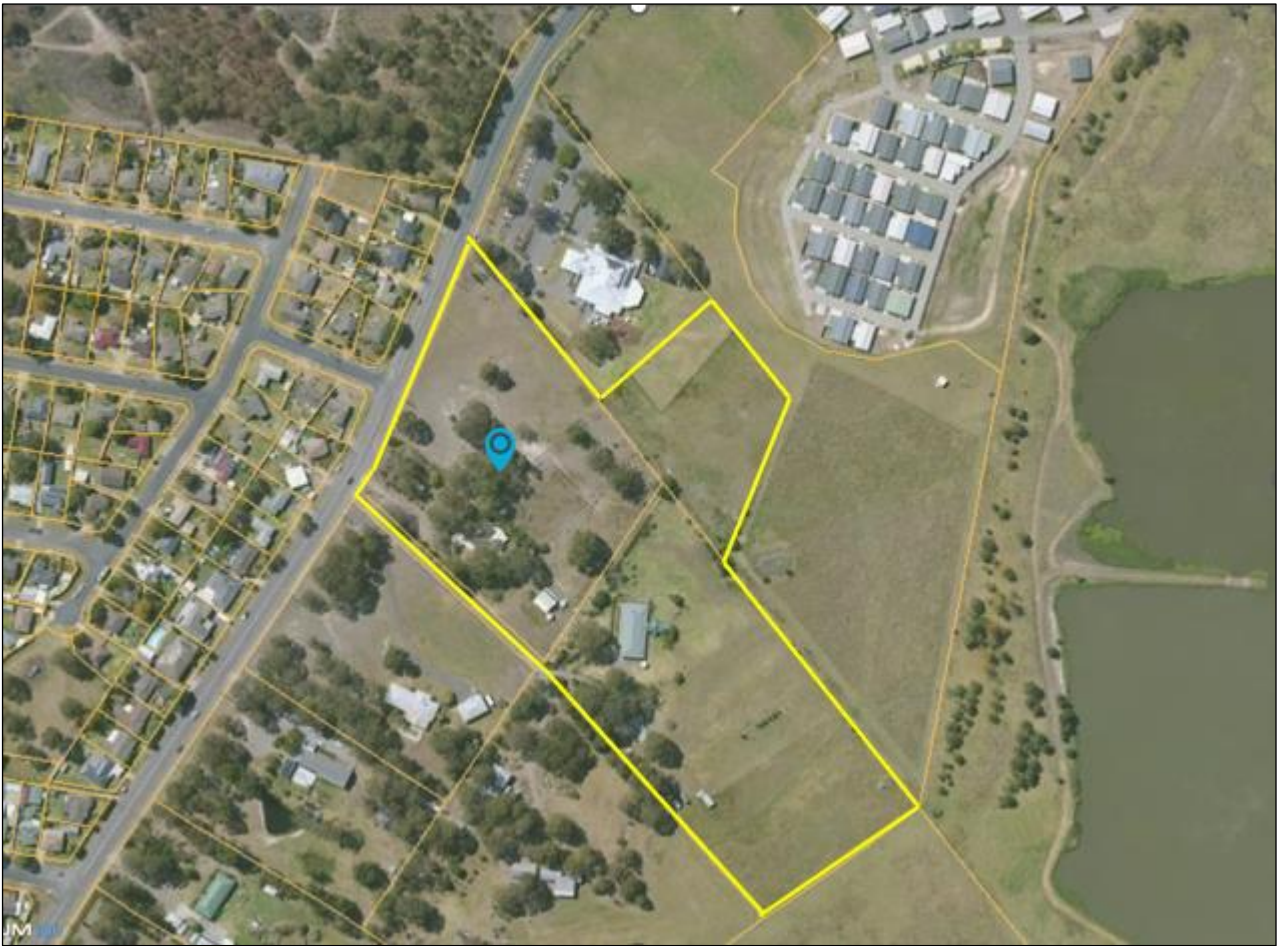
Figure 1: Site boundary (in yellow)

It is understood that the proposed development of the site includes the construction of a manufactured home estate (MHE) comprising of 101 dwelling sites. Associated works include the demolition of existing dwellings and structures, vegetation clearing, bulk earthworks, construction of roads, stormwater infrastructure and landscaping works. The approximate site extent is shown in Figure 1 below.

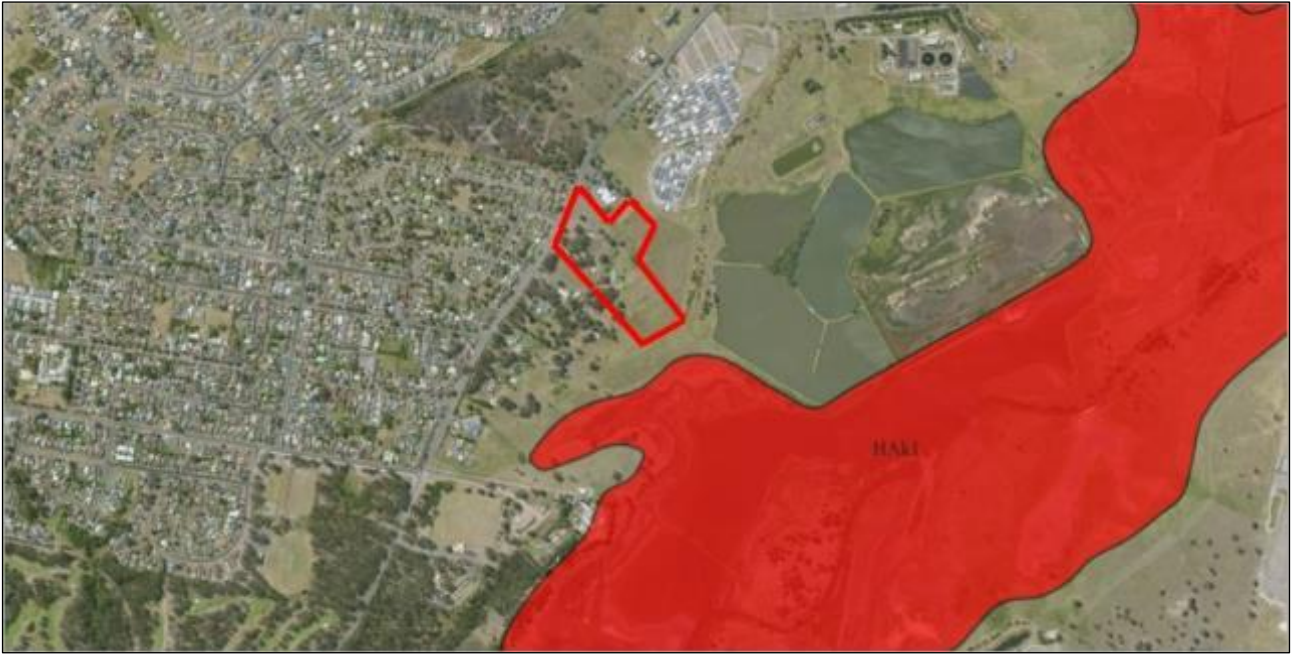
Figure 2: Acid sulfate soil mapping

Published acid sulfate soils (ASS) risk mapping indicates that the site is outside mapped ASS data. It is noted, however, that an area of mapped high probability of ASS occurring within 1 m of the ground surface is located approximately 85 m southeast of the site.
