SITE AUDIT REPORT

ENVIRONMENTAL

MANAGEMENT PLAN,

EASTERN PORTION OF

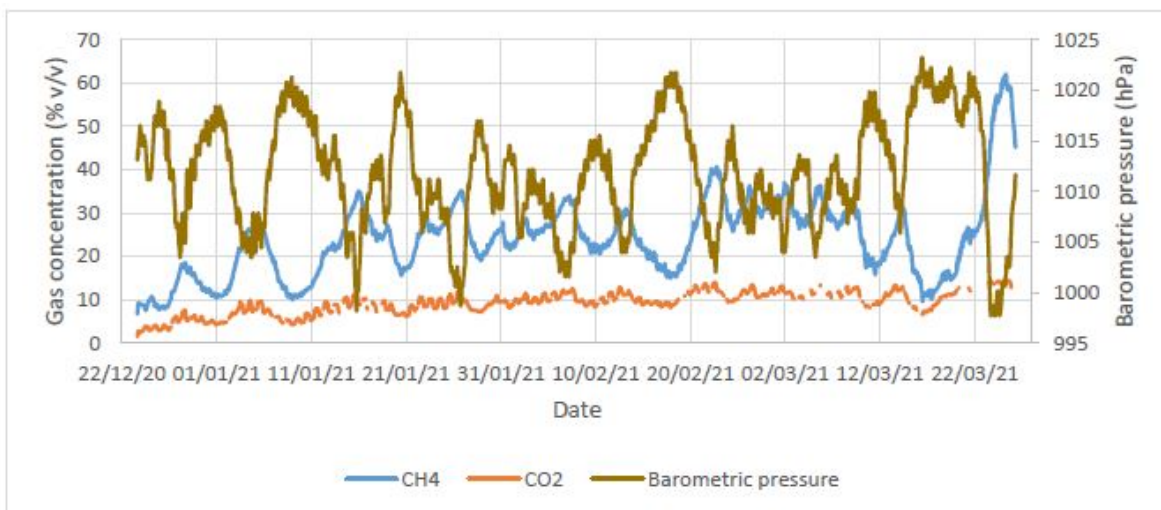
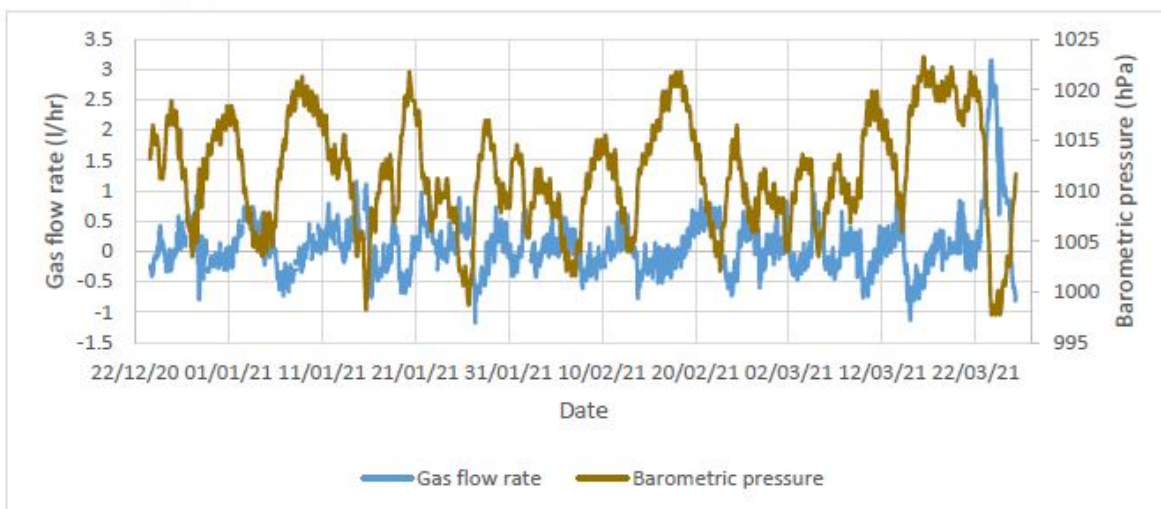
Figure 9.1: Summary of A5 GasfluX results (Source: LFGDA)

Figure 7-1 Comparison of methane and carbon dioxide concentrations with barometric pressure at well A5 – 23 December 2020 to 26 March 2021

Figure 7-2 Comparison of gas flow rate with barometric pressure at well A5 – 23 December 2020 to 26 March 2021

Figure 9.1 indicates that methane concentrations and gas flow rates were at their greatest during or immediately after periods of falling barometric pressure. Carbon dioxide concentration trends reflect methane trends. Methane concentrations and gas flow rates were observed to reach their peaks during the largest and most sustained drop in barometric pressure which occurred at the end of the monitoring period. These peaks were also directly after a period of heavy rainfall, which would be expected to saturate surface soils and increase the tendency for lateral migration of LFG.

Results for the GasfluX monitoring in well A5, located within the Lot, beyond the western boundary of the site, are presented in Figure 9.1 below.

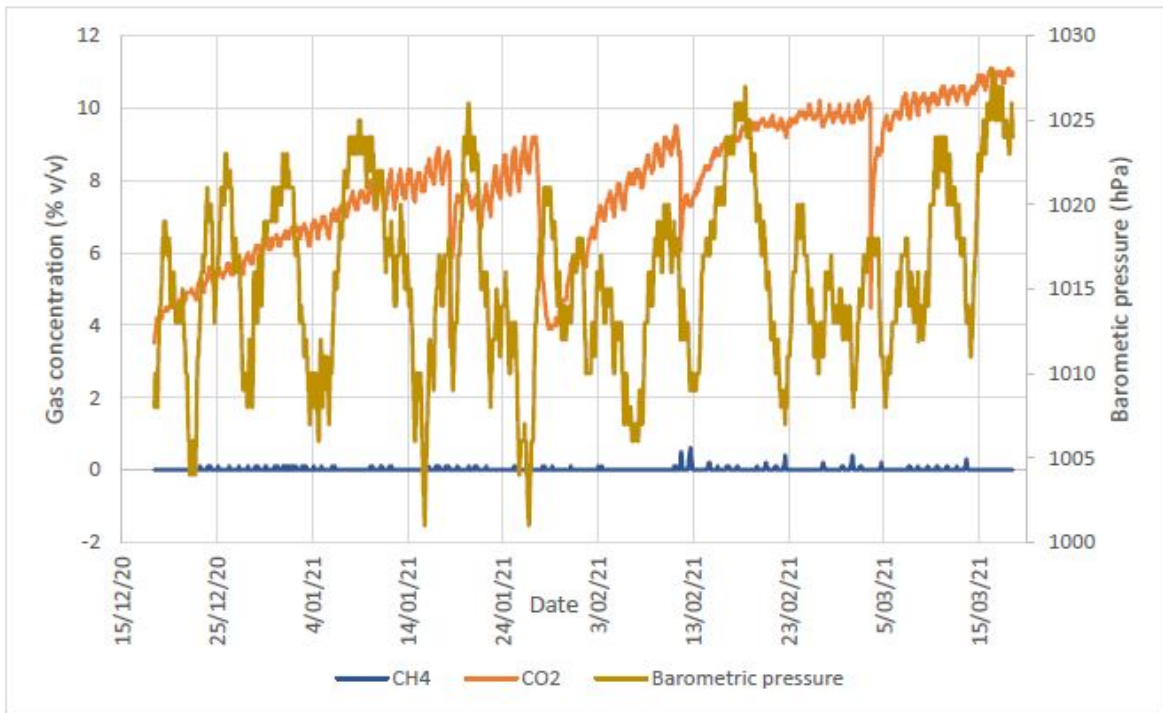
Figure 9.2: Summary of A10 GasClam results (Source: LFGDA)

Figure 7-5 Comparison of methane and carbon dioxide concentrations with barometric pressure at well A10

The GasClam continuous monitors were installed in wells A9 and A10, located toward the centre of the Lot. These locations are along the boundary defined by GHD between the eastern and western portions and are close to the western site boundary which is 18 m from the GHD defined boundary. Methane concentrations of 0.1% v/v were recorded at A9 while a maximum methane concentration of 0.6% v/v was reported for A10. Carbon dioxide concentrations were recorded at 5.8% v/v at A9 and 11.1% v/v at A10. A comparison of methane and carbon dioxide concentrations with barometric pressure for location A10 is presented in Figure 9.2 below.

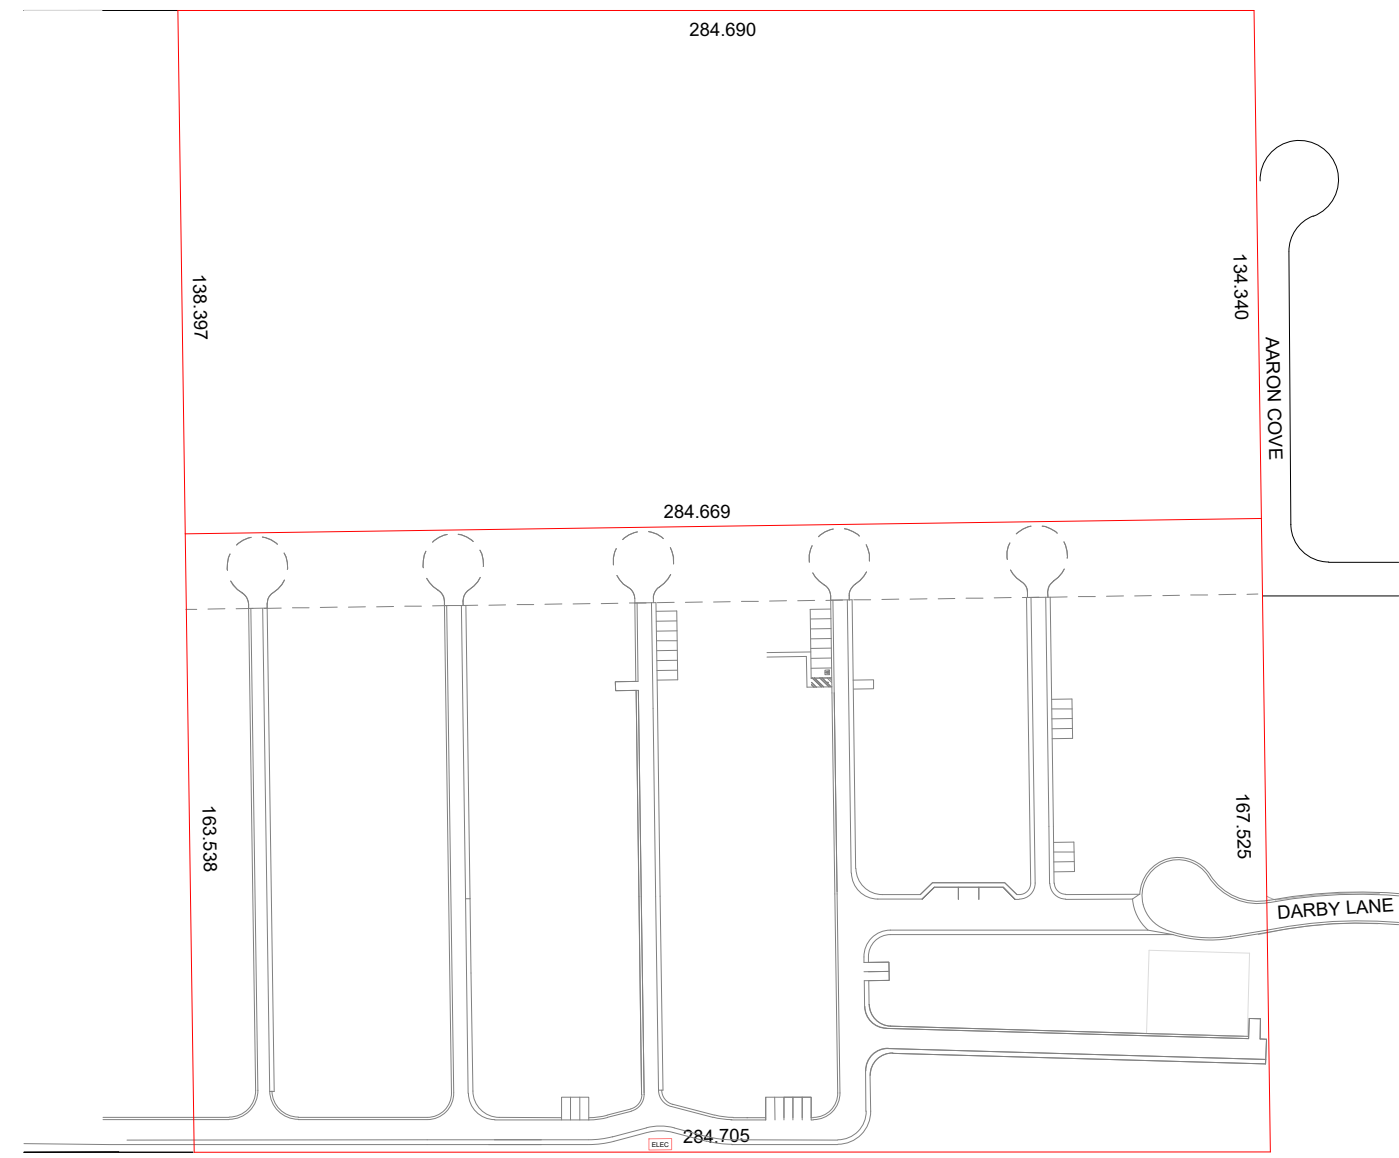
JOB No. > 21035
 DATE > 21/06/2021
 REVISION > A

Proposed Subdivision

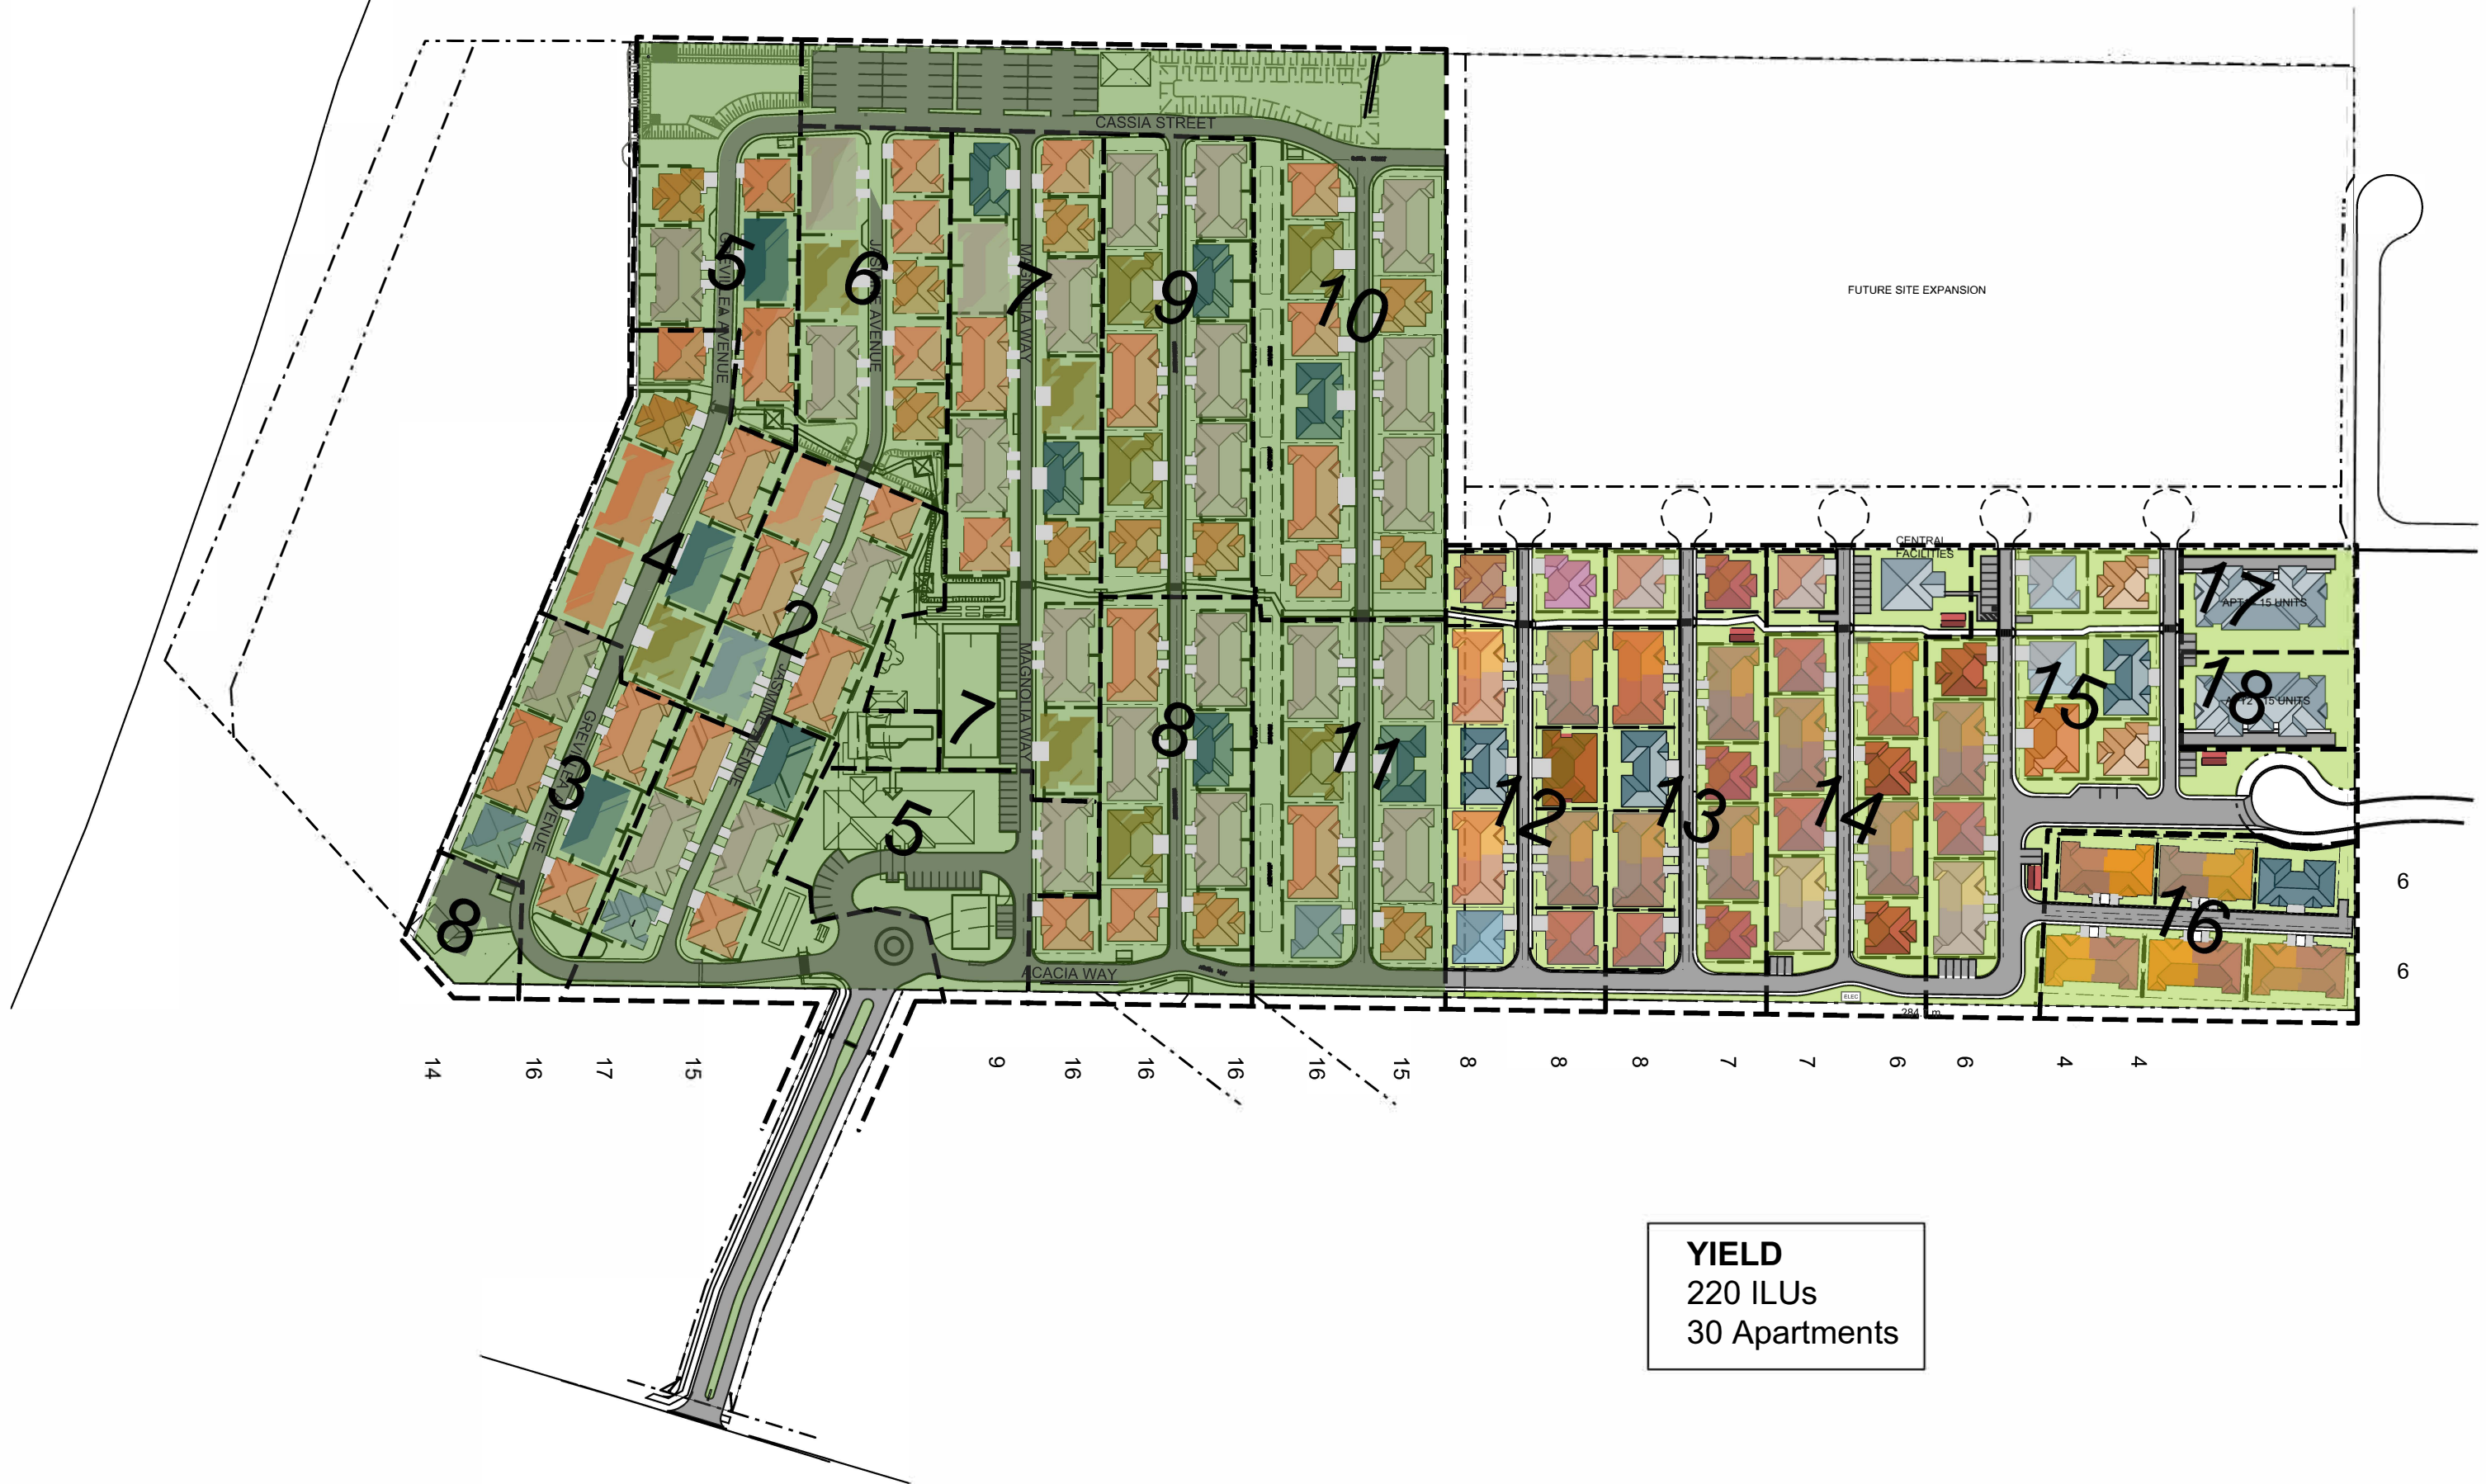
PROJ No. : 5169
DATE : 07/06/2021
SCALE : 1:2000 @ A3
DRG No. : SK-09 A

OVERALL SITE PLAN & STAGING

INDEPENDENT LIVING UNITS
