Statement of Heritage Impact

Proposed Change of Use: Coach House to Dwelling and
Secondary Dwelling to Eco-Tourist Facility at 'Clifton'
245 Station Lane LOCHINVAR NSW
Lot 80 DP 1003006

Eikos Environment and Heritage

7 June 2024

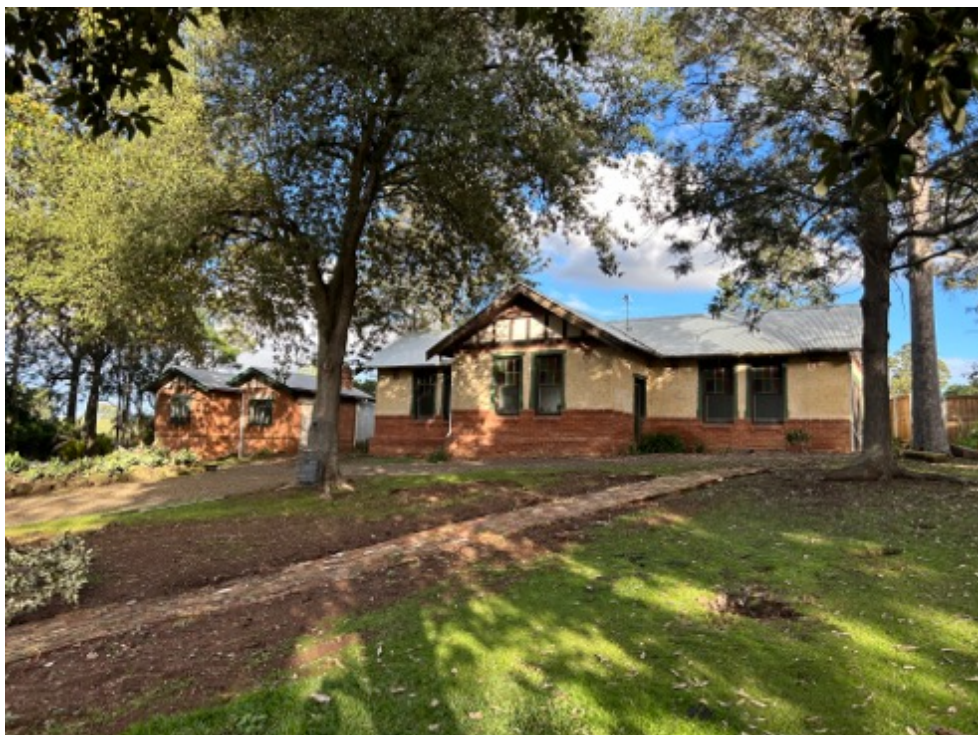
Plate 1 – Photo showing the former Gardeners Cottage on the lhs and the former Coach House on the left – the works have not impacted the front façade of either building (*source: Eikos 8/05/24*)

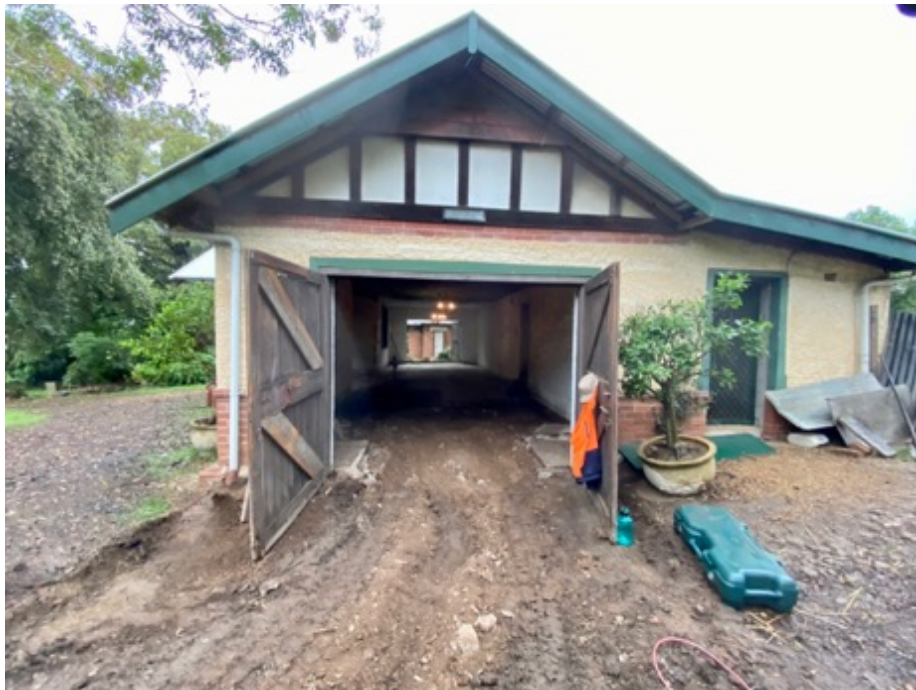
Plate 2 – Photo showing works in progress on the former Coach House – removal of concrete slab and installation of new concrete slab. The original double timber doors and façade are retained (source: Craig Favelle)

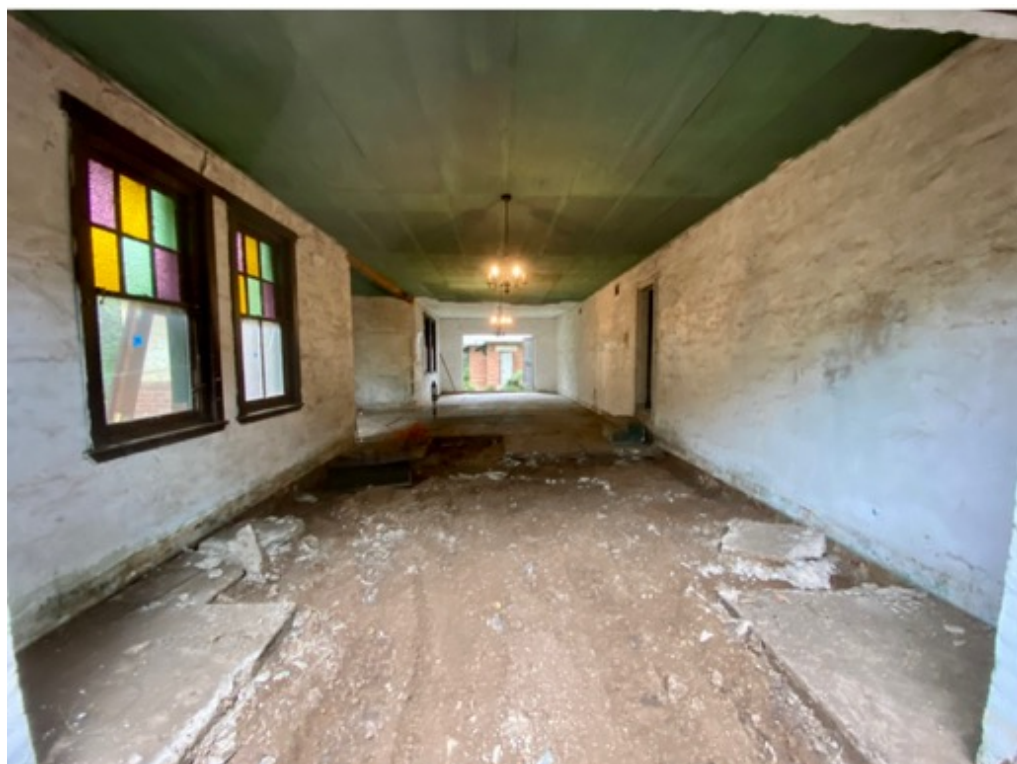
Plate 3 – Photo showing internal works on the former Coach House – all stained glass windows throughout the building are retained (source: Craig Favelle)

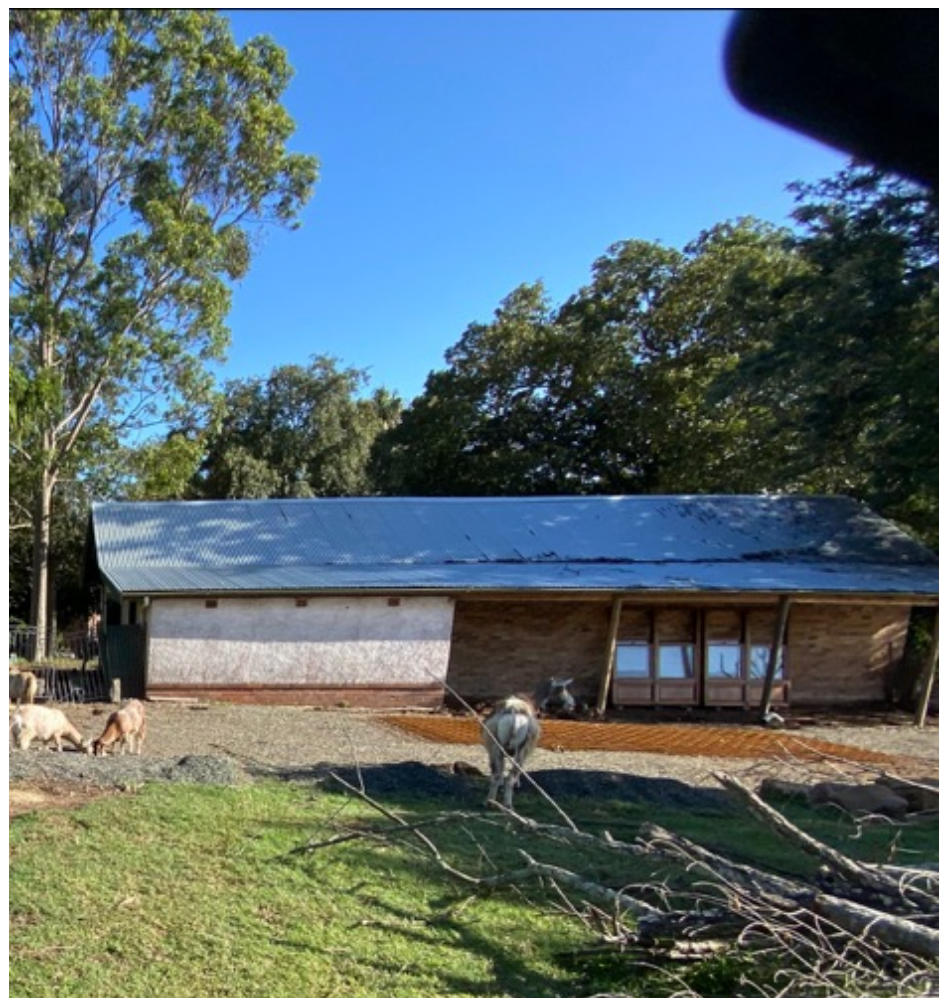
Plate 5 – Before photo showing works in progress for new deck at rear of former Coach House. Part of the brick work on the south elevation was removed to install new windows and doors (source: Craig Favelle).

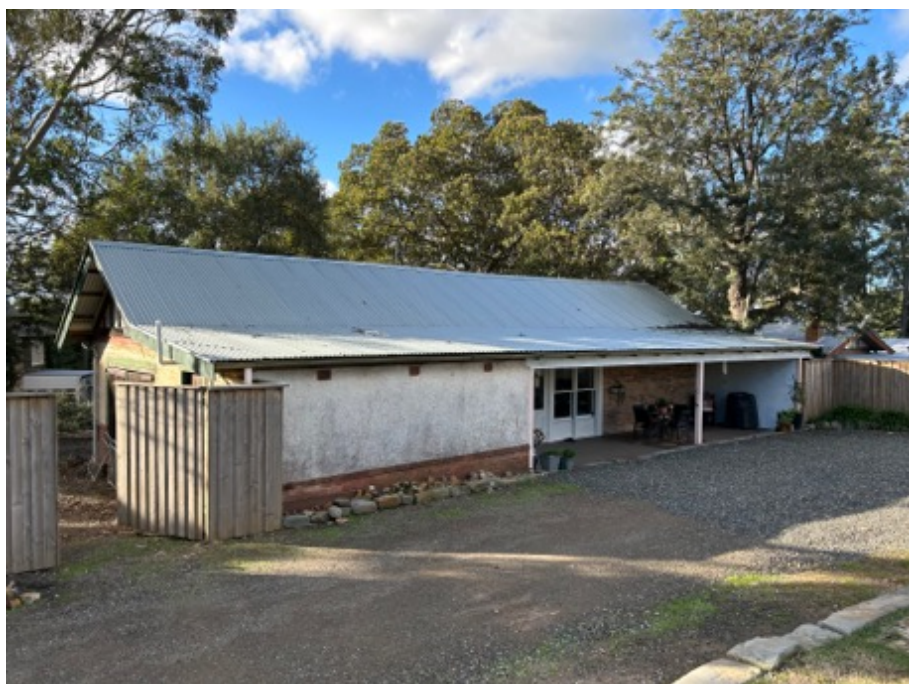
Plate 6 – After photo showing work completed including the new deck, windows and doors (source: Eikos 8/05/24).

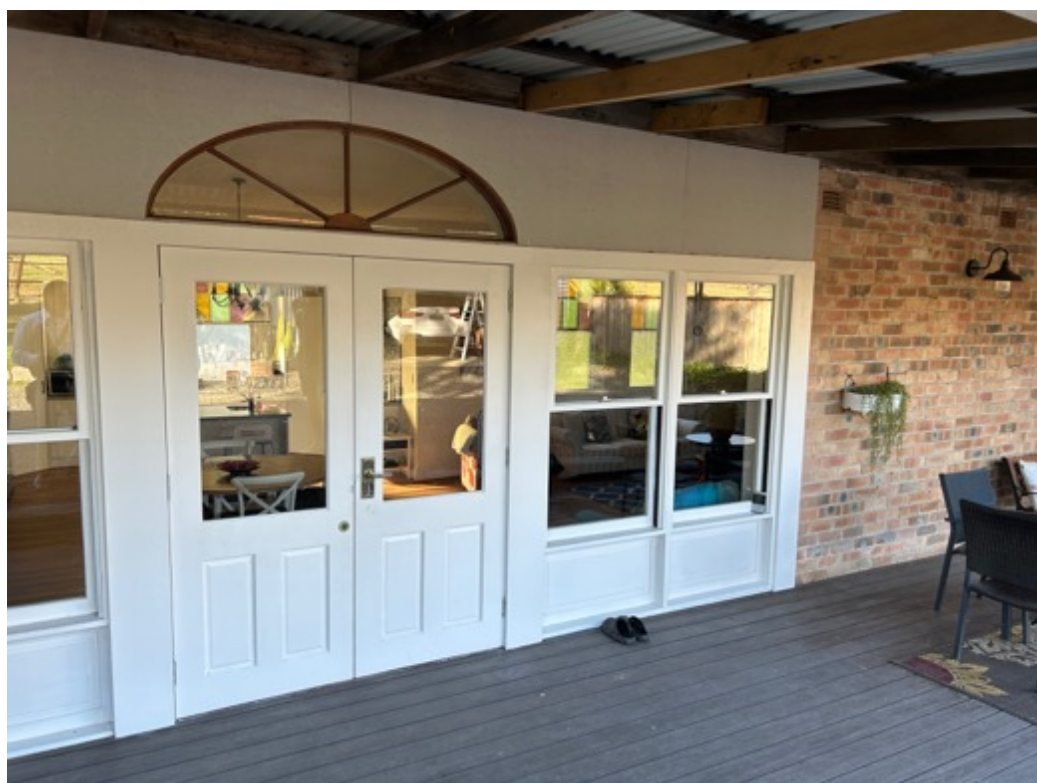
Plate 7 – Close up photo showing the new deck with windows and doors added to the rear of the former Coach House forming the main entry to the dwelling. The removed bricks were re-used as pavement outside entrance to Coach House (source: Eikos 8/05/24).

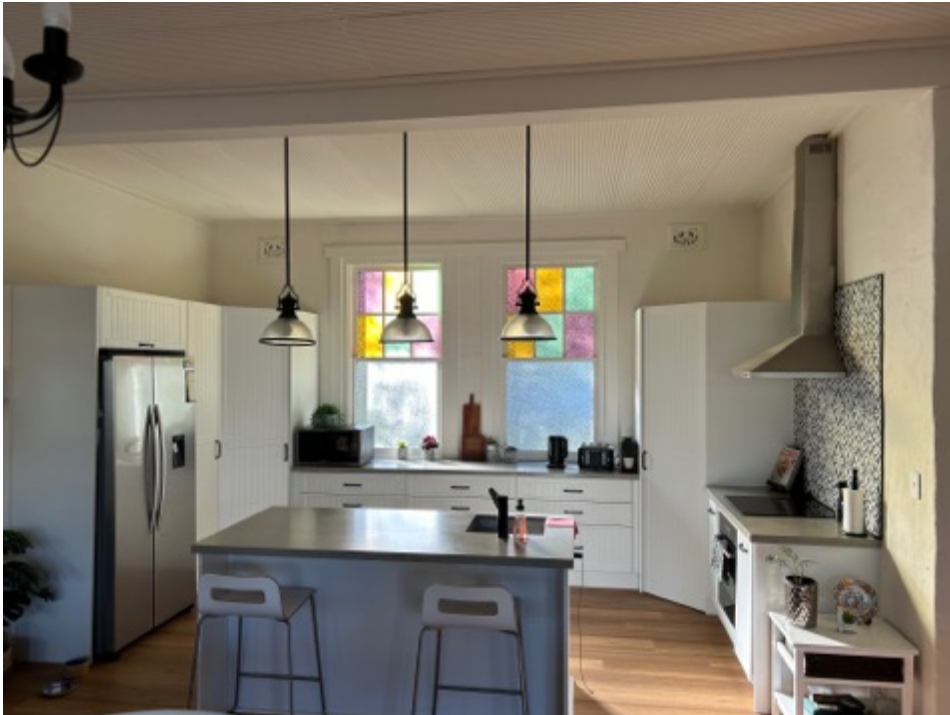
Plate 8 – Photo showing the new kitchen installed in the former Coach House – note the retention of the metal ceilings and stained glass windows (source: Eikos 8/05/24).

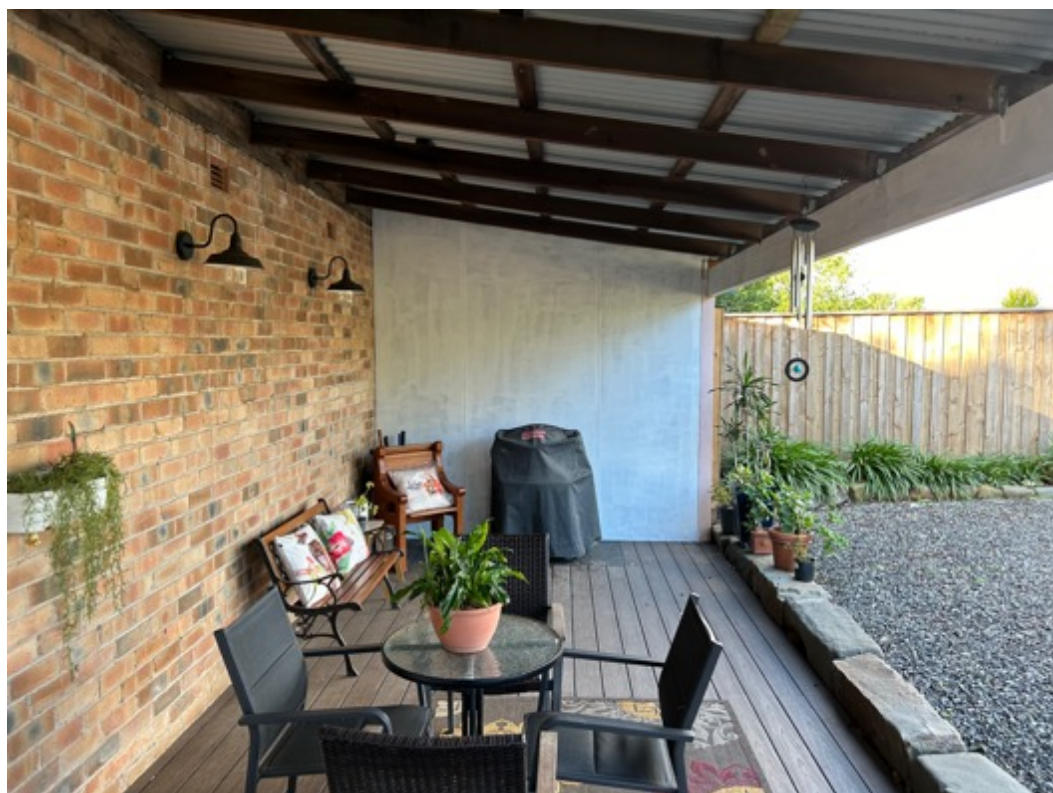
Plate 11 –Photo showing the skillion deck added to the rear of the former Coach House including the new fence, gravel driveway and sandstone retaining wall (source: Eikos 8/05/24).

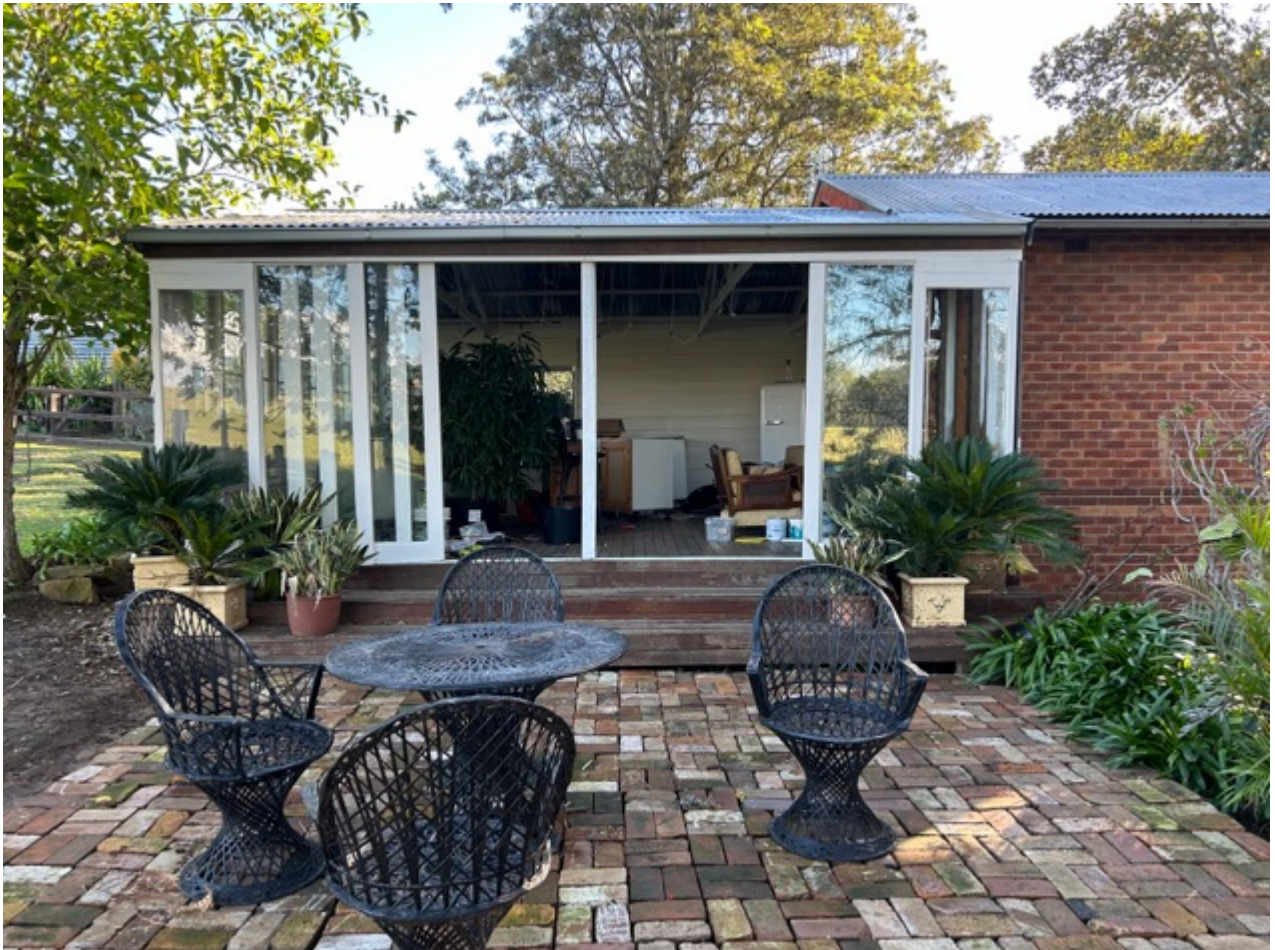
Plate 12 –Photo showing the rear addition to the former Gardeners Cottage – a work in progress. The bricks in the foreground are re-purposed on site (source: Eikos)

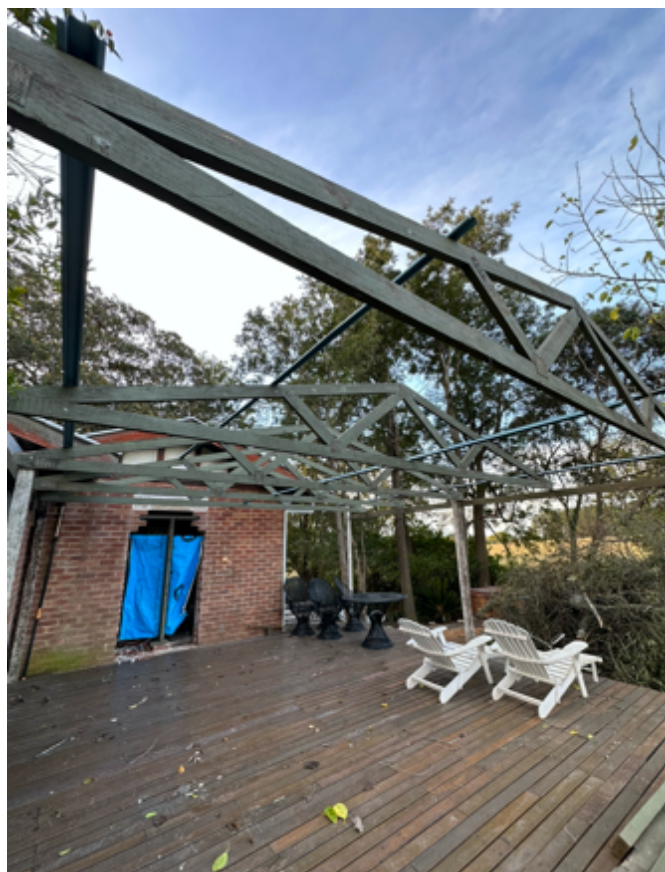
Plate 16 – Photo of the rear addition to the former Gardeners Cottage under construction (source: Craig Favelle)

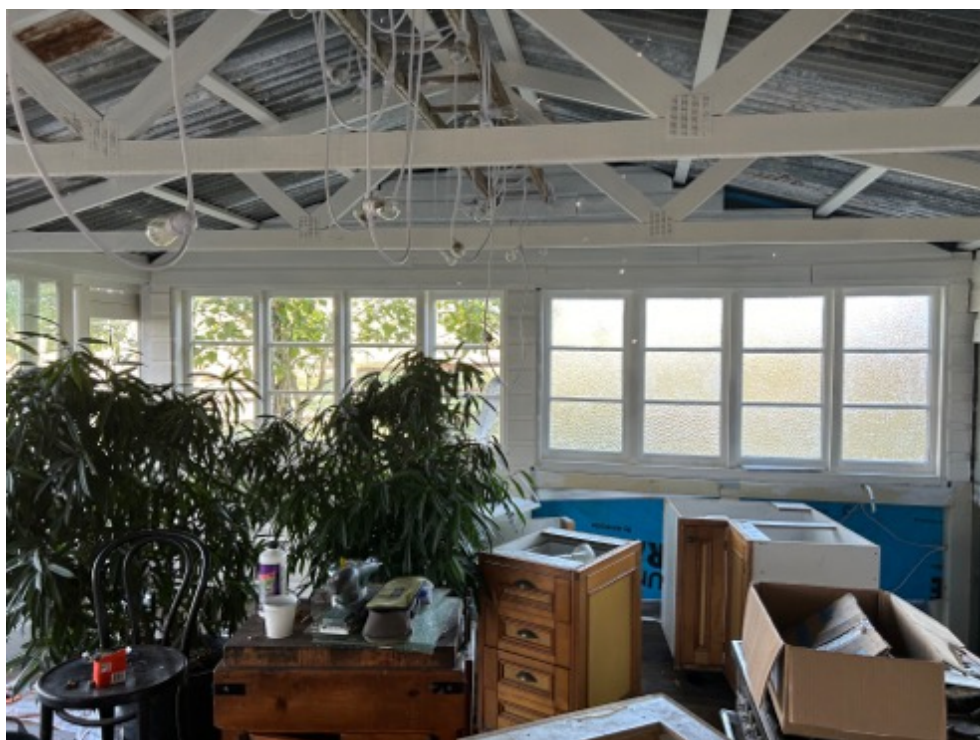
Plate 17 – Photo of the rear addition to the former Gardeners Cottage – work in progress (source: Eikos).

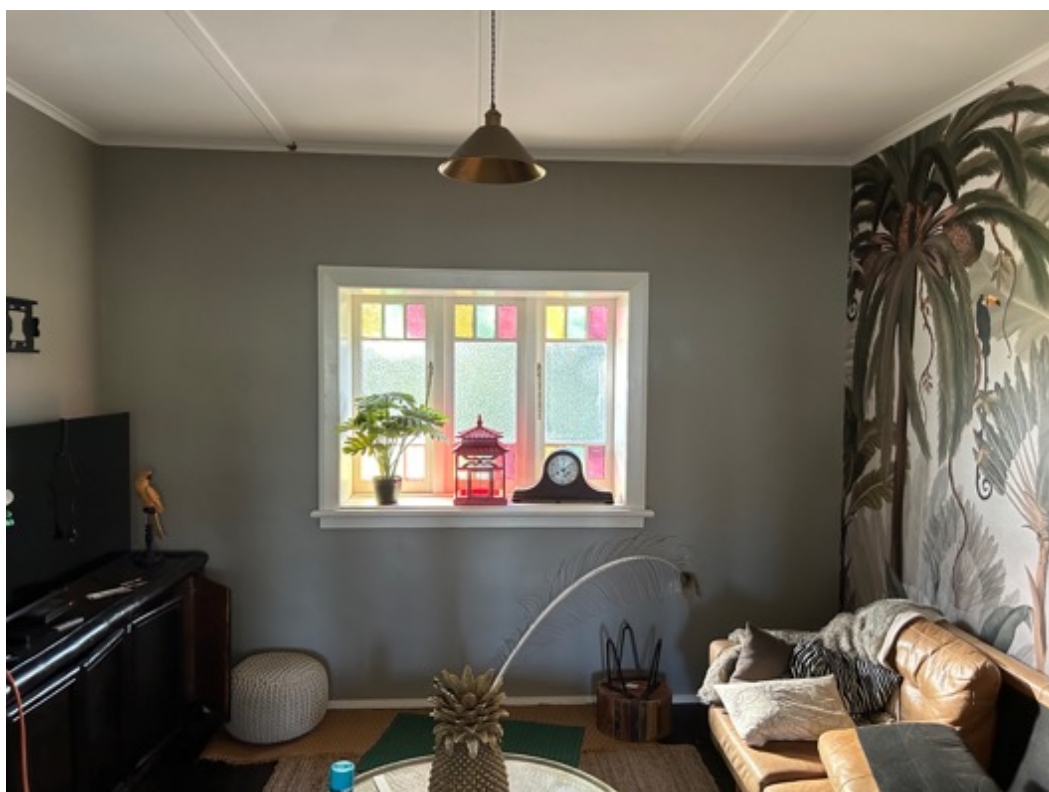
Plate 18 – Photo showing internal alterations (sitting room) to the former Gardeners Cottage (source: Eikos).

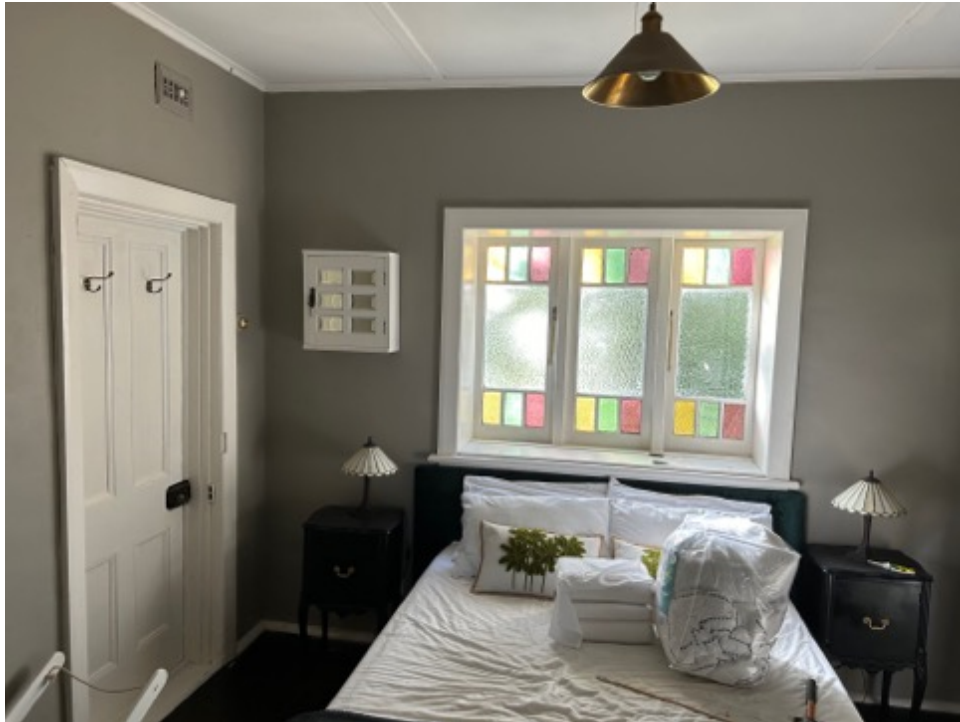
Plate 19 – Photo showing internal alterations (bed-room) to the former Gardeners Cottage (source: Eikos).

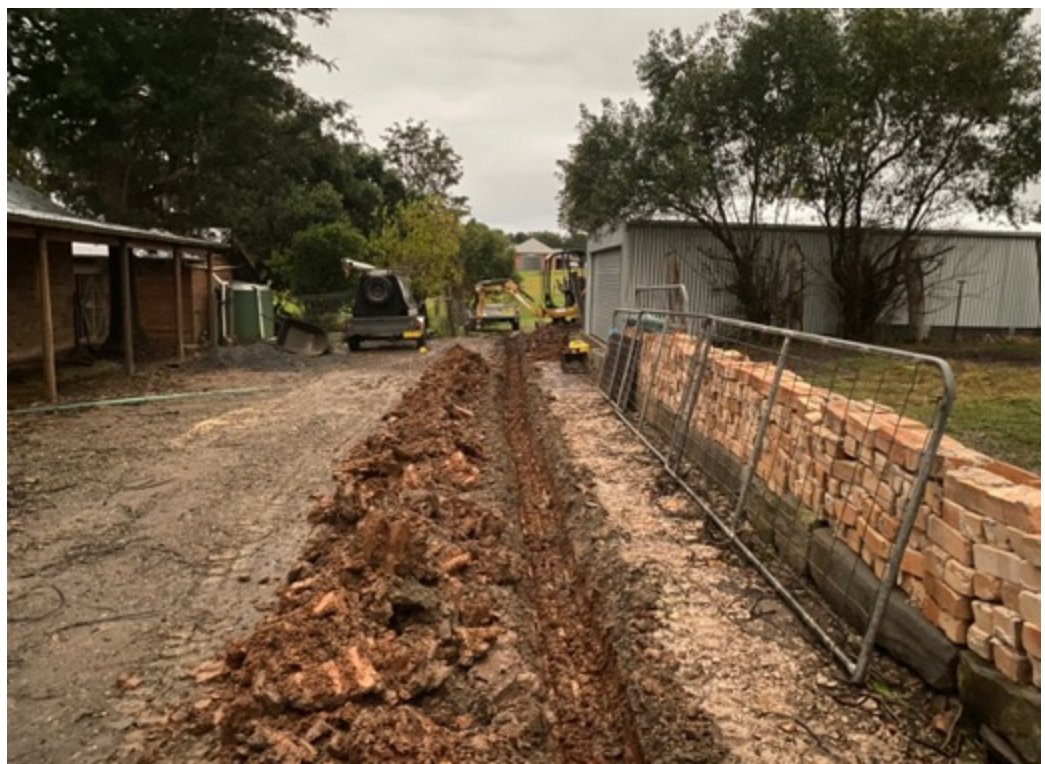
Plate 20 – Photo showing drainage works and new shed to rear of the former Coach House. The bricks on the rhs were re-used on site (source: Craig Favelle).

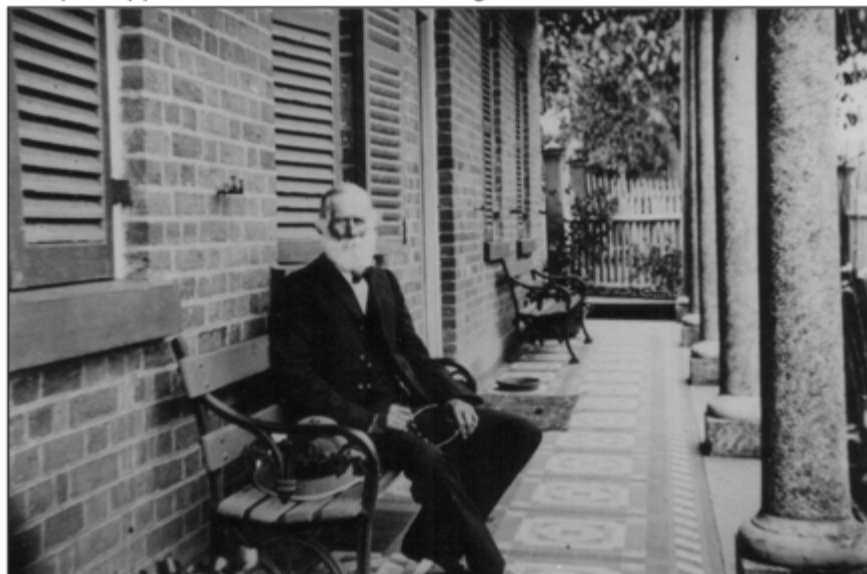
**Joseph Clift
on the Front
Verandah of
Clifton –
Circa
1910^{xvii}**

Note: *The
imitation
marble
verandah
columns and
mosaic tiling
to the floor.*
