Conservation Management Plan

'Former Smith's Flour Mill' 99-101 Newcastle Street, East Maitland

> July 2023 EHC2022/0256

EDWARDS HERITAGE CONSULTANTS PTY LTD

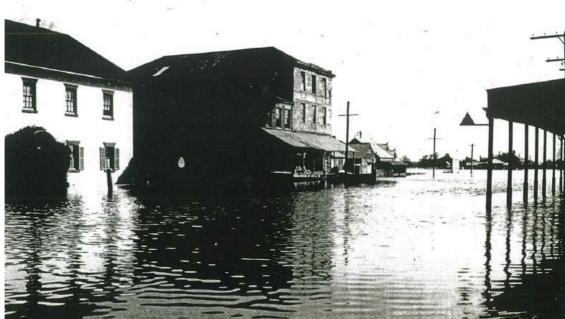
Figure 6: Photo of the former Golden Fleece and Smiths Flour Mill, possibly taken during the 1893 flood. [Source: 'Bound for Wallis Plains: Maitland's Convict Settlers', Maitland City Council. 2023]

Severe flood damage and cumulative impacts was a harsh truth for many commercial businesses in the area. It is not clear who owned the Flour Mill during this time, however the use of the building as a flour mill had ceased. The next registered sale of the site occurred in 1918, when it was purchased by Joseph Cook, a renowned timber miller who established Joseph Cook and Sons. It is postulated that the flour mill was then converted for use as a steam joinery workshop.²⁷

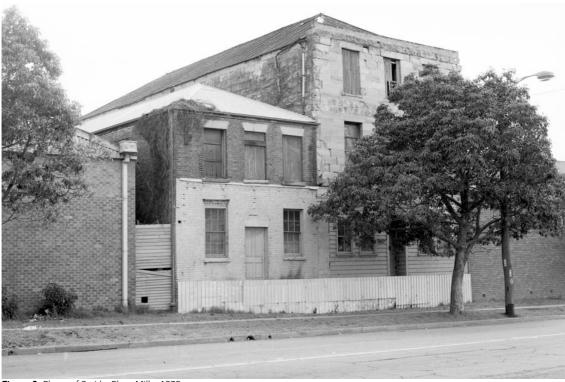
Figure 8: Photo of Smiths Flour Mill, c1979. [Source: The University of Newcastle Australia, Living Histories, 2023. B10406-N2523]

A photographic examination of the building was undertaken in 1979, likely because of the increasing architectural interest in the building. The photos evidence that by now, the former Flour Mill was in a severely derelict state and appears disused. Many windows had by now been boarded up or were missing and the front verandah at the ground floor had been demolished. Curiously, the front elevation at the ground floor of the three-storey mill had been clad in weatherboards and featured a series of double-hung sash windows.

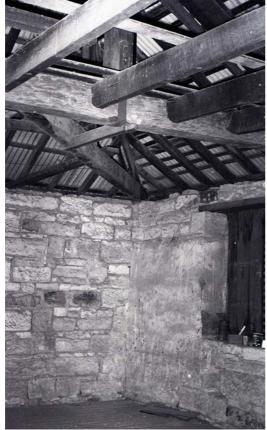
Figure 10: View of interior roof framing and walls c1979. [Source: Damaris Bairstow, The University of Newcastle, Living Histories. C919-0866]

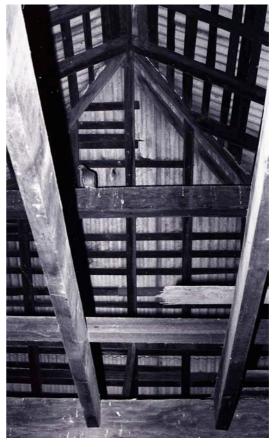
Figure 9: View of the internal roof framing to the second floor. [Source: Damaris Bairstow, The University of Newcastle, Living Histories, 2023. C919-0870

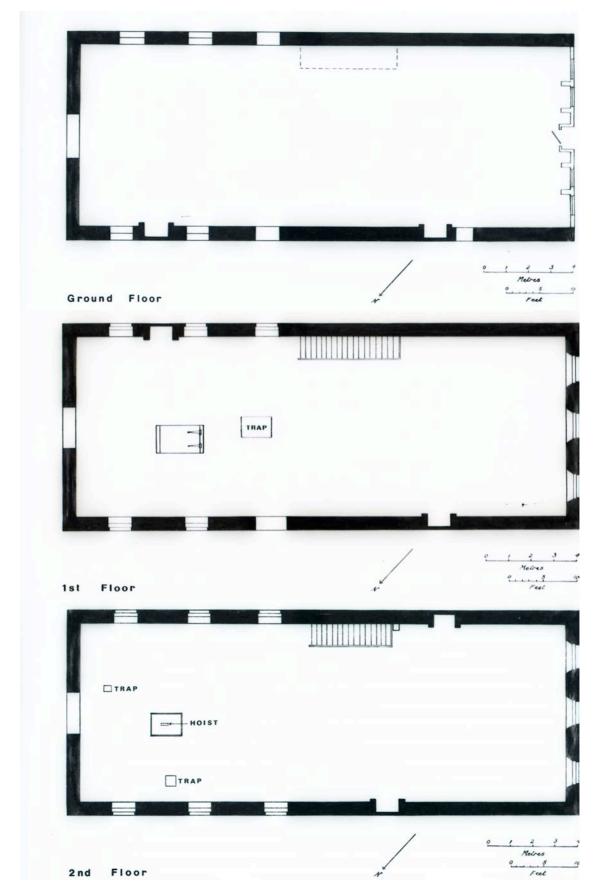
Figure 11: Floor plans of Smiths Flour Mill, c.1979. [Source: Damaris Bairstow, 1979. The University of Newcastle, Living Histories, C919-0959]

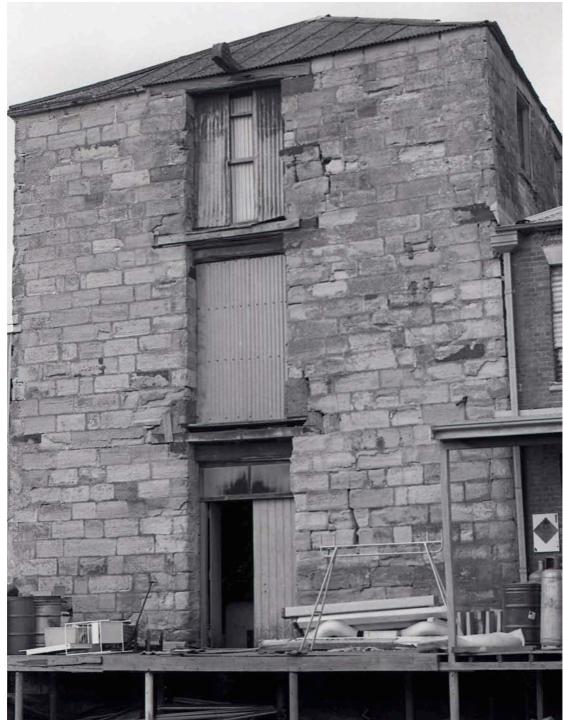
Figure 12: View of the rear elevation of the former Smiths Flour Mill, c1979. [Source: Damaris Bairstow, 1979. University of Newcastle, Living Histories C919-866]

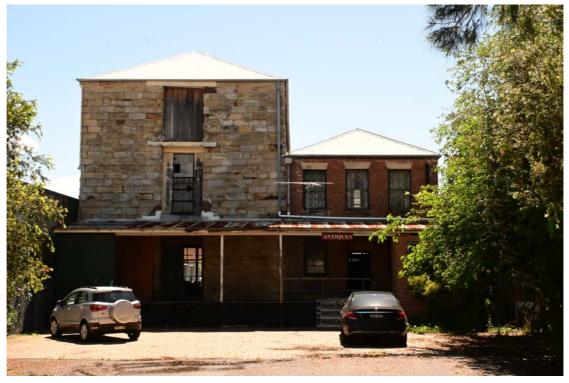
Figure 29: View of the rear elevation.

The rear elevation features a centrally positioned single opening to each of the three levels, hinting at the former use for goods handling via a jib (since removed). The openings are supported by a large timber lintel. At the ground floor, the opening supports two large timber doors, while the openings to the first and second floors have been enclosed by various timber framed doors and windows.

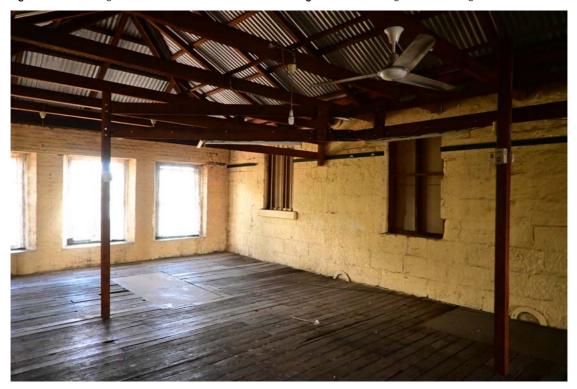
Figure 40: View of the first floor facing towards the rear and showing the former external wall to the southern side of the adjoining former flour mill.

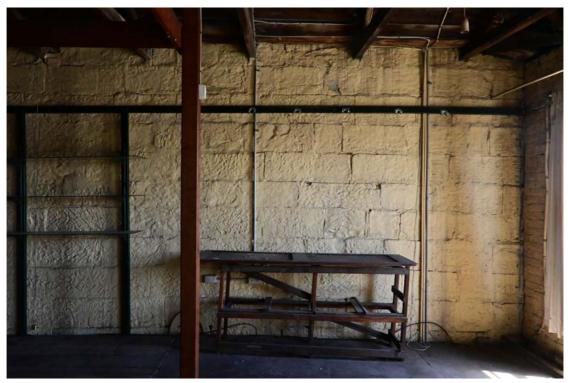
Figure 45: View of the former southern side external wall to the adjoining three-storey flour mill.

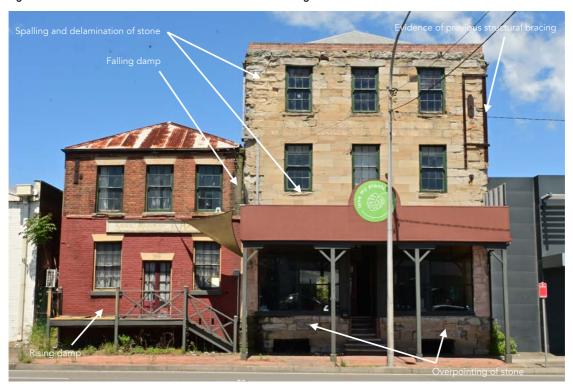
• Wet and dry rot to timber window frames and sashes, particularly evident on the ground floor front elevation and the reproduction verandah and stairs to the front elevation.

- Rising damp in the brick walls evident through discolouration on the bricks and microbial growth, together with blistering paint on the front elevation.
- There are numerous localised areas of failed mortar joints and cracking to the bricks.

Figure 82: Visible defects to the front elevation.

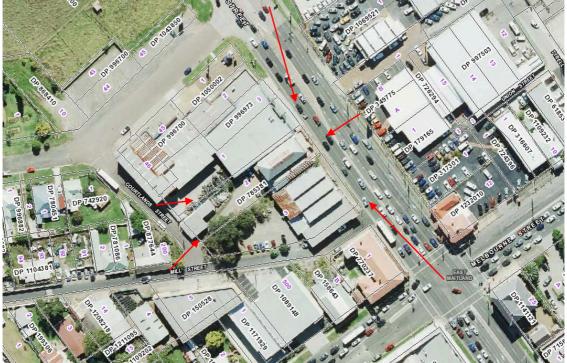
Figure 89: Diagram showing important view corridors to the site.
[Source: NSW Land and Property Information, 2023, with EHC overlay]

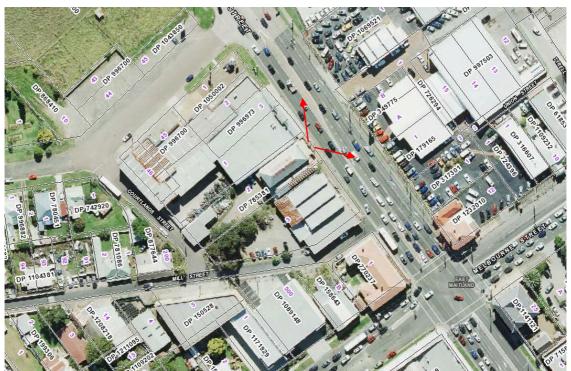
Views from the site are represented in the following diagram:

Figure 90: Diagram showing important view corridors from the site. [Source: NSW Land and Property Information, 2023, with EHC overlay]

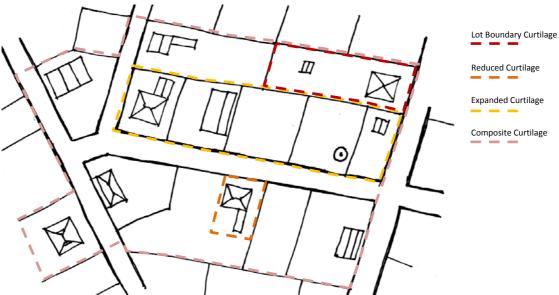
Figure 97: Diagram showing the four defined heritage curtilages.

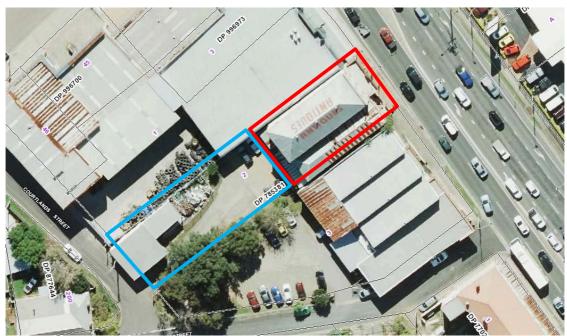
2. **Rear portion of the site (blue)** – comprising the small, landscaped area, driveway, ancillary building (shed) and cementitious apron.

Figure 98: Aerial photograph of the site with EHC overlay indicating precinct boundaries.

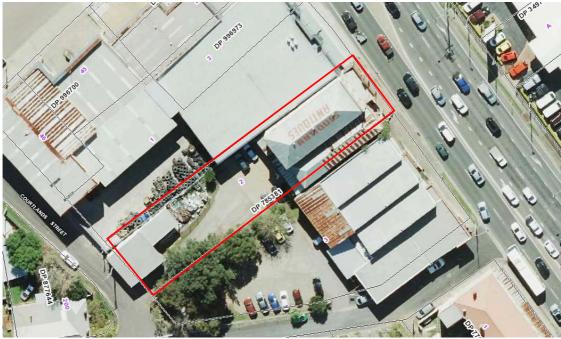
The recommended heritage curtilage is represented in the following diagram:

Figure 99: Aerial photograph of the site with EHC overlay indicating the lot boundary heritage curtilage.
