Riparian Assessment Report

**898 New England Hwy, 25 Wyndella Rd and 39 Wyndella Rd
Lochinvar, NSW**

**Prepared for: Lochinvar Developments Pty Ltd
C/- ADW Johnson Pty Ltd**

July 2024

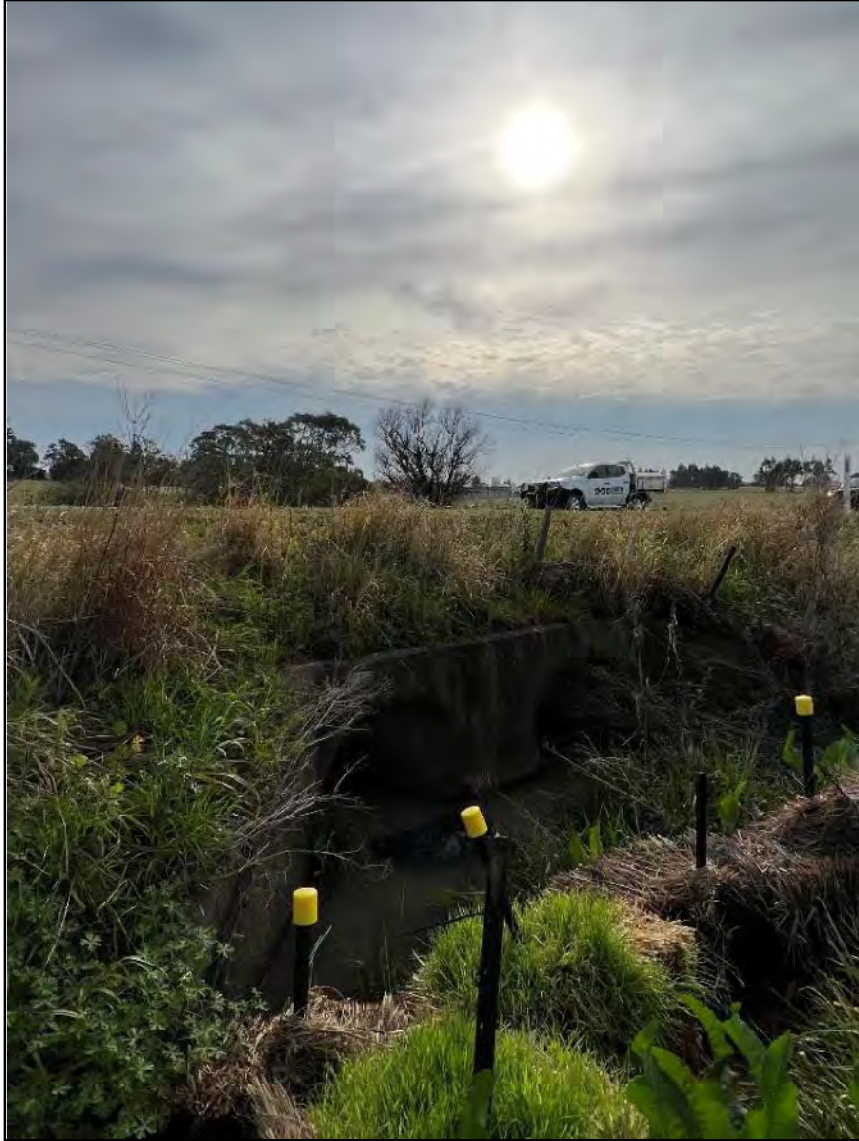
A photograph showing a survey point in a rural landscape. In the foreground, there is a concrete structure, possibly a culvert or drainage pipe, partially obscured by tall grasses and weeds. Several black survey stakes with yellow caps are placed around the structure. In the background, a white van is parked on a road, and there are trees and a cloudy sky with a bright sun. <p data-bbox="607 1440 1015 1470">Survey Point 3.1 mapped downstream</p>

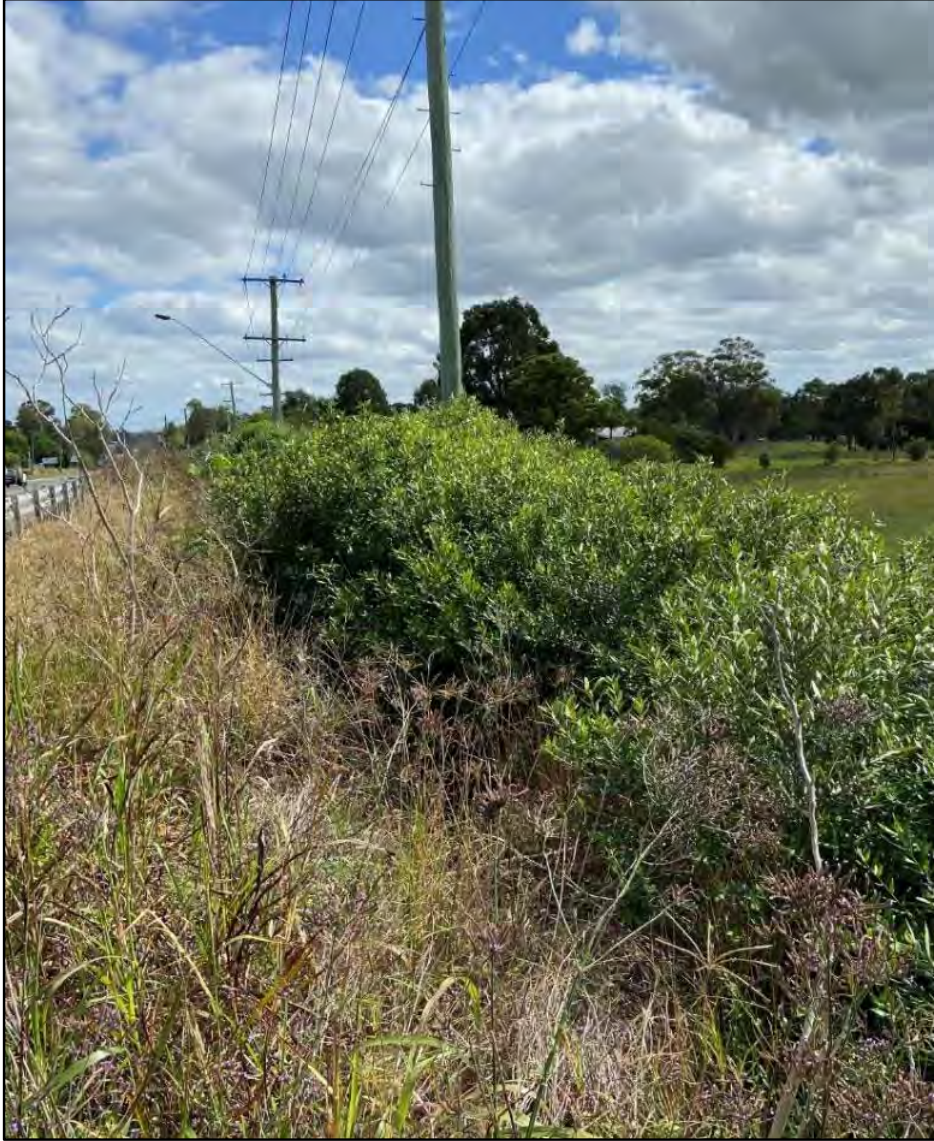
A photograph showing a dense thicket of tall, green and brown grasses and shrubs. In the background, there are utility poles with power lines stretching across a blue sky with scattered white clouds. A road and some trees are visible in the distance. <p data-bbox="597 1436 1024 1465">Survey Point 4.1 – mapped downstream</p>

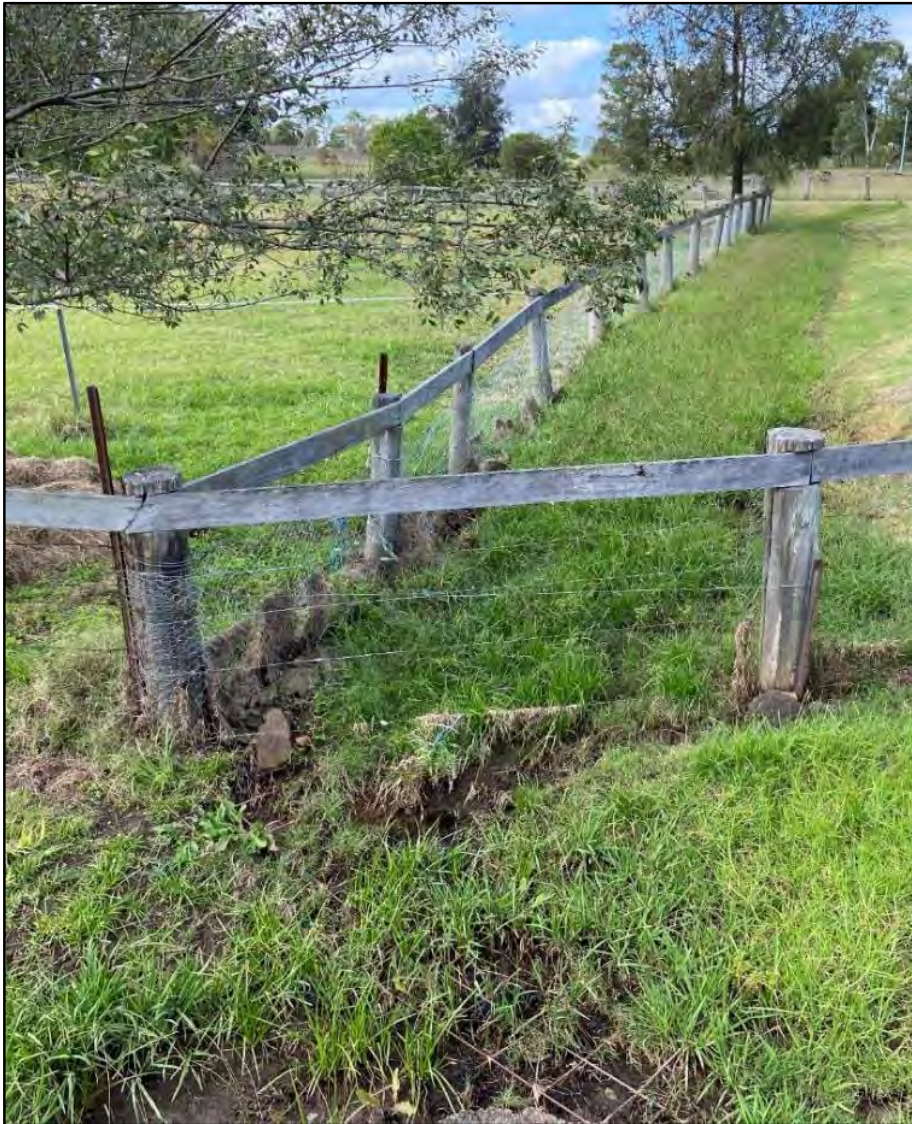
Site Photos – Survey Point 5.1

Task – Waterland Tool (2020)	Assessment	Comments (provide evidence)	Figures
Controlled Activity Approval Required (Y / N)	N/A	WFL does not occur at this survey point.	-
Vegetated Riparian Zone Required (m)	No	Not applicable	-
Comments	<p>Segment 5 is mapped as a 2nd order stream. Urban development has altered the hydrological and geomorphological characteristics of the landscape. The adjacent rural property is occupied by a farm dam and dam overflow flows under an internal access road culvert and along a straight drainage channel to an existing culvert under Wyndella road.</p> <p>The inspection showed farm and stormwater infrastructure through a modified environment. No WFL features, such as a defined bed and bank or a change in vegetation indicating a wetland were observed. Survey Point 5.1 does not constitute waterfront land.</p>

Survey Point 5.1 – mapped upstream

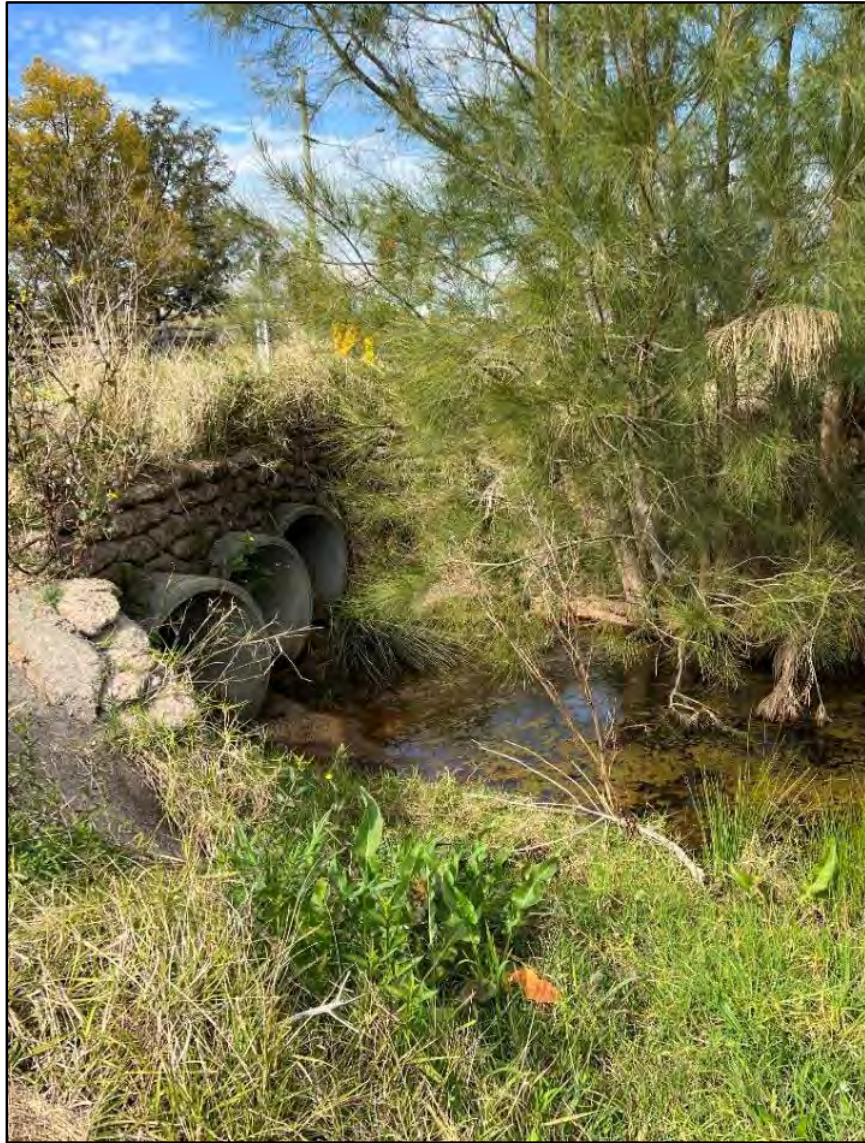
Site Photos – Survey Point 7.1

Task – Waterland Tool (2020)	Assessment	Comments (provide evidence)	Figures
		considered Order 1 for the purposes of determining the appropriate VRZ.	
Controlled Activity Approval Required (Y / N)	Yes	CAA required for works within 40m of the top of banks.	6
Vegetated Riparian Zone Requirement	10m	A VRZ of 10m is required from the top of bank either side of the watercourse.	7
Comments	<p>Survey Point 7.1 occurs at a culvert on the western side of Wyndella, Road. Discharge from the culvert has resulted in WFL and includes watercourse features such as a defined bed and bank, pools and a change in vegetation indicating a wetland.</p> <p>Survey Point 7.1 constitutes waterfront land and a CAA is required for works within 40m of the top of bank.</p>

Survey Point 7.1 - upstream

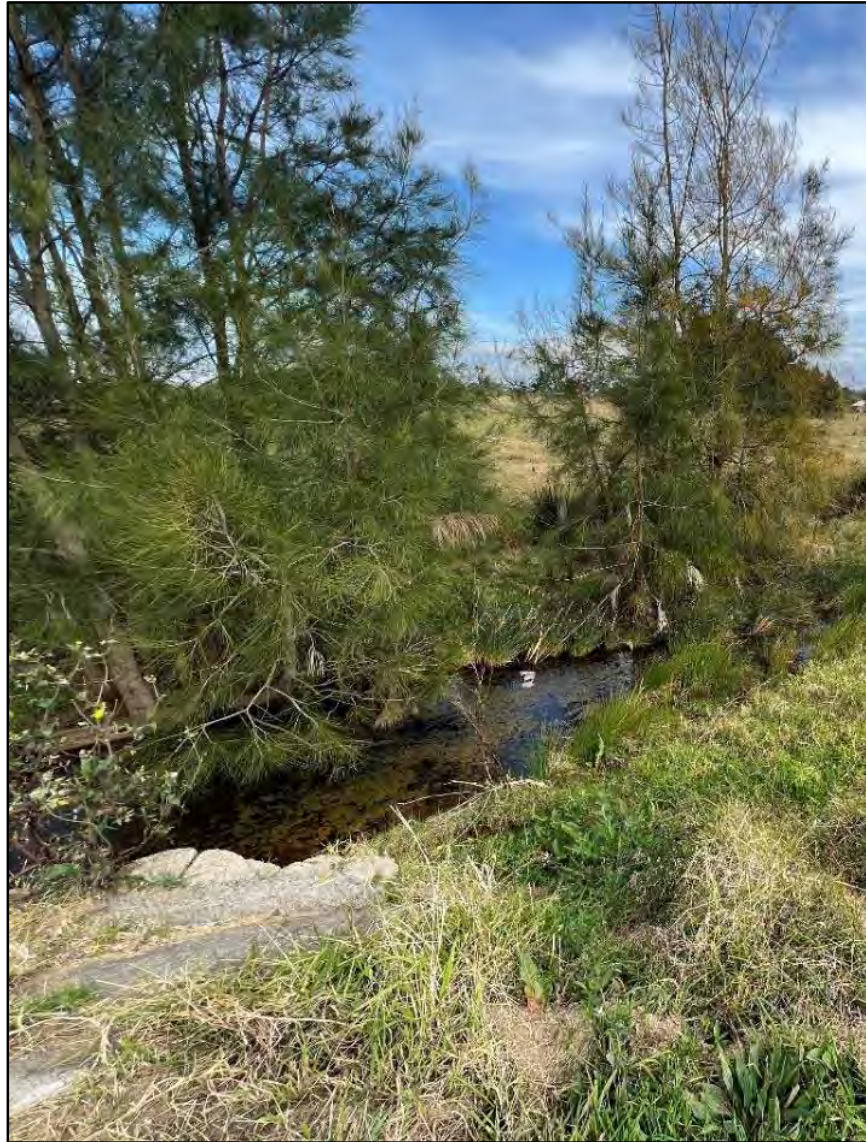
Survey Point 7.1 - downstream

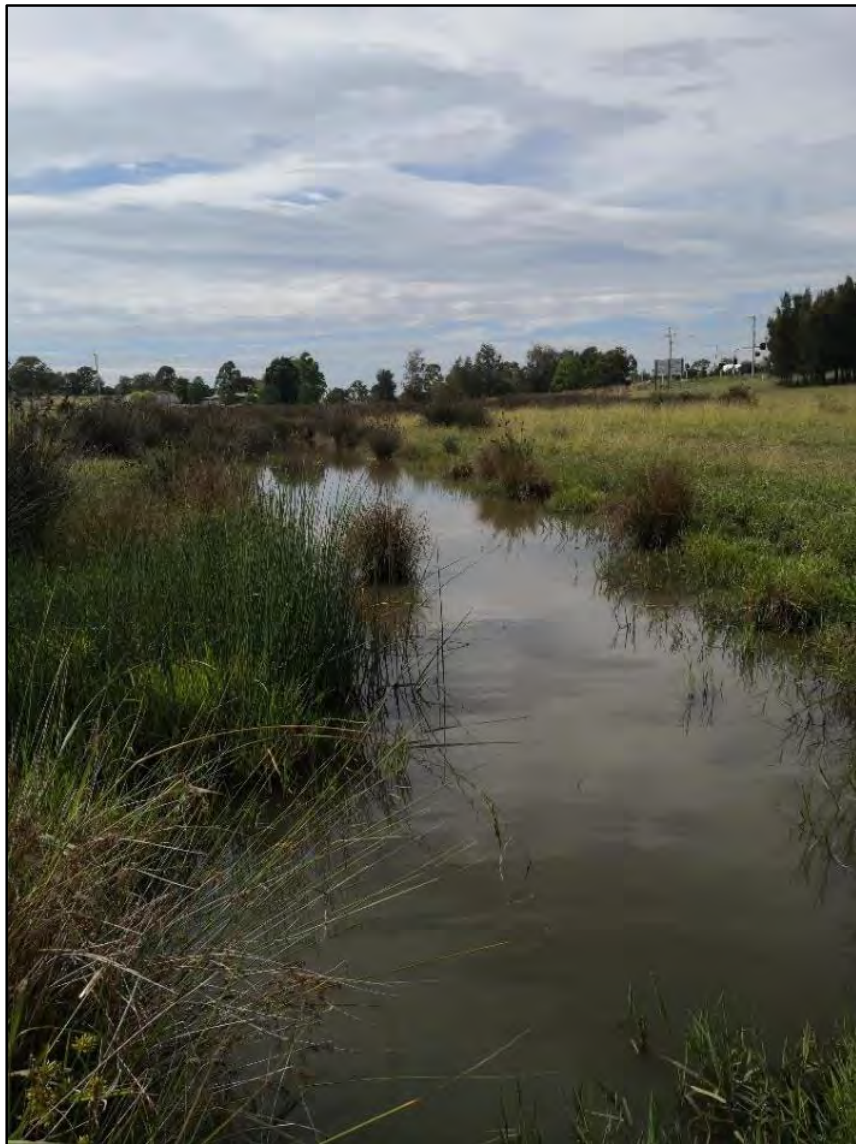
Site Photos – Survey Point 7.2

Task – Waterland Tool (2020)	Assessment	Comments (provide evidence)	Figures
		considered Order 1 for the purposes of determining the appropriate VRZ.	
Controlled Activity Approval Required (Y / N)	Yes	CAA required for works within 40m of the top of banks.	6
Vegetated Riparian Zone Required (m)	10m	A VRZ of 10m is required from the top of bank either side of the watercourse.	7
Comments	Watercourse features are present at Survey Point 7.2. Survey Point 7.2 constitutes waterfront land and a CAA is required for works within 40m of the top of bank.

Survey Point 7.2 - upstream

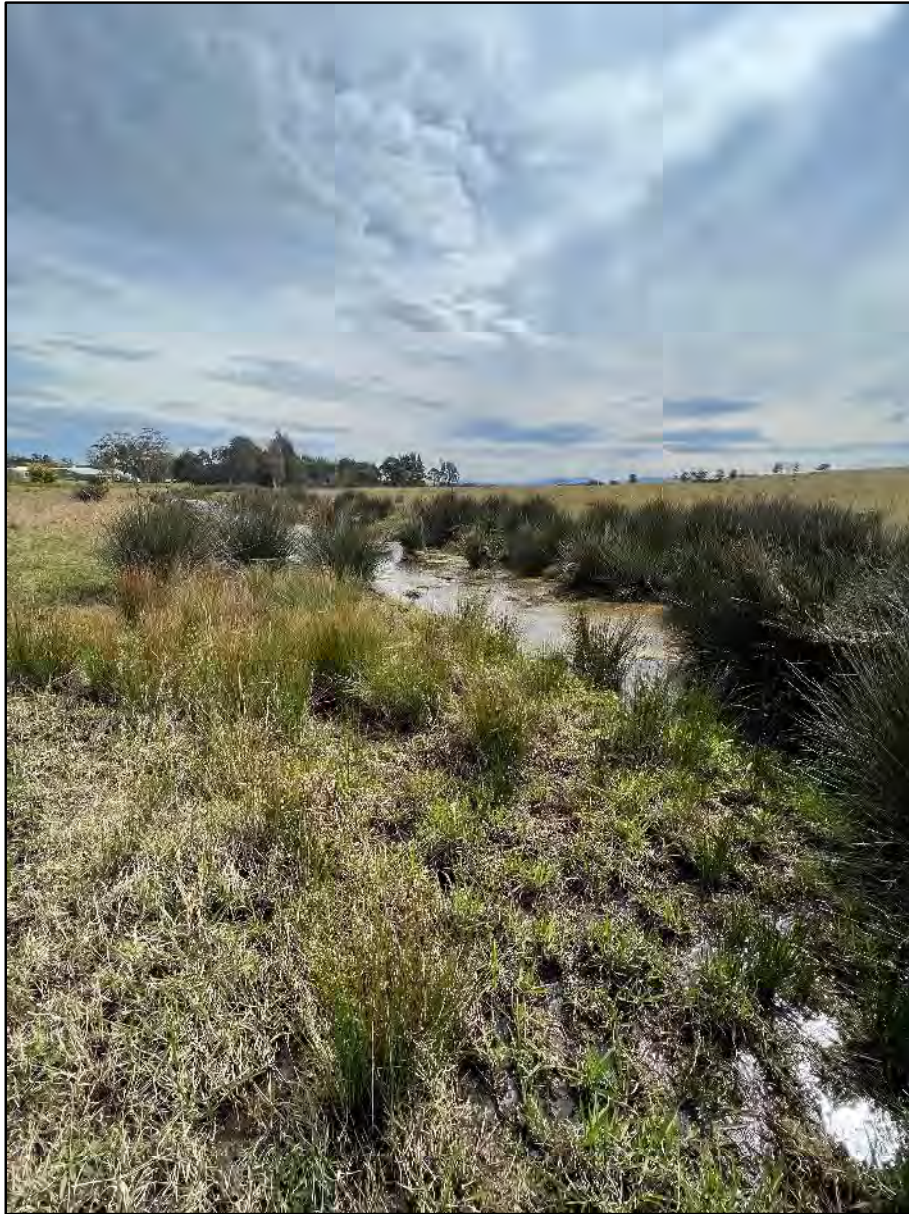
Survey Point 7.2 - downstream

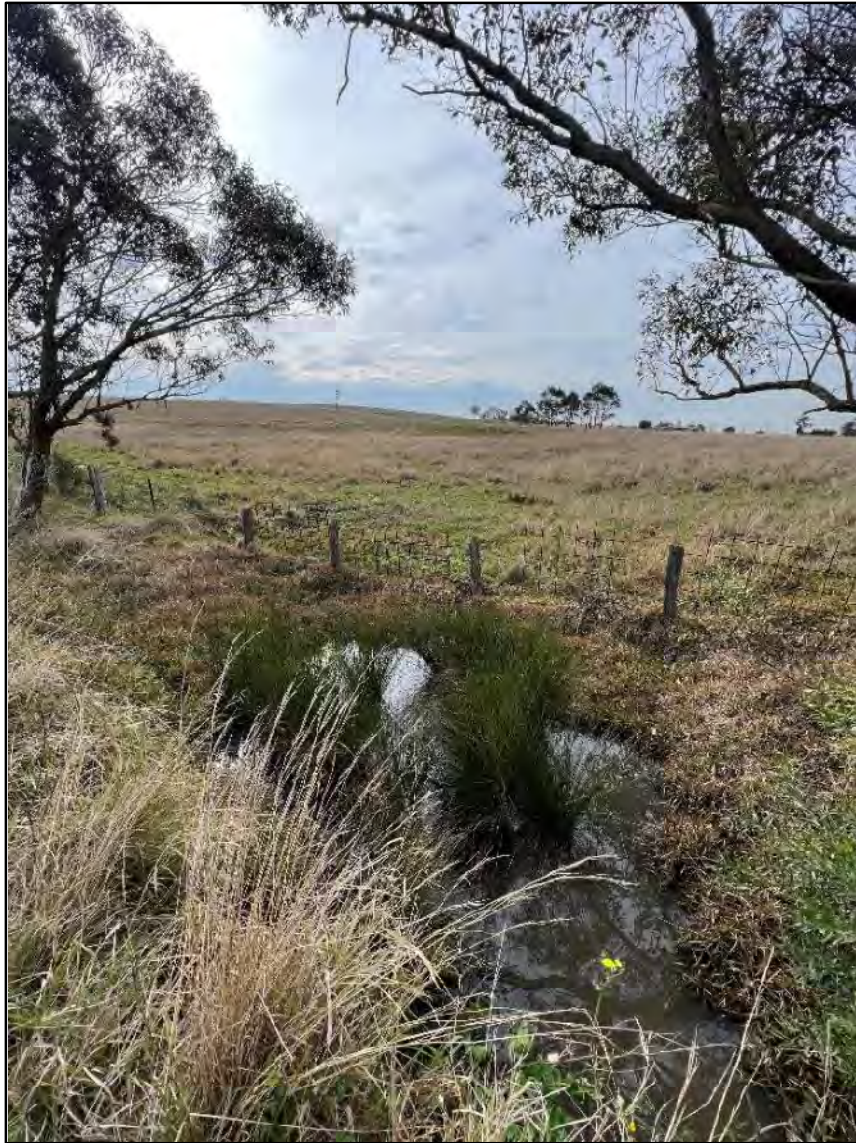
Site Photos – Survey Point 10.1

Task – Waterland Tool (2020)	Assessment	Comments (provide evidence)	Figures
Controlled Activity Approval Required (Y / N)	N/A	WFL does not occur at this survey point.	-
Vegetated Riparian Zone Required (m)	No	Not applicable	-
Comments	<p>Segment 10 is mapped as a 2nd order stream and Survey Point 10.1 represents the juncture of Segment 8 and 9. Roadside inspection reveal a lack of bed and bank, and watercourse features, north east in the direction of mapped Segment 8 and 9.</p> <p>A culvert is present under Wyndella Road, with small erosion pools at the entrance and exit points, formed by the convergence of over land flow at the culvert. No WFL features, such as a defined bed and bank or a change in vegetation indicating a wetland were observed.</p> <p>Survey Point 10.1 does not constitute waterfront land.</p>

Survey Point 10.1 – mapped upstream

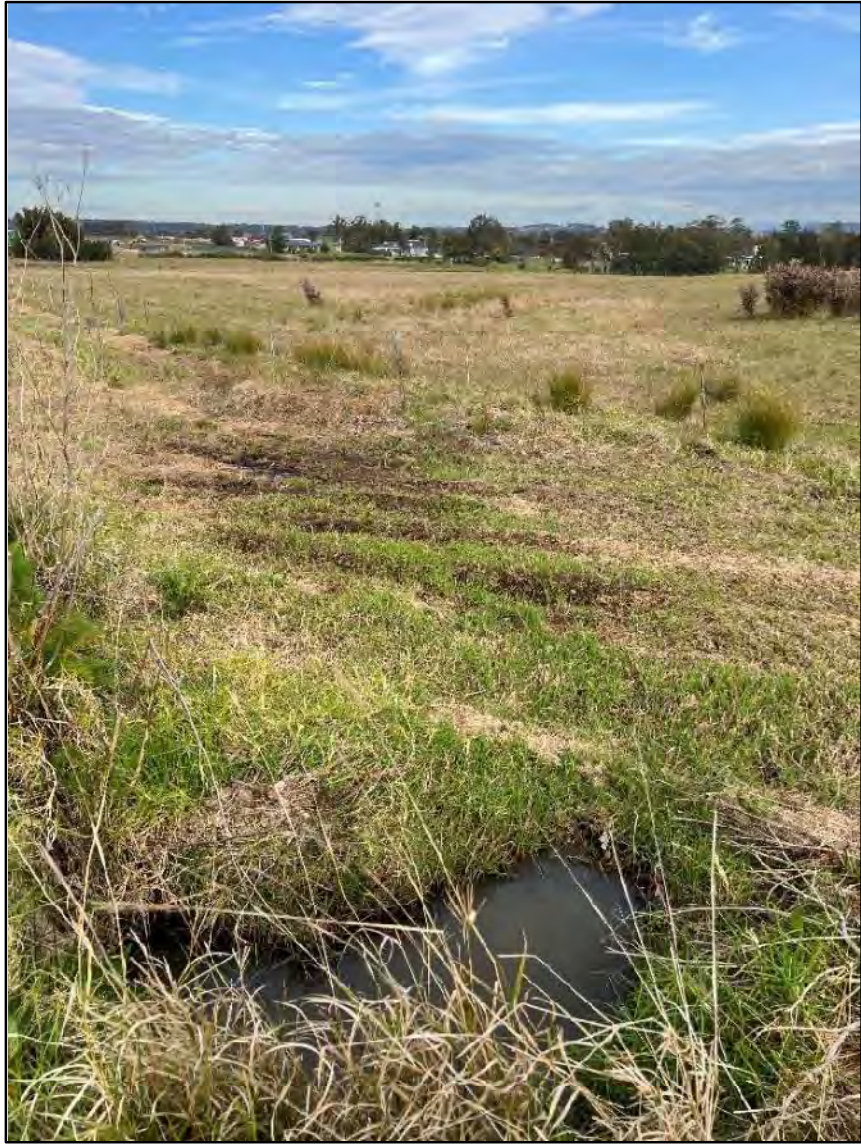
Survey Point 10.1 - downstream

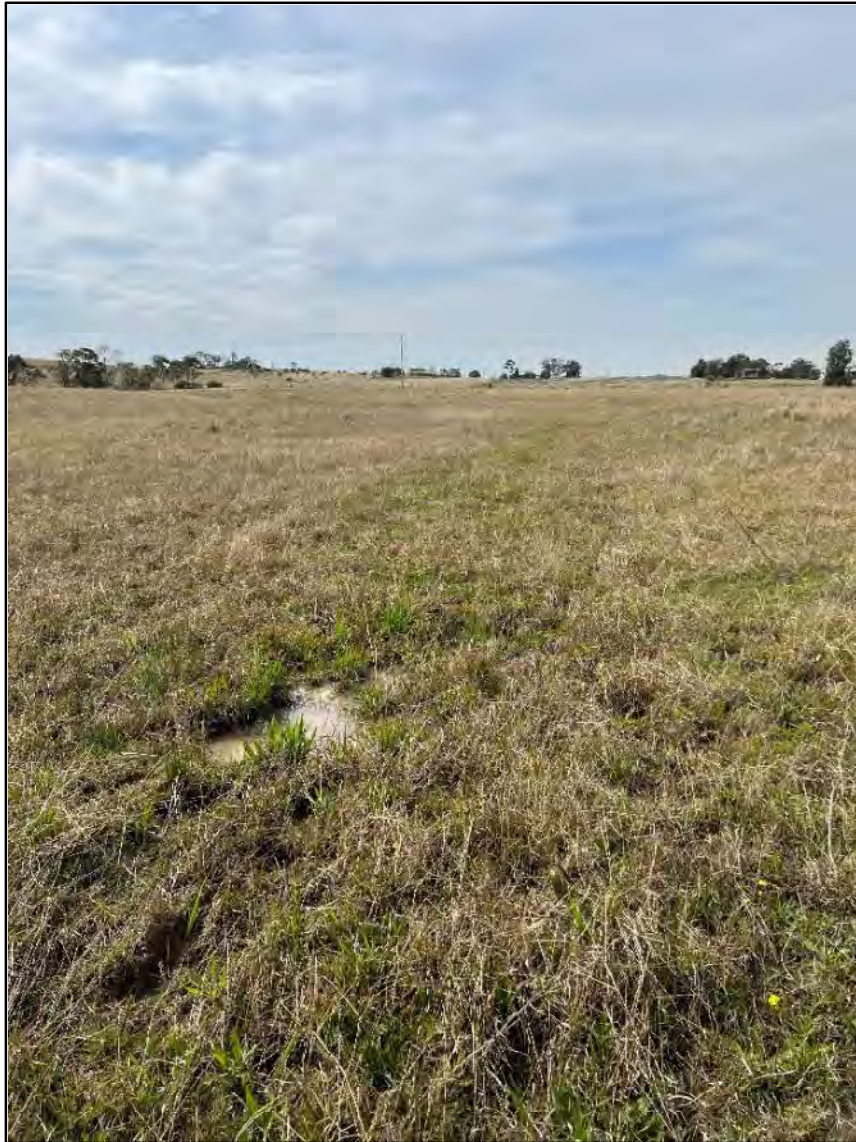
Site Photos – Survey Point 10.2

Task – Waterland Tool (2020)	Assessment	Comments (provide evidence)	Figures
Vegetated Riparian Zone Required (m)	No	Not applicable	-
Comments	<p>Segment 10 is mapped as a 2nd order stream and the location is now occupied by managed grassland. Rural development has likely altered the hydrological and geomorphological characteristics of the landscape through pastoral land use and construction of farm dams and drainage lines.</p> <p>No WFL features, such as a defined bed and bank or a change in vegetation indicating a wetland.</p> <p>Survey Point 10.2 does not constitute waterfront land.</p>

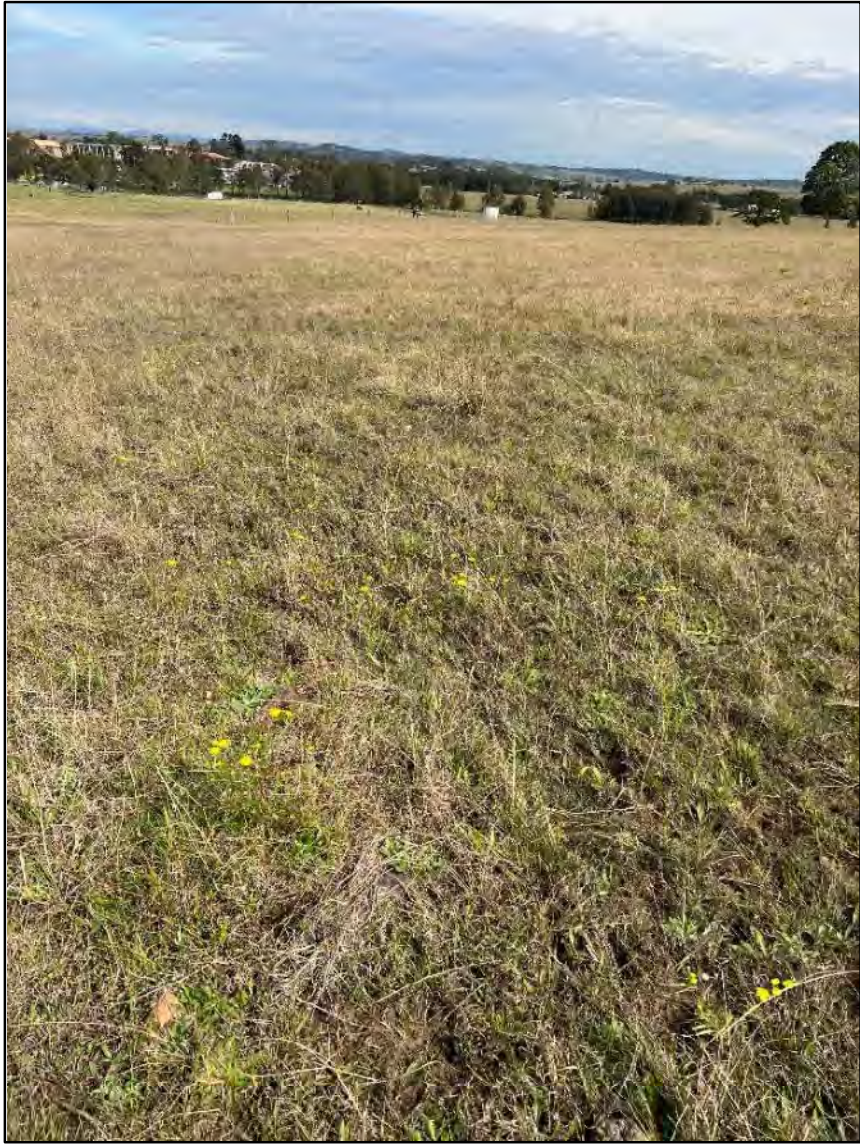
Survey Point 10.2 -downstream

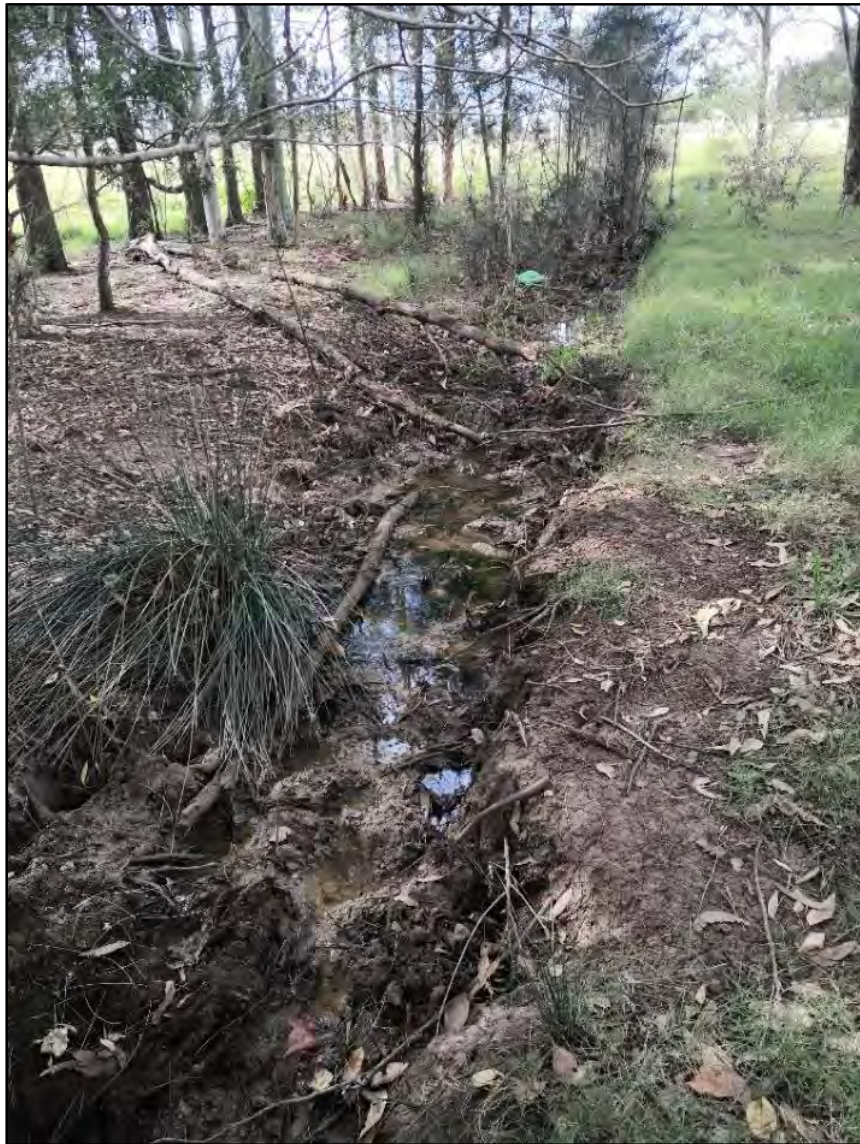
Site Photos – Survey Point 11.1

Task – Waterland Tool (2020)	Assessment	Comments (provide evidence)	Figures
Controlled Activity Approval Required (Y / N)	Yes	CAA required.	6
Vegetated Riparian Zone Required (m)	10m	Defined bed and bank visible	7
Comments	Watercourse features are present at Survey Point 11.1. The bed and bank have been heavily impacted by cattle. Survey Point 11.1 constitutes waterfront land and a CAA is required for works within 40m of the top of bank.

Survey Point 11.1 – upstream

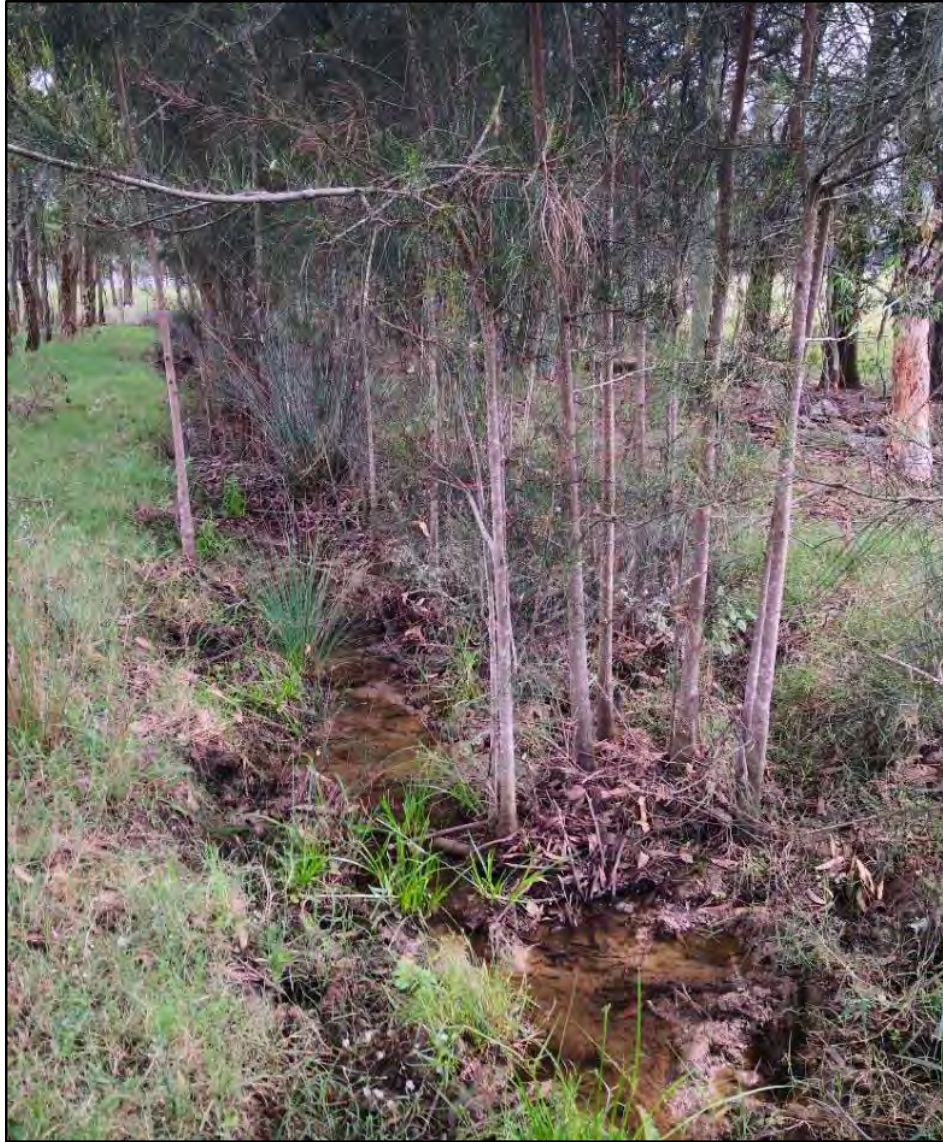
Survey Point 11.1 - downstream

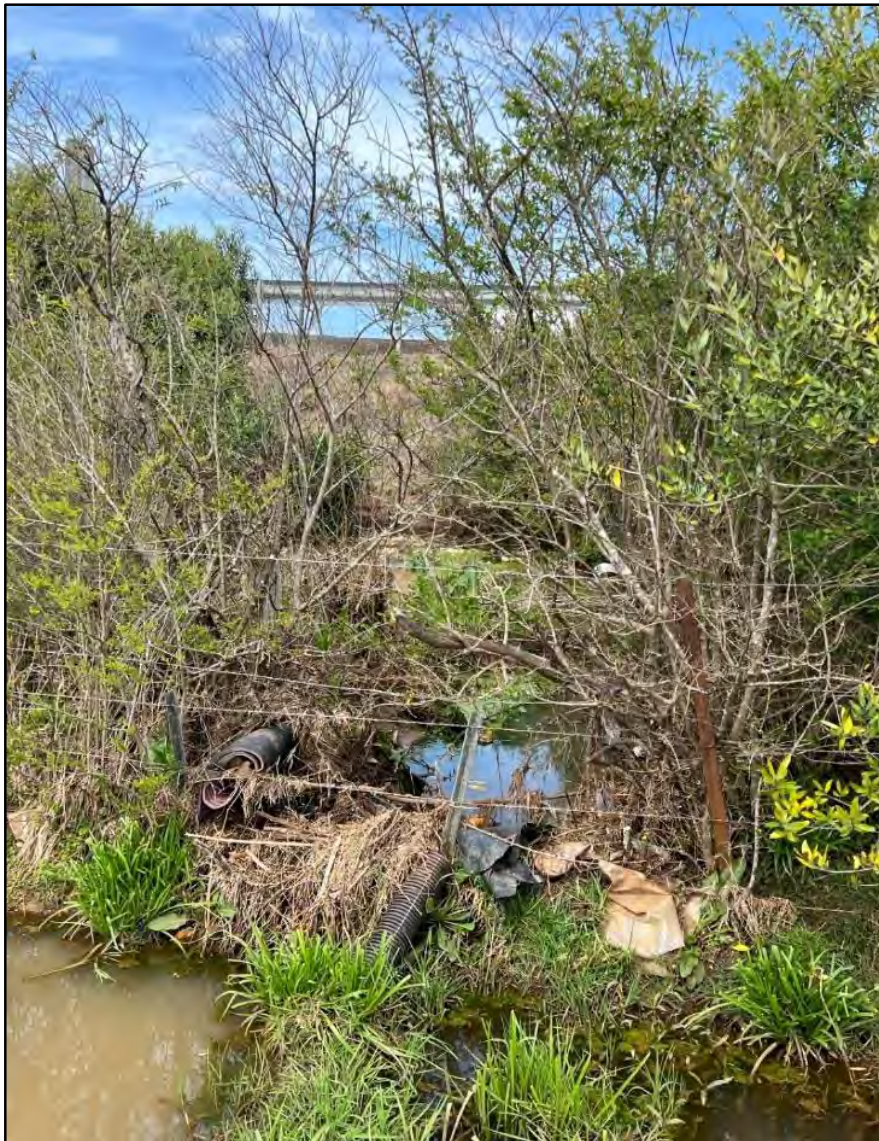
Site Photos – Survey Point 12.1

Task – Waterland Tool (2020)	Assessment	Comments (provide evidence)	Figures
Controlled Activity Approval Required (Y / N)	N/A	WFL does not occur at this survey point.	-
Vegetated Riparian Zone Required (m)	No	Not applicable	-
Comments	<p>A roadside swale along the NEH and recently constructed detention Basin for a subdivision development on the southern side of the NEH have likely altered the hydrological and geomorphological characteristics of the landscape.</p> <p>The inspection showed stormwater infrastructure through an urban environment (swales, culverts and detention basin). No WFL features, such as a defined bed and bank were observed.</p> <p>Inundation due to discharge from the NEH culvert has resulted in sporadic occurrence of <i>Juncus spp.</i></p> <p>Survey Point 12.1 does not constitute waterfront land.</p>

Survey Point 12.1 – mapped upstream

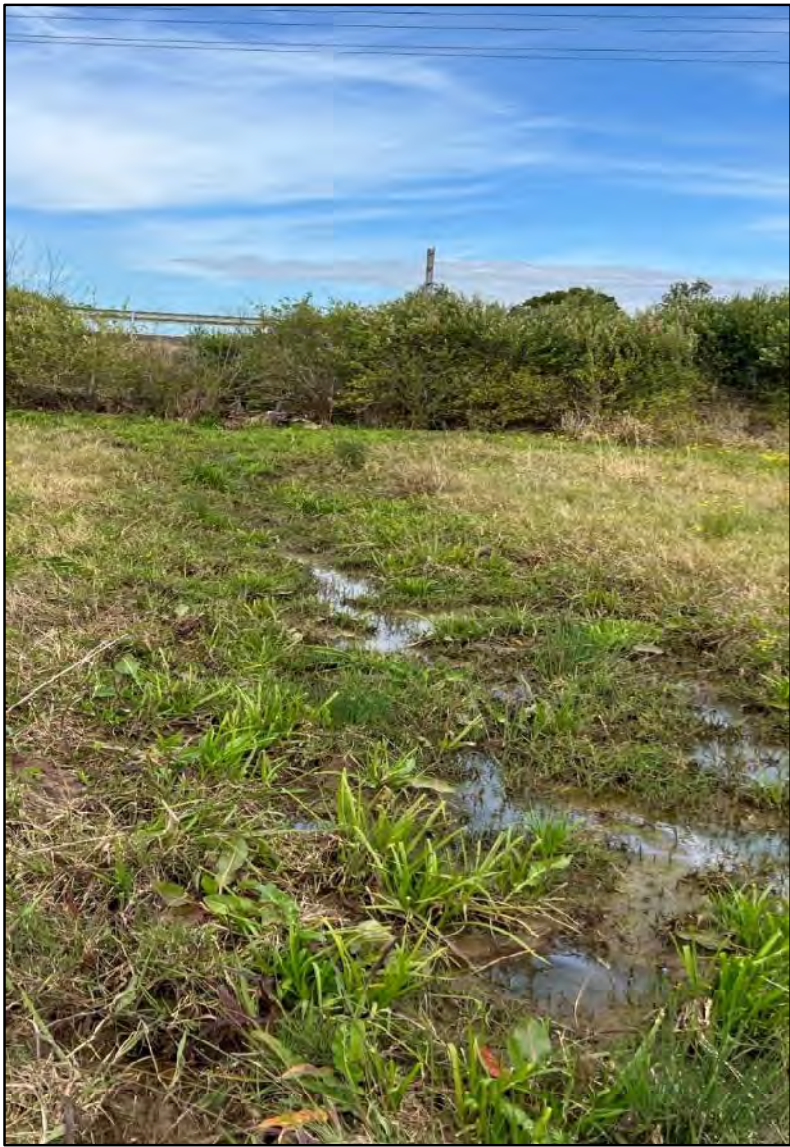
Survey Point 12.1 – mapped downstream

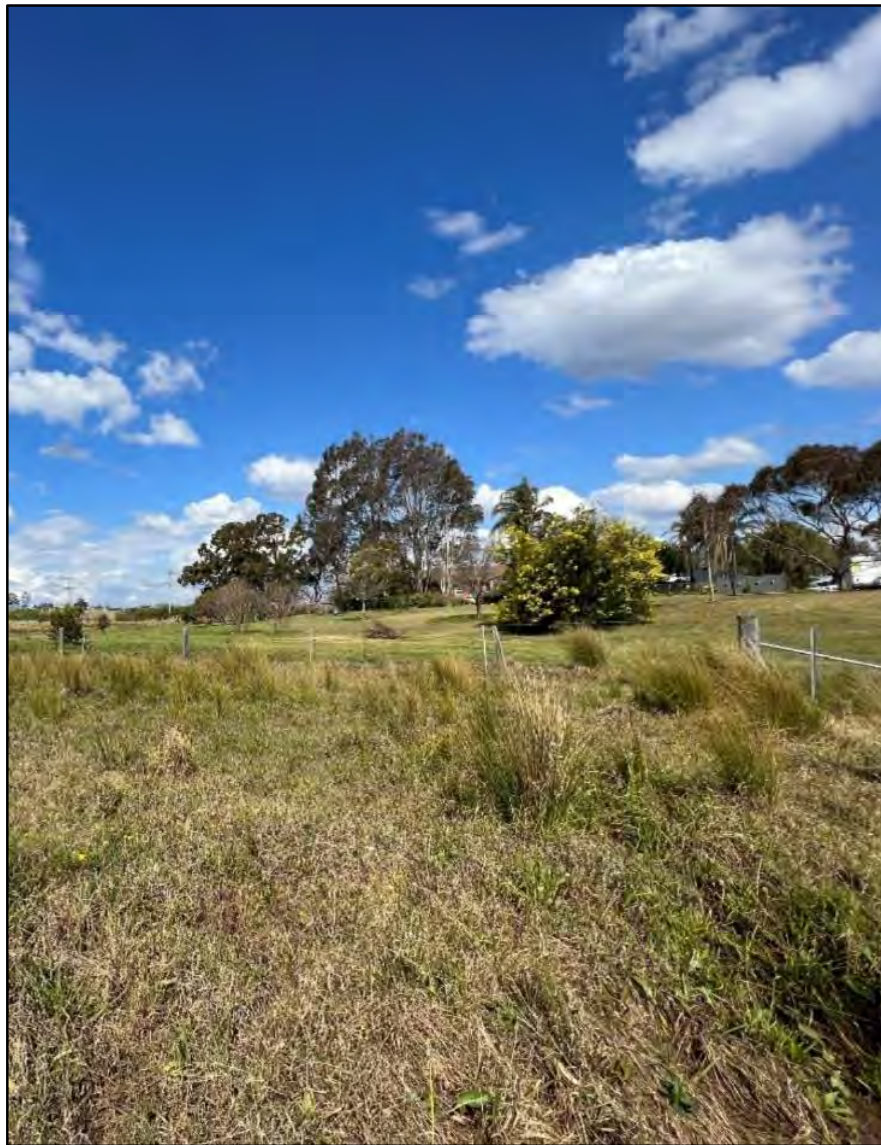
Survey Point 12.2 – mapped upstream

Task – Waterland Tool (2020)	Assessment	Comments (provide evidence)	Figures
Vegetated Riparian Zone Required (m)	No	Not applicable	-
Comments	<p>A roadside swale along the NEH and recently constructed detention Basin for a subdivision development on the southern side of the NEH have likely altered the hydrological and geomorphological characteristics of the landscape.</p> <p>No WFL features, such as a defined bed and bank were observed.</p> <p>Inundation due to discharge from the NEH culvert has resulted in sporadic occurrence of <i>Juncus spp.</i></p> <p>Survey Point 12.2 does not constitute waterfront land.</p>

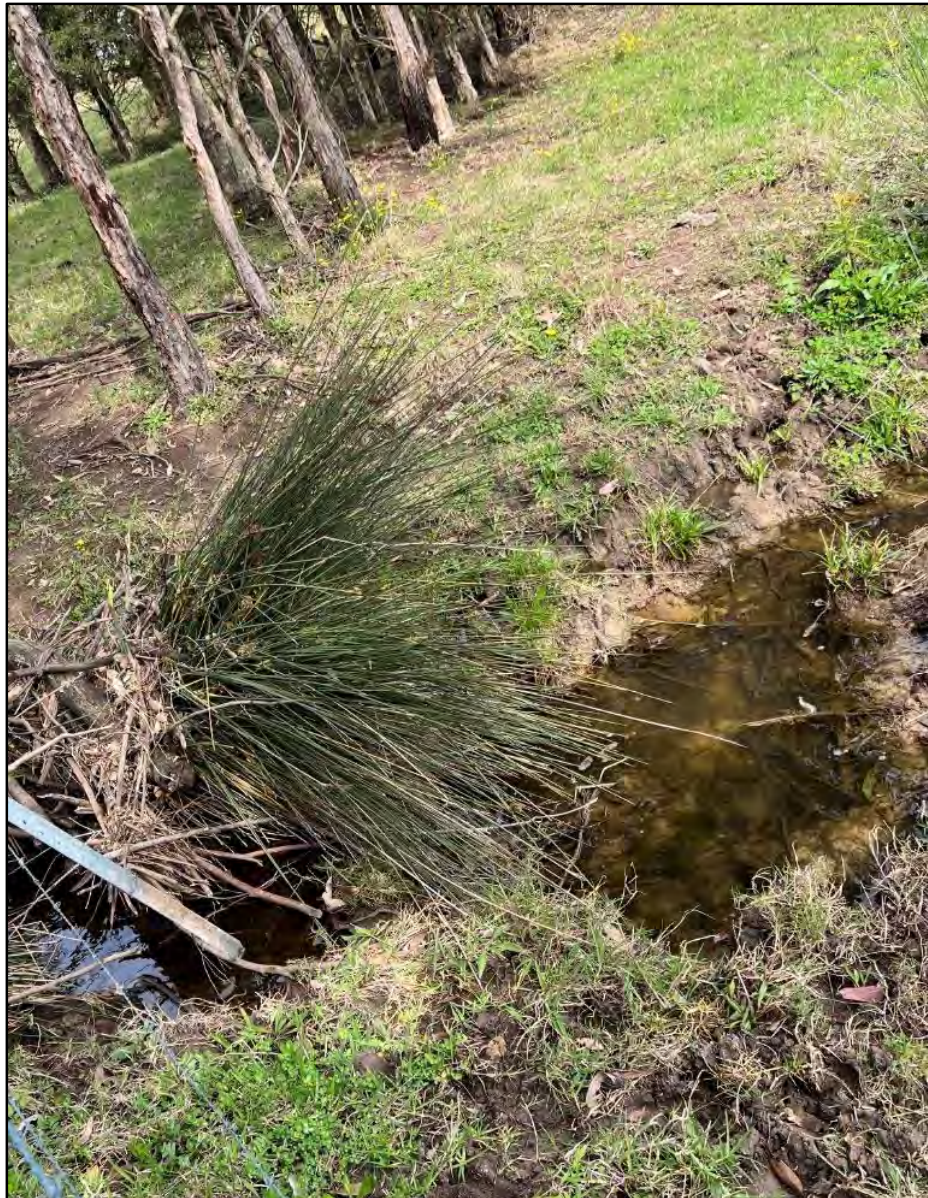
Site Photos – Survey Point 13.1

Task – Waterland Tool (2020)	Assessment	Comments (provide evidence)	Figures
Controlled Activity Approval Required (Y / N)	Yes	CAA required.	6
Vegetated Riparian Zone Required (m)	10m	Defined bed and bank visible	7
Comments	Watercourse features are present at Survey Point 13.1. Survey Point 13.1 constitutes waterfront land and a CAA is required for works within 40m of the top of bank.

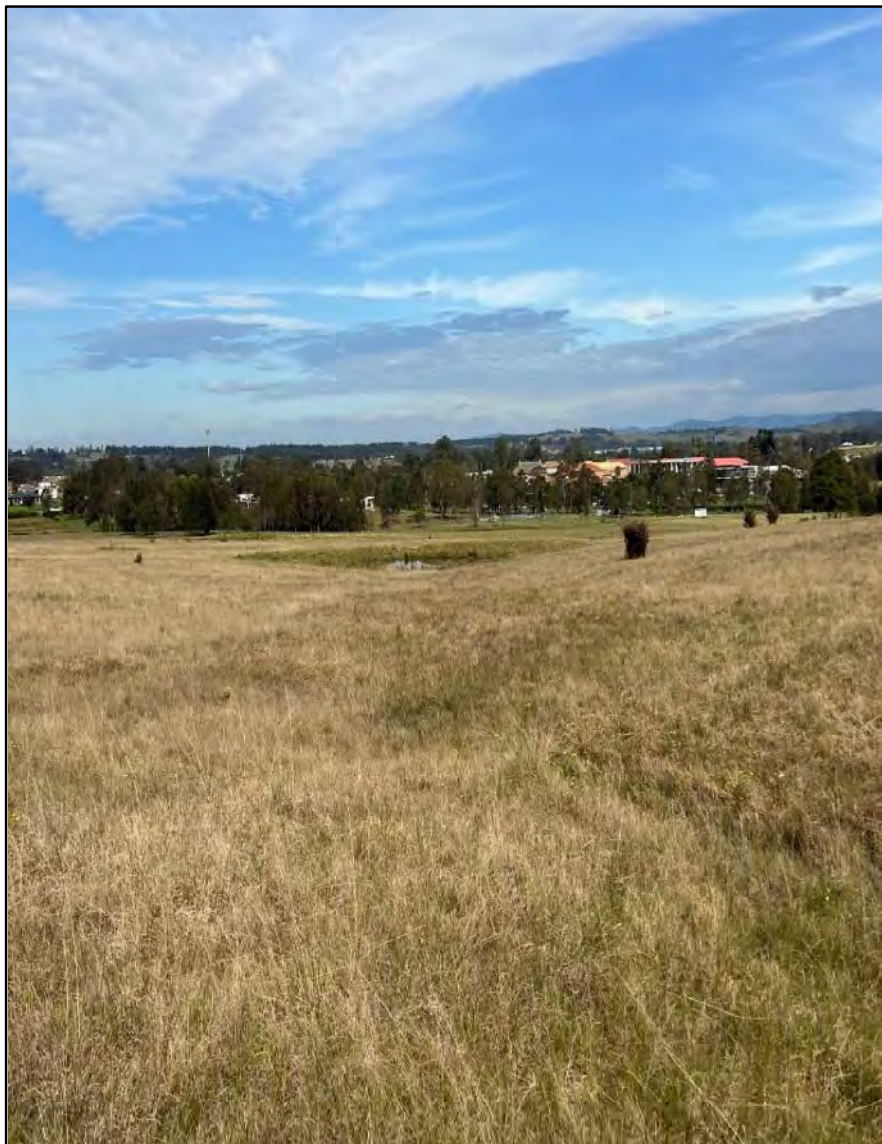
Site Photos – Survey Point 14.1

Task – Waterland Tool (2020)	Assessment	Comments (provide evidence)	Figures
Controlled Activity Approval Required (Y / N)	N/A	WFL does not occur at this survey point.	-
Vegetated Riparian Zone Required (m)	No	Not applicable	-
Comments	<p>Survey Point 14.1 is occupied by managed grassland. Rural development has likely altered the hydrological and geomorphological characteristics of the landscape through pastoral land use and construction of farm dams and drainage lines.</p> <p>No WFL features, such as a defined bed and bank or a change in vegetation indicating a wetland.</p> <p>Survey Point 14.1 does not constitute waterfront land.</p>

Survey Point 14.1 – mapped downstream
