Riparian Assessment Report

**898 New England Hwy, 25 Wyndella Rd and 39 Wyndella Rd
Lochinvar, NSW**

**Prepared for: Lochinvar Developments Pty Ltd
C/- ADW Johnson Pty Ltd**

July 2024

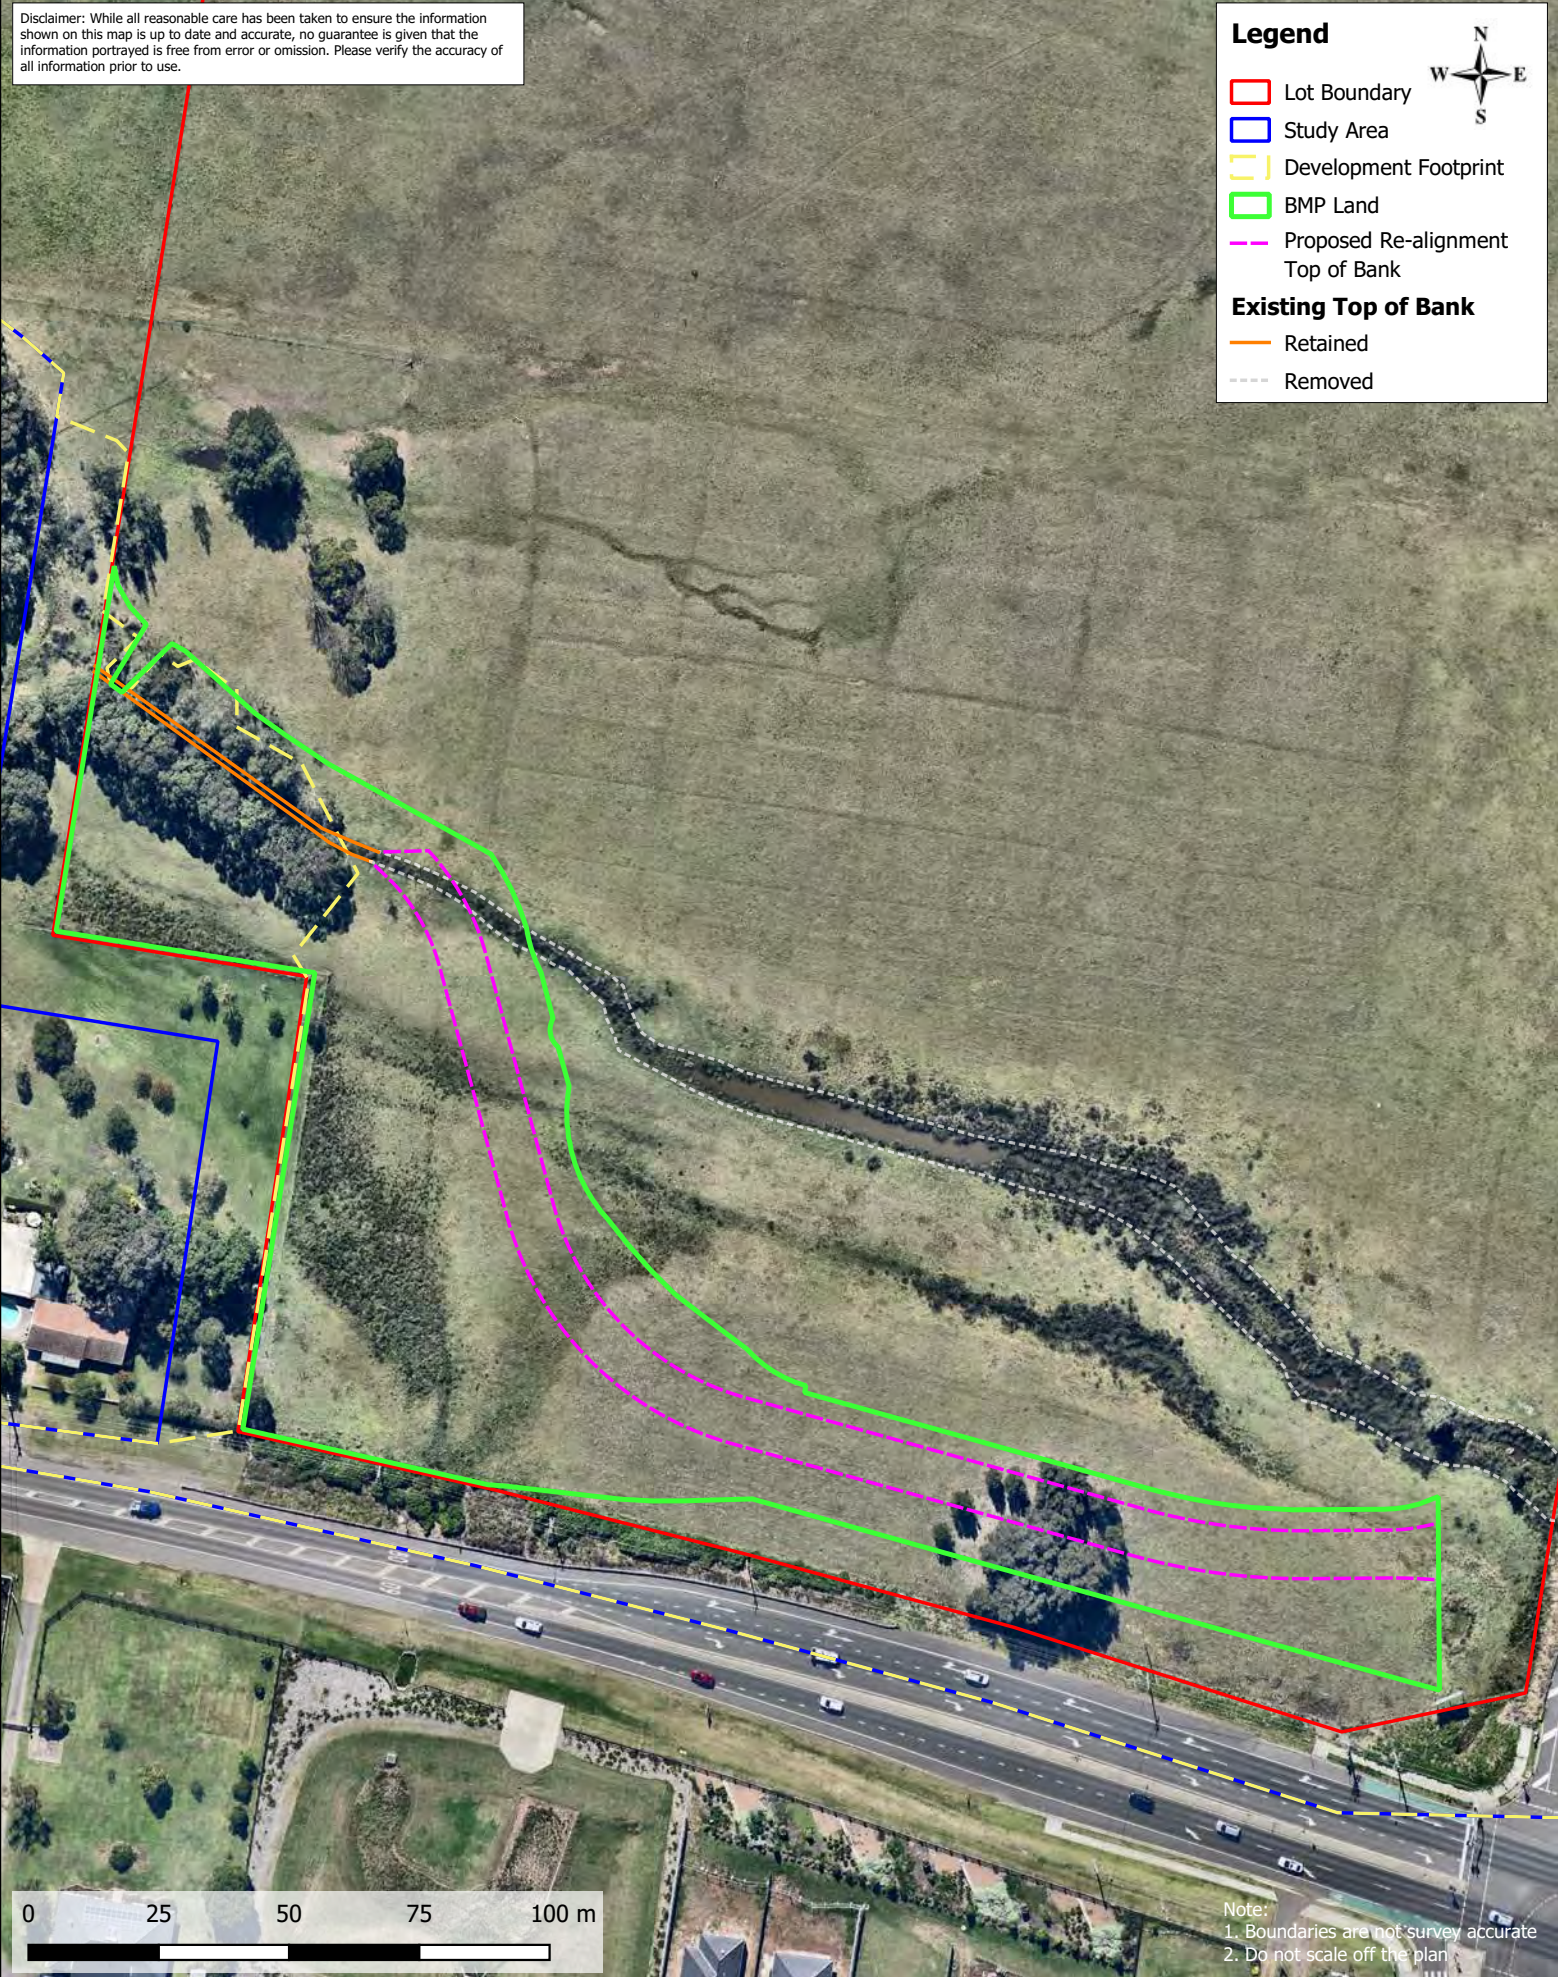
Figure 7 - Stream Re-alignment

Table 14 outlines the works and activities that can occur on WFL and in riparian corridors under the WM Act (note approvals may be required under other legislation). **Figure 7** provides the location of the stream re-alignment of Segment 7. A Biodiversity Management Plan (BMP) has been created to support the CAA and rehabilitate works that disturb or modify the riparian corridor, including regeneration an area of freshwater wetland (**Appendix B**).

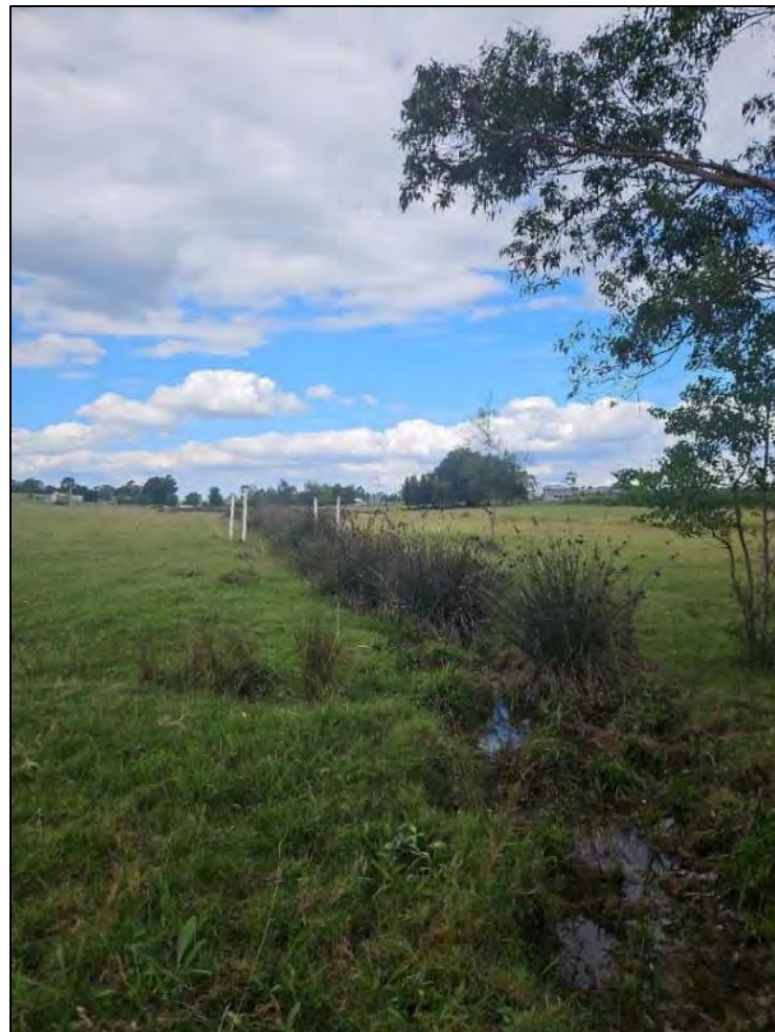
Plate 1 – Existing creek line north west of BMP lands

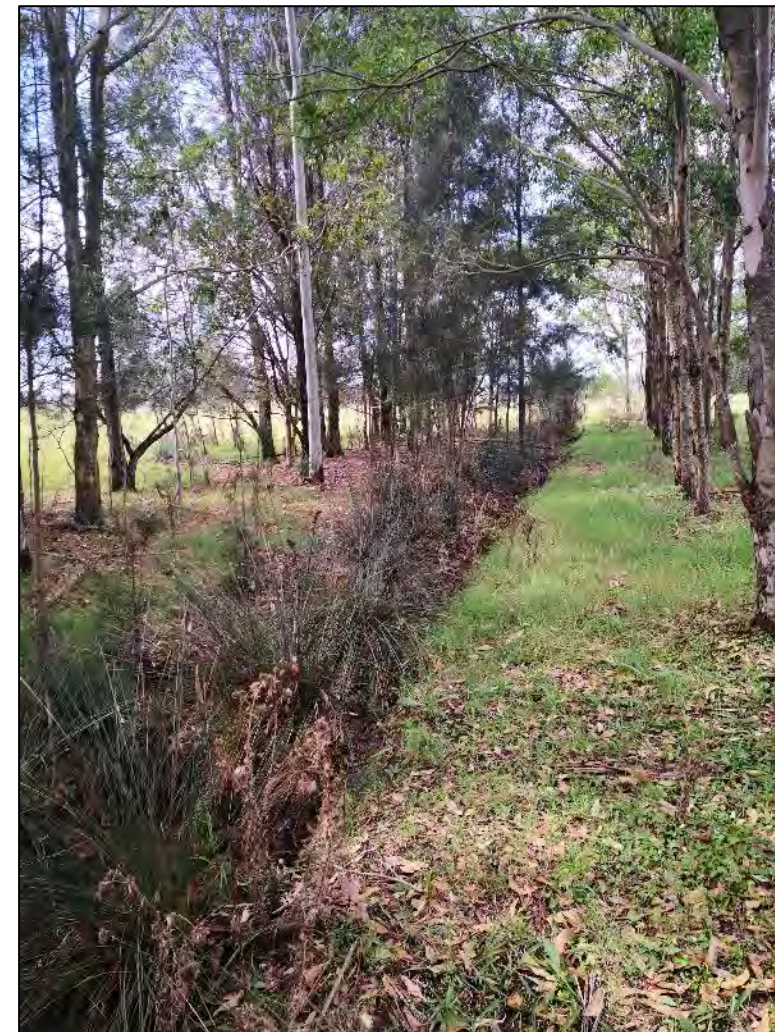
Plate 2 – Planted native vegetation resembles PCT 3433

It should be noted that PCT 3433, a dry sclerophyll forest community (**Plate 2**), was planted approximately 20 years ago at the western extent of the riparian corridor. However, this vegetation type is not the most appropriate for a riparian zone as it does not naturally occur in these low-lying areas. PCT 4044 is expected to occur within this area and is likely to have been the naturally occurring plant community type historically.

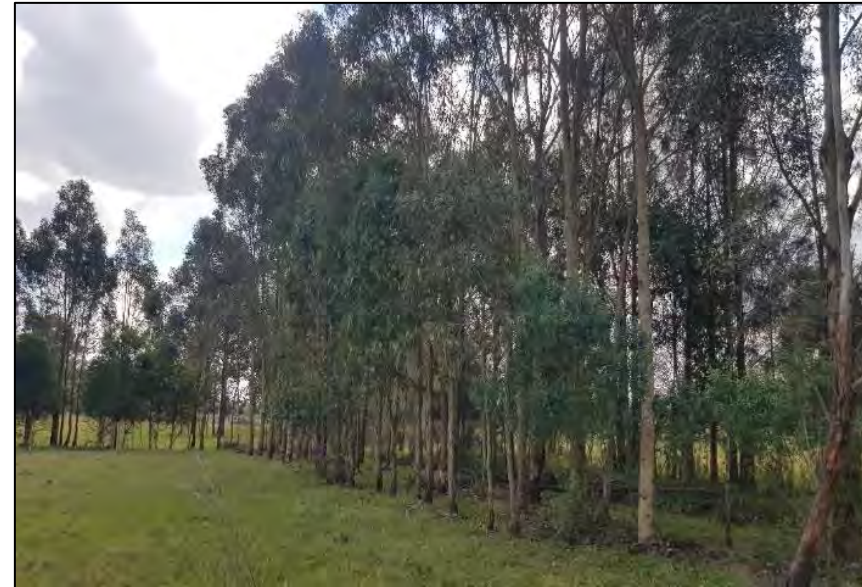
PCT 3433 – Hunter Coast Foothills Spotted Gum-Ironbark Grassy Forest is associated with the Endangered Ecological Community Lower Hunter Spotted Gum – Ironbark Forest (BC Act 2016). Given the absence of midstory, sparse native understory and fragmented condition of the site, the vegetation present is a highly disturbed variant of the EEC.

Plate 3 – PCT 3433 – Hunter Coast Foothills Spotted Gum – Ironbark Grassy Forest

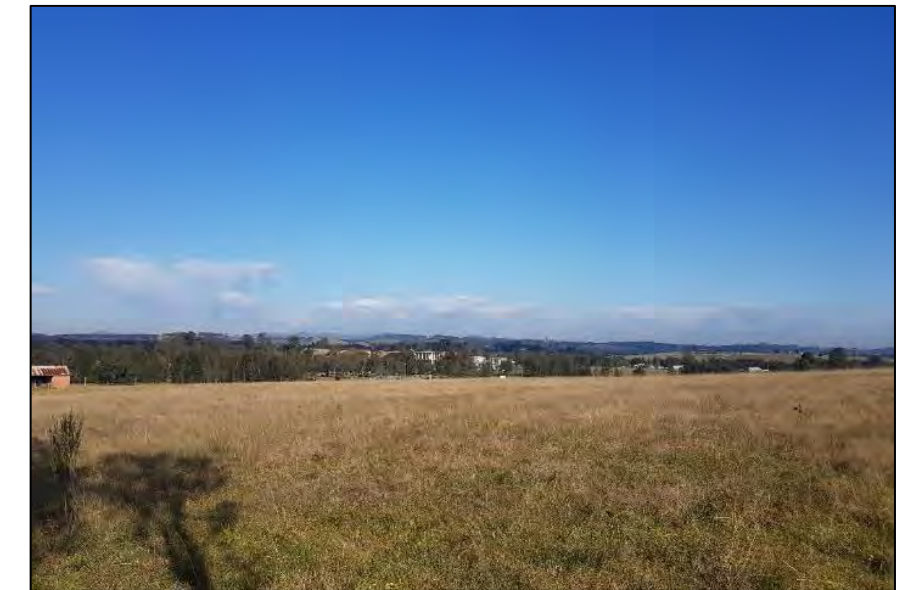
Plate 5 – Exotic grassland in southern BMP lands

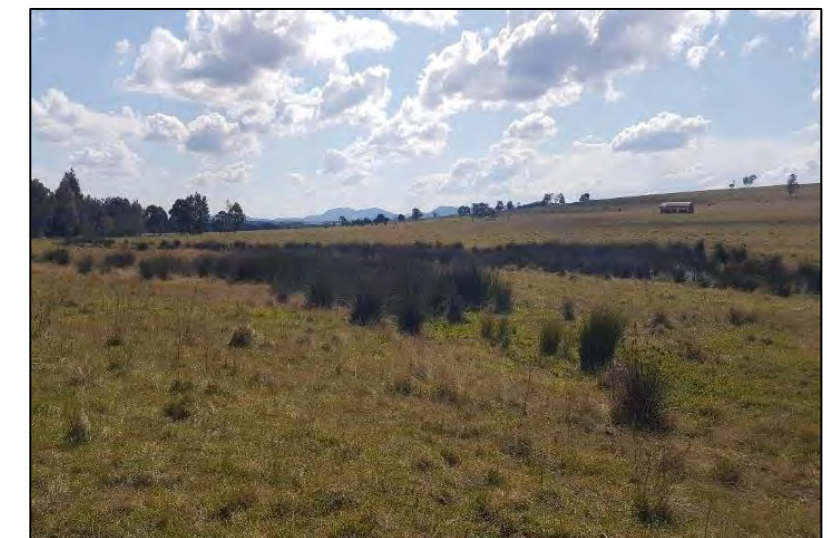
The riparian zone of the BMP lands located in the south, is dominated by exotic species including *Juncus acutus*, *Hypochaeris radicata* and *Cyperus eragrostis*.

Plate 6 – Exotic riparian vegetation in unaltered hydroline alignment

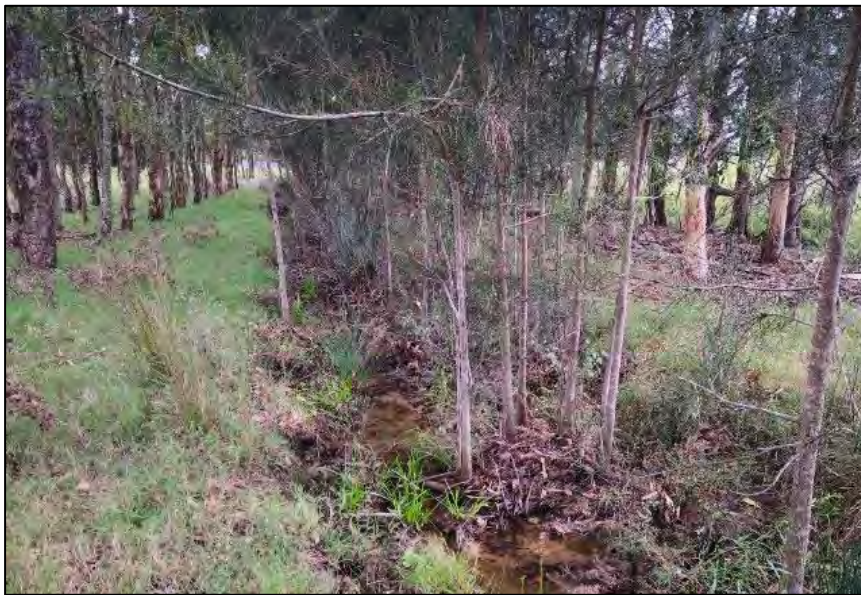
Areas of PCT 3433 are in moderate condition as a result of edge effects and disturbance from grazing cattle. The mid stratum is absent likely due to suppression of shrubs from grazing. The lower stratum, although highly disturbed, containing a large number of exotics, also comprises regenerating native understory species.

Plate 7 – PCT 3433 in moderate condition in west of BMP lands

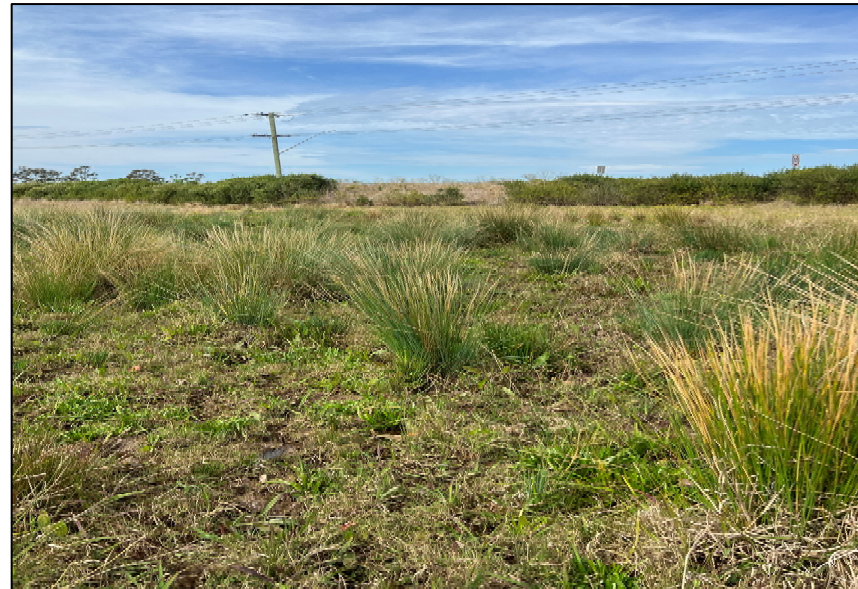
PCT 4044 within the BMP lands is in a highly degraded condition. The native vegetation is limited to a small number of native species including *Casuarina glauca*, *Carex appressa* and *Juncus usitatus*. The majority of weed load in this area is comprised of understory species *Cyperus eragrostis* and *Juncus acutus*. Degraded ground cover in the south west is subject to extensive runoff from the development south of the NEH draining into this area and is starting to form a freshwater wetland, albeit in the early stages. Areas directly impacted by increased runoff will be reconstructed with aquatic species from PCT 3975 *Southern Lower Floodplain Freshwater Wetland* to reflect and support the change in conditions, assist in water treatment from road runoff and from adjoining residential subdivision, the species in this PCT are known for their ability to improve water quality. Additionally, reconstruction of PCT 3975 will be undertaken to ensure vegetation communities are commensurate with the Threatened Ecological Community (TEC) *Freshwater Wetlands on Coastal Floodplains of the New South Wales North Coast, Sydney Basin and South East Corner Bioregions*. The wetland PCT will also provide potential habitat for amphibians such as Green and Golden Bell Frog.

Plate 8 – PCT 4044 in poor condition view facing east to west, proposed to be regenerated with PCT 3975 as freshwater wetland.

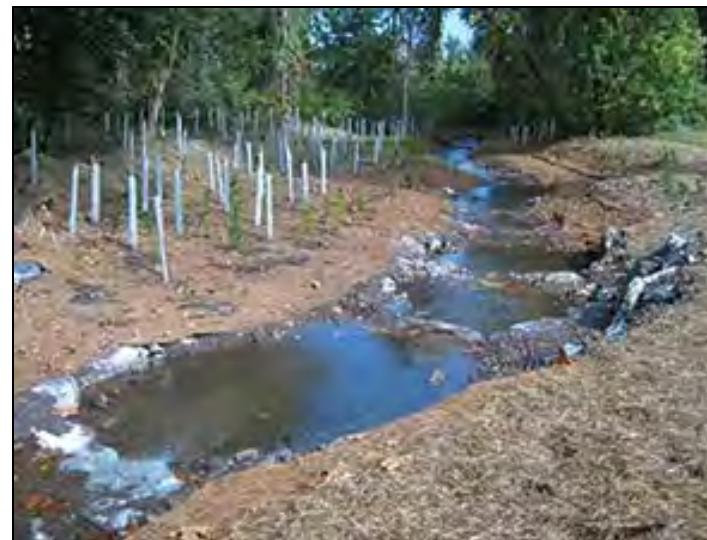
Plate 10 – Meanders, Riffles and shallow pools (STORMWATER, 2018).

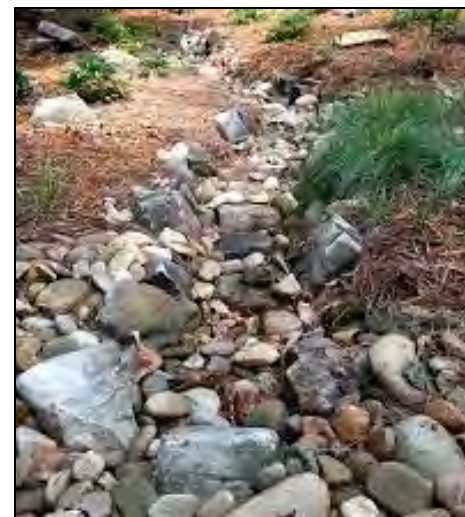
Plate 11 – Low Flow Channel (Australian Wetland Consulting, 2018).

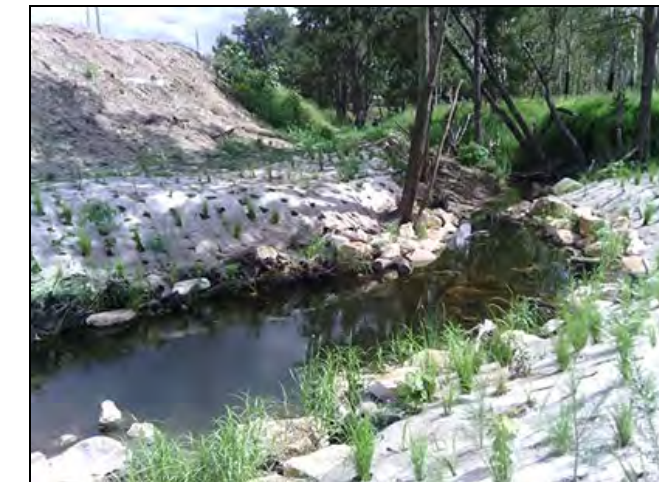
Plate 12 – Bundamba Creek Restoration works (Australian Wetland Consulting, 2018)

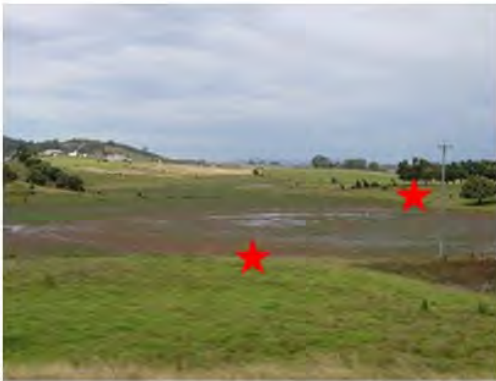
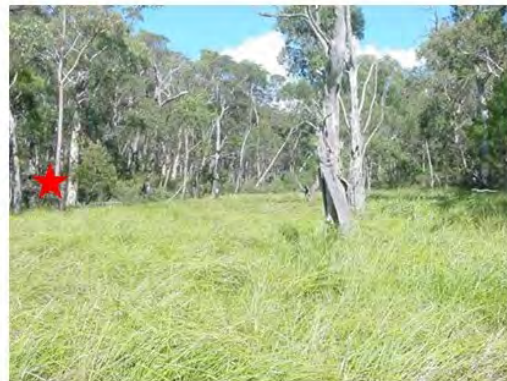
Wetlands

- ★ Top of High Bank is defined by the edge of the frequently wet area. This can be identified by a shore area, a change in vegetation type or soil type.
