Streamlined Biodiversity Development Assessment Report

Proposed Residential Subdivision and Associated Infrastructure within 898 New England Hwy, 25 Wyndella Rd and 39 Wyndella Rd, Lochinvar, NSW

July 2024

AEP Ref: 2699

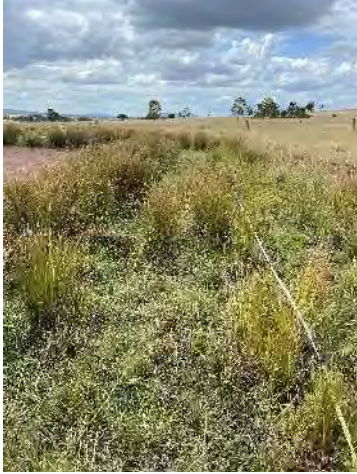
<p>Plate 10 – PCT 4042 – BAM 9: Start</p>

Category	Description
Description of Vegetation Zone	PCT 4042 BAM 9 (AEP) was undertaken in the central section of the allotment. This area is a modified dam plot, with no present canopy or shrub layer. The ground layer has some <i>Juncus usitatus</i> , <i>Ludwigia peploides subsp. montevidensis</i> , and <i>Lachnagrostis aemula</i> , however is dominated by exotics including <i>Cynodon</i> spp., <i>Paspalum dilatatum</i> , <i>Cyperus eragrostis</i> , and <i>Briza subaristata</i> .
Area of Vegetation Zone (ha)	This vegetation zone covers approximately 0.13ha of the Subject Site of which 0.13ha will be impacted.
BAM plots	9

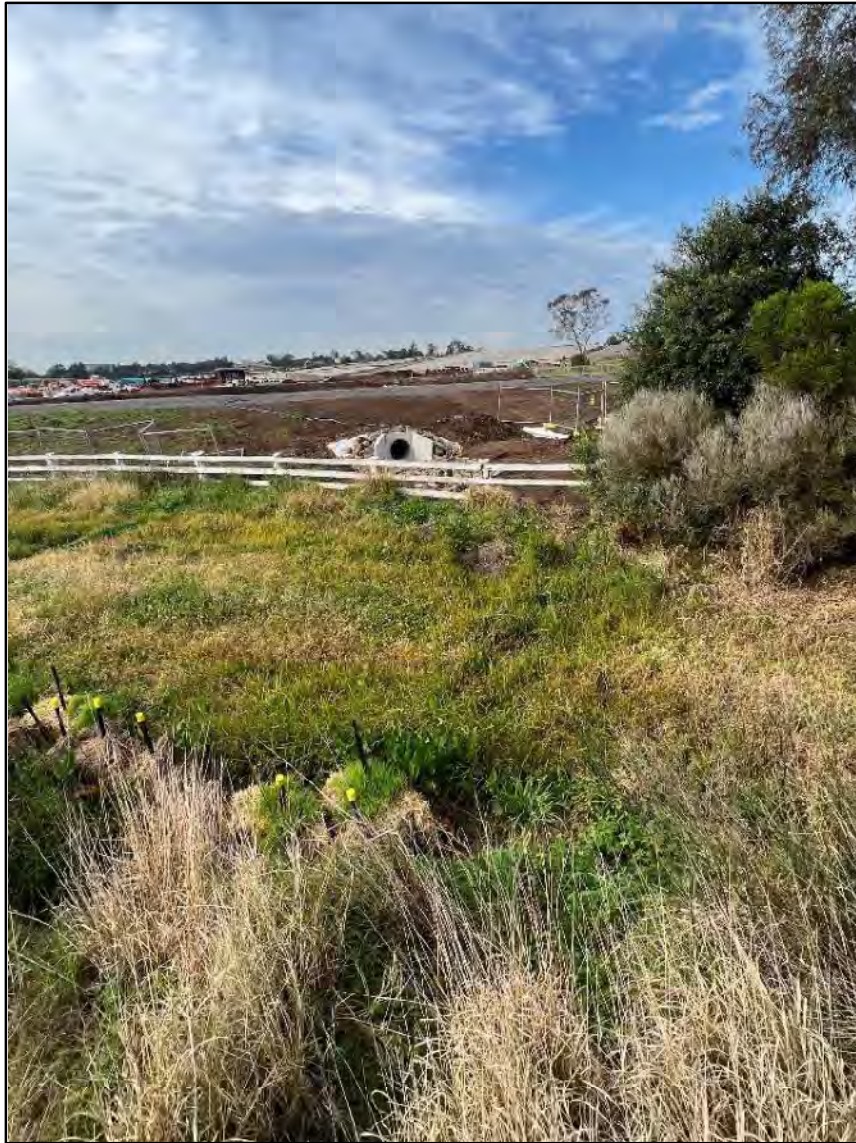
Survey Point 3.1 mapped upstream

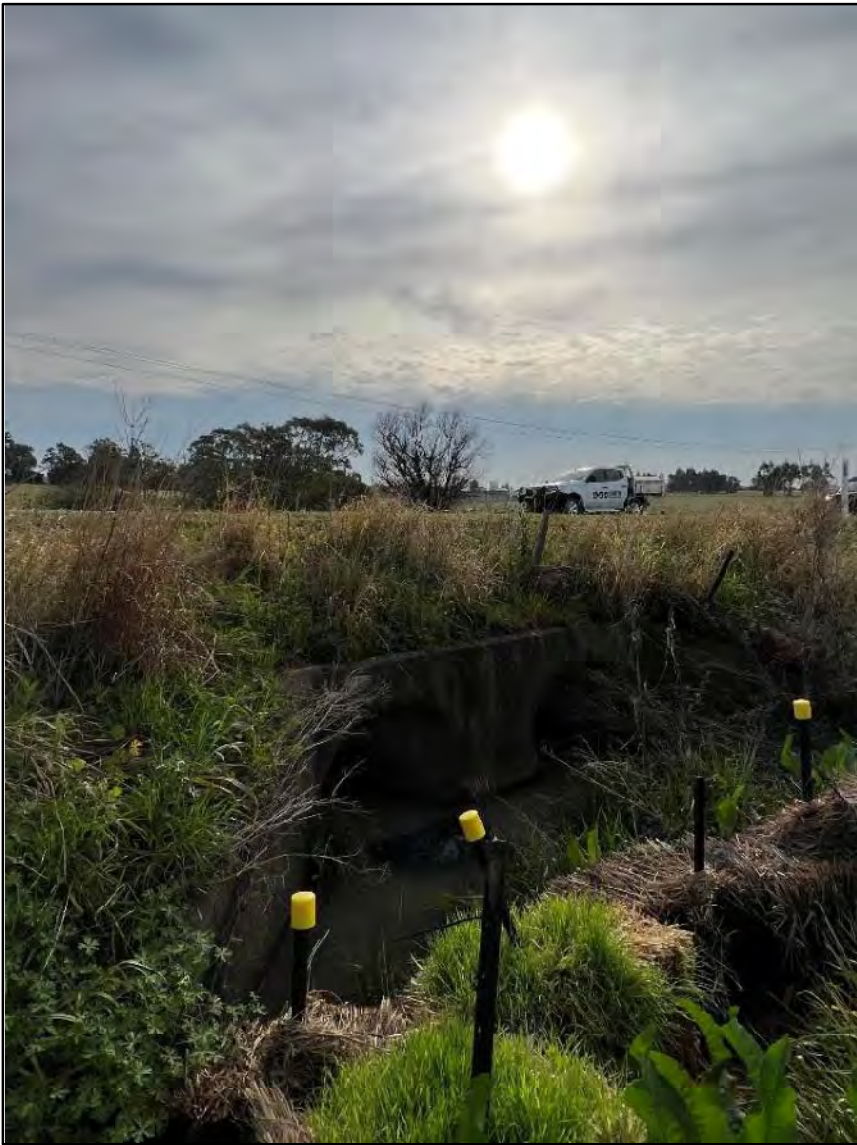
<p data-bbox="607 1440 1015 1470">Survey Point 3.1 mapped downstream</p> The photograph shows a rural landscape with a field of tall, dry grasses in the foreground. A dark, rectangular structure, possibly a culvert or a small bridge, is partially obscured by the vegetation. Several black survey stakes with yellow caps are placed around the structure. In the background, a white van is parked on a road, and a line of trees is visible under a cloudy sky with a bright sun.

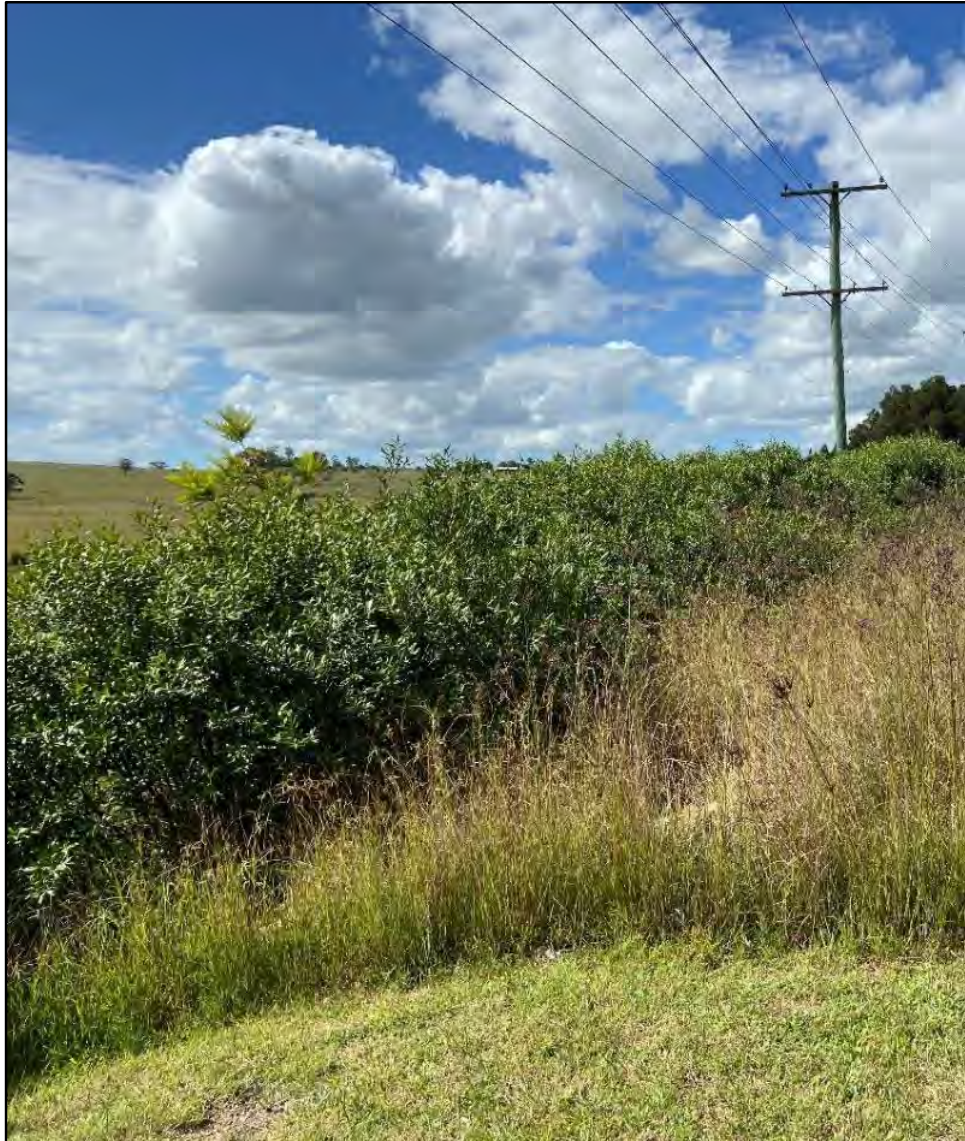
Survey Point 4.1 – mapped upstream

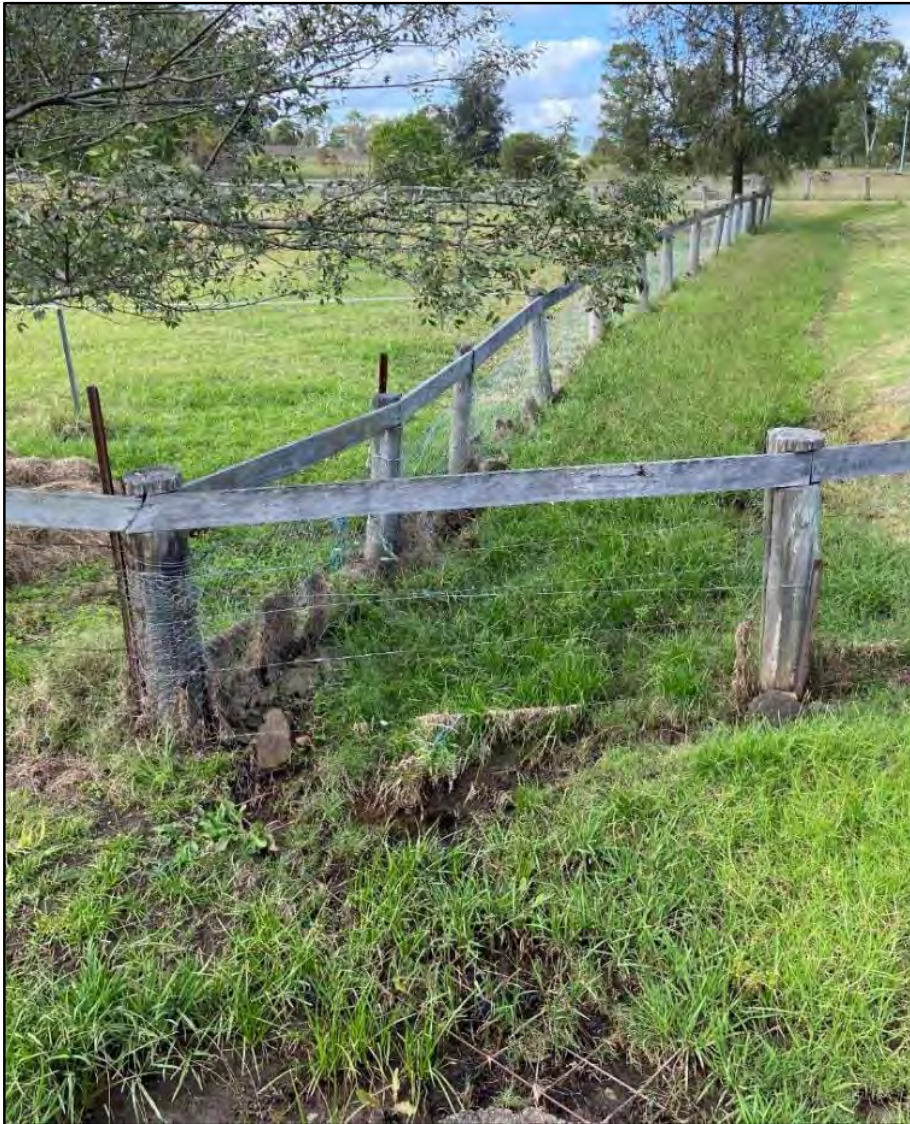
Survey Point 5.1 – mapped upstream

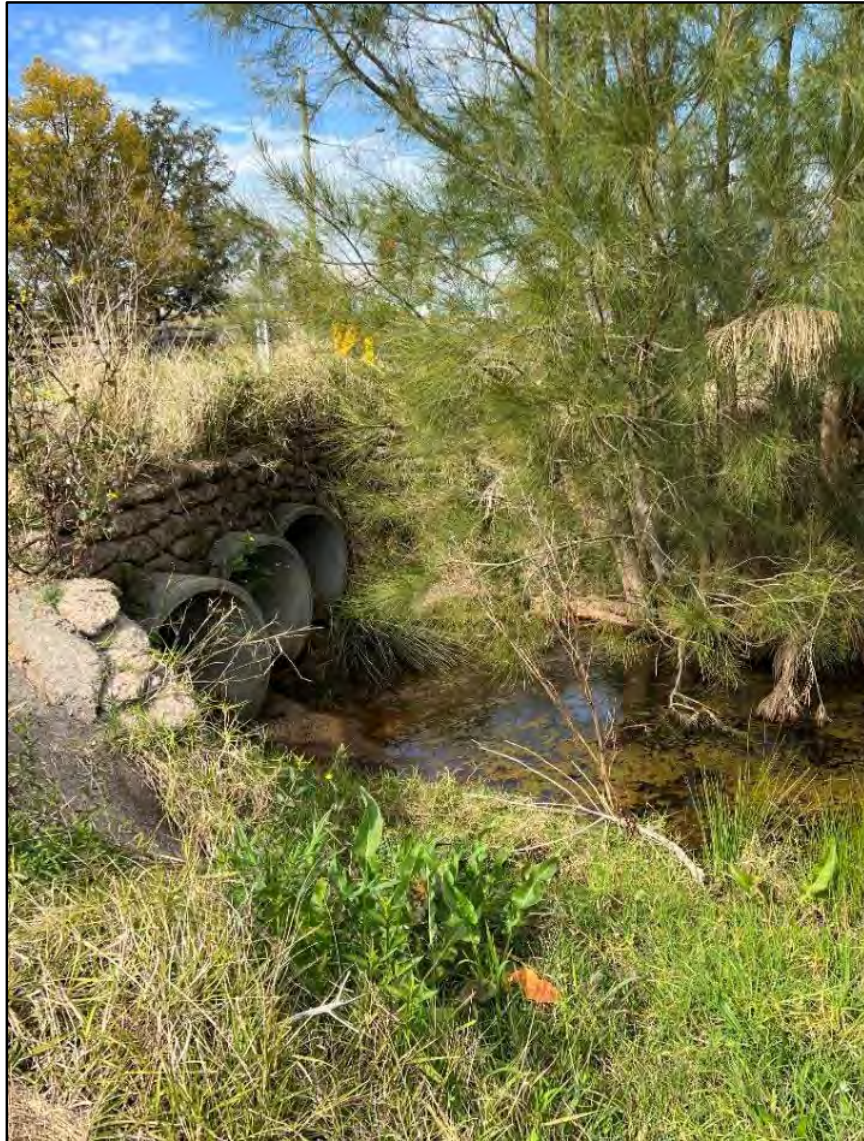
Survey Point 7.1 - upstream

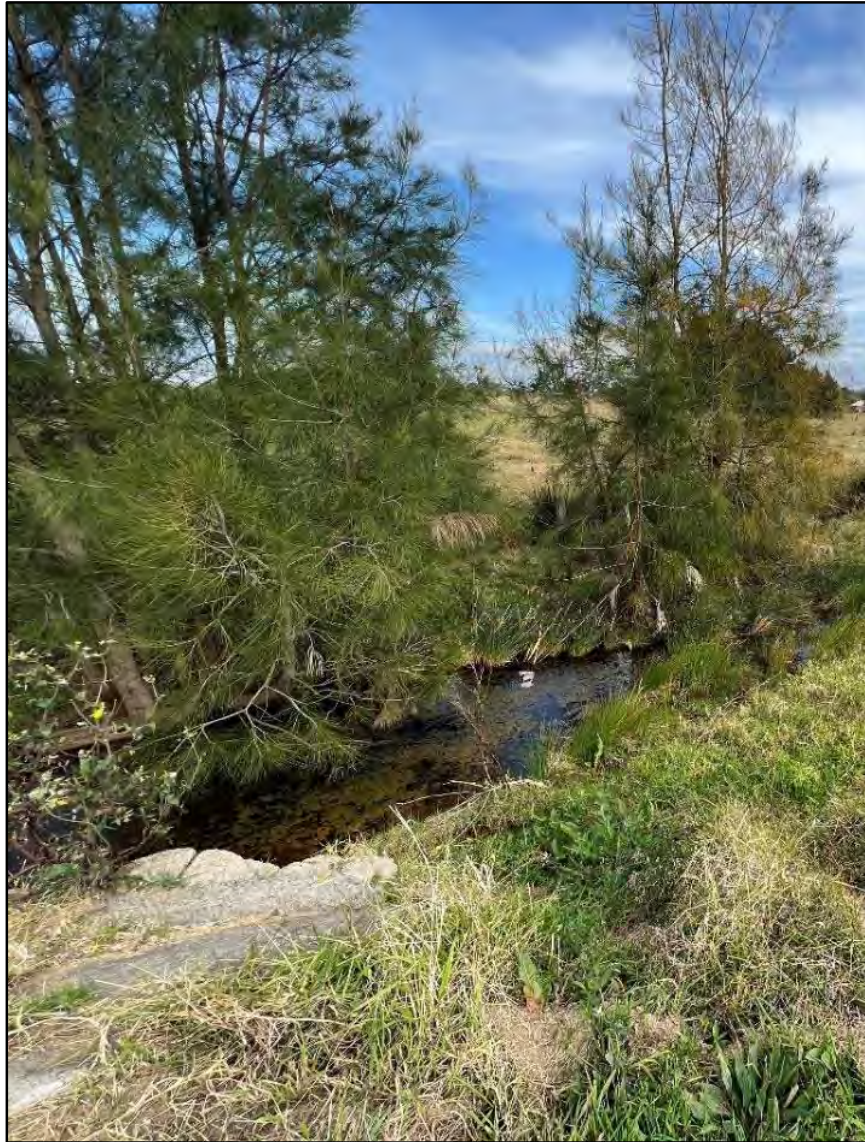
Survey Point 7.1 - downstream

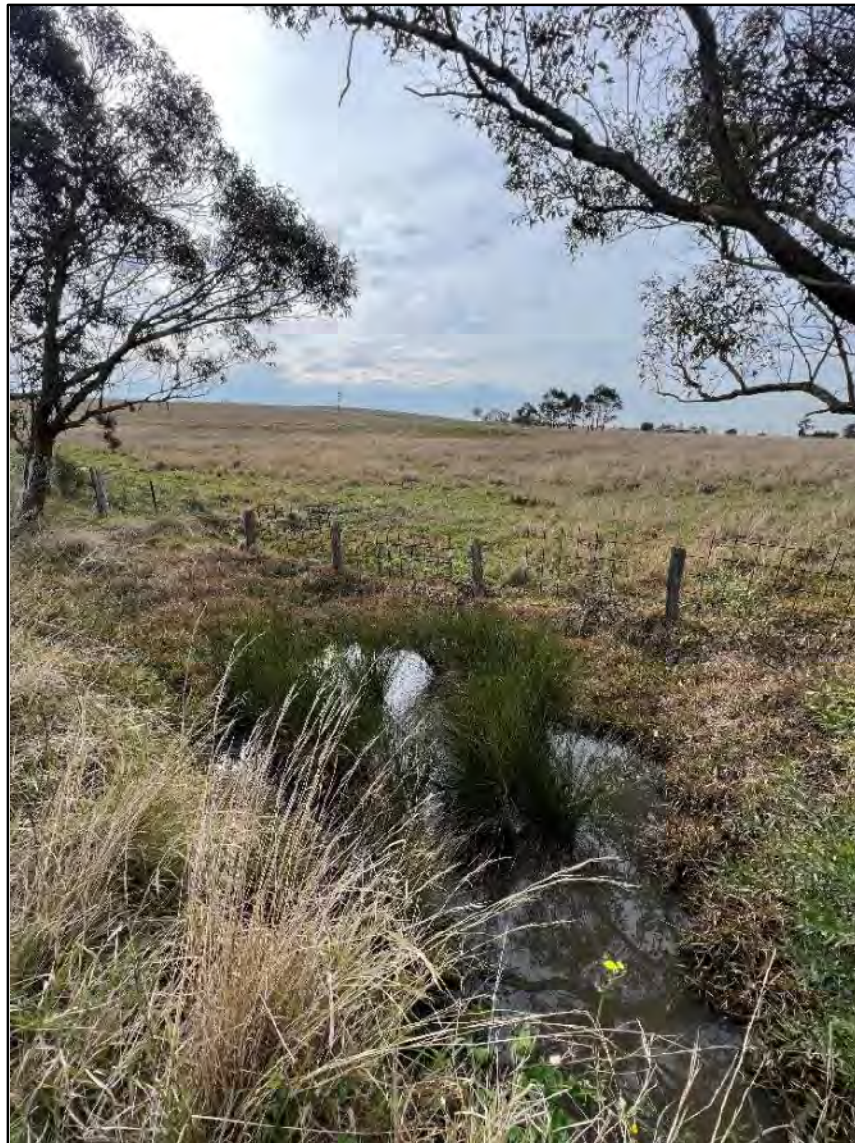
Survey Point 10.1 – mapped upstream

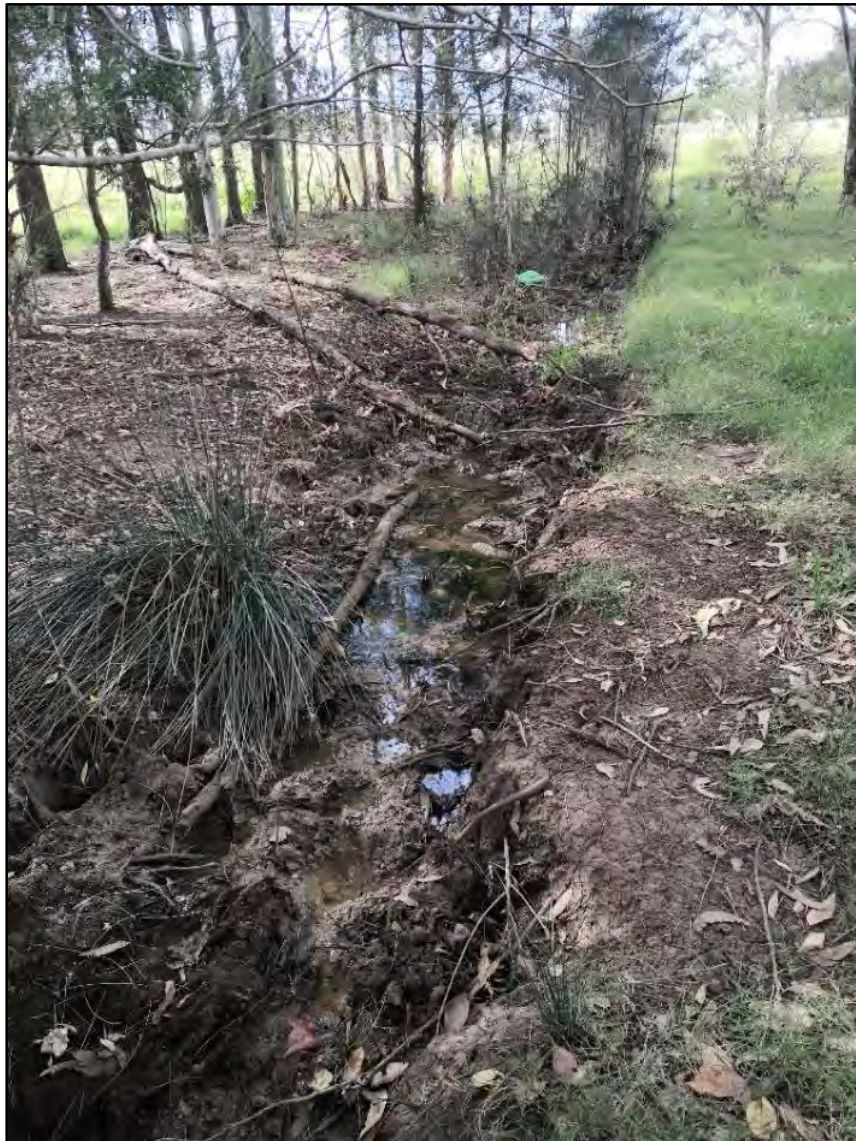
Survey Point 11.1 – upstream

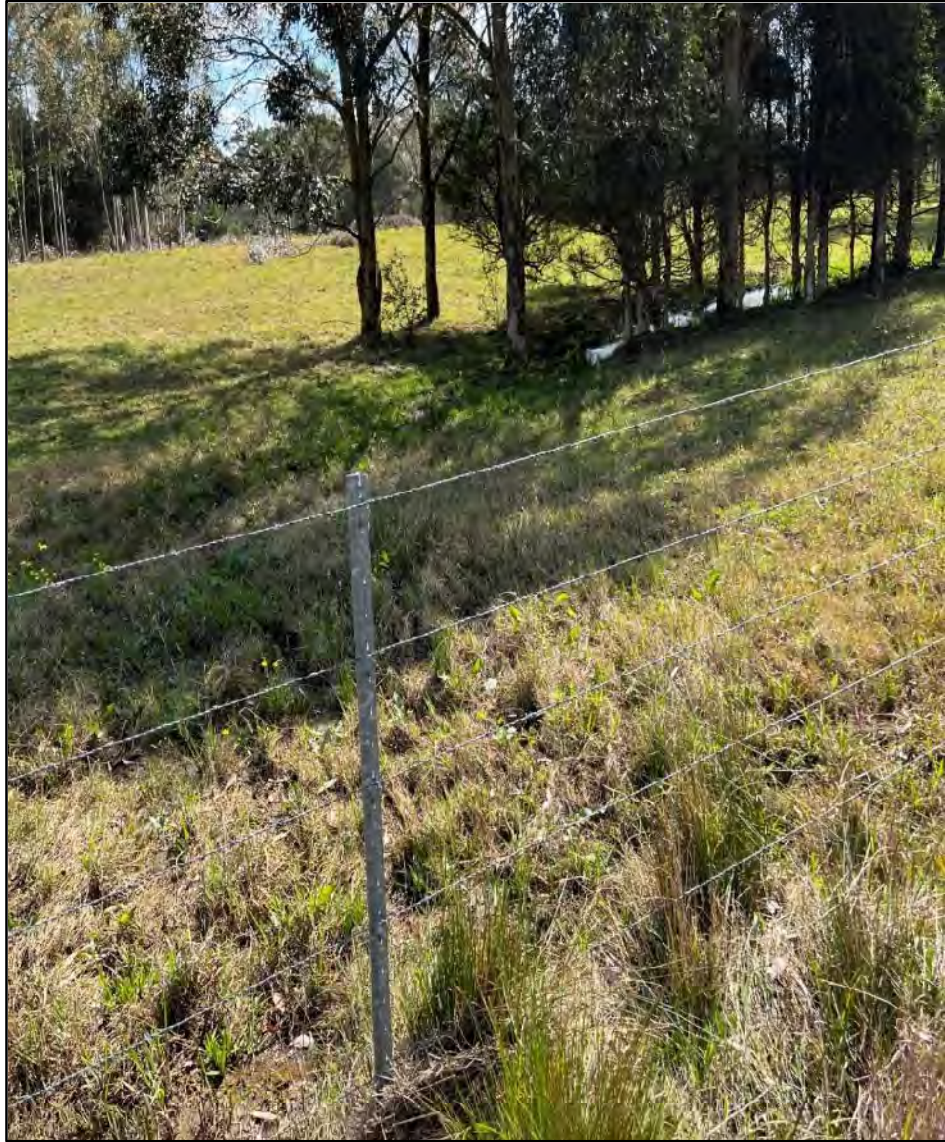
Survey Point 12.2 – mapped downstream

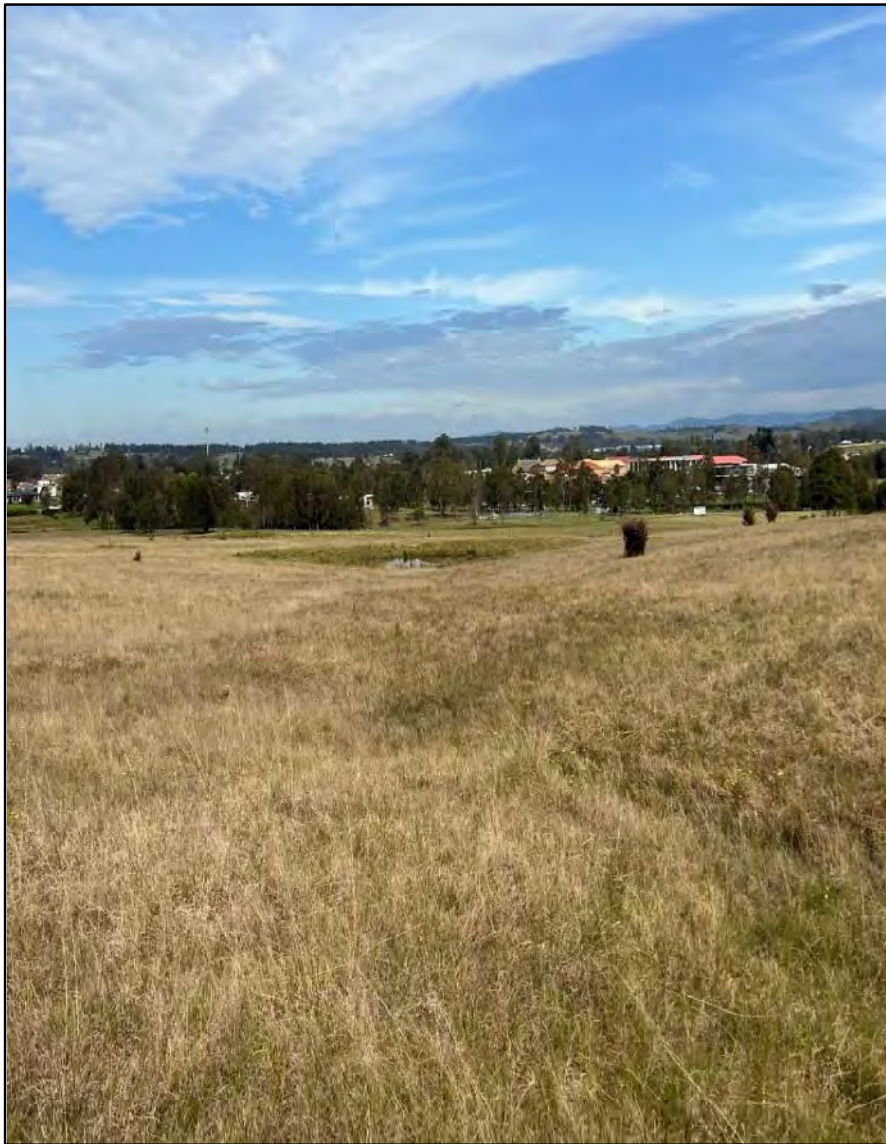
Survey Point 14.1 – mapped downstream

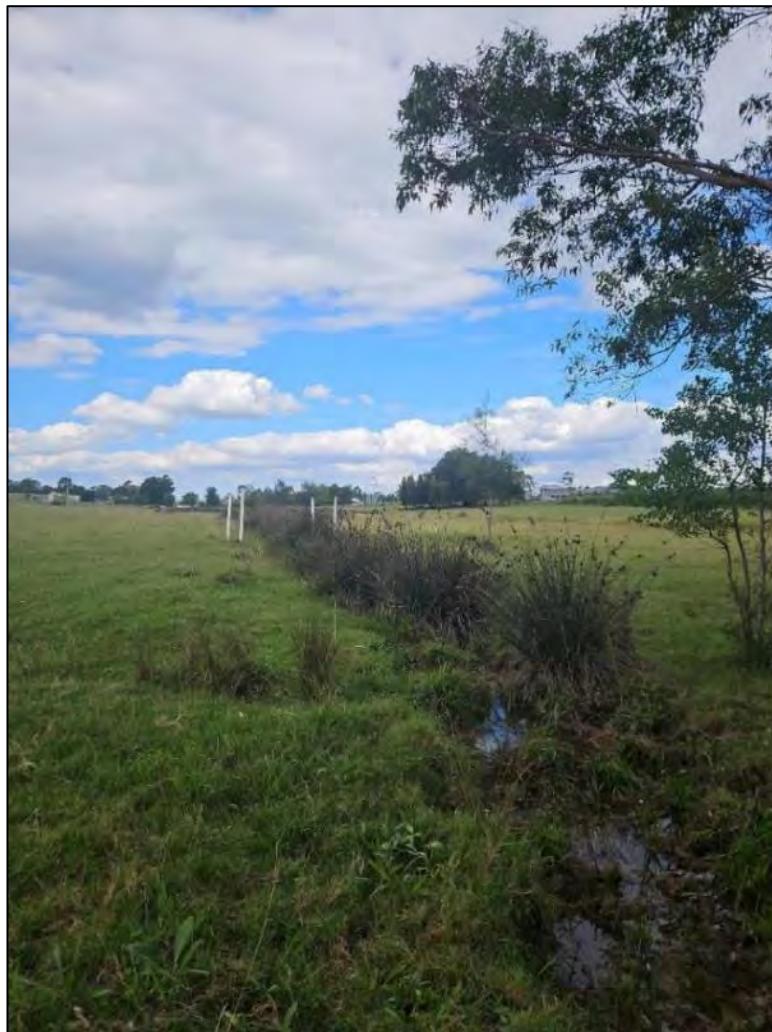
Plate 1 – Existing creek line north west of BMP lands

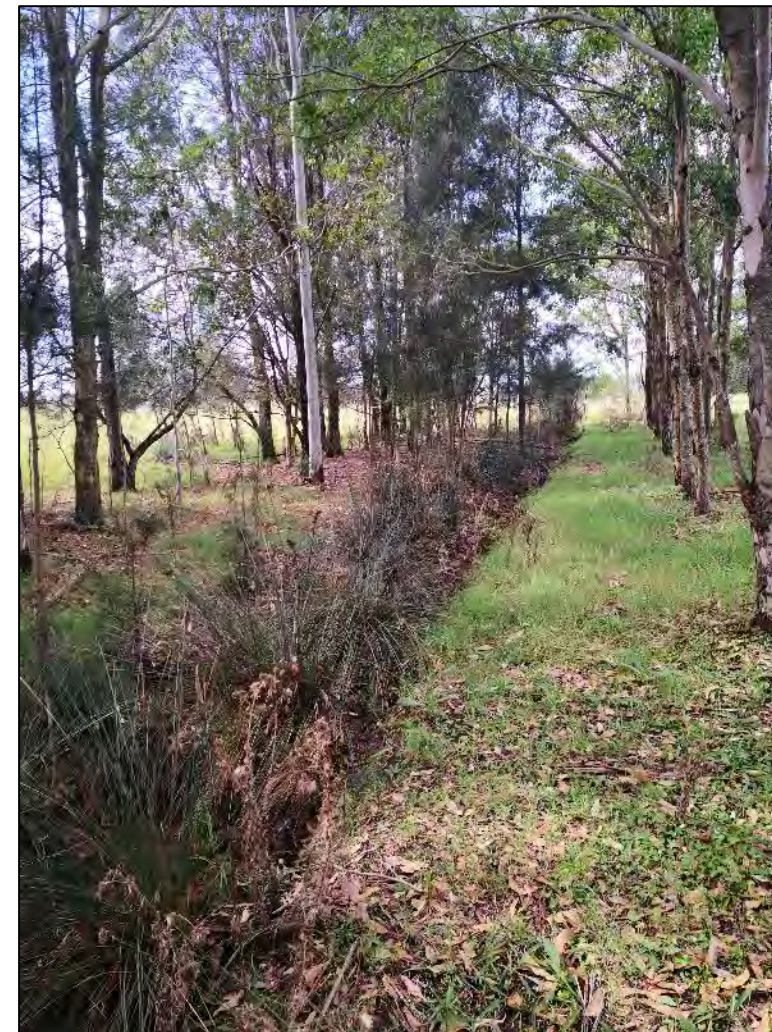
Plate 2 – Planted native vegetation resembles PCT 3433

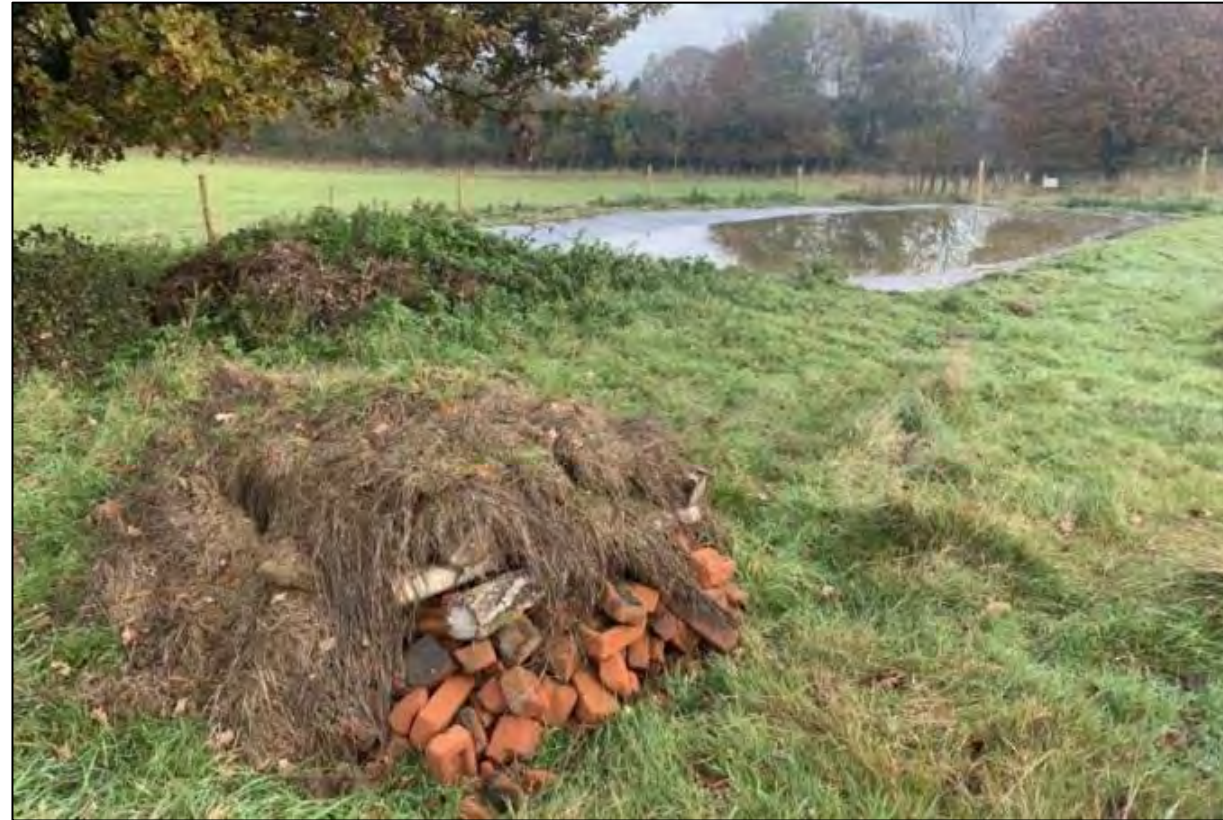
Example of a hibernacula made from bricks and wood and grass material (AggNet – Brickworth, UK)

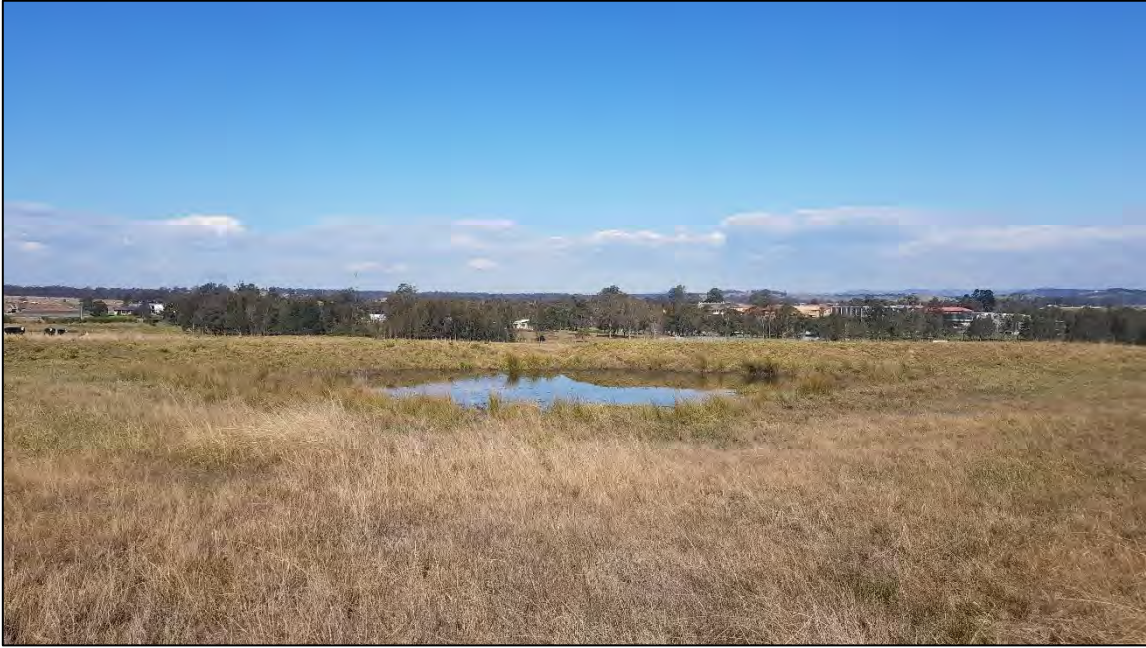
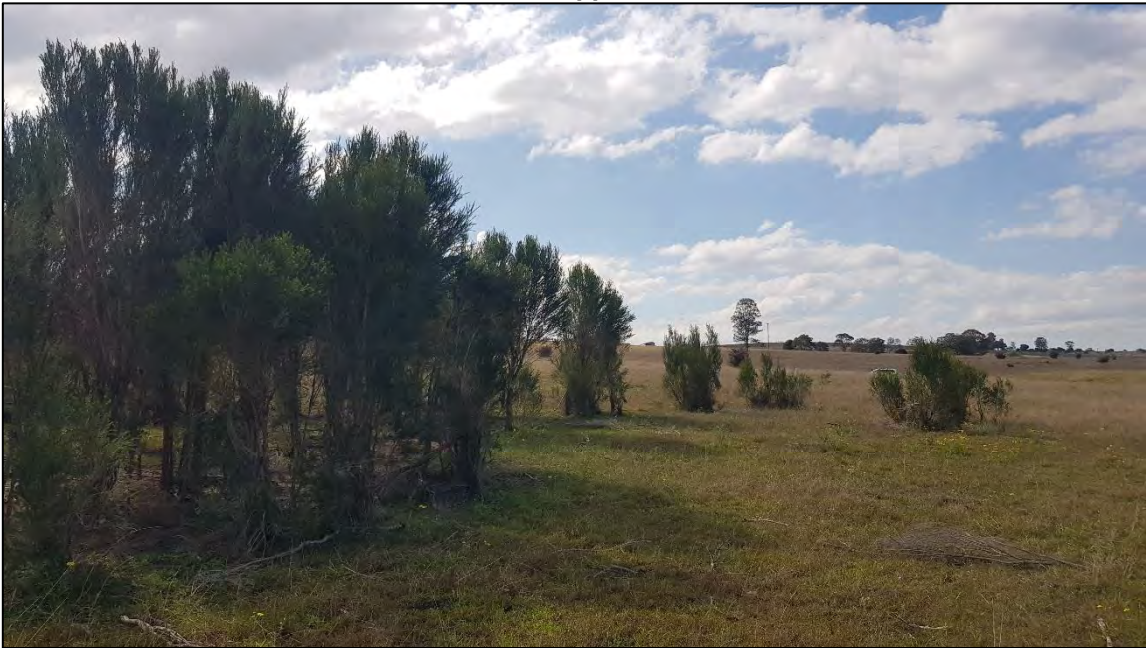
Above: Largest dam in south west of site

Below: Melaleuca spp. in center of site

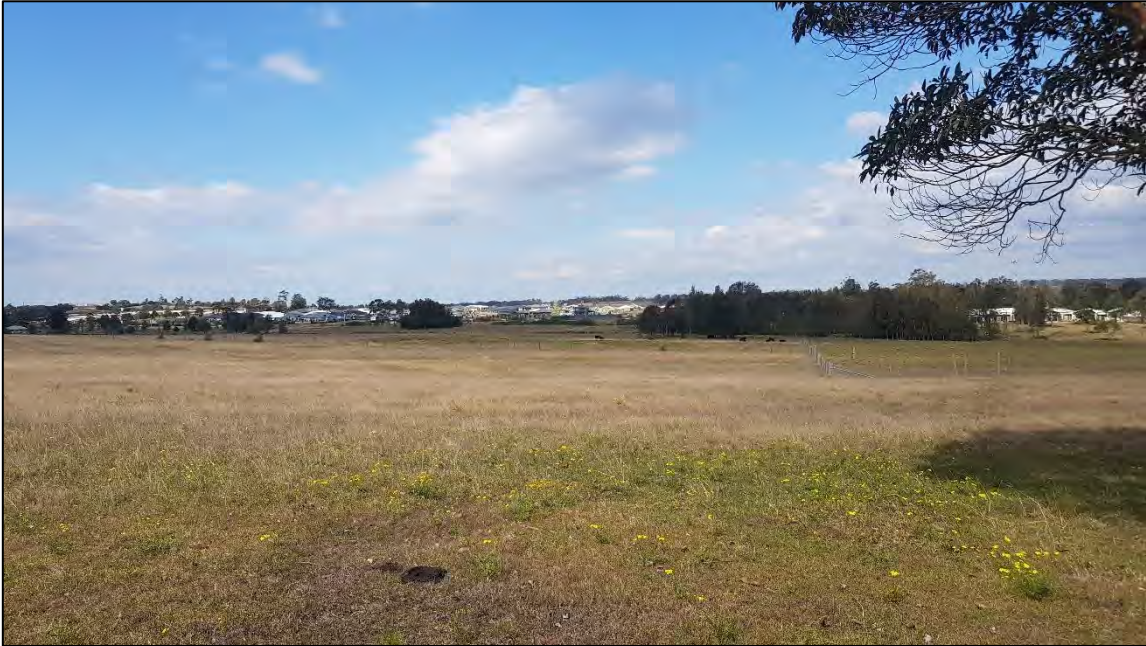
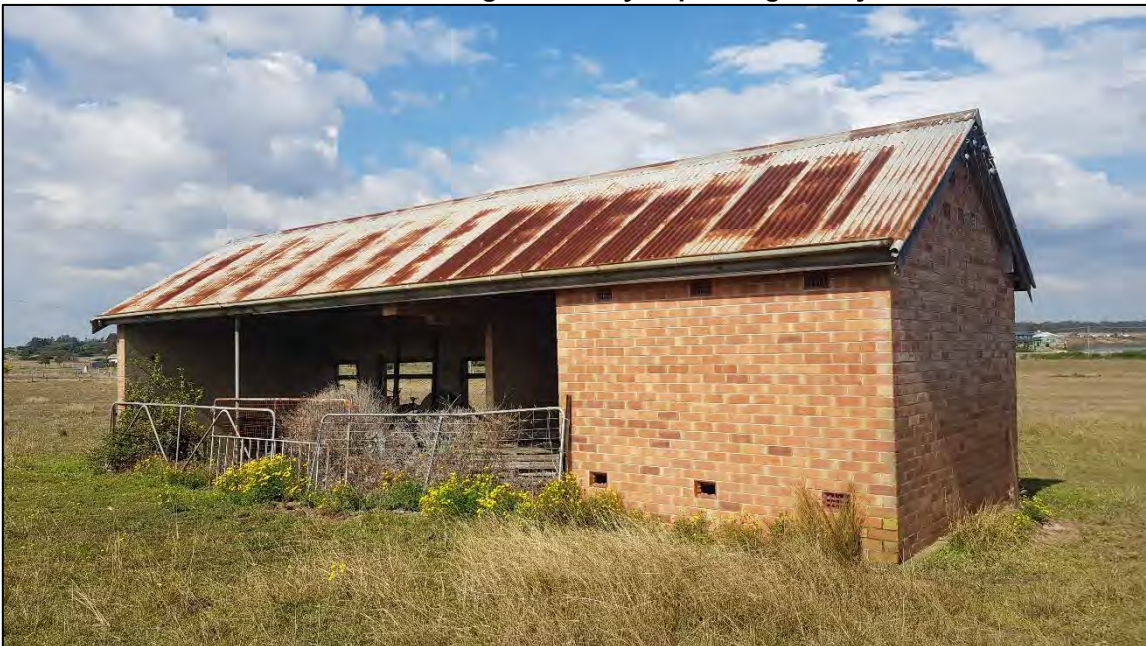
Above: Centre west of site looking south

Below: Farm shed containing several *Nyctophilus geoffroyi* individuals

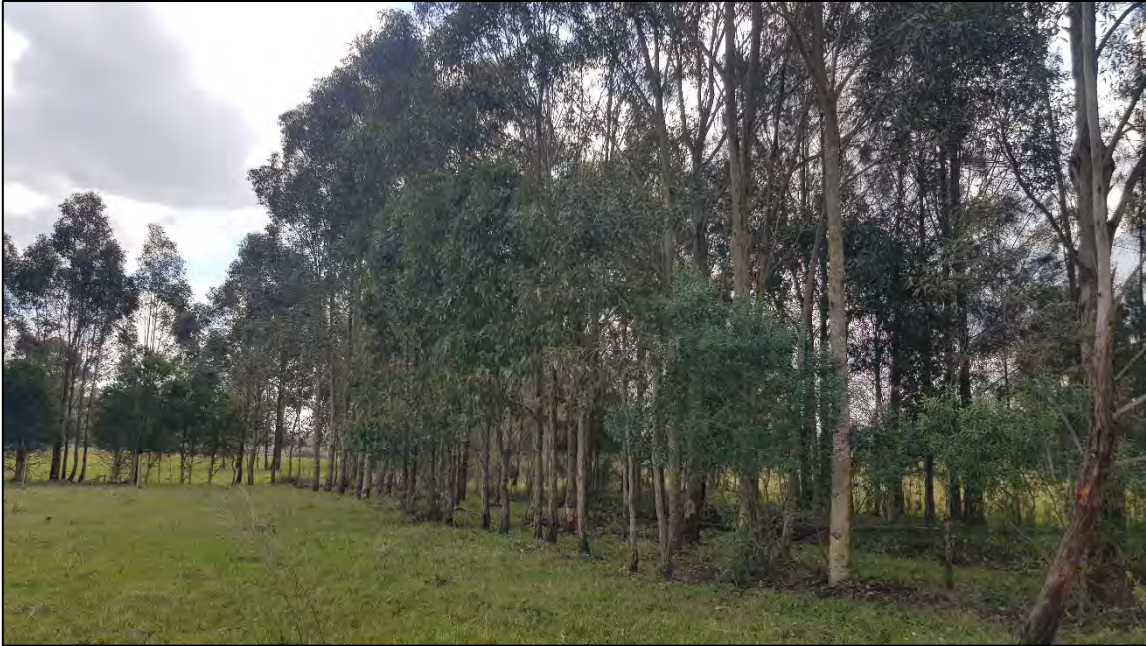
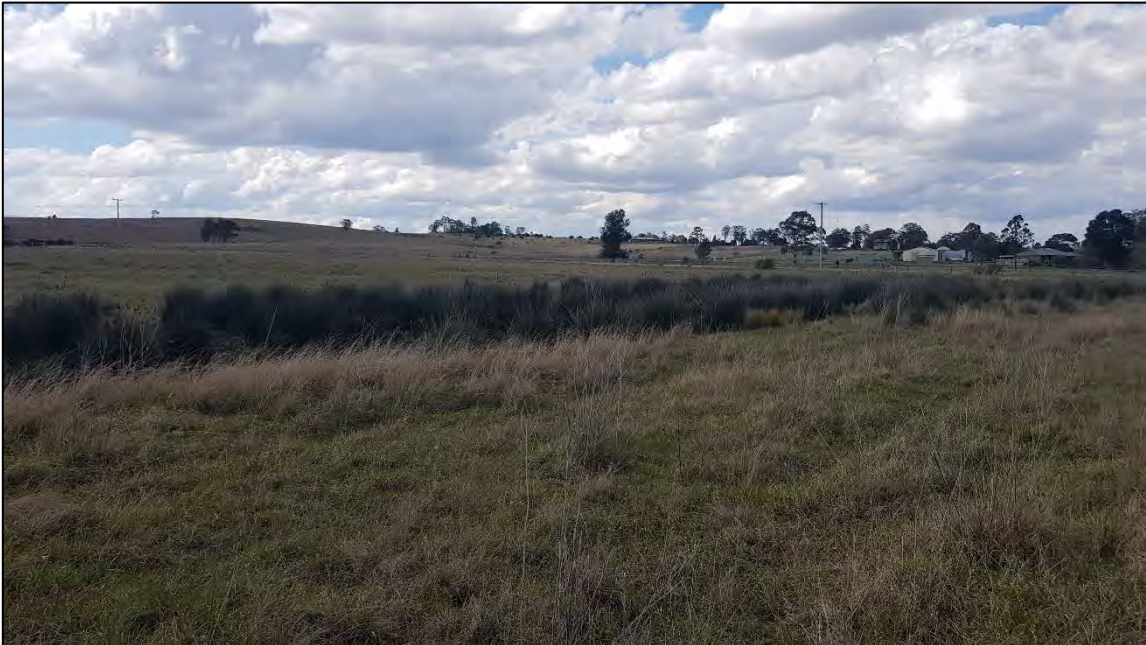
Above: Planted vegetation along riparian zone in the south west of site Below: Predominantly exotic riparian area

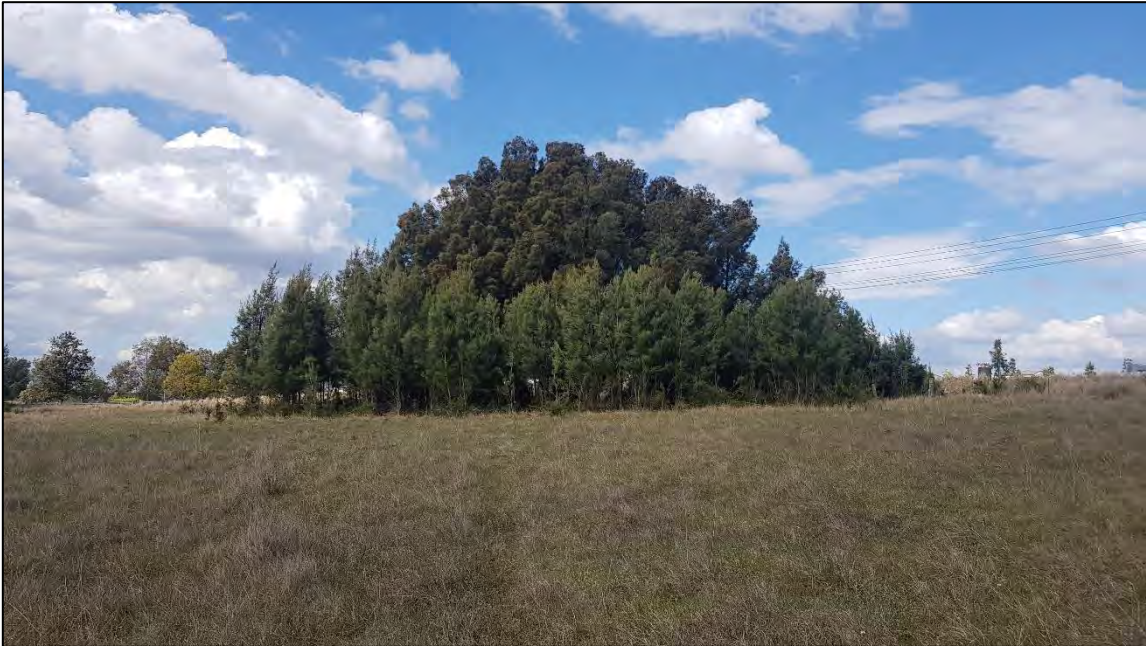
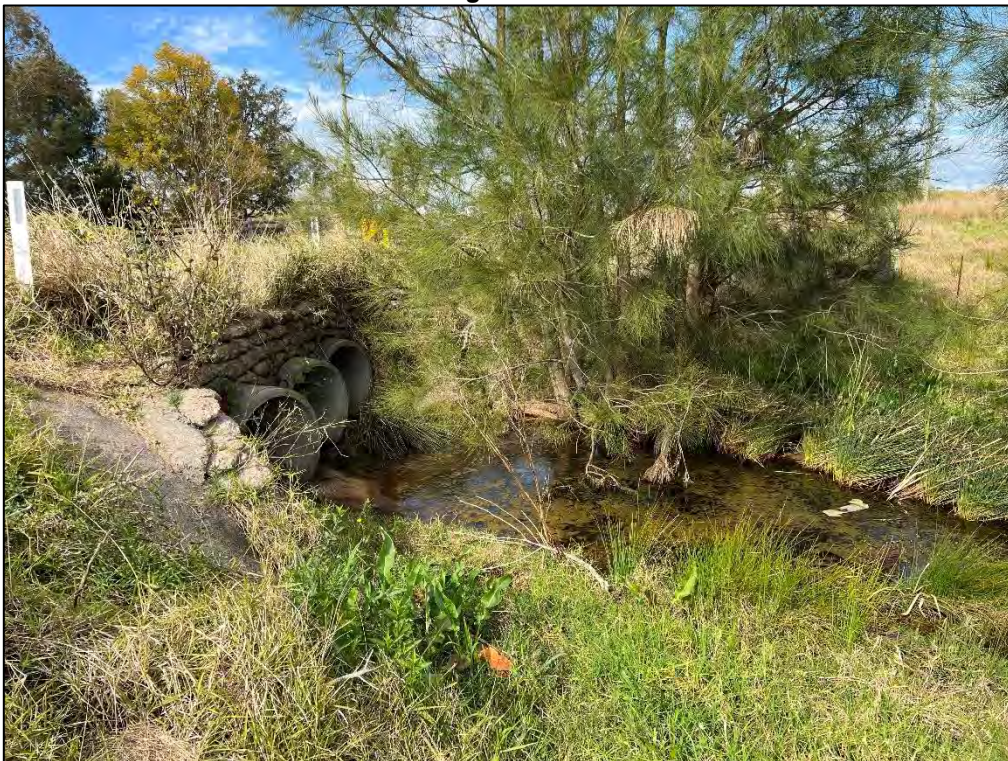
Above: Stand of retained PCT 3433 at the southern boundary

Below: Predominantly exotic riparian zone in the south east corner with scattered *Casuarina glauca*
