Section 140 Excavation Report
[s140/2021/010]

Former Morpeth Courthouse
123 Swan Street, Morpeth

Prepared for
Maitland City Council
by Eureka Heritage

Project No 200302_ExcavationReport

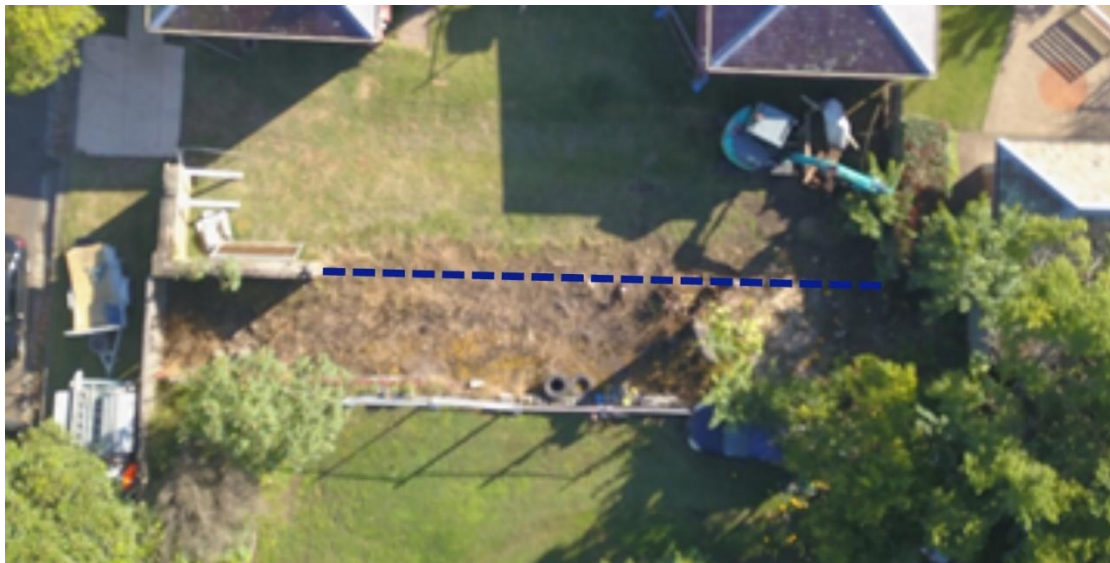
Figure 1.3 – Aerial view of the Morpeth Courthouse showing the project area just prior to commencement of excavation. Trench line shown in blue.

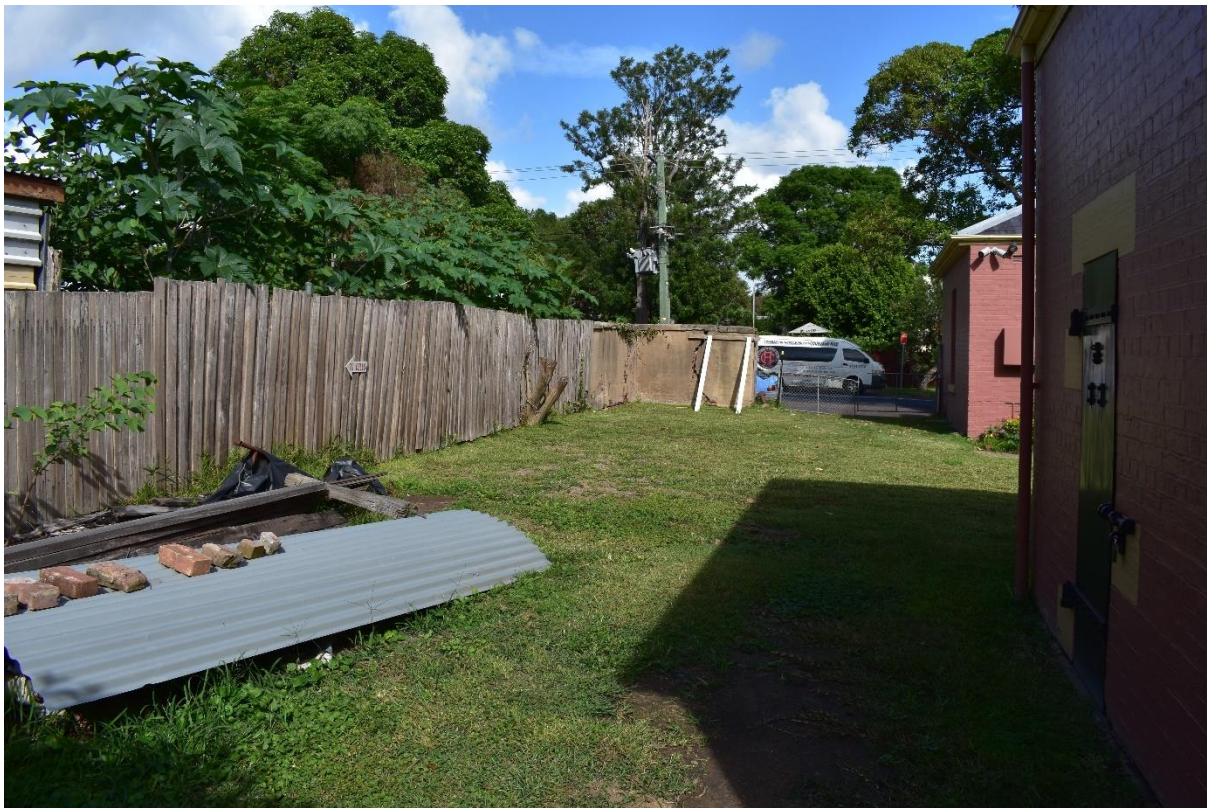
Figure 1.4 – Looking west across the rear yard in March 2020.
Photograph by Eureka.

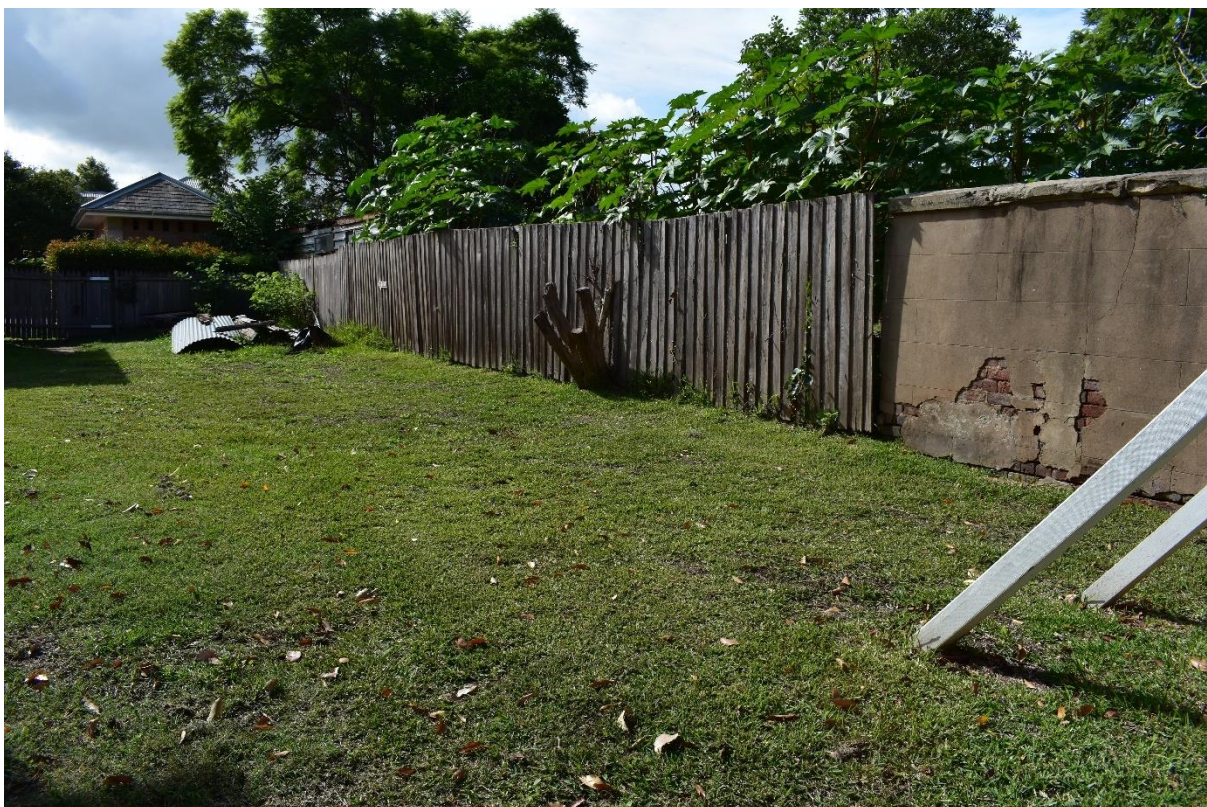
Figure 1.5 – Looking east across the rear yard in March 2020.
Photograph by Eureka.

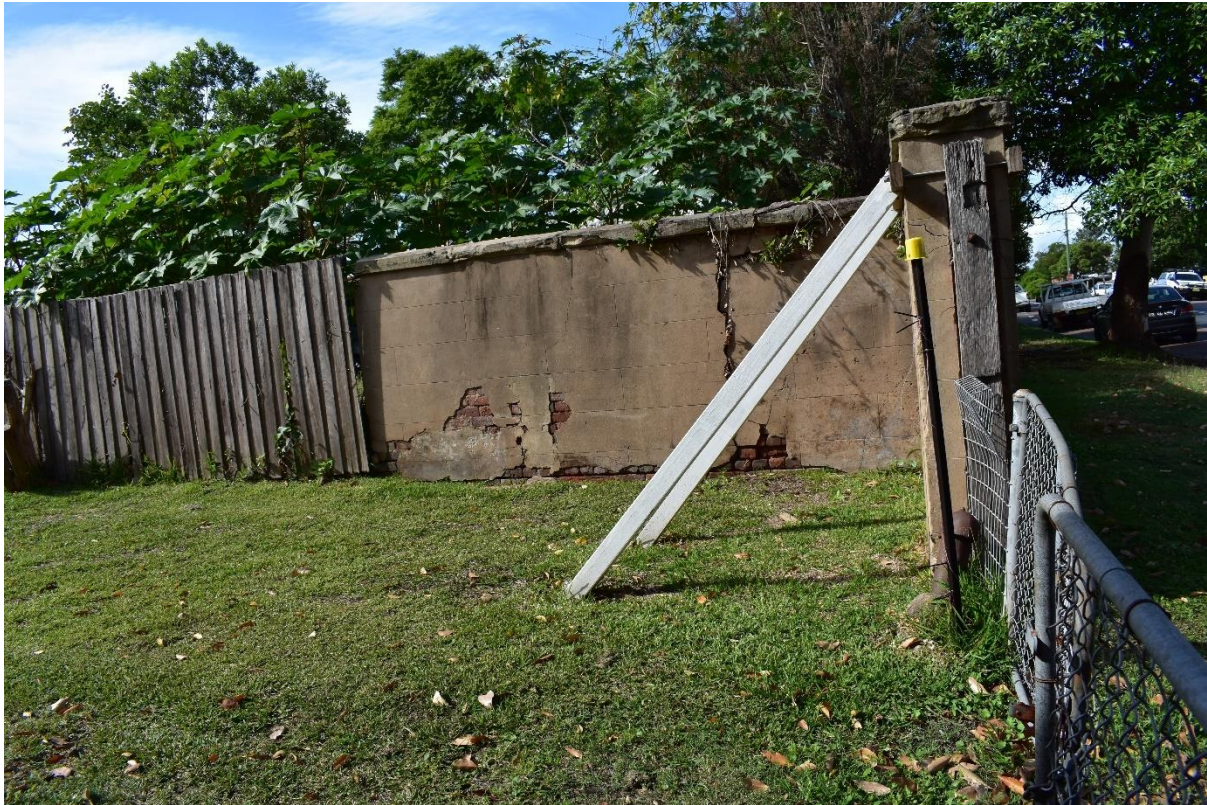
Figure 1.6 – Remnant masonry wall of rear boundary, requiring support, in March 2020.
Photograph by Eureka.

It has also come to light that a rear masonry wall with return, a mirror of that still standing on the western boundary, was demolished sometime after a survey of 1966. This survey has only recently come to light and is presented as **Figure 1.8**. The survey clearly identifies that the new fence was built upon the “remains of the old wall”.

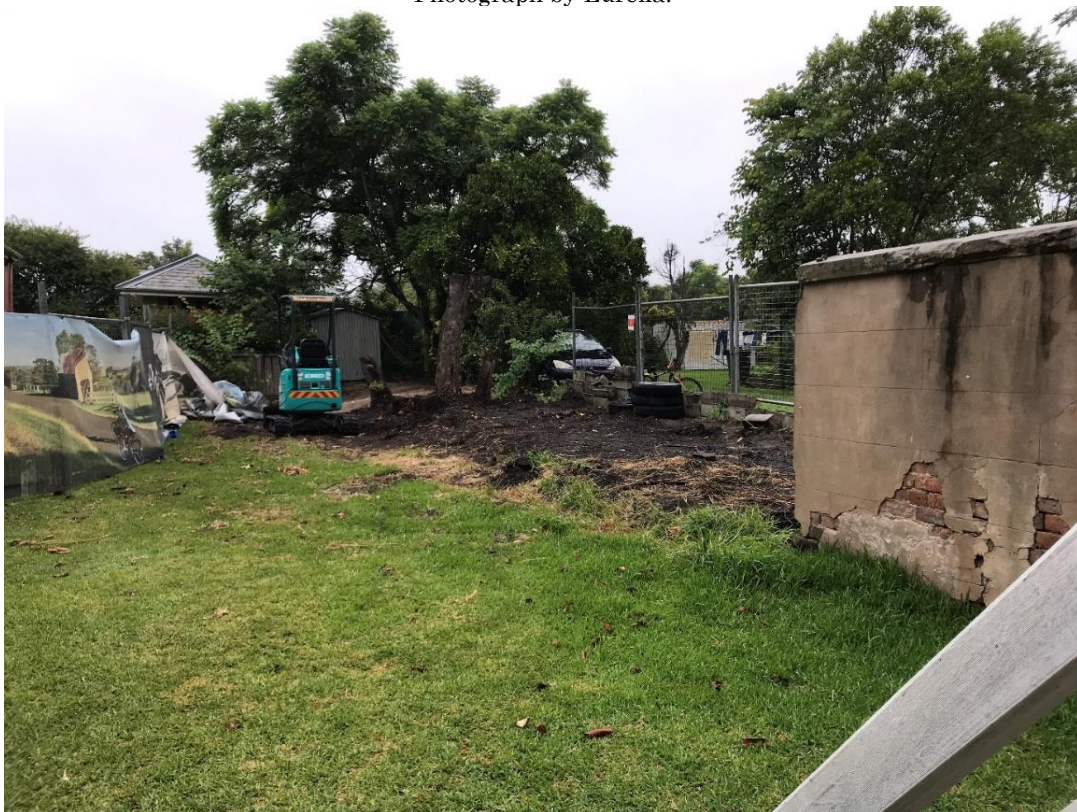
Figure 1.7 – Looking east across rear yard following demolition and removal of the timber fence.
Photograph by Scott Warner, MCC.

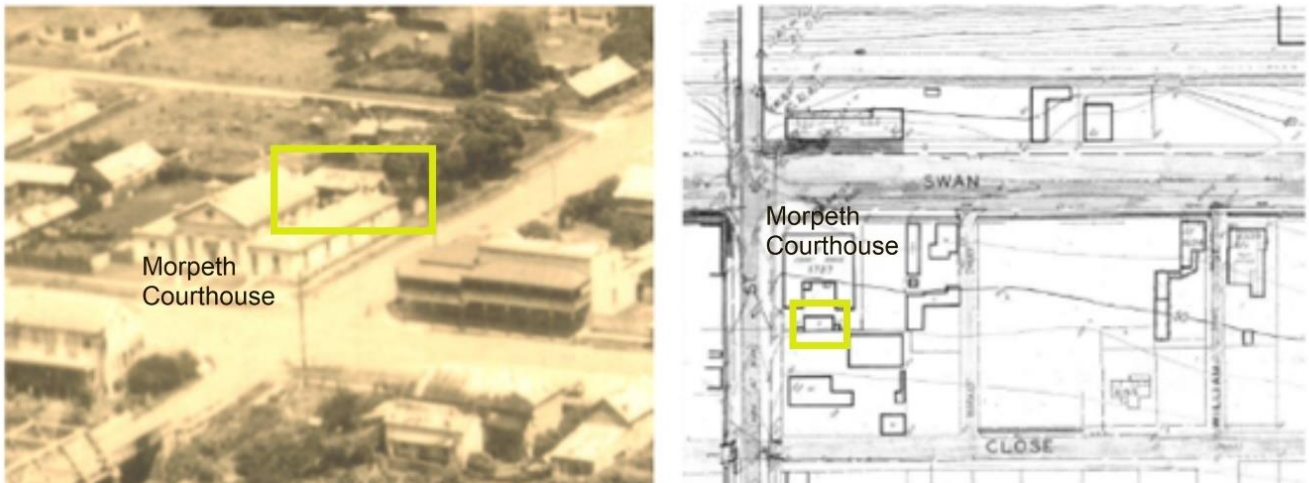
Figure 2.2 – Morpeth Courthouse in the 1940s with aerial view mid-1940s at left and in plan c1949 at right highlighting stables in yellow.
Source: SOHI, Placemark, 2019 (Images 28 and 29).

However, literature review during the current study has found evidence that can now more conclusively date demolition of the stables to the 1950s as demonstrated in **Figure 2.2** and **Figure 2.3** below.

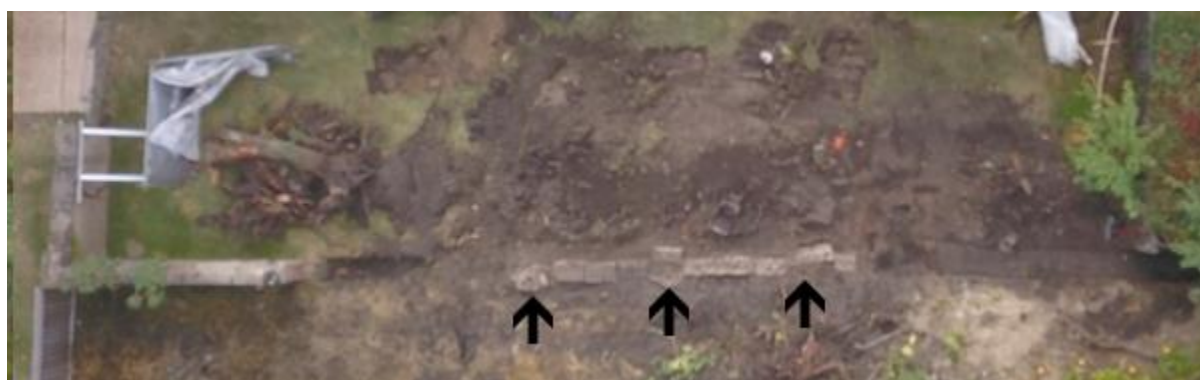
Figure 3.2 – Aerial view of completed excavation demonstrating a high level of disturbance, particularly at the western extreme of the footings where the sandstone blocks have been removed. Arrows indicate disturbance for post holes c1966 when a fence was constructed on the

Concrete footings for post holes, remnants of the c1966 fence, had caused disturbance to the remnants of the stable's footings by displacing stones at three locations (shown by arrows **Figure 3.2**). Invasive tree roots were present, particularly at the eastern extreme of the trench, where weeds and trees located on the adjacent property had been allowed to become well established. Along with sediment build up against the fence of the neighbouring property, disturbance was also apparent through the absence of artefacts along the entire trench until the point at which the brickwork of the eastern cesspit was exposed. See **Figure 3.3** to **Figure 3.8**.

A trench was excavated along the anticipated line of the foundations of the rear wall of the stables building, commencing at the intact western masonry wall (**Figure 3.2**). Excavations revealed that although some sandstone blocks of the footings survived, the footings were highly disturbed.

Disturbance occurred largely through construction of the rear boundary fence shown in the survey plan of 1966. Additional disturbance occurred when a garage/shed was constructed with the footprint of the former stables building (refer **Figure 1.8**). The garage/shed was subsequently demolished, possibly at the same time the rear fence was again reconstructed in the early 1990s.

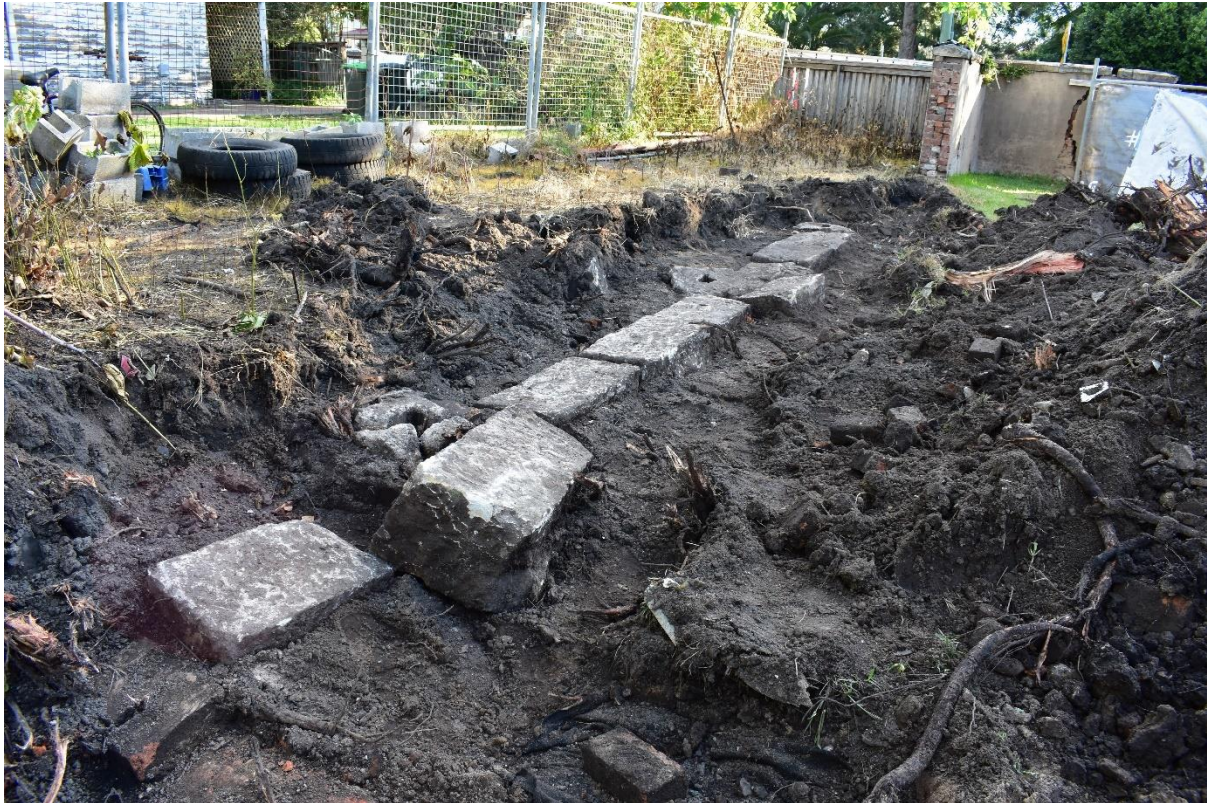
**Figure 3.4 – Rear wall stable’s footings, looking south-west
And surviving western masonry wall at upper right of view.**

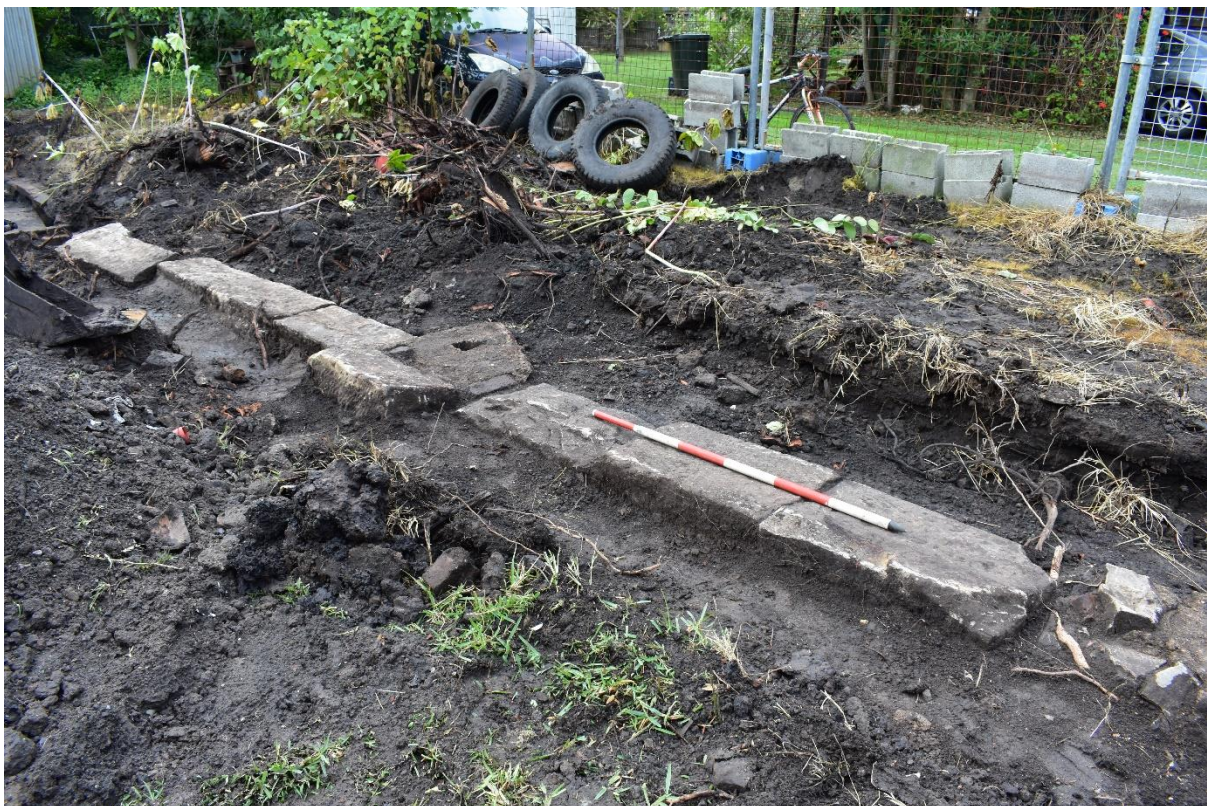
**Figure 3.5 – Stable’s footings looking south-east.
Scale 200mm inc.**

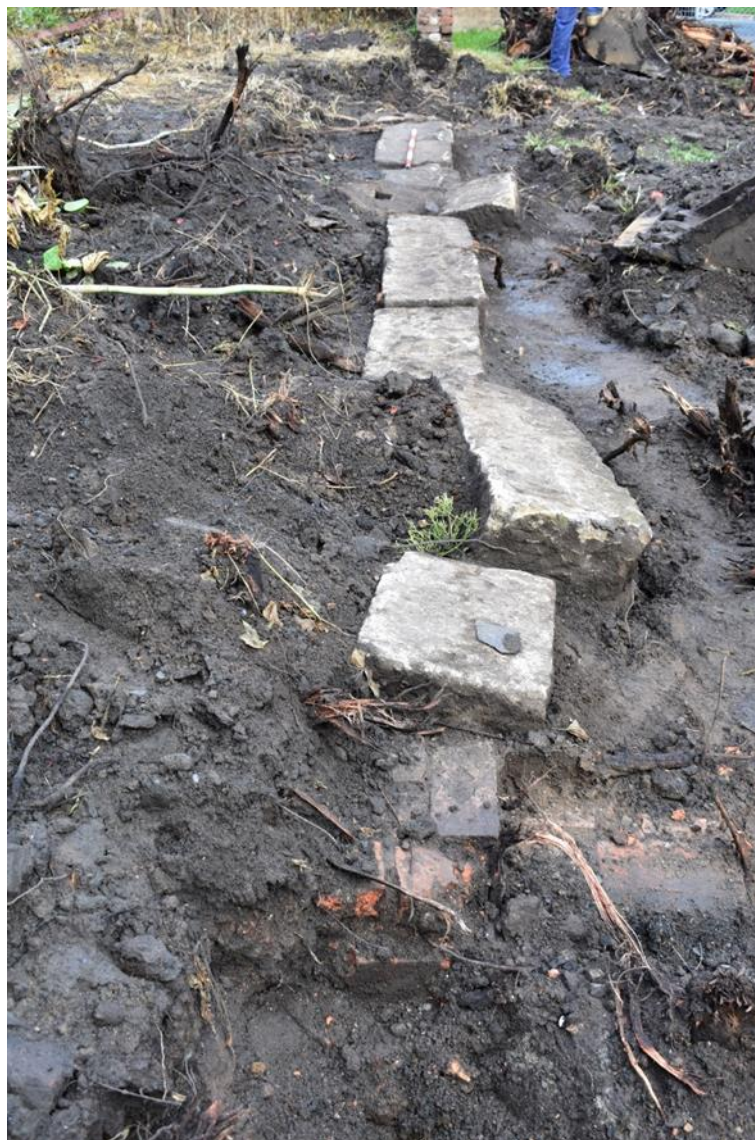
Figure 3.6 – Rear wall stable's footings, looking west.

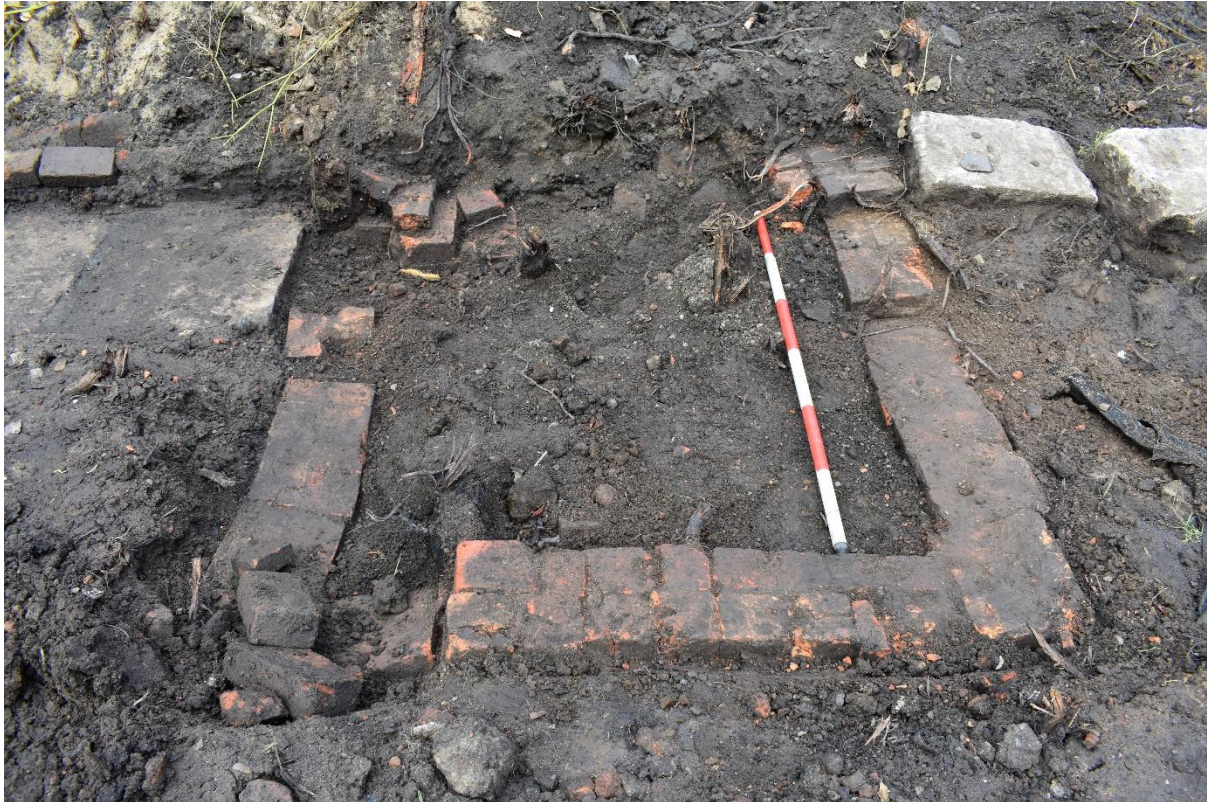
**Figure 3.7 – Brickwork of eastern cesspit, looking south.
Scale 200mm inc.**

The structural works of the eastern cesspit were exposed at the anticipated location on the eastern extreme of the stable footings (refer **Figure 3.3**). Comprised of hand-made bricks with diamond frog, the brickwork was relatively intact with bricks fragile from water logging. A section of brickwork along the southern boundary had been removed.

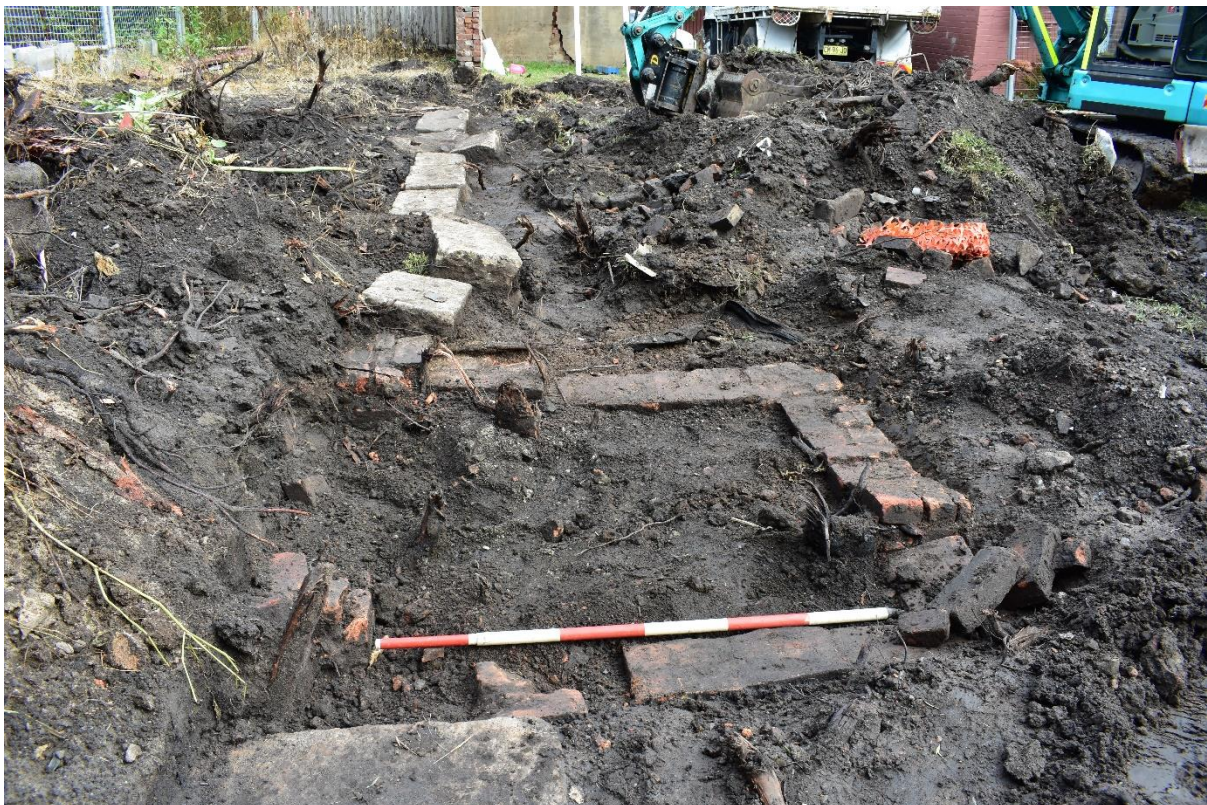
**Figure 3.8 – Eastern cesspit in relation to stables footing and eastern wall footings.
Looking west. Scale 200mm inc.**

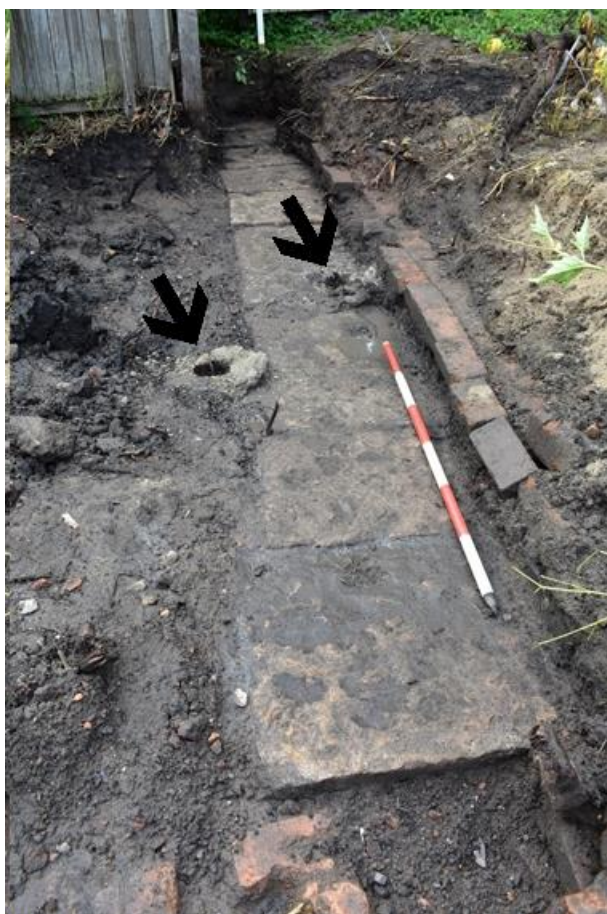
The footings were intact, although water logged, with modern concrete intrusions in the sub-soil above, placed for the posts of the c1966 fence (**Figure 3.9**). Artefacts were recovered from the spoil during excavation and were a mix of 19th and 20th century items indicating the area had been turned over and disturbed perhaps more than once. Adjacent to the footings, loose bricks formed a retaining barrier of sorts, likely put in place by the neighbouring property and are not of historical significance (**Figure 3.10**).

Figure 3.9 – Sandstone footing of eastern masonry wall, looking east. Remnants of concrete for fence post holes shown by arrows.

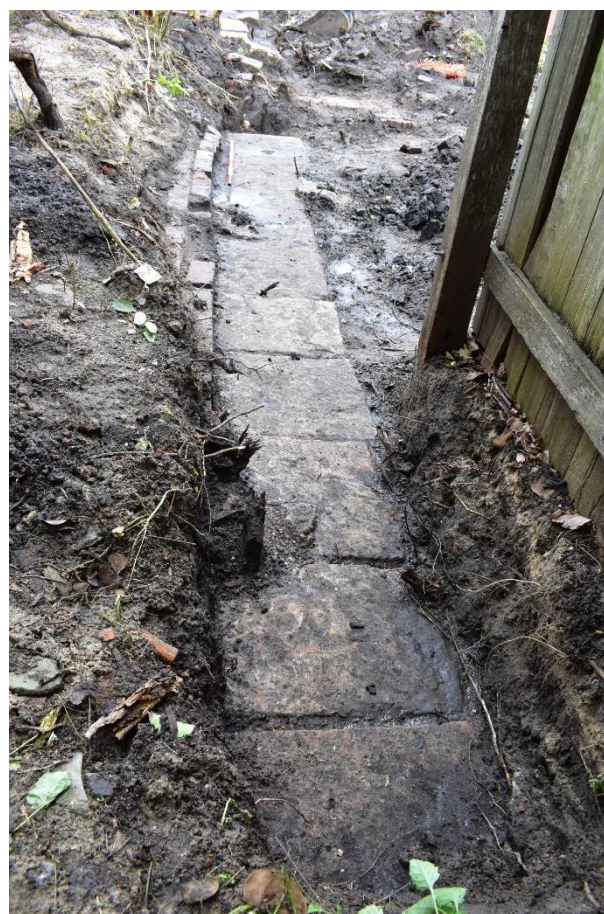
Figure 3.10 – Sandstone footings of eastern masonry wall, looking west.

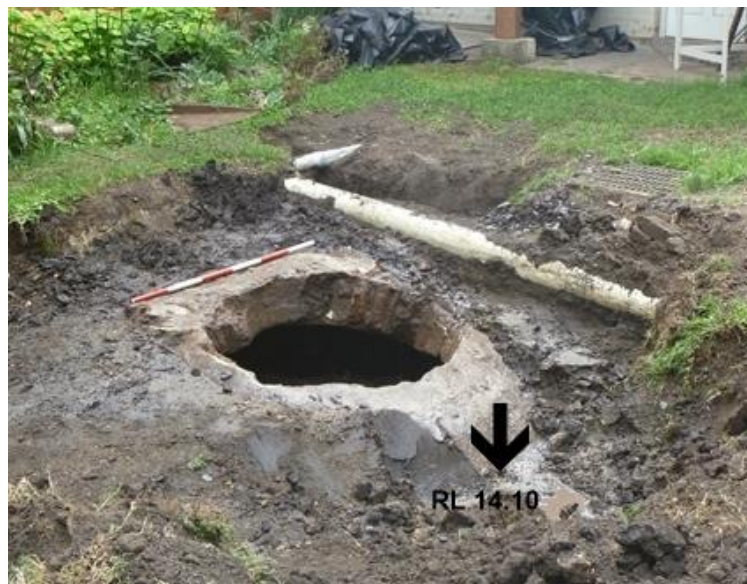
Figure 3.11 – Domed brick cover of the underground cistern located in the rear yard of the Morpeth Courthouse during excavation in 2013.

In 2013, excavated works had been covered with geofabric and clean sand prior to backfilling with top soil – see **Figure 3.11** to **Figure 3.13**. This assisted with the easy re-location of the works for survey. Following survey, the re-exposed works were recovered with new geofabric and backfilled. Survey results including levels to AHD are included as **Appendix 2**.

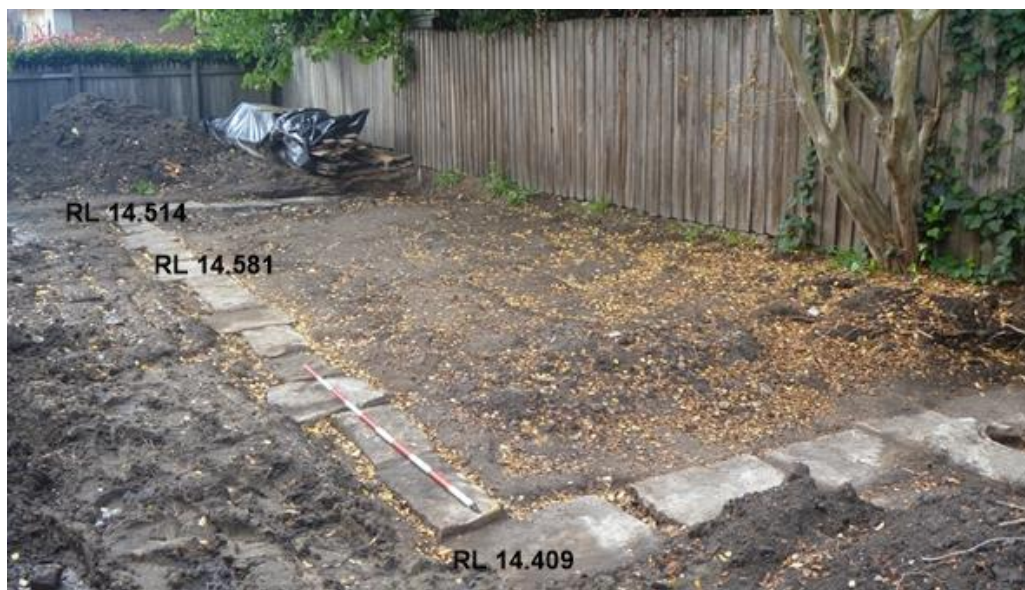
Figure 3.12 – Extent of sandstone footings of the c1862/63 Police Stables, At conclusion of 2013 excavation, looking south-east and showing RL taken in 2021.

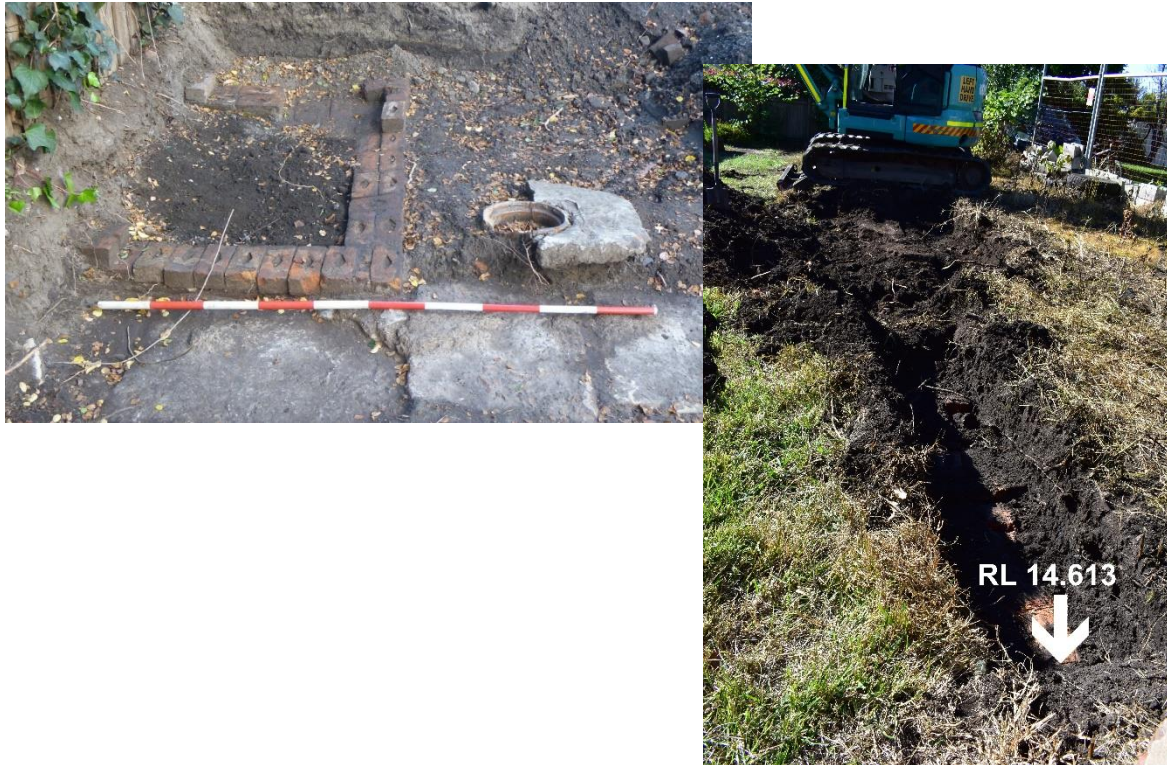
Figure 3.13 – Left: Brick footings of the western cesspit adjoining the sandstone footings of the police stables, at conclusion of excavation in 2013. Scale 200mm inc. Right: Brickwork of rear wall western cesspit excavated in 2021 showing RL.
Source: Eureka Heritage, 2014.

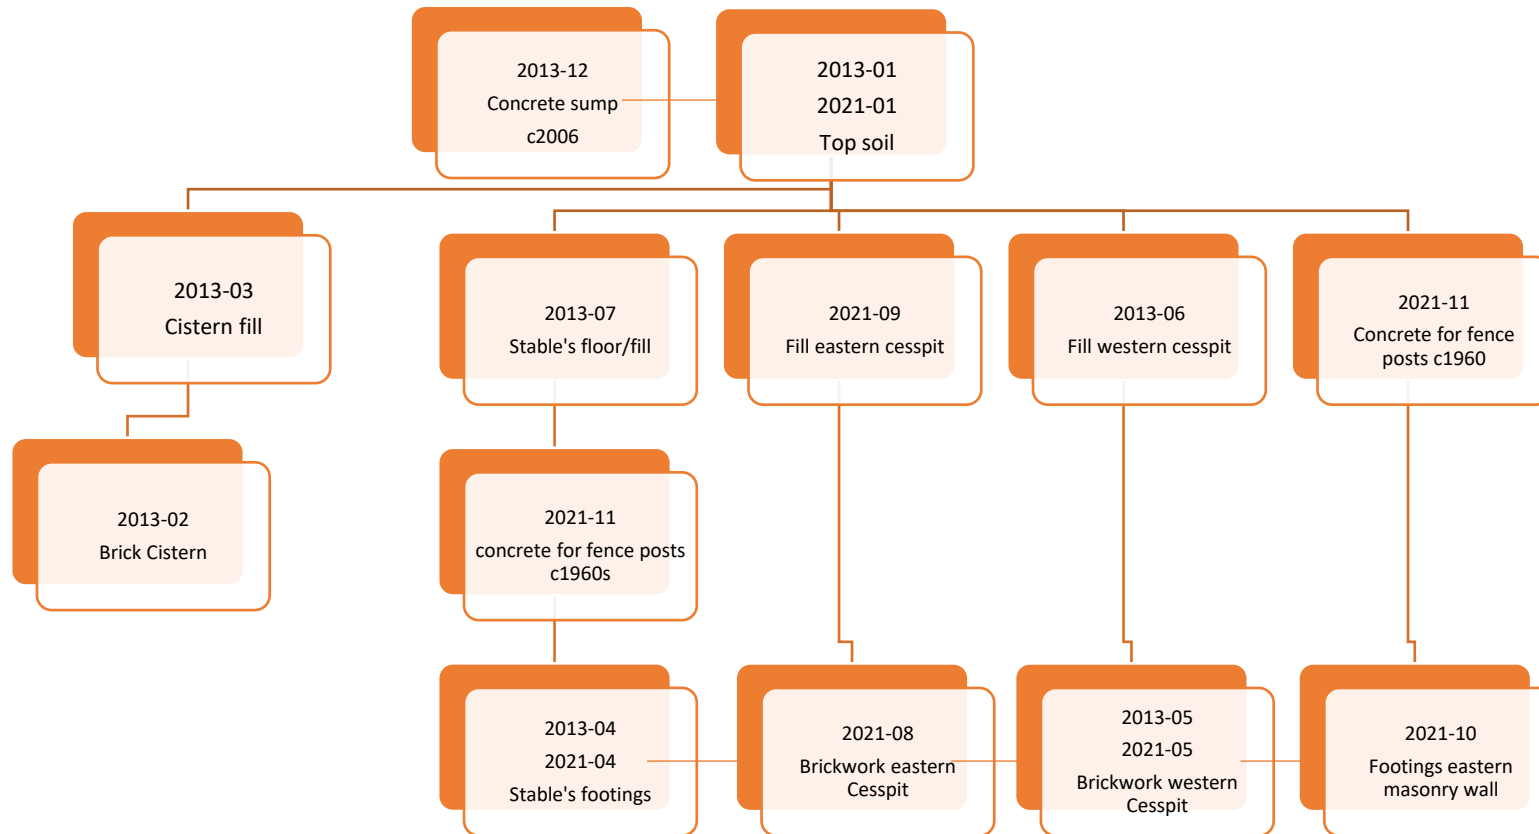
Figure 3.15 – Harris Matrix
Showing stratigraphic relationship between contexts

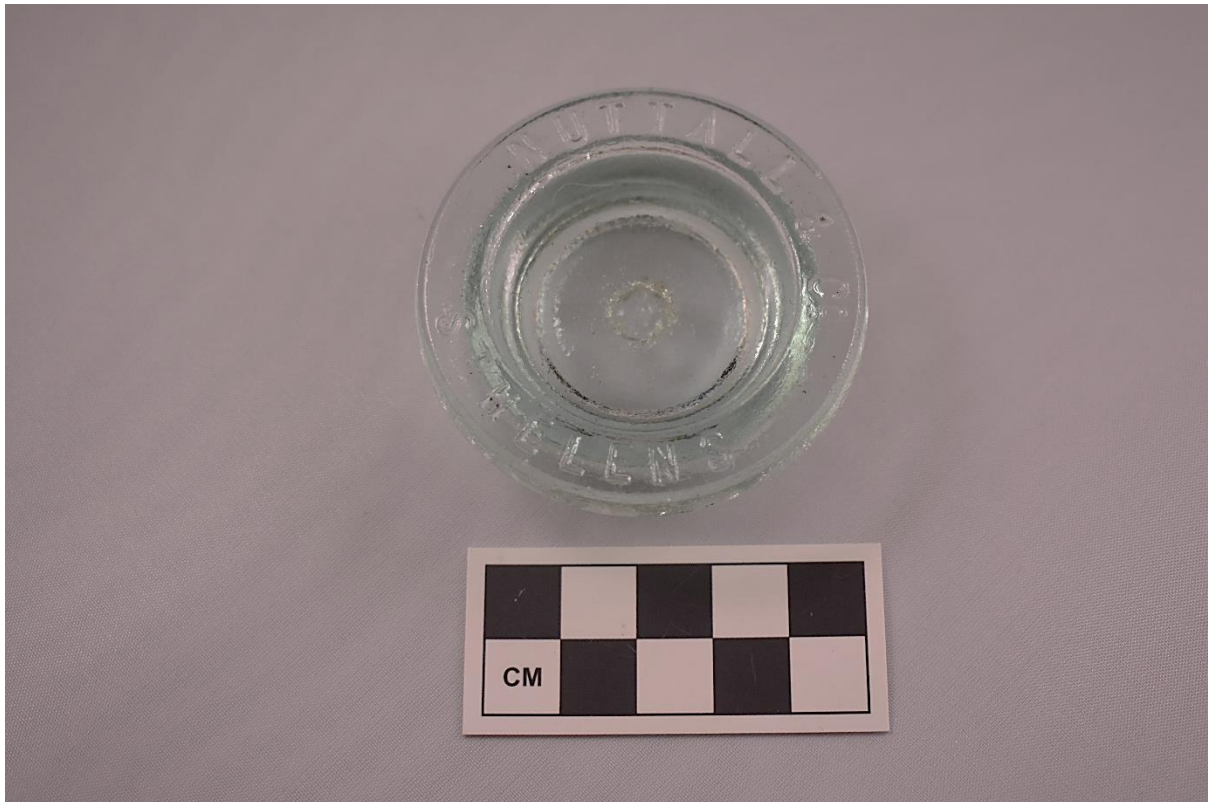
**Figure 3.18 – Artefact No 20- Glass lid by Nutall and Co, St Helens c1871-1913.
Artefact No 20 Context 2021-09.**

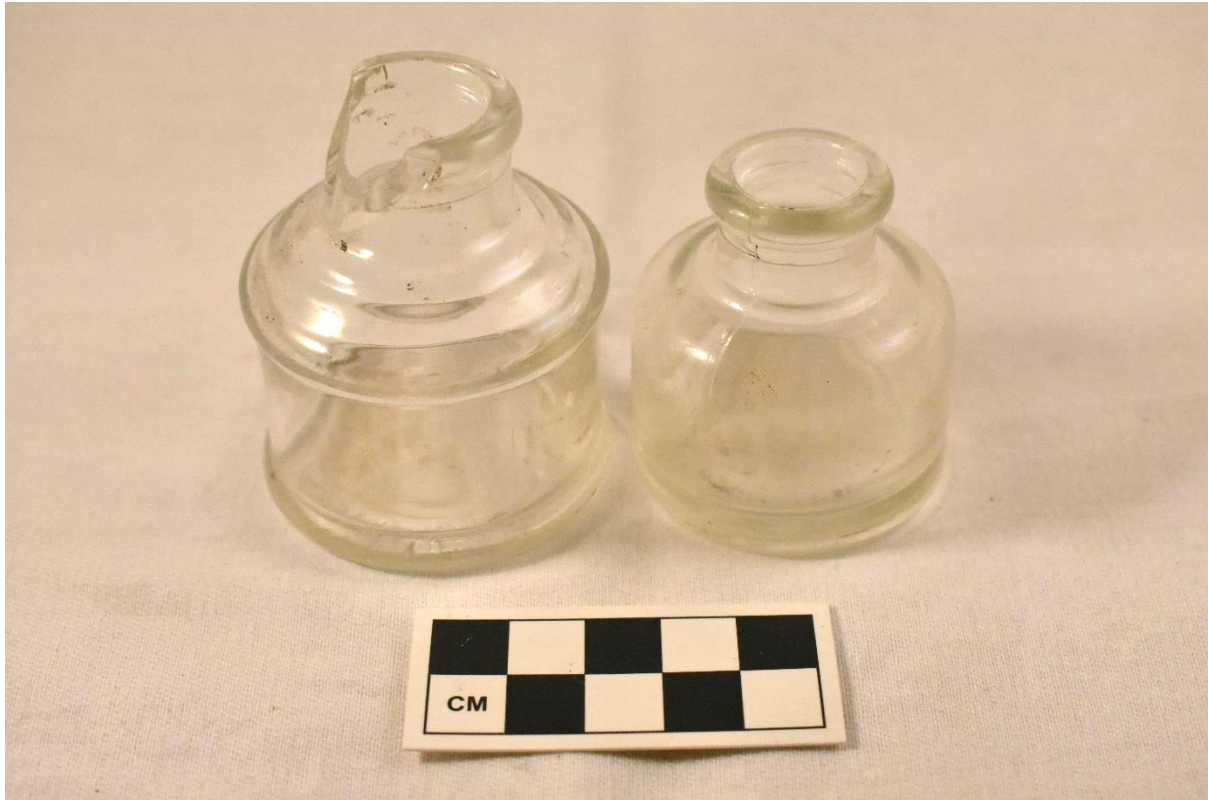
**Figure 3.22 - Two styles of ink bottle recovered from the eastern wall footings Context 2021-01.
Left: Artefact No 2 Stephen's Inks c1916-1939.
Right: Artefact No 1 generic ink bottle without markings.**

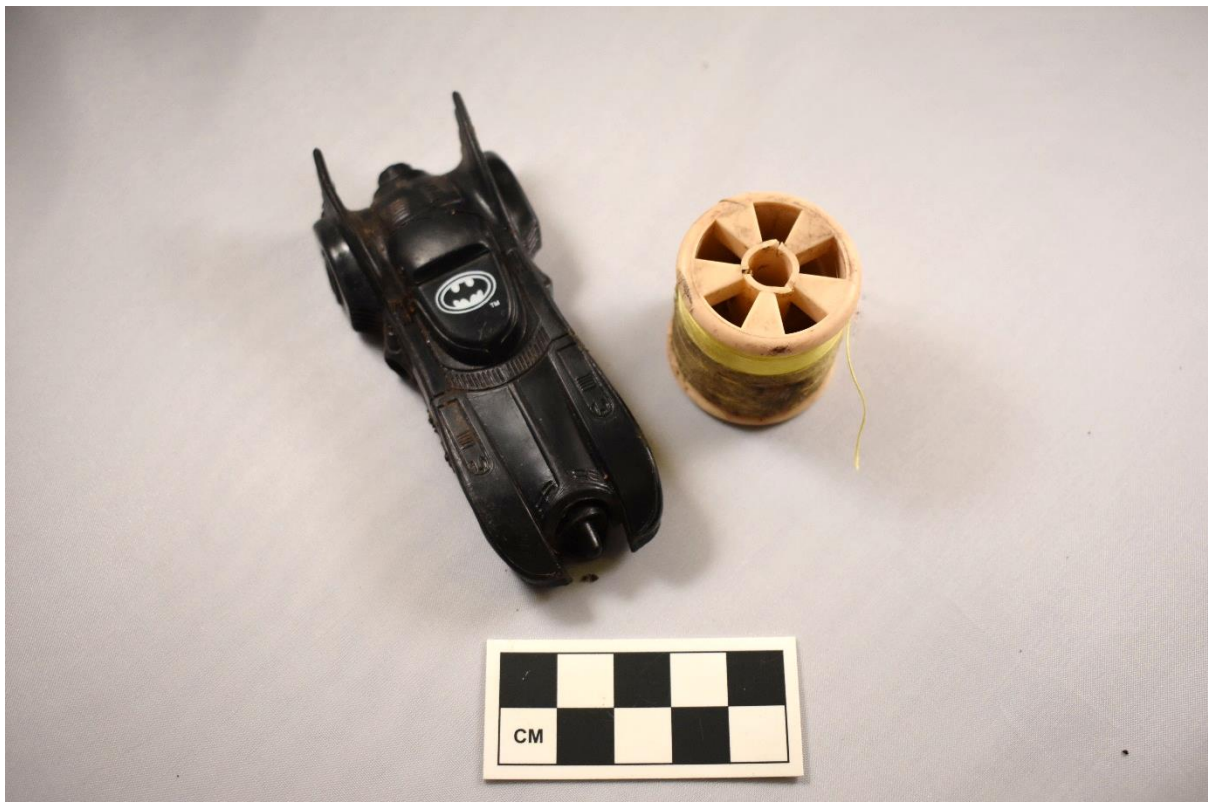
**Figure 3.23 - Evidence of disturbance along the eastern wall footing
Toy Batmobile dated 1991 and plastic spool Silko cotton thread (Context 2021-01).**

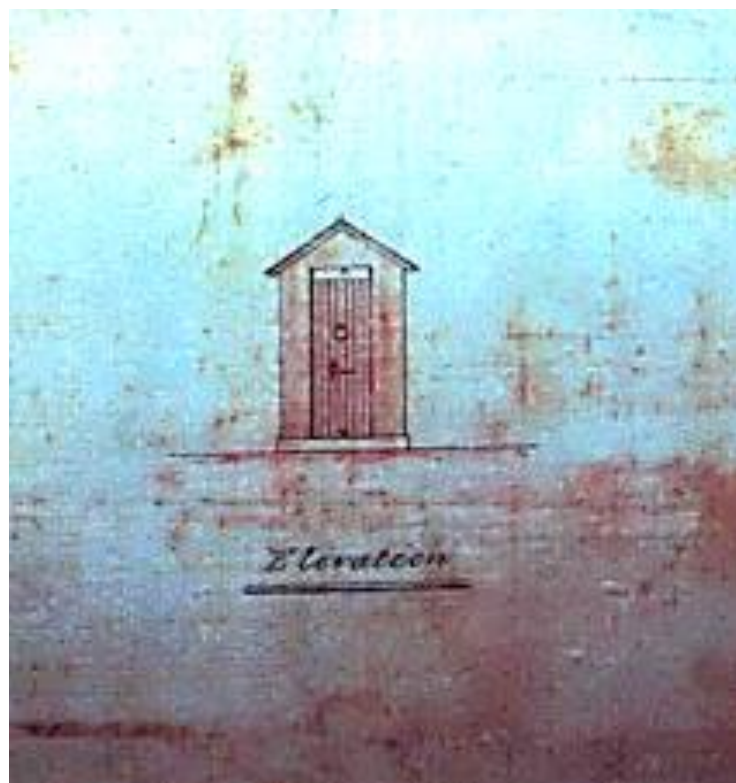
Figure 3.27 – Orange Courthouse Barnet design 1881/3– detail Closet elevation.
Source: Source: AONSW Plan 834 in Mider, 1998

The former c1881 stables of the Orange Courthouse are comparable to those of the Morpeth Courthouse in their design and plan, and in accommodating five stalls for five horses. That the privies of the Morpeth Courthouse were constructed alongside the stables is likely due to the limited space available at the Morpeth site in contrast to the stand alone privy of the Orange Courthouse. Copies of the Government Plans of the Orange Courthouse showing the stables and privies in plan and elevation are reproduced in **Figure 3.24** to **Figure 3.27** below. It is unfortunate that the stables and privy structures of the Orange Courthouse do not survive in 2021 having been demolished well before the assessment report of 1998.
