MAITLAND GAOL REDEVELOPMENT

Archaeology

Project Director: Tim Adams
Project Manager: Karyn Cook
Report No. 23153 R02
Date: September 2023

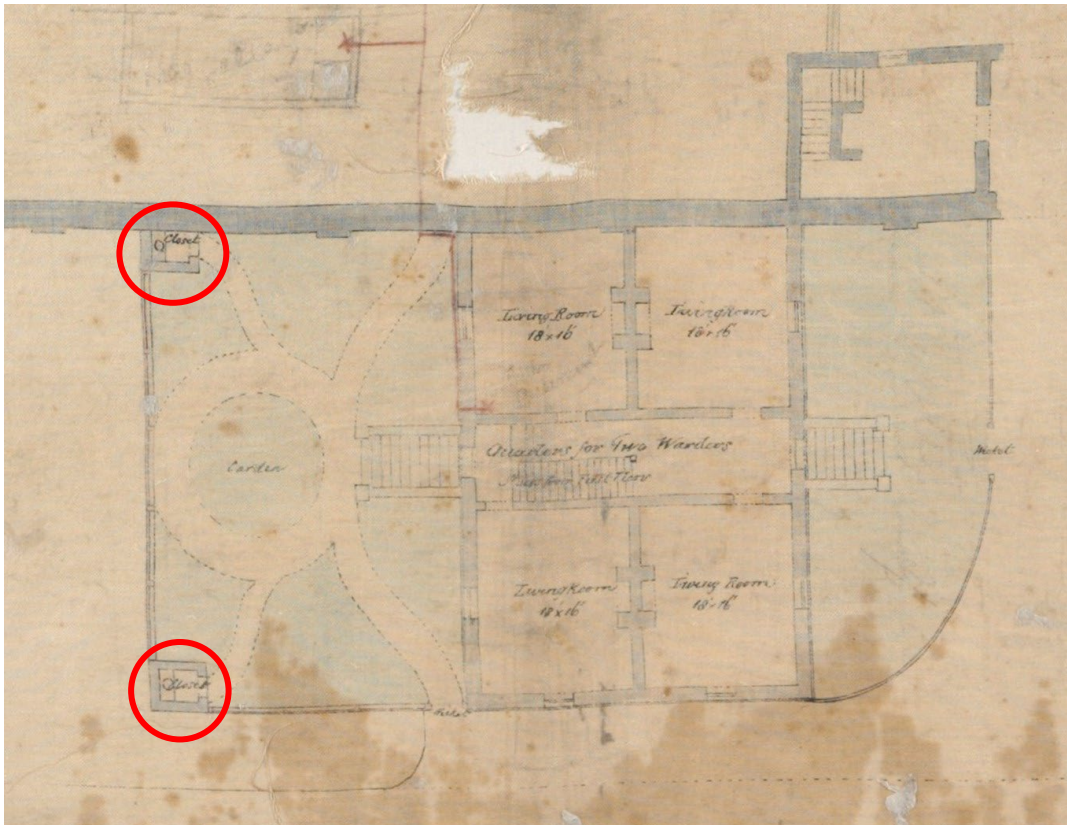
Figure 4.3 Detail of Undated Plan of Proposed Additions

Detail shows the Wardens Quarters on the north side of the John Street entrance with a formal garden layout and two closets (circled).

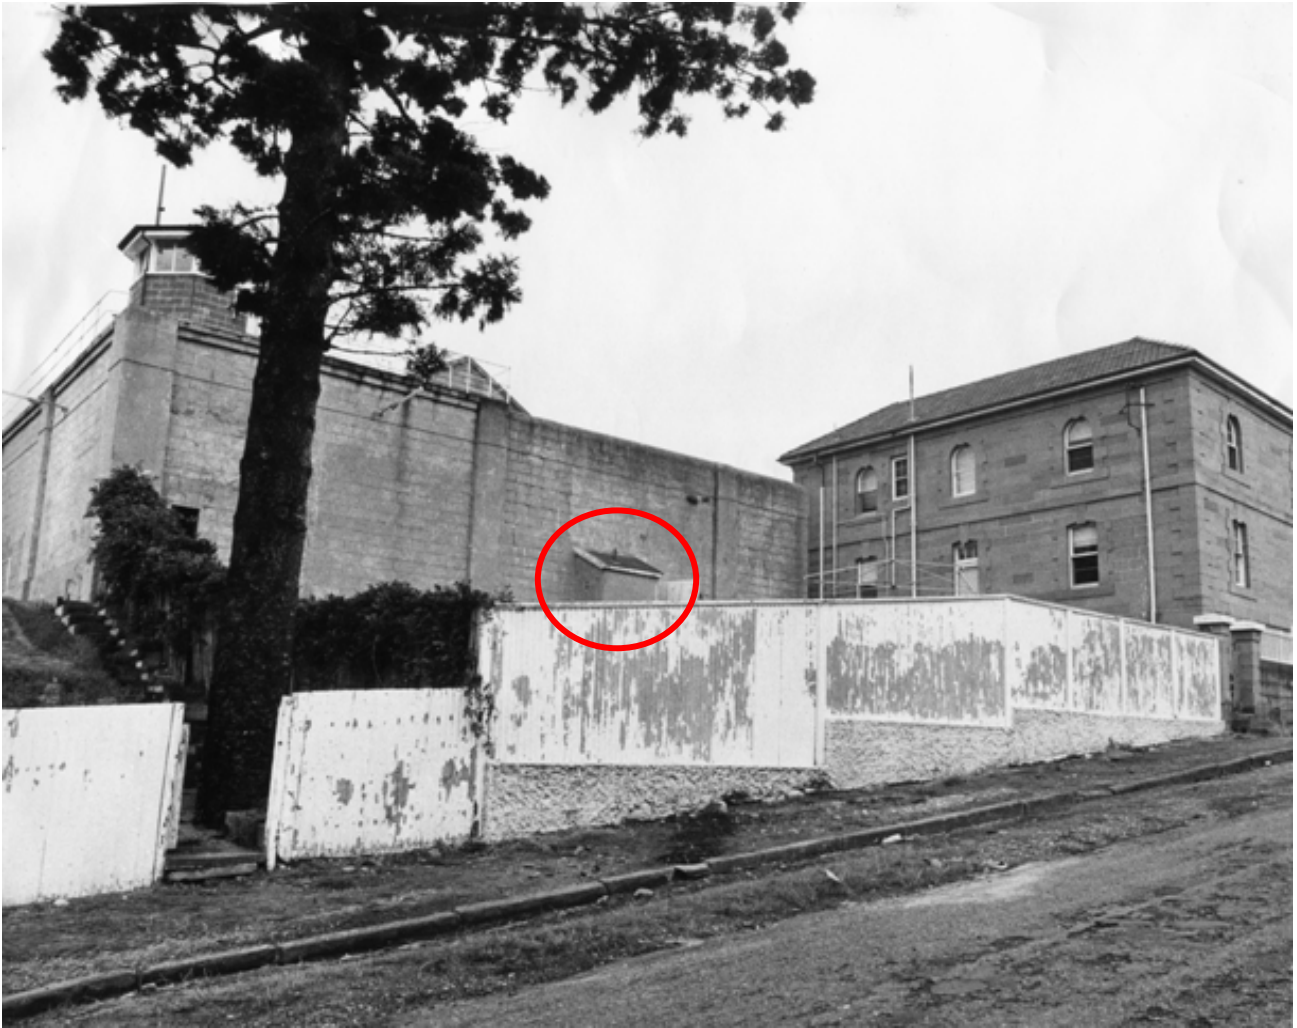
Figure 4.11 View Maitland Gaol from the west, January 1974

Photograph taken prior to the construction of the Staff and Warder's Amenities, now cafe. The location of the 'closet' against the wall can be seen (circled).

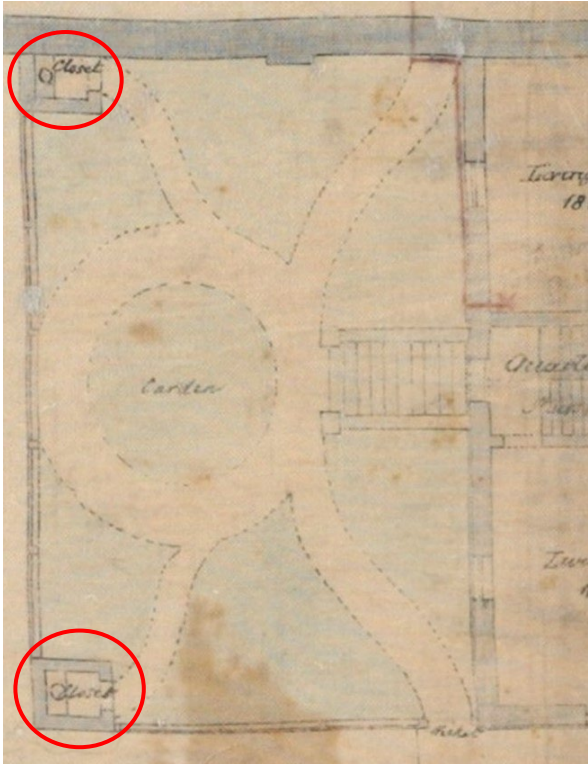
<p>Plan shows the Wardens Quarters on the north side of the John Street entrance with a formal garden layout and closets (circled) at the corners of the garden.</p> <p>Source: State Archives, NRS-4335-4-Plan794-PC321/43.</p>

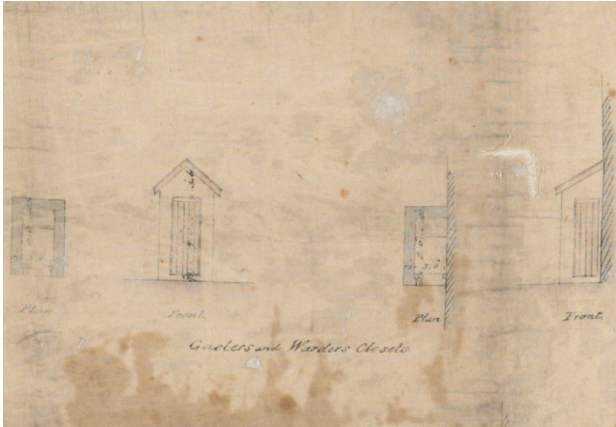
<p>Construction details of the closets.</p> <p>Source: State Archives, NRS-4335-4-Plan794-PC321/43.</p>

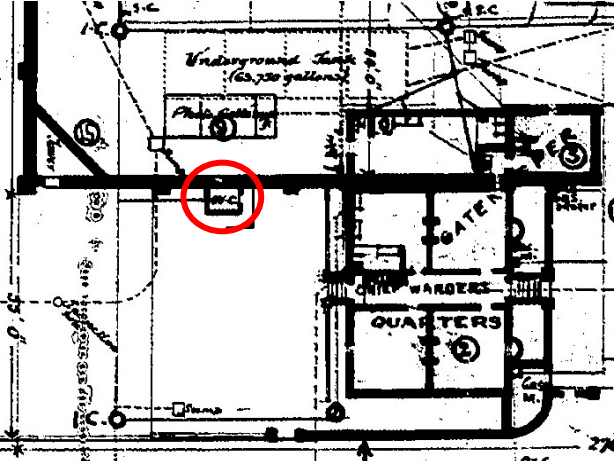
<p>Detail of undated plan showing single W.C. against wall of Gaol. A sump is indicated in the approximate location of the second closet shown on the 1860s plan.</p> <p>Source: GAO drawing PC321_12.</p>

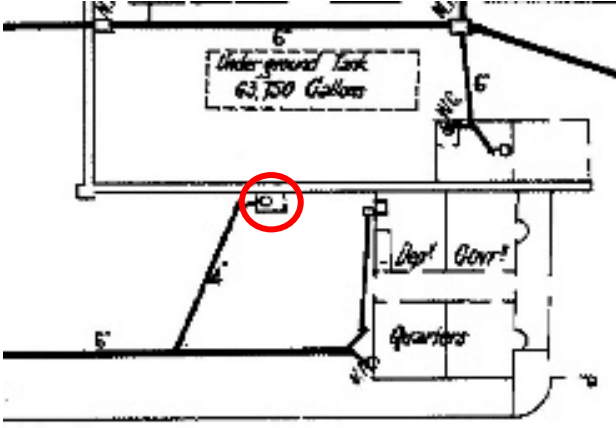
<p>Detail of undated plan showing water and sewerage services (including to the closet) and the below ground tank inside the Gaol walls.</p> <p>Source: GAO drawing 30114.</p>
