# MAITLAND GAOL CONSERVATION MANAGEMENT PLAN

Maitland City Council

**FINAL DRAFT**  
ISSUE 3  
22207  
7 August 2024

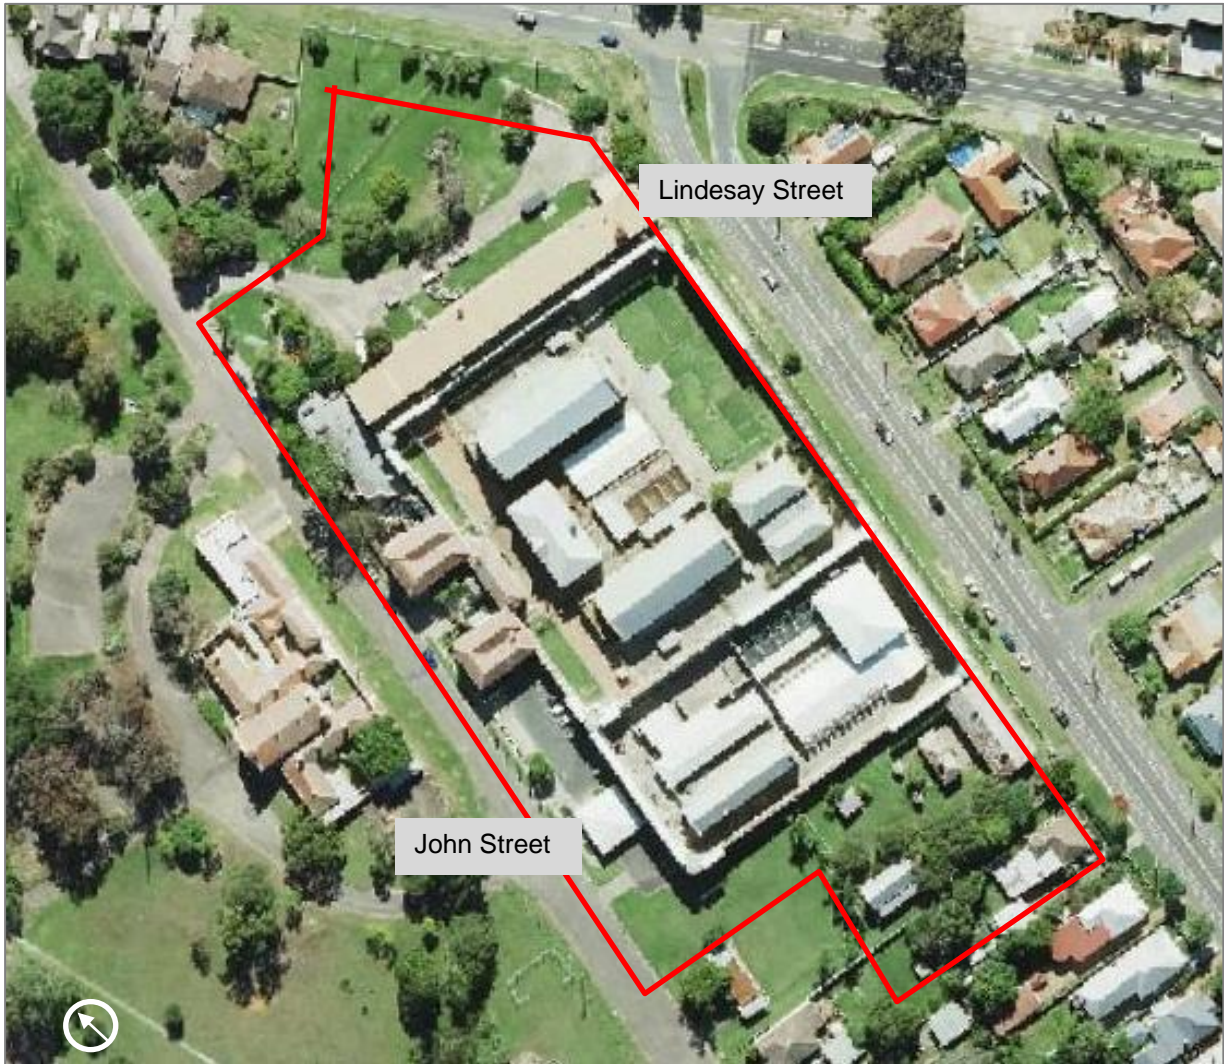
**Figure 2: Site Plan**

An aerial view of the site is shown in Figure 2 and the location of each building is shown in Figure 3.

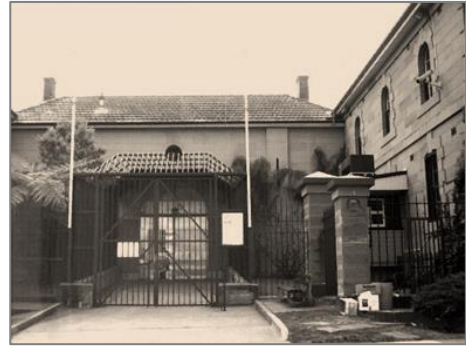
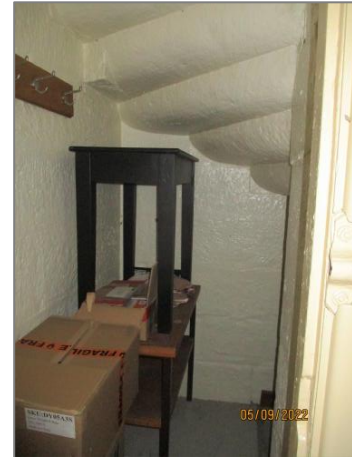
Built of sandstone, the building is incorporated in the compound wall and protrudes into the sterile zone within the compound. It is two storeys with the original two chimneys. Steel doors have replaced the original iron bar gates at the inside and outside elevations of the building. A two-storey high structure within the original two chimneys.

**Condition: Reasonable**

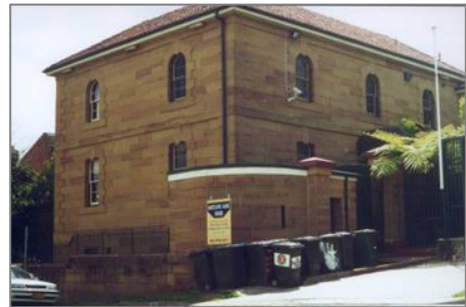
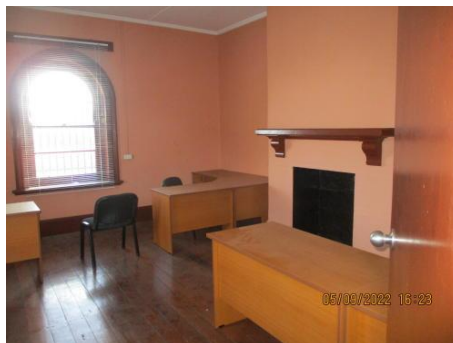
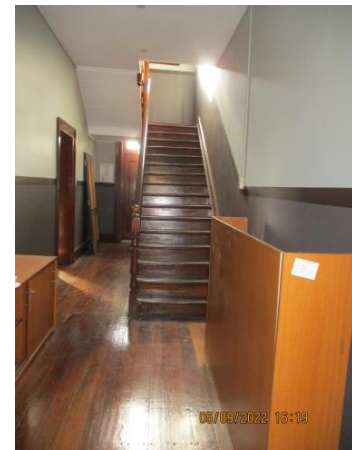
**Building 2 Superintendent's Office (former Lieutenant Governor's Residence)**

A three-storey building, including basement, of ashlar sandstone with heavily rusticated windows and corners this building projects forward from the compound wall. The chimneys have been demolished as have the eastern projecting stairs, and an unsympathetic security stair built in its place.

**Condition: Poor through lack of use**

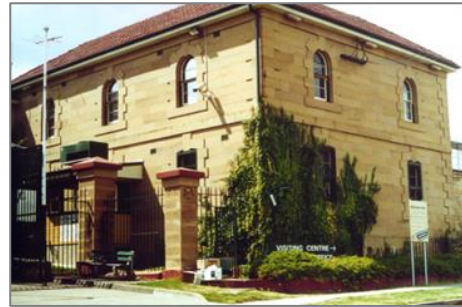
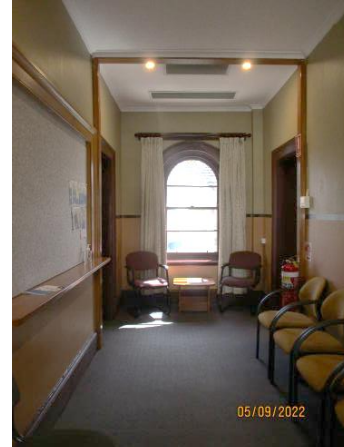
**Building 3 Governor’s Residence**

Three-storey building, including basement, ashlar sandstone with heavily rusticated arched windows and corners, this building projects forward from the compound wall to form a three-sided court with its twin the lieutenant governor’s house and the gatehouse. The chimney has been demolished.

**Condition: Reasonable except for the basement which has rising damp and water ponding in the light well.**

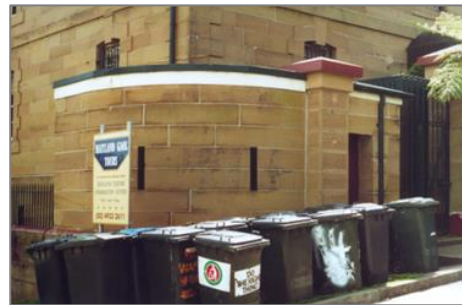
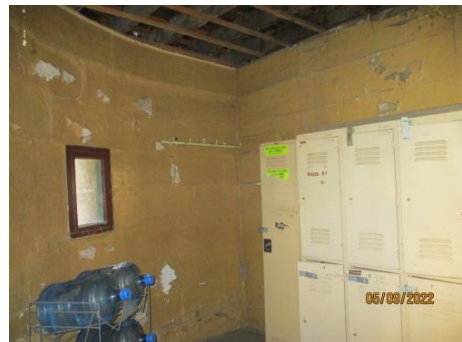
**Building 4 Sentry Box**

Single storey sandstone addition to Building 2 for sentries to guard the main entrance.

**Condition: Reasonable**

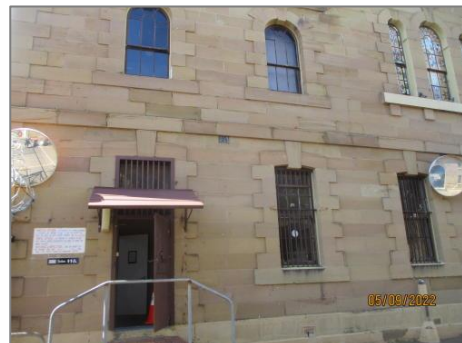
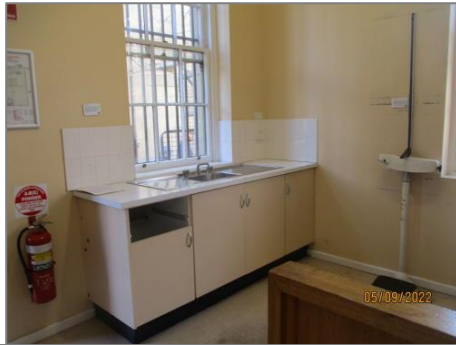
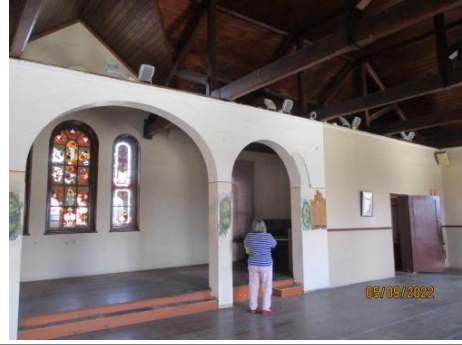
**Building 5 Administration and Former Chapel**

Two-storey building of ashlar sandstone with heavily rusticated arched windows and quoins. The roof is hipped with a central gable, on the gatehouse elevation, over Chapel and Governor’s Office.

The Chapel has large, exposed timber trusses and stained-glass windows.

**Condition: Quite good**

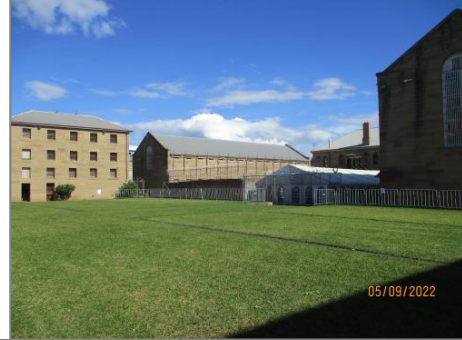
**Building 7 Exercise Field**

**Condition: Good**

This is the site of the demolished female wing and cook house.

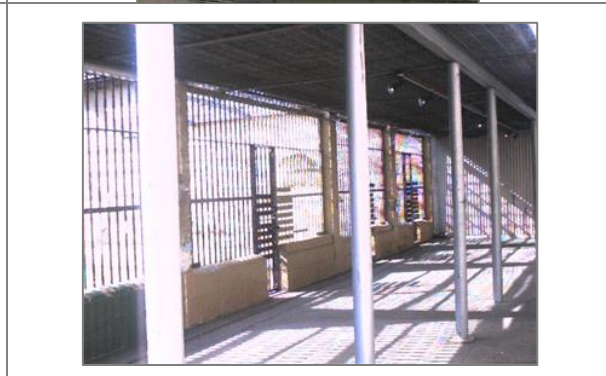
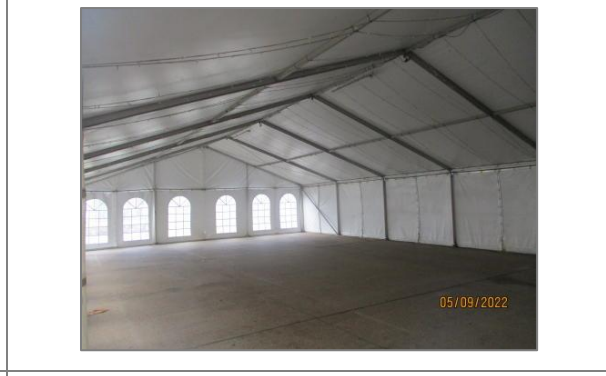
**Buildings 10 and 11 Exercise Yards**

The yards are similar to each other, in that there is a covered area to the rear, a low vaulted grille over the remainder of the roof, and a toilet, shower and basin unit and bench built integral to the walls of the yards.

**Condition: Quite good**

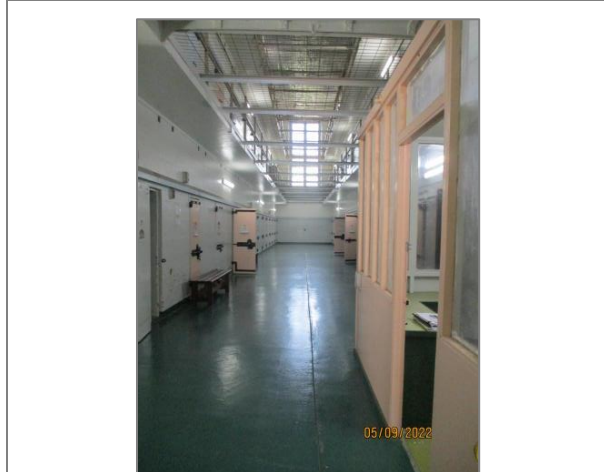
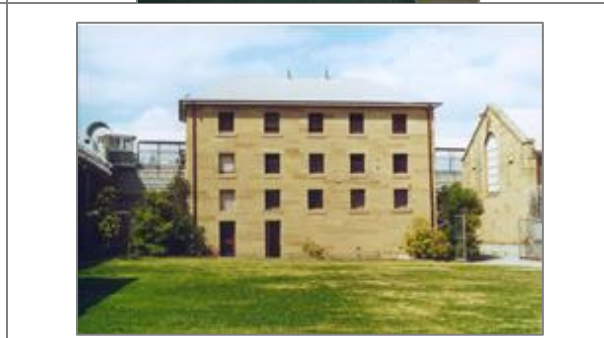
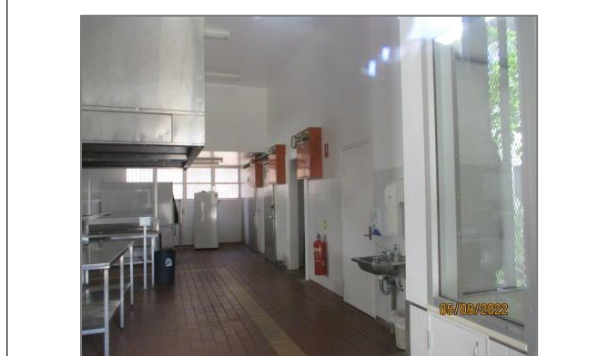
**Building 13 Kitchen**

This is a four-storey sandstone building with kitchen at lower level and cells above.

**Condition: Reasonable**

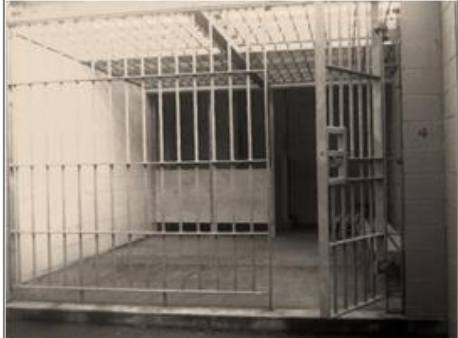
<p><b>Building 17 Yards</b> Four separate yards built during the 1991 upgrade of facilities at the Gaol.  <b>Condition: Reasonable</b></p>

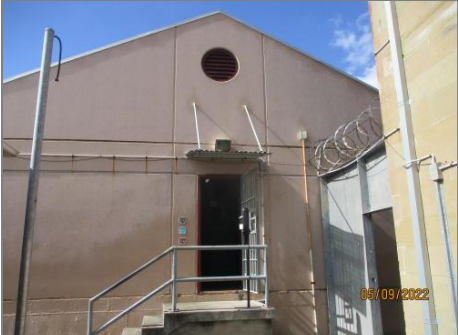
<p><b>Building 18 5 Wing Maximum Security Building</b> This is a relatively modern single storey cell block comprising 22 cells with individual yards.  <b>Condition: Reasonable</b></p>

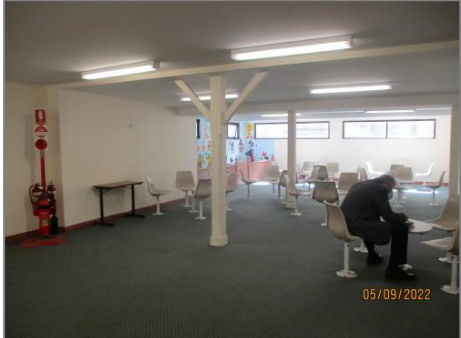
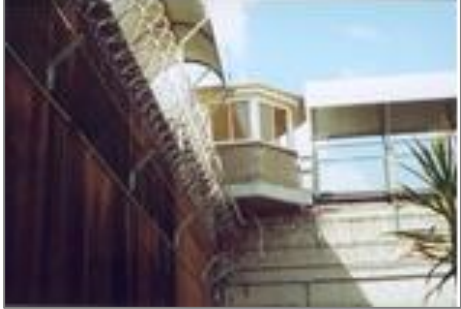
<p><b>Building 21 Prison Walls and Towers</b></p> <p>The perimeter wall of the first compound is rendered sandstone with semi-circular coping. Quadrant capped buttresses were placed on the exterior to keep the interior face of the wall flush and difficult to climb. Access to the three watch towers was from the exterior of the compound.</p> <p><b>Condition: Reasonable</b></p>

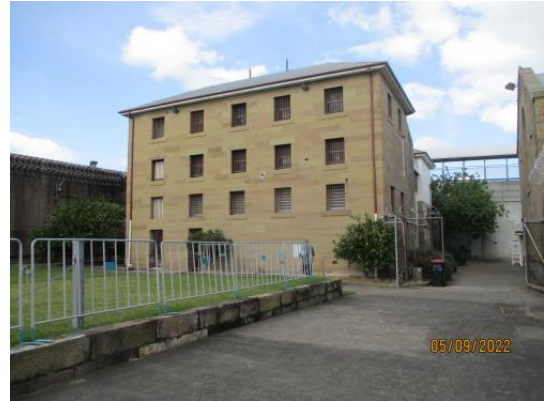
**Figure 18 Kitchen Block. Kitchen block with cells above.**

The forms of the original two buildings are still clearly recognisable when an early drawing is compared with a current photograph (Figure 17 and Figure 18). Asset 013 are still recognisable as can be seen by comparing Figure 17 and Figure 18, however the fabric has been substantially changed in many ways. The buildings have been joined (c.1974)<sup>40</sup>, to create one floor plate on the ground and first floor. The former two storey hospital was Modified to incorporate three Storeys within the existing envelope. Its southeast elevation was substantially demolished in the process.

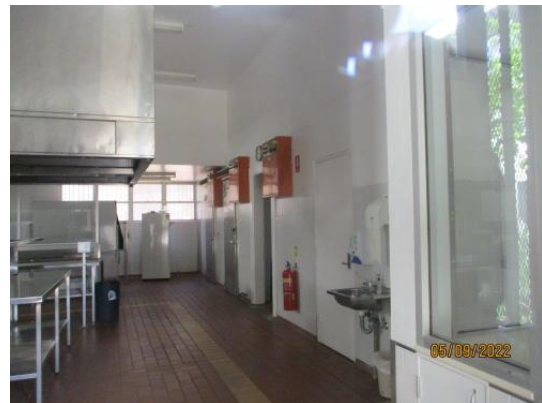
**Figure 19 Kitchen Interior – Ground floor**

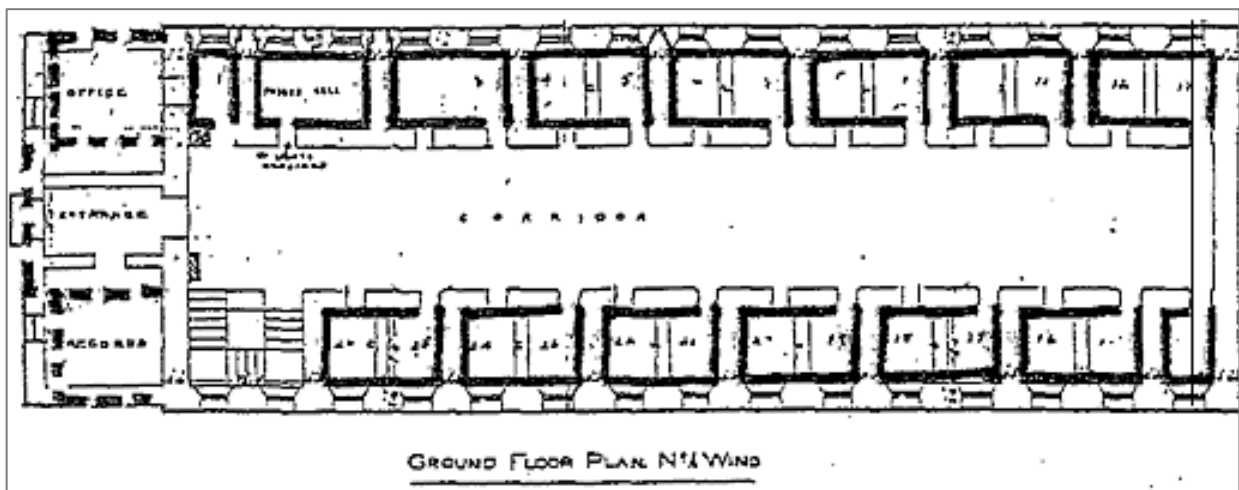
**Figure 21 Ground Floor plan of A Wing. This diagram is based on a 1925 plan with the original cell sizes in bold and the original rooms on the front shown dotted.**

One of the earliest alterations to the gaol was the subdivision of the cells in 'A wing', doubling the number of cells in the wing by reducing their size from 8' x 12' to 5' x 8'. This provided extra single cells in line with the 'separate system' introduced by Harold Maclean in 1867 but it returned inmates to the mean space standards of earlier years. Cells in the new gaols at Bathurst and Goulburn were made the same size as those of the Model Prison at Pentonville, England, i.e., 7' x 13', more than twice the floor area. The first evidence of this change is a plan dated 1899.<sup>42</sup> Figure 20 shows a 1925 ground floor plan of 'A wing' with the 5' x 8' cells with an overlay in bold of the original cell layout.

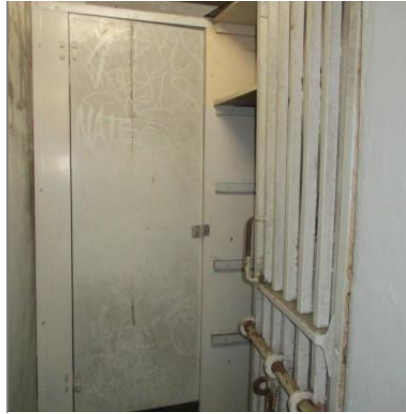
**Figure 22 View from inside a typical A Wing cell without a grille door. There is no rebate in the reveal. This opening was created at the time of doubling the cell numbers.**

The cell doors are built of sheet metal, hinged outwards on the passage side of the cell wall. These doors are probably not original. Every second cell has an iron grille door (opening inwards) indicating the original doorways to the double cells. The detail of the later intermediate doorways (without iron grilles) varies slightly from the original. The later doorway reveal is flush with the internal cell wall (Figure 22). The original doorway has a rebate on the inner face to house the iron grille in the closed position. The rebate creates a 'nib' from the internal cell wall, which is tapered outwards to be wider outside the cell (Figure 23)

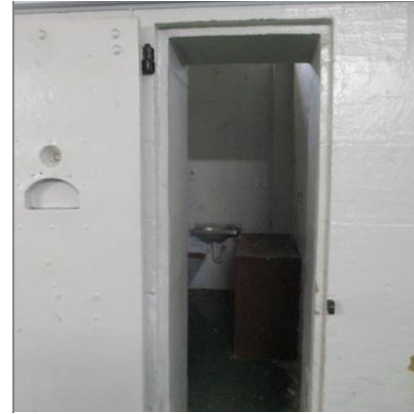
**Figure 23 View from inside a typical A Wing cell with a grille door and a solid door. There is a rebate to house the grille door in the closed position.**

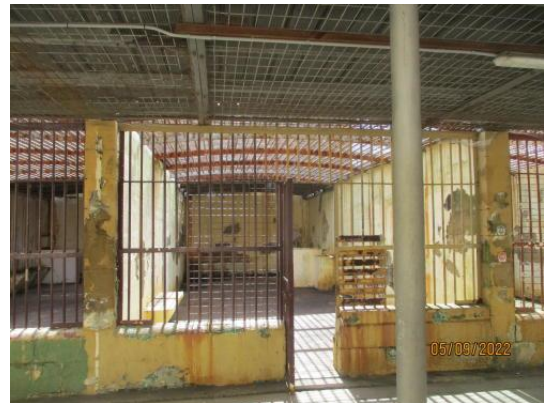
**Figure 27 Interior of a typical yard**

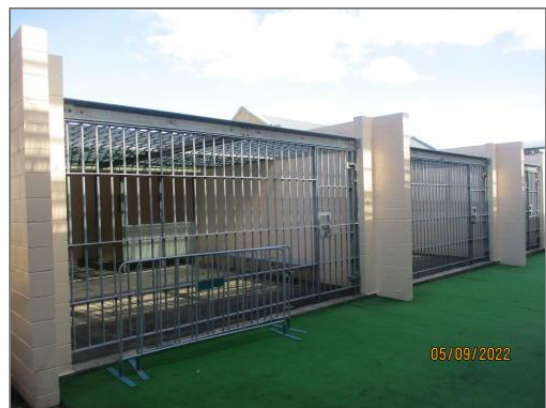
**Figure 29 View of the Eastern Extension. Shows the new Yards in the foreground and the cell block behind.**

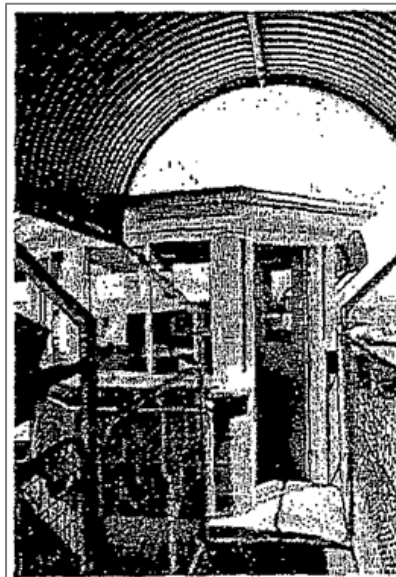
Figure 33 Detail photograph of the same tower as in Figure 32 East tower of central gaol.

The concrete block towers lead to modern catwalks, built in the 1980s, with mesh floors and curved roofs attached to the top of the walls (Figure 33). The 19th century photographs indicate that the original towers were of stone construction and that the walkways originally extended as far as the flat coping stones of the walls (i.e., providing the walking surface), and had iron handrails. The remainder of the wall copings are curved. The original catwalks were extended by an earlier of the current design. This earlier catwalk was also perched over the walls, with a timber floor deck and had no roof.

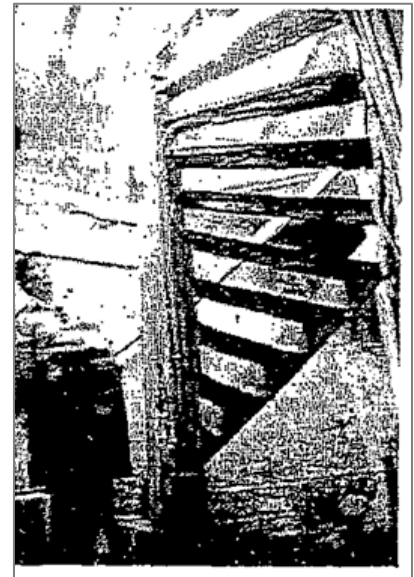
Figure 34 Interior photograph of the early timber stair inside a triangular.

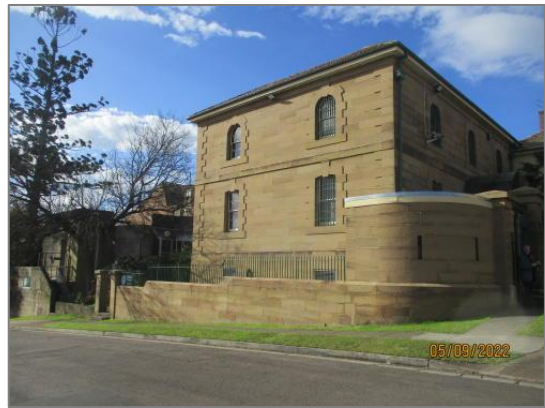
**Figure 40 The c1890 Hoop Pine near the former Deputy Governor's Residence, west of the main entrance to the Gaol.**

As these did not appear in the early photographs, it is assumed that they were not original plantings, but put in a little later, perhaps towards the turn of the century. Although, the one now remaining at the front entrance (there could have been a pair, originally) appears to be in good health, the other two remaining ones are in a poor state; the hoop pine in front of the former Police Station is unfortunately senescent and the Lindesay Street tree was struck by lightning a few years ago and is dead from 4 metres up Their location is shown on a 1990 Survey Plan.<sup>61</sup>

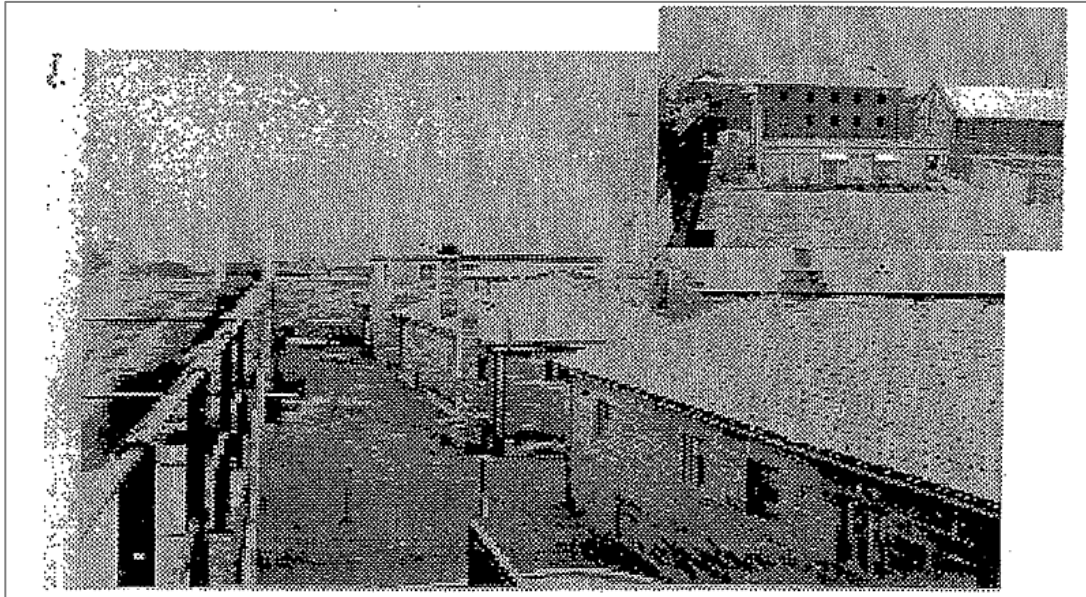
**Figure 42** View from North Tower looking towards Asset No's 013 and 009. This photograph clearly shows the two buildings: the Cookhouse (3) and the Female Surgery/Workroom buildings (4) that were demolished to provide an open area. The Bathroom and Hospital (2) have been modified to create the present Kitchen Block.

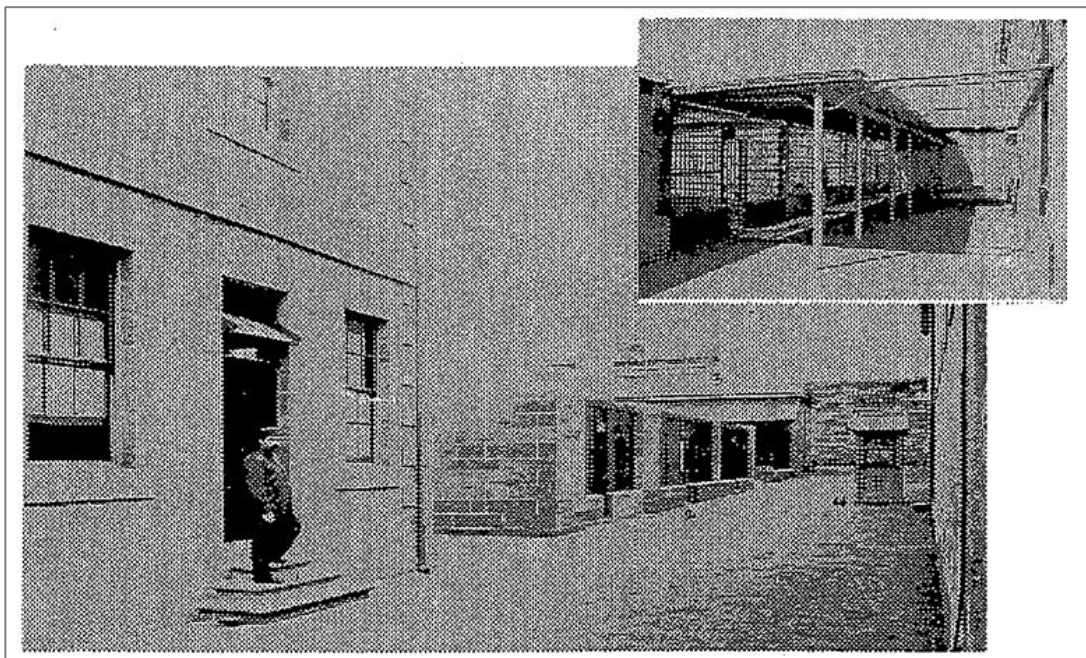
**Figure 43** View looking north-east between Asset No's 005 and 009. This photograph shows an early configuration of the special yards, with the Cookhouse in the background. The wall of the closest yard in the c1897 photograph has been blocked in and an opening created on the north-western side. An infill wall at the end of this space and lightweight shelter-type structures built over this space detract from the appreciation of this area.

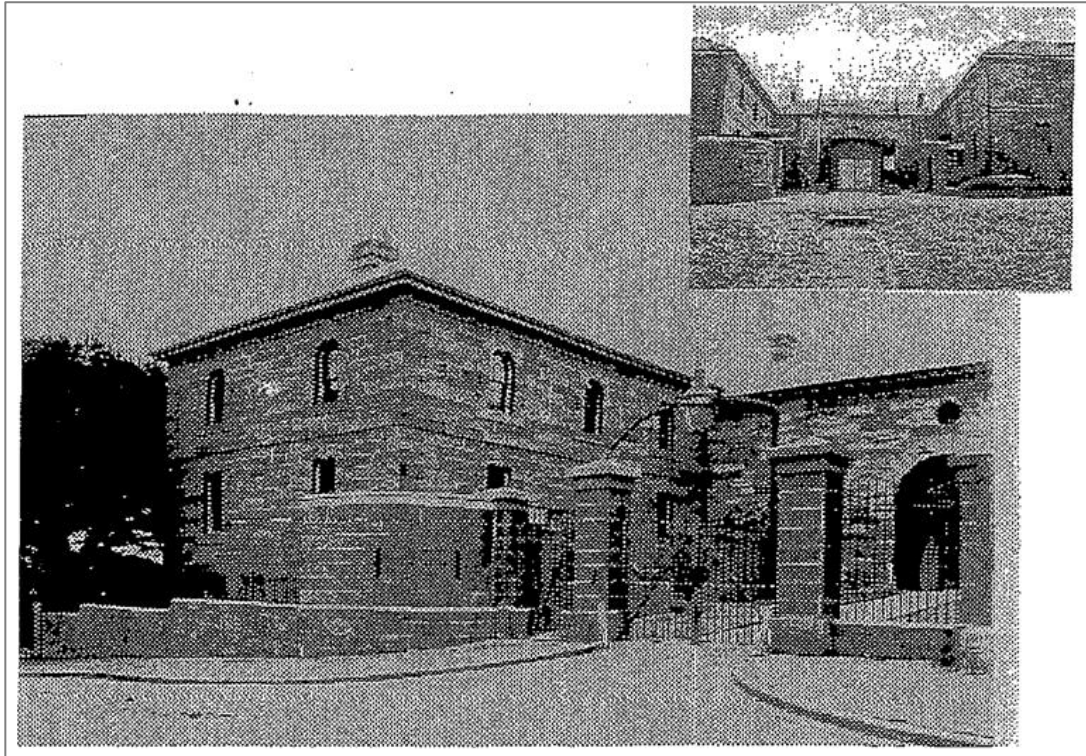
**Figure 48 View looking towards main entry of the gaol complex from John Street. Note the original gateposts with lamp over and current cage canopy concealing main arch of entrance way. The central building has been rendered on the street façade.**

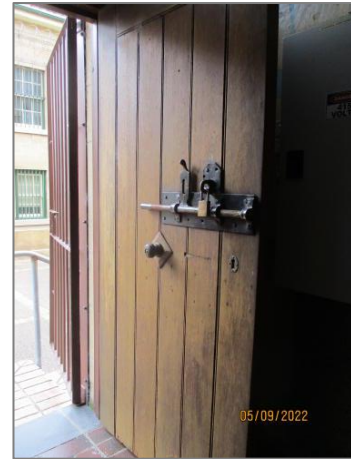
**Figure 53 Typical cell door bolt and lock. This lock is one of the more recent Abloy Lock types.**

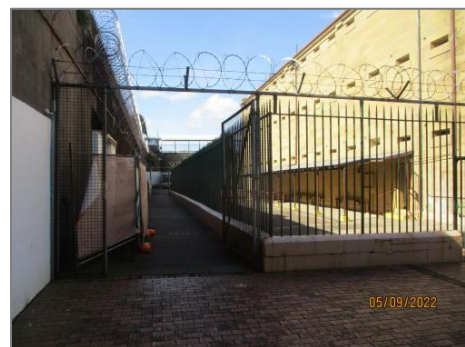
**Figure 55 Typical security fences etc. (Eastern Extension)**

Security measures such as lighting and razor wire are evidence of the current use of the Gaol and may be left in place. The smaller miscellaneous objects and systems associated with the security of the gaol include close circuit TV monitor systems, infra-red beams, razor wire, barbed wire and mirrors.

In summary, it is recommended that some of these elements remain. It is desirable that the fabric which is retained relates to a particular precinct in terms of security and operation of the Gaol, such as the maximum security area of the Eastern Extension.

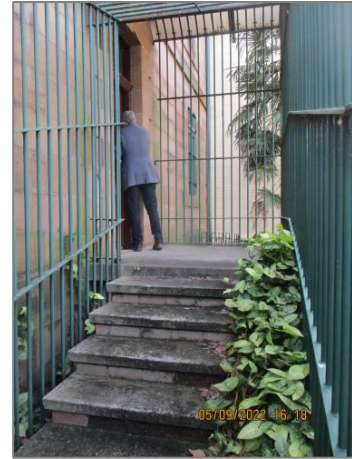
**Figure 56 Detail of modern stair and security bars to Asset No. 002.**

Archival recording should take place before and after removal, and should only be undertaken if removal is followed by positive action to repair any damage to significant fabric and the overall result is to regain lost significance. These elements include the 'pergola' type structures built between 'A wing' and the Special Yards, and entry structures (including paving, security cages and ramps) to both Asset Nos 002 and 003 (refer Figure 56).
