Geotechnical Investigation Report

559 Anambah Road, Gosforth NSW 2320

Prepared for: Thirdi Anambah Pty Ltd c/- Vara Consulting
EP3627.002 29 August 2024

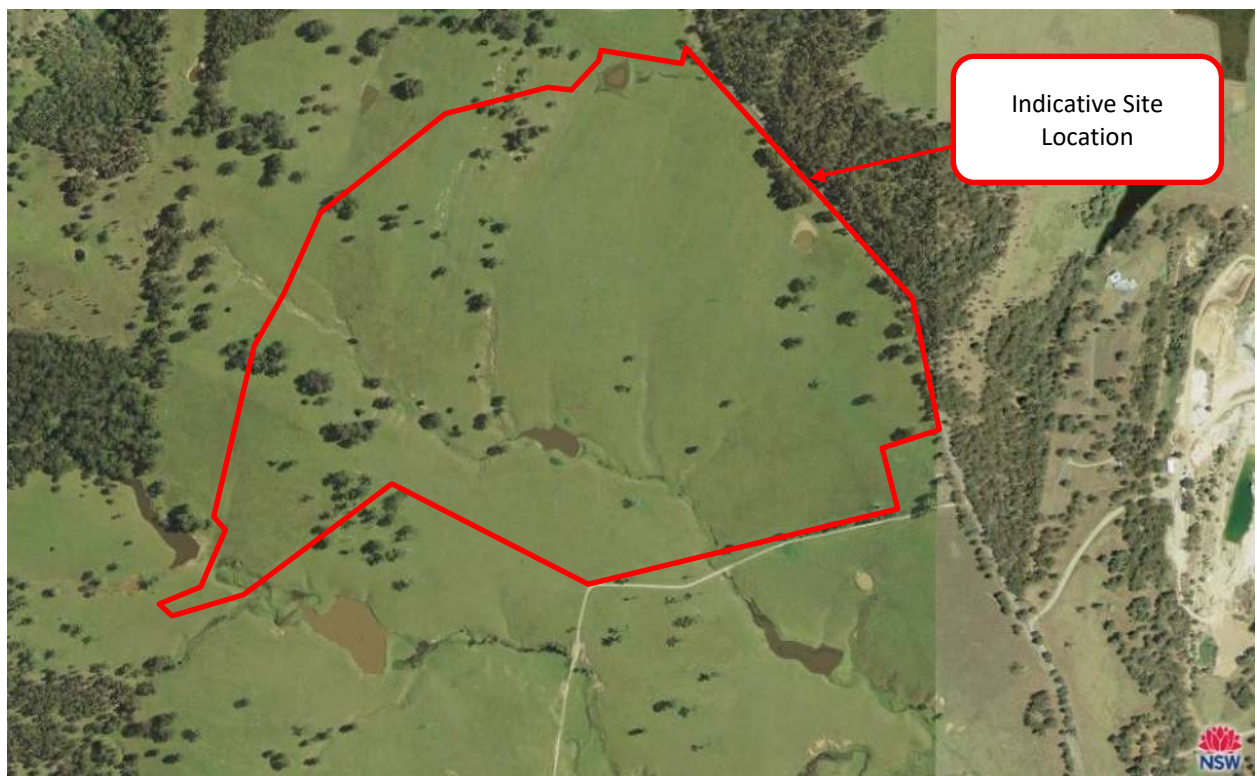
Figure 1. Indicative Site Location

An excerpt from SixMaps showing the indicative location of the site is presented in Figure 1.

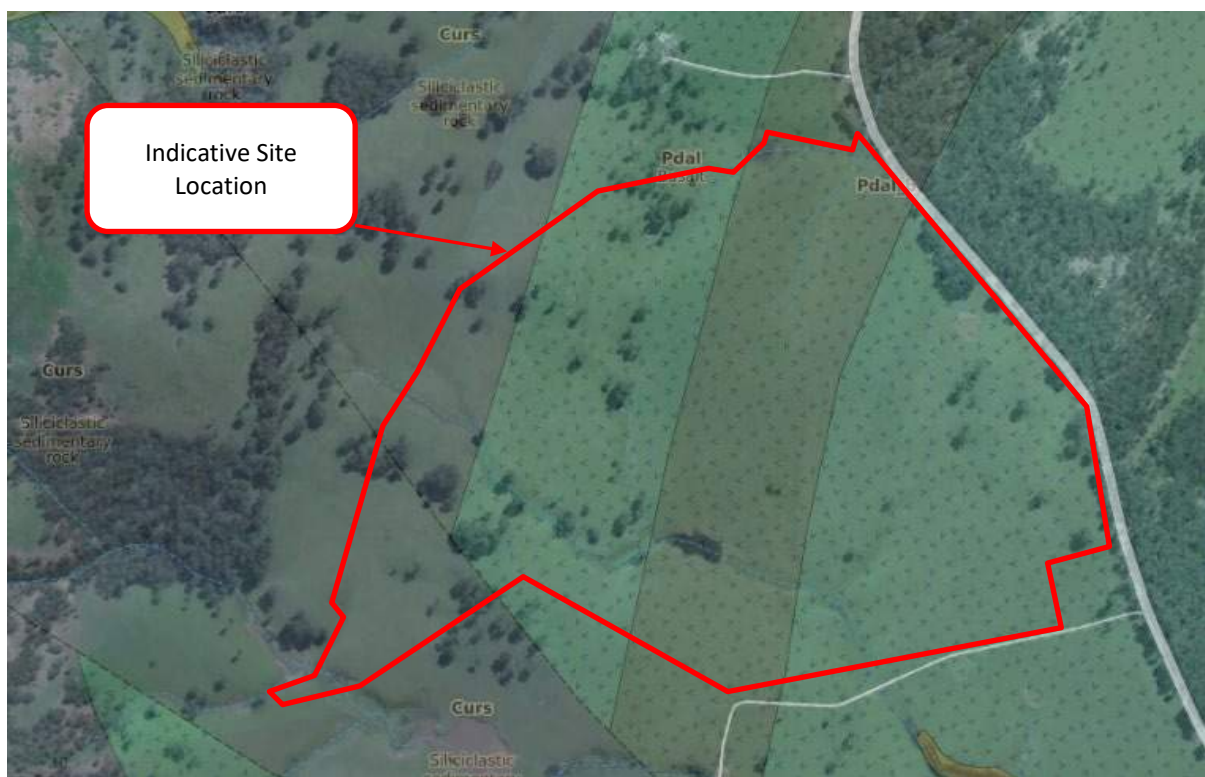
Figure 2. Geological Map Excerpt

- Carboniferous Aged - Seaham Formation (Curs) known to contain tillite, varved siltstone, tuff, red and green zeolitic mudstone with dropstones interbedded in thick-bedded lithic sandstone and conglomerate.
- Permian Aged - Lochinvar Formation (Pdal and Pdal_b) containing basalt, siltstone, sandstone.

An excerpt of the geological map is shown in Figure 2.

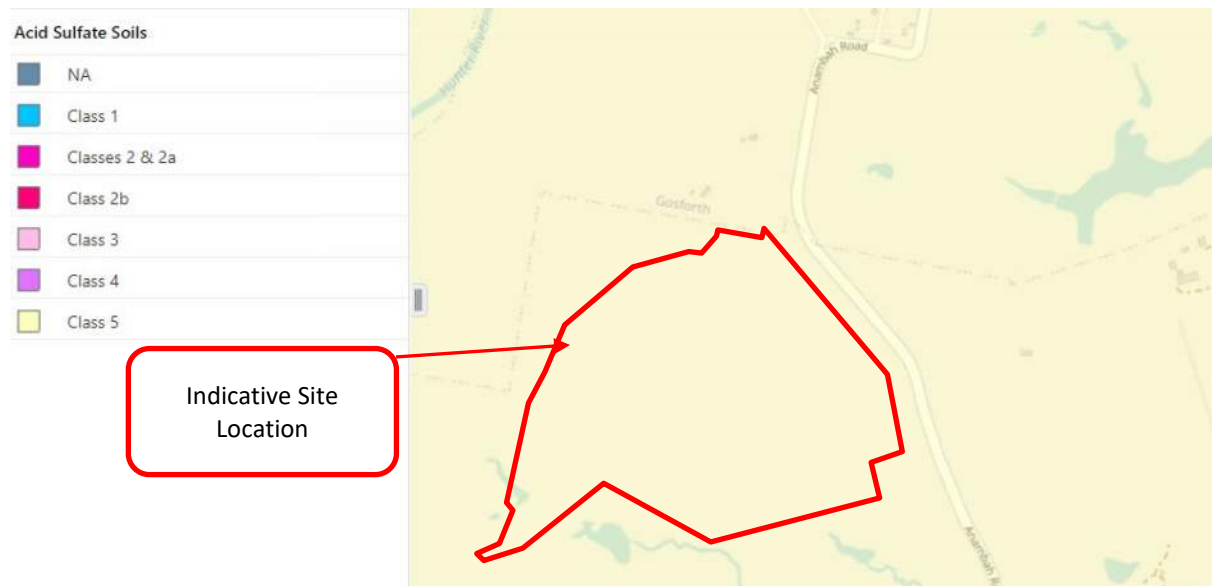
Figure 3. Acid Sulphate Soil Map Extract

The NSW Government data available on www.geo.seed.nsw.gov.au indicates the site is located within Class 5 acid sulphate soil classification. Acid sulfate soils are not typically found in Class 5 areas. Areas classified as Class 5 are located within 500 metres on adjacent class 1,2,3 or 4 land. An extract of the acid sulphate soil map is shown in Figure 3.

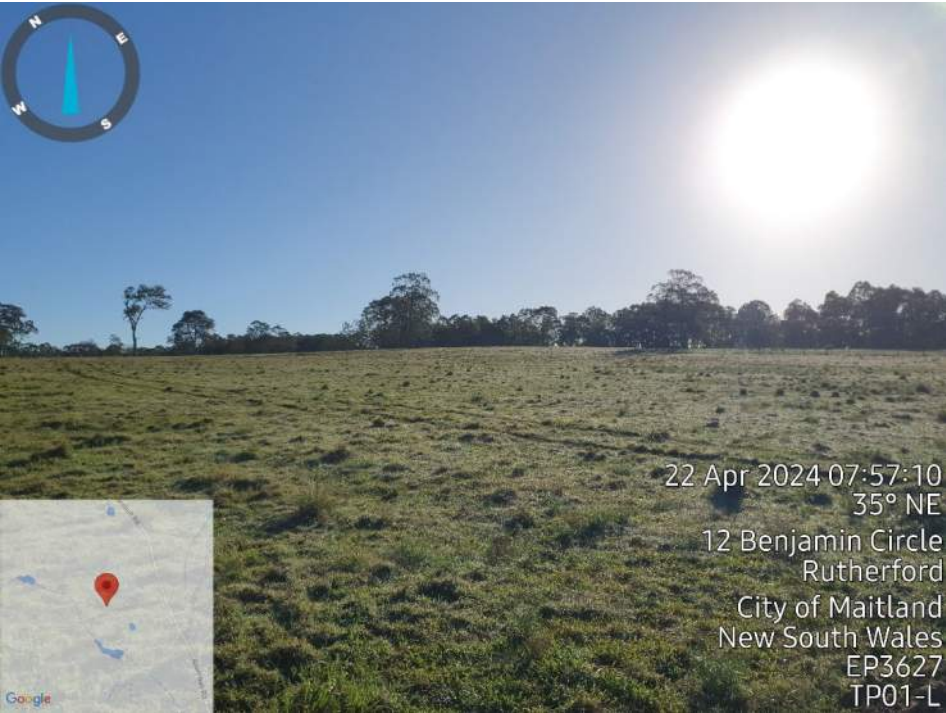
<p>22 Apr 2024 07:57:10 35° NE 12 Benjamin Circle Rutherford City of Maitland New South Wales EP3627 TP01-L</p>	<p>Plate 2</p> <p>Description:</p> <p>The site facing north-east.</p> <p>Date:</p> <p>22.04.24</p>

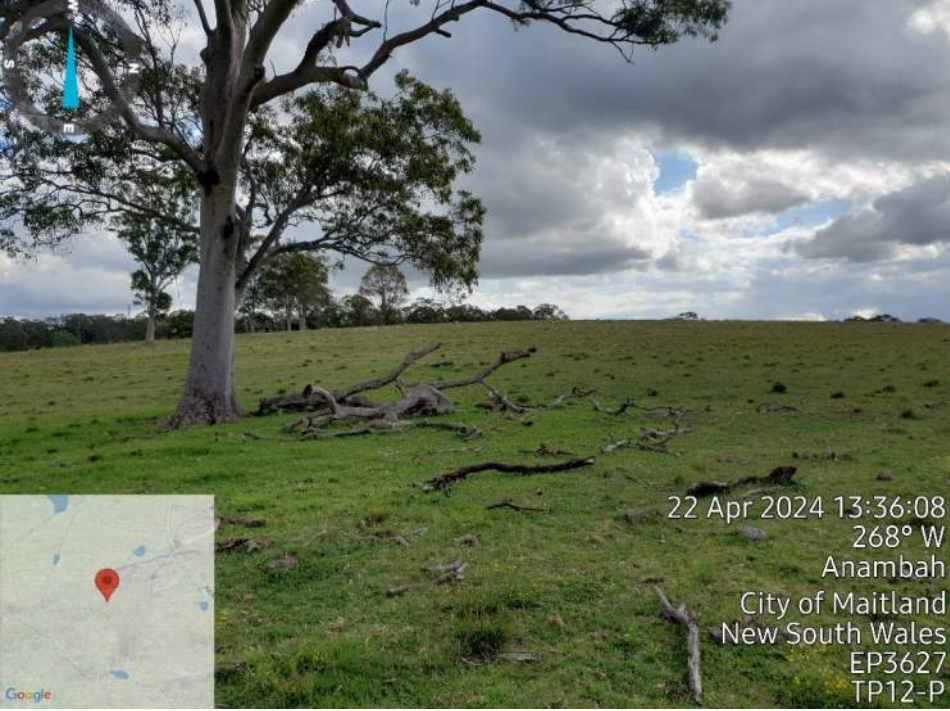
<p>22 Apr 2024 13:36:08 268° W Anambah City of Maitland New South Wales EP3627 TP12-P</p>	<p>Plate 6</p> <p>Description:</p> <p>Looking west from the TP12-P location.</p> <p>Date:</p> <p>22.04.24</p>

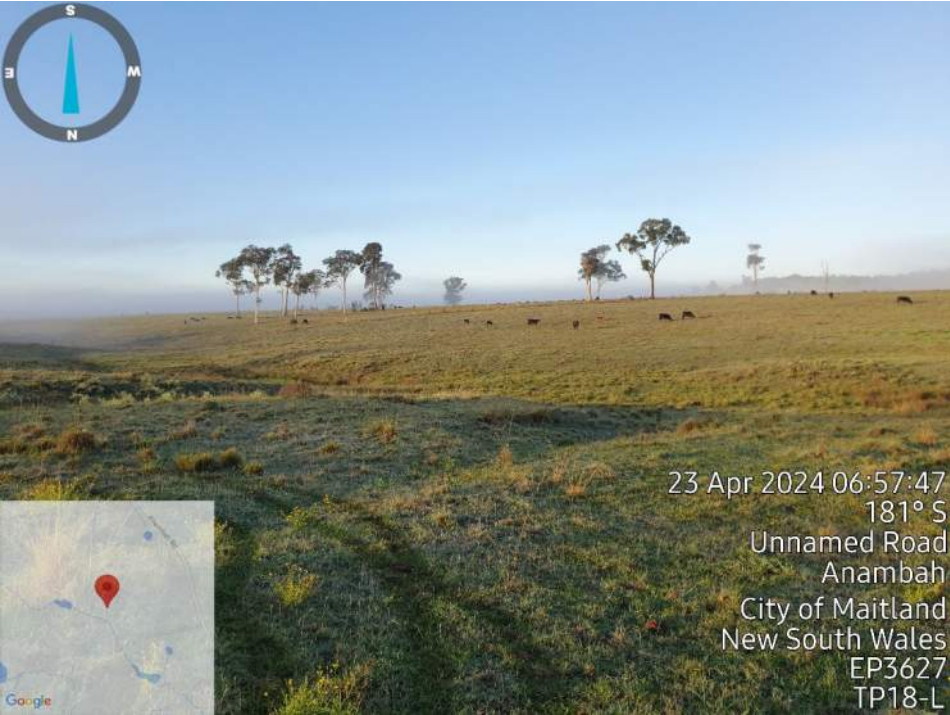
<p>Plate 7</p> <p>Description:</p> <p>The site facing south.</p> <p>Date:</p> <p>23.04.24</p>

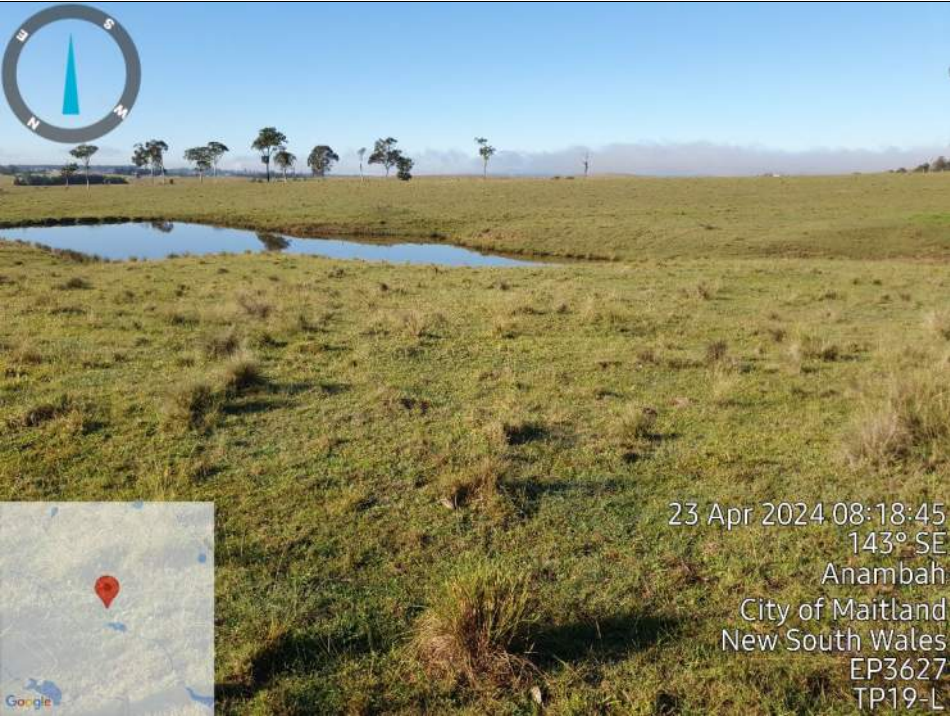
<p>Plate 8</p> <p>Description:</p> <p>Water dam close to</p> <p>TP19-L</p> <p>Date:</p> <p>23.04.24</p>

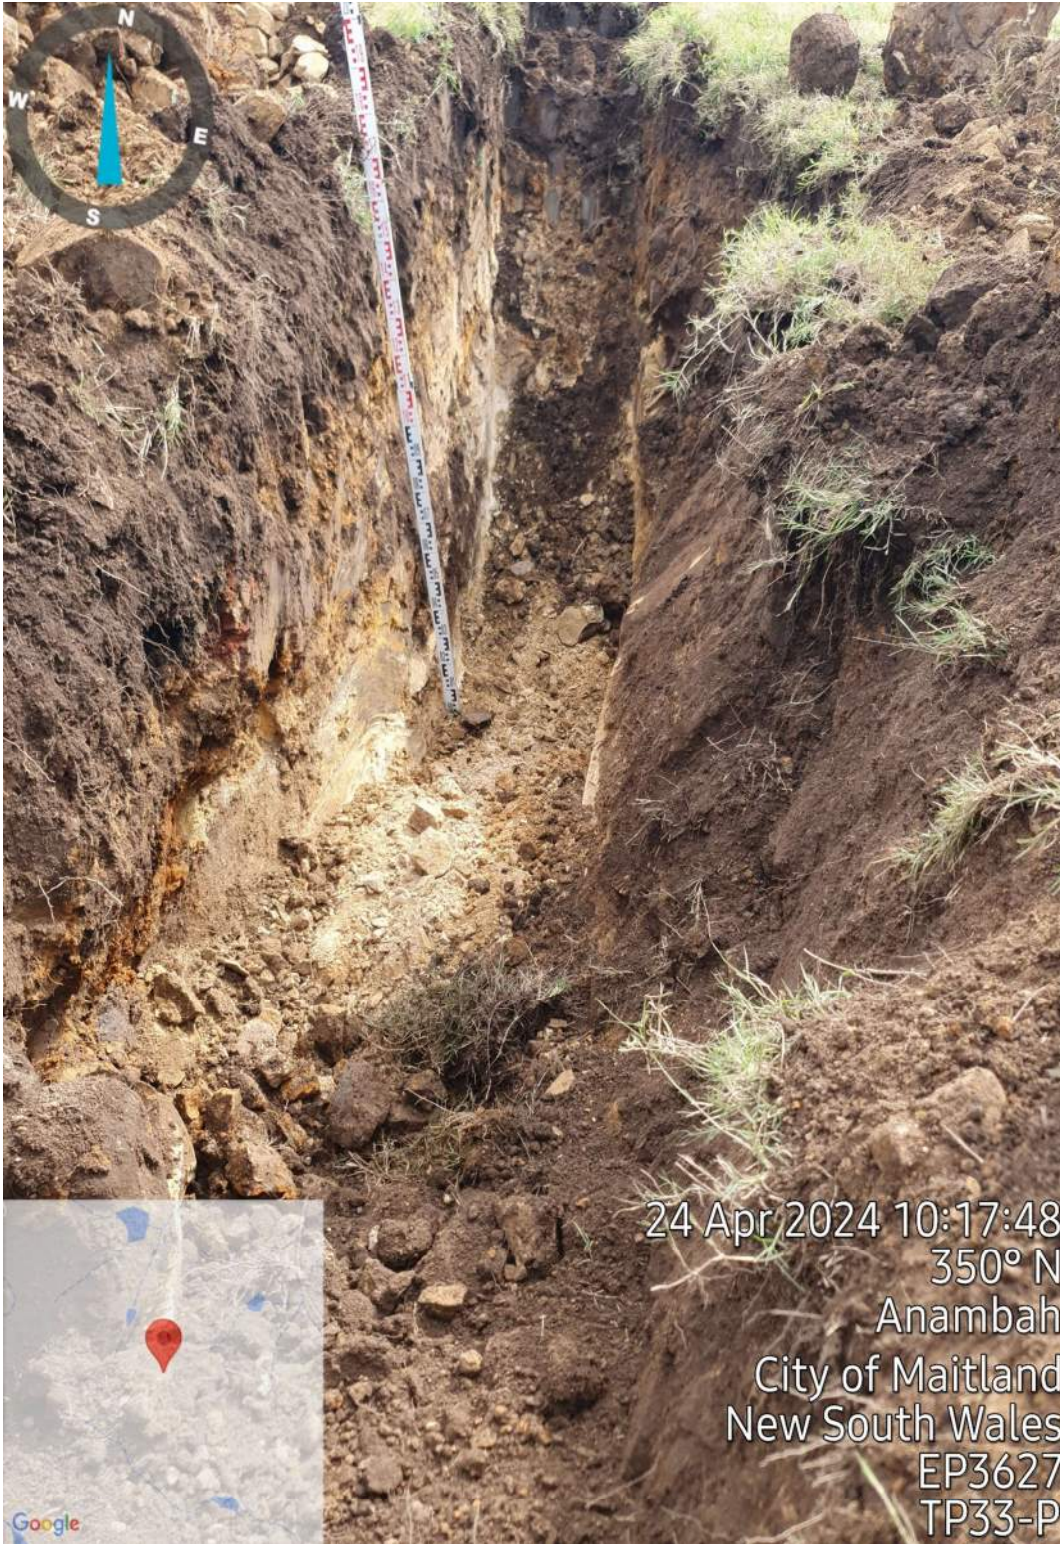
EXCAVATION		MATERIAL DESCRIPTION				TESTING, SAMPLING & OTHER INFORMATION						
Method	Water	RL (m)	Depth (m)	Graphic Log	Classification	Description of Soil (soil type: plasticity/grainsize, colour and other components)	Moisture Condition	Consistency	Tests DCP Results (blows/ 100mm)	Samples	Additional Comments (material origin, pocket penetrometer values, investigation observations)	
E		57	1		CL-CI	TOPSOIL: Silty CLAY: low to medium plasticity, dark grey	~PL	F to St	2	B	TOPSOIL	
					CI-CH	Sandy CLAY: medium to high plasticity, grey, brown, fine to medium grained sand	~PL to >PL		2		RESIDUAL SOIL	
					SC	Extremely weathered Sandstone recovered as Clayey SAND, fine to coarse grained, brown, grey	D		VD		5	DCP:-HB
											EXTREMELY WEATHERED ROCK	
R						Test Pit TP33-P Terminated at 1.80 m				Refusal

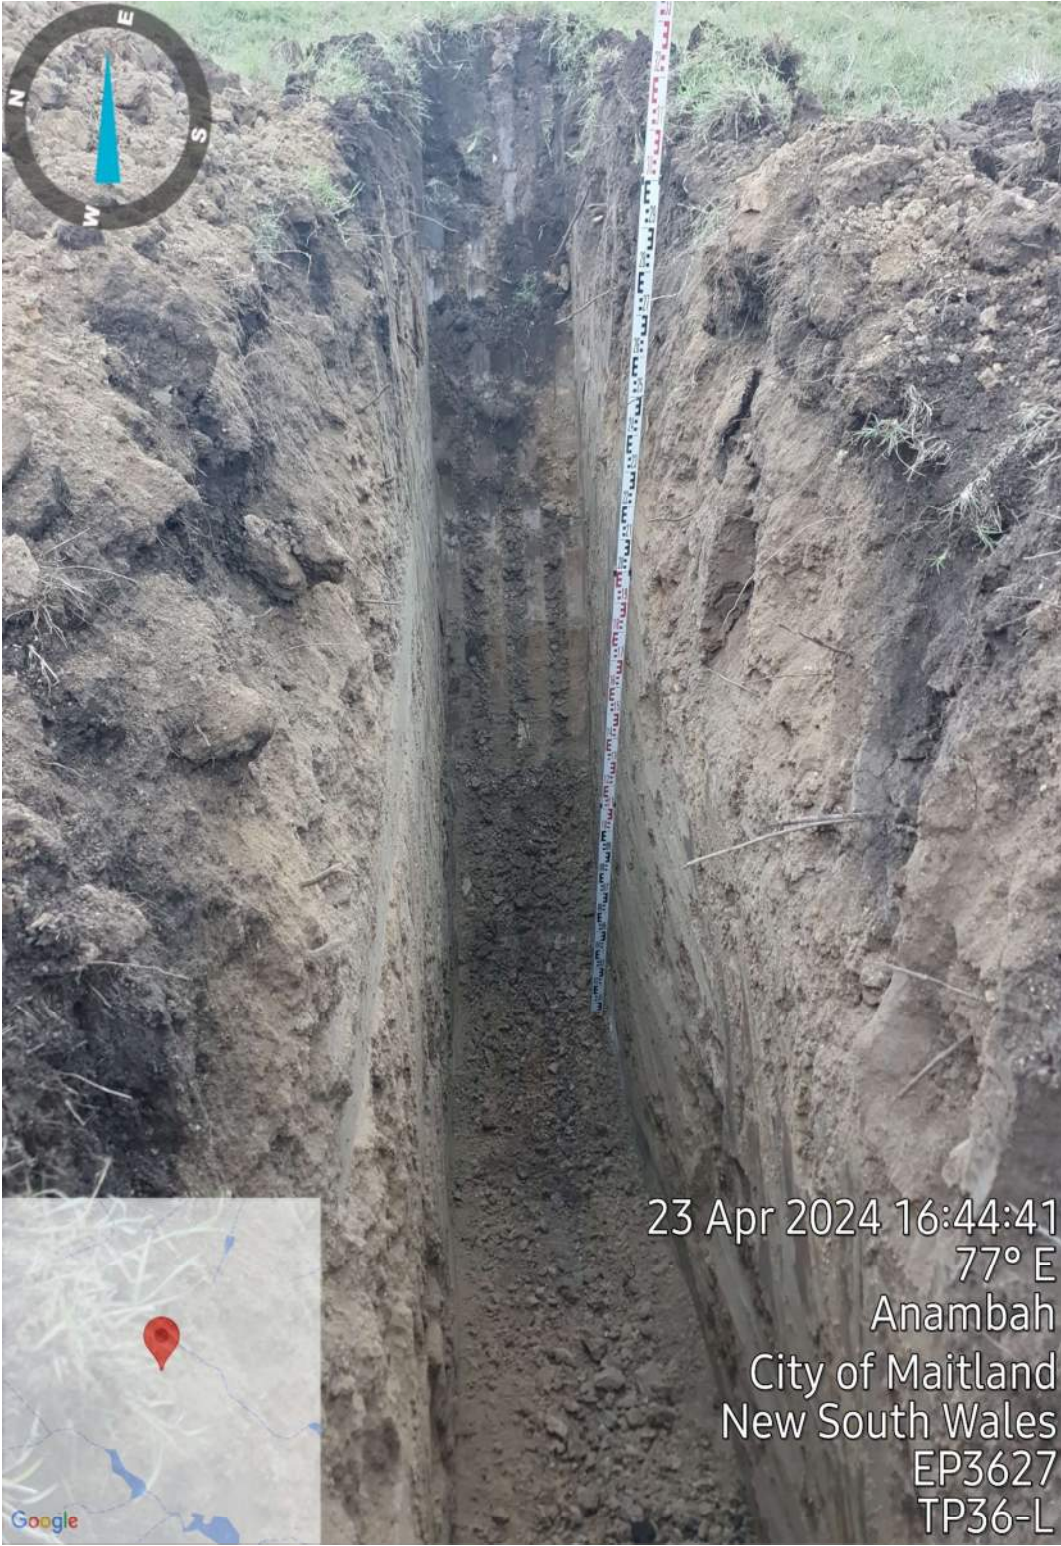
Samples		B				Additional Comments		TOPSOIL			
Classification		CI-CH				Description of Soil		Extremely weathered Sandstone recovered as Sandy CLAY, medium to high plasticity, brown, fine to coarse grained sand			
Moisture Condition		<PL				Consistency		H			
Tests		15				DCP Results		blows/100mm			
Samples		B				Additional Comments		RESIDUAL SOIL			
Classification		CI-CH				Description of Soil		Extremely weathered Sandstone recovered as Sandy CLAY, medium to high plasticity, brown, fine to coarse grained sand			
Moisture Condition		<PL				Consistency		H			
Tests		15				DCP Results		blows/100mm			
Samples		B				Additional Comments		EXTREMELY WEATHERED ROCK DCP:-HB			
Remarks:											
Test Pit TP36-L Terminated at 3.00 m											
Target depth

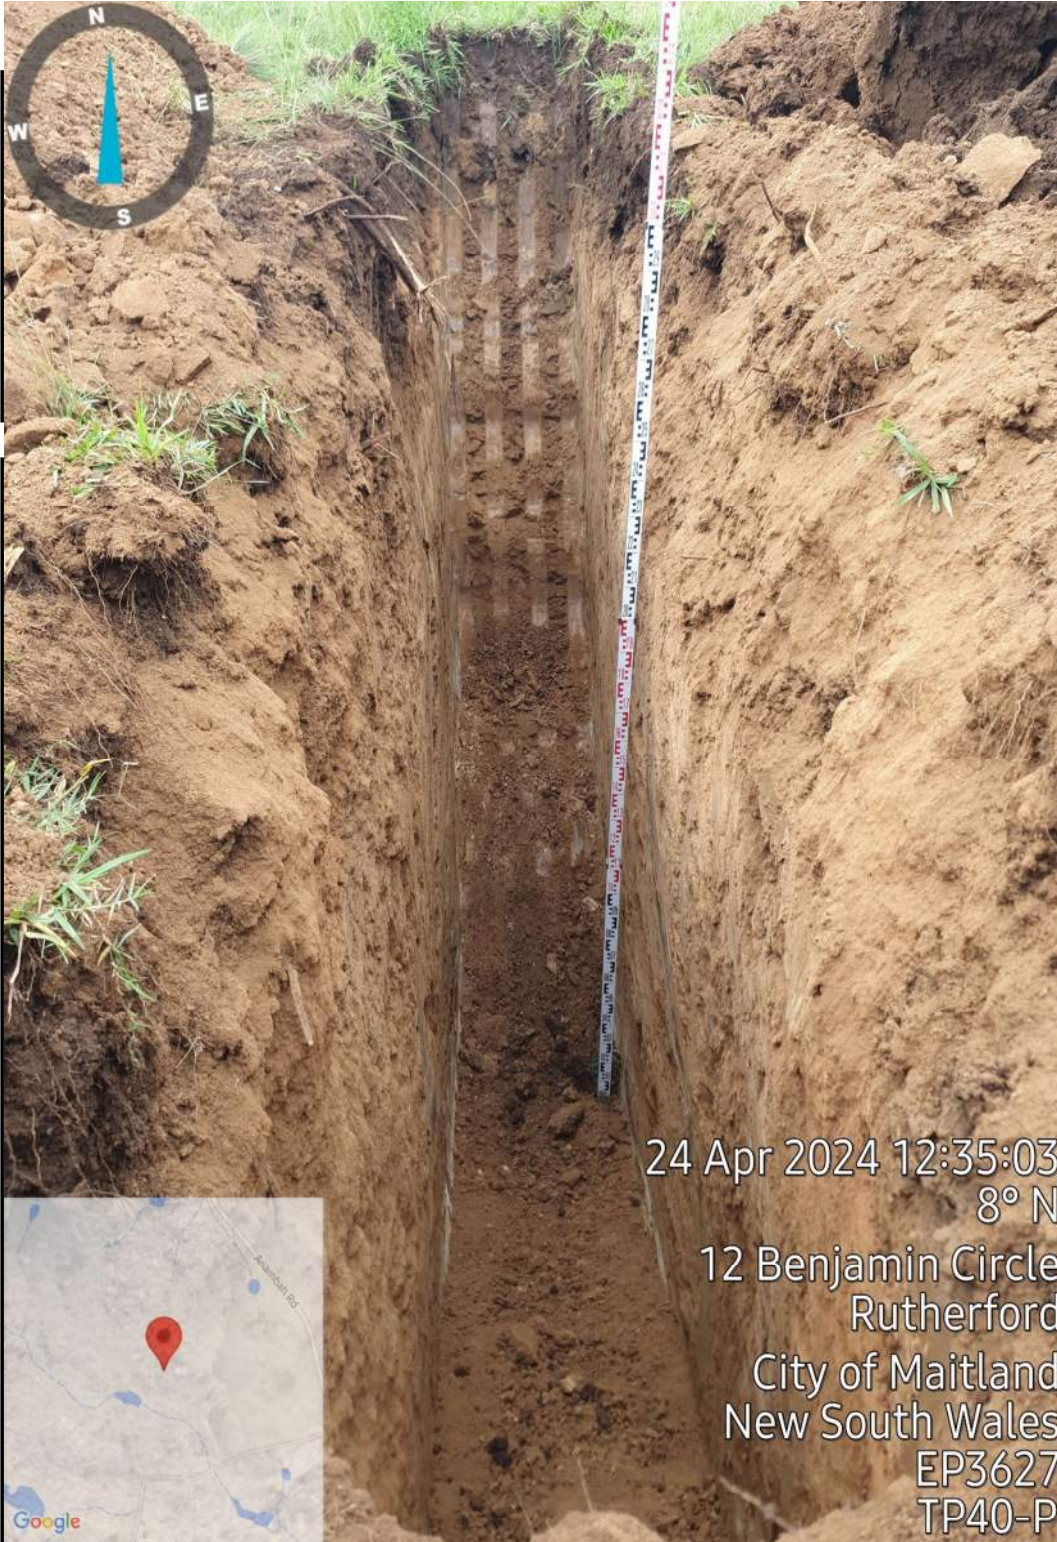
EXCAVATION		MATERIAL DESCRIPTION				TESTING, SAMPLING & OTHER INFORMATION						
Method	Water	RL (m)	Depth (m)	Graphic Log	Classification	Description of Soil (soil type: plasticity/grainsize, colour and other components)	Moisture Condition	Consistency	Tests DCP Results (blows/ 100mm)	Samples	Additional Comments (material origin, pocket penetrometer values, investigation observations)	
E		32	1		CL-CI	TOPSOIL: Silty CLAY: low to medium plasticity, dark grey	~PL		2	D	TOPSOIL	
												2
					CI-CH	Silty CLAY: medium to high plasticity, brown, yellow	~PL	F to St	2		RESIDUAL SOIL	
									2			
									3			
					SC	Extremely weathered Sandstone recovered as Clayey SAND, fine to coarse grained, dark brown with fine to coarse grained, subangular gravel			7		EXTREMELY WEATHERED ROCK	
									7			
									7			
									10			
									12			
									9			
									10			
				10	DCP-:/50mm HB							
		31	2				M to D	VD

30	3			Test Pit TP40-P Terminated at 3.00 m					Target depth	
		29	4

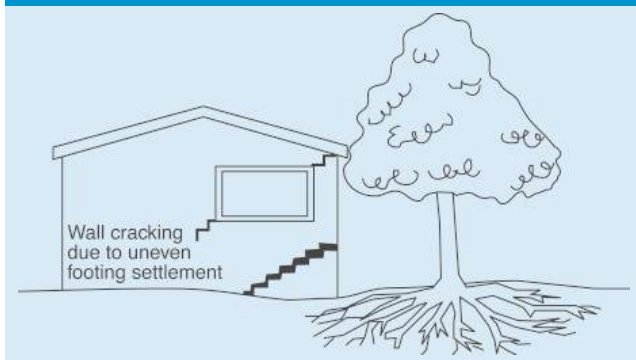
As the weather pattern changes and the soil begins to dry out, the external footings will be first affected, beginning with the locations where the sun's effect is strongest. This has the effect of lowering the external footings. The doming is accentuated and cracking reduces or disappears where it occurred because of dishing, but other cracks open up. The roof lines may become convex.
