Proposed Subdivision -
Preliminary Geotechnical
Assessment

20 & 20A Cantwell Road,
Lochinvar

NEW24P-0120-AB
29 July 2024

**RE: PROPOSED SUBDIVISION
20 & 20A CANTWELL ROAD, LOCHINVAR
PRELIMINARY GEOTECHNICAL ASSESSMENT**

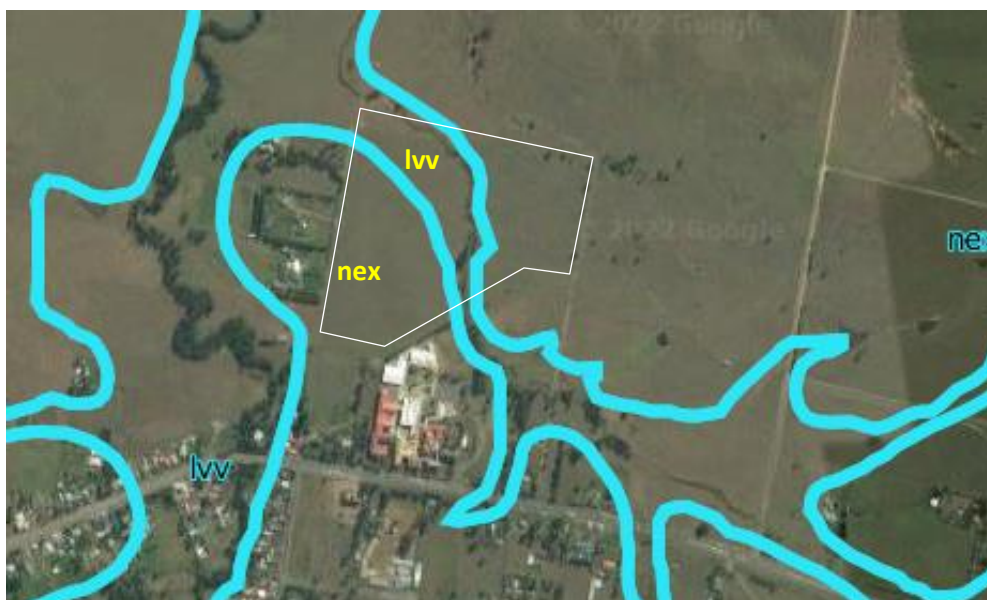
Figure 1: Soil Landscape Map Overlay: Soil landscape units are labelled in yellow text. Approximate site boundary shown in white.

The south-western and north-eastern areas (majority of the site) are mapped as the North Eelah Landscape (nex), and typical qualities and limitations include the following: localised shallow soils, localised rock outcrop hazard, widespread foundation hazard, widespread productive arable land, widespread recharge zone, localised gully erosion hazard, widespread sheet erosion hazard, localised high run-on, localised seasonal waterlogging.

The middle area is mapped as the Lovedale Landscape (lvv), and typical qualities and limitations include the following: localised non-cohesive soils, widespread foundation hazard, localised discharge zone, localised salinity hazard, localised gully erosion hazard, widespread sheet erosion hazard, localised streambank erosion hazard, widespread high run-on, widespread poor drainage, localised permanent waterlogging, localised seasonal waterlogging, localised flood hazard.

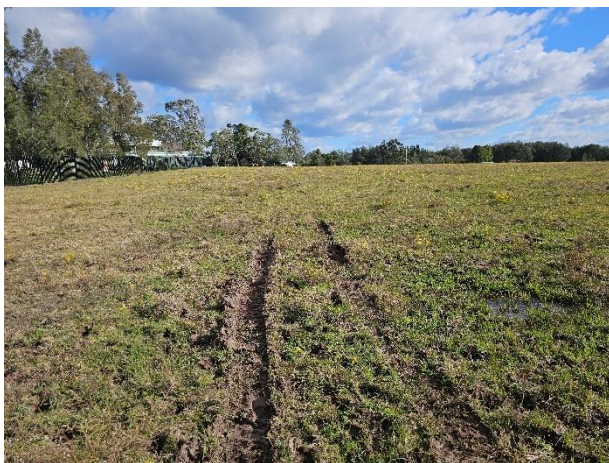
The majority of the site was judged to have fair to poor trafficability by way of 4WD vehicle on the day of the field investigation. Much of the site was observed to have wet boggy / moisture affected ground surface, with multiple small areas of ponded water, (noting the fieldwork was conducted following a recent period of wet weather / rainfall in the month prior).

Photograph 7: Facing southwest from near TPQ12. Showing Excavator tracks formed within area of soft / moisture affected ground surface, localised ponded water.

- The presence of wet / boggy areas in parts of the site, as well as a watercourse, drainage depressions, and areas of ponded water. Although the wet/boggy areas appeared to be generally related to recent wet weather, and the residual soils logged at the test locations were generally of stiff or better consistency, these may include areas or layers of inadequate bearing capacity for support of footings / earthworks and construction plant. There is also potential for abnormal moisture conditions associated with prolonged wet conditions. Measures such as drainage improvements and localised over-excavation, deepened footings, subgrade treatment or bridging layers may be required.

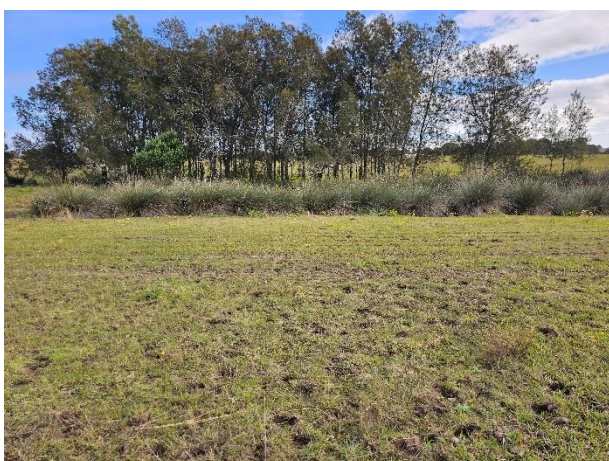
Photograph 13: Facing west from near TPQ18, towards existing Lochinvar Creek.

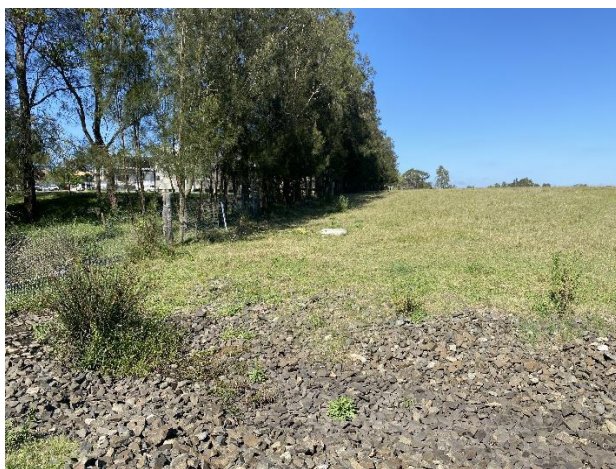
Photograph 17: Facing southwest from beside southern boundary of the site. Showing ballast crossing area within Lochinvar Creek.

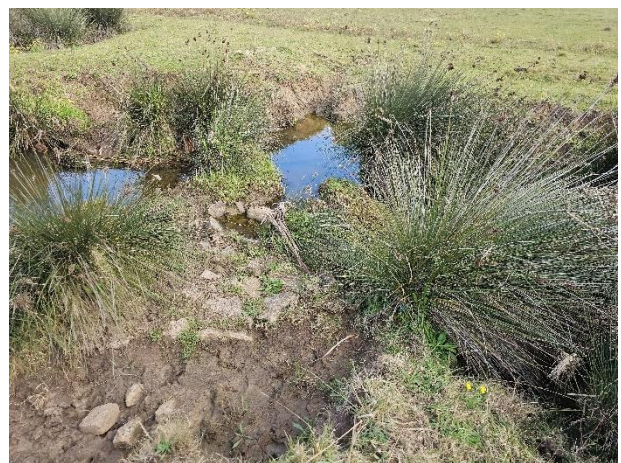
Observed development was generally limited to wire fencing generally located around the lot boundary. Some concrete and bricks were observed in the central portion of Lochinvar Creek (in the vicinity of TPQ14), likely used for a former stock crossing. A ballast rock crossing was observed in southern portion of Lochinvar Creek, likely used for erosion protection and vehicle crossing.

Photograph 18: Facing west from near TPQ14, within central part of site. Showing a localised area with existing building rubble, generally comprising of concrete blocks within the base of Lochinvar Creek.

- The presence or possible presence of localised areas of uncontrolled fill. Residential footings and pavements should be founded in suitable material beneath all uncontrolled fill, or the fill should be removed and replaced under engineering supervision.

Footings should not be founded within any existing uncontrolled fill. If uncontrolled fill is encountered, this will require piered foundations founded beneath the fill, removal of the fill, or removal and replacement of the fill to engineering specification.
