PRELIMINARY (ENVIRONMENTAL) SITE INVESTIGATION

PROPOSED SERVICE STATION

**71 TURTON STREET
METFORD, NSW, 2323**

Lots 418 & 419, DP 41113

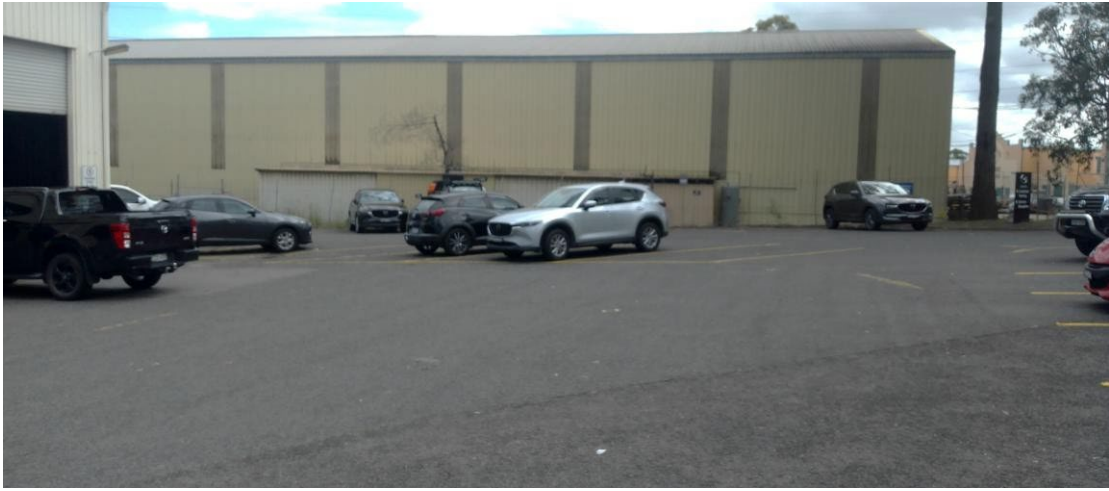
- Customer vehicle parking was located on the asphalt area on the eastern portion of the site and vehicles being repaired were stored on the northern boundary and in the rear western portion of the site.

Eastern customer vehicle parking area

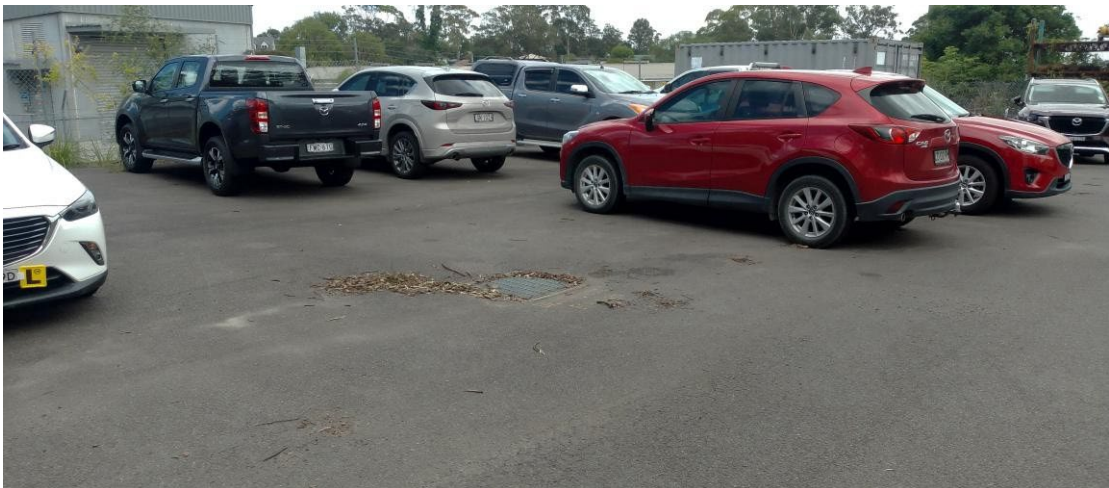
Rear western area used for vehicle storage

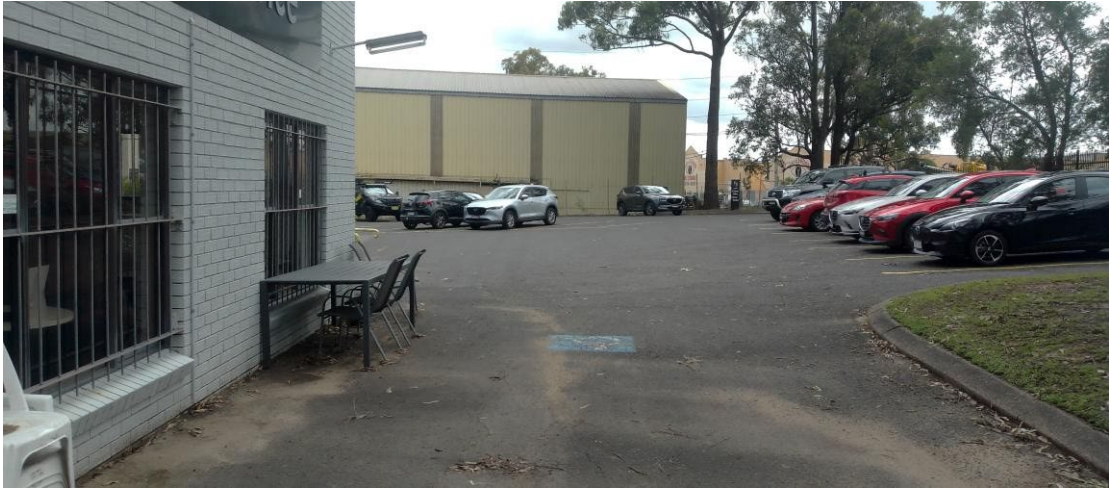
Eastern parking area with office on left

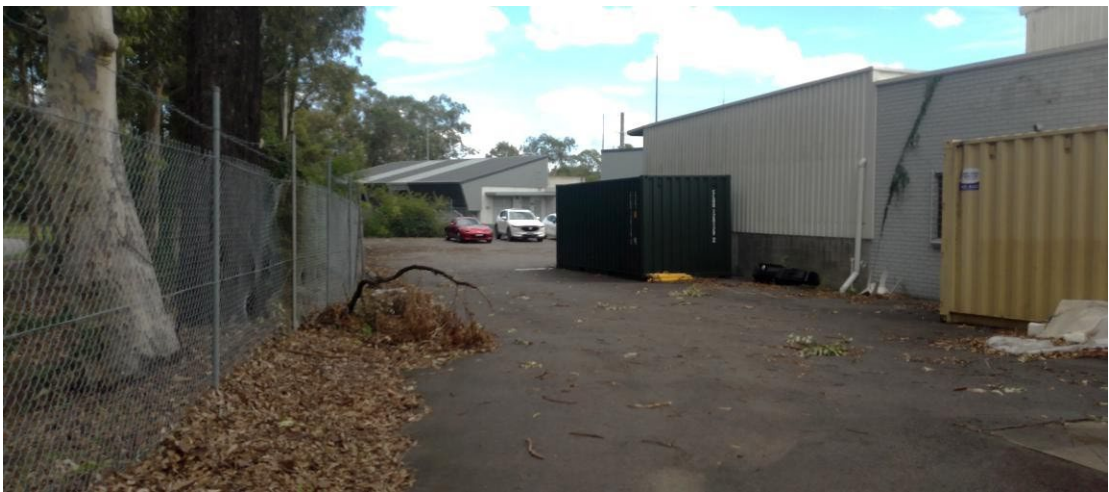
- The majority of the site was sealed with hardstand material in the form of concrete building foundations and internal pavements with asphalt external pavements. The areas upslope and adjacent to the southern and eastern boundaries are the only areas not sealed as seen on the attached photographs. Stormwater exited the site via roof gutters and a system of pits and pipes;

Area adjacent to southern boundary

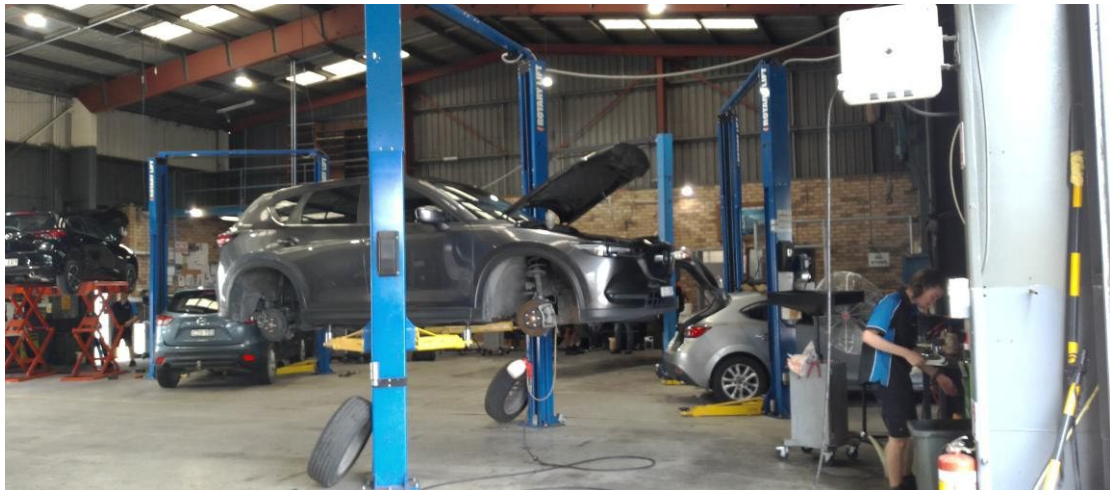
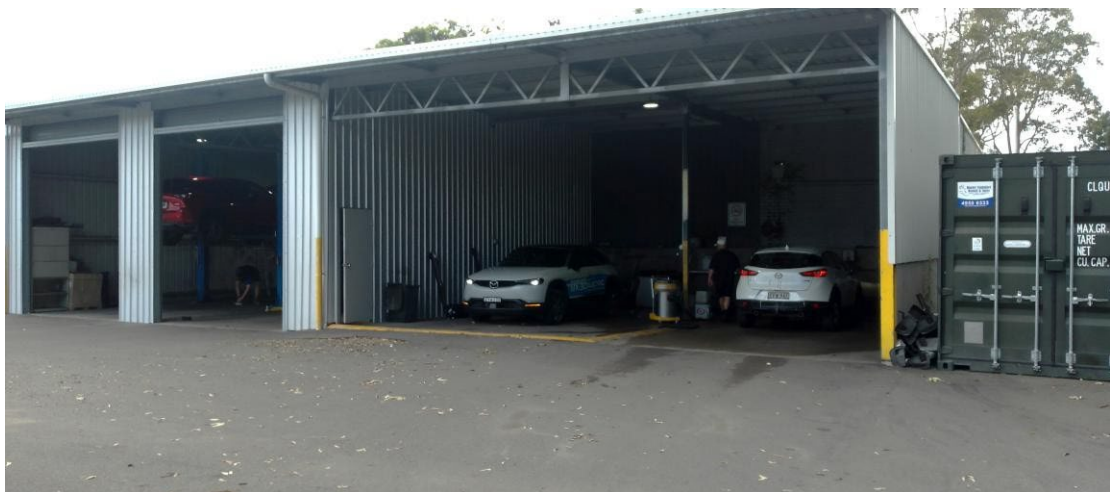
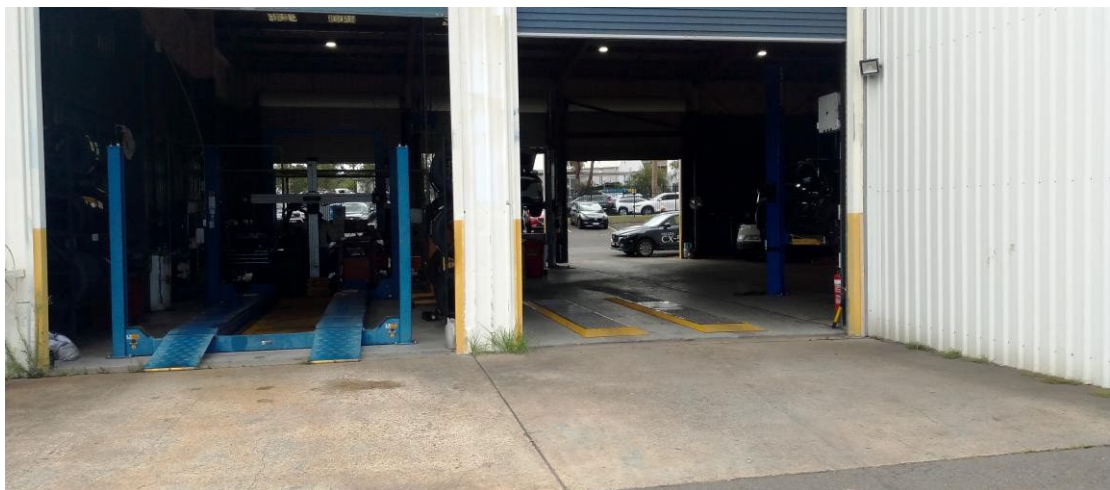
- Mechanics service and repair workshop in the centre portion of the site comprising an office area in the southern portion of the building, workshop area in the centre portion and wash bays at the rear western portion of the building;

Vehicle workshop and wash bay areas

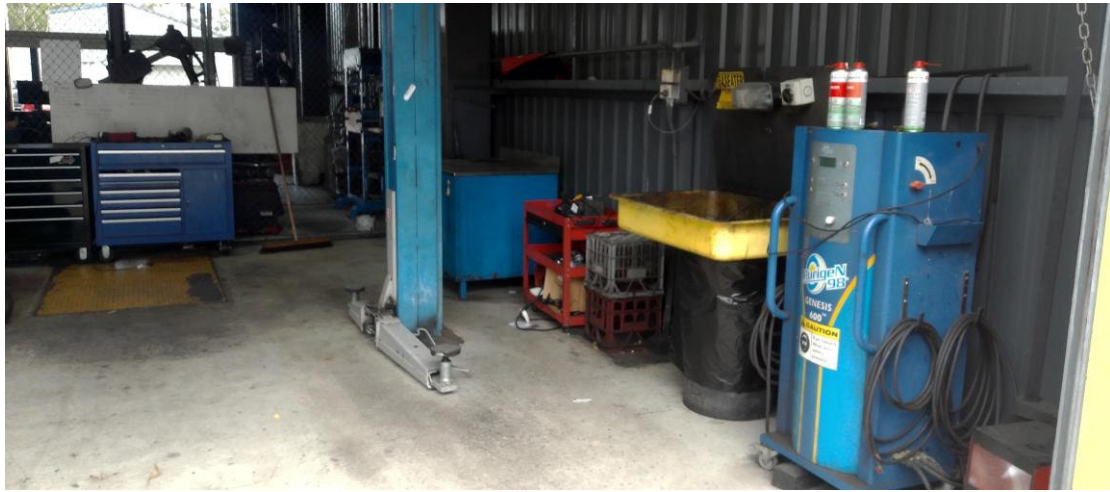
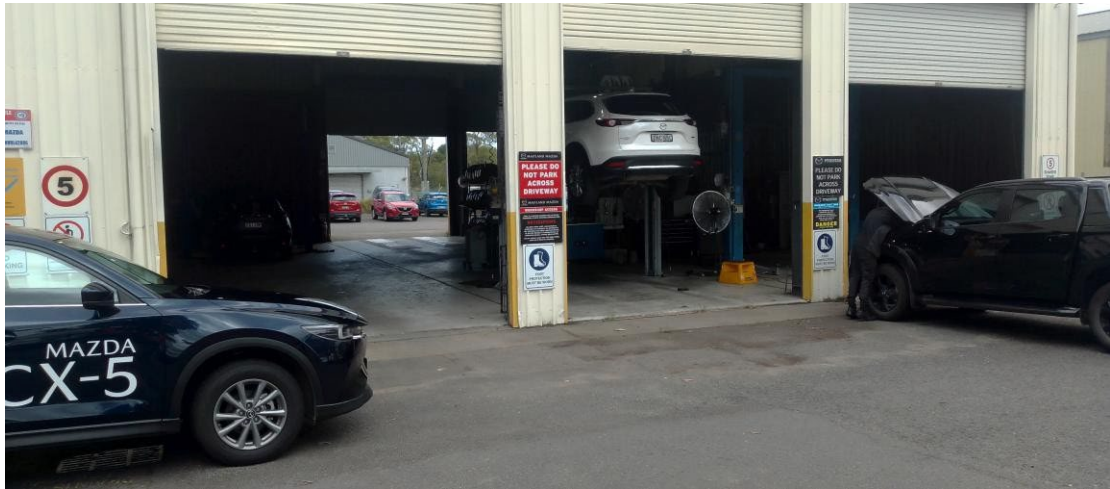
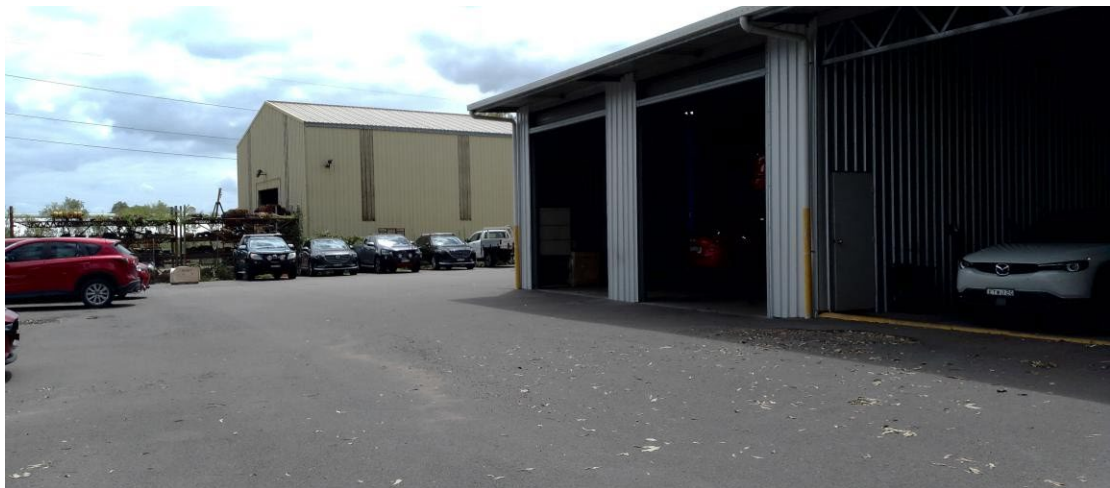
Vehicle workshop and wash bay areas

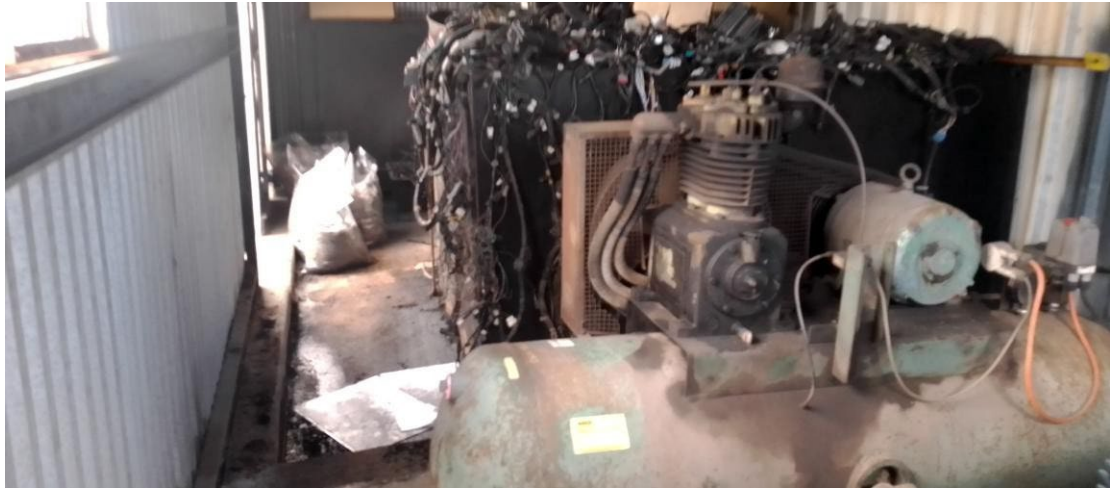
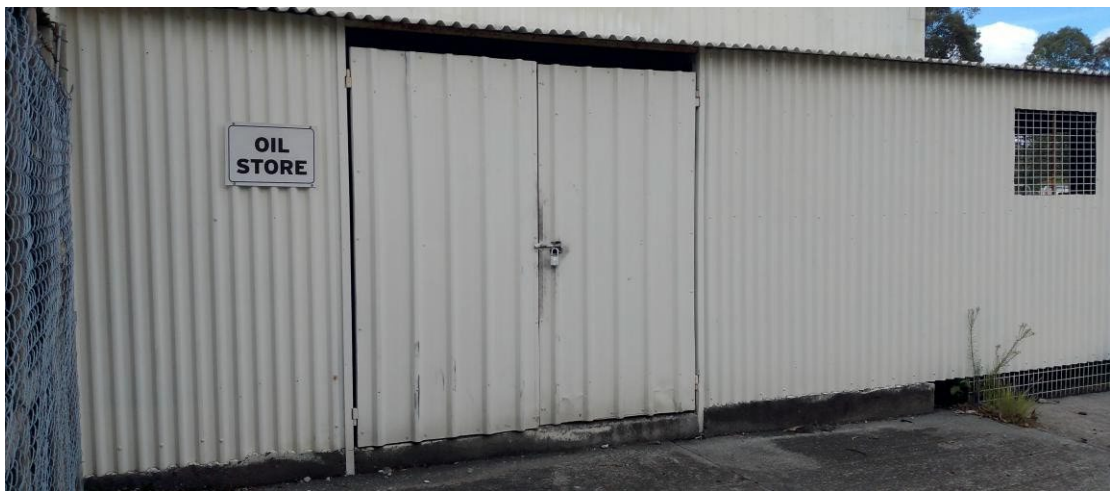
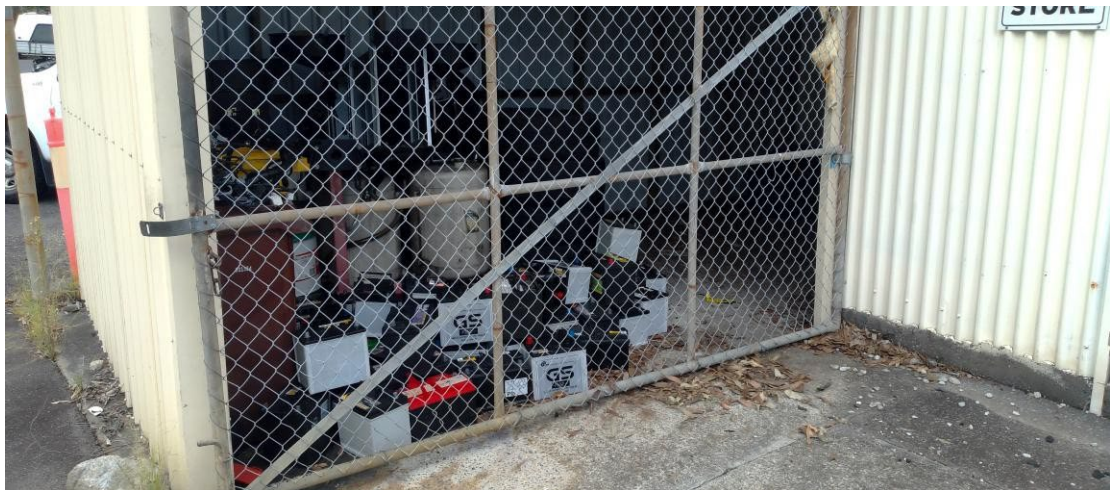
- Waste oil and used battery storage areas are located in the bunded sheds attached to the northern side of the building;
- Evidence of any existing or former Underground Petroleum Storage System (UPSS) was NOT observed on the site at the time of assessment. It should be noted that evidence of former systems may not be visible at the time of assessment as they may have been covered over in the years prior to the assessment;

The majority of chemical waste material was stored in dedicated bunded areas including waste oil, batteries and electrical wiring harnesses at the time of assessment. Odours were not noted over the site at the time of assessment.

Waste Oil and Battery storage areas

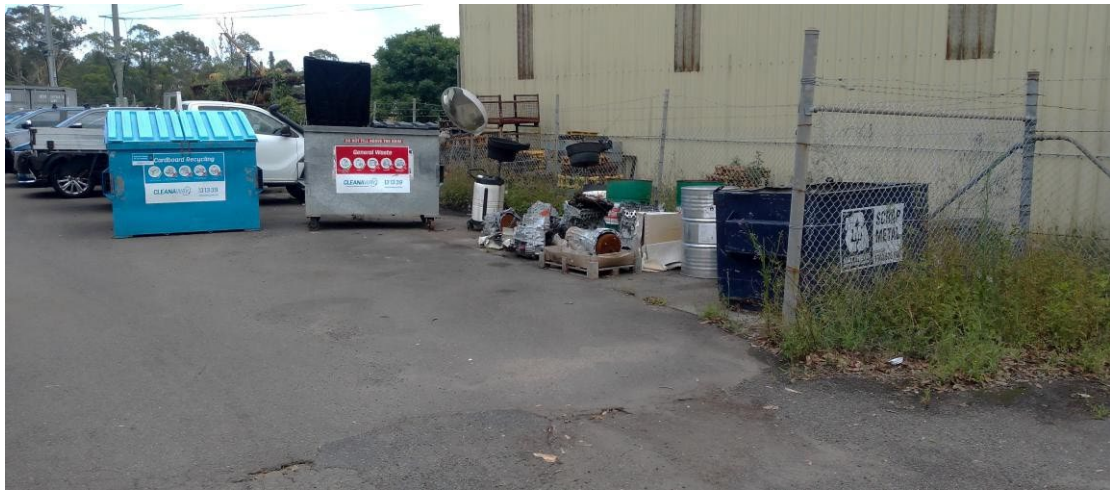
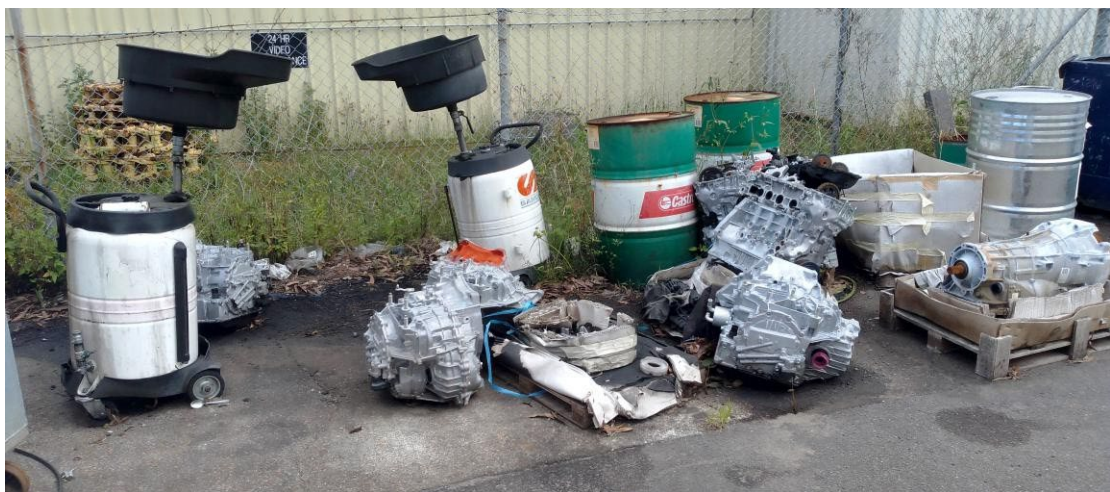
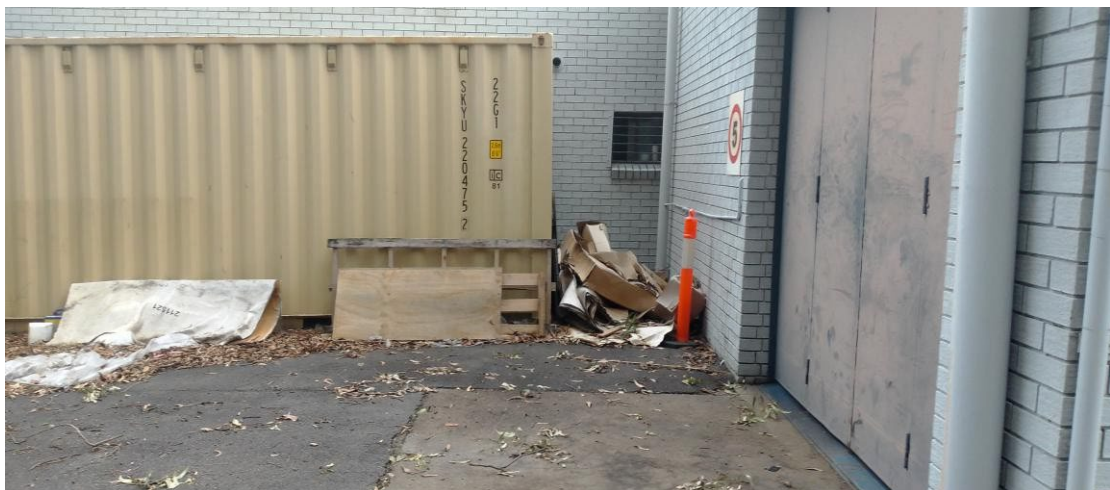
- Fill material used to construct the hardstand layer over the majority of the site;
- Historical and current use of the site, namely a vehicle repair and service centre;
- General rubbish and used vehicle parts including stored engines on the rear northern boundary of the site;
- Possible Historical Fill located on the rear western portion of the site, however this is unlikely based on site topography.

General rubbish and used vehicle parts

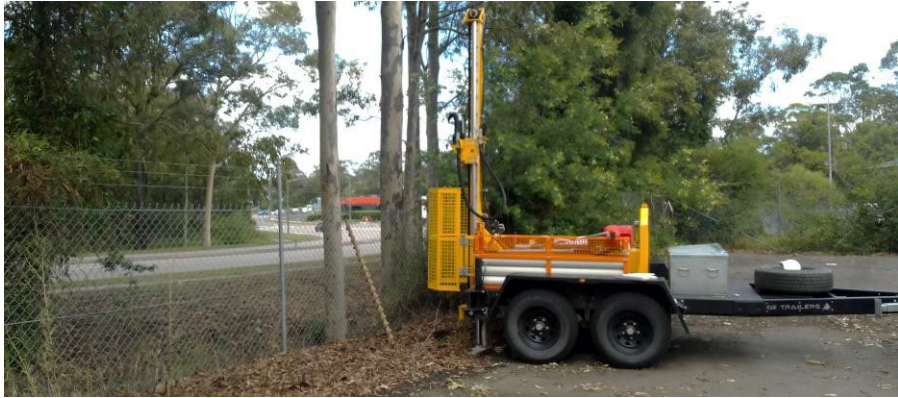
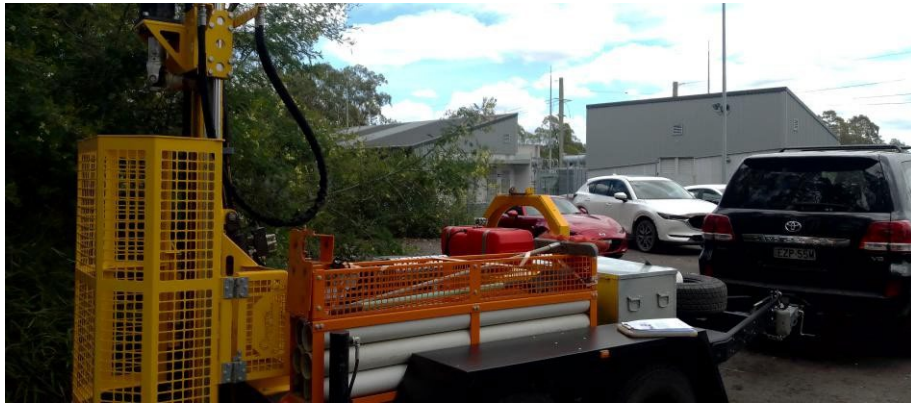
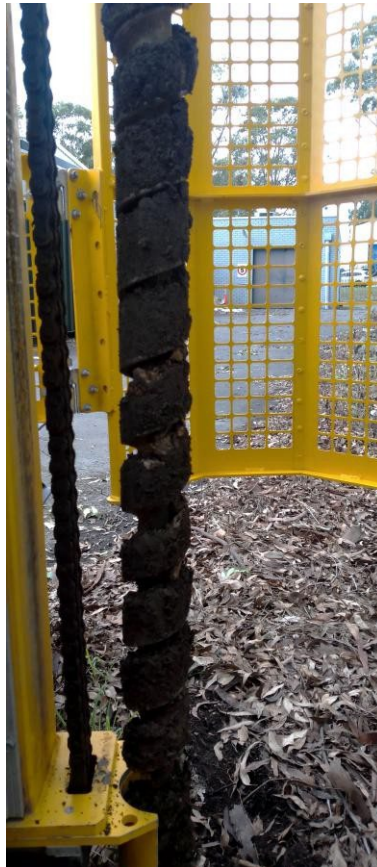
New neoprene gloves were worn during sampling and replaced prior to collection of each sample directly from the auger. All collected samples were placed in laboratory supplied glass with Teflon coated lids. Decontamination of sampling equipment was carried out with Decon 90 and clean water. Samples were then placed on ice and transported to a fridge at our premises prior to dispatch to the laboratory.

Examples of site drilling
