Conservation Management Plan

MAITLAND JEWISH CEMETERY

Prepared by Rookwood Management Services Pty Ltd for
Maitland City Council

November 2012

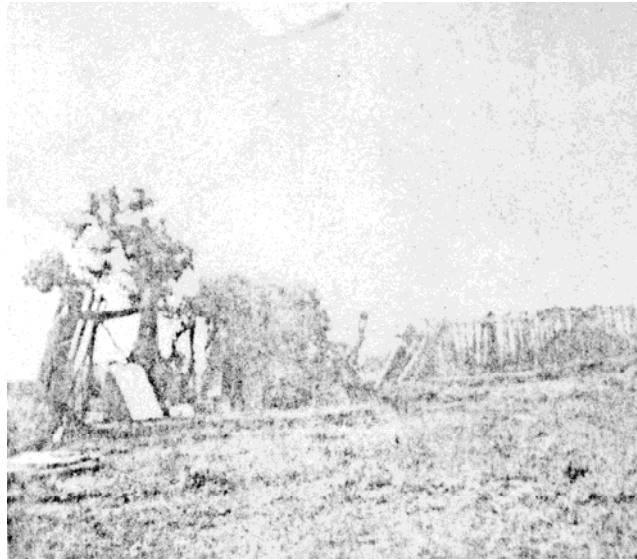
Photographic evidence of the cemetery indicates a 6 foot picket fence would have been in place from the late 1800s until the late 1950s. The earliest known photograph is one of the gravestone of Rachel Lewis from the 1920s (refer to the inside back cover of Janis Wilton's book, Maitland Jewish Cemetery: A Monument to Dreams and Deeds) which shows a high picket fence in situ. The latest known photograph to show a similar fence (albeit in a dilapidated state) was found in the

Figure 11: Photograph from the Australian Jewish Historical Society Archives believed to have been taken by George Bergman taken in the mid-late 1960s.

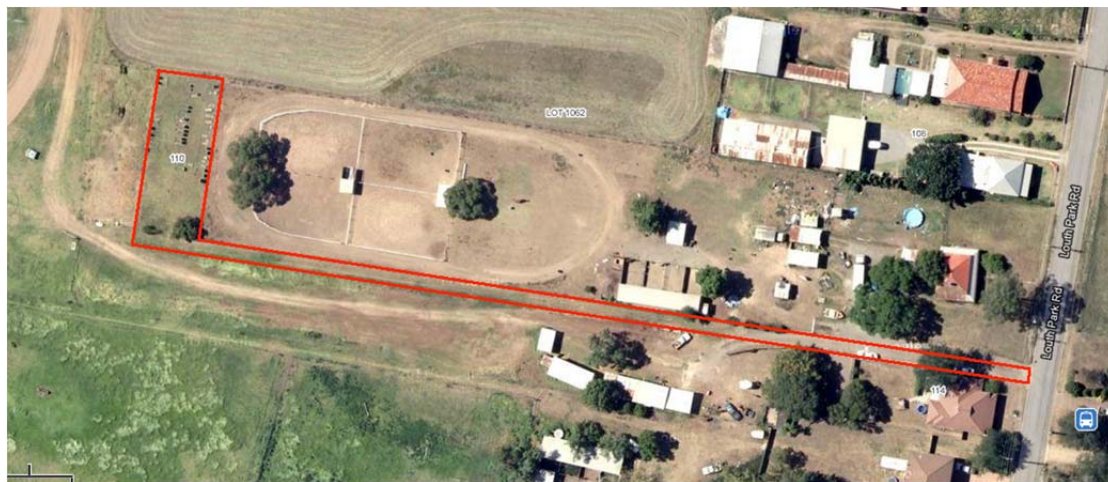
[Figure 13: Maitland Jewish Cemetery Curtilage Plan. Map scale 1:1,000 \(Modified from Google Maps, 2013\)](#)

The cemetery's curtilage is defined as the fencing enclosing the site and the laneway to the south of the site (Figure 13). The curtilage is deemed reasonable for maintaining the original rural character of cemetery. The inclusion of the laneway as part of the curtilage would enhance the rural feeling for visitors. Further, as the laneway has a historic function as an access route to the cemetery, it would further contribute to the significance of the site.

The land surrounding the cemetery is flood prone so it is unlikely that non-rural development will be permitted or that the current zoning would be changed in the future to permit higher density development. However, should the surrounding land be rezoned in the future, a 3 rod (49.5 feet or 15.088 meter) buffer should be created around the cemetery in addition to the curtilage. The buffer would prevent livestock moving against the fence and would improve the micro-climate of the cemetery site by creating shade areas and reducing the effect of wind on the site. It would also assist in stabilising the diurnal temperatures that affect the normal wear and tear of the monuments being fully exposed to the elements. The extra buffer would also assist in maintaining a low water table around the site thus reducing the risk of salt damage on the monuments.

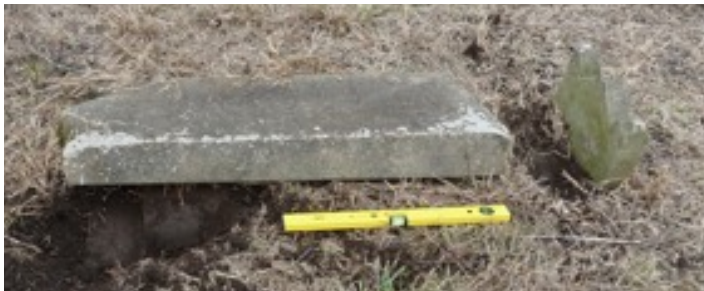
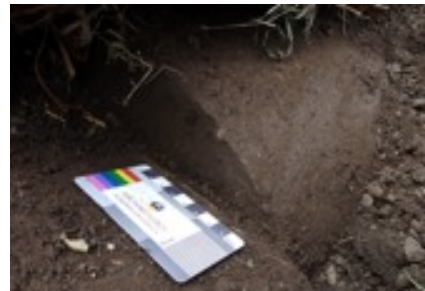
MJC_11_LEVIEN_George-Myalla_20120220_01

*The George and Myalla LEVIEN gravesite (#11, 1852) with unidentified stonework element.
Monumental mason: Charles Cobby of Maitland.*

Among the most surprising finds is that there is a rare (or possibly unique) grave covering hidden under the fallen George and Myalla LEVIEN stele. The memorial object appears to be a long rounded stone—potentially a tapered half-cylinder covering the gravesite. It was left *in situ* during the survey: with any decision for more invasive investigation, and possible excavation and re-installation, left to the consideration of Maitland City Council and The Friends of Maitland Cemetery based on the forthcoming Conservation Management Plan.

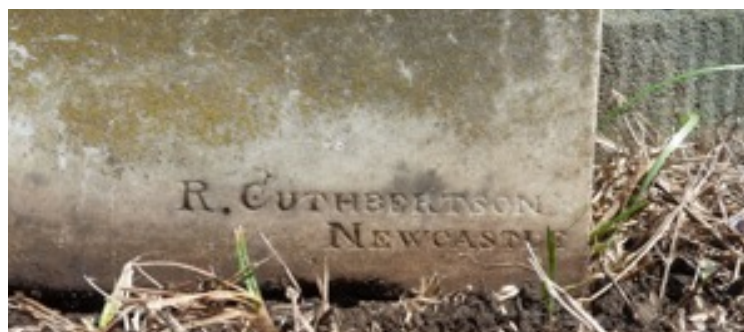
The Isaac MARTIN stele (#3, 1879). Each monument was assessed on at least two different occasions, with photographs timed to attempt to maximise the readability of inscriptions and clarity of detail. Particular care was taken to document any past repairs or alterations and to locate mason's marks: R. CUTHBERTSON / NEWCASTLE shown.

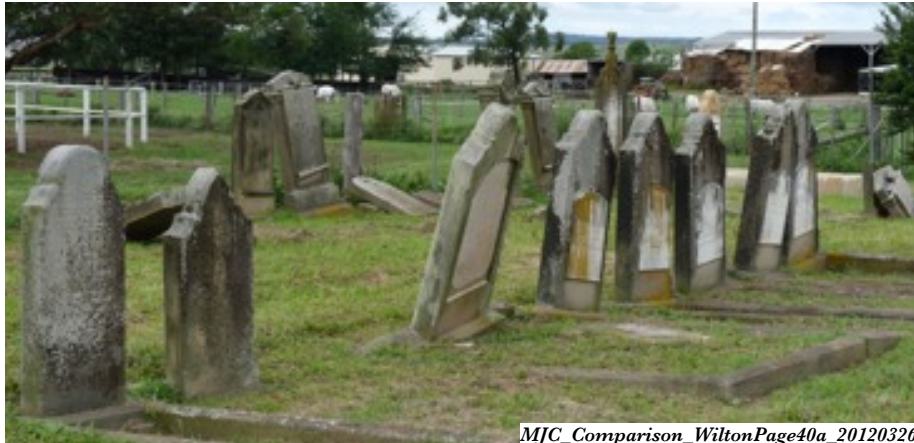
MJC_Comparison_WiltonPage40a_20120326

View from northern boundary of cemetery across central area showing predominance of simple stele-type headstones.

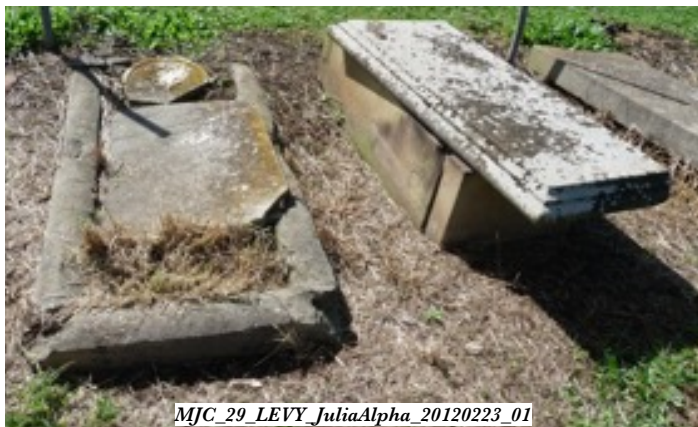
MJC_29_LEVY_JuliaAlpha_20120223_01

LEVY and COHEN monuments along the eastern boundary showing the following general design types left-to-right: marble stele (fallen and fractured), box tomb, and, low ledgerstone.

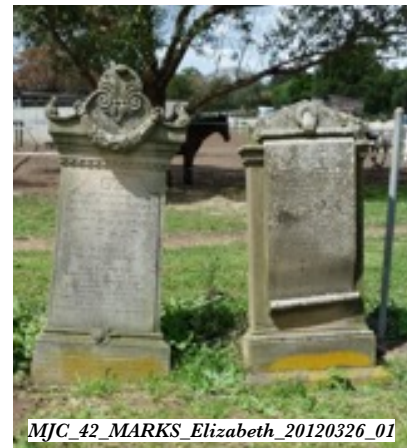
Above right: the Elizabeth MARKS (#42, 1875) and Samuel HART (#43, 1877) steles comprised of Sydney-like sandstone and Ravensfield Sandstone respectively.

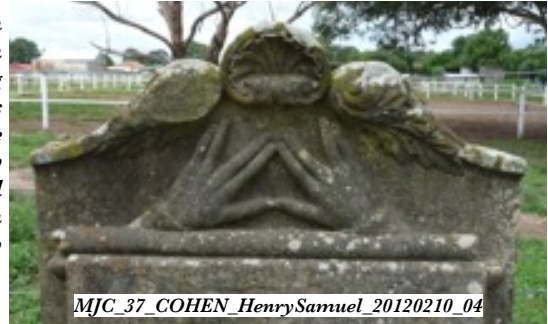
MJC_37_COHEN_HenrySamuel_20120210_04

Right: symbolism at Maitland Jewish Cemetery including COHEN hands blessing above scroll and below clamshell and acanthus volutes on gravestone likely dating to 1862.

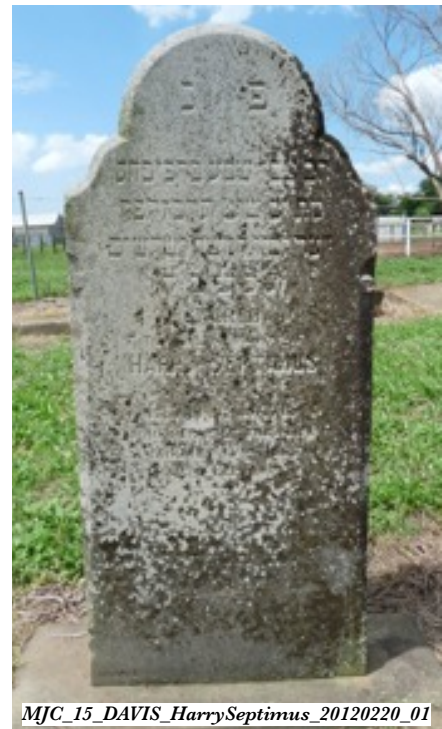
Design A: 5 very similar examples with another 2 monuments being quite similar. Pictured example by stonemason Thomas BROWNE c1897

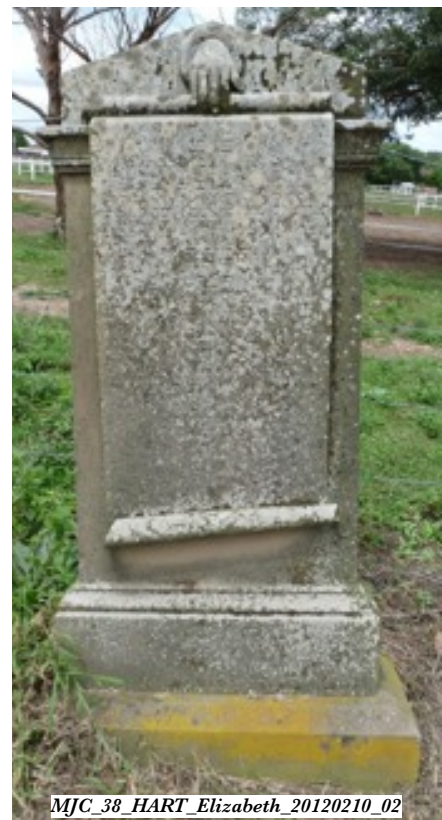
The evolution of this design is interesting in that there is an early version by Charles COBBY on the Elizabeth HART stele (#38) in 1869 which has clearly been copied by Thomas BROWNE on the Samuel HART stele (#43) in 1877 which was then replicated for the HART family in 1905 and 1931 despite the transition to plainer, easier and cheaper monuments designs.

Design B: 4 very similar examples with another 3 monuments having considerable similarities. Pictured example by stonemason Charles COBBY c1869

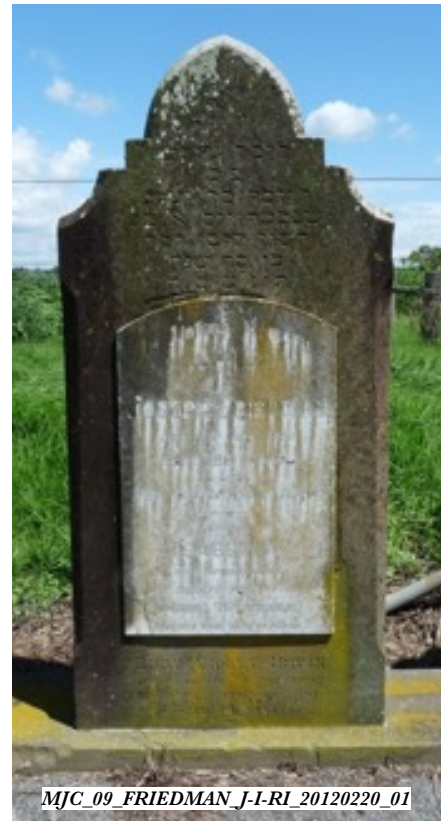
Note that numbers 18, 19, & 22 also have similar infills with diaper pattern tiles of white marble and slate set on concrete. These monuments all appear to have been constructed by Thomas BROWNE of Maitland. The lack of a makers mark on #9 likely relates to the lack of room for such as the third inscription (for Ruby Violet IRWIN) is completed in the sandstone below the marble inscription panel: ie where the Thomas BROWNE inscription is located on the other steles.

Design C: 7 very similar examples.

Pictured example by stonemason Thomas BROWNE– likely 1906.

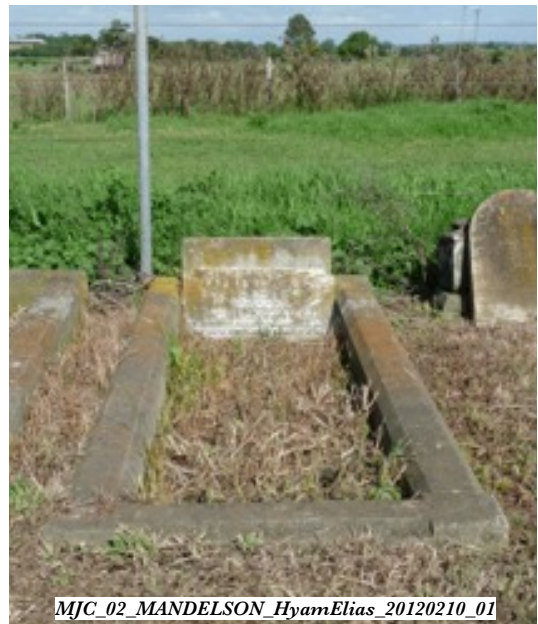
Design D: 2 very similar examples.

No mason's marks or identifiers were located for the desk-style monuments.

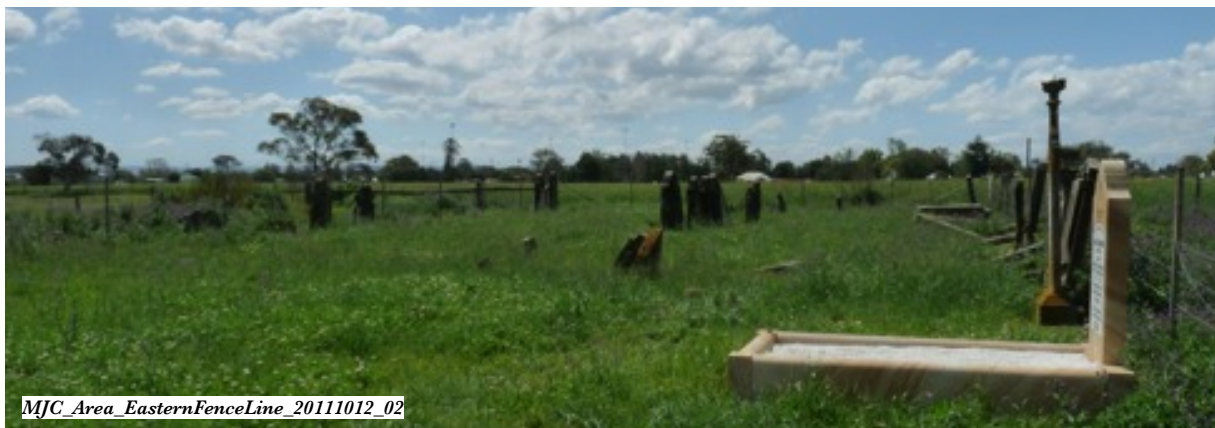
MJC_Area_EasternFenceLine_20111012_02

Essentially there are four clear rows of graves which extend on north-south lines (graves facing east or west), with the centre two overlapping. An additional set of children’s graves is located against the northern limit of the cemetery and appears to have graves facing in different directions.

Wide view showing the general design of the cemetery in four main rows of graves.

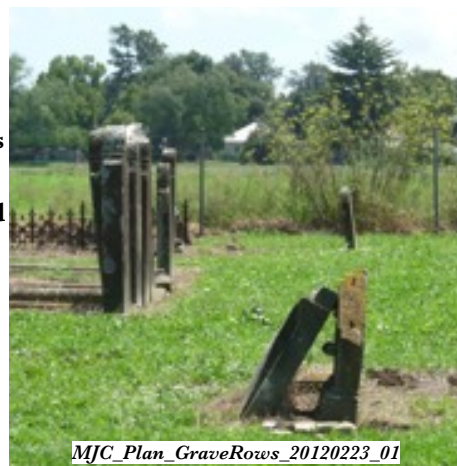
MJC_Plan_GraveRows_20120223_01

View to the north with tightened focus to show the overlapping of central two rows of graves.

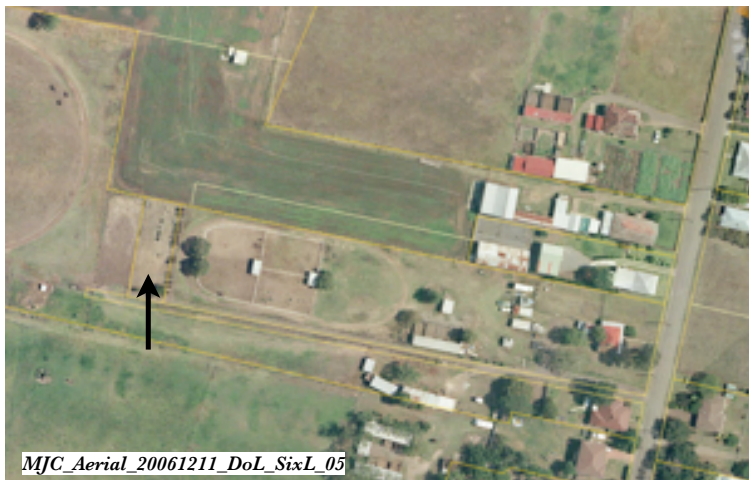
2006 aerial images showing the general plan of Maitland Jewish Cemetery. Top of each photo is North.

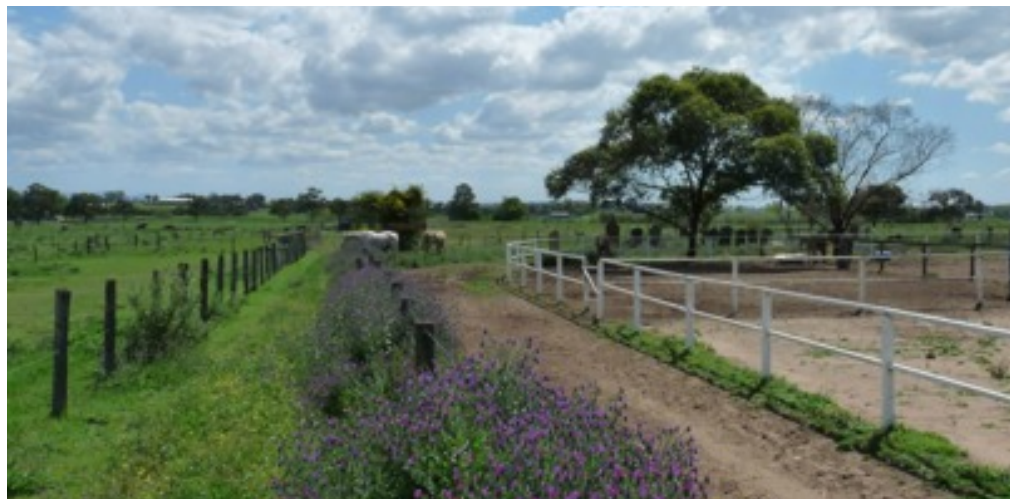
MJC_Area_Entranceway_20111012_03

Entrance laneway to Maitland Jewish Cemetery (front left) facing East: gravestones visible on the right in the background.

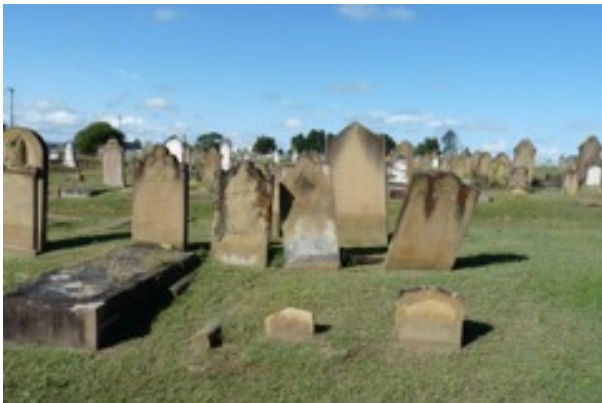
COBBY_1855_CampbellsHill_STILSBY-SIMPSON-etc_01

Note the general scale of monuments is similar to Maitland Jewish Cemetery. Gravestone are also predominantly in sandstone from the nearby Ravensfield quarries.

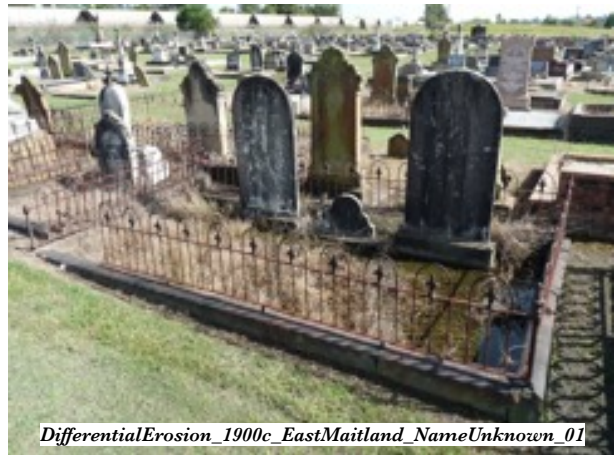
DifferentialErosion_1900c_EastMaitland_NameUnknown_01

Designs and sizing is more varied than found in Maitland Jewish Cemetery, likely a product of demand for accessory crosses as well as a later range of dates of installation.

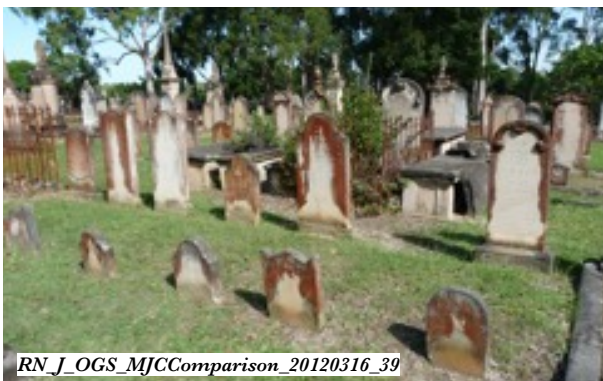
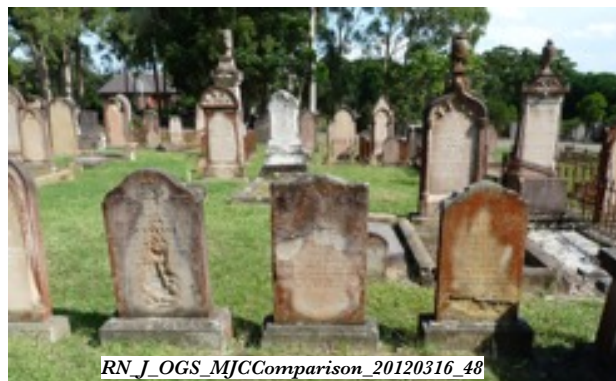
Monuments, predominantly Sydney Sandstone, in the Jewish Old Ground of Rookwood. Note that the boxtombs (left centreground) and small steles (right foreground) are removals from Devonshire street and date from the 1850s through 1860s. Note also similarity to Design A found in Maitland Jewish Cemetery.

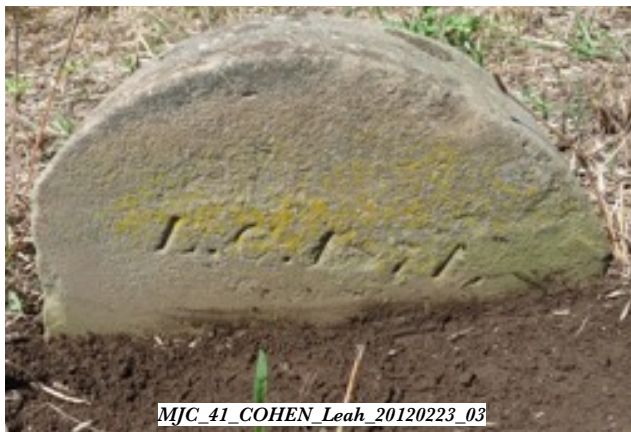
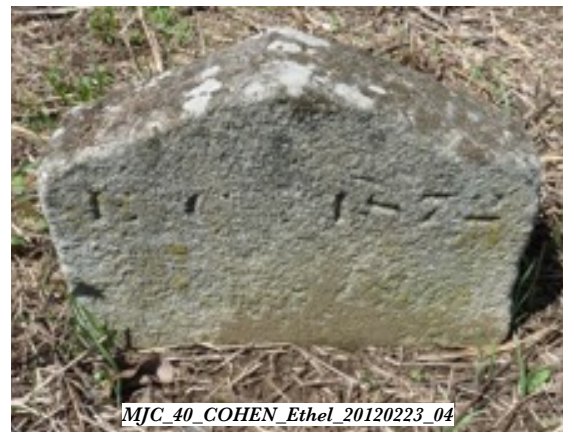
Footstones with notably different spacing for the lettering. The leftmost, for Leah COHEN (#41) probably dates to 1874 while the rightmost, for Ethel COHEN (#40), has much wider spacing and a larger font size and likely dates to 1872. Given the clear differences, it would appear highly unlikely that the same stonemason completed both jobs.

* The footstones may prove an important resource for tracing the work of stonemasons at Maitland Jewish Cemetery: there is a marked difference in spacing of initials and between the initials and year of death. Future maintenance work, if undertaken, will likely reveal additional monumental mason's marks: it would then be potentially possible to use the footstone inscription spacing to determine likely attributions for the few remaining unidentified works.

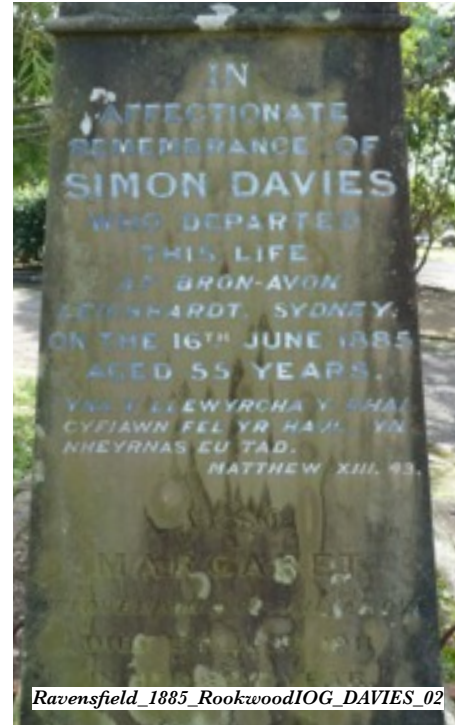
Ravensfield_1885_RookwoodIOG_DAVIES_02

Rare example of lead lettering in Ravensfield sandstone (in the Independent Old Ground of Rookwood Necropolis: monumental mason unidentified). Note that the v-cut lettering below is less legible despite the very fine carving work.

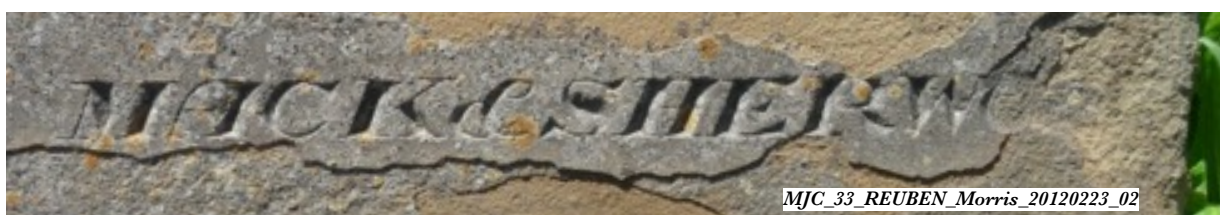
Mason's marking by "Mack & Sherwood" on the Reuben MORRIS stele (#33, 1859). The surface deterioration could be evidence of a sealant or characteristic of the stone that they were quarrying at that time. The serif-style font with non-standard 'A' and '&' are unusual and could help identify other works by Mack & Sherwood.

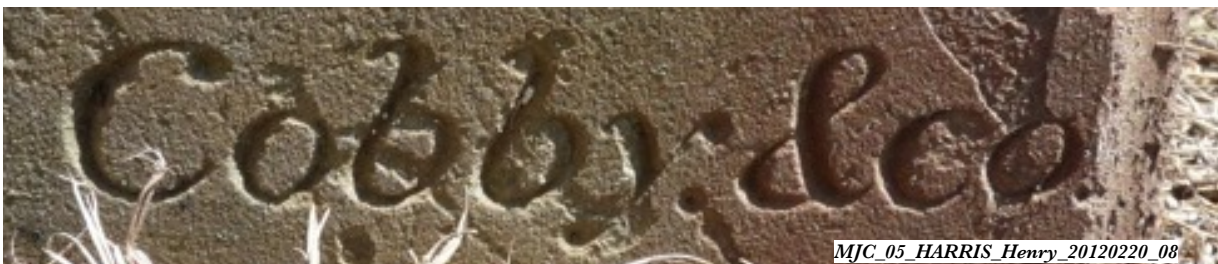
Mason's mark by "Cobby. & Co." on the Henry HARRIS stele (#05, 1859).

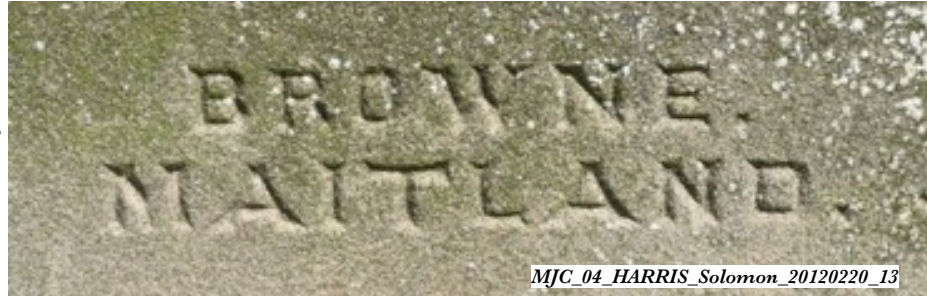
*Mason's mark by
"BROWNE. MAITLAND"
on the Solomon HARRIS
stele (#04, 1878).*

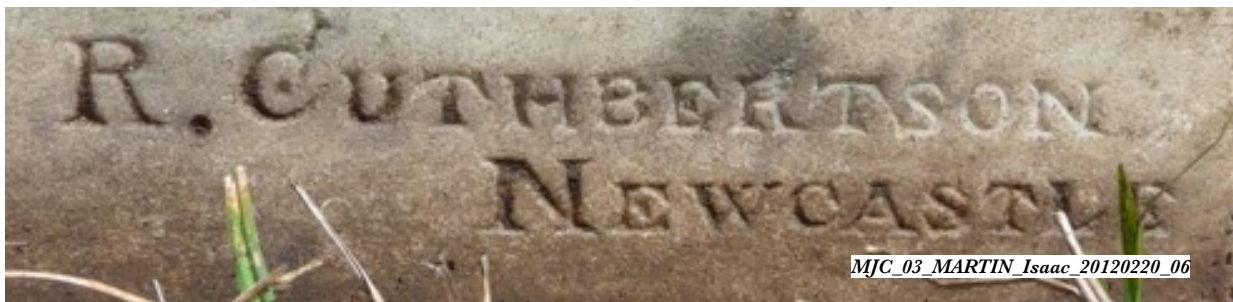
Mason's mark by "R. CUTHBERTSON NEWCASTLE" on the Isaac MARTIN stele (#03, 1879).

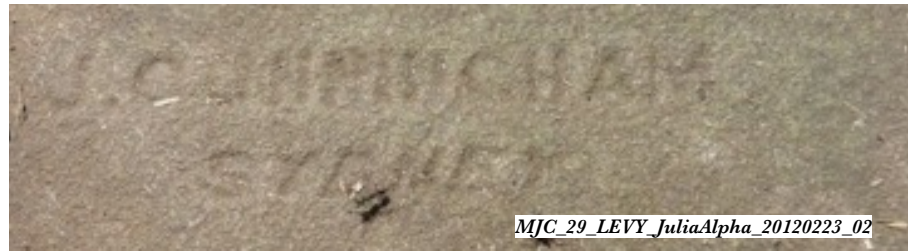
MJC_29_LEVY_JuliaAlpha_20120223_02

Mason's mark by
"J. CUNNINGHAM
SYDNEY"
on the Julia Alpha LEVY
marble stele (#29, 1880).

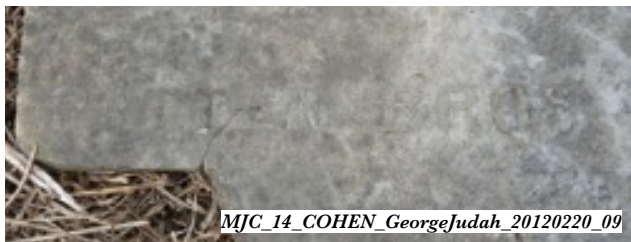
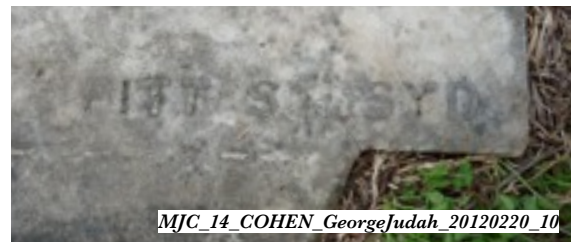
Mason's inscription in lead lettering: "J.PATTEN BROS PITT ST SYD."
on the George Judah COHEN stele (#14, 1889).

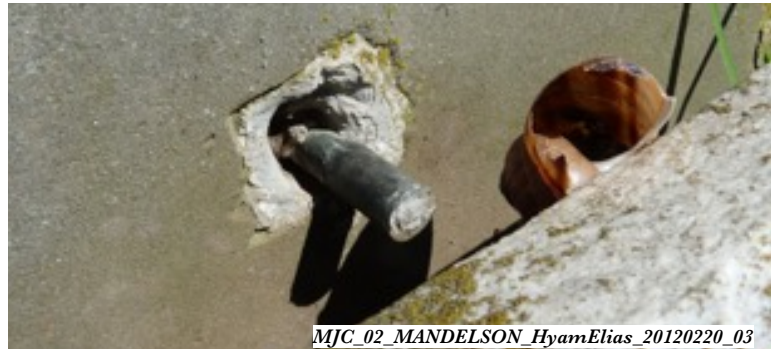
#2 MANDELSON (1919), the marble panel for this desk-style monument has fallen off revealing that it was set with two short copper pins set in white cement,

Copper pin set in white cement on the Hyam Elias MANDELSON monument: stonemason not identified.

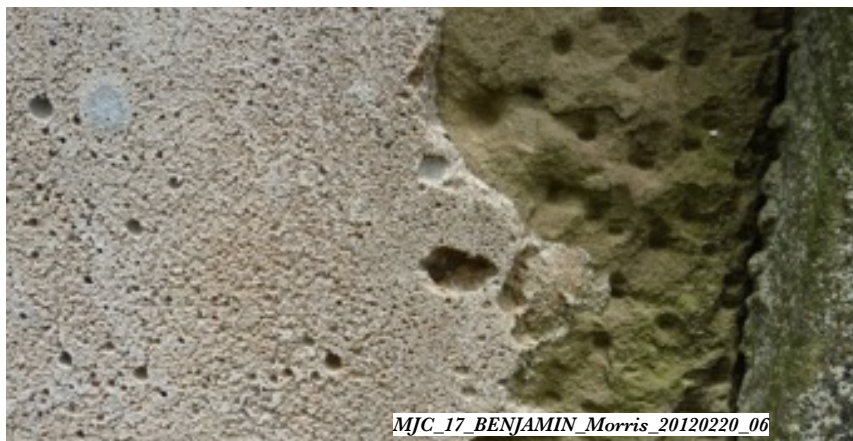
#17 BENJAMIN (1897), is the only Thomas Browne panel to have fallen off but was exposed to considerable and constant gravitational pull due to its heavy lean (seen already in 1972). The panel was set using a white cementitious grouting on a keyed back, with the panel inset within the sandstone stele. While pressure was vertical, the panel was held in place, however, as the lean of the stele continued, the tensile strength and adhesion of the grouting was tested and eventually failed. The grouting mix has air pockets, suggesting that it may have reactive while setting (ie a hot lime mix), but could, instead have been quite thick and uneven on the sandstone when the marble panel was set in (thereby trapping small pockets of air). The grout did not extend to the sides and it appears that a small bead of mix was then applied to the open surrounding joint. Note that the lack of a full bedding of the marble slab may be the condition which allows deformation of the marble to occur: see Section B: Cracks and Deformation, below).

Detail showing the grouting mortar used on the 1897 panel for Morris BENJAMIN (#17). Note also the prepared keying in the Ravensfield Sandstone panel area.

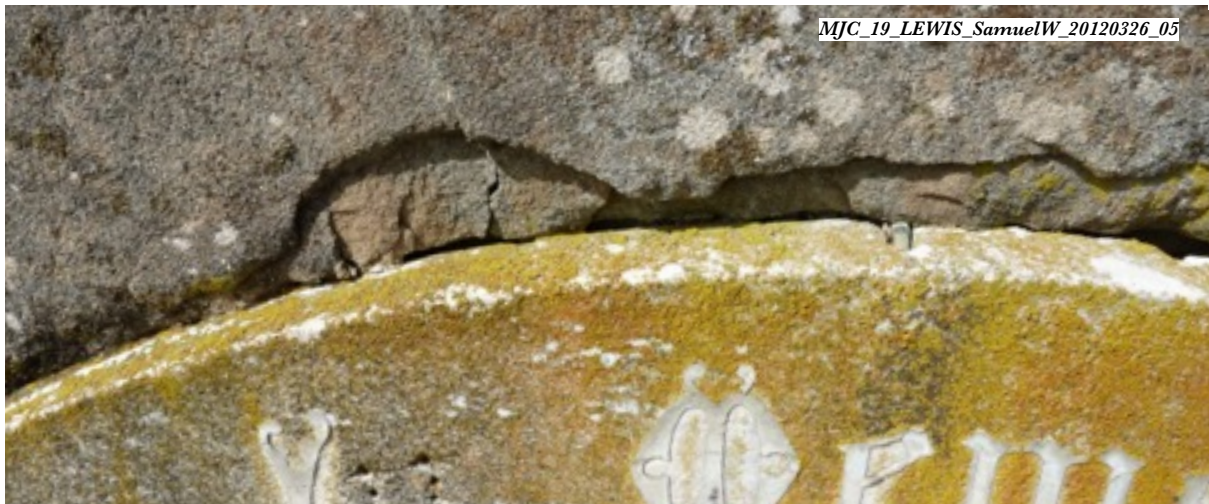
The marble inscription panel for Samuel W. LEWIS (#19, 1903) has held in place despite deterioration of the surrounding sandstone edges. Thomas Browne secured the panel with additional copper staples.

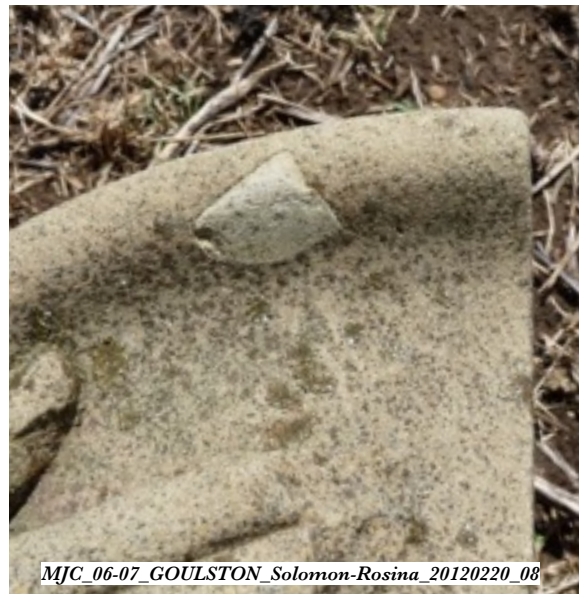
#6 The Solomon GOULSTON (1862) monument has a small patch to the upper right acroter. The patch sits on the curved upper rim and has been professionally profiled to match both the curve and the colour of the stone. Additionally, the patch is directly above fingers which have broken off with the fractures being heavily weathered: dating the repair to the distant past. The patch appears to have been completed using a mix of cement with crushed Hunter Valley sandstone. (This type of repair is known as a 'plastic repair' in masonry, with the term 'plastic' relating to its historical meaning of something moldable before the current meaning of something using the synthetic product 'plastic'.) The cementitious binder is likely something between the strength of a natural cement and Natural Hydraulic Lime: it was not tested as the testing, even with a fingernail, could mar the impressive condition of this historic repair.

Plastic repair in the Ravensfield Sandstone of the Solomon GOULSTON stele (#6, 1862).

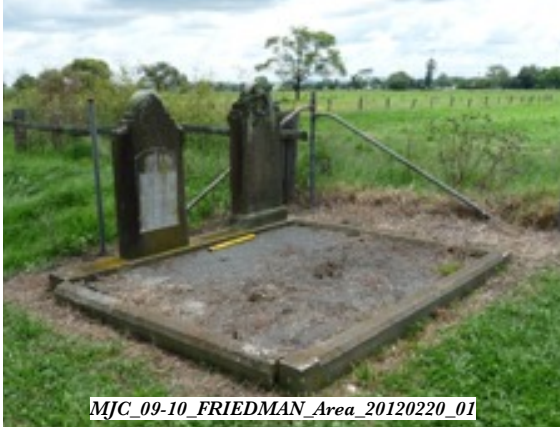
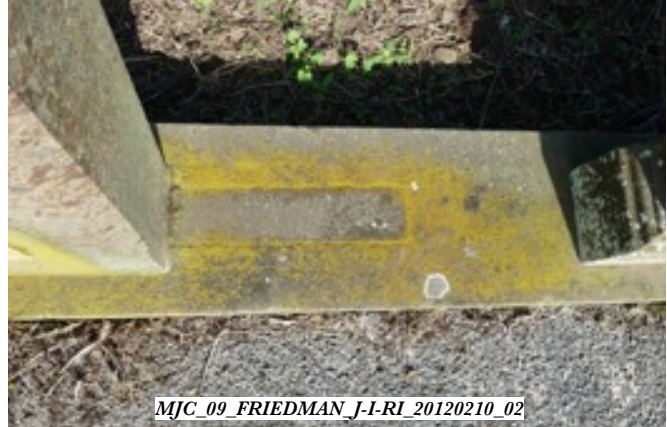
- * the concrete appears relatively new and does not have the characteristic cracks which develop after 10 or 20 years over such a thin skin,
- * the blue metal chips covering the grave are clearly too shallow: this is recent practice, reflecting the general lack of high standards in the industry (ie cost minimisation with little thought of the visual impact). The surrounding grounds do not contain masses of blue metal chips: they did not migrate off the grave but were simply never installed in an adequate number to effectively cover the concrete.

The current appearance of the FRIEDMAN area (#09 and #10) showing relatively recent alterations and, above right, a filled-in socket hole in the back plinth.

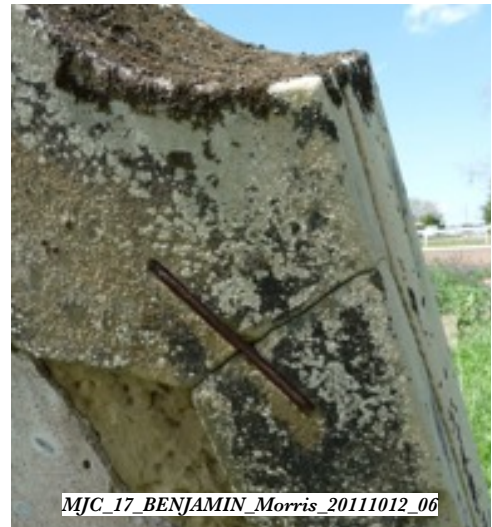
MJC_17_BENJAMIN_Morris_20111012_06

#17 The Morris Benjamin (1897) monument has an historic repair to delamination in the sandstone. Two iron staples were installed spanning deep cracks and preventing them from continuing to open up: one on the upper right of the front face and one in the middle of the right face. The workmanship of the repairs is curious as, on the one hand, the grooves have been very professionally executed: they are almost exactly to the size and length of the staples. On the other hand, however, the iron staples are not inset below the surface area, suggesting that they were not hidden from view. The front staple has cuts where it appears that a chisel was placed in an effort to force the staple in. This, again, is a rather poor technique— tapping in with a thick punch or blunt chisel would have been more effective and avoided any damage, without being any more difficult or time-consuming. The repairs are at least 20 years old, judging from the rusting and the weathering in the grooves, but could be much older. Almost all modern monumental masons would execute the repair using an angle-grinder to cut out the stone: a quick technique but one which would leave very different sides and projecting ends where the roundness of the blade requires extra cutting: unnecessary when actually carving the groove with chisels. The repairs, however, are unlikely to date as far back as the neighbouring Thomas Browne monument installations: as those included copper staples attaching the marble panels (visible for #18- c1902, #19- c1903, and #20- c1903). Copper or bronze staples would be significantly more weather-resistant (though not as strong) and were clearly favoured by Thomas Browne who also avoided the use of iron cramps for kerbing: so appears to have been keenly aware of the inevitability and damage caused by rust jacking. Interestingly, there is also a small vertical cut in the sandstone above the inset panel space on the upper right. It may be possible to ascertain more about the historic repairs if the Morris BENJAMIN panel is excavated out of the ground and then examined before being reinstalled.

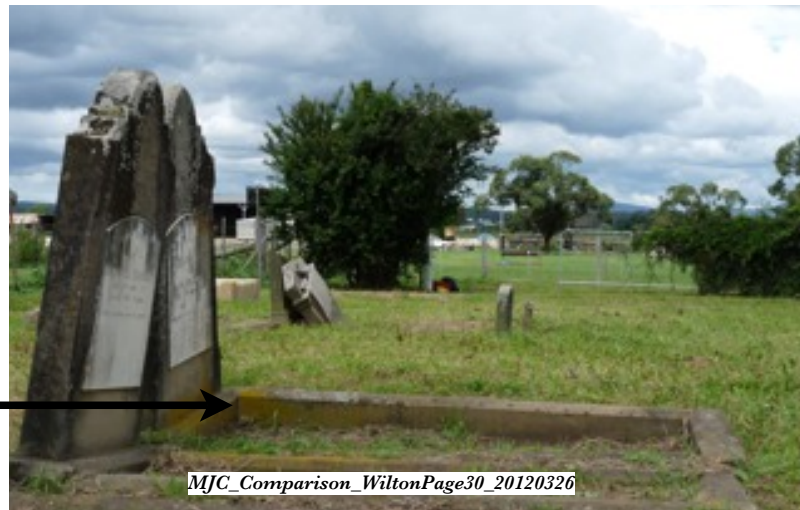
#24 The Benjamin HART monument (#24, 1905) was historically repaired with a combination of two short galvanised iron pins and a thick sand-and-cement mortar. The repair failed prior to 1979, perhaps under stress from an uncorrected backwards lean (visible in the lower portion which remains upright).

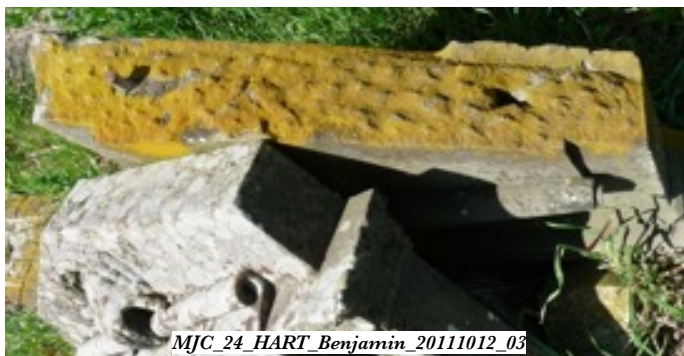
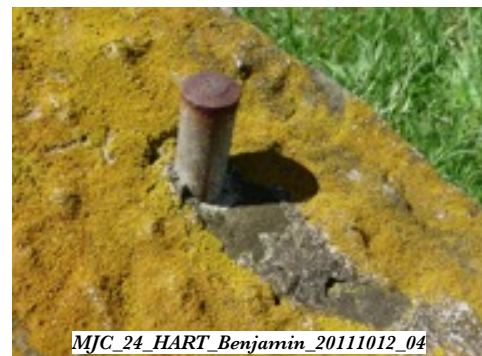
Without lifting out the fallen top piece, it was impossible to fully examine the attempted repair, but there appears to be an interesting juxtaposition of care and skill on the one hand, with naive or unaccomplished technique and design on the other. The repair was never likely to hold fast as the pins are so short as to provide no tensile resistance: they would only function to stop the pieces sliding on one another. Interestingly, there does appear to have been an attempt to ensure the cement mortar was effective: the visible upper surface of the repair joint has a clear keying impression. The stonemason may have taken care to key the break area to ensure a stronger connection (a technique which is generally not advised on conservation terms but does reveal a considered attempt to complete effective work). Conservation repairs to the stele will allow for further investigation into the historic repair technique: it is important than any new repairs fully documents the earlier work.

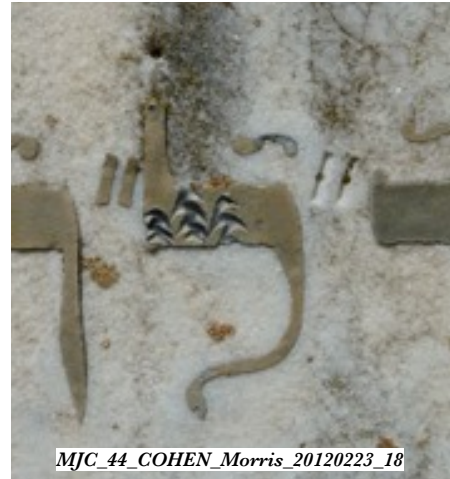
MJC_44_COHEN_Morris_20120223_18

#44 A number of lead letters on the Morris COHEN monument (1878) have been damaged in an apparent attempt to re-seat and re-tap them. Re-tapping lead letters is a simple, inexpensive and highly effective maintenance method: but only if completed sensitively and with the correct tool– an ebonite leading mallet. Rough attempts to re-tap letters with inappropriate tools leads to damage that matches that visible in a number of places across the face of the monument. Note that although the damage appears to be very recent, the extremely slow rate of oxidation of lead (unless catalysed with sulphur compounds) actually means that the damage may have occurred at any point in the last 50 years.

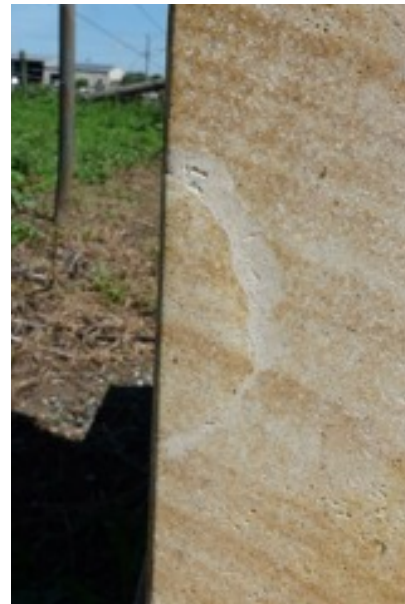
MJC_45_ABADEE_Leah_20120223_11

#45 A large chip has been re-attached to the Leah ABADEE monument at the bottom back right of the stele. The setting compound appears to be Megapoxy but may be a coloured polyester adhesive (such as Tenax), and the damage likely relates to the transportation or installation of the monument as it is unlikely that a distributor would supply stone with such a noticeable chip and repair. Megapoxy is not UV resistant and has been observed to fail under exposure within 20 years in the context of New South Wales. Tenax polyester adhesive, in contrast, is not highly vulnerable to UV deterioration but will also isolate the fractured chip from the main portion of the stone. Such repairs will often become more noticeable over time as the isolation of the piece from natural water movements through the stone will lead to visible differences in weathering. Tenax is effective in indoor situations but, because of the weathering effects on the stone abutting the joint, tends to fail in exposed situations.

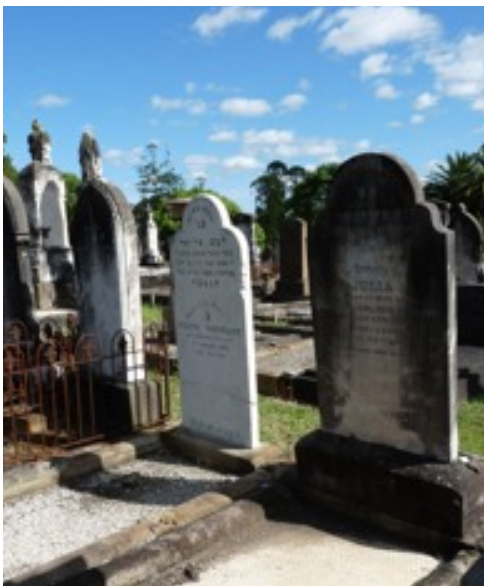
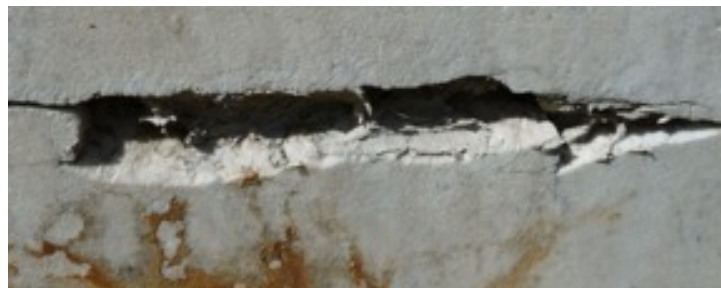
This monument in the Jewish Old Ground of Rookwood appears to have been repaired with Megapoxy in addition to having its surface removed by acid-washing which has effaced part of the historic lead-lettered inscription. The Megapoxy has now started to degrade: it has become soft and flexible, putting the monument at risk after less than 10 years.

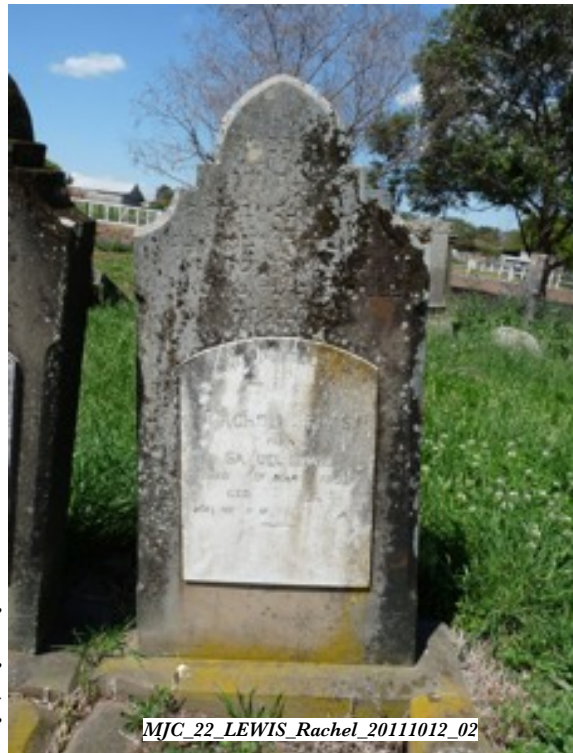
In this photo, taken at 2pm in early October, the sun is at a similar angle past north but it is much higher above the horizon. Note also that the mason's mark does not show up clearly even though the Hebrew lettering is quite legible despite the biological colonisation.

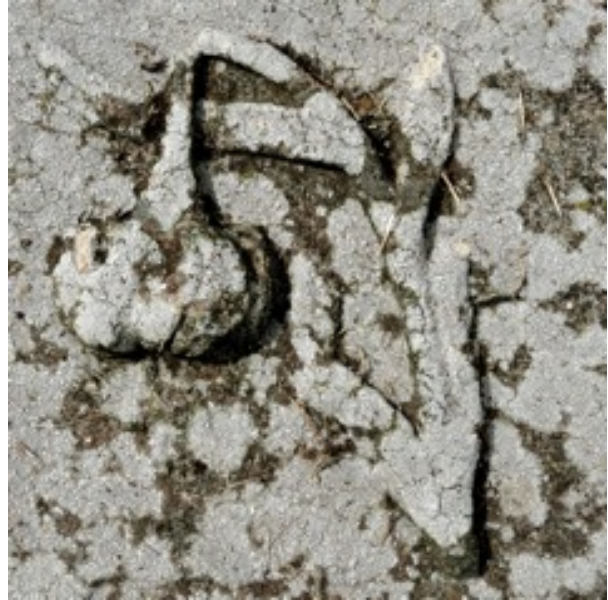
MJC_Comparison_WiltonPage73a_20120326

Maitland Jewish Cemetery, 1970s (MJC, front cover, Australian Jewish Historical Society Archives).

* The Morris COHEN (#44, 1878) gravestone was already missing the marble finial knob in the 1970s: a portion, however, was extant at the time and is visible on the top of the marble stele. All portions of the finial knob are now missing: with only a lead-encased pin projecting out of the top as of 2012.

* The Morris COHEN (#44, 1878) finial knob was broken off and missing but a portion remained in the 1970s (see above)

* The finial is slightly turned counter-clockwise: this partial turn is still visible today

* The inscription for the Morris COHEN (#44, 1878), completed by the monument company J. Hanson c1878, was missing a large number of lead letters by the 1970s. Close comparisons with the currently extant lead letters shows, however, that there has been little change in the subsequent decades

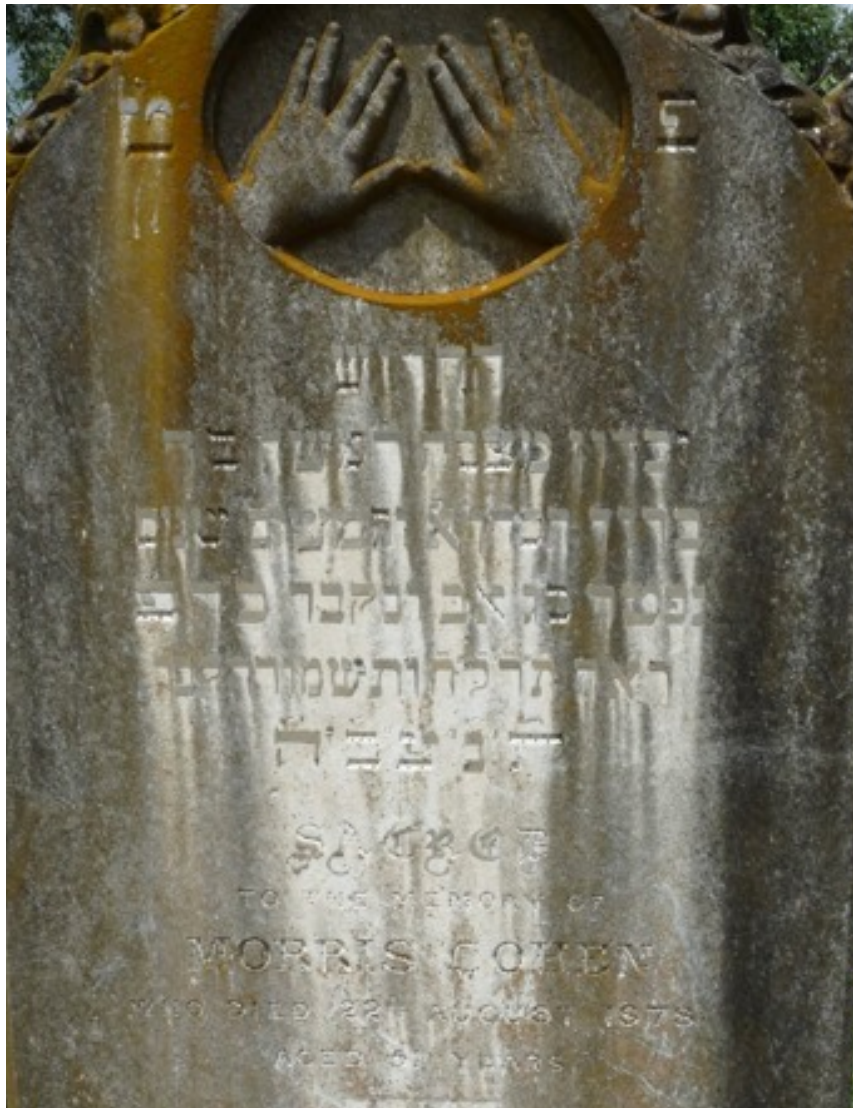
MJC_44_COHEN_Morris_20120210_02

Gravestone of George Judah Cohen (detail), 1978 (MJC, inside front cover flap, Terry Newman)

* The marble was fractured before 1978: with either recent chipping or a repair mortar patch evident along areas of the joint.

* The lead lettering, completed by PATTEN BROS c1889, was in almost exactly the same apparent condition in 1978 as it is now. Despite evident failure before 1978, with many missing letters, only the 'E' in 'October' and one or two portions of Hebrew letters appear to have been lost in the past 34 years (in the area visible in the photo detail).

* The water flow patterns under the uppermost letters, particularly the 'In, M, GEO, GE, JU' is clearly visible but complex. On upright monuments, lead letters often have cleaner spaces directly below them: a combination of channelling water away and the slight toxicity of the metal. In this case, however, the space below the lead letters appears to be a better and less toxic environment for biological colonisation. It may have been that the monument is sitting very close to level, but with a slight angle down into the fracture line (from both top and bottom). There would then be only slight water movement and channelisation to the sides, with the effect overwhelmed by the impact of increased water retention in and around the indentations in the lead. The fractured area definitely appears to be a low spot with water accumulation leading to preferential biological colonisation.

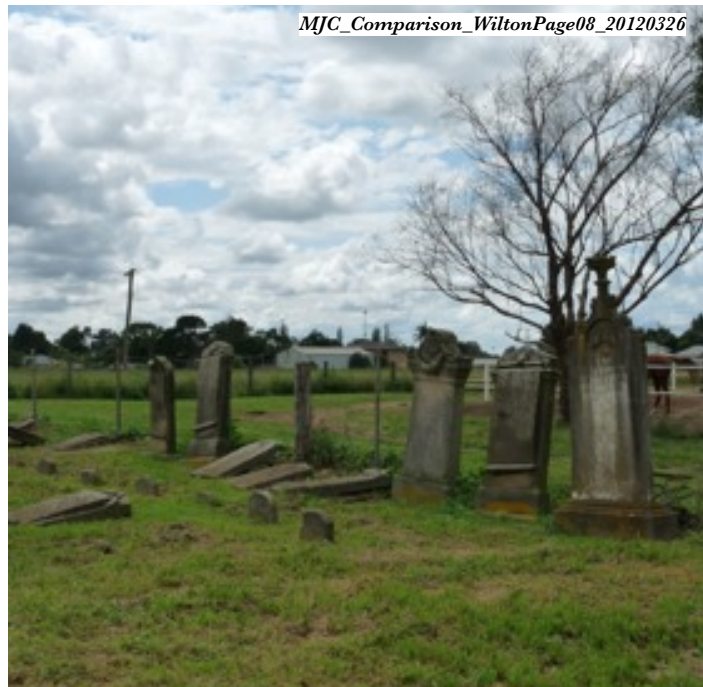
MJC_Comparison_WiltonPage08_20120326

Comparison photo from March 2012.

* The Rachel LEWIS stele had a small but visible backwards lean in 1979. The joint between the plinth and kerb can also be seen to be slightly open. The monument currently leans forward, with the plinth and kerb butted tightly against each other. It is highly likely that the monument lean was corrected at some point in the 1980s or 1990s: the force of gravity would have exerted pressure to increase the backwards lean— without repair, the lean would only have remained stable or increased.

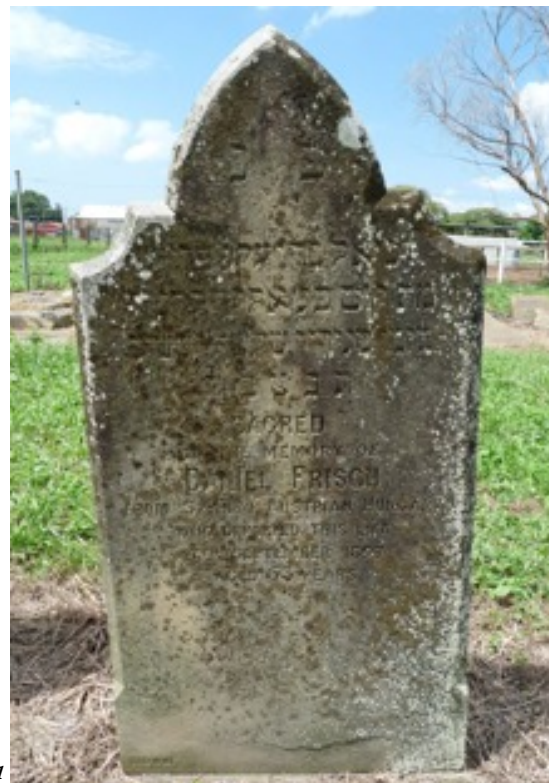
MJC_16_FRISCH_Daniel_20120220_01

* Microcracking is visible on the surface of the Daniel FRISCH stele (#36, 1897). Examination of the same areas on the Ravensfield sandstone monument show that the cracking does not appear significantly different in 2012

* The Daniel FRISCH monument (#36, 1897) was cleaned at some point between 1972 and 2001, likely in 2001 prior to the photo being taken. The Terry Newman photograph *Maitland Jewish Cemetery, 1972* (MJC page 40) has slightly more biological growths on the stone. Note that the monument does not show any signs of aggressive cleaning or damage, and that algae and lichens have recolonised the stone which now matches the 1972 appearance more closely than the 2001 appearance.

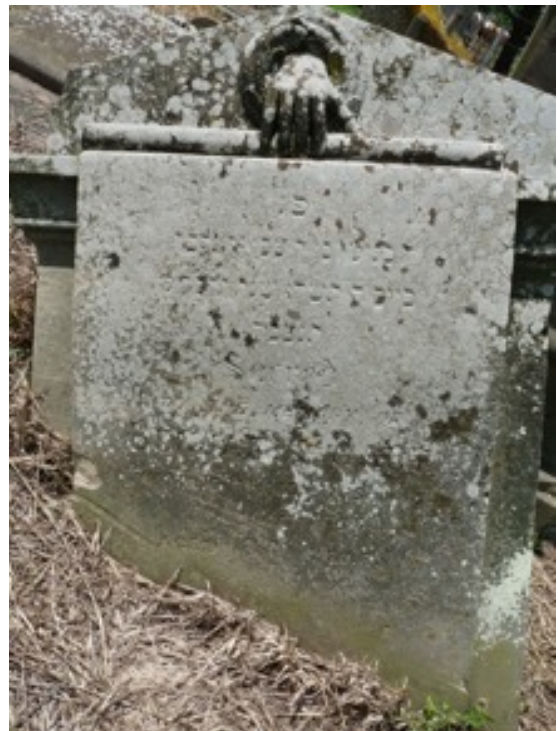
MJC_24_HART_Benjamin_20120220_02

Detail of gravestone of Benjamin Hart, 2001 (MJC, page 58, Maitland Family History Circle)

* The 2001 photograph of the upper portion of the Benjamin HART (#24, 1905) stele suggests that it had just been cleaned. There is no algae and only a few small lichens growths, as well as a colouration at the bottom where it appears that it had been covered in dirt which was recently removed and cleaned off. In comparison, almost the entire front face is covered with lichens as of 2012: with the only clear areas being close to the ground where the algae may have been discouraged through any combination of overgrowth (cutting off sunlight), pesticide poisons, or repeated abrasion and removal by nylon-cord trimmers. Note that the monument does not show any signs of aggressive cleaning or long-term poisoning as the lichens have successfully colonised the stone. (There is, however, significant impact damage from a lawn mower with a large chip of the stone lost and multiple scratches.)
