Conservation Management Plan

MAITLAND JEWISH CEMETERY

Prepared by Rookwood Management Services Pty Ltd for
Maitland City Council

November 2012

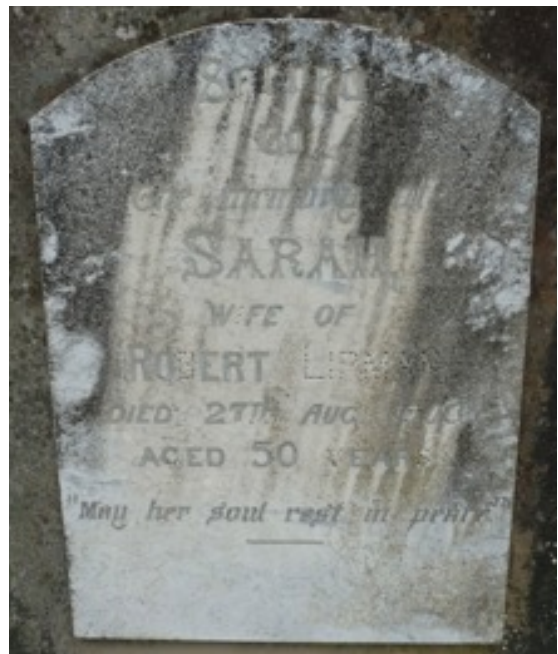
MJC_20_LIPMAN_Sarah_20120220_02

Part of the English inscription from the gravestone of Sarah Lipman, 2001 (MJC page 67, Maitland Family History Circle)

* The Sarah LIPMAN panel (#20, 1903) was missing a significant proportion of its lead lettering in 2001. When compared to 2012, it can be seen that no new letters have been lost and there is no apparent loosening or incremental progression towards loss.

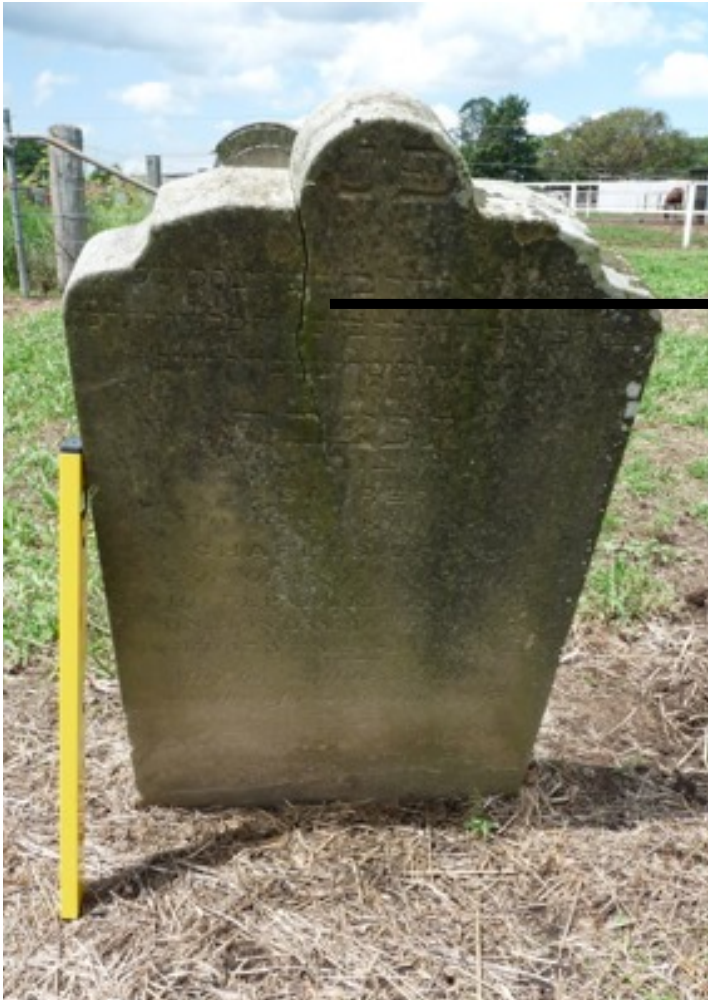
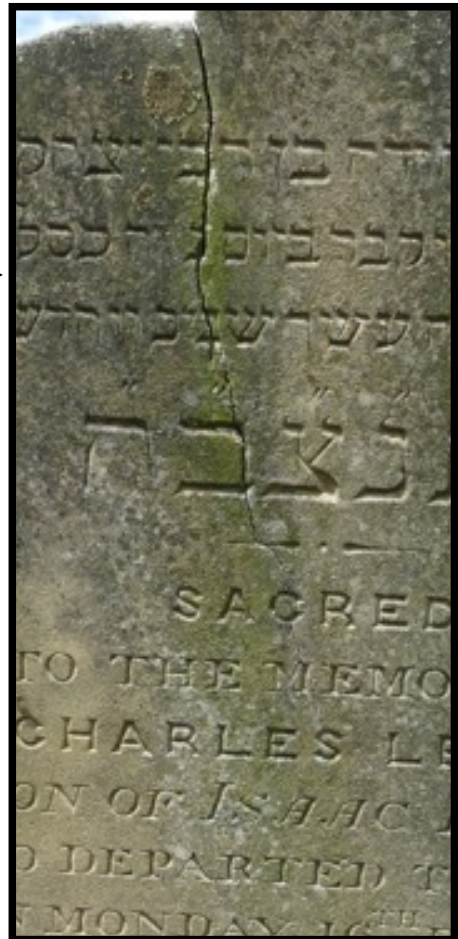
MJC_12_ISRAEL_CharlesLewis_20120220_04

Hebrew inscription on the gravestone of Charles Lewis Israel, 2002 (MJC page 62, Australian Jewish Genealogical Society)

* The crack through the Charles Lewis ISRAEL (#12, 1867) stele extended entirely through the top of the stone and down the face at least as far as the 'c' in SACRED in 2002 with the remainder not shown on the print in *Maitland Jewish Cemetery: A Monument to Dreams and Deeds*. The crack currently extends through the 'M' in MEMORY and past the 'S' of CHARLES, but matches the appearance in the upper section as per 2002. The crack may be worsening, but the damage is progressively slowly. The significant lean of the monument (at 34% forward) is probably increasing pressure on the crack as the separate upper sections can move and extend differently in response to thermal and wetting expansion/contraction stresses.

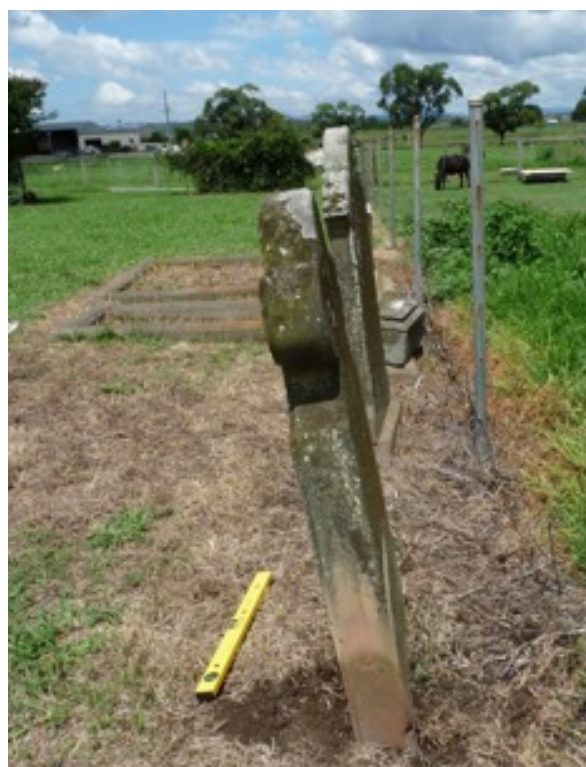
MJC_05_HARRIS_Henry_20120220_03

The Henry HARRIS (#05, 1859) stele by Cobby & Co. The forward lean of 58/600mm has been categorised as Condition 5: catastrophic. If action is not undertaken soon to correct the lean, the monument is likely to fall forward and fracture– damage which has been observed in numerous cases since 1972.

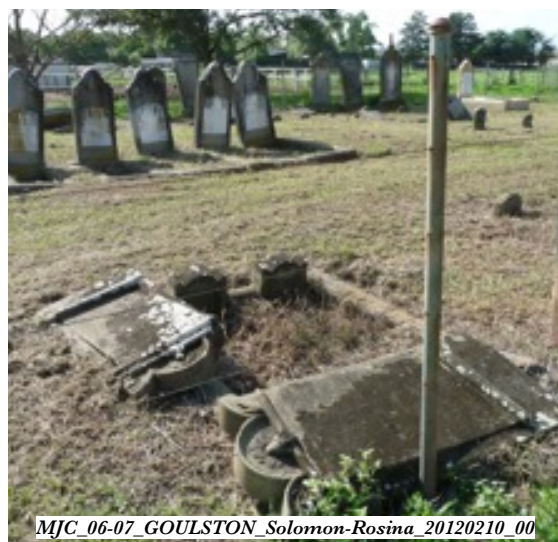
MJC 06-07 GOULSTON Solomon-Rosina 20120210_00

The relatively low level of the GOULSTON lot (#06-07, 1862) will also encourage the pooling of surface water which is often linked to eventual soluble salt damage

In terms of conservation of Maitland Jewish Cemetery, it would be useful to fill-in the GOULSTON gravesites (#6 & #7), particularly if the fallen steles are being repaired. The raising of the tiled infills to their intended level is a significantly more difficult and expensive possibility: the benefits not necessarily outweighing the costs (both monetary and in terms of potential damage to the infill or kerbing during operations to lift out and then reinstall the infill).

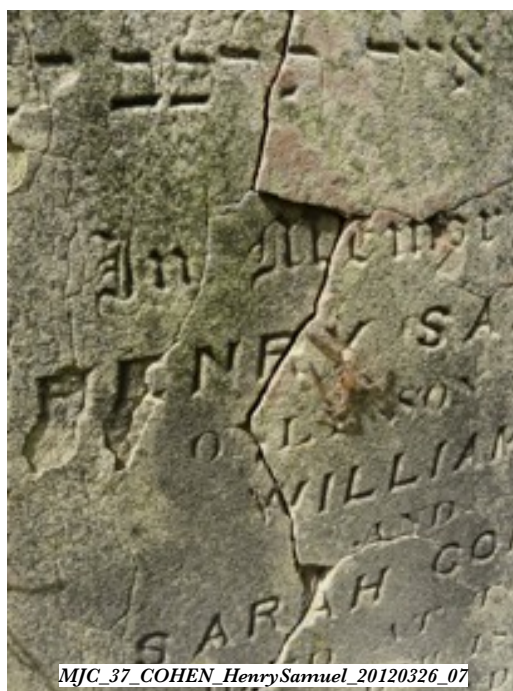
Craquele ranked as 4: significantly heavy on the Henry Samuel COHEN stele (#37, 1862).

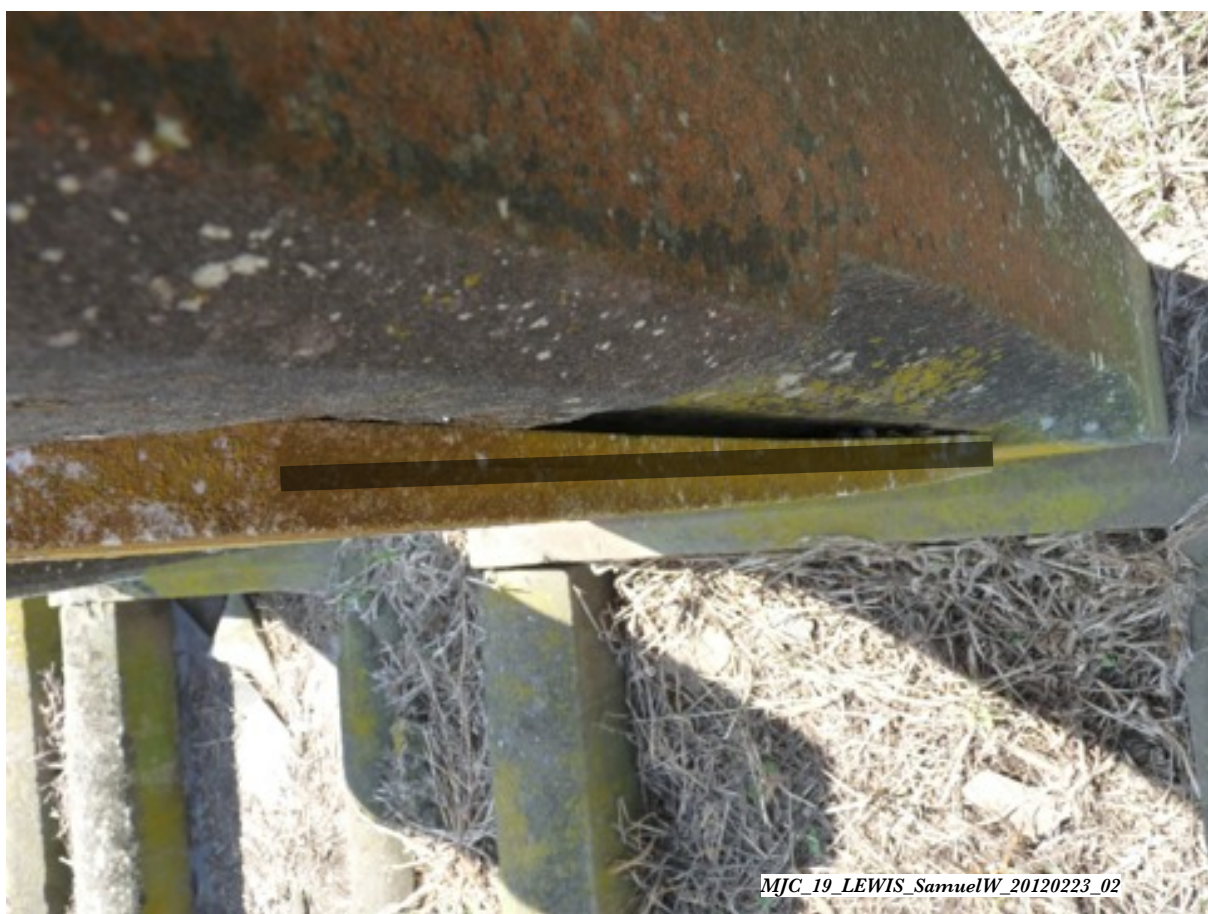
*Deformation of the marble inscription panel on the Samuel W. LEWIS stele
(#19, 1903, stonemason Thomas BROWNE).
Opaque black line superimposed for reference and drawn over centre line of panel.*

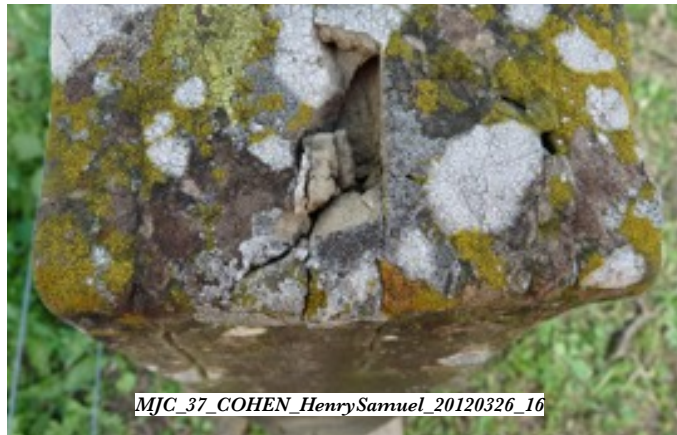
Crumbling at the top of the Henry Samuel COHEN stele (#37, 1862).

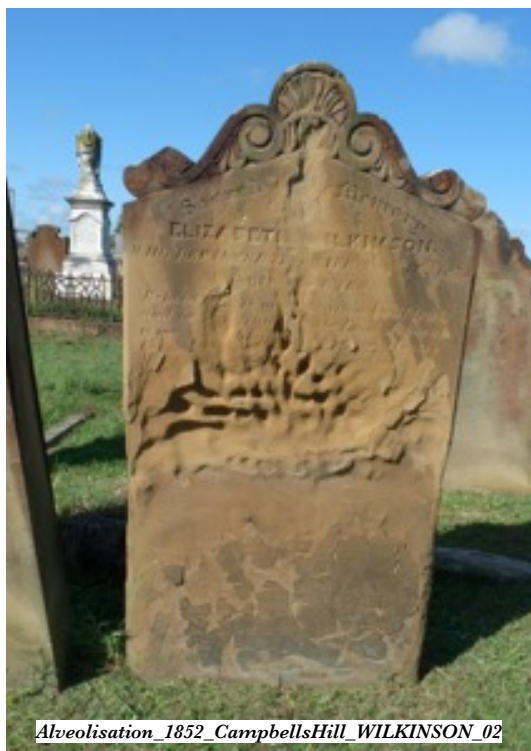
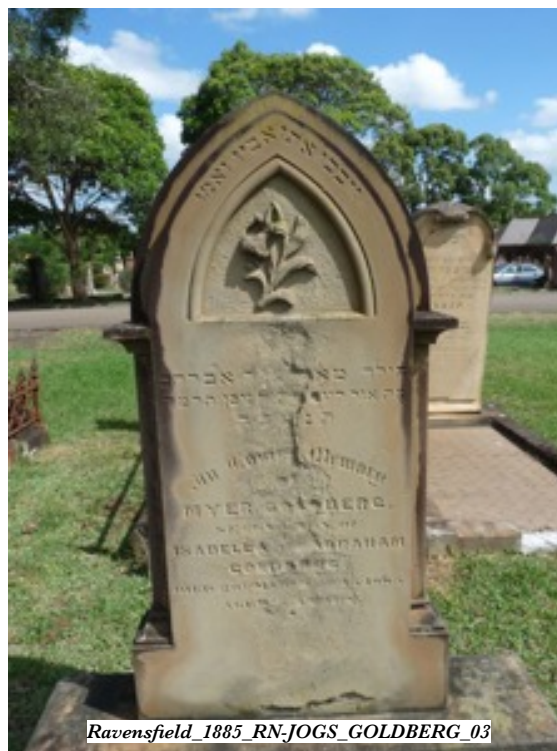
Alveolisation_1852_CampbellsHill_WILKINSON_02

FEATURES INDUCED BY MATERIAL LOSS ICOMOS-ISCS :Illustrated glossary on stone deterioration patterns (2008)
 Alveolisation: Formation, on the stone surface, of cavities (alveoles) which may be interconnected and may have variable shapes and sizes (generally centimetric, sometimes metric).

Examples of alveolar deterioration patterning.

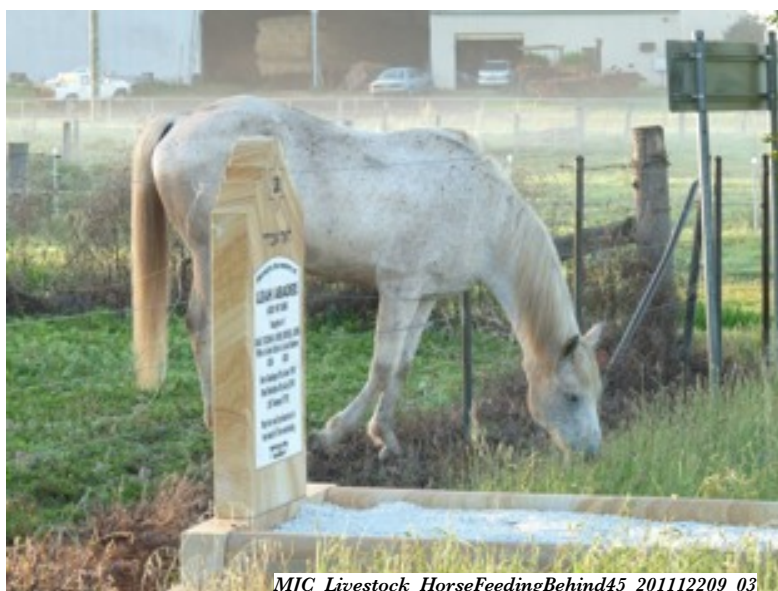
MJC_Livestock_HorseFeedingBehind45_201112209_03

Specific damage from livestock was observed in February 2012 and it will have been a continuing problem whenever the fence or gate has fallen into disrepair- as now with both the fence failing and the gate un-latched.

Horse pushing through fence to feed inside the cemetery. During the condition survey, a large pony was also observed rubbing itself heavily against a monument leaning into the fenceline.

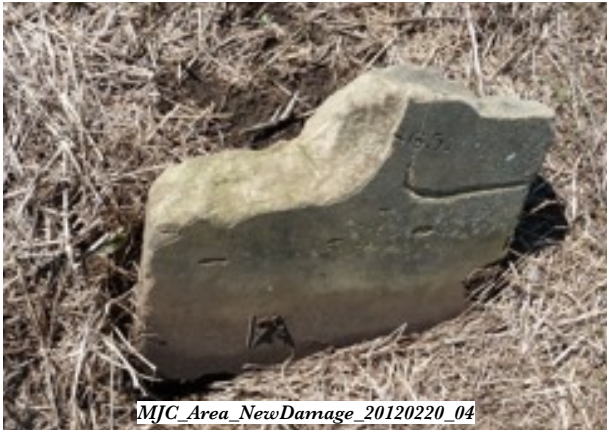
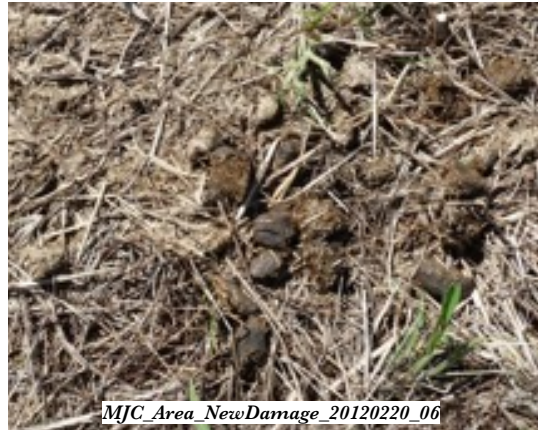
MJC Area_NewDamage_20120220_04

The Elizabeth ISRAEL footstone (#27) from 1865 was dislodged by a heavy impact between February 10th and February 20th, 2012. The gate was open and relatively fresh horse manure was found nearby.

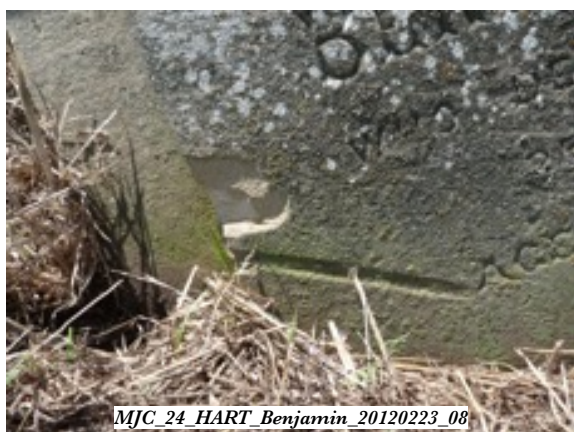
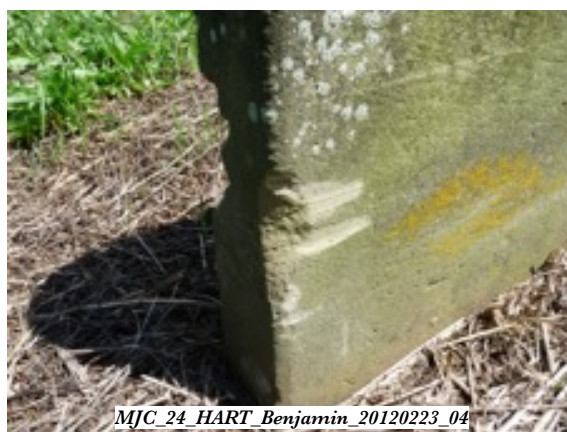
Both the Benjamin HART gravestone and footmarker (#24, 1905) experienced lawn mower damage that must have occurred during short course of the survey. The monument is broken and lying at an angle, making it difficult to see where it emerges from the ground. Both markers are, however, in flat and relatively clear and unobstructed areas– damage could have easily been avoided.

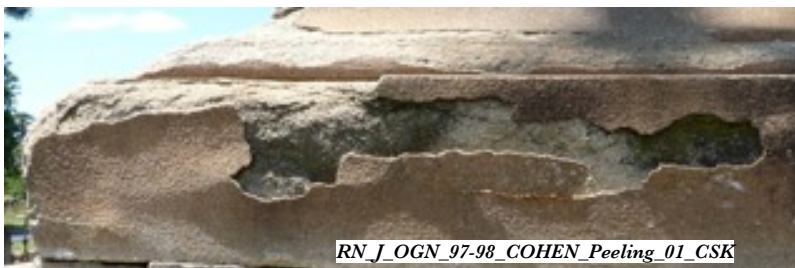
RN_J_OGN_97-98_COHEN_Peeling_01_CSK

One of the most noticeable findings of the on-going State of Vaults & Grand Monuments project in Rookwood Necropolis has been a specific form of peeling found on monuments which appear to have had historic or more recent stone sealant treatments.

Note that no outdoor monuments should be treated with a stone sealer. Despite claims made by each new generation of (miracle) stone sealants, each appears to have eventually caused terrible damage to the very stones they were intended to protect.

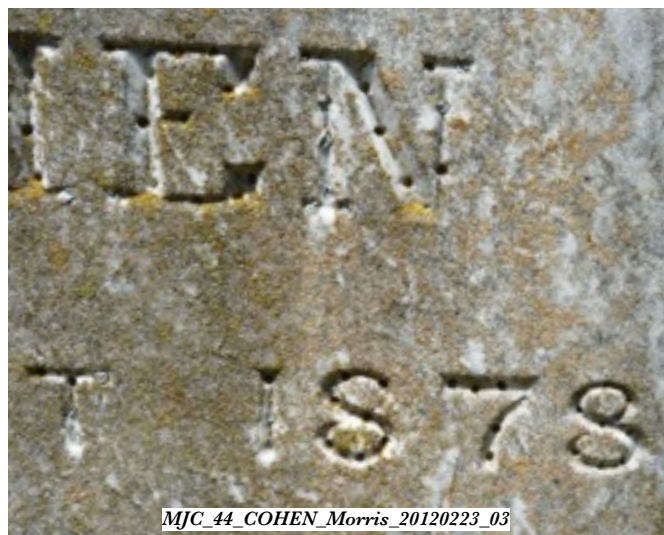
Note the remnant lead plugs in a number of letters– especially the N, T, and I– on the Morris COHEN stele. There has been no observation of similar problems with works by the monumental mason HANSON in numerous works in Rookwood Necropolis, Sydney.

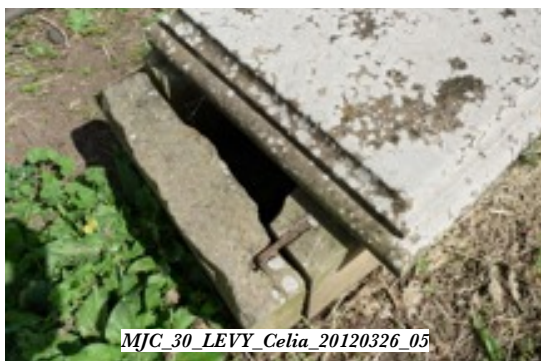
Rusting is a significant problem for a limited number of monuments at Maitland Jewish Cemetery. The Celia LEVY boxtomb (#30, 1854) is ranked as a potentially catastrophic problem (rank 5), as the iron cramps are failing and will inevitably lead to serious damage to the stone: both by rust jacking (which will appear as star cracking and then fractures) and by the lack of support for a monument which allowing it to separate, fall apart and collapse. Heavily significant problems were recorded for the Henry HART and Benjamin HART steles (#23 & #24): both at risk from iron pins which were installed to provide support but which failed and are now rusting. The ironwork fence which originally surrounded the Julia Alpha LEVY grave (#29) has created considerable damage to the sandstone kerbset through rust expansion. The fence sections, which appear both on the grave and likely comprise most of the stack of ironwork behind the Morris COHEN stele (#44), are rusting heavily and could deteriorate beyond repair if they do not receive conservation maintenance. Simple fish-oil treatment would be an effective, if short-lived, method to preserve the ironwork, although reinstallation might prove more effective in the long term. The latter would require, however, both a program (possibly by the Friends of Maitland) to document all surviving ironwork at determine its correct location and then either conservation or restoration works to reinstall the fencework and replace functional portions as needed. Note that an additional minor problem was recorded with the cast iron fencework on the George Judah COHEN gravesite (#14, rank 2): it is rusting at a much slower rate than that observed for pieces of the Julia Alpha LEVY ironwork and is not currently at risk. Conservation maintenance could be usefully undertaken to stabilise the extant section and, potentially, to reinstall surviving pieces and preserve them with a fishoil treatment.

Active rusting and rust-related damage on the Celia LEVY boxtomb (#30, 1854). The photo on the right shows a corner of a side section which has fractured— probably as a function of pressure exerted with the pushing open of the top slab combined with rust jacking.

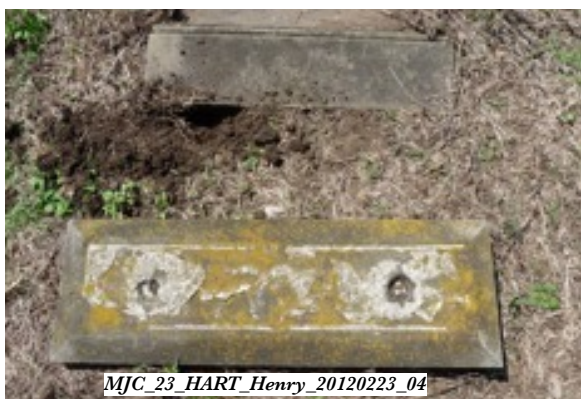
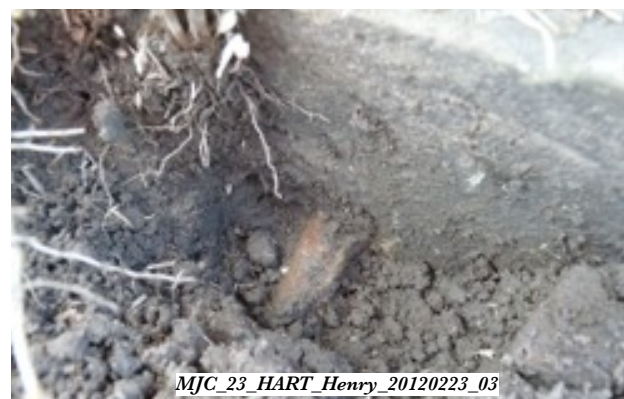
The Henry HART stele (#23, 1931) was not held securely despite cement and iron pins. At least one pin remains in the sub-base and is rusting: it will inevitably cause damage in the form of star-cracking and, subsequently, the fracturing of the stone.

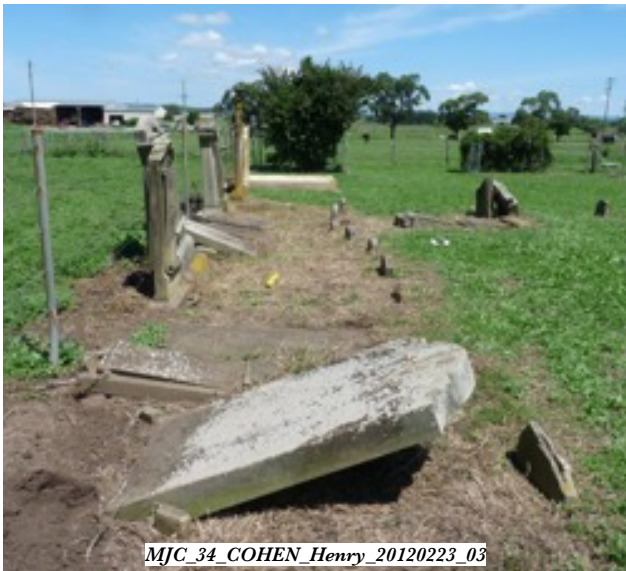
The Henry COHEN stele (#34, 1860) is just about to fall and fracture. It may not have broken as it may be designed as a 'tabletstone': a single piece which is traditionally installed 1/3rd in the ground and 2/3rd above.

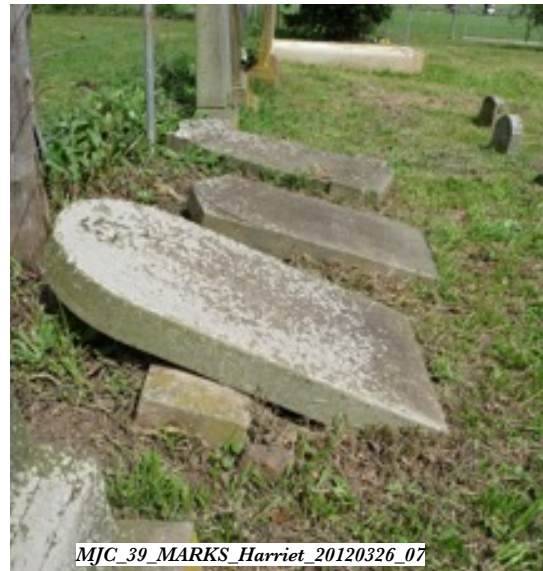
The forward lean of the Harriet MARKS base (#39, 1869) reveals that it was leaning significantly forward before it fractured and fell.

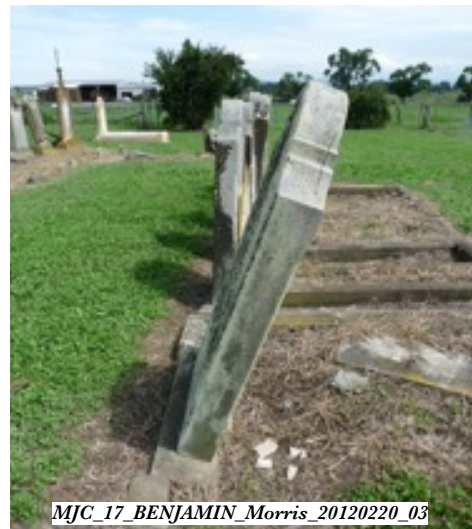
MJC_17_BENJAMIN_Morris_20120220_03

The Morris BENJAMIN stele (#17, 1897) leans heavily forward such that it is a possible public safety risk, and a danger to itself. The marble inscription panel as already fallen and the stele is leaning at 33% forward (measured at 200mm forward over 600mm) with the plinth unsecured and partially out of the ground. Previous repairs to secure delaminating front sections are intact but are placed under increased stresses by the lean and will be at risk if the monument falls.

The forward lean of the Morris BENJAMIN stele (#17, 1897) has already led to the loosening and fall of the inscription panel. The monument, which does not appear to be tied into or fixed to the kerbset, is at risk of falling.

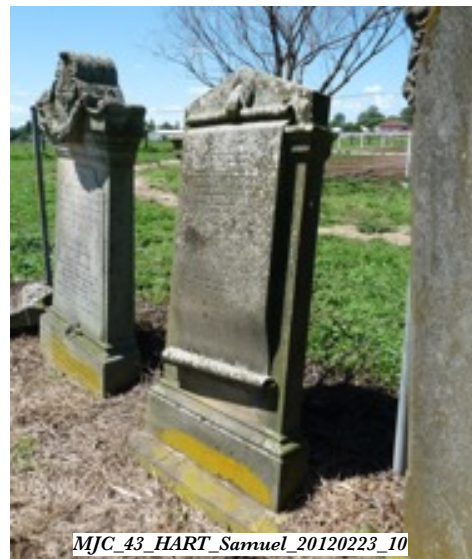
MJC_43_HART_Samuel_20120223_10

The Samuel HART stele (#43, 1877) leans backward by 19% (measured at 112mm back over 600mm). Combined with significant cracking and delamination, the stability of the monument is compromised. Conservation maintenance to level the stele may be sufficient to address the immediate safety risk: but further conservation repair works to secure the cracking should be considered.

The backwards lean of the Samuel HART stele (#43, 1877) is placing it at risk both of falling and through exposure to livestock and hazards outside the fence.

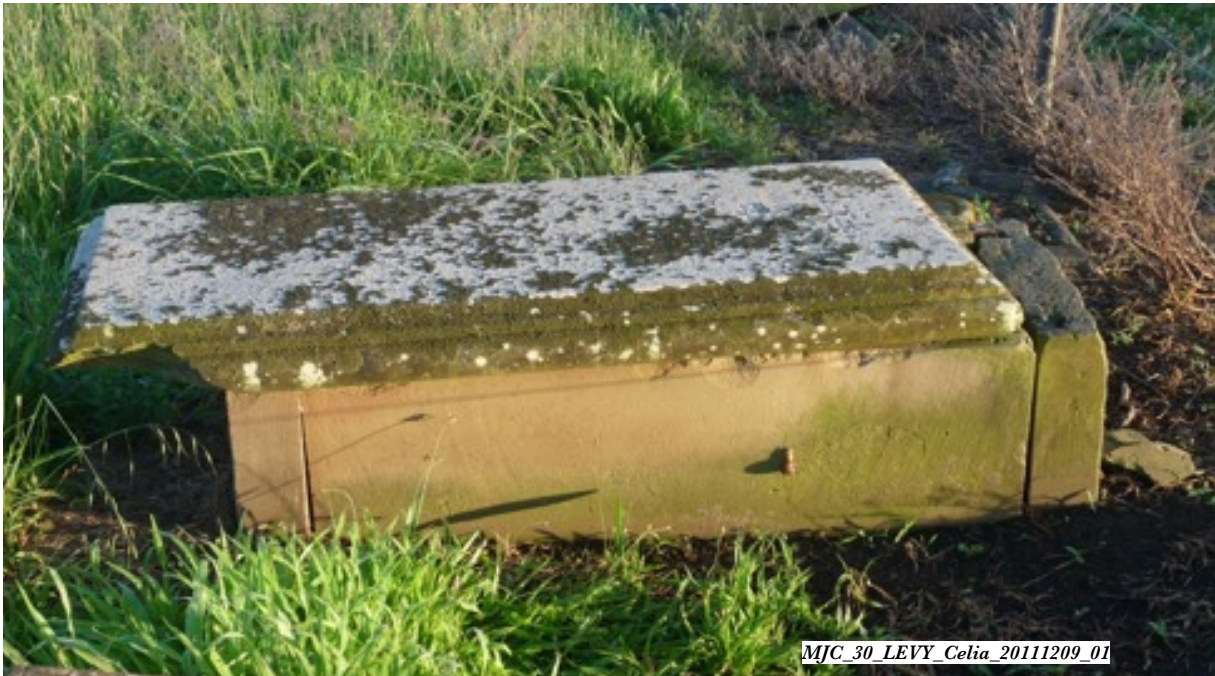
Movement of the top slab, coupled with rusting of the fixing cramps, is placing the Celia LEVY boxtomb (#30, 1854) at risk of collapse.

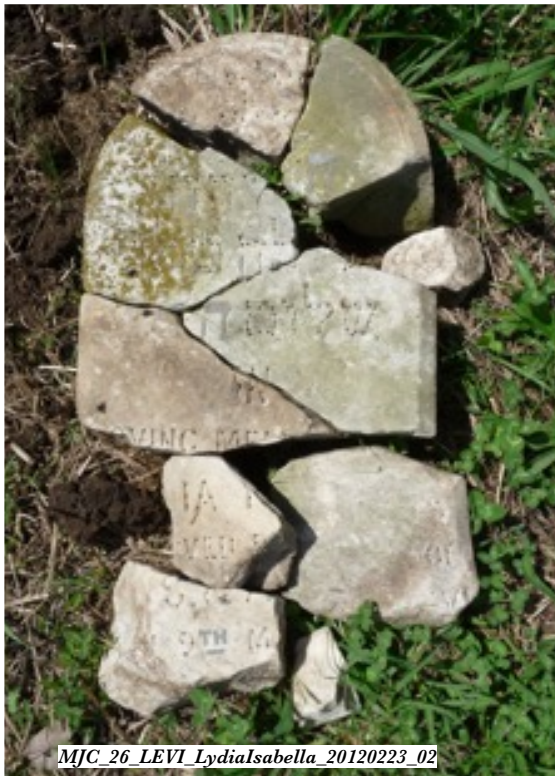
The small marble monument for Lydia Isabella LEVI (#26, 1898) is in danger of continuing loss of fabric: multiple pieces are already missing, and its correct gravesite location is unknown.

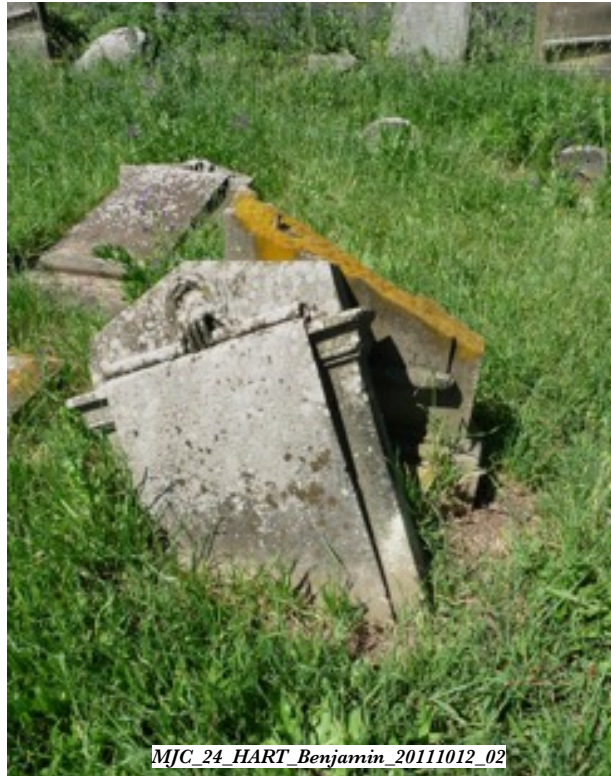
The Benjamin HART stele (#24, 1905) is at considerable risk of ongoing impact damage: as clearly shown by heavy chipping, scratching, and cuts which occurred from lawn mowers during the site survey.

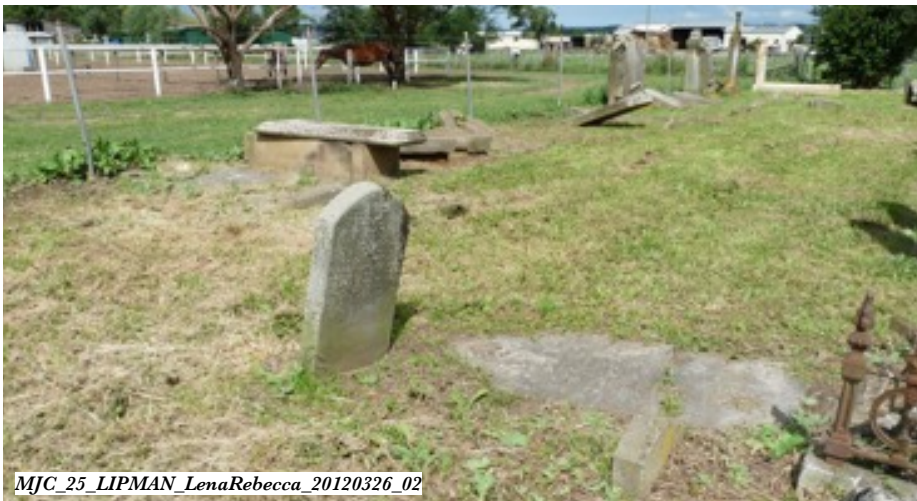
Foreground monuments for Lena Rebecca LIPMAN (#25, 1882, on left) and George Judah COHEN (#14, 1889, on right) are both High Conservation Priorities: the former as it has a structural lean, the latter being at risk of accelerated deterioration as well as further impact damage lying on the ground.

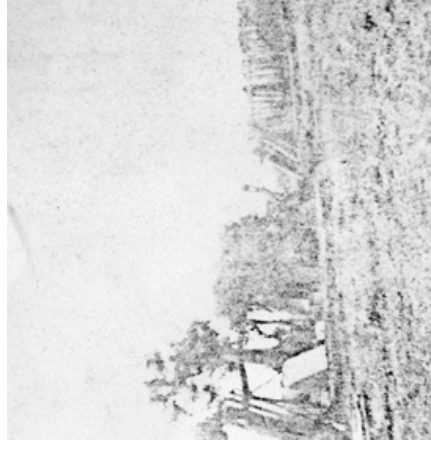
Fence

From historic pictures of the cemetery, we know that a picket fence has always surrounded the site. Historic evidence suggests that a boundary fence for the cemetery has always been maintained in one form or another as the only persistent man-made features on the site through the years. Photographic evidence shows a fence that appears to be approximately 6ft high and of timber picket construction.
