Proposed Residential
Subdivision – Addendum
Contamination
Assessment

Stages 8 to 14 - 70
Christopher Road,
Lochinvar NSW

NEW17P-0034A-AE.Rev2
22 October 2021

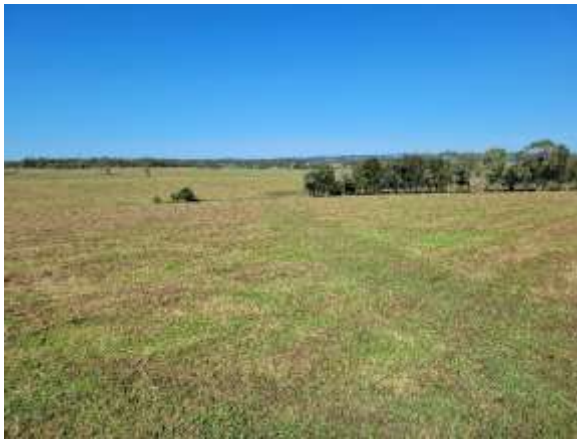
- The site appears to be generally unchanged and consisted of grazing land. The residential dwellings on Lot 2 and Lot 310 and Lot 32, formerly assessed by Coffey (2015 & 2017) are not included in the current assessment area, and/or the land use is not proposed to be changed, and therefore have not been assessed.

Looking SW from NE portion of the site

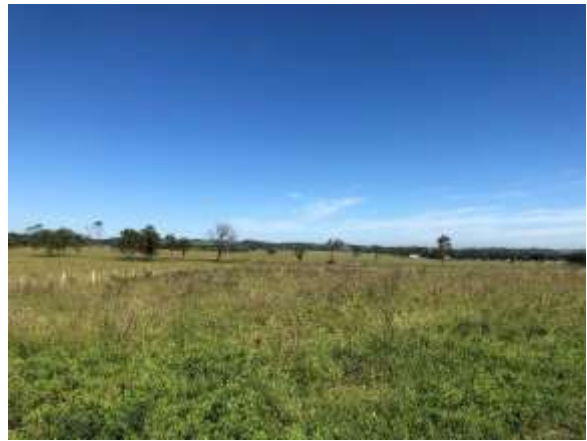
Looking NE from SE portion of the site

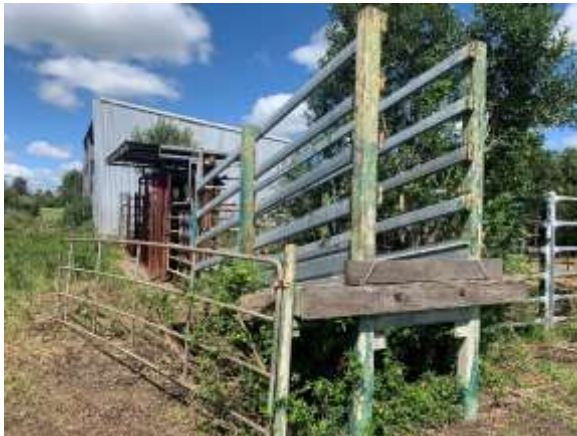
- A farm shed and cattle ramp/yard were observed on the north eastern portion of the site (former Lot 32). The shed was observed to be constructed from timber and corrugated iron/metal sheeting and earth floor. The shed was observed to contain timber, corrugated iron, wire, metal poles, tyres, general household waste, PVC and a mower. No oils, paints or chemicals were observed.

Cattle Ramp – NE portion of the site (former Lot 32)

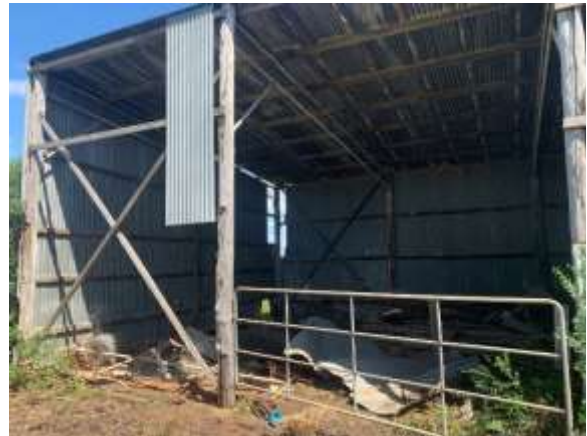
Farm shed – NE portion of site (former Lot 32)

- *“The farm waste inside the shed Lot 32 (north eastern portion of the current site) is removed and the surface soils inside the shed observed. If evidence of potential contamination is identified (such as stained or odorous soils), an environmental consultant should be contacted to collect additional surface soil samples”.*
- *A Construction Environmental Management Plan (CEMP) is implemented, prior to earthworks commencing, in order to appropriately manage the on-site and off-site disposal of soil, sediment and water.” The CEMP will also be required to manage anthropogenic materials observed across the site.*

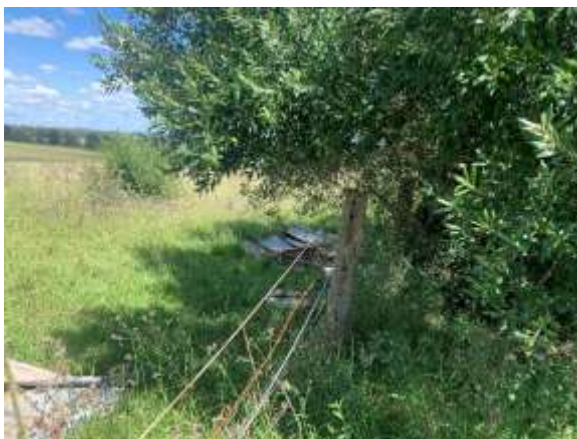
- Corrugated iron/metal sheeting was observed on the site surface along the eastern boundary of the site.

NE portion of the site

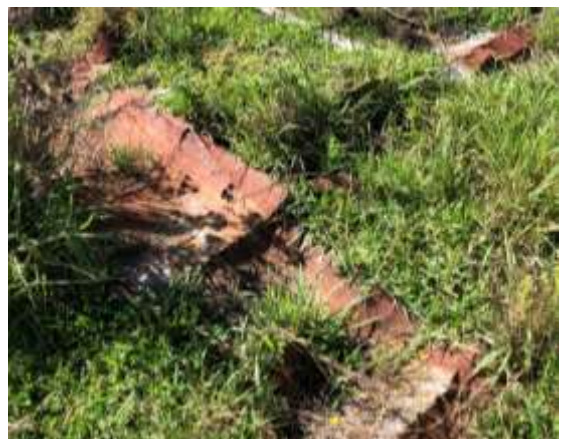
Eastern boundary of the site

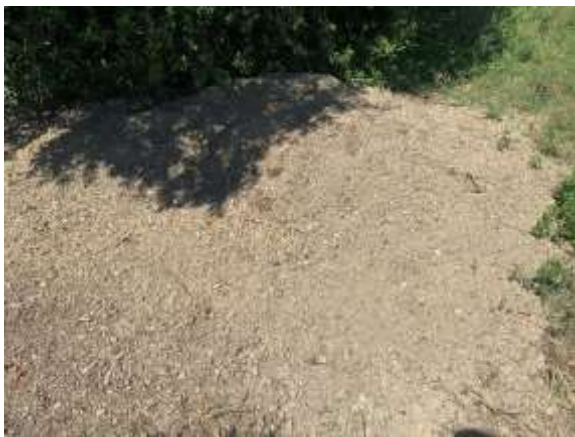
- A small gravel stockpile was observed to the north east of the cattle yard. The stockpile was observed to be 5m^3 and appears to be imported quarry material used for a driveway to the north of the cattle yard. Concrete piping was also observed in the area.

Gravel Stockpile NE portion of the site

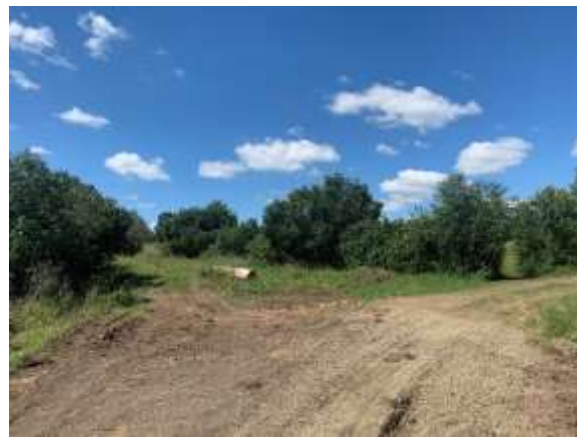
Driveway north of cattle yard

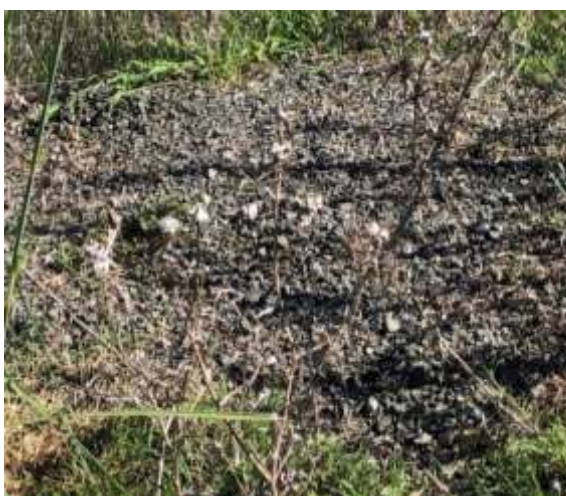
- A gravel stockpile and timber/vegetation were observed stockpiled along the north eastern boundary of the site. The stockpile appeared to consist of quarried gravel/ballast.

Gravel/Ballast

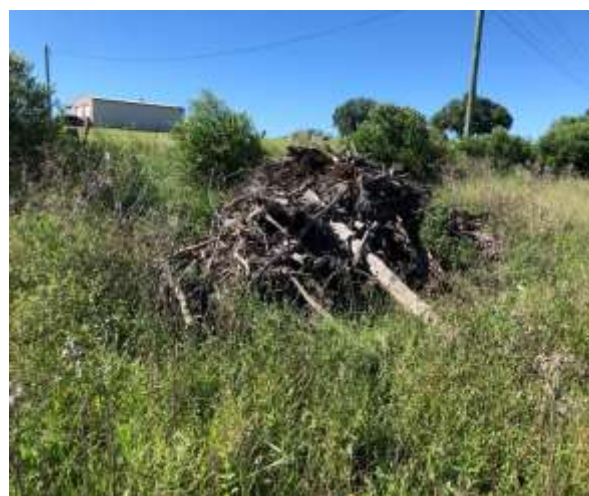
Timber/vegetation

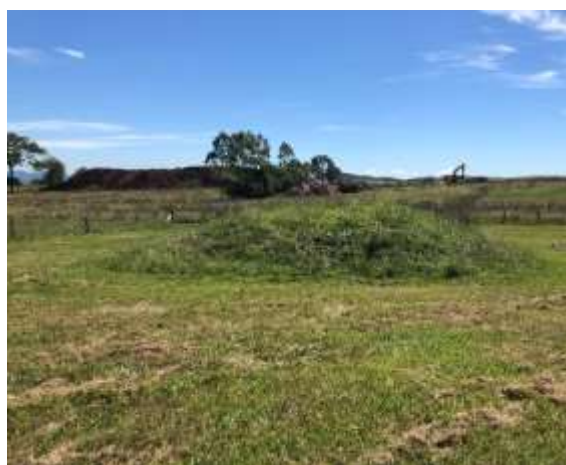
- Three stockpiles (SP1, SP2 and SP3) of sandy clay material were observed in the centre of the site. The stockpiles were observed to be the following approximate volumes; 240m³ (SP1), 550m³ (SP2) and 400m³ (SP3). The stockpiles were observed to be brown sandy clay with some shale, consistent with site material.

SP1 – Central western portion of the west

- The sandy clay fill mounds (SP1 to SP3) were generated during the installation of a water main by Hunter Water in late 2016/early 2017. The fill mounds consist of site material including topsoil, residual clay and weathered shale.
- The ballast stockpiles were imported to site as part of the Hunter Water watermain installation works. Hunter Water's contractors used the eastern portion of the site as a site compound, with temporary fencing, stockpiling of imported gravel/ballast and storage of machines. Mr Aird did not note any staining, or observe refuelling activities at the compound.
- The gravel/ballast stockpile observed in the north eastern portion of the site, north of cattle yard, was left over imported gravel/ballast from the watermain works and used in the driveway.

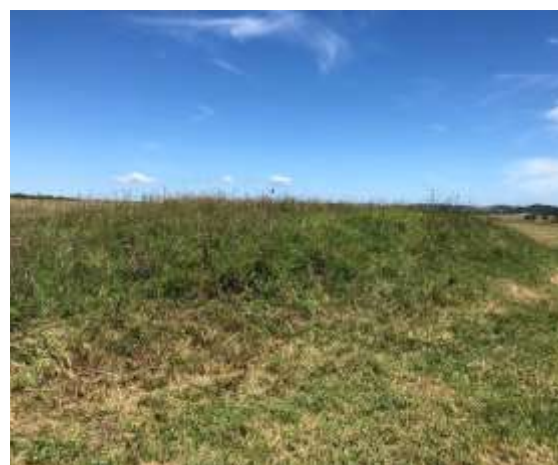
SP2 – Centre of the site

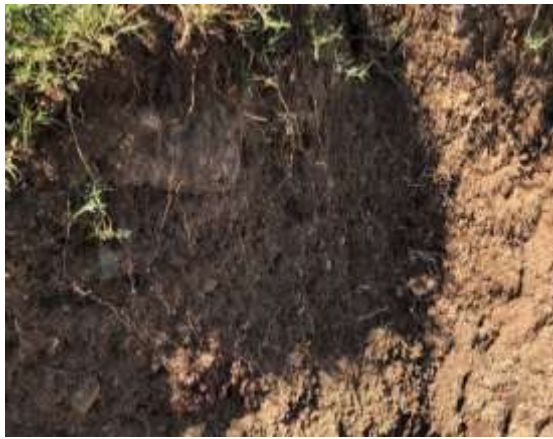
Sandy Clay material - SP2

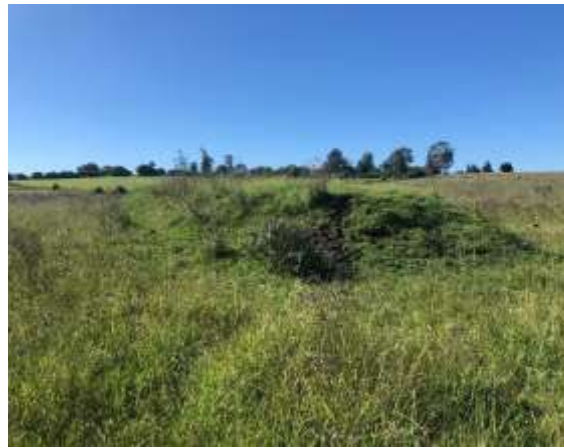
SP3 - Central eastern portion of the site

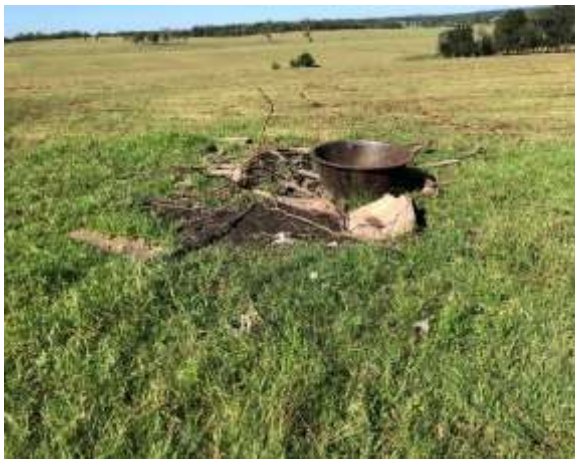
- A metal fire pit with timber/cardboard, and chicken shed, were observed in the northern portion of the site. The shed was constructed with corrugated iron/metal sheeting with earth floor.

Fire pit – northern portion of the site

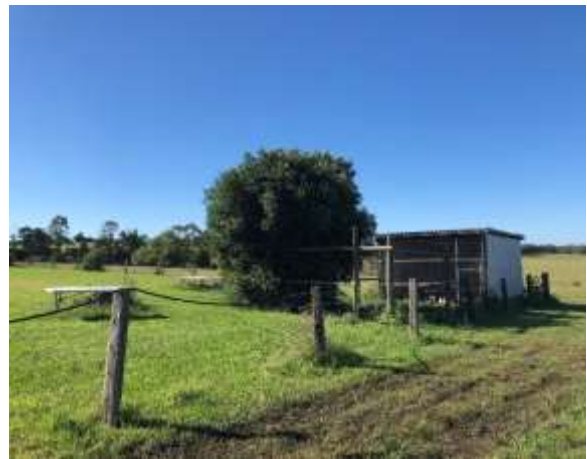
Chicken shed – northern portion of the site

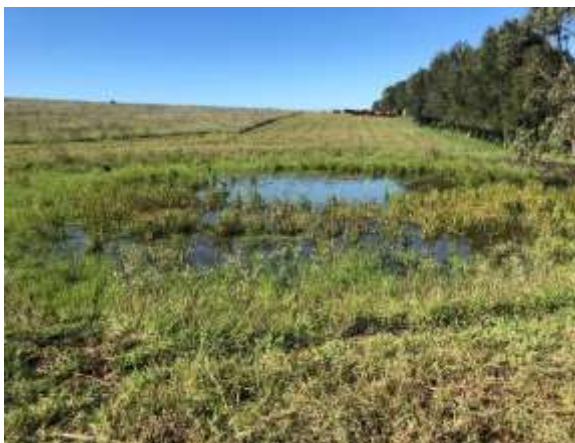
- Two dams/ponds (Dam 1 and Pond 1) and drainage lines were observed on the site. Pond 1 was consistent with Pond 1 identified by Coffey (2017). It is noted that Dam 1 was not discussed in Coffey (2017) or shown on the Figure, however was likely discussed in the Coffey (2015) report, which was not provided to Qualtest. Qualtest considers it likely that SW2 (Coffey 2017) was collected from Dam 1.

Dam 1 – Central portion of site

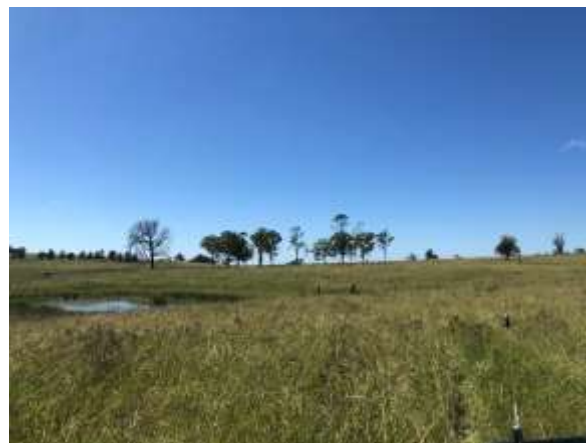
Pond 1 – SW of site

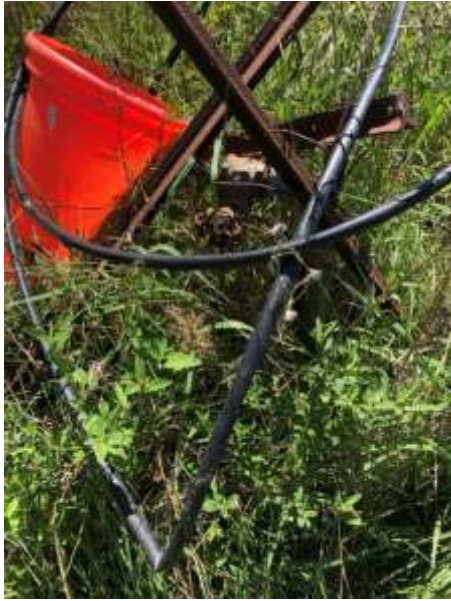
- PVC irrigation pipe work was observed in north western portion of the site.

Metal & PVC piping – NW portion of the site

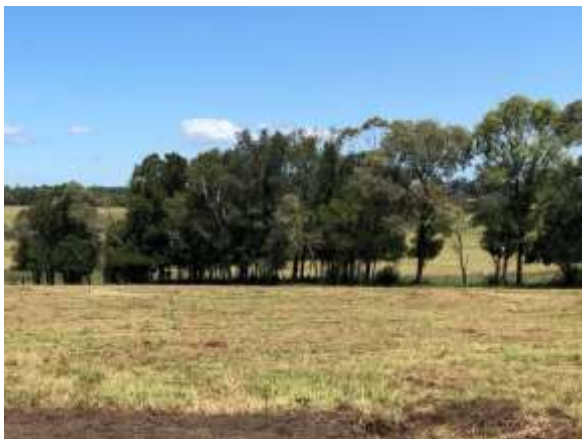
- Disused 205L drums were observed along the north western boundary of the site and offsite to the west.

Disused 205L drum – NW boundary in treeline

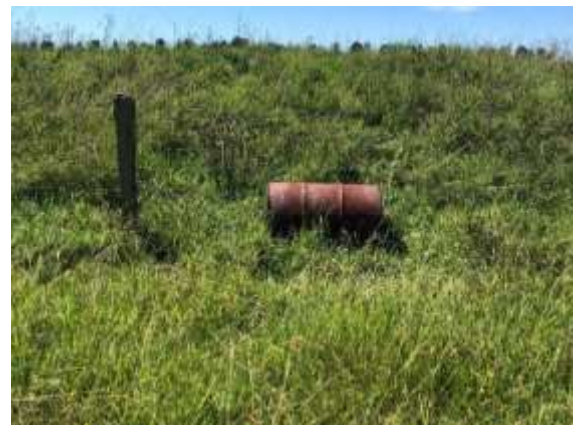
Disused 205L drum – Offsite to the west
