FR 077

SITE AUDIT REPORT

107-117 SWAN STREET, MORPETH

SITE AUDIT REPORT - 107-117 SWAN STREET, MORPETH

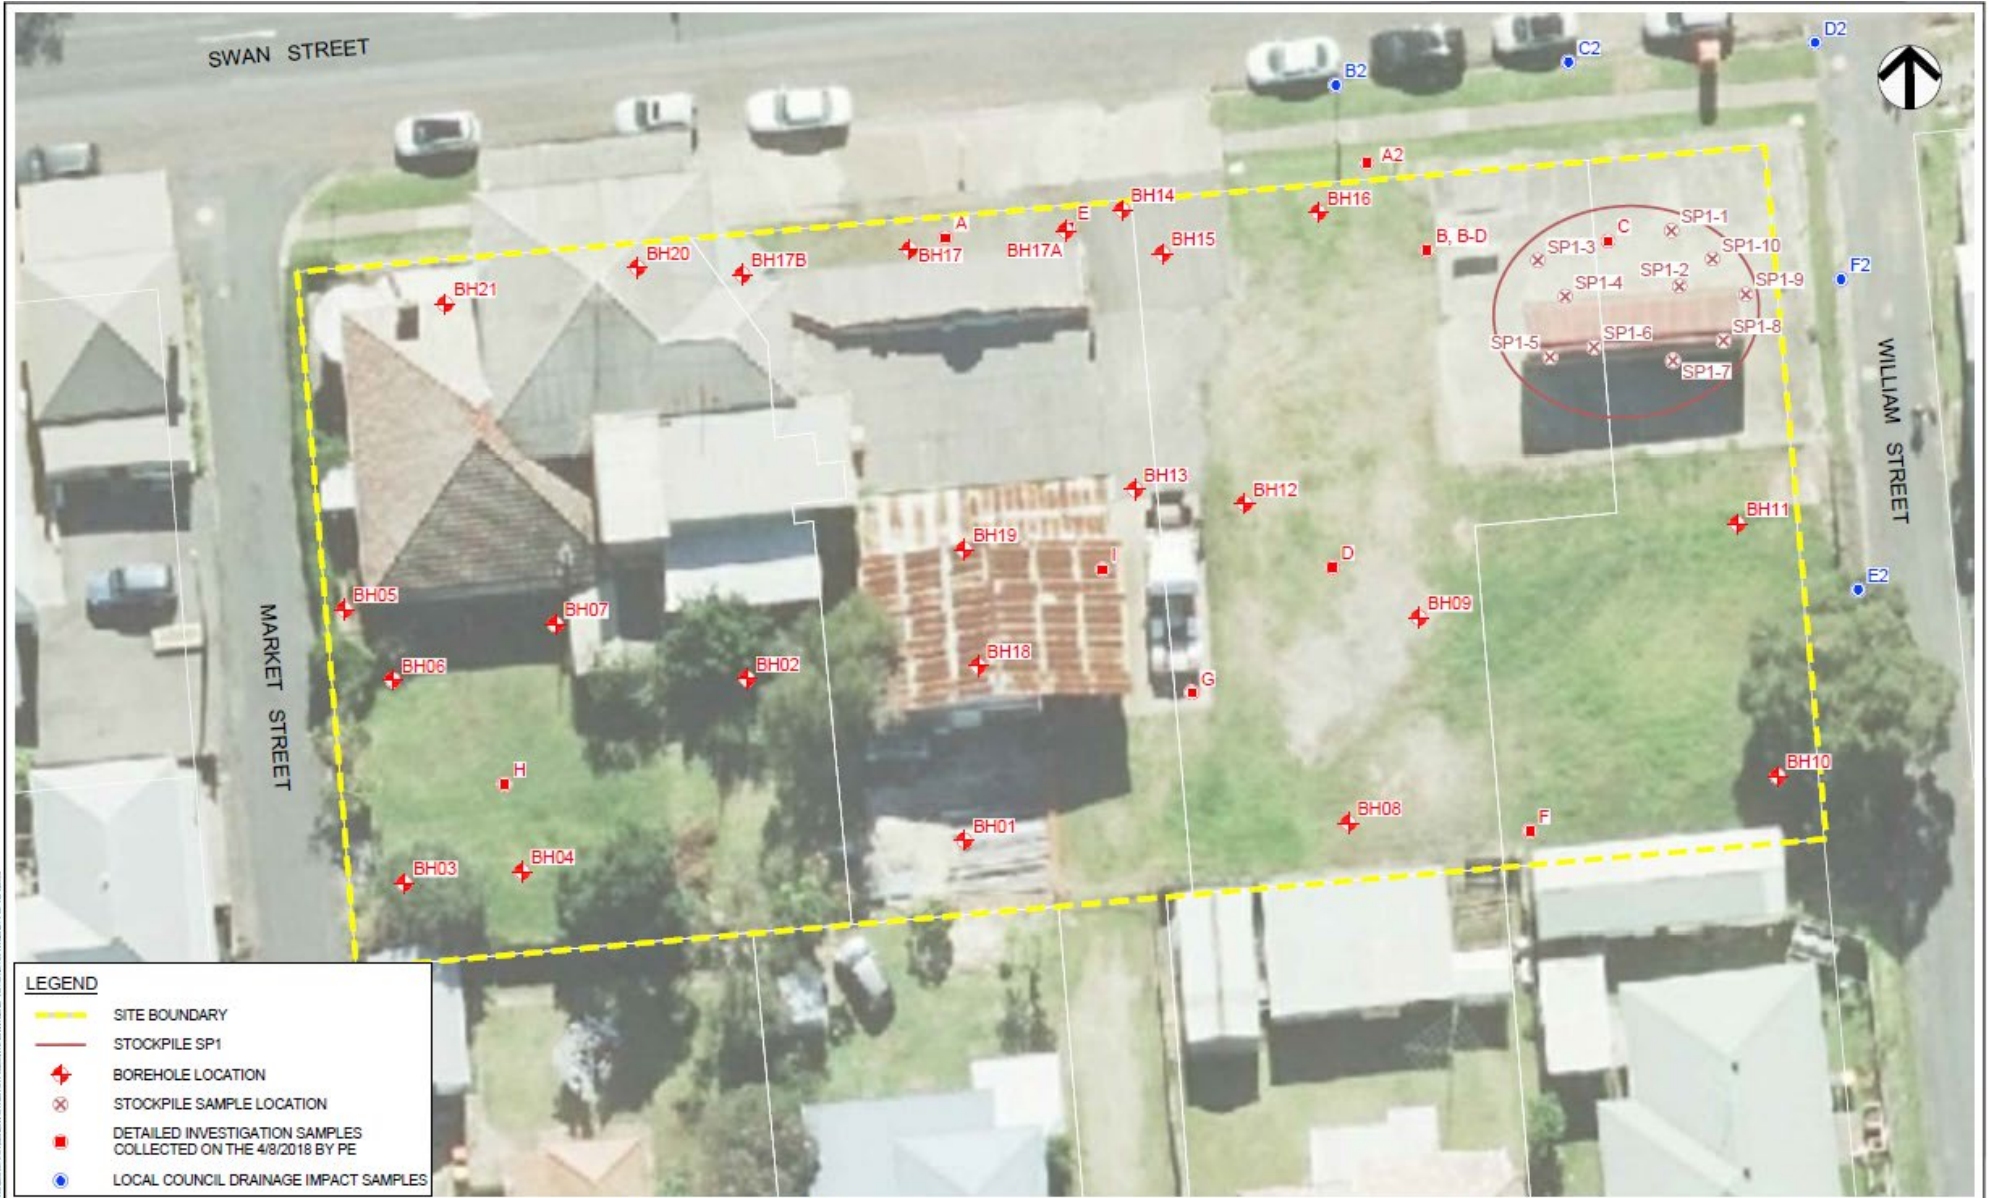
Attachment 2: Site Plan and Sampling Locations

The boundaries of the site are well defined by streets and adjoining properties (**Attachment 2, Appendix A**).

- Buildings were present on the western portion of the site as shown in **Attachment 2, Appendix A** and demolition had commenced. Mr Unicomb indicated demolition early works to comprise asbestos removal works. There was evidence of an in ground hoist cylinder in the eastern most retained building. There was no evidence of underground or above ground storage tanks.
- The building shown on **Attachment 2, Appendix A** on the eastern side had previously been removed and this area contained a soil stockpile. A shallow excavation existed to the west and southwest of the soil stockpile.
- The remainder of the site was grassed. The site sloped to the north toward Swan Street and was elevated above the river height.
