**BUSHFIRE ASSESSMENT REPORT**

**PROPOSED LAND CHANGE OF USE TO SCHOOL GROUNDS**

**LOT 1 DP 1247459  
118 Dragonfly Drive, Chisholm**

Prepared for: **Catholic Diocese of Maitland-Newcastle**

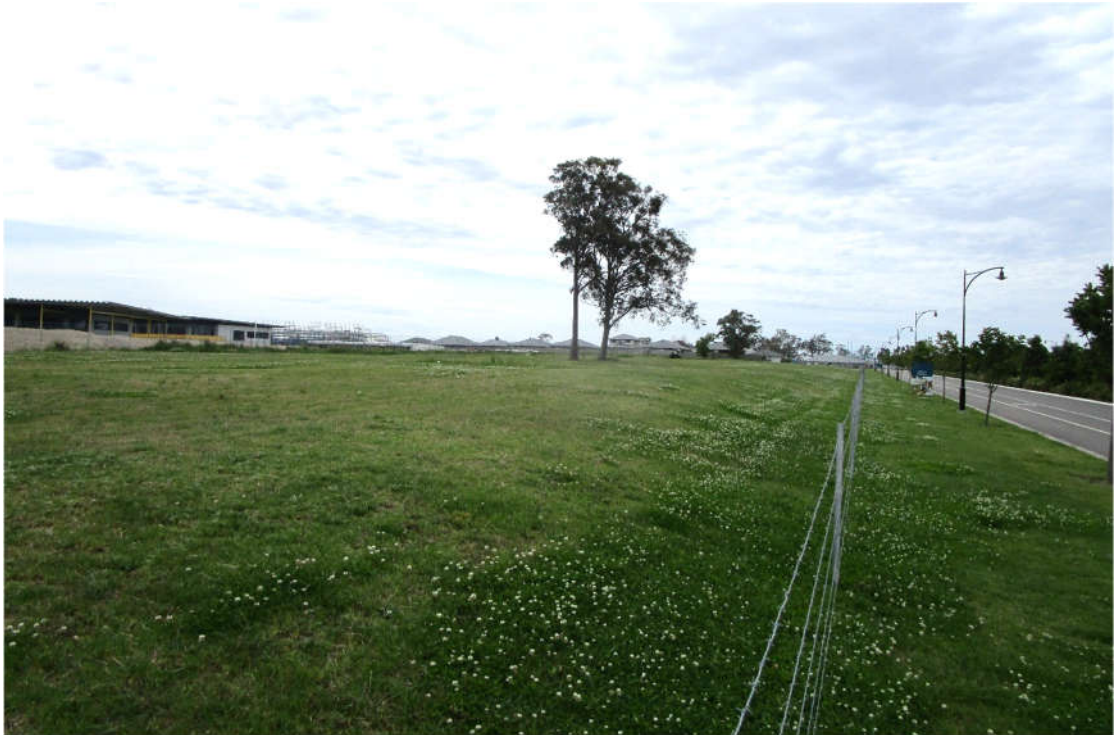
PHOTOGRAPH 1 – SITE PHOTO

View of the subject site looking north. The subject site is mown grass with the existing school visible to the west.

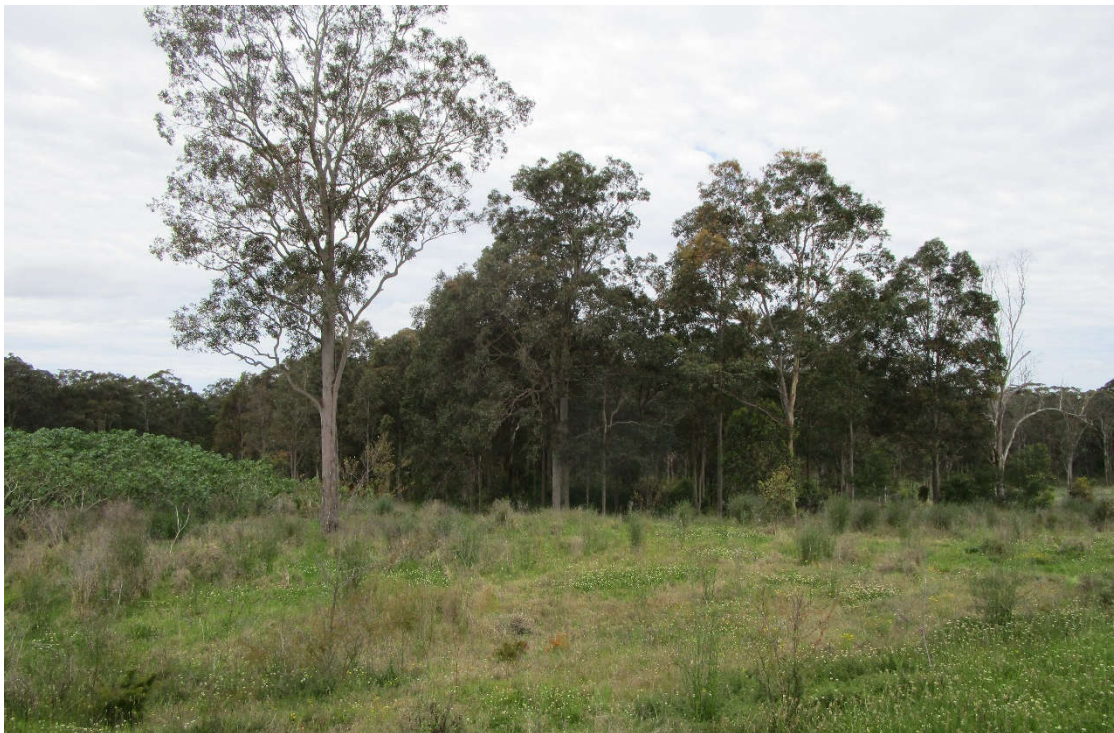
PHOTOGRAPH 2 – EASTERN GRASS AND FOREST

View of grassland and Hunter Macleay Dry Sclerophyll Forest located east of the site. The forest is dominated by eucalypts in the upper stratum with a sparse grassy understorey. Significant clearing has occurred in recent years and will continue as further subdivision stages progress.

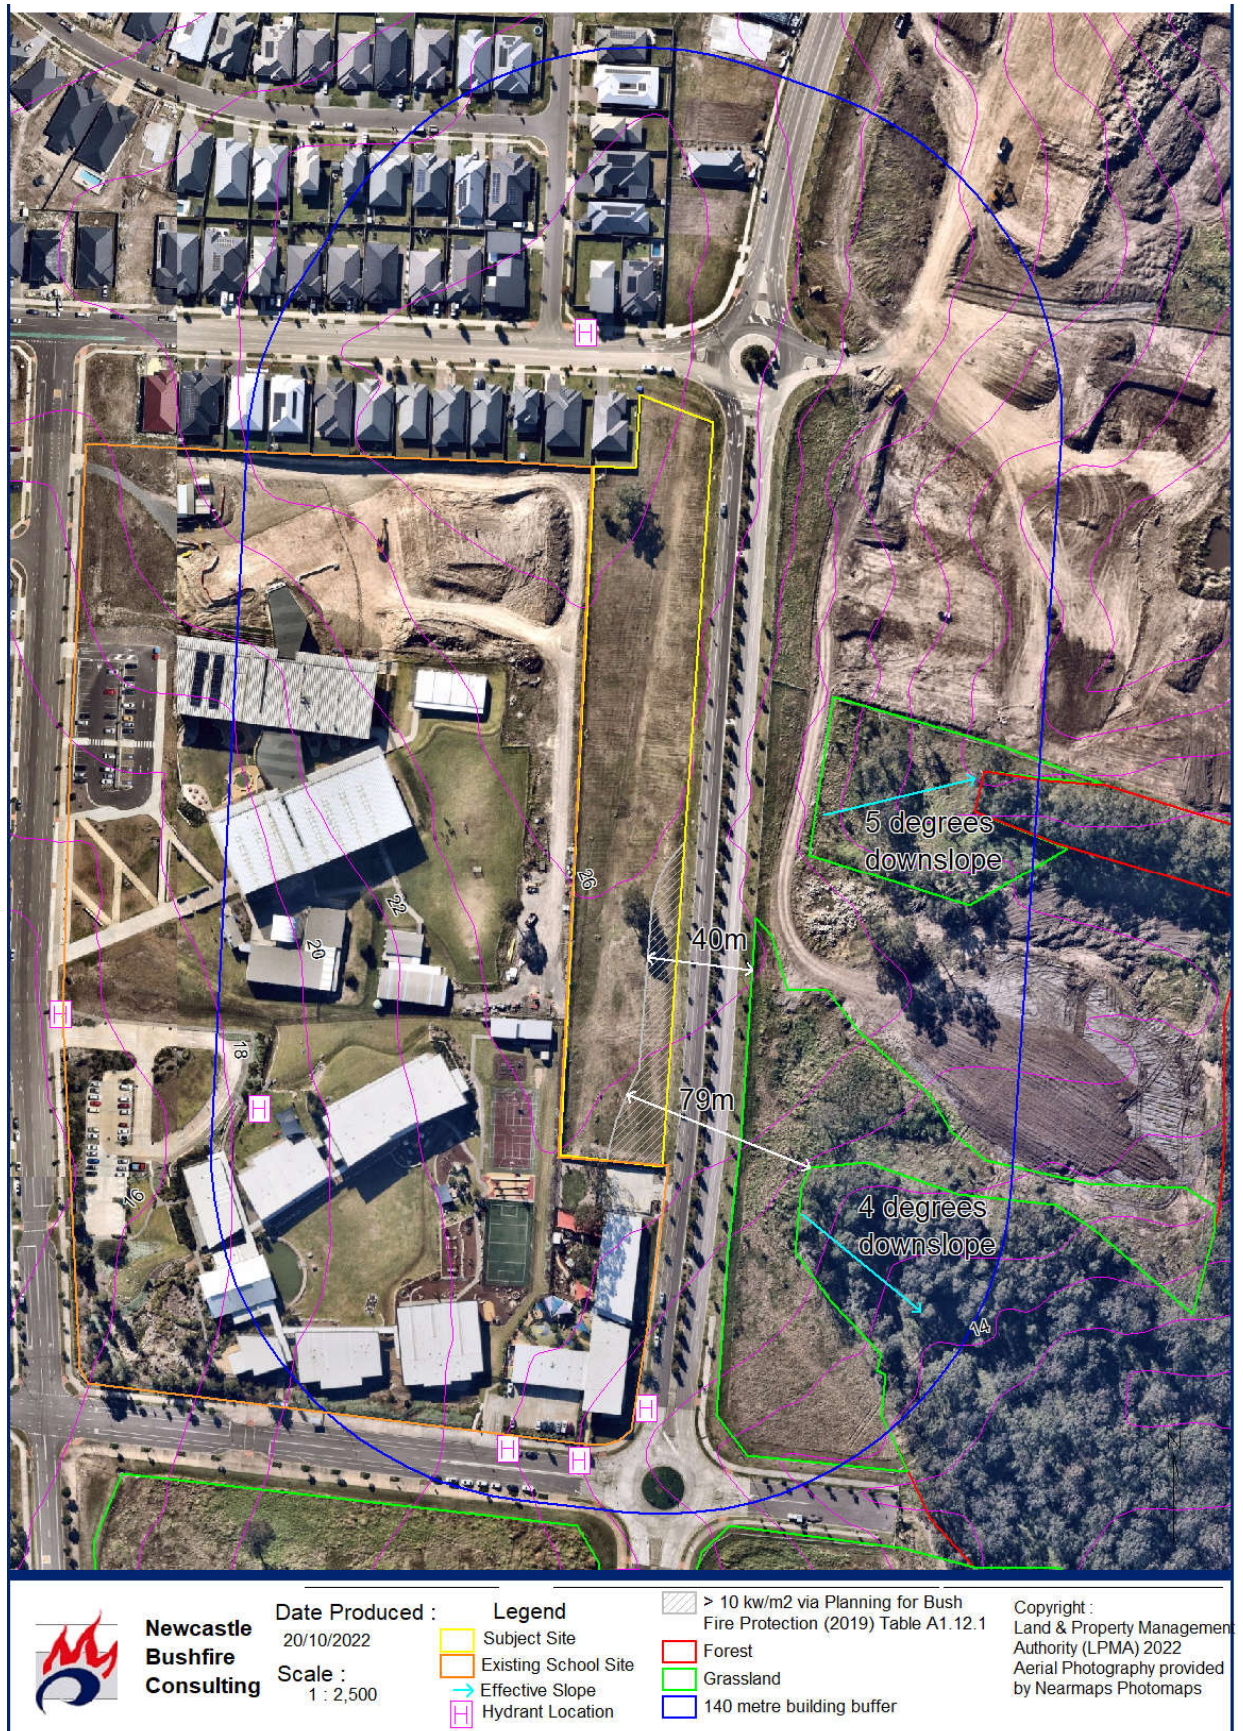
FIGURE 1 – SITE CONSTRAINTS MAP

Primary Vegetation Structures have been identified in Figure 1 – Site Constraints Map and separation distances shown in Table 2 – Bushfire Attack Assessment.

Effective slopes have been identified in Figure 1 – Site Constraints Map and slope ranges are shown in Table 2 – Bushfire Threat Assessment.

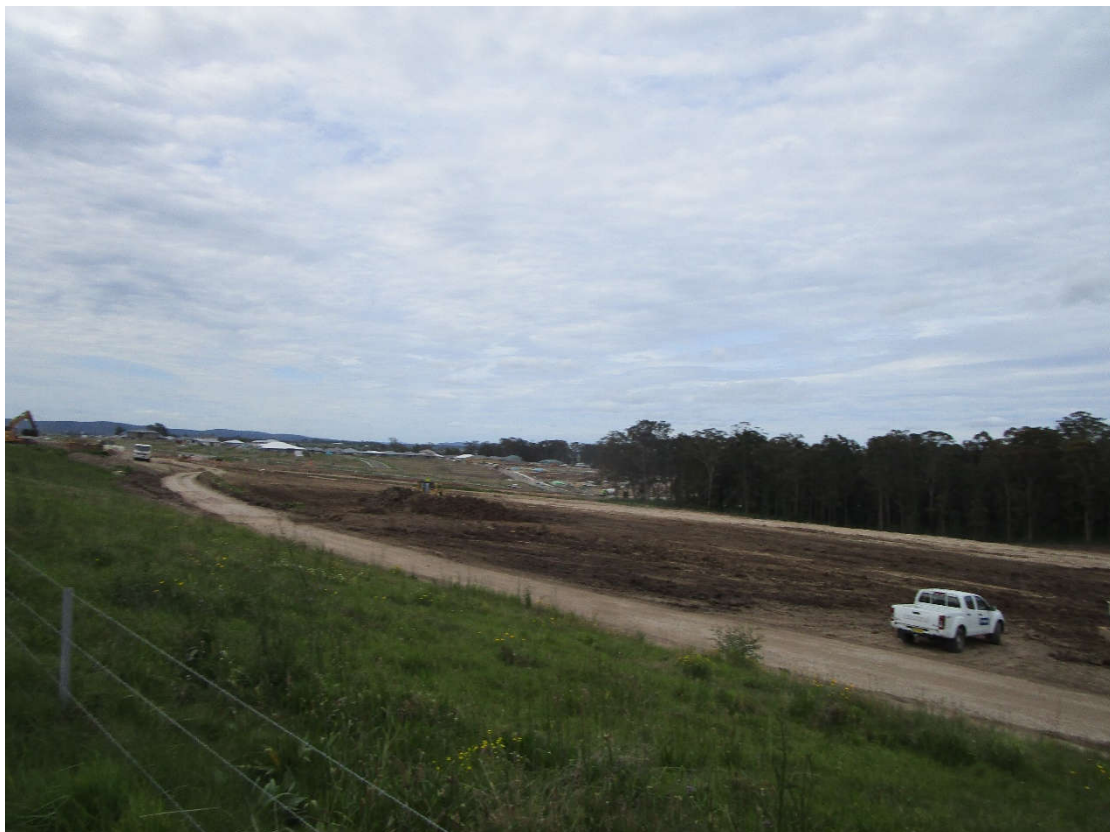
**PHOTOGRAPH 3 – NORTHEASTERN CLEARED LAND FOR RESIDENTIAL DEVELOPMENT**  
View of cleared land located northeast of the site for future residential development stages within Waterford County.
