BUSHFIRE ASSESSMENT REPORT

PROPOSED 1 INTO 2 LOT SUBDIVISION

**LOT 1 DP 1224700
20 Heritage Drive, Chisholm**

NEWCASTLE BUSHFIRE CONSULTING

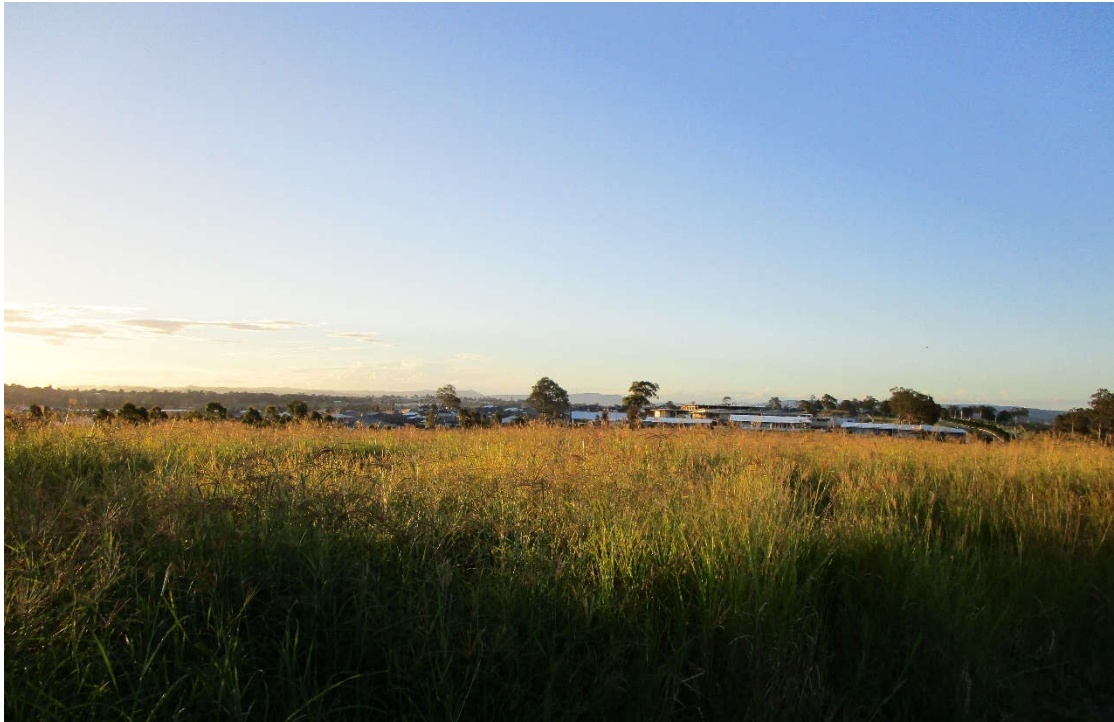
PHOTOGRAPH 1 – SITE PHOTO LOOKING NORTH

View of the subject site looking north. The site is predominantly unmanaged grass exceeding 50 centimetres in length. The neighbouring school can be seen in the distance.

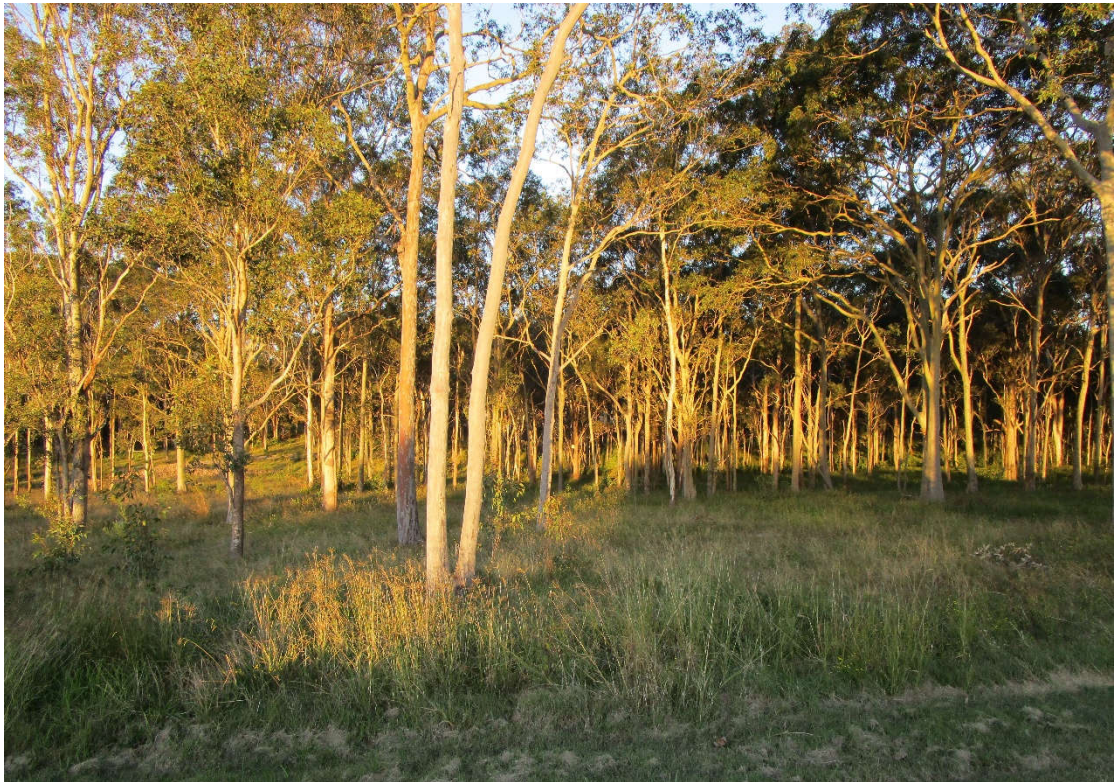
PHOTOGRAPH 2 – EASTERN FOREST

View of dry sclerophyll forest located east of the site. The forest is dominated by eucalypts with a low density, grassy understorey.

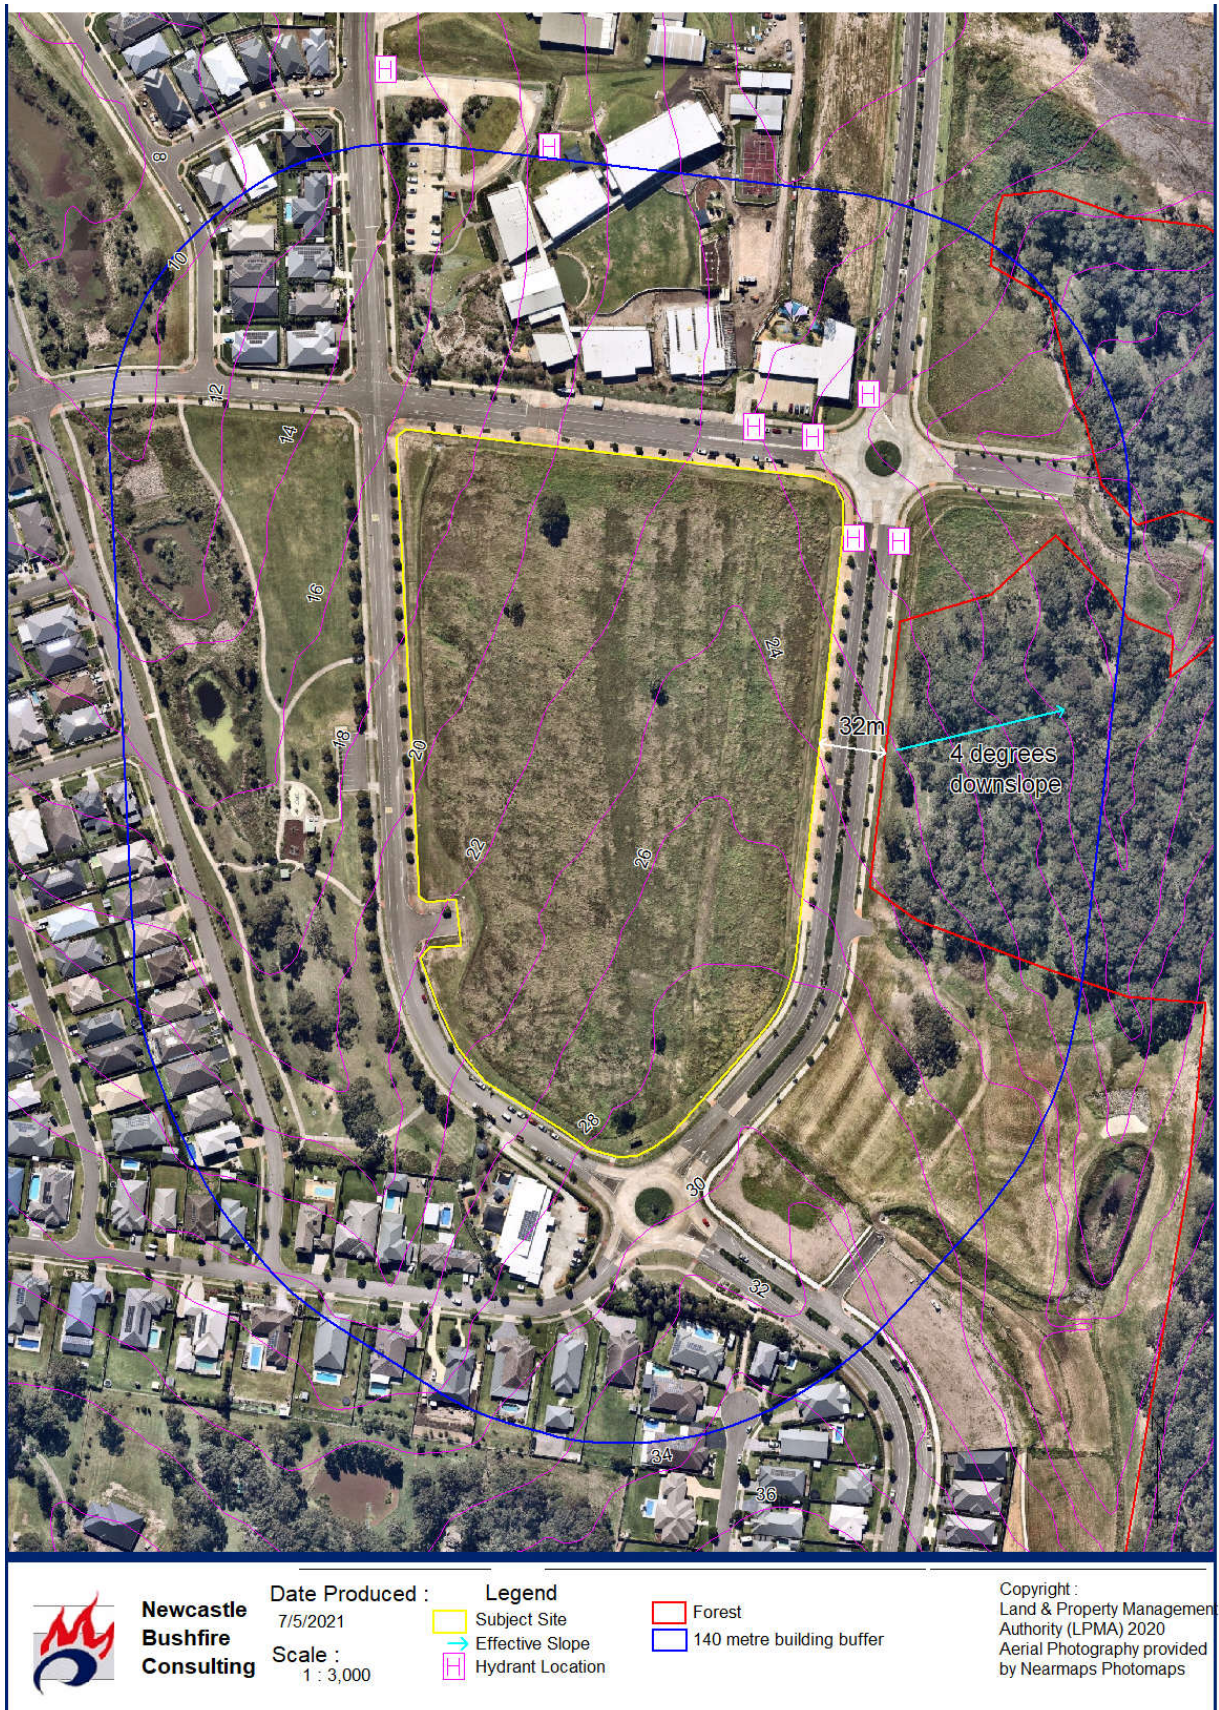
FIGURE 1 – SITE CONSTRAINTS MAP

Primary Vegetation Structures have been identified in Figure 1 – Site Constraints Map and separation distances shown in Table 2 – Bushfire Attack Assessment.

Effective slopes have been identified in Figure 1 – Site Constraints Map and slope ranges are shown in Table 2 – Bushfire Threat Assessment.

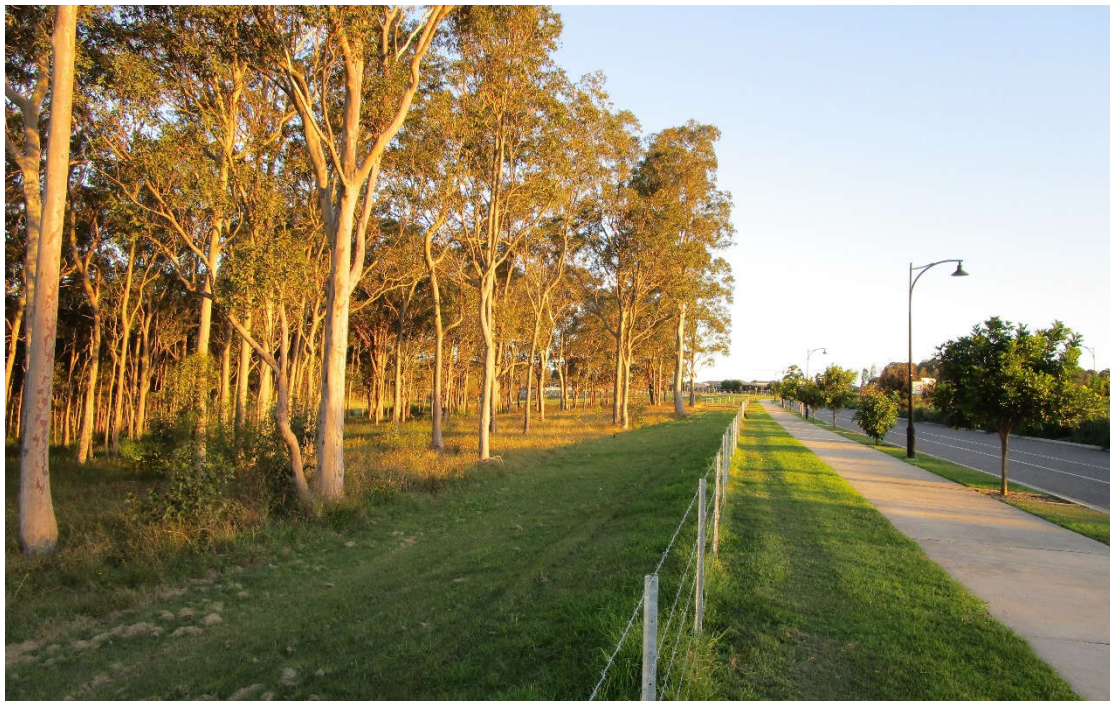
PHOTOGRAPH 3 – DELINEATION OF MANAGED LAND AND FOREST

View of the interface of Settlers Drive road reserve and the forest. Despite vegetation management occurring east of the road reserve, the asset protection zone has been measured to the road reserve boundary, due to the lack of a known perpetual management agreement.

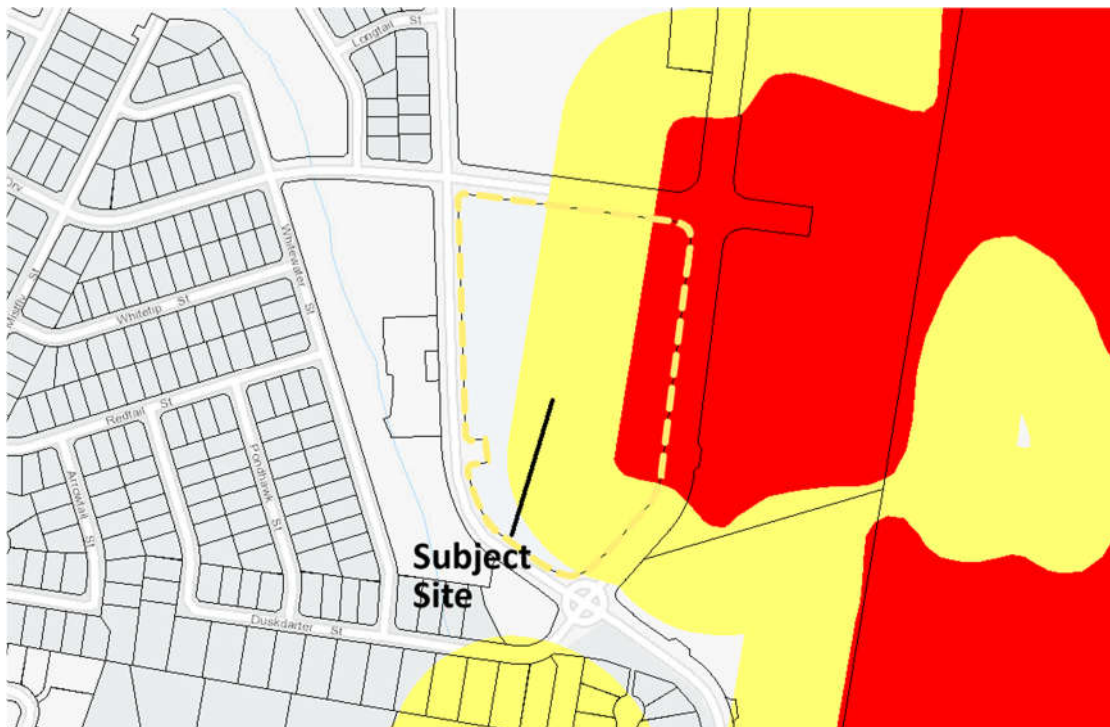
FIGURE 3 – COUNCIL'S BUSHFIRE PRONE LAND MAP

Potential bushfire hazards were identified from Maitland Council bushfire prone mapping as occurring within the investigation area. Aerial mapping and inspection of the site reveals that the bushfire prone land map is somewhat inaccurate in respect to the current bushfire hazard.
