Civil Engineering Report Development Application

Diana Pet Food Manufacturing Facility, Rutherford

Prepared for: **SPF Diana Australia Pty Ltd**

Document no: **NSW212100-CIV-RPT-DA-001**

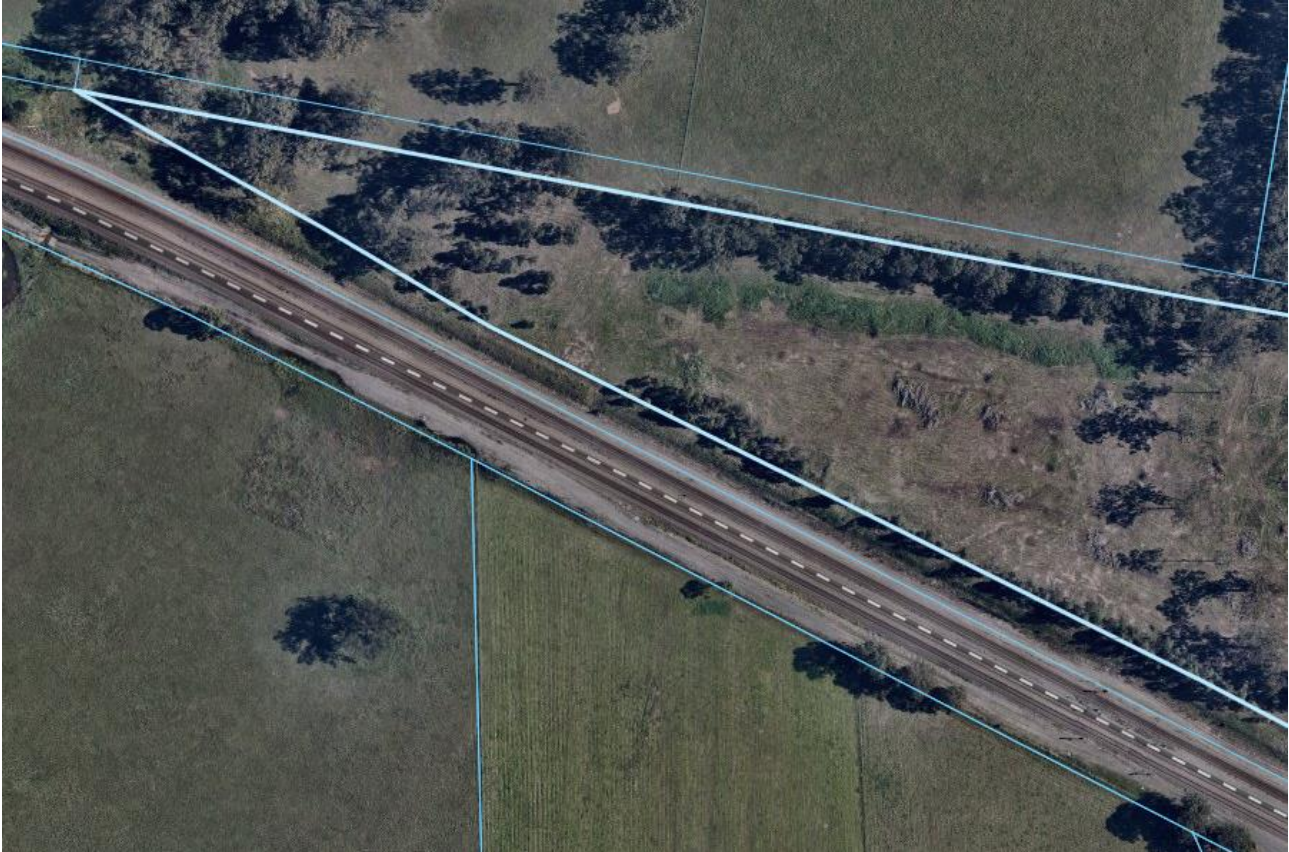
Figure 2 Nearmap image (3 Nov 2021)

The site is currently undeveloped rural land which has generally been cleared of trees. Vegetation consists of medium dense shrubs and grass. There are trees along the northern and southern boundaries as well as adjacent the banks of the first order stream.

The existing site has a high point of RL32.95 at the southern boundary and a low point of RL28.27 at the northeast corner of the property. The majority of the site grades to the northeast at 3% while the remainder of the site generally grades to the northwest at 3%.

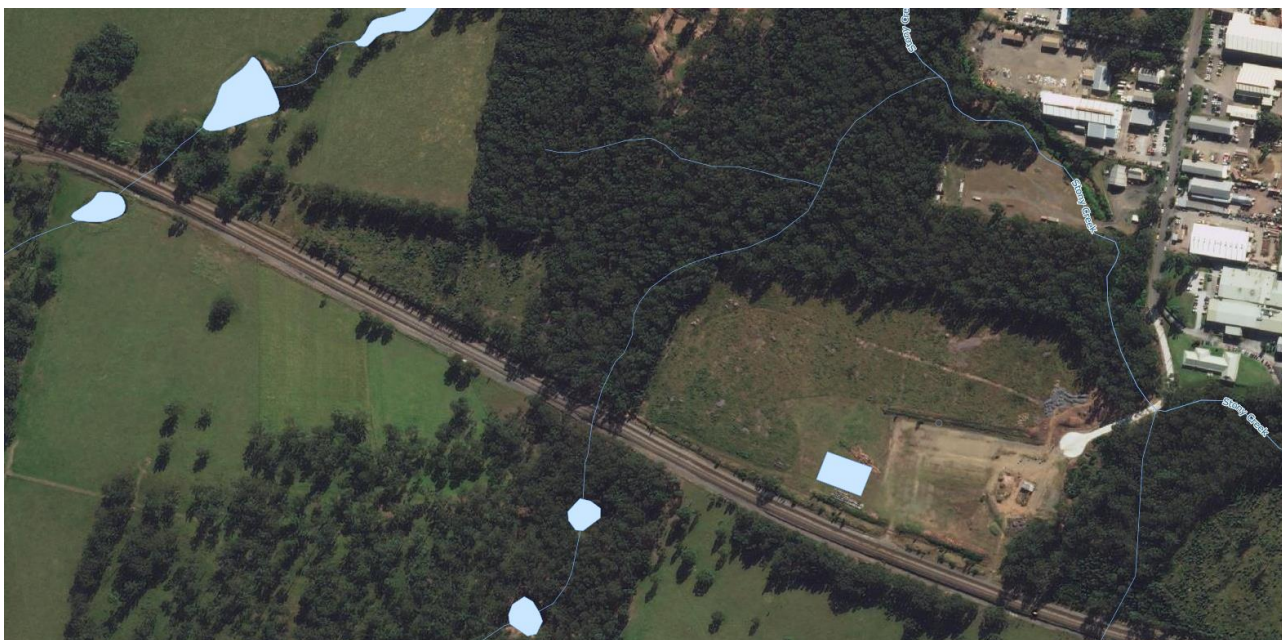
Figure 3 Hydro Line spatial data

There is an existing first order water course at the far western extent of the proposed development site. Based on the detailed survey information available, the bank definition of the water course is unclear. It is not expected that the proposed development will impact the existing water course.

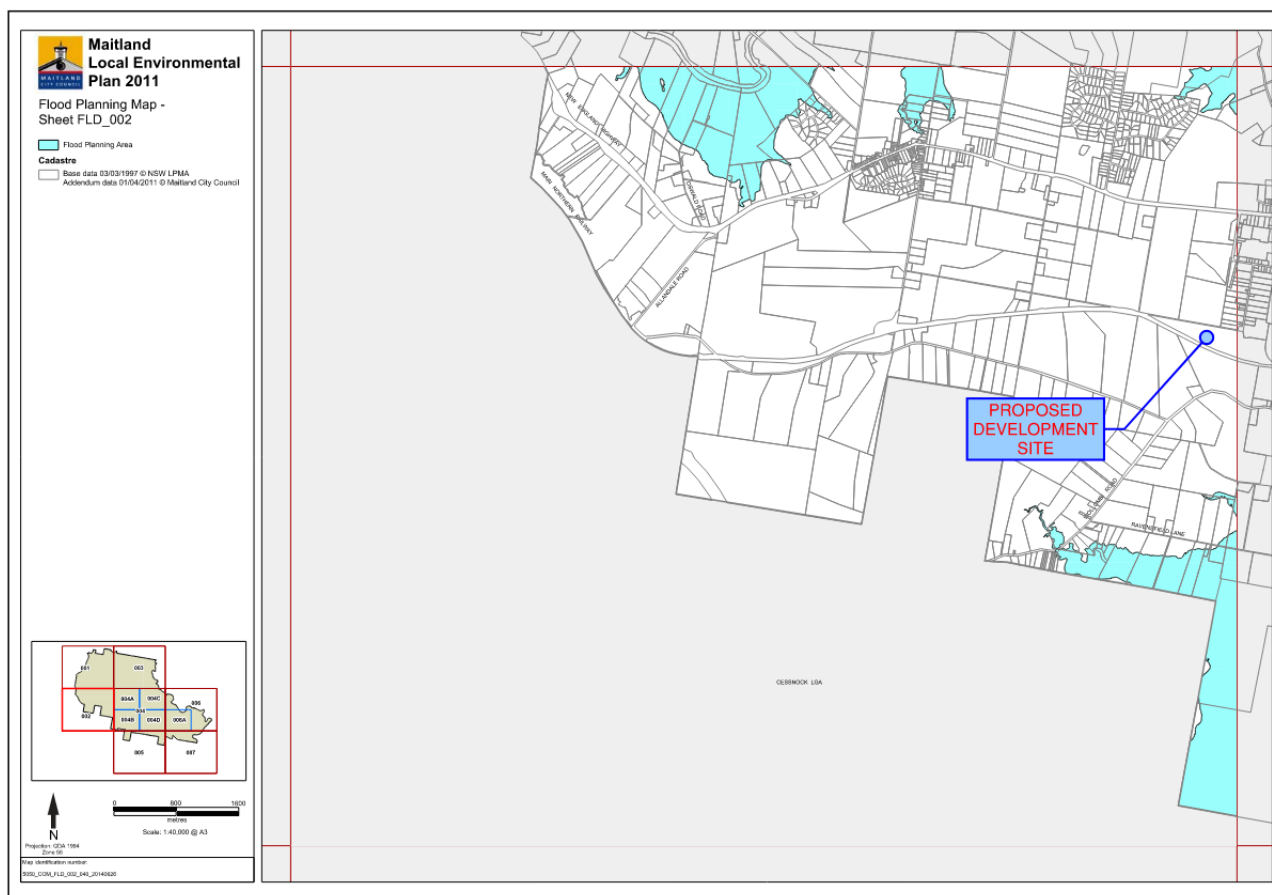
Figure 5 Flood Planning Map FLD_002 (Maitland Local Environmental Plan 2011)

The proposed development site is not identified within the Maitland Local Environmental Plan 2011 as being impacted by flood planning requirements.

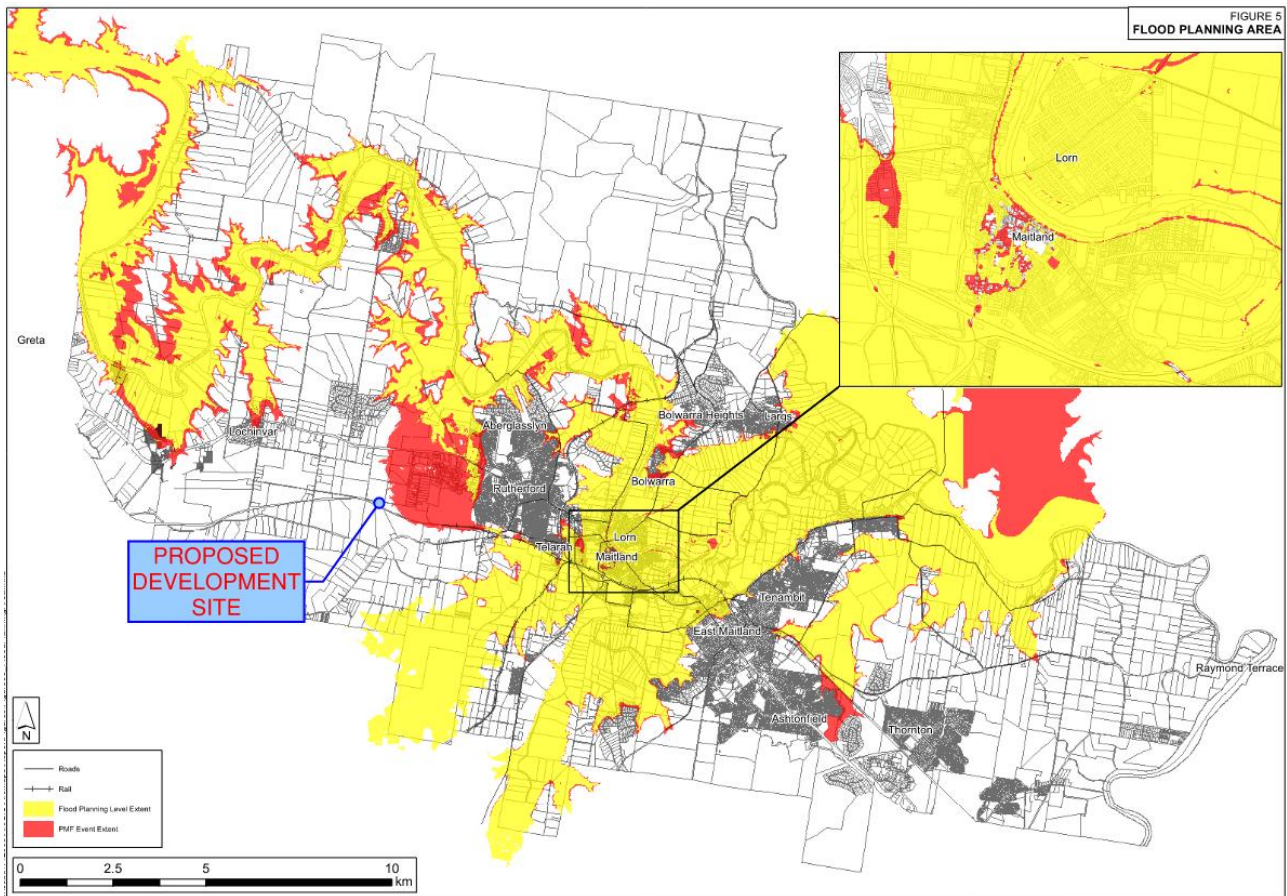
Figure 6 Flood Planning Area (Hunter River Floodplain Risk Management Study and Plan 2015)

The proposed development site has a lowest level of approximately 28.27m AHD and is not shown to be impacted by any flood scenario modelled within the Hunter River Floodplain Risk Management Study and Plan (2015). Peak flood levels outlined within the Hunter River Floodplain Risk Management Study and Plan average between 10-12m AHD.

The Hunter River Floodplain Risk Management Study and Plan has not identified the proposed development site is within the flood planning area or the flood risk area.

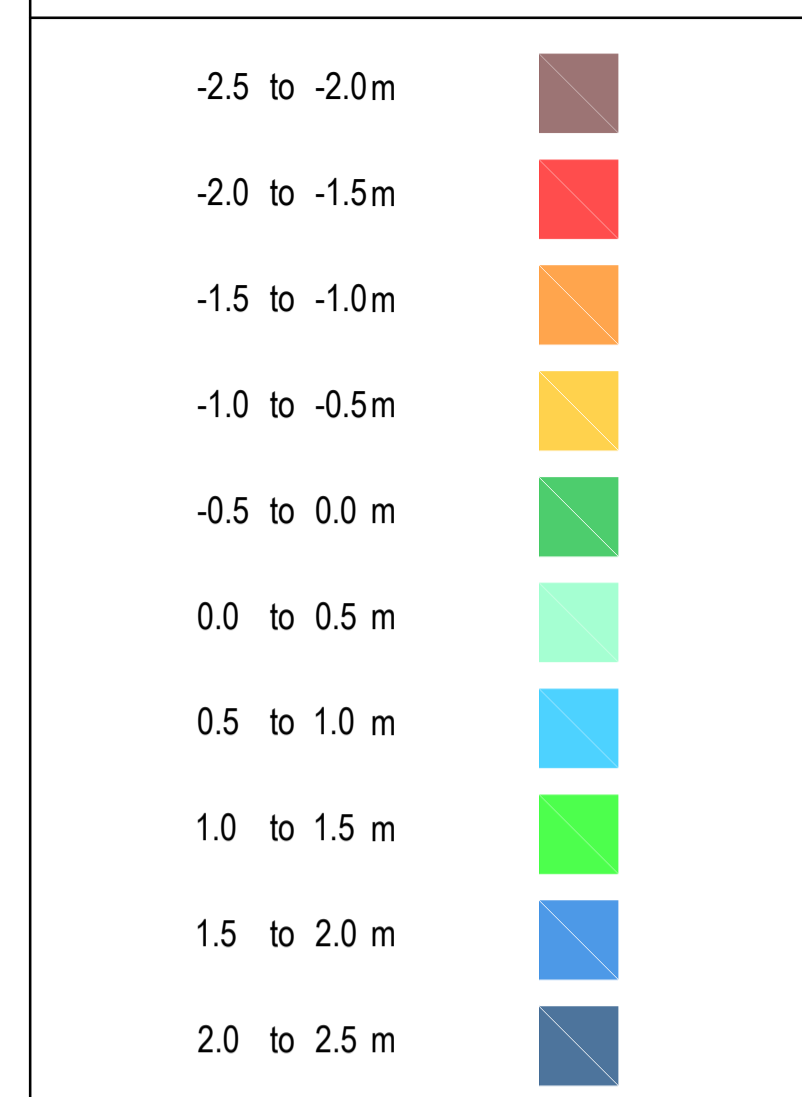
CUT / FILL EARTHWORKS DEPTHS

NOTES:
 TOTAL CUT: -9520m³
 TOTAL FILL: 10325m³
 TOTAL BALANCE (FILL OVER CUT): 805m³
 1. CUT/FILL EARTHWORKS AND VOLUMES REPRESENT DIFFERENCE BETWEEN FINISHED DESIGN SURFACE AND EXISTING SURFACE.
 2. NO STRIPPING, PAVEMENT DEPTH, BULKING FACTOR OR ALLOWANCE FOR UNSUITABLE MATERIAL HAS BEEN ACCOUNTED FOR.

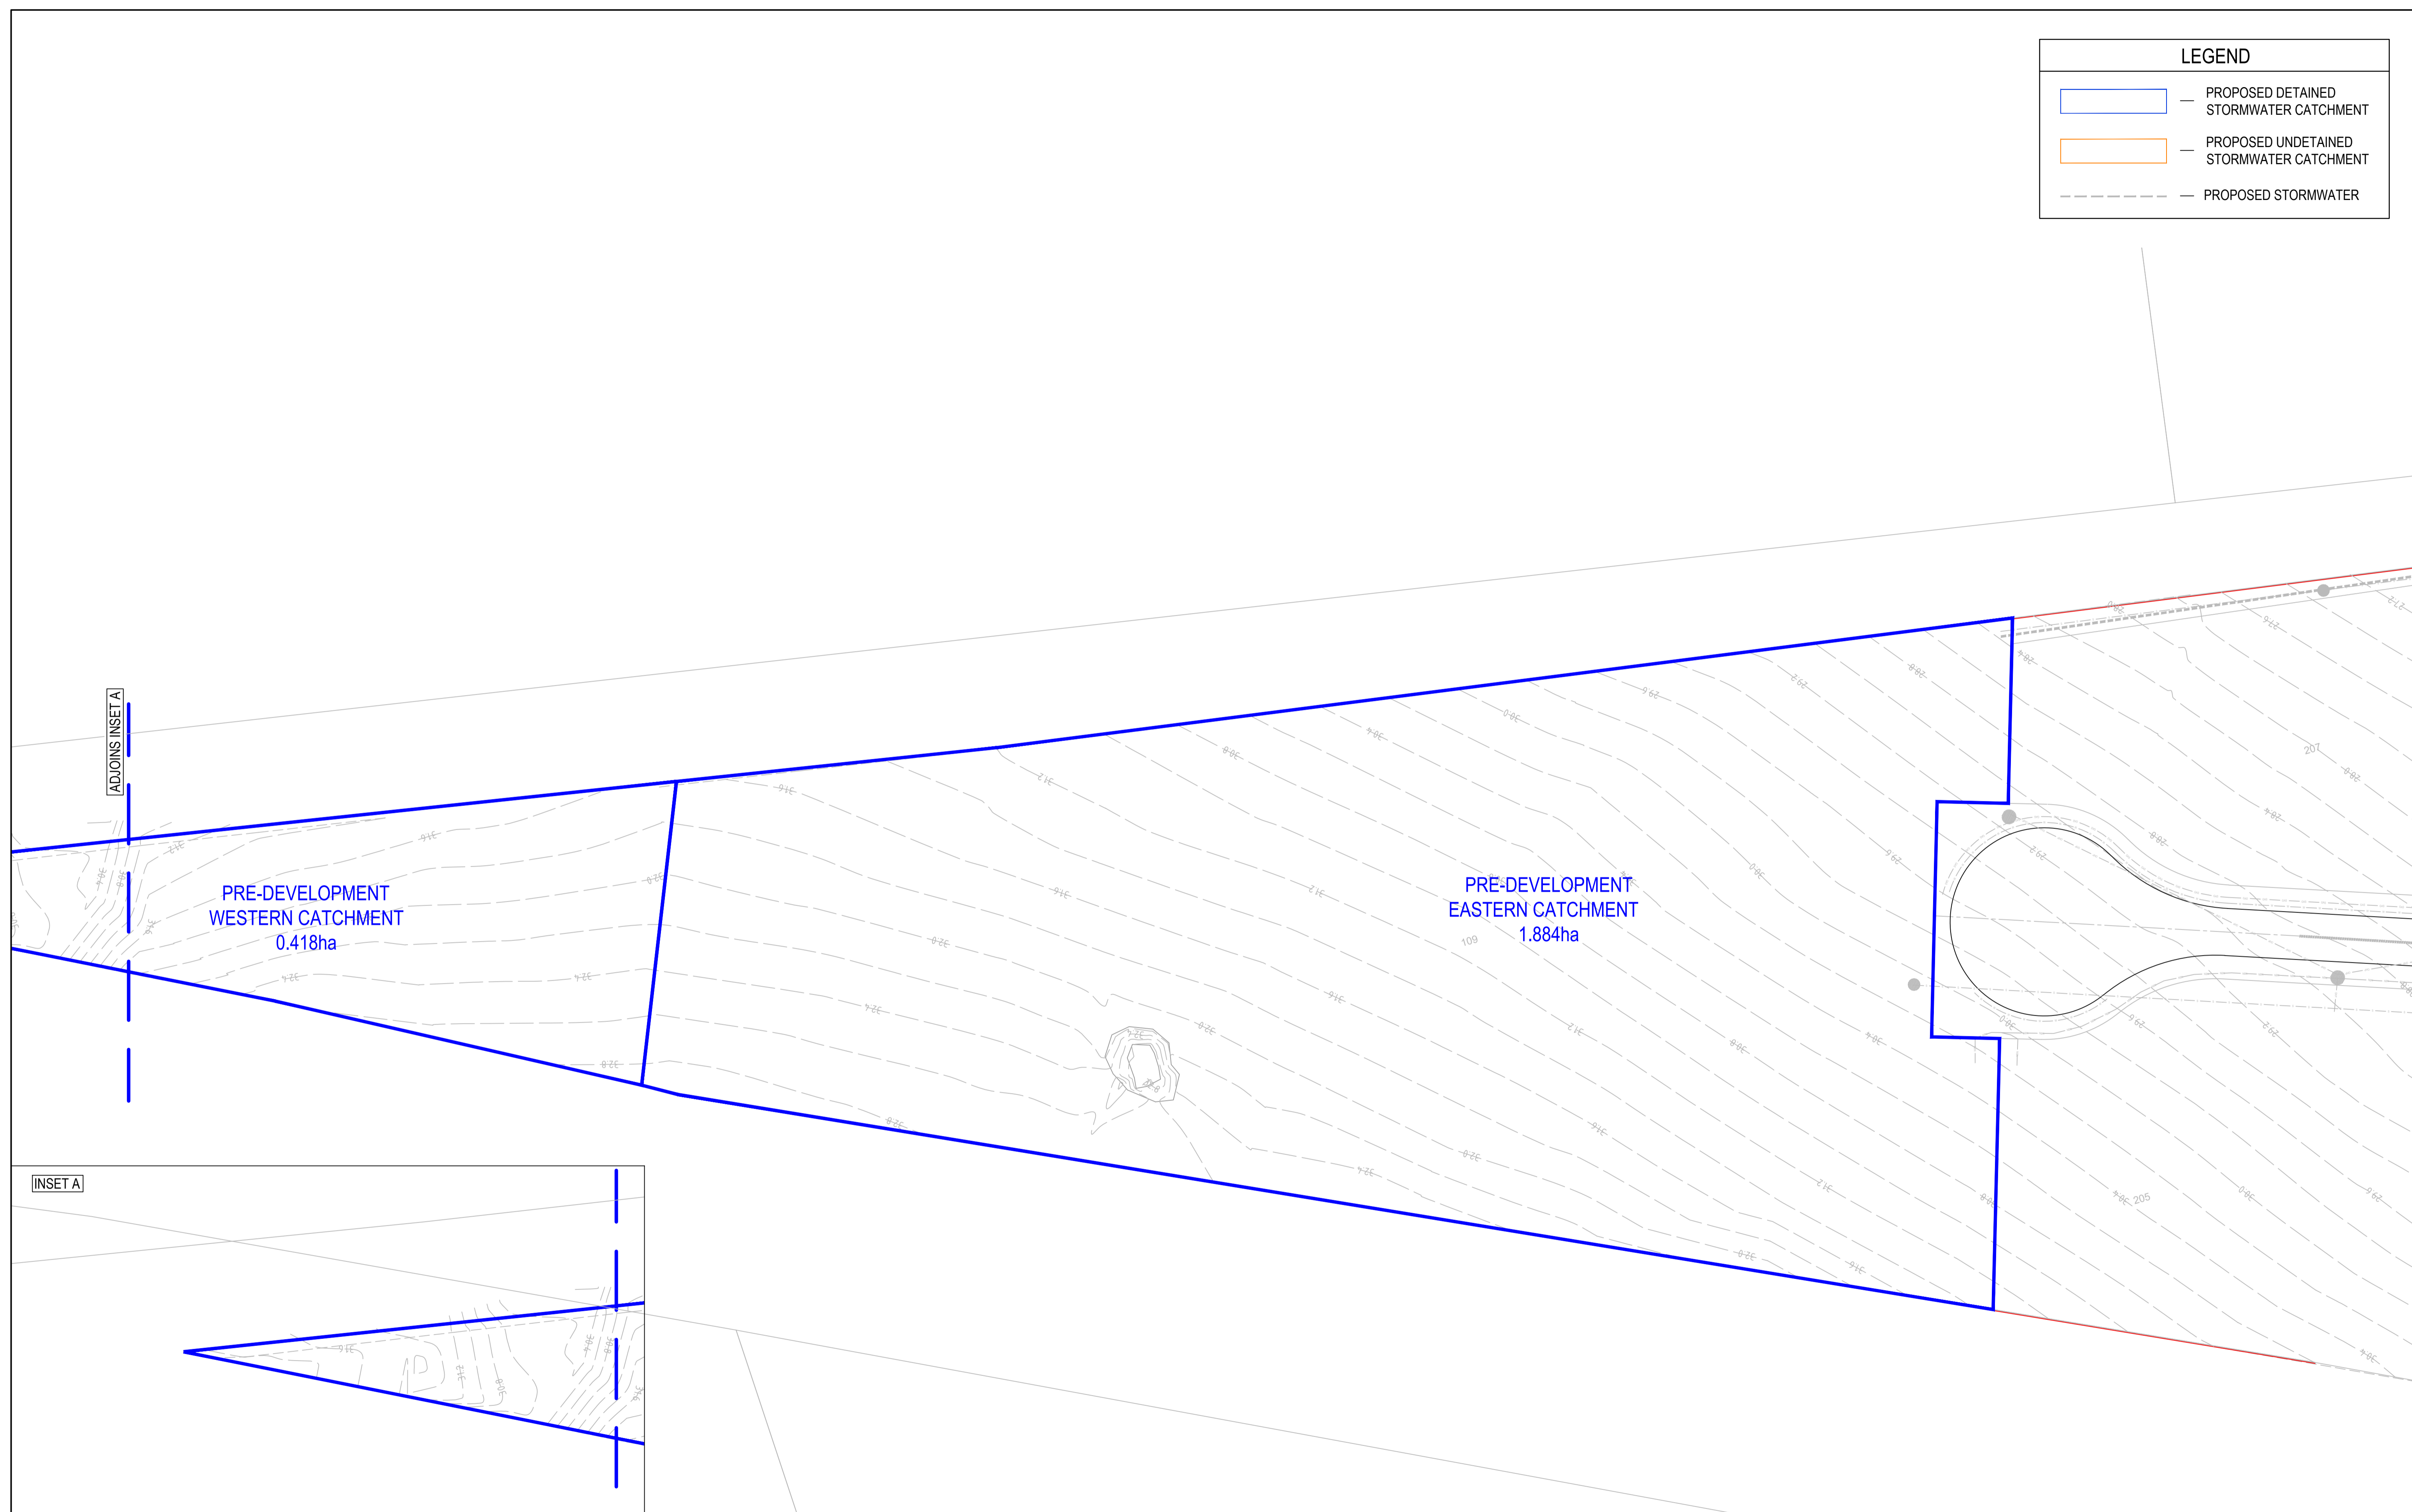
Drawing Title PRE-DEVELOPMENT CATCHMENT PLAN			
Drawn	Date	Scale	A1
MDM	FEB 2022	AS SHOWN	TRC
Designed	Project No.	Dwg. No.	Issue
SJO	NSW212100	DA-15	C

PRE-DEVELOPMENT
WESTERN CATCHMENT
0.418ha

PRE-DEVELOPMENT
EASTERN CATCHMENT
1.884ha

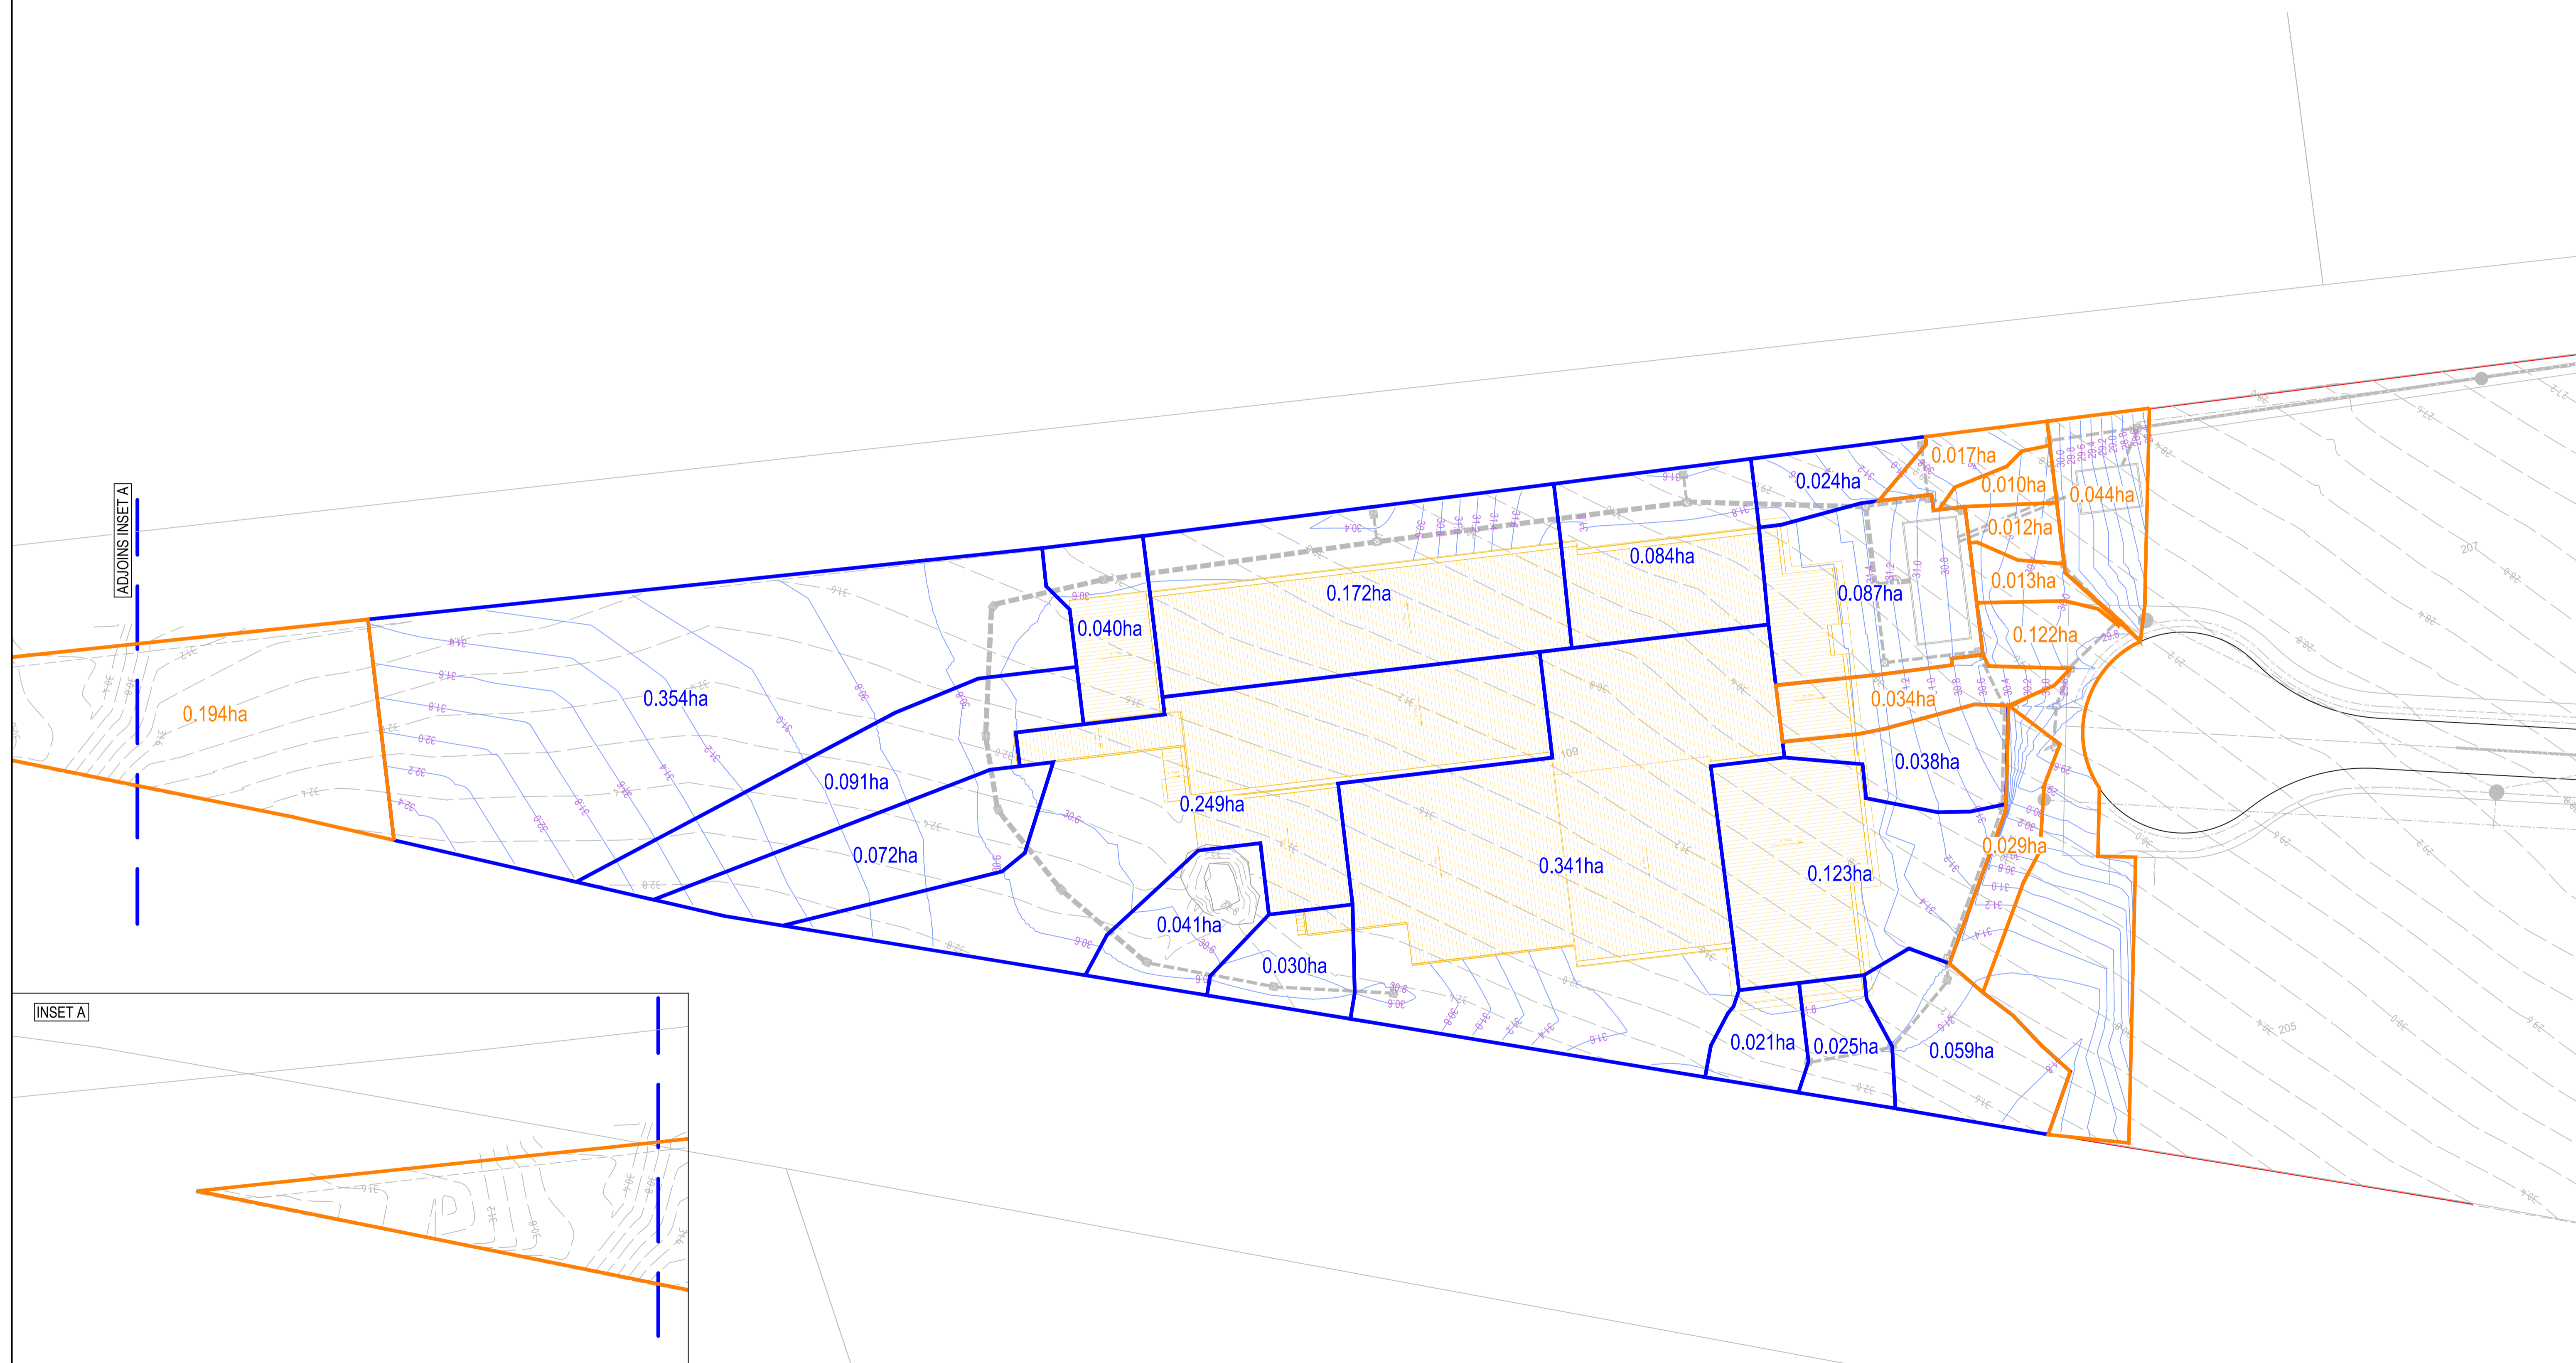
Drawing Title POST-DEVELOPMENT CATCHMENT PLAN					
Drawn MDM	Date FEB 2022	Scale 1:500	A1	Q.A. Check TRC	Date 16.03.22
Designed SJO	Project No. NSW212100	Dwg. No. DA-16	Issue C

LEGEND	
 	PROPOSED DETAINED STORMWATER CATCHMENT
 	PROPOSED UNDETAINED STORMWATER CATCHMENT
 	PROPOSED STORMWATER

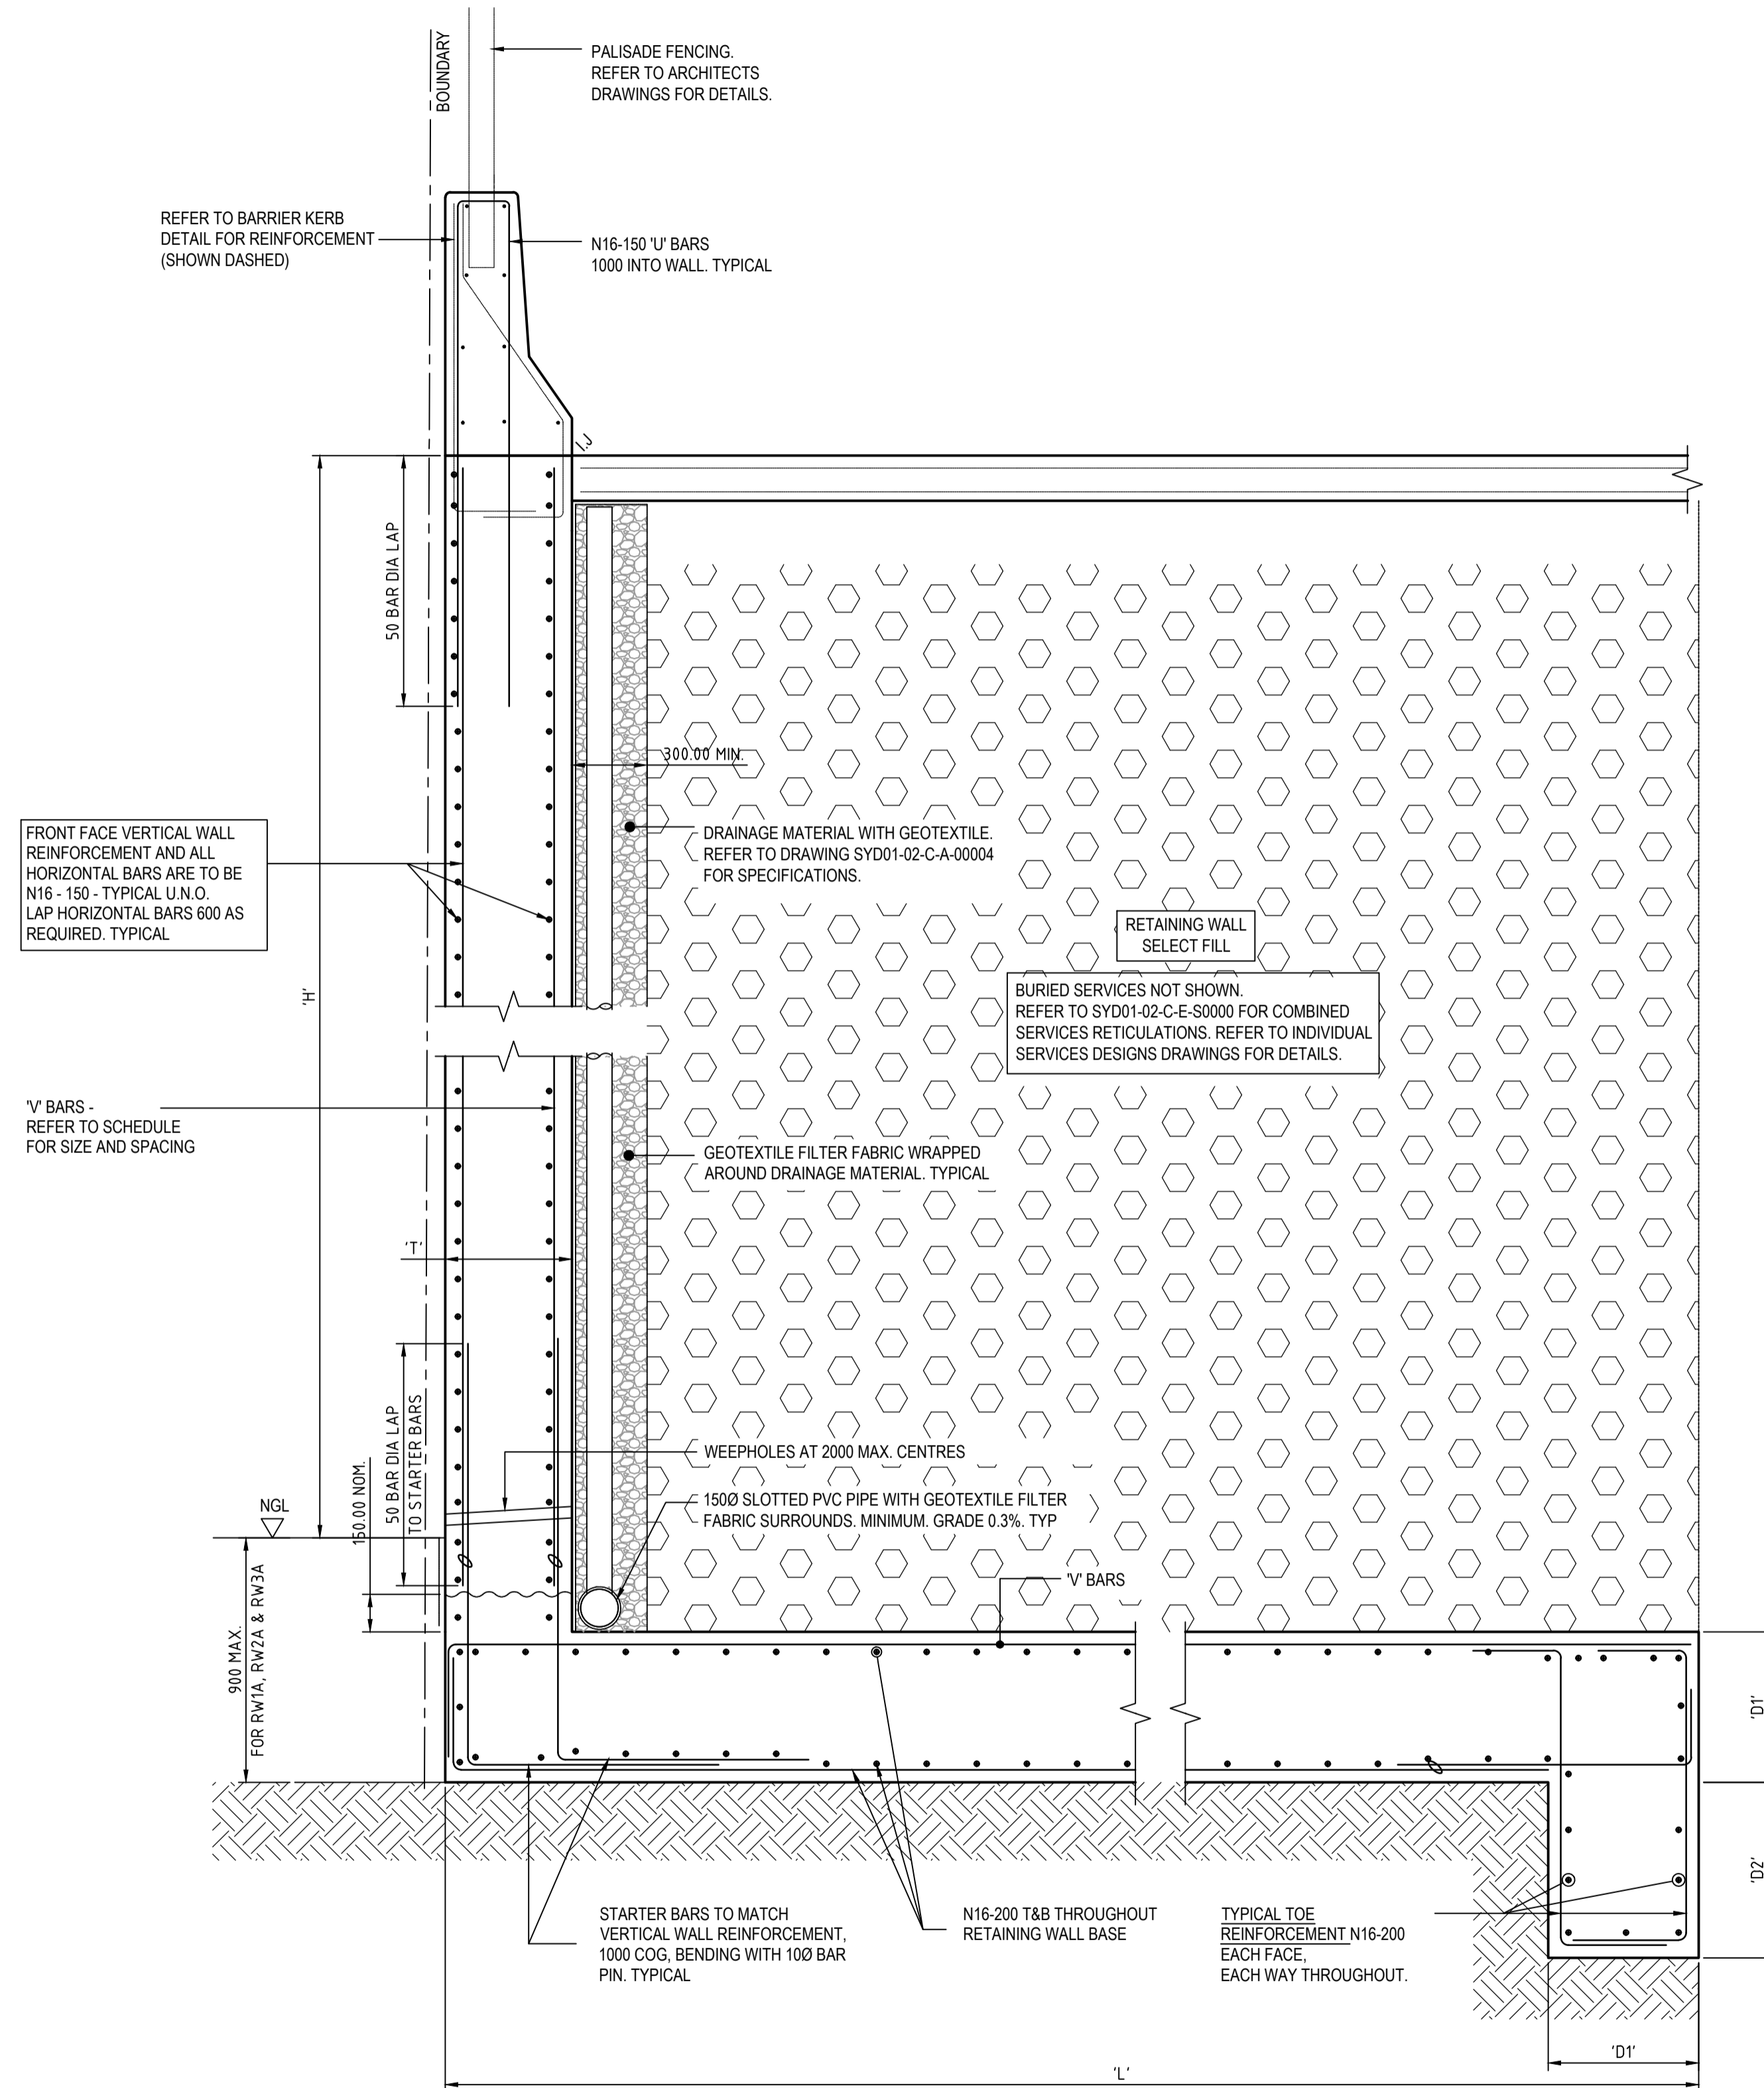
TYPICAL RETAINING WALL DETAIL

- RETAINING WALL BASE TO BE FOUNDED ON GROUND WITH ALLOWABLE BEARING CAPACITY OF 200kPa OR BETTER T.B.C BY GEOTECHNICAL ENGINEER.
- DOWELLED JOINTS TO BE:
 - IN WALL AT LESSER OF 3x HEIGHT AND 16m, OR WHERE FOOTING TRANSITIONS FROM CLAY TO ROCK.
 - IN FOOTINGS AT 40m MAX. CENTRES.
- WHERE ALLOWABLE BEARING IS INSUFFICIENT, FOOTINGS SHALL BE EXCAVATED UNTIL THE REQUIRED FOUNDING MATERIAL IS REACHED AND CONFIRMED BY GEOTECHNICAL ENGINEER. OVER-EXCAVATION SHALL BE BACKFILLED WITH N15 CONCRETE.
- EXCAVATION OF BACKFILL FOR SERVICES INSTALLATION MUST BE REINSTATED TO REQUIREMENTS OF THE BACKFILL SPECIFICATION.

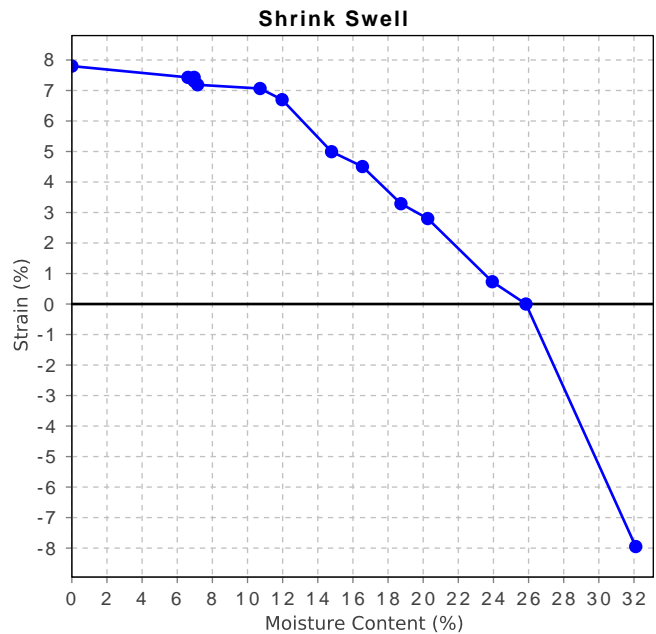
Material Test Report

Core Shrinkage Test	
Shrinkage Strain - Oven Dried (%)	7.8
Estimated % by volume of significant inert inclusions	2
Cracking	Slightly Cracked
Crumbling	No
Moisture Content (%)	25.9

Swell Test	
Initial Pocket Penetrometer (kPa)	210
Final Pocket Penetrometer (kPa)	50
Initial Moisture Content (%)	28.0
Final Moisture Content (%)	32.1
Swell (%)	8.0
* NATA Accreditation does not cover the performance of pocket penetrometer readings.

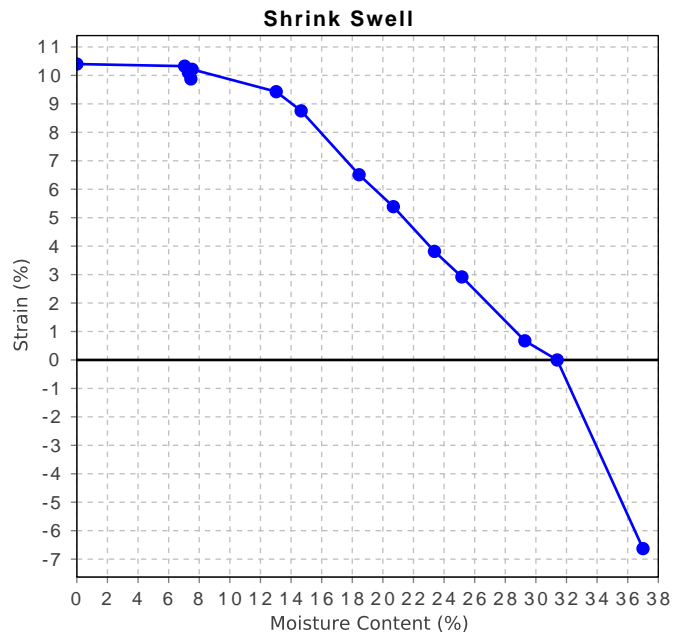
Material Test Report

Core Shrinkage Test	
Shrinkage Strain - Oven Dried (%)	10.4
Estimated % by volume of significant inert inclusions	0
Cracking	Slightly Cracked
Crumbling	No
Moisture Content (%)	31.4

Swell Test	
Initial Pocket Penetrometer (kPa)	110
Final Pocket Penetrometer (kPa)	50
Initial Moisture Content (%)	33.2
Final Moisture Content (%)	37.0
Swell (%)	6.6
* NATA Accreditation does not cover the performance of pocket penetrometer readings.

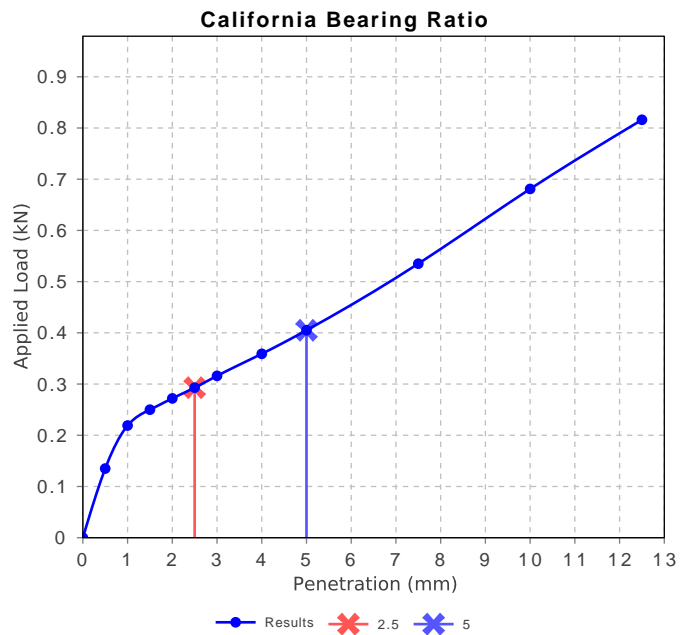
Material Test Report

California Bearing Ratio (AS 1289 6.1.1 & 2.1.1)		Min	Max
CBR taken at	2.5 mm		
CBR %	2.0		
Method of Compactive Effort	Standard		
Method used to Determine MDD	AS 1289 5.1.1 & 2.1.1		
Method used to Determine Plasticity	vt		
Maximum Dry Density (t/m ³)	1.58		
Optimum Moisture Content (%)	24.0		
Laboratory Density Ratio (%)	100.0		
Laboratory Moisture Ratio (%)	96.0		
Dry Density after Soaking (t/m ³)	1.55		
Field Moisture Content (%)	23.9		
Moisture Content at Placement (%)	23.3		
Moisture Content Top 30mm (%)	28.4		
Moisture Content Rest of Sample (%)	24.0		
Mass Surcharge (kg)	4.5		
Soaking Period (days)	4		
Curing Hours	189.8		
Swell (%)	2.0		
Oversize Material (mm)	19		
Oversize Material Included	Excluded		
Oversize Material (%)	0

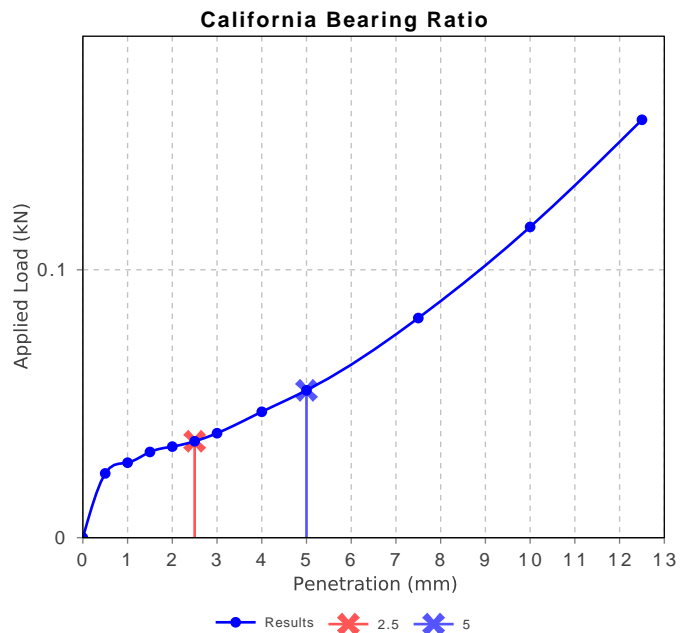
Material Test Report

California Bearing Ratio (AS 1289 6.1.1 & 2.1.1)		Min	Max
CBR taken at	5 mm		
CBR %	0.5		
Method of Compactive Effort	Standard		
Method used to Determine MDD	AS 1289 5.1.1 & 2.1.1		
Method used to Determine Plasticity	vt		
Maximum Dry Density (t/m ³)	1.58		
Optimum Moisture Content (%)	22.0		
Laboratory Density Ratio (%)	97.0		
Laboratory Moisture Ratio (%)	101.0		
Dry Density after Soaking (t/m ³)	1.45		
Field Moisture Content (%)	28.0		
Moisture Content at Placement (%)	22.1		
Moisture Content Top 30mm (%)	40.5		
Moisture Content Rest of Sample (%)	26.5		
Mass Surcharge (kg)	4.5		
Soaking Period (days)	4		
Curing Hours	190.2		
Swell (%)	6.0		
Oversize Material (mm)	19		
Oversize Material Included	Excluded		
Oversize Material (%)	0		
Variation from Test Method	moulded outside method tolerance.

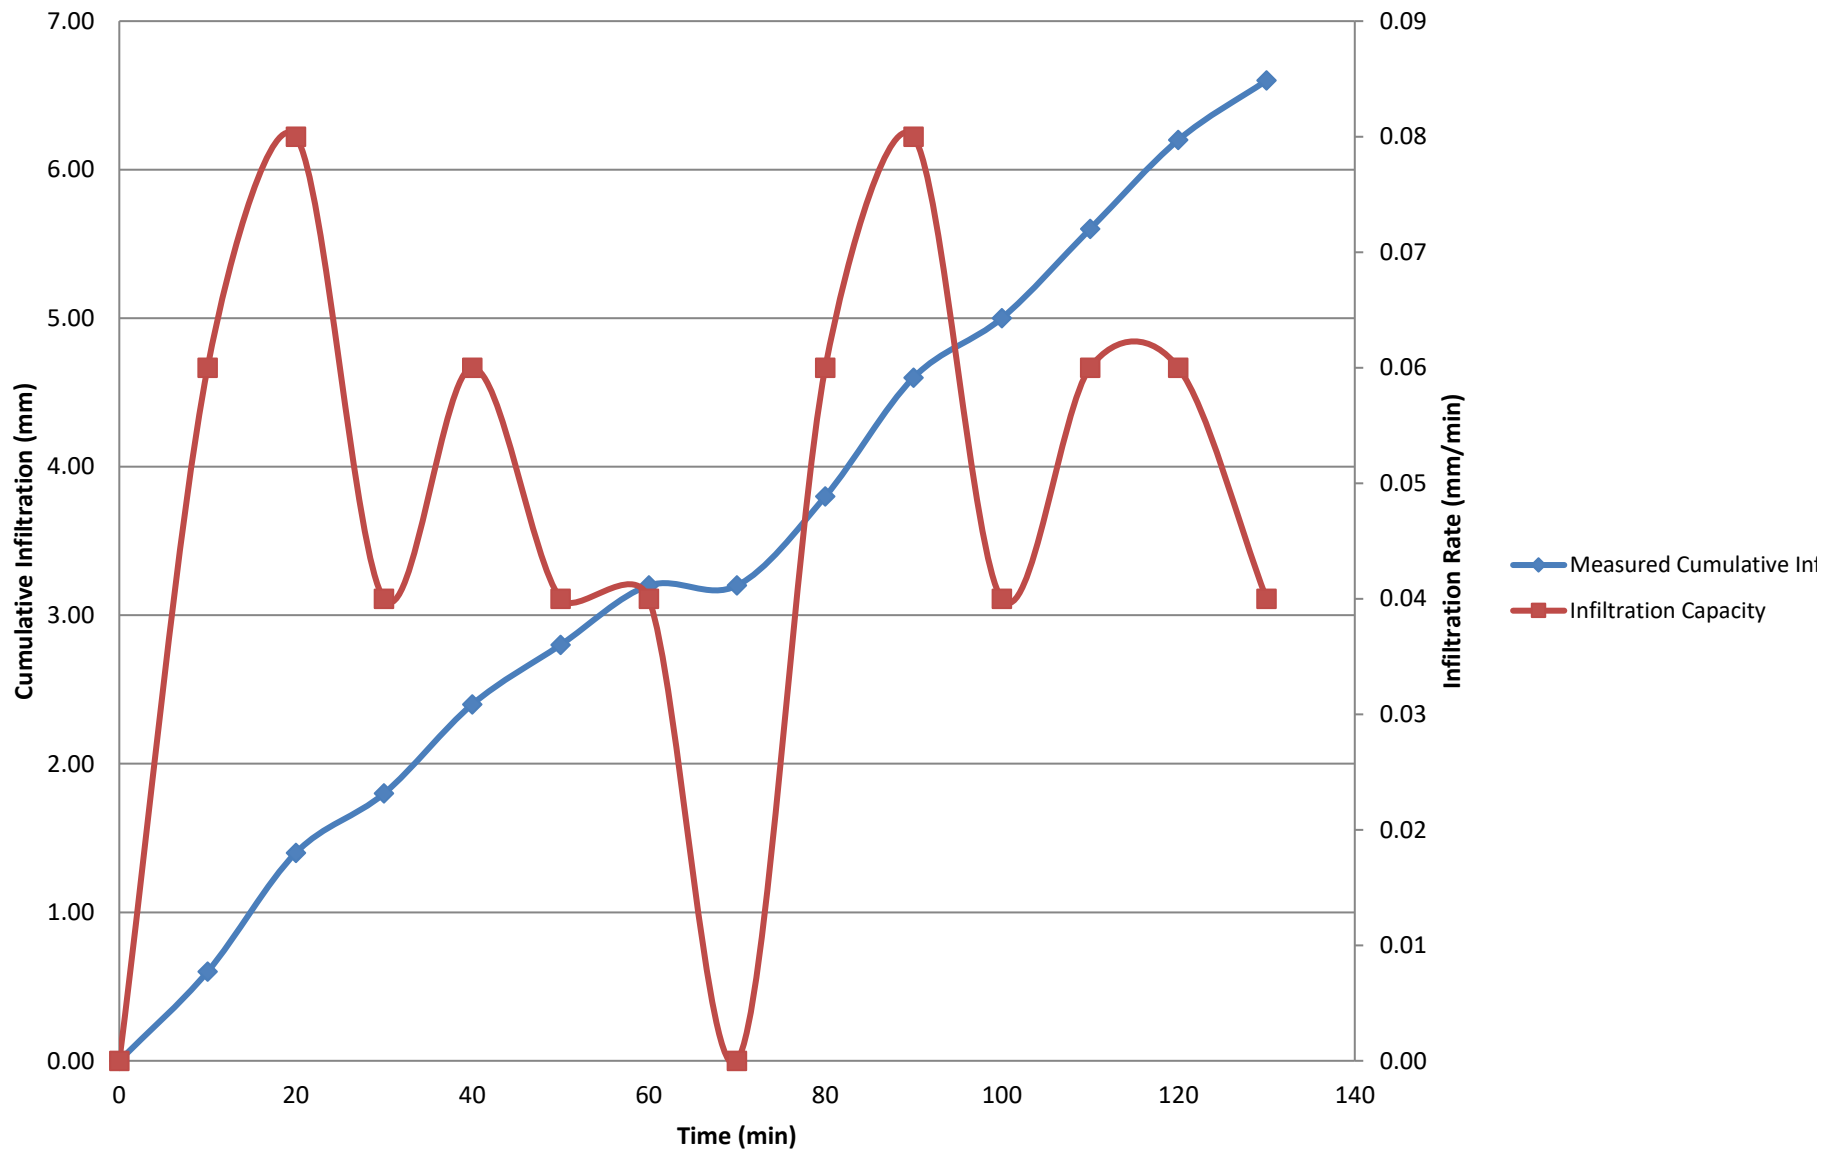
DOUBLE RING INFILTRATION TEST

Cumulative Infiltration and Infiltration Rate

An infiltration test was undertaken and indicated a steady state saturation infiltration rate of 5mm/hr would be suitable for the site.
