Civil Engineering Report Development Application

Diana Pet Food Manufacturing Facility, Rutherford

Prepared for: **SPF Diana Australia Pty Ltd**

Document no: **NSW212100-CIV-RPT-DA-001**

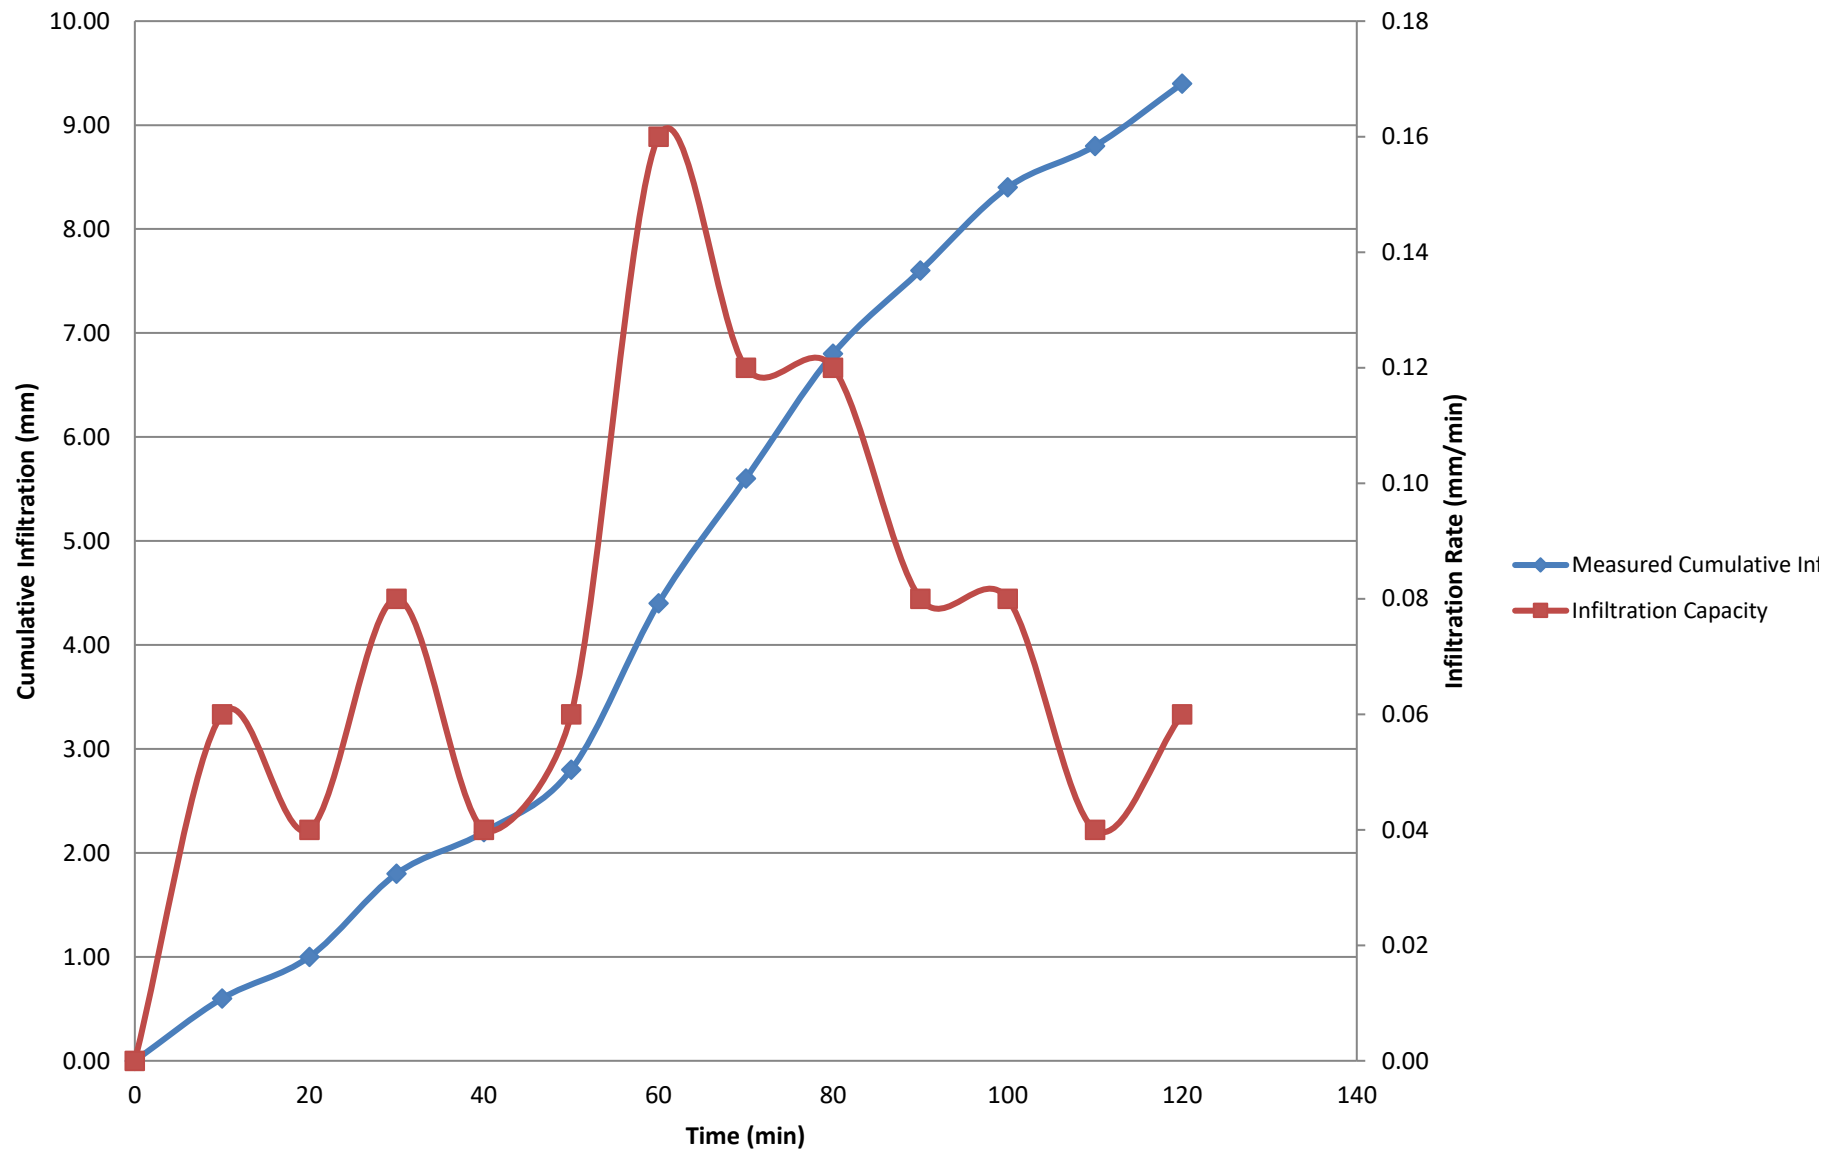
DOUBLE RING INFILTRATION TEST

Cumulative Infiltration and Infiltration Rate

An infiltration test was undertaken and indicated a steady state saturation infiltration rate of 5mm/hr would be suitable for the site.

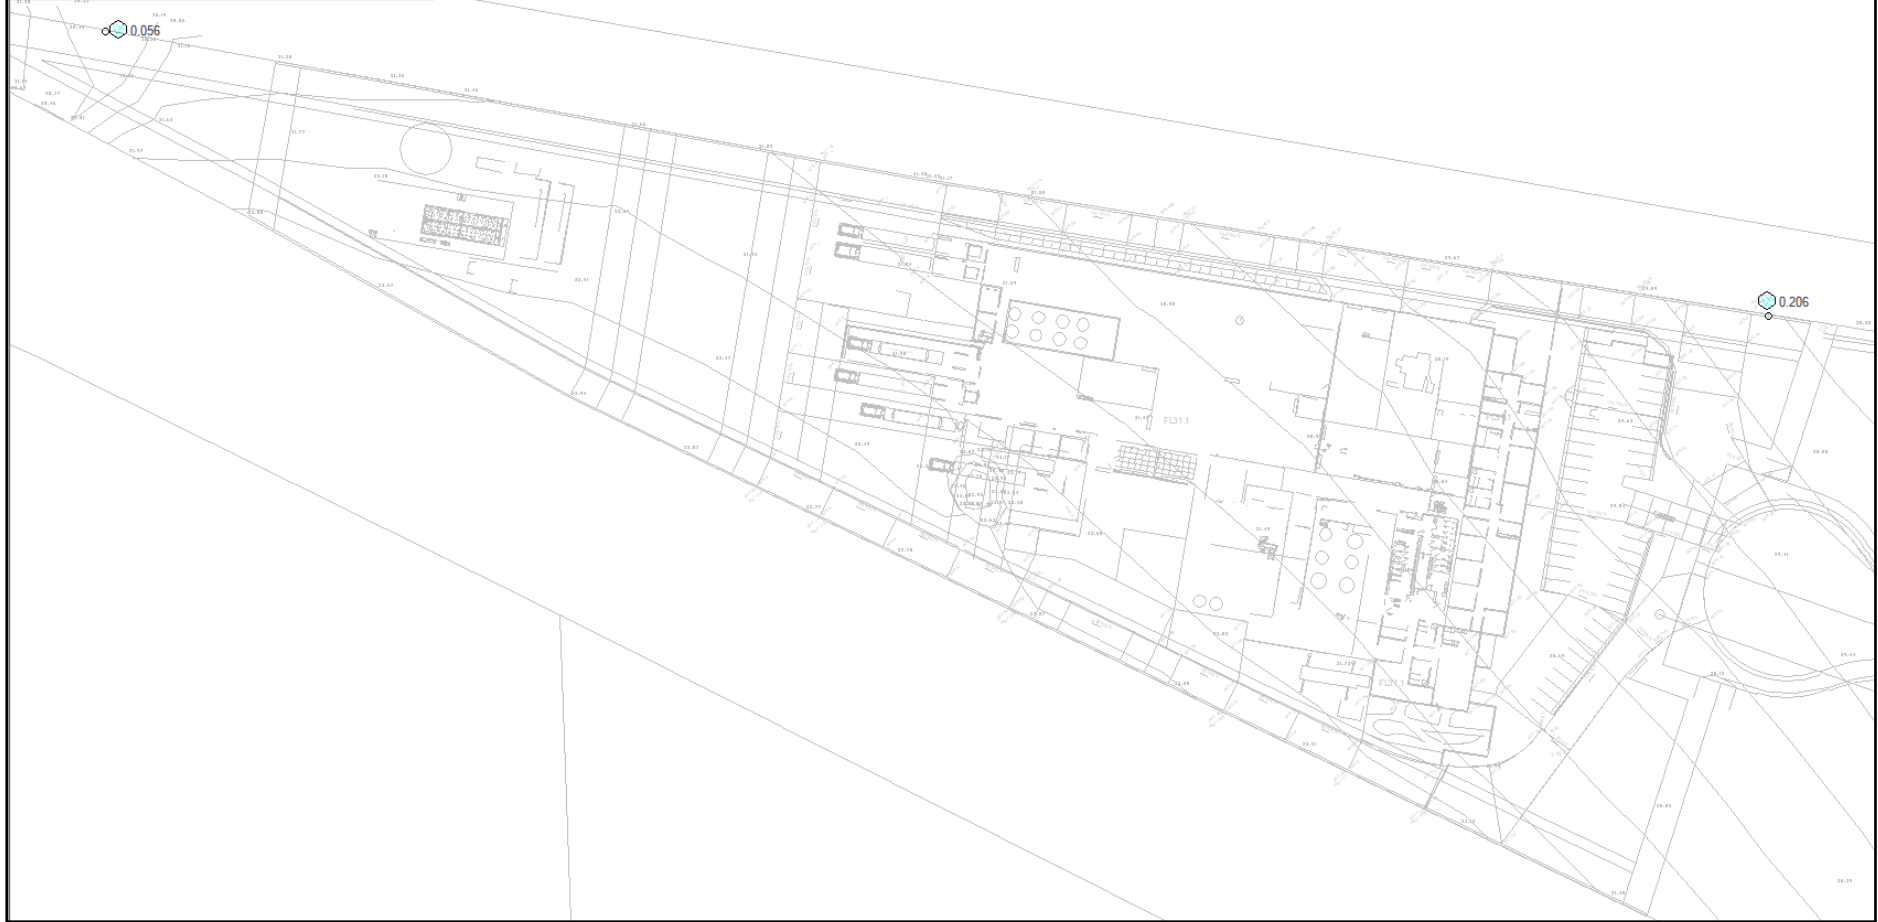
Results for median storm in critical 10% AEP ensembles using Lite hydraulic model.

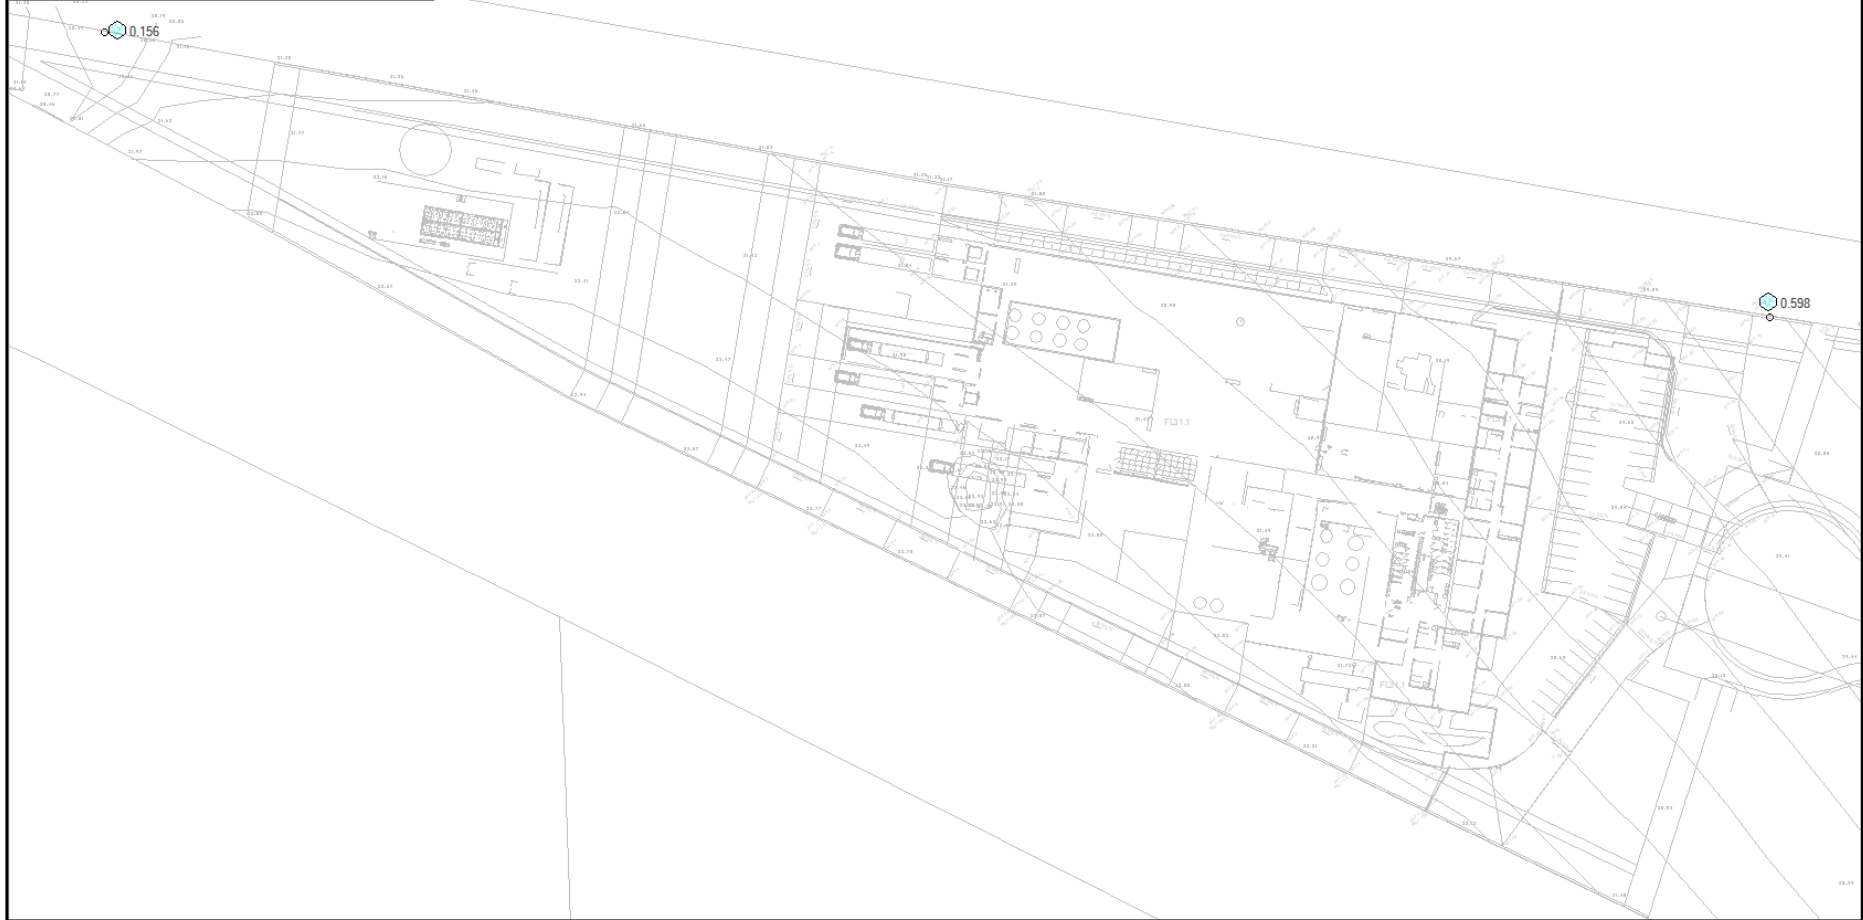
Results for median storm in critical 1% AEP ensembles using Lite hydraulic model.

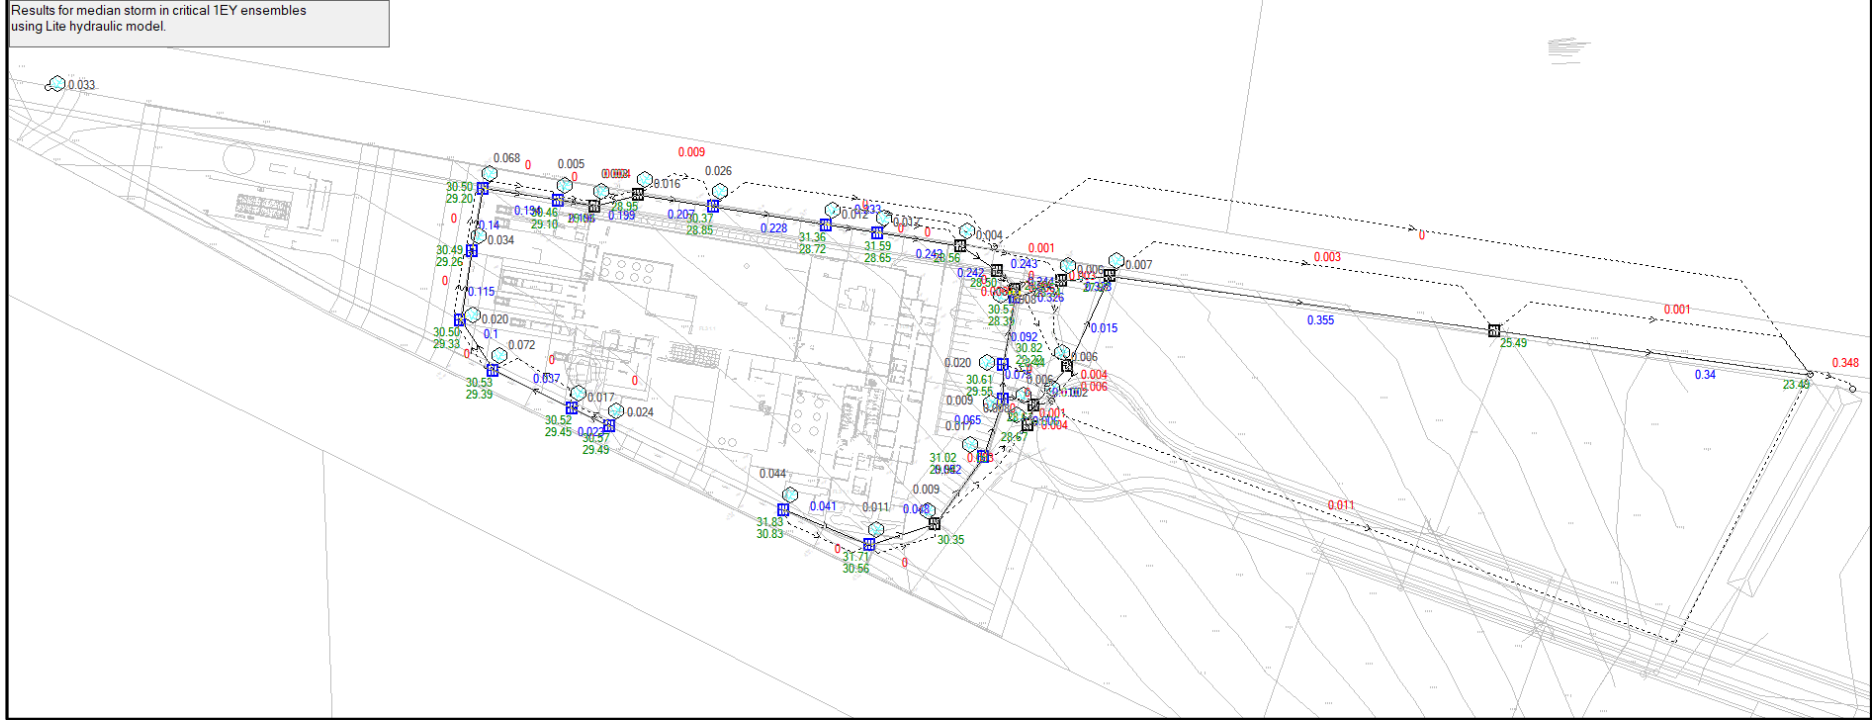
Results for median storm in critical 10% AEP ensembles using Lite hydraulic model.

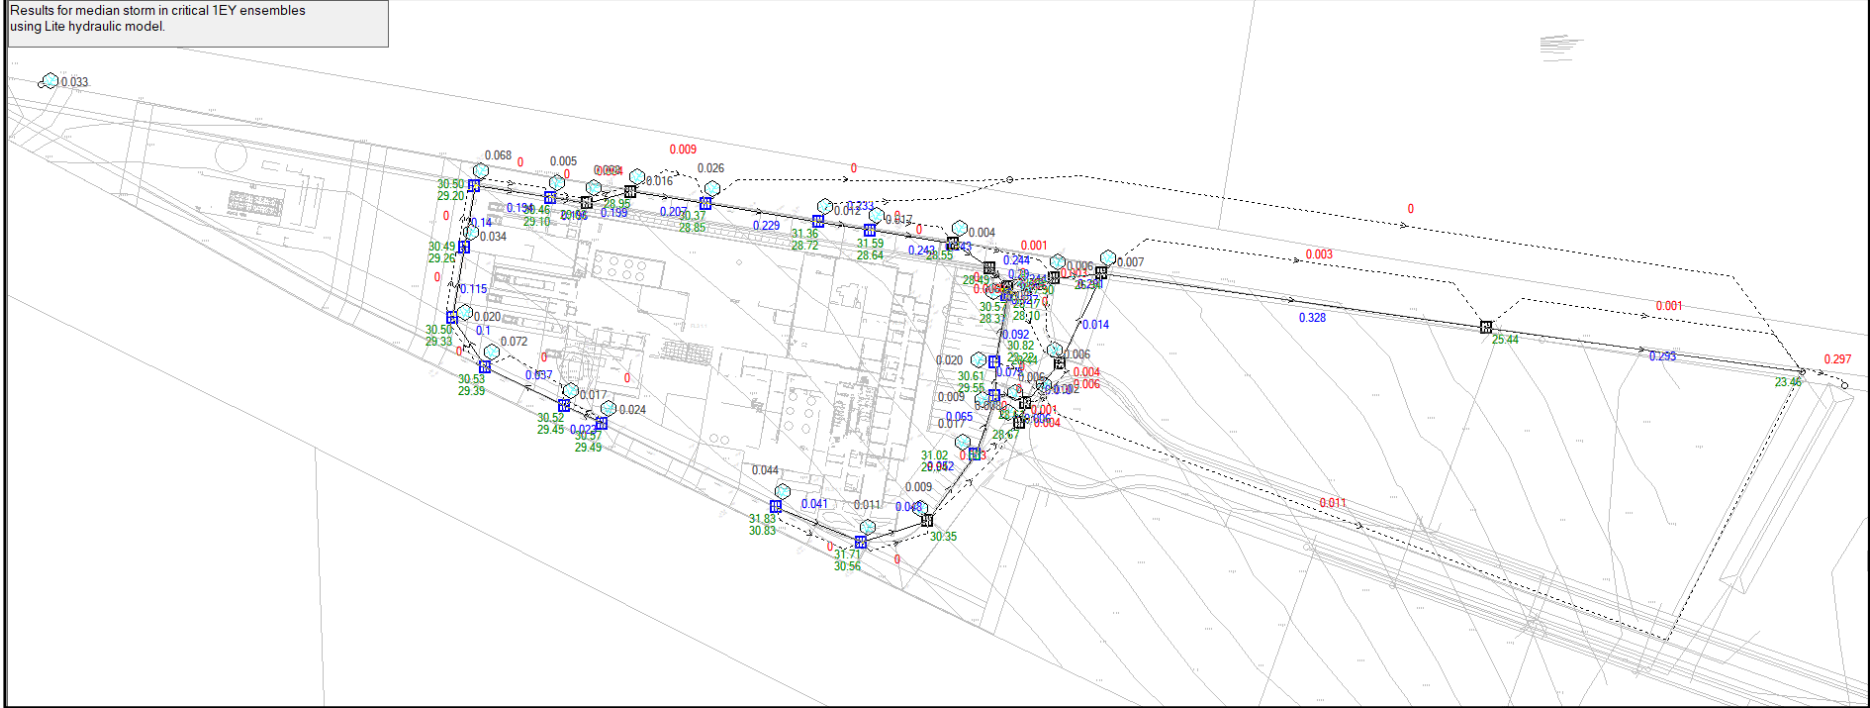
Results for median storm in critical 10% AEP ensembles
using Lite hydraulic model.

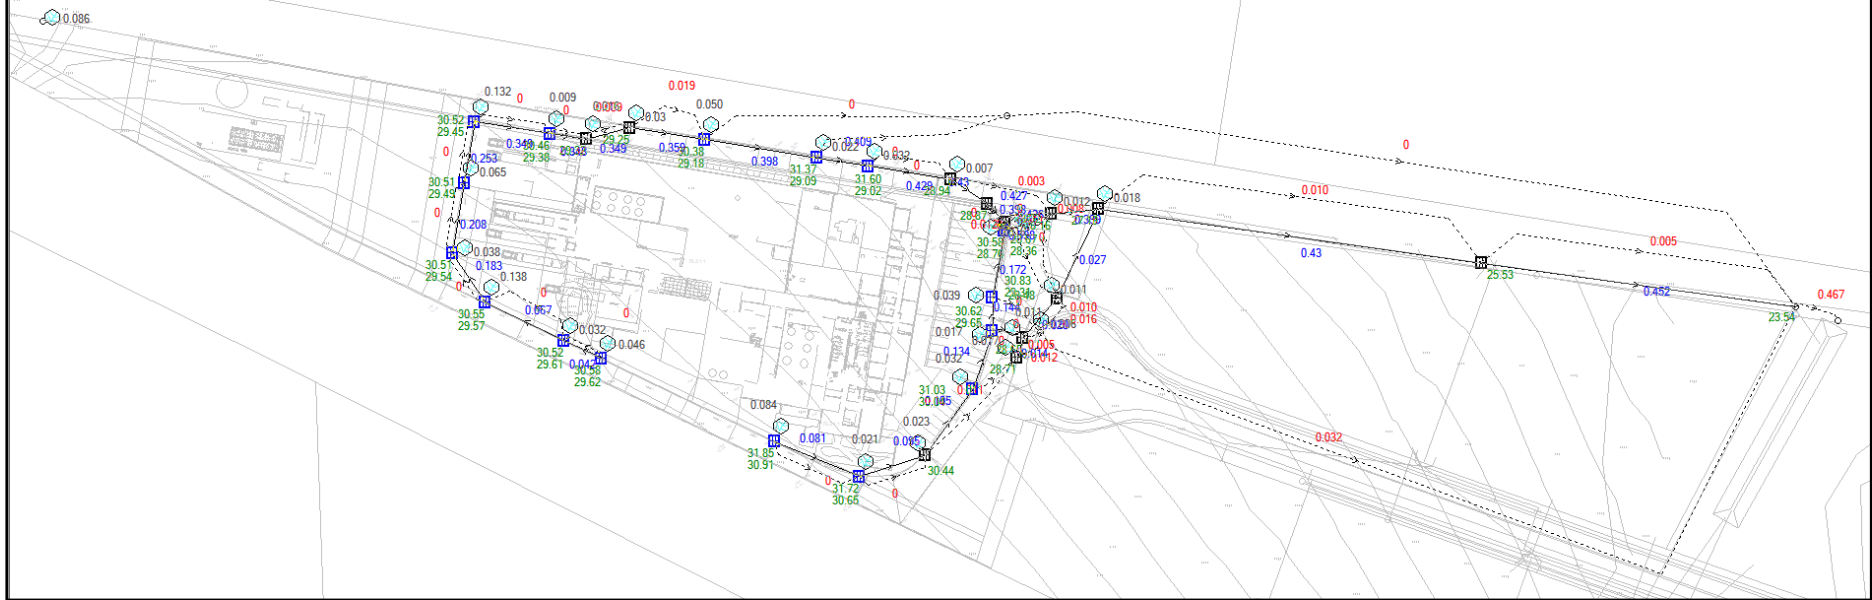
Results for median storm in critical 1% AEP ensembles using Lite hydraulic model.

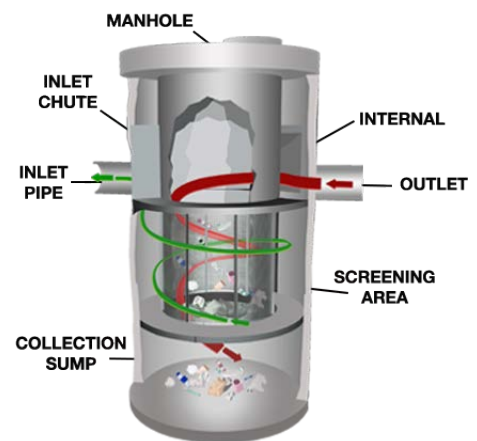
- One or more inlet pipes within a 130deg range of the outlet pipe direct stormwater flow through a chute to the treatment chamber.
- The specially designed inlet initiates a vortex at a higher flows than other similar sized vortex separators.
- The specially designed screen in conjunction with swirling flow ensures screen blinding is eliminated unlike other direct screening devices.
- The forces created by the vortex allow for pollutants to concentrate in the centre where they can either settle into the sump or remain floating within the screening area. Neutrally buoyant material will also be trapped and retained.
- A hydrocarbon baffle ensures that free hydrocarbons and oils are retained and prevented from escaping
- Flows that exceed the treatable flow rate are diverted to the outlet via an internal weir.
- Treated and bypass flows exit via the outlet pipe.

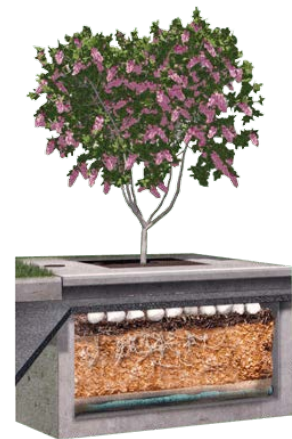
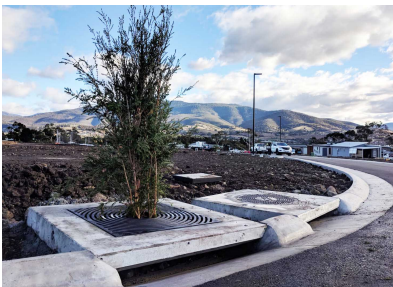
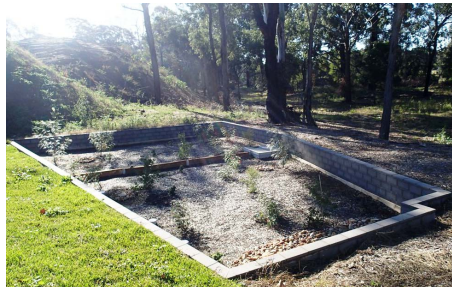
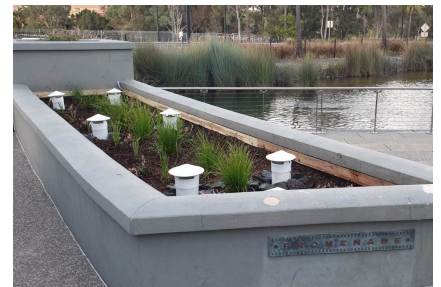
Stormwater runoff enters the Filterra system through a kerb-inlet opening or pipe and flows through a specially designed filter media mixture contained in a landscaped concrete container. The filter media captures and immobilises pollutants; those pollutants are then decomposed, volatilised and incorporated into the biomass of the Filterra system's micro/macro flora and fauna. Stormwater runoff flows through the media and into an underdrain system at the bottom of the container, where the treated water is discharged.
