# Conservation Management Plan

**Former Maitland Technical College  
High Street  
Maitland NSW.**

January 2012

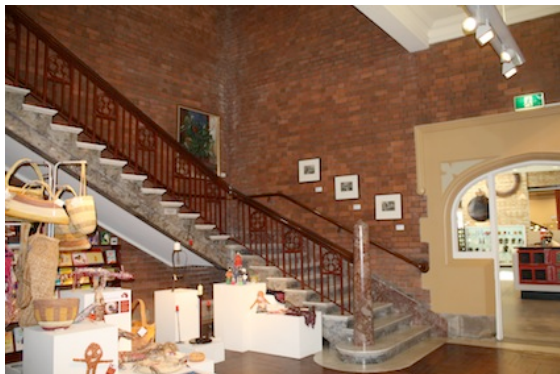
The stair hall includes similar material to the vestibule area with a cantilevered staircase in white and pink marble which is lit by natural daylight from above by a glass lantern detailed with coloured glass in a Art Nouveau pattern. The stair hall is used for access by the public and is also used for the display of shop items and art works.

Staircase showing the use of contrasting materials and the simple detailing of the newel post.

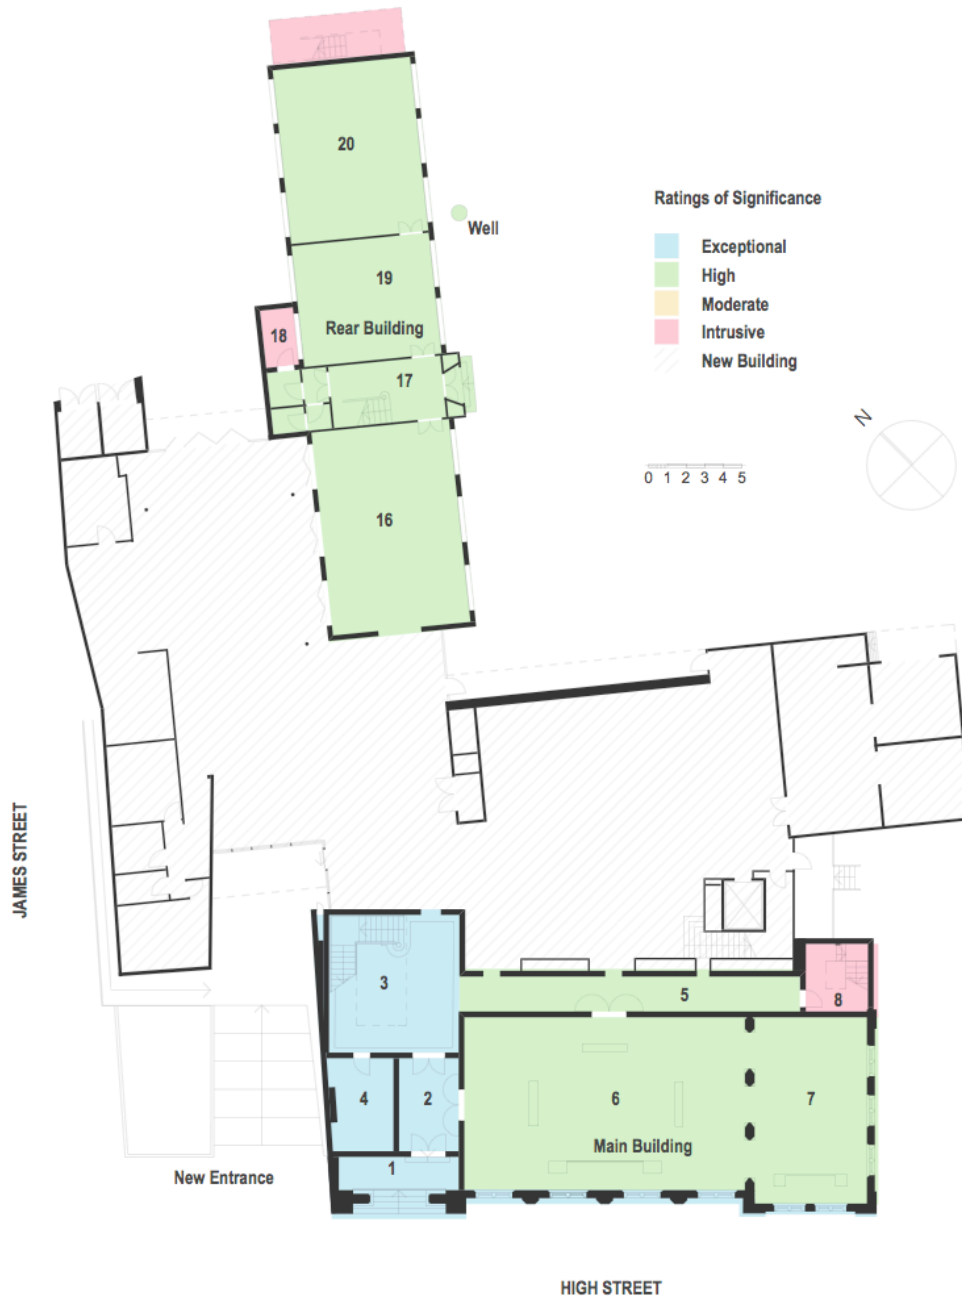
**Figure 14** Ground Floor Plan showing ratings of significance for each area.

The Inventory, Appendix A, includes more detail on the integrity of each room and a grading of significance for each room of the Main Building and Rear Building.

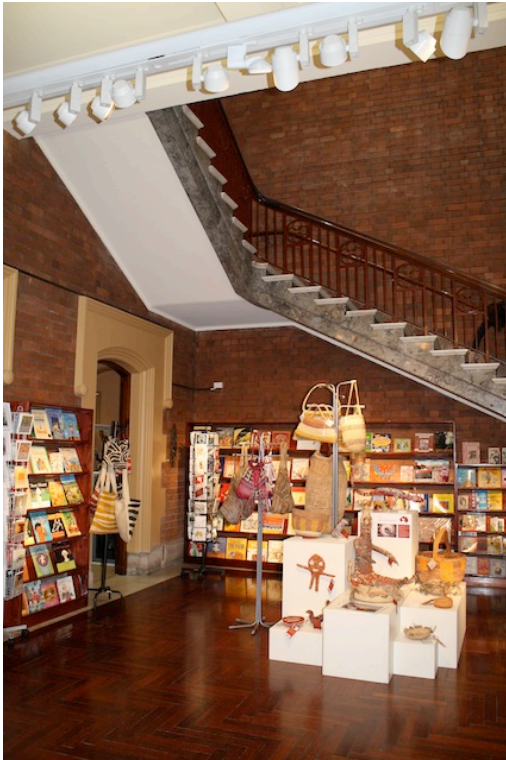
View of west corner of Stair Hall showing cantilevered marble staircase

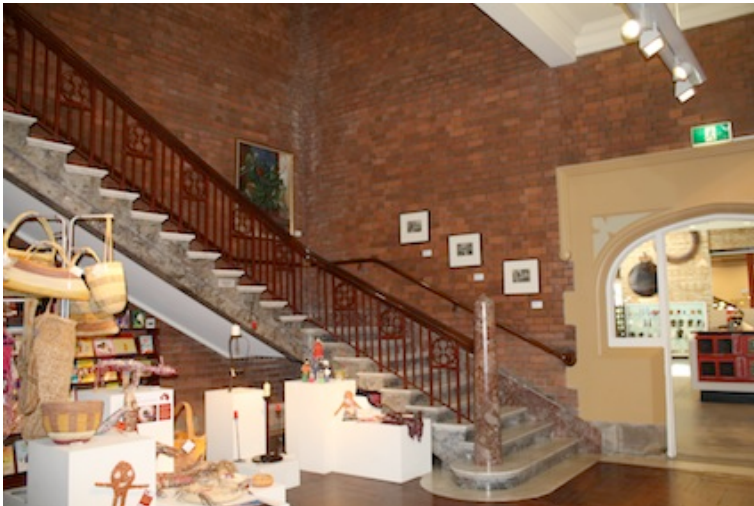
View of north corner of Stair Hall showing pink marble newell post.  
Note evidence of former water entry in north west corner.

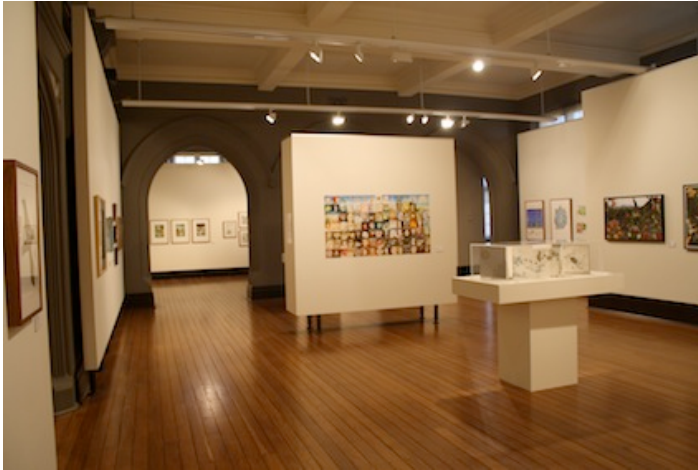
View toward south east arcuated wall showing new partitions

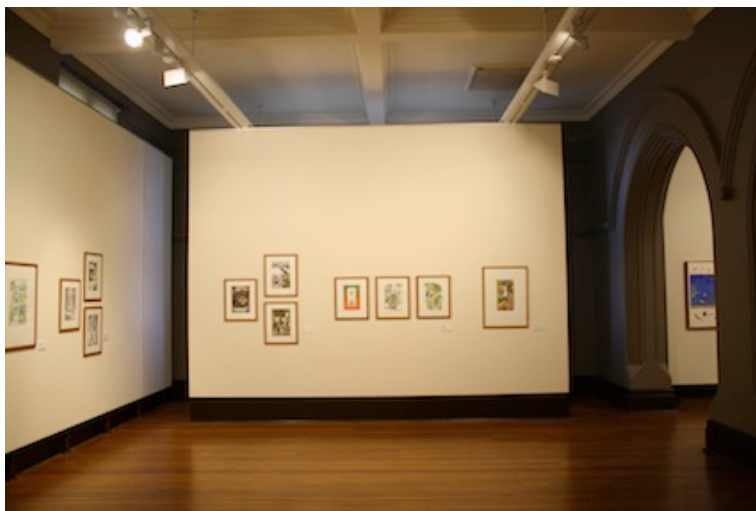
View toward south-west wall with new partition concealing perimeter wall behind

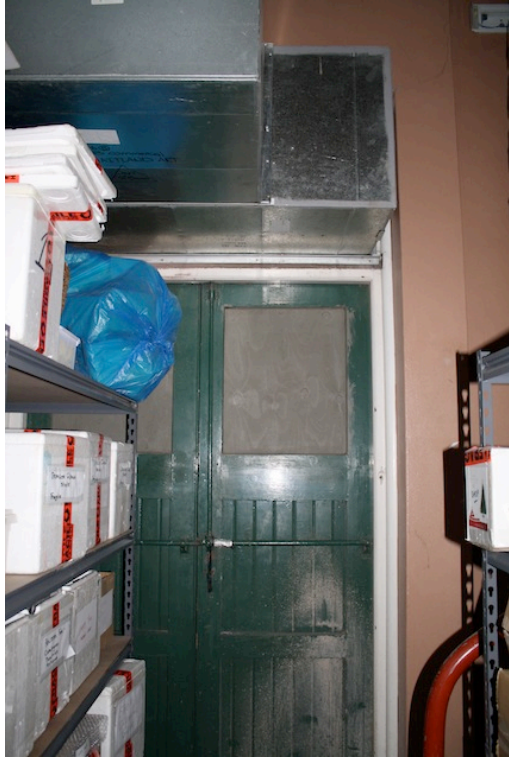
<b>Room Name/Use</b>	<b>8 Storage Space</b>
<b>Former Name/ Use</b>	<b>Fire Stair</b>
<b>Description:</b>	
Floor	Concrete.
Skirting	Nil
Walls	Painted render.
Ceiling	Painted render.
Cornice	Nil
Doors	Painted timber framed doors with vertical boarding and figured glass at top. Panic bars on inside.
Architraves	Painted quad architraves.
Windows	Painted timber framed 12 light fixed glazed
Fireplace	Nil
Lights	Surface mounted fluorescent lights.
Electrical Fittings	PVC light switches and Exit signs.
Other	Concrete stair with granolithic topping and painted steel pipe handrail.
<b>Condition</b>	Good
<b>Modifications</b>	<b>New MRAG 2009:</b> Not used as fire escape as does not comply with BCA and it is now redundant as new MRAG has replacement fire exit.
<b>Integrity</b>	Not part of the original building. No longer used as a fire escape as does not comply with the BCA.
<b>Significance rating</b>	<b>Intrusive</b> - The stair was built at a later stage (date unknown), is now redundant and detracts from the significance of the original design.

View of north-east wall showing new air conditioning ducting

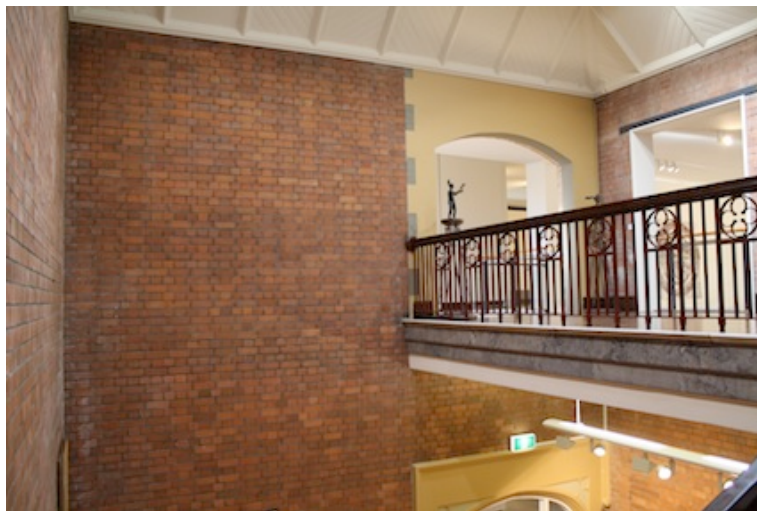
timber panelling in area of op4.
<b>Integrity</b>	Appears original throughout except for new openings and electrical fittings. Remove paint from face brick quoins at openings as this detracts from the quoins.
<b>Significance</b>	<p><b>Exceptional significance</b> - The original public areas/ entrance areas of the interior of the Main Building and all original fabric in these areas. All fabric that is representative of the Federation Gothic style.</p> <p><b>Exceptional Significance</b> - The elements of this room which include the doorsets, structure, detail and design and materials of the cantilvered staircase including the contrasting pink and white marble, lantern. The face brickwork, sandstone skirtings, white marble borders and parquet floor.</p>

View toward north-east wall showing new opening on south-east wall with new building beyond.

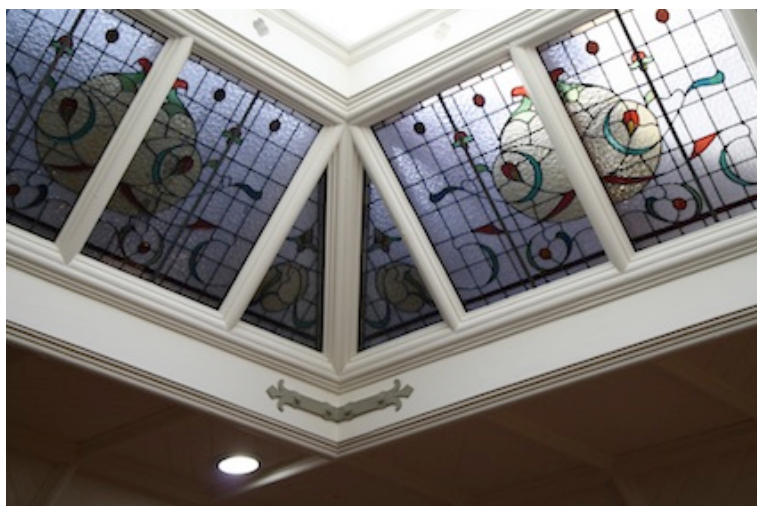
View of north corner of Art Nouveau lantern glazing

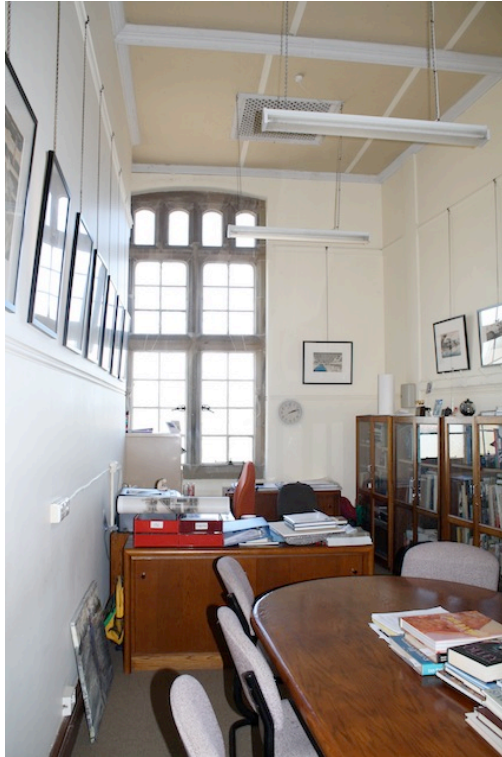
<b>Integrity</b>	<p>Appears to be original fabric throughout except for carpet, plasterboard ceiling, electrical fittings and deadlock.</p> <p>Two large ventilators in ceiling and vents in internal walls are evidence of original ventilation system.</p>
<b>Significance</b>	<p><b>High significance</b> – The original interior of the Main Building and all original fabric. All fabric that is representative of the Federation Gothic style and fabric that represents innovative design and construction, such as the ventilation system and reinforced concrete and steel structure.</p> <p>The elements of this room which include, doors, vents, windows, evidence of Library use are significant features of Vernon’s design.</p> <p><b>Little to Intrusive</b> - Plasterboard ceiling lining to prevent dust ingress. Reversible intervention</p>

View toward south west wall with original ceiling concealed behind plasterboard

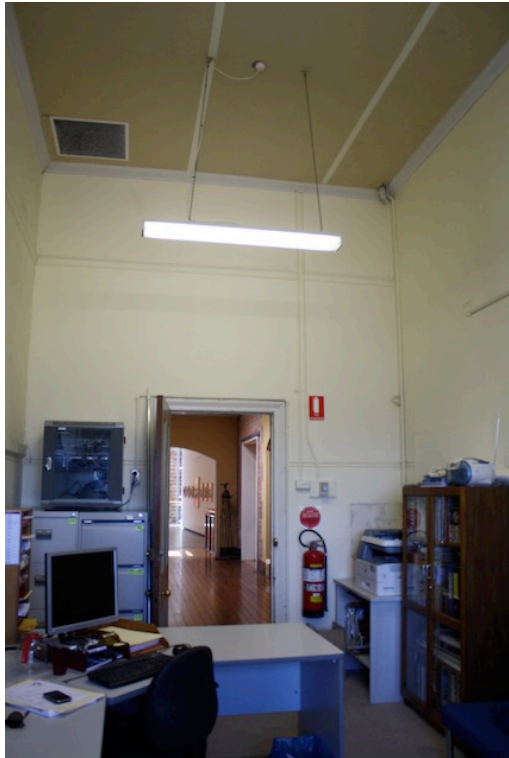
<b>Integrity:</b>	Appears to be original fabric throughout except for floor finish, electrical fittings, other fittings, cover over door and blind. Evidence of ventilation system remains in ceiling.
<b>Significance</b>	<p><b>High significance</b> – The original interior of the Main Building and all original fabric. All fabric that is representative of the Federation Gothic style and fabric that represents innovative design and construction, such as the ventilation system and reinforced concrete and steel structure.</p> <p>The elements of this room which include, doors, vents and windows, are significant features of Vernon's design.</p> <p><b>Intrusive</b> - Plasterboard ceiling lining to prevent dust ingress. Reversible intervention</p>

View toward north east wall with original ceiling concealed behind plasterboard

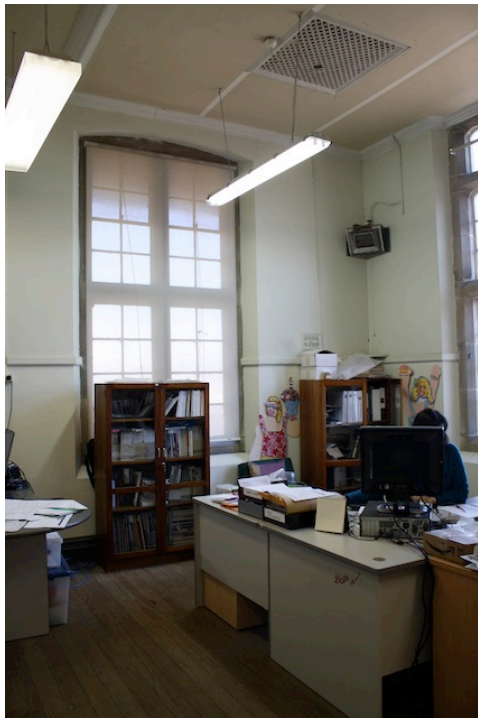
<b>Integrity:</b>	Appears to be original fabric throughout except for, electrical fittings, and deadlock, a/c supply , fluorescent lights, gas heaters and plasterboard ceiling.
<b>Significance</b>	<b>High significance</b> – The original interior of the Main Building and all original fabric. All fabric that is representative of the Federation Gothic style and fabric that represents innovative design and construction, such as the ventilation system and reinforced concrete and steel structure.  The elements of this room which include the doors, windows, arched recesses, the ventilation system in the attic space which are features of Vernon's design. <b>Little significance</b> - Plasterboard ceiling lining to prevent dust ingress. Reversible intervention. Gas heaters.

View of south corner with original ceiling concealed behind plasterboard.

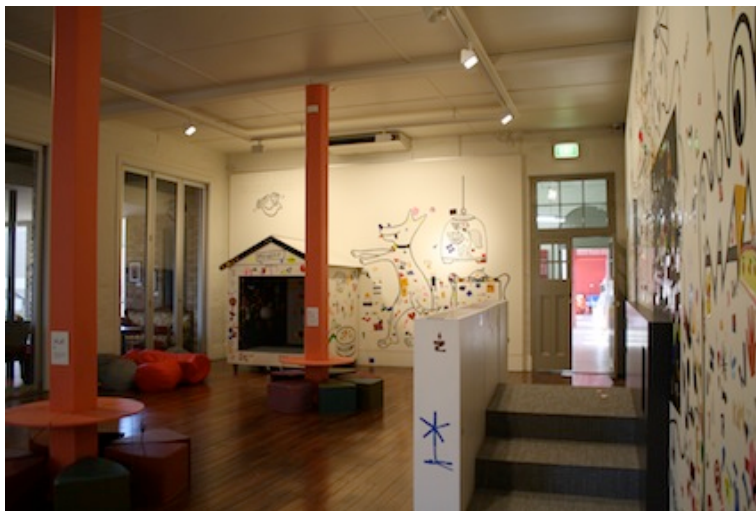
View toward north east wall showing new track lighting and ceiling mounted a/c unit.
