# Detailed Contamination Assessment

51,134 & 146 Station  
Street, Lochinvar NSW

NEW21P-0129-AD  
27 April 2022

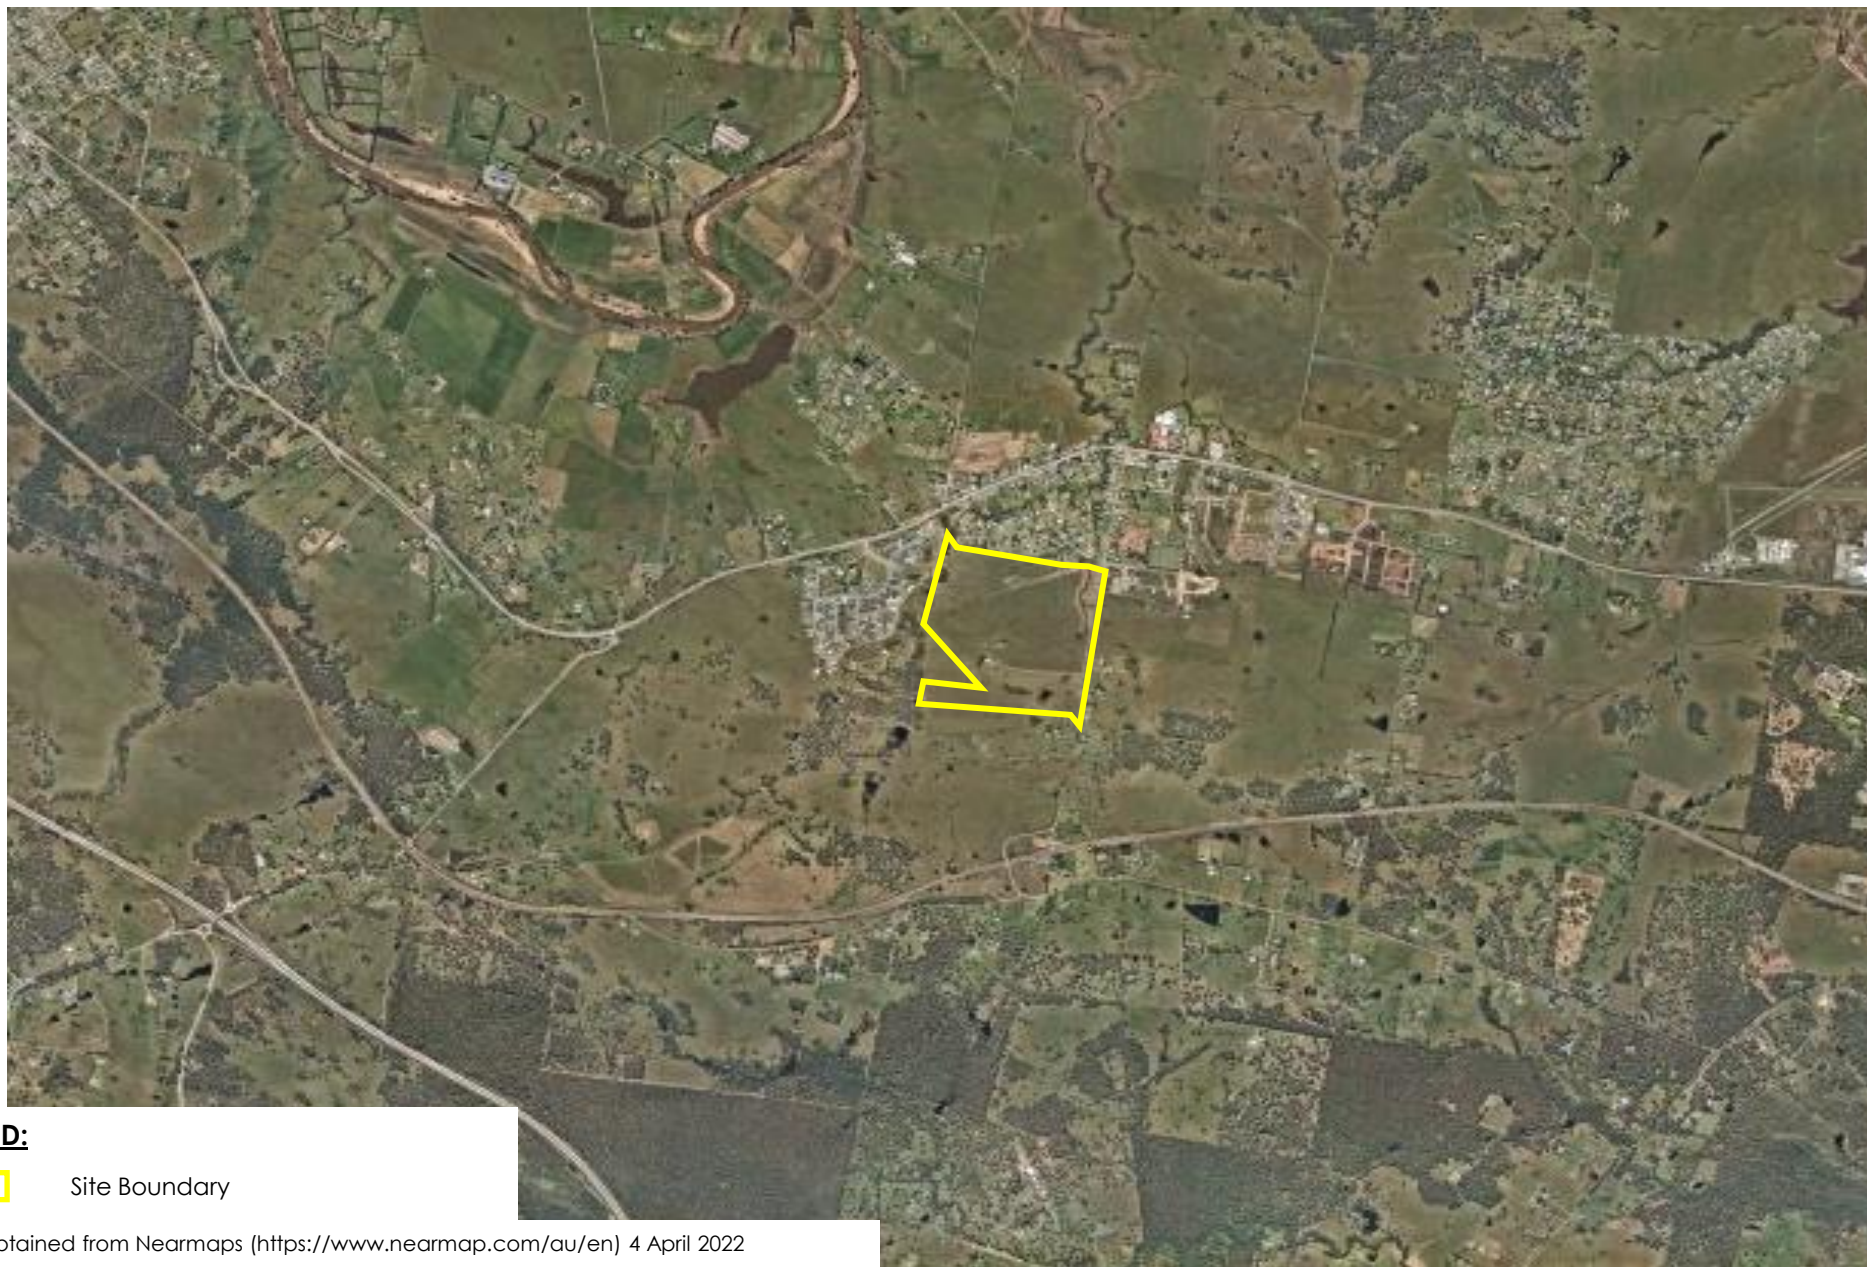
| Title: | SITE LOCATION PLAN | Date: | 4/04/2022 |

Qualtest Laboratory NSW Pty Ltd (Qualtest) has carried out a Detailed Contamination Assessment (DCA) for McCloy Project Management Pty Ltd (McCloy) for the site located at 51, 134 and 146 Station Lane, Lochinvar, NSW (the site). Figure 1, Appendix A, shows the site location.

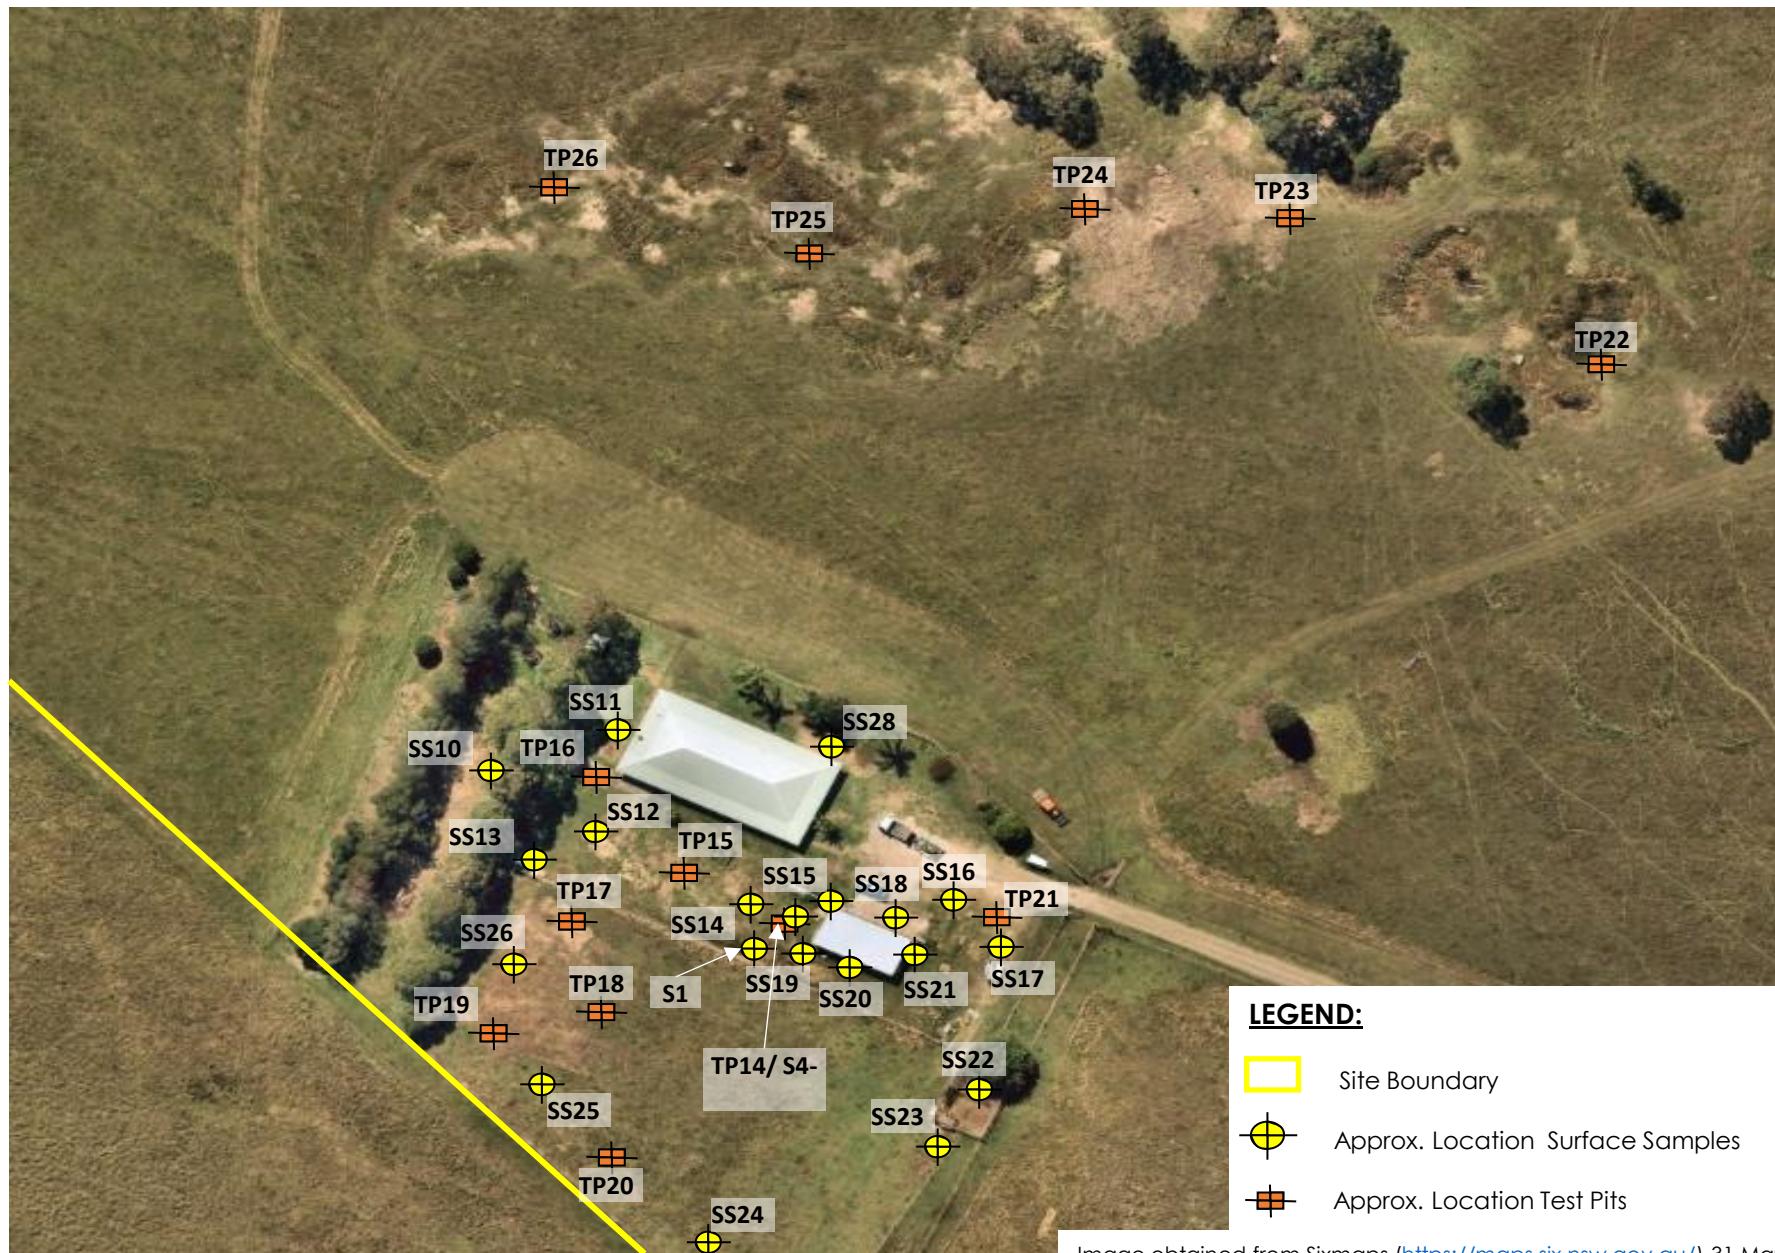
| Title: | SAMPLING PLAN - NORTHERN PORTION | Date: | 4/04/2022 |

- Site Boundary
- ⊗ Approx. Location Surface Samples
- ⊗ Approx. Location Test Pits
