Report on
Geotechnical and Waste Classification Investigation

Proposed Aged Care Facility
Morpeth Road, Morpeth

Prepared for
Lend Lease (Retirement Living)

Project 81251.10
April 2016

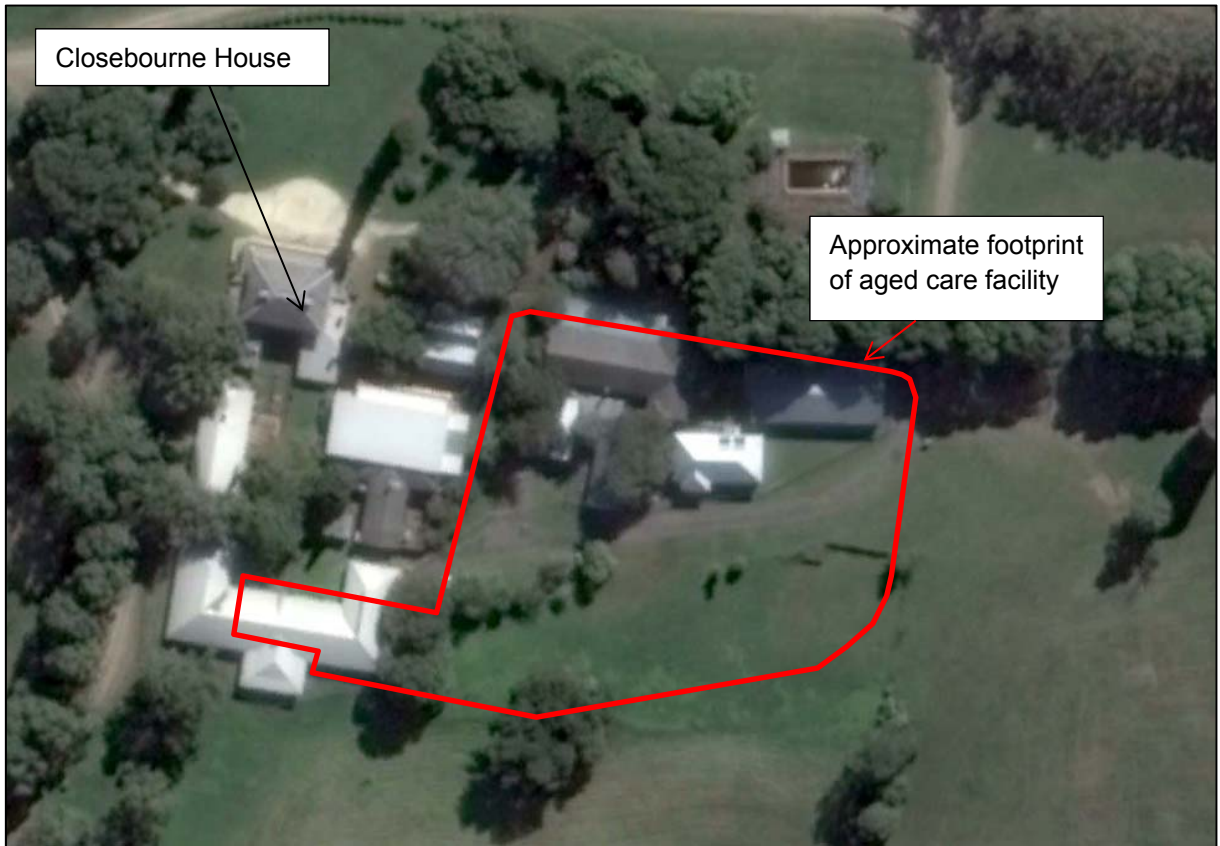
Figure 1: Aerial image of site with approximate aged care footprint (sourced from Google Earth)

A number of existing buildings are located within the proposed aged care facility footprint (refer Figure 1).

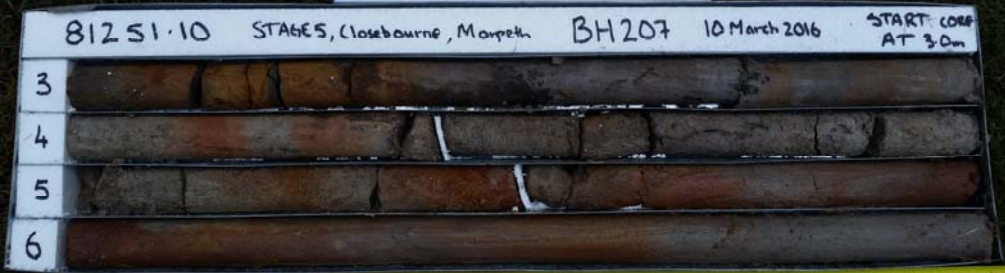
DOUGLAS PARTNERS PTY LTD
Proposed Aged Care, Closebourne, MORPETH
BORE 207 PROJECT 81251.10 2016

3.00 m – 7.00 m

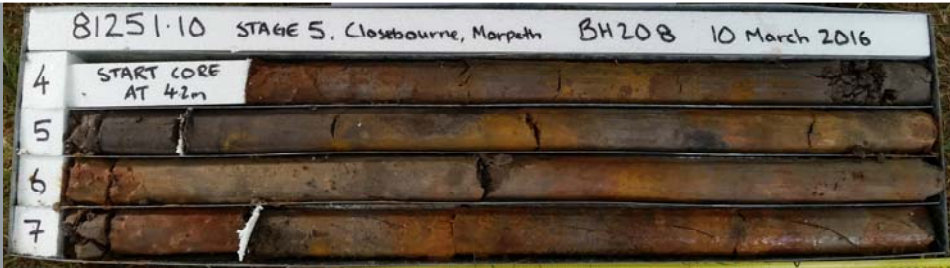
DOUGLAS PARTNERS PTY LTD
Proposed Aged Care, Closebourne, MORPETH
BORE 208 PROJECT 81251.10 2016

4.20 m – 8.00 m

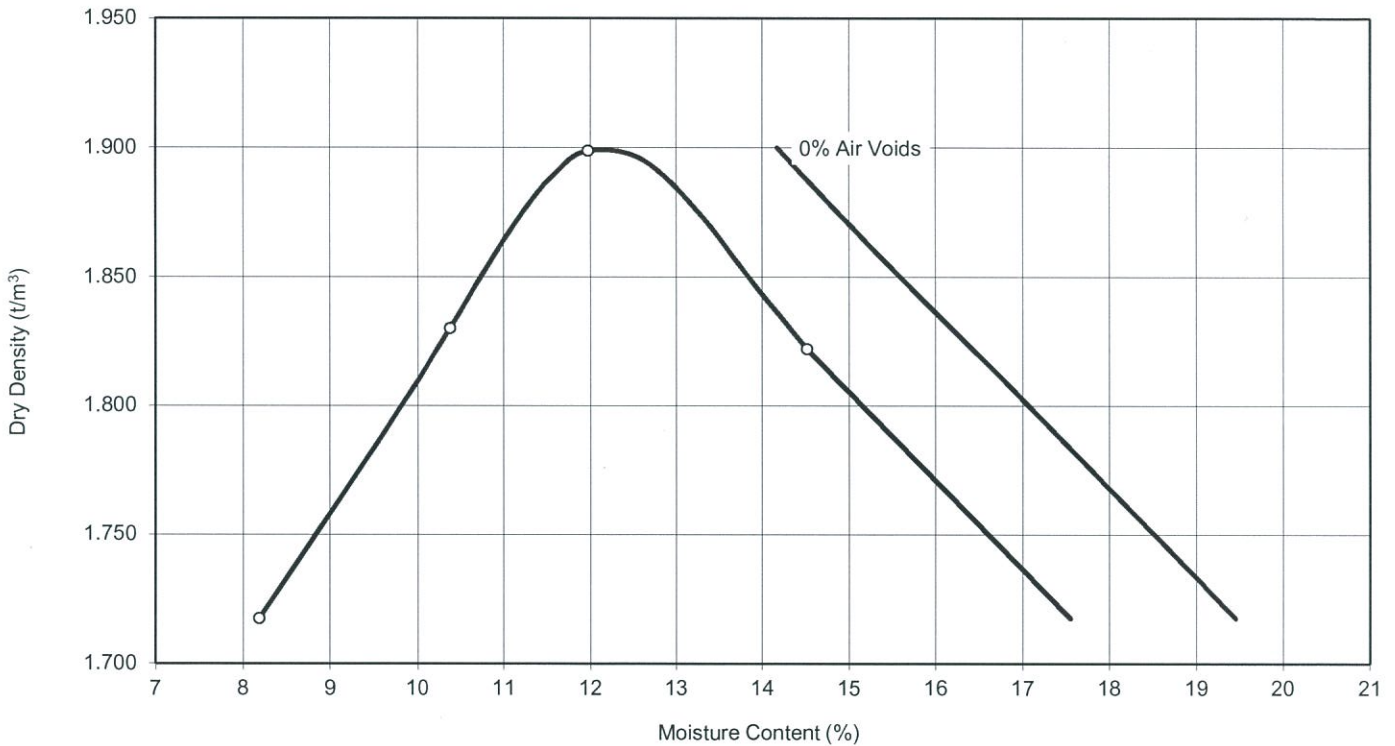
Results of Compaction Test

Sample Details: Location: Pit 209
Depth: 0.9 - 1.0m

Particles > 19mm: 0%
