Prepared for: Avid Property Group Pty Ltd EP1995.003 30 August 2021

Preliminary Geotechnical Assessment

487 Raymond Terrace Road, Chisholm, NSW

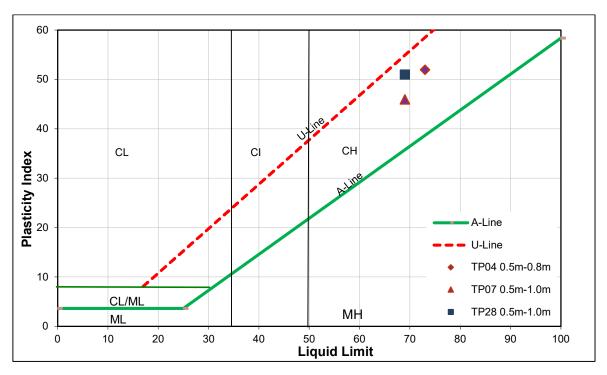
Figure 2. Atterberg limit plot

Based on the analytical results presented in **Table 7** the residual sandy CLAY/ Clay with sand encountered in most the test pits can be classified as being high plasticity clay. It should be noted that the residual sandy CLAY / CLAY with sand soils will vary in plasticity depending on sand, silt and clay content.

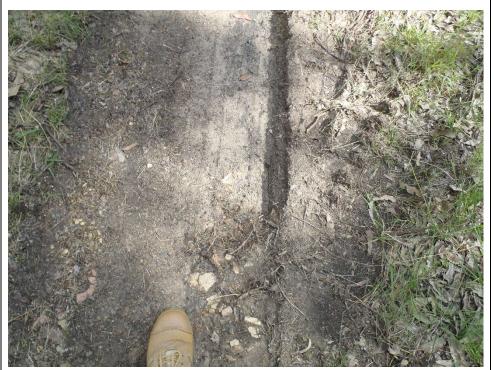
Brick and Coal Waste in access track in southern potion of site

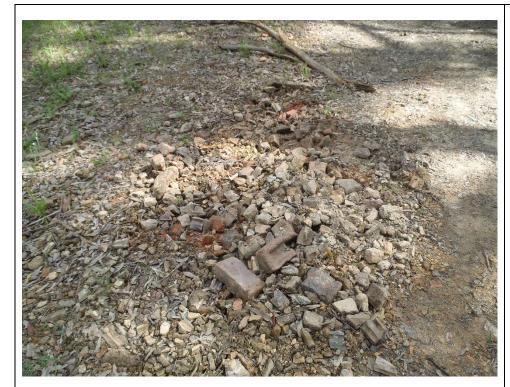
Brick and Refractory at side of access trach in the southern portion of site

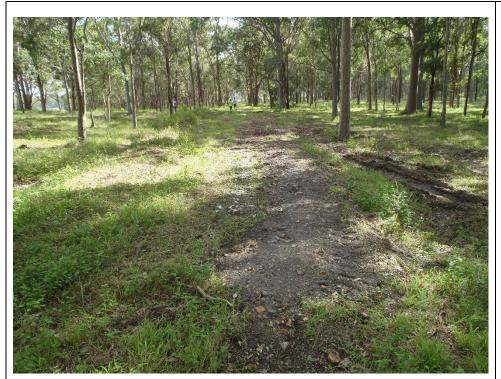
Mounded brick and coal waste Near western boundary front of site.

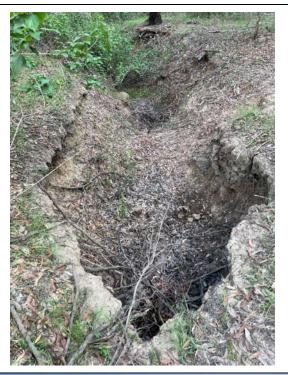
Description:Erosional
feature north of
quarry eastern
track

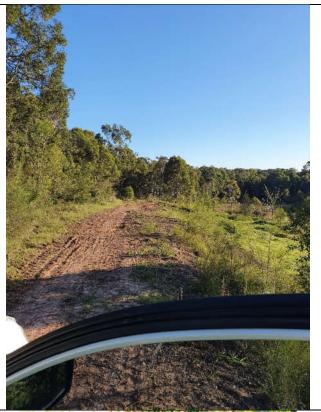
Western access track running along the edge of the quarry, photo taken from TP113 facing north.

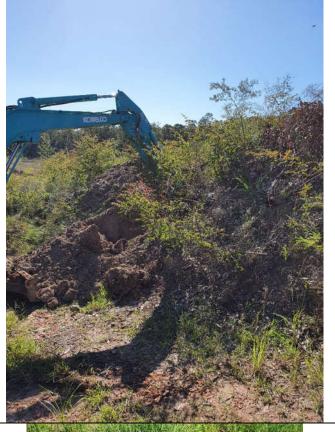
Test pit location TP137 located within the side of SP07 on the southern edge of the quarry adjacent to the access track entering the quarry.

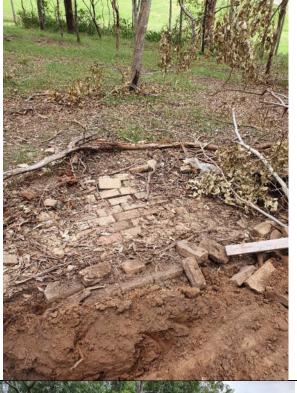
Old structure and anthropogenic waste stockpile, test pit location TP24.

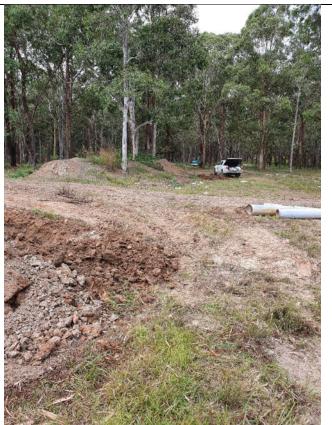
Old pipe and anthopogenic material adjacent to the two stockpiles SP11 and SP14.

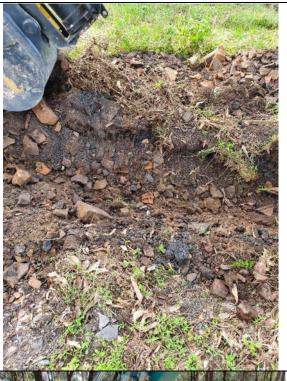
Test Pit TP06 located within the old access track in the south west corner of the Site. Contained brick, tiles and coal chitter.

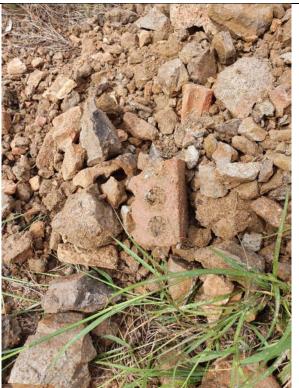
Brick and tiles located within the access track entering the quarry on the south eastern corner.

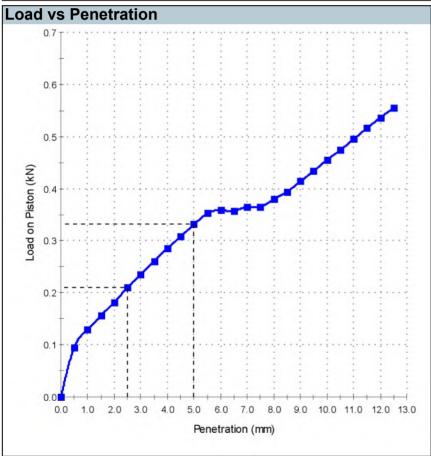
Test Results AS 1289.6.1.1 CBR at 5.0mm (%): 1.5 Dry Density before Soaking (t/m³): 1.45 Density Ratio before Soaking (%): 100.0 27.3 Moisture Content before Soaking (%): Moisture Ratio before Soaking (%): 98.5 Dry Density after Soaking (t/m³): 1 43 Density Ratio after Soaking (%): 98.5 Swell (%): 2.0 Moisture Content of Top 30mm (%): 32.3 Moisture Content of Remaining Depth (%): 28.5 Compaction Hammer Used: Standard AS 1289.5.1.1 Surcharge Mass (kg): 4.50 Period of Soaking (Days): Retained on 19 mm Sieve (%): CBR Moisture Content Method: AS 1289.2.1.1 Sample Curing Time (h): Plasticity Determination Method: Visual/Tactile - AS 1289.2.1.1 -In Situ (Field) Moisture Content (%): 33.0

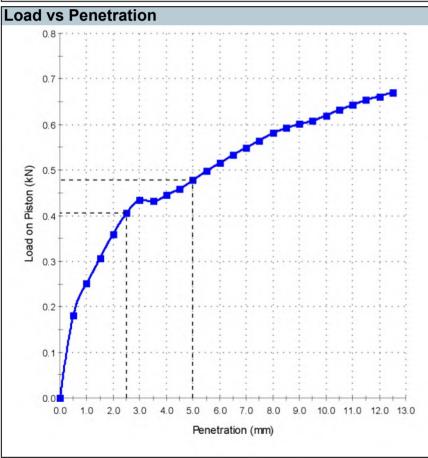
Test Results AS 1289.6.1.1 CBR at 2.5mm (%): 3.0 Dry Density before Soaking (t/m3): 1.55 Density Ratio before Soaking (%): 100.0 Moisture Content before Soaking (%): 24.6 101.0 Moisture Ratio before Soaking (%): Dry Density after Soaking (t/m³): 1 53 Density Ratio after Soaking (%): 98.0 Swell (%): 2.0 Moisture Content of Top 30mm (%): 29.0 Moisture Content of Remaining Depth (%): 25.9 Compaction Hammer Used: Standard AS 1289.5.1.1 Surcharge Mass (kg): 4.50 Period of Soaking (Days): Retained on 19 mm Sieve (%): CBR Moisture Content Method: AS 1289.2.1.1 Sample Curing Time (h): Plasticity Determination Method: Visual/Tactile - AS 1289.2.1.1 -In Situ (Field) Moisture Content (%): 22 1

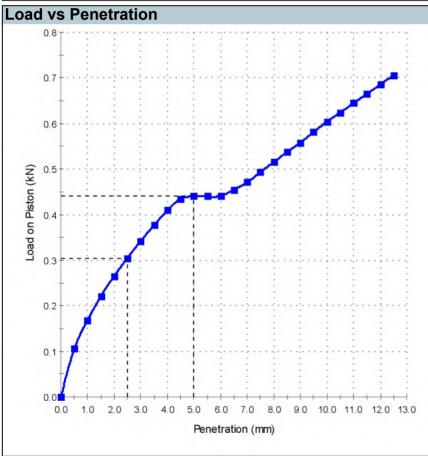
Test Results AS 1289.6.1.1 CBR at 2.5mm (%): 2.5 Dry Density before Soaking (t/m3): 1.62 Density Ratio before Soaking (%): 100.5 Moisture Content before Soaking (%): 22.6 97.5 Moisture Ratio before Soaking (%): Dry Density after Soaking (t/m³): 1.58 Density Ratio after Soaking (%): 97.5 Swell (%): 3.0 Moisture Content of Top 30mm (%): 29.4 Moisture Content of Remaining Depth (%): 23.6 Compaction Hammer Used: Standard AS 1289.5.1.1 Surcharge Mass (kg): 4.50 Period of Soaking (Days): Retained on 19 mm Sieve (%): CBR Moisture Content Method: AS 1289.2.1.1 Sample Curing Time (h): Plasticity Determination Method: Visual/Tactile - AS 1289.2.1.1 -In Situ (Field) Moisture Content (%): 24 9

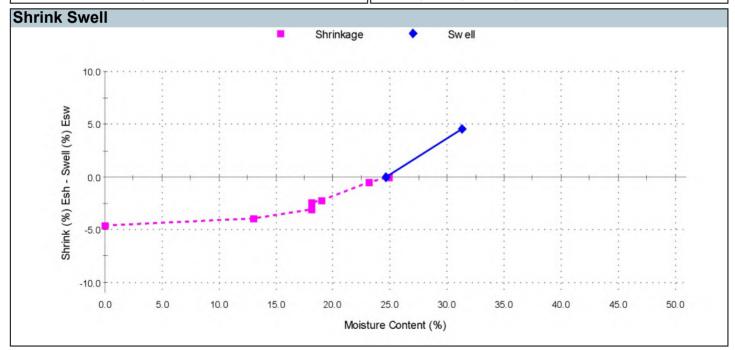
Shrink on drying (%): Shrinkage Moisture Content (%): 24.9 Est. inert material (%): Crumbling during shrinkage: Nil Cracking during shrinkage: Slight

Shrink Swell Index - Iss (%): 3.8

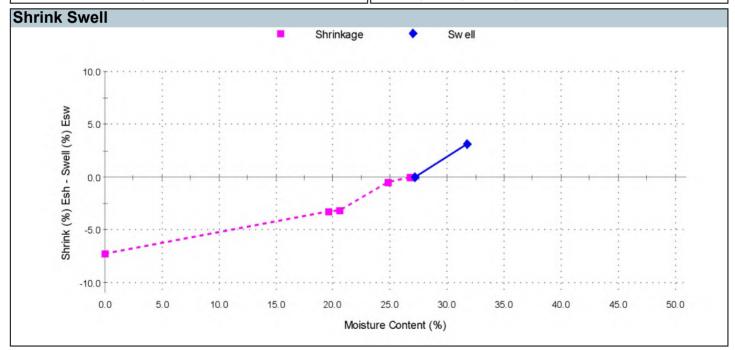
Shrink on drying (%): 7.3 Shrinkage Moisture Content (%): 26.7 Est. inert material (%): Crumbling during shrinkage: Nil Cracking during shrinkage: Slight

Shrink Swell Index - Iss (%): 4.9

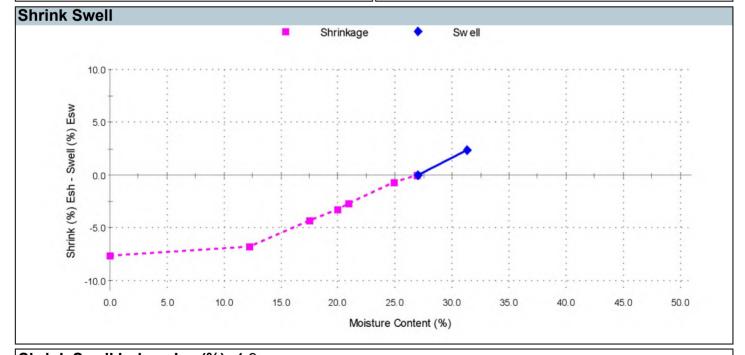
AS 1289.7.1.1 **Swell Test** Swell on Saturation (%): 2.4 Moisture Content before (%): 27.0 Moisture Content after (%): Est. Unc. Comp. Strength before (kPa): 150 Est. Unc. Comp. Strength after (kPa):

Shrink Swell Index - Iss (%): 4.9

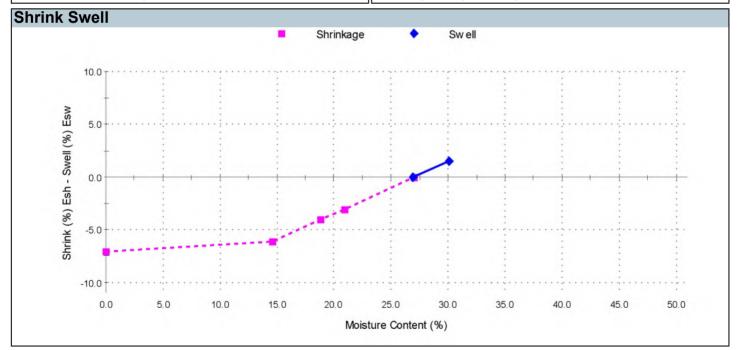
Shrink on drying (%): 7.1 Shrinkage Moisture Content (%): 27.0 Est. inert material (%): Crumbling during shrinkage: Nil Cracking during shrinkage: Nil

Shrink Swell Index - Iss (%): 4.4
