## GEOTECHNICAL ASSESSMENT PAVEMENT INVESTIGATION AND DESIGN

### PROPOSED REAR ACCESS ROAD

BUNNINGS WAREHOUSE  
BUNGAREE STREET  
MAITLAND, NSW

**Document – E21 053-A\_BunningsMaitland\_PAVE.Rpt**

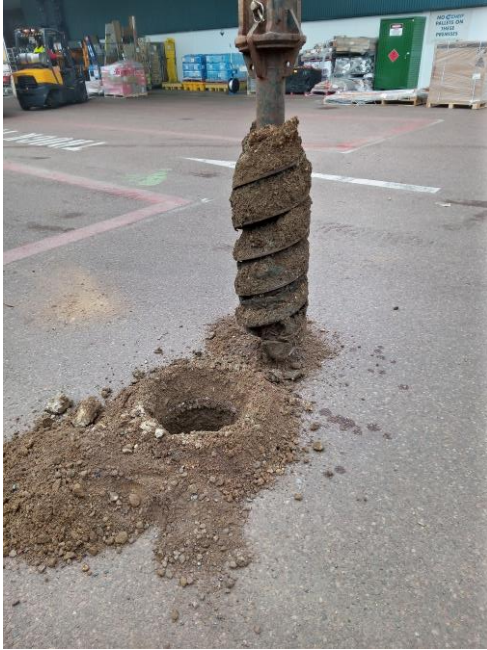
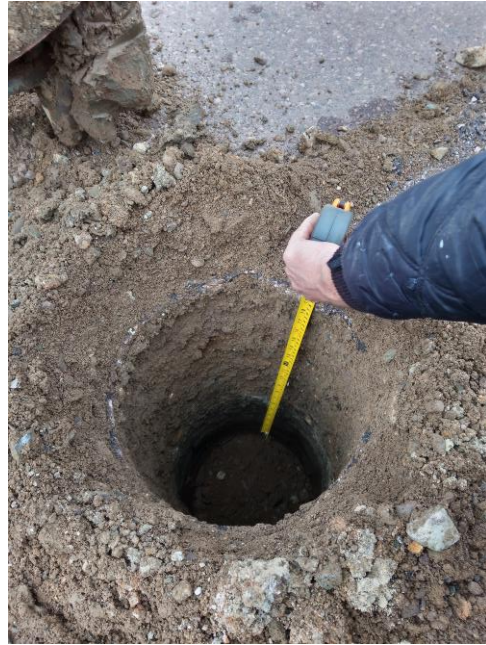
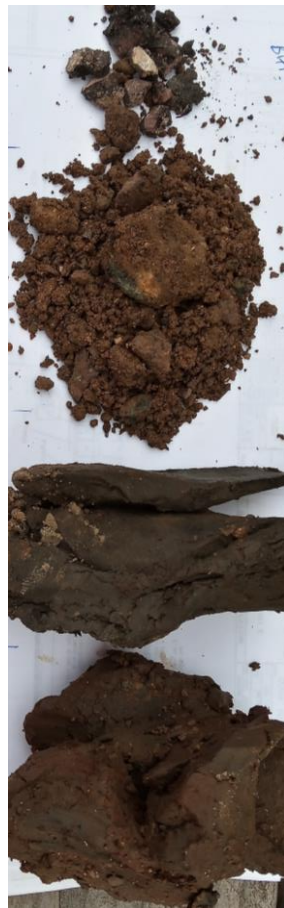
**BH1**

AC SEAL

UNIT 1 – FILL

UNIT 2A – RESIDUAL

UNIT 2B - RESIDUAL

Location		Bunnings Maitland Rear Access			Date	23.6.21		
Method		Auger			<b>BH1</b>		Logger	DGS
Method	DCP	Depth	Graphic	Material	Moisture	Con.Den	Obs	
SFA		0.03

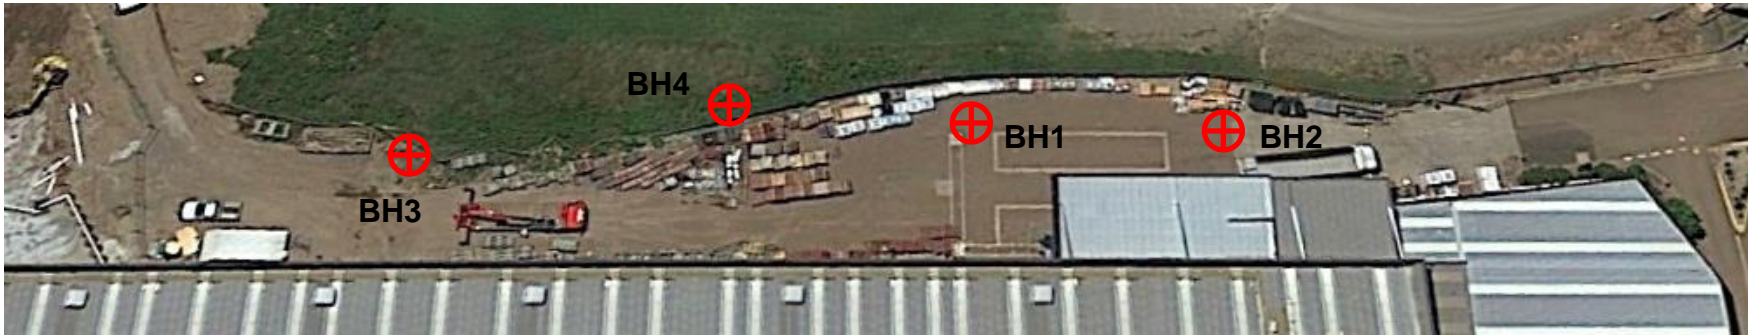
**FIGURE 2 – TEST LOCATIONS**

⊗ Borehole Location

The location of the proposed road reconstruction is located at the rear access of the existing building in the location shown on the attached Figure 2.

All field work was carried out in the full-time presence of a Senior Geotechnical Engineer from Sanko who located the boreholes, directed the sampling and testing and produced engineering logs of the boreholes. The engineering logs of the boreholes are presented in the appendix, together with explanation sheets defining the terms and symbols used in their preparation. The borehole locations are shown on the attached Figure 1.
