Report on
Geotechnical Investigation

Proposed Residential Subdivision
Cessnock Road, Gillieston Heights

Prepared for
Loxford Project Management Pty Ltd

Project 81520.01
February 2022

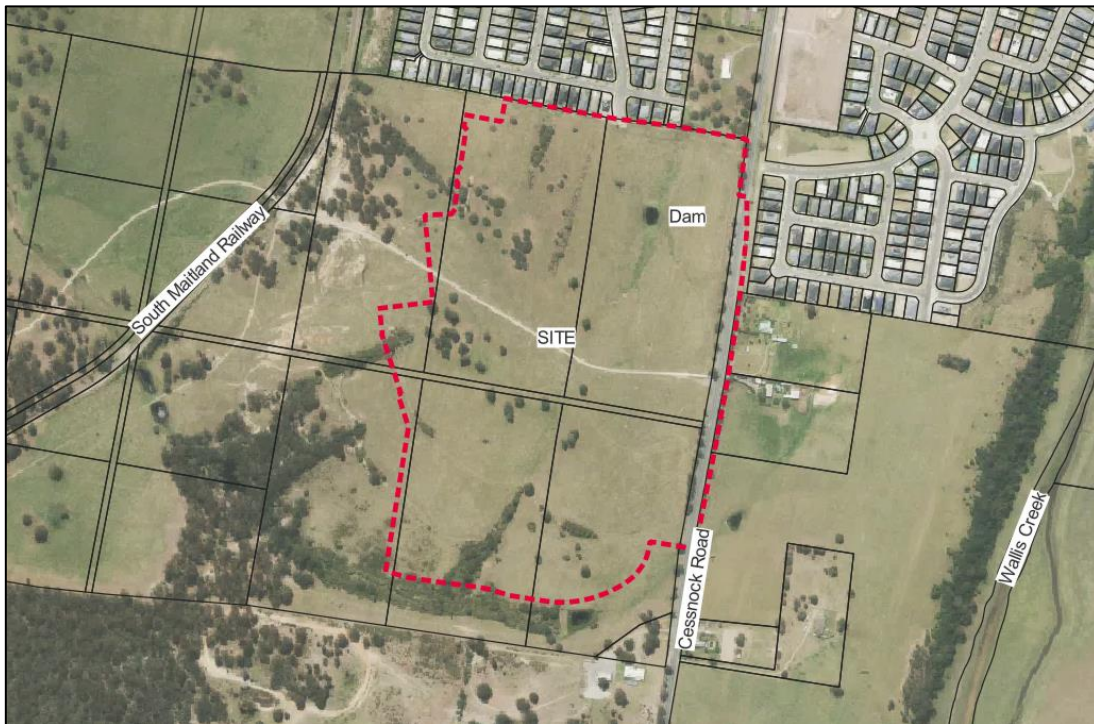
The site is an irregular shape and covers an area of approximately 50 ha. The indicative site extents are shown below in Figure 1.

Figure 1: Indicative Site Extents (Red Outline)

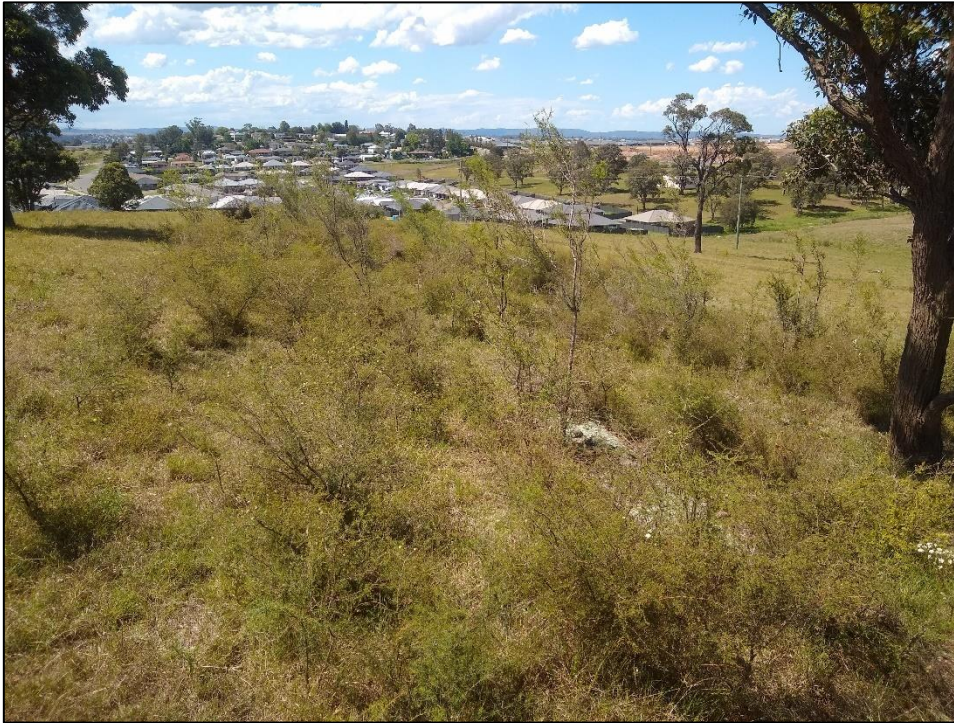
Figure 6: Looking north-east down slope from high point in north-west part of site, towards neighbouring residential development (note exposed rock)

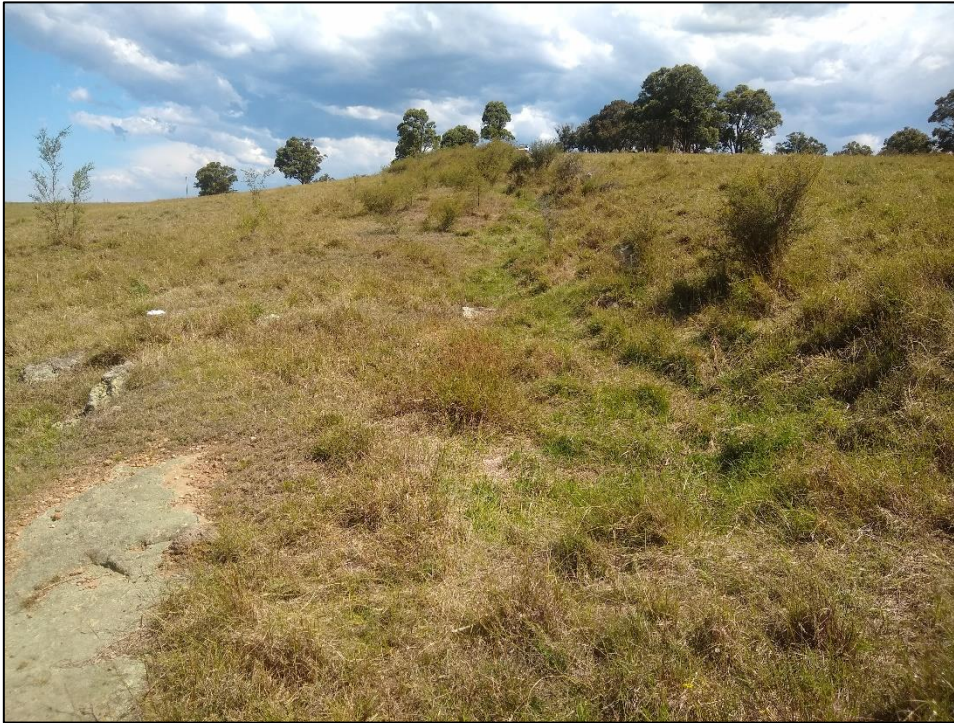
Figure 8: Looking south from northern part of site, along slope down from site high point (note exposed rock)

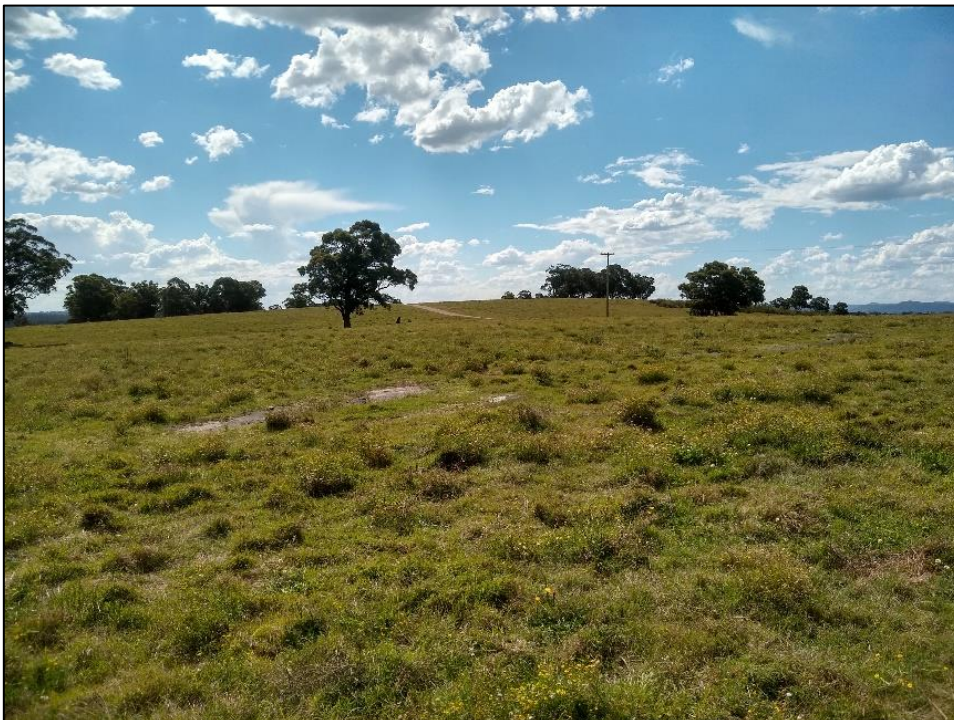
Figure 9: Looking north-west from the south-east part of the site (note outcropping rock)

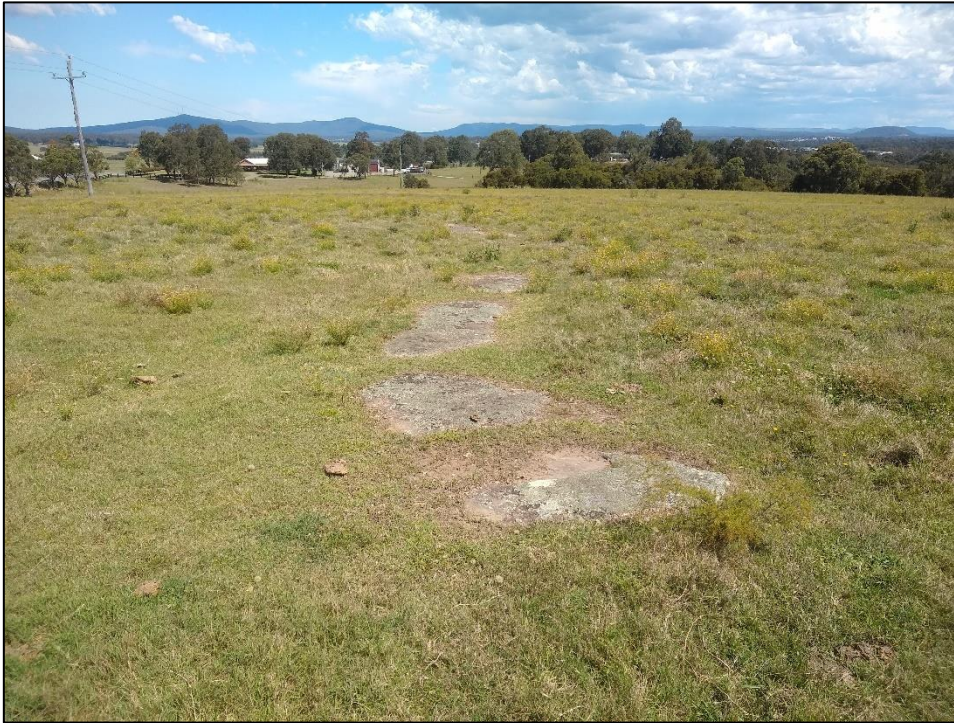
Figure 10: Looking south / south-east from central part of site (note outcropping rock)

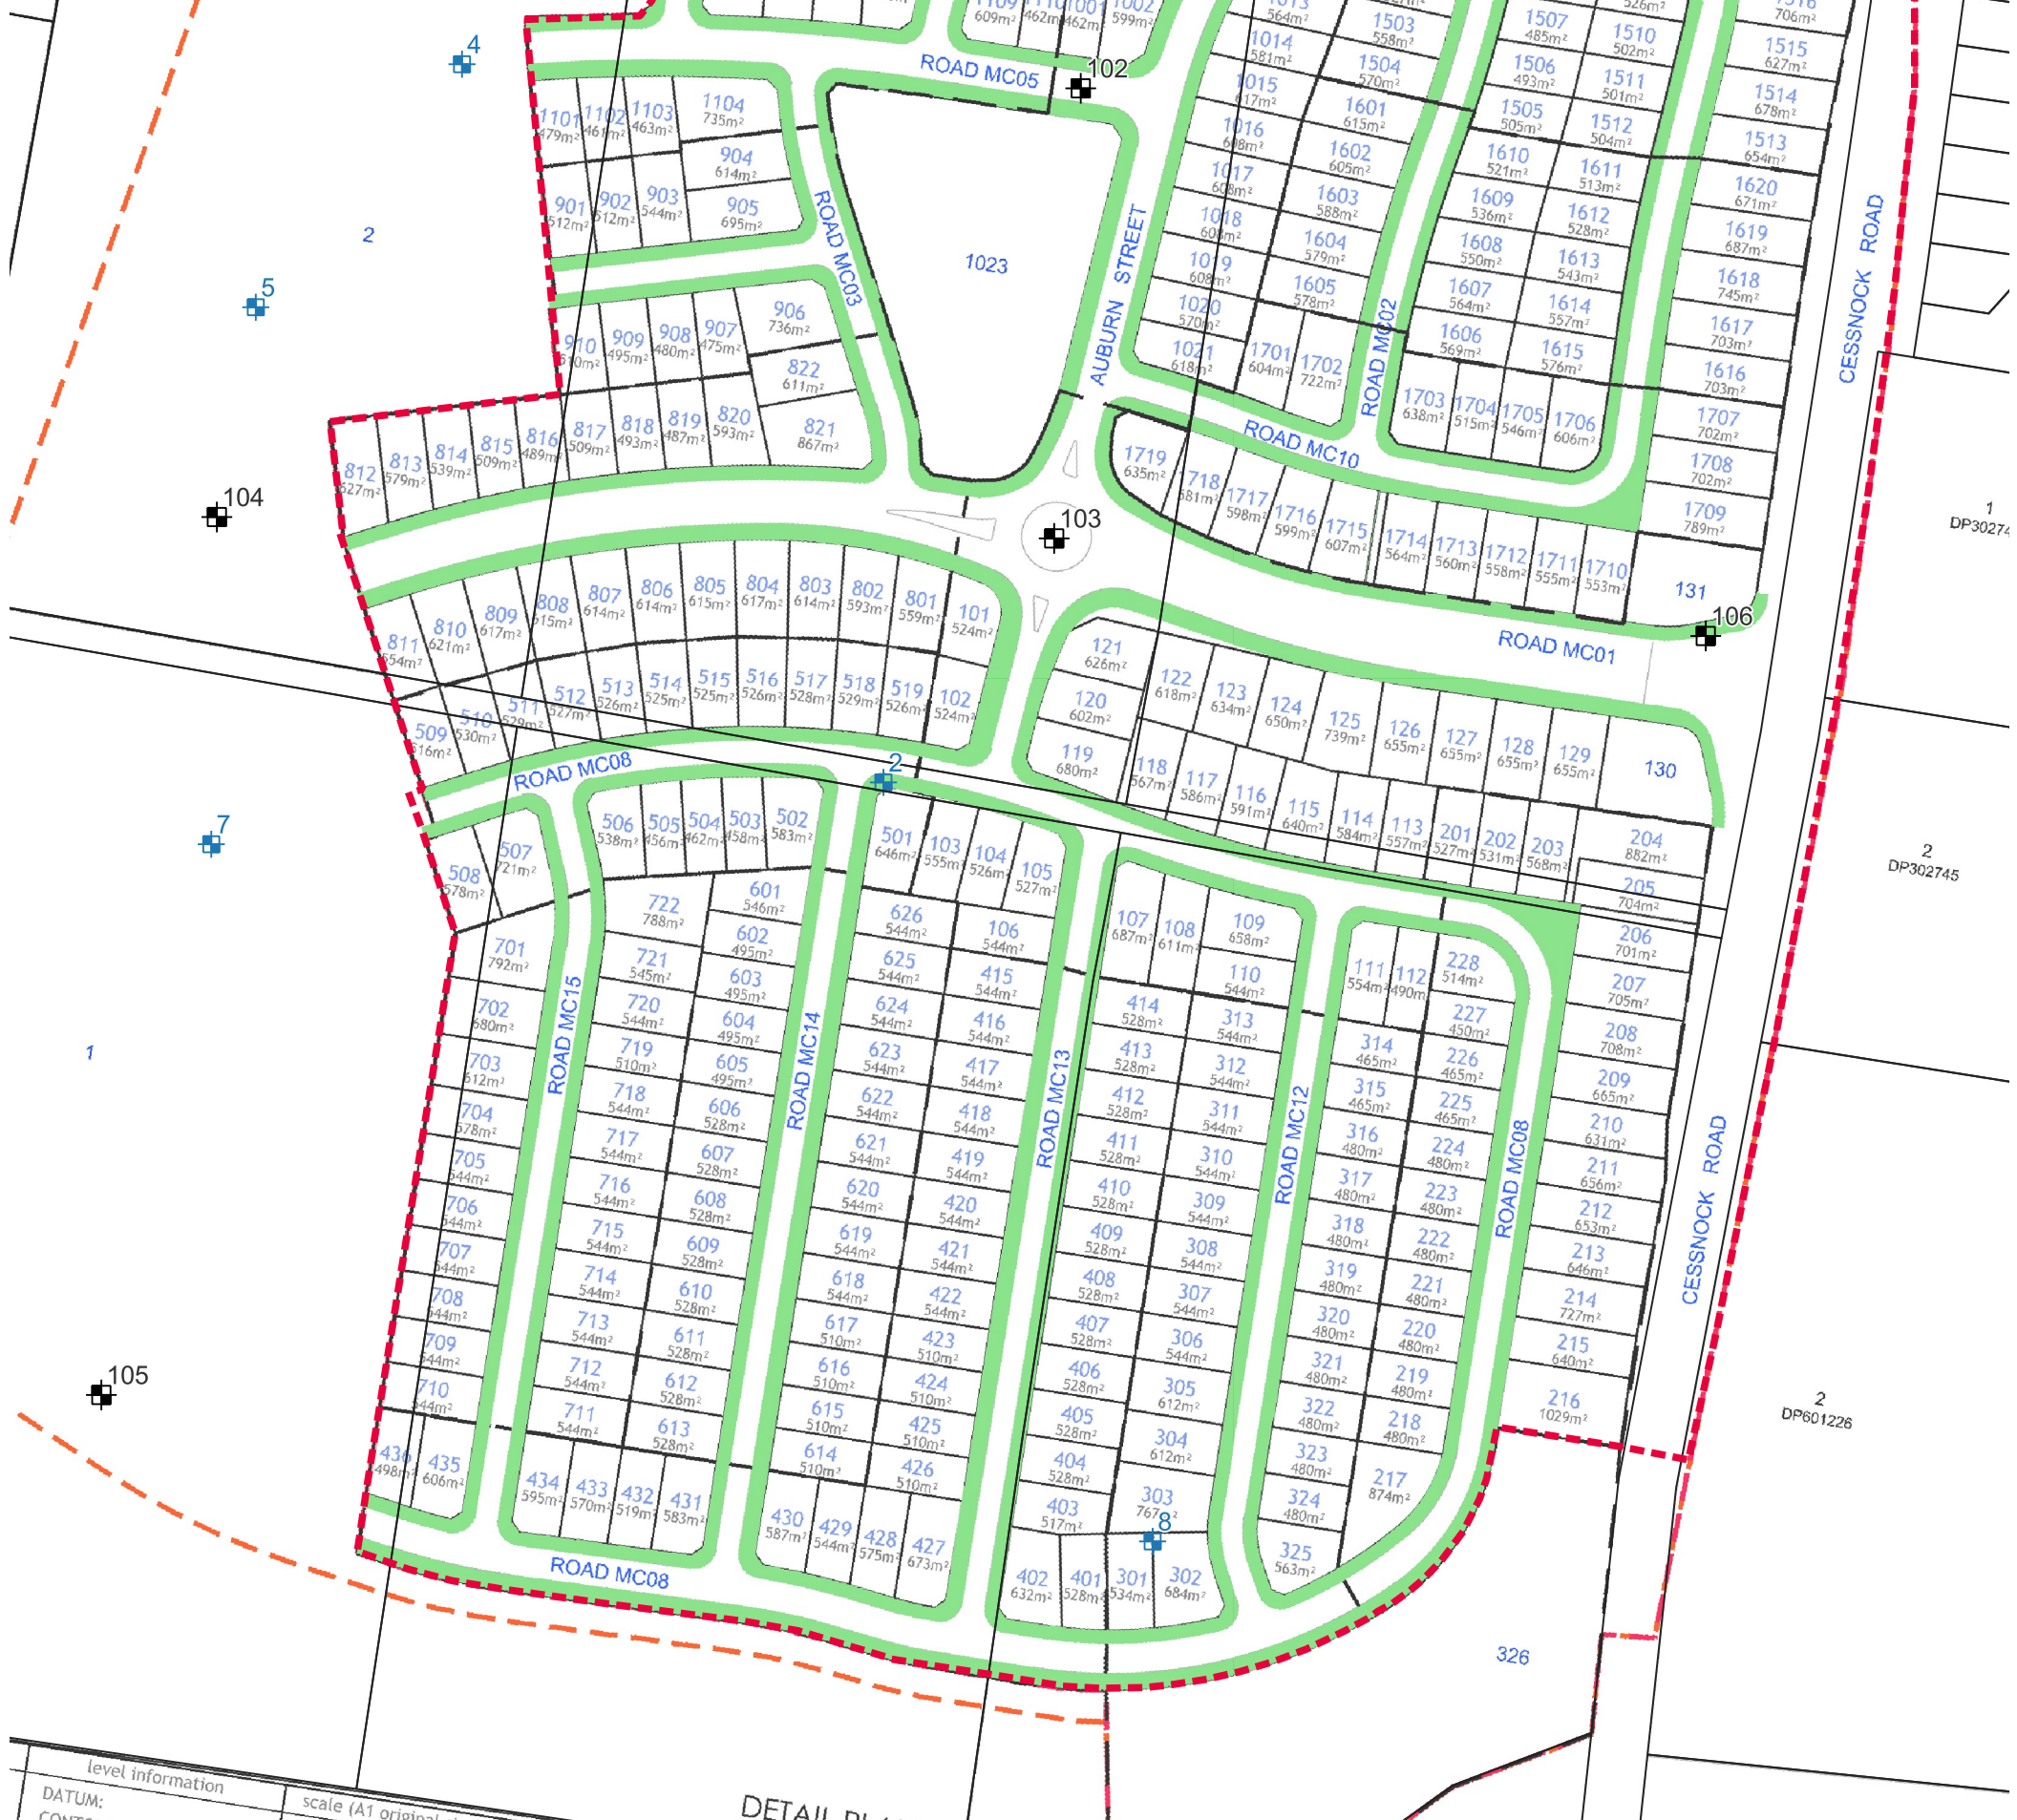
Drawing 1 -Test Location Plan

DETAIL PLAN
SCALE 1:1500
