# **GEOTECHNICAL SITE INVESTIGATION**

131 Wollombi Road, Farley, NSW 2320

Bathla Group

REPORT No.: NE1372

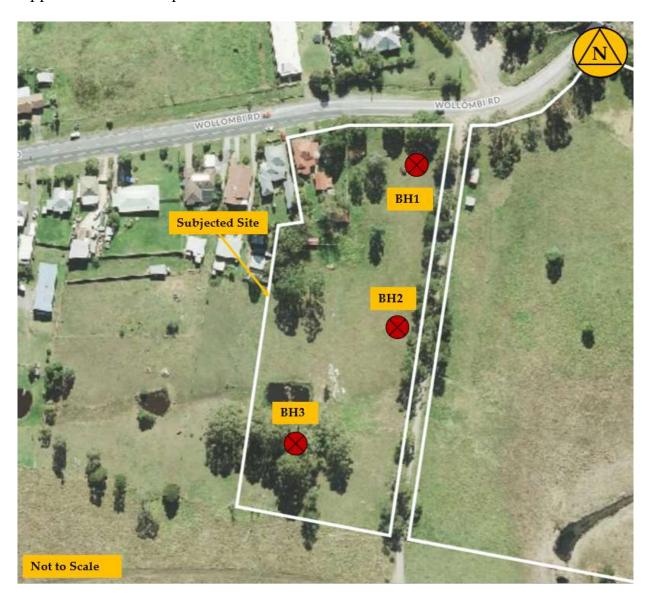
Figure 1: Site Plan and Boreholes

The investigation involves drilling three (3) boreholes (BH1–BH3) to a maximum depth of 2.2m due to auger refusal. The boreholes' location was determined by Geotesta, according to site accessibility and the locations of underground services.

A site plan showing the boreholes location is presented in Figure 1. Borehole drilling was carried out using a Ute-mounted drilling rig using a solid flight auger method. Dynamic Cone Penetrometer Testings were performed next to boreholes to determine the soil strength of soil layers.

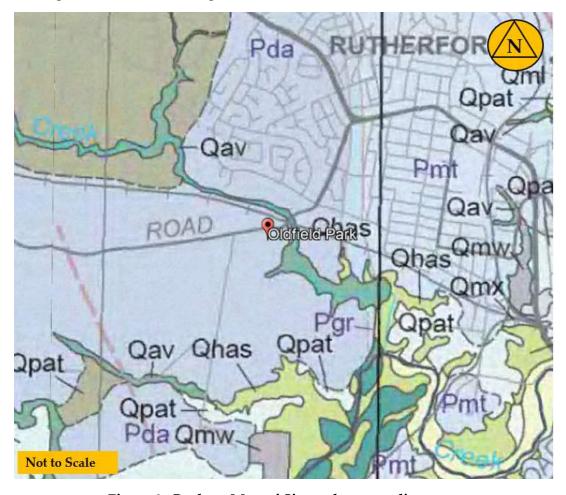
Figure 2: Geology Map of Site and surrounding area

The geological origin of the soil profile was identified from our visual examination of the soil samples, geotechnical experience, and reference to geological maps of the area. The Newcastle-Hunter Area 1:100 000, Coastal Quaternary Geology Map (2016) indicates the site is situated in Dalwood Group (Pda) comprising of sandstone, lithic sandstone, conglomerate, siltstone, and basalt. The geology map of the site and surrounding areas is shown in Figure 2.
