Our Ref: 2103903REa Maitland Gaol Experience- Heritage Structural Commentary

MAITLAND GAOL TOWER EXPERIENCE: HERITAGE STRUCTURAL COMMENTARY.

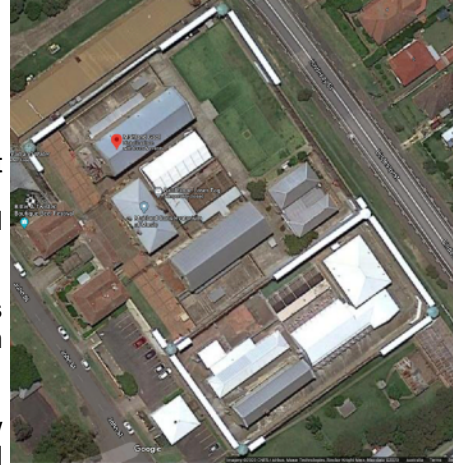
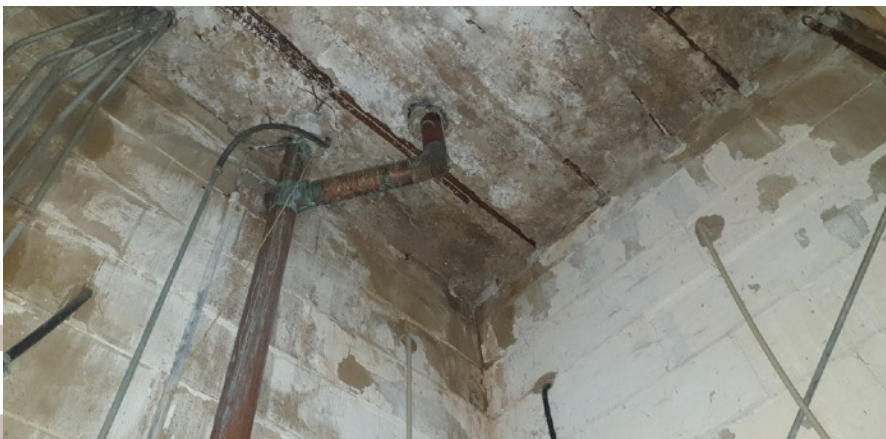
2.2.1. The existing structural condition of the concrete slab at the Tower is unconfirmed. However from observations that have been made, the under side of the slab appears to be reinforced with longitudinal bars, which are not adequately covered by concrete. From the observations of the slab from the underside, there are questions regarding the stability of the slab following the creation of the required penetrations. Consequently, a conservative approach has to be taken in the creation of this new penetration. A view of the underside of the slab is provided below.

2.2.2. Several options have been considered for the creation of the new opening within the existing slab, they are listed below, with reasons as to why they have not been adopted in this final design:

- **Slab removal back to inside face of sandstone tower shaft, leaving the remaining portion of the slab intact.** The condition of the slab reinforcement is unlikely to allow for the adequate support of the remaining sections of concrete which remain between the sandstone tower and the Tower. This is due to the unusual reinforcement seen in the concrete slab .

- **Entire slab removal, including the section under the Tower.** Removal of the entire slab, will require the Tower above the slab to be supported whilst the slab under the walls is removed, this option will not only cause disruption to the Tower itself, but also mean that the slab, with its unusual reinforcement, will be lost.

- **Slab removal extent to suit '3 o'clock shape' spiral stair penetration with use of trimmer beams radiating out from central CHS.** This method of creating the penetration is an idealised method of being able to support the remaining slab, whilst minimising the fixings into the sandstone walls. However, due to the unconfirmed structural condition of the slab, this idealised support methodology is not likely possible to be implemented.

- **Slab removal extent to suit '3 o'clock shape' spiral stair penetration, with new steelwork, fixed to the sandstone, which supports the remaining concrete slab.** This is the more conservative approach for the treatment of slab support. A support frame will be installed under the slab, which is fixed off to the sandstone walls. This support frame will allow for the adequate support of the remaining concrete slab and also offer a floor frame to fix-off an infill steel floor that will need to be constructed at the same level as the remaining slab.

2.2.3. The final method of support for the concrete slab will be decided once the works to install the stairs are commenced, as the underside of the slab will be accessible. It is desirable that where possible, the amount of steel frame work to support the slab be minimised. The fixings into the sandstone will be minimised and they will be carried out, inline with best practice for fixing into a heritage building; they will be 316 S/S chemical anchor fixings, designed to not damage the sandstone they are being fixed into.

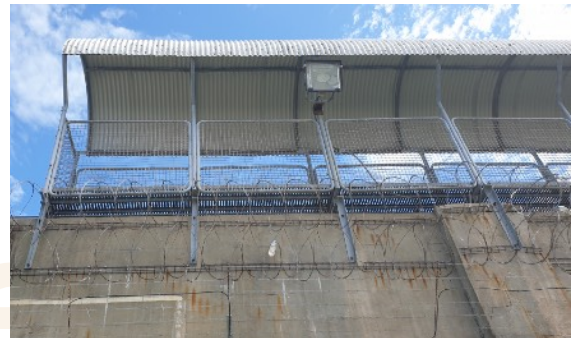
2.3.1. The eastern section of the gantry to Tower 6, deflects to a greater extent laterally, compared to the other sections of the gantry. Due to this difference in lateral performance under load, compared to the other sections it is believed that the fixing of the gantry to the wall will need to be remediated.

2.3.2. The remediation of the fixing, will be undertaken by either replacing the existing fixings with new fixings or the addition of a vertical steel support member to the wall, similar to that which has been used to install the gantry sections to other locations of the wall. The decision as which is the required structural solution will be decided once works to site commence. An image of the sections with a vertical steel member is shown below for reference.
