Preliminary Contamination Assessment

349 McFarlanes Road,
Berry Park, NSW

NEW21P-0170-AA
17 November 2021

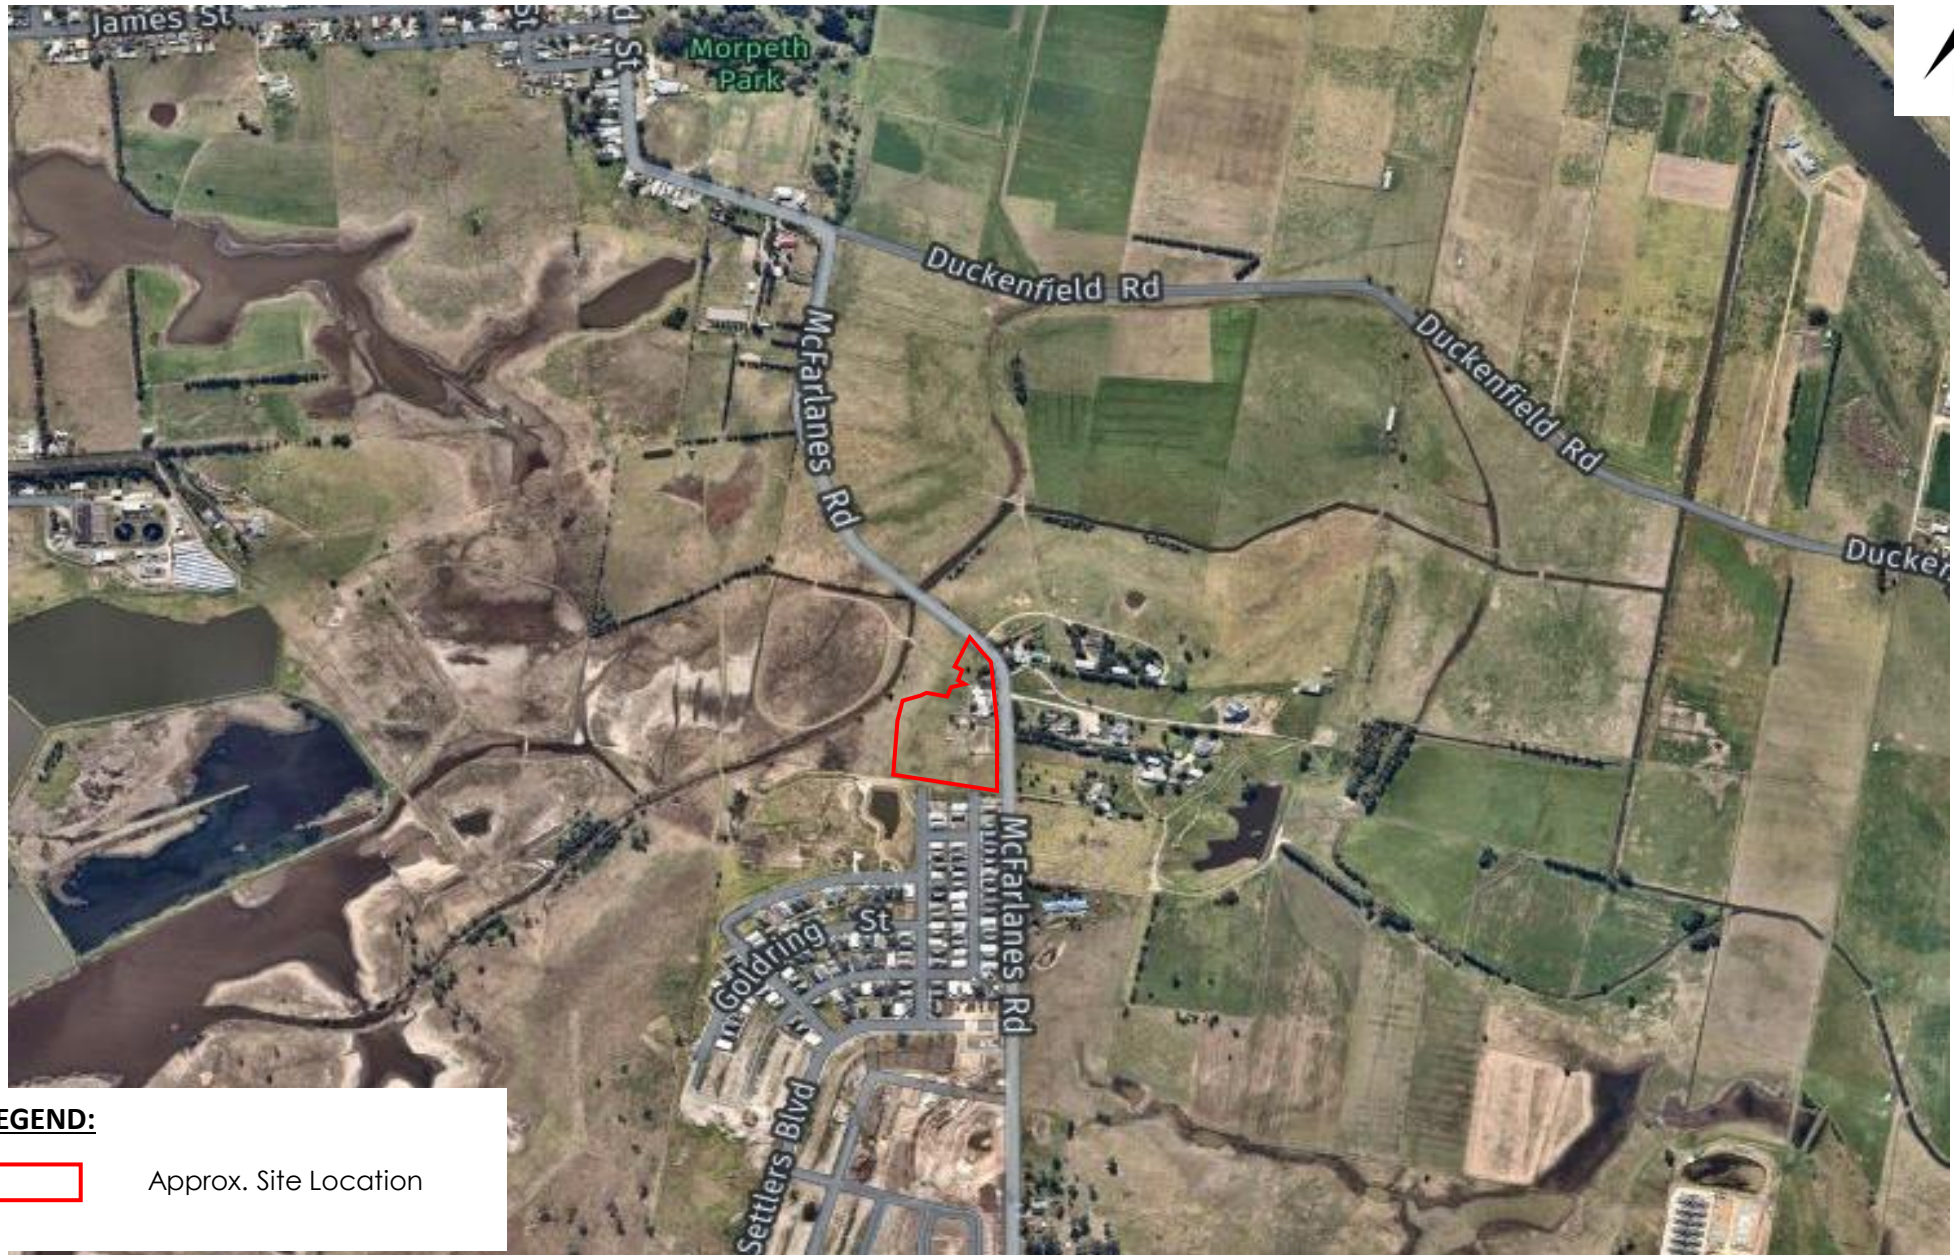
Qualtest Laboratory NSW Pty Ltd (Qualtest) has carried out a Preliminary Contamination Assessment (PCA) for Terry and Dianne Lumsden C/- Perception Planning Pty Ltd (Perception Planning) for the site located at 349 McFarlanes Road, Berry Park, NSW (the Site). Refer to Figure 1, Appendix A.

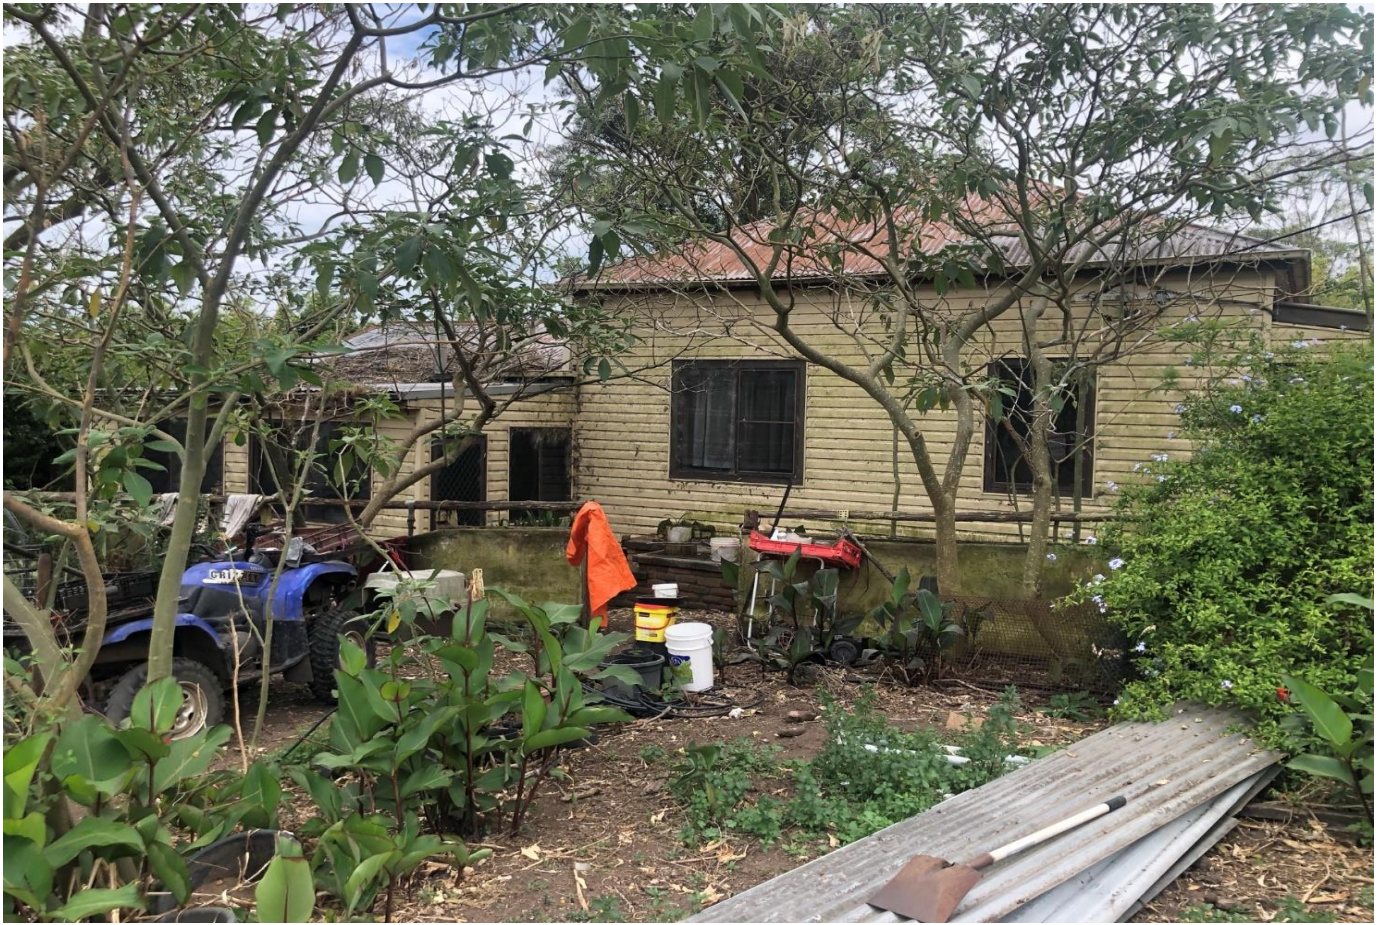
- A residential dwelling was observed in the northern portion of the site. The dwelling was observed to have been constructed with vinyl cladding, brick footings and a metal roof. Garden beds and vegetation surrounded the house (see photograph 1);

Photograph 1 - Residential dwelling - northern portion of the site

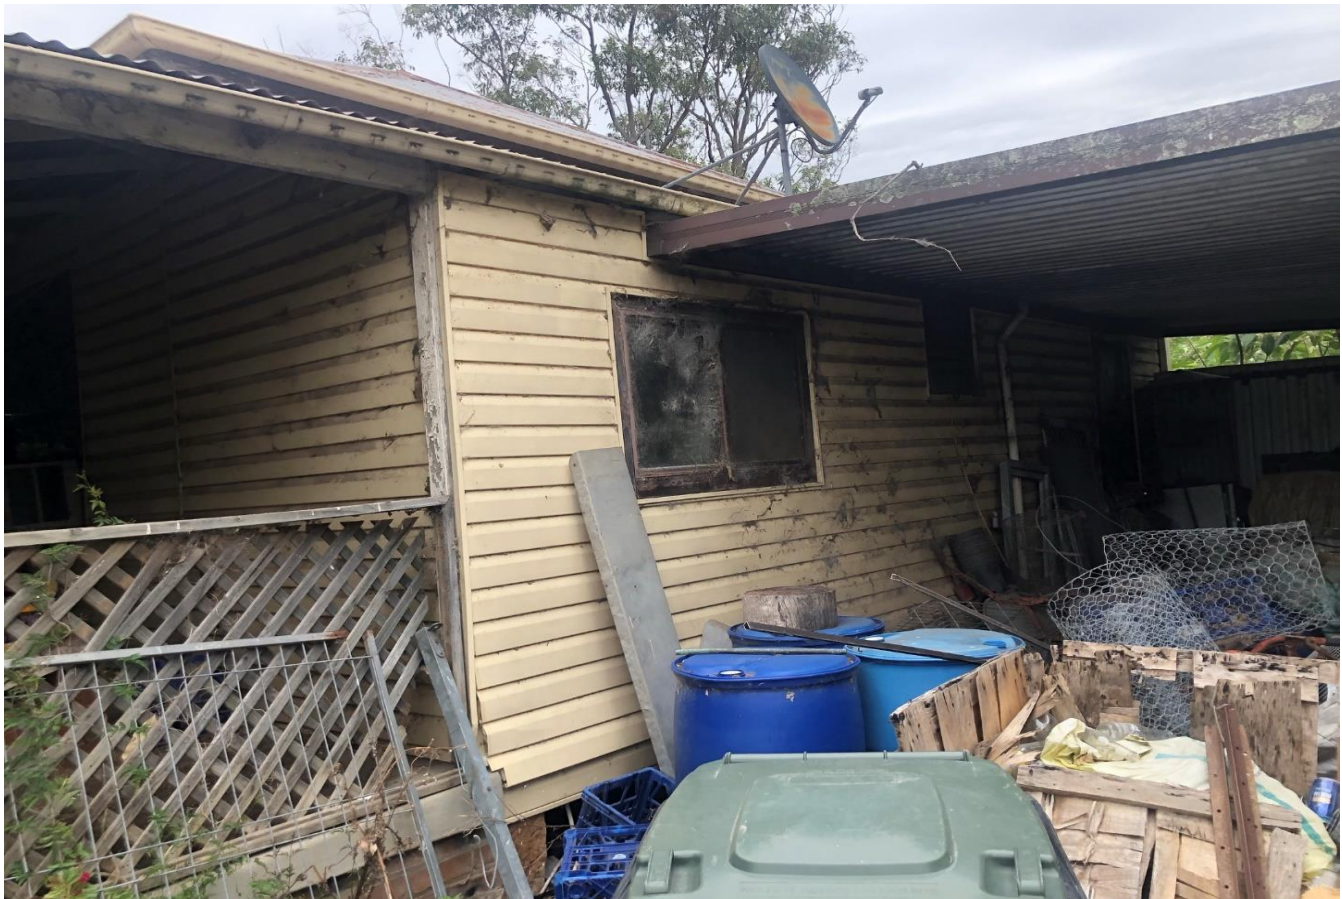
- A carport was attached to the northern portion of the residential dwelling. The carport was observed to have been constructed with timber, metal roofing and earth floor. Various items were observed stored in the carport including; empty molasses feed drums (205L drums), a 20 L oil drum, timber, metal, wire, glass and plastic bottles/tins, car seats, tyres, 2 x chest freezers, large quantities of bread for stock feed and general household items (see photographs 2 to 4);

Photograph 2 - Showing carport - north of residential dwelling

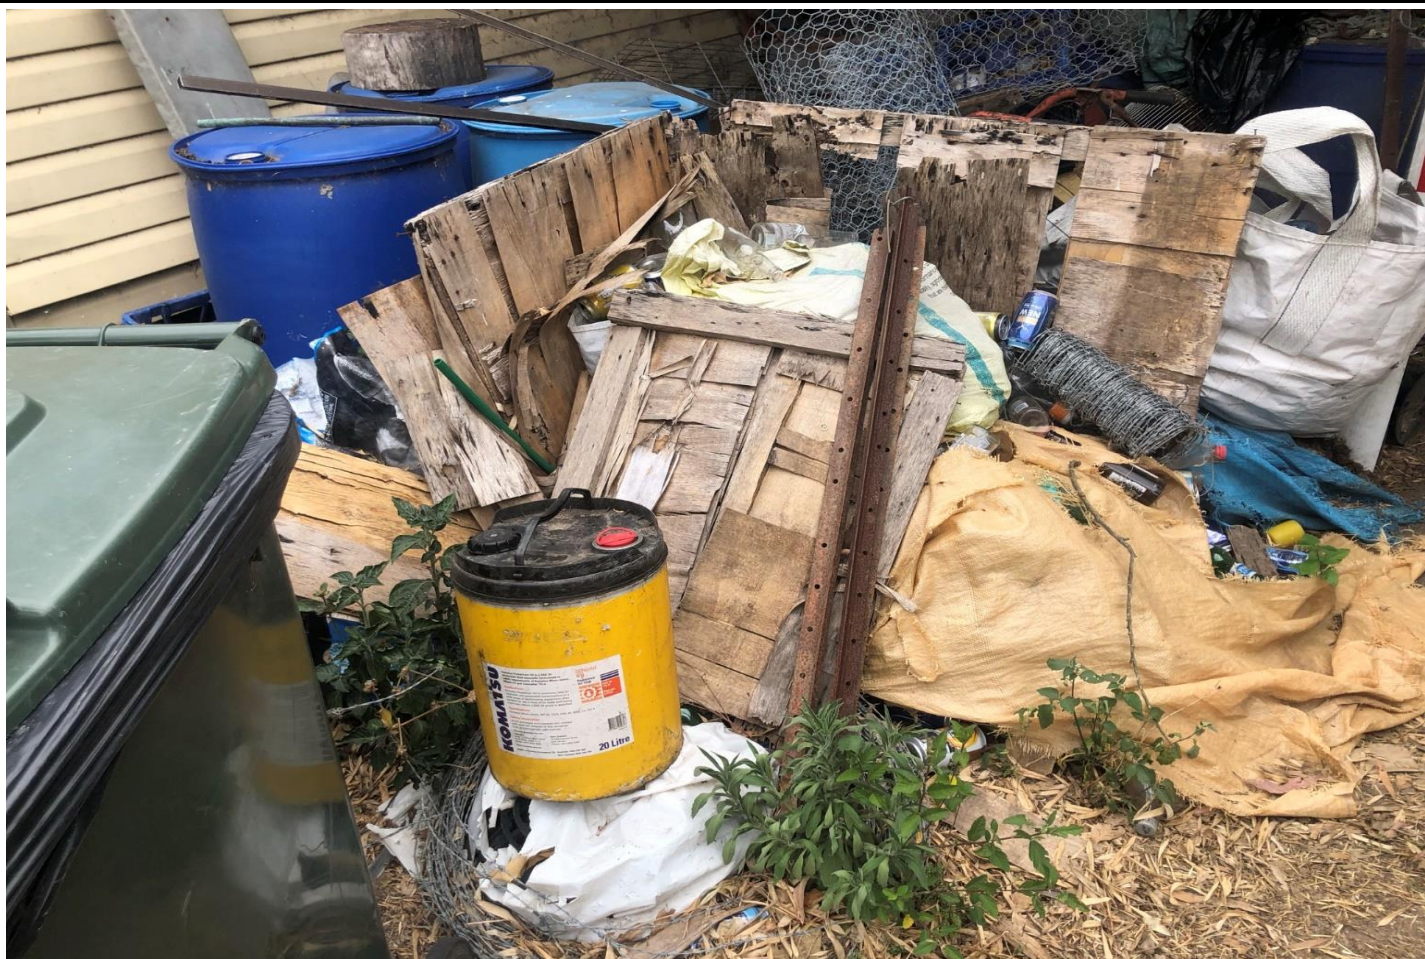
Photograph 3 - Showing carport - north of residential dwelling

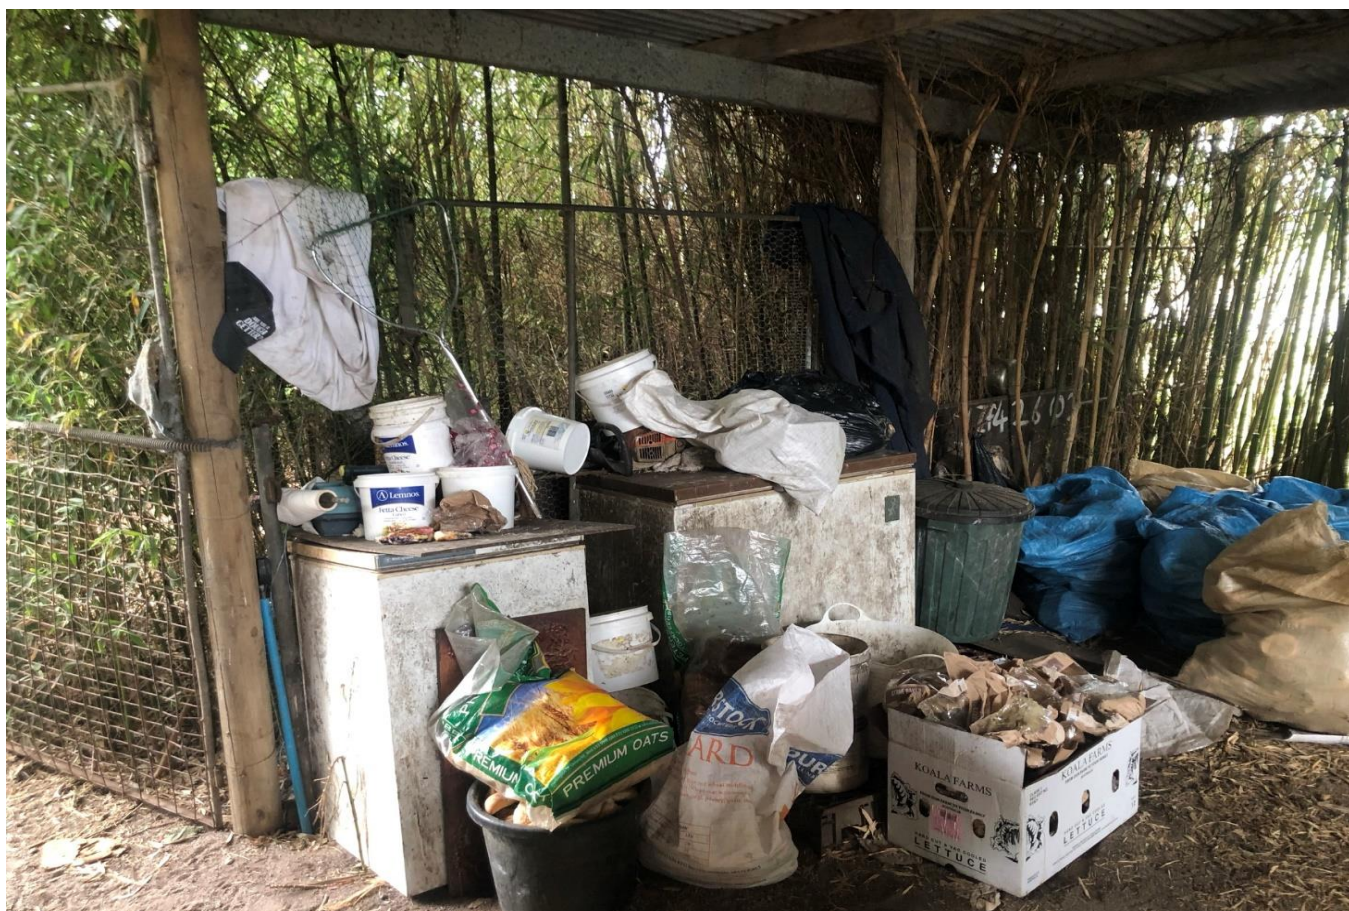
Photograph 4 - Showing carport - north of residential dwelling

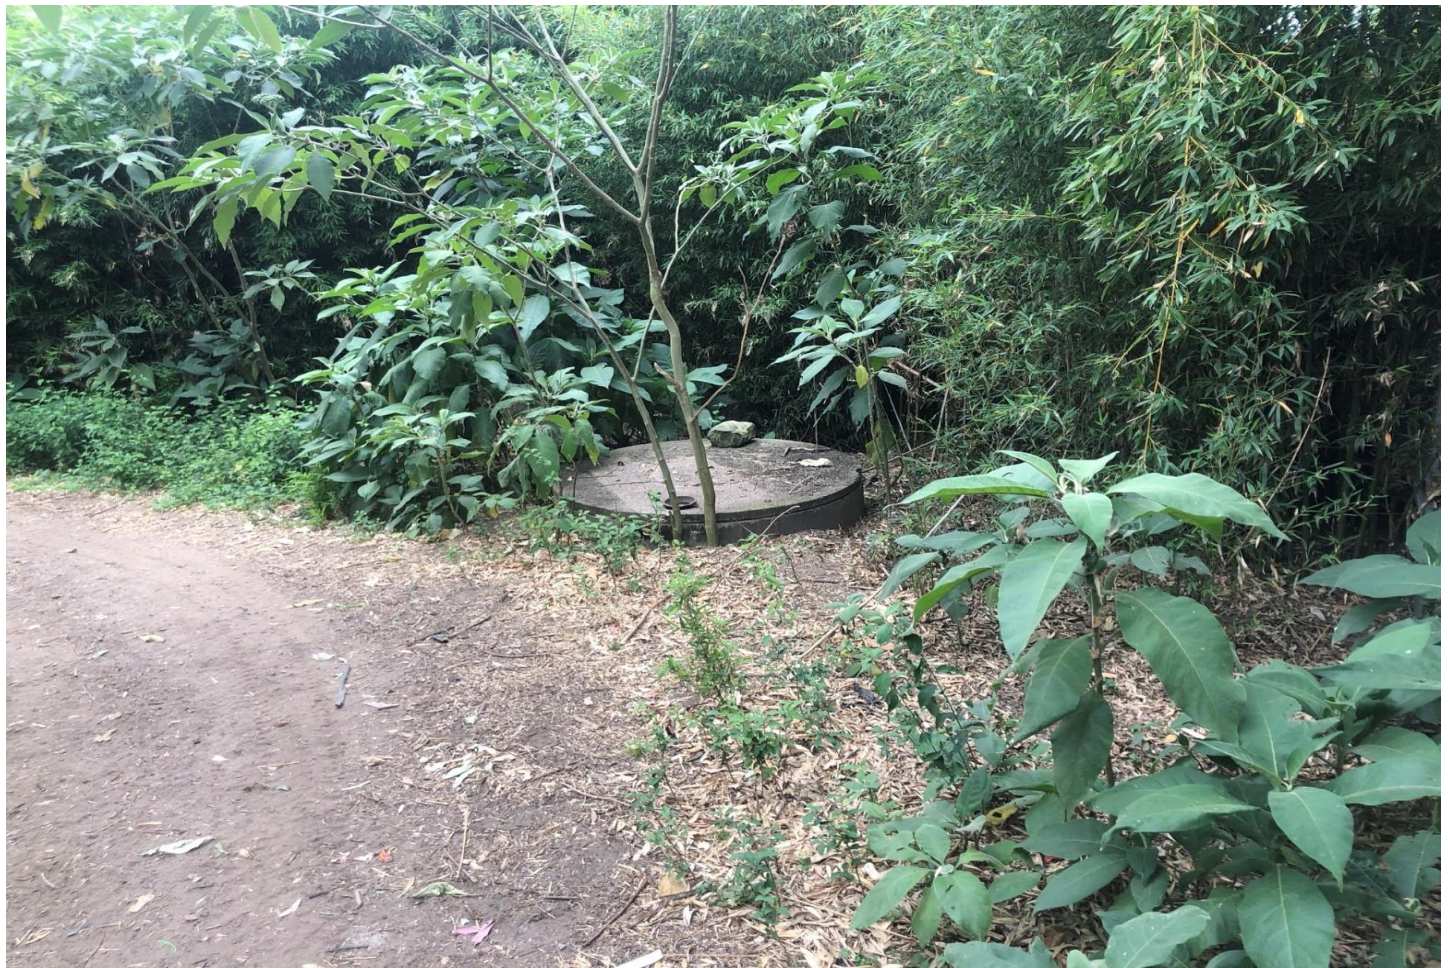
- A septic tank and soak away area was observed to the west of the residential dwelling. The soak away area was also used as a former bird aviary. The aviary was overgrown and could not be accessed but appeared to have been constructed with metal and wire. A metal shed was also observed in the area. Due to overgrown vegetation this shed could not be accessed and the contents of the shed are unknown (see photographs 5 and 6);

Photograph 5 - Showing septic tank and overgrown soakaway area

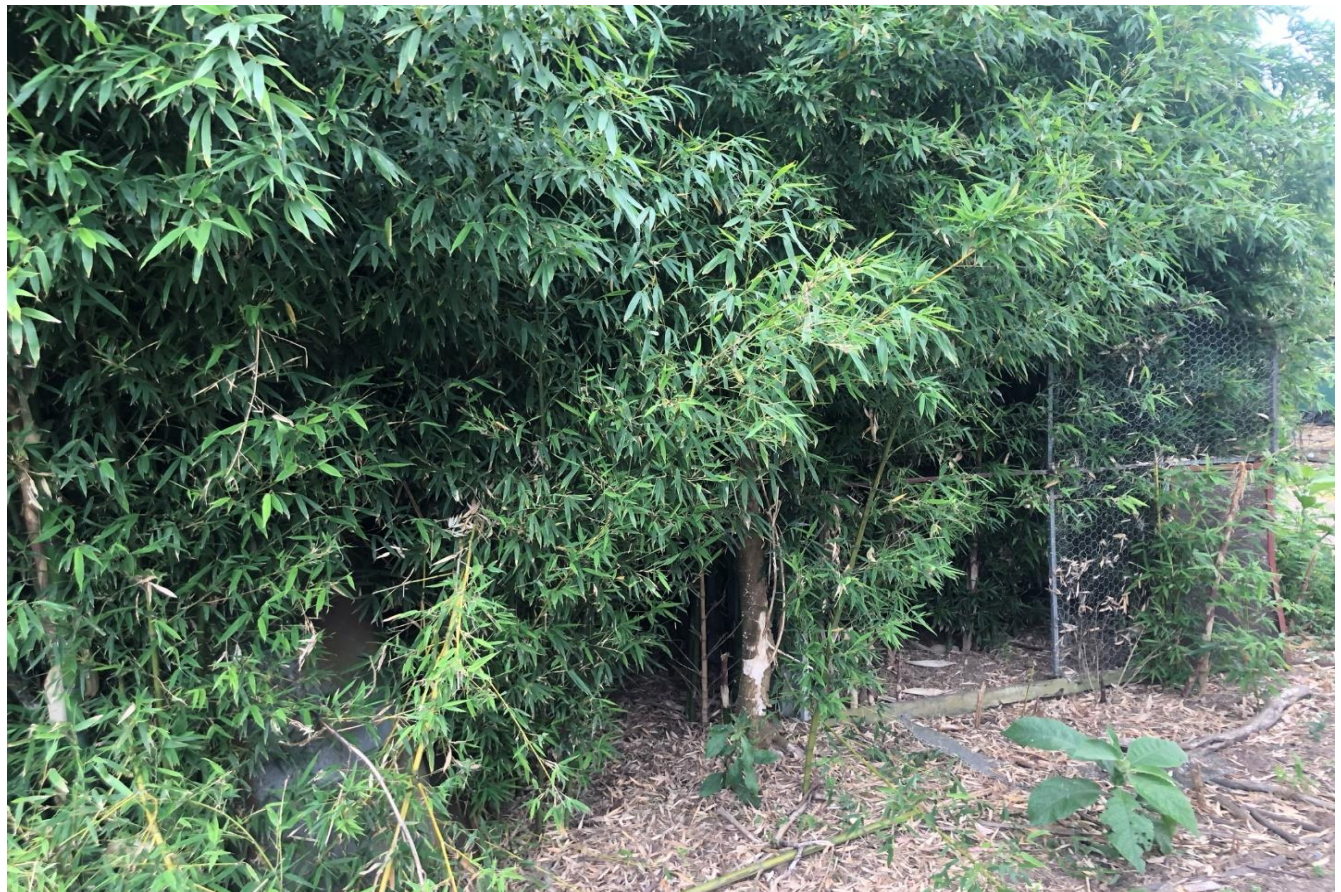
Photograph 6 - Showing area of metal shed and former aviary

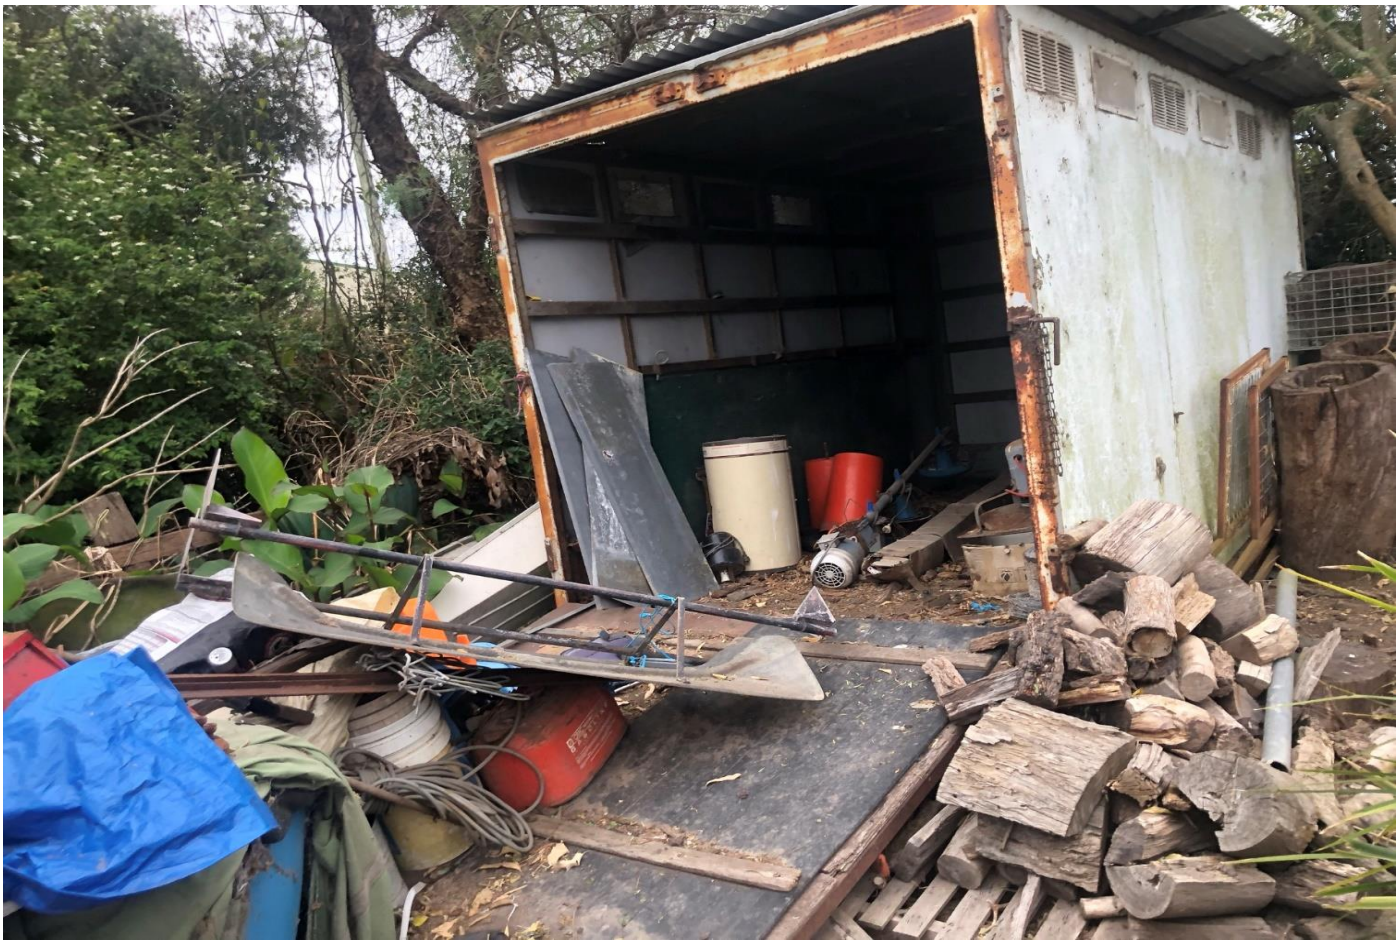
- A shed (Shed 1) was observed to the south east of the residential dwelling. The shed was a former horse float/trailer and was observed to have been constructed with timber and metal with timber flooring. Various items were observed stored in and around the shed included; a hot water system, metal, timber, electrical equipment, plastic tarps, buckets, tool boxes, 205L molasses feed drums and general household items (see photograph 7);

Photograph 7 - Shed 1 - South east of residence

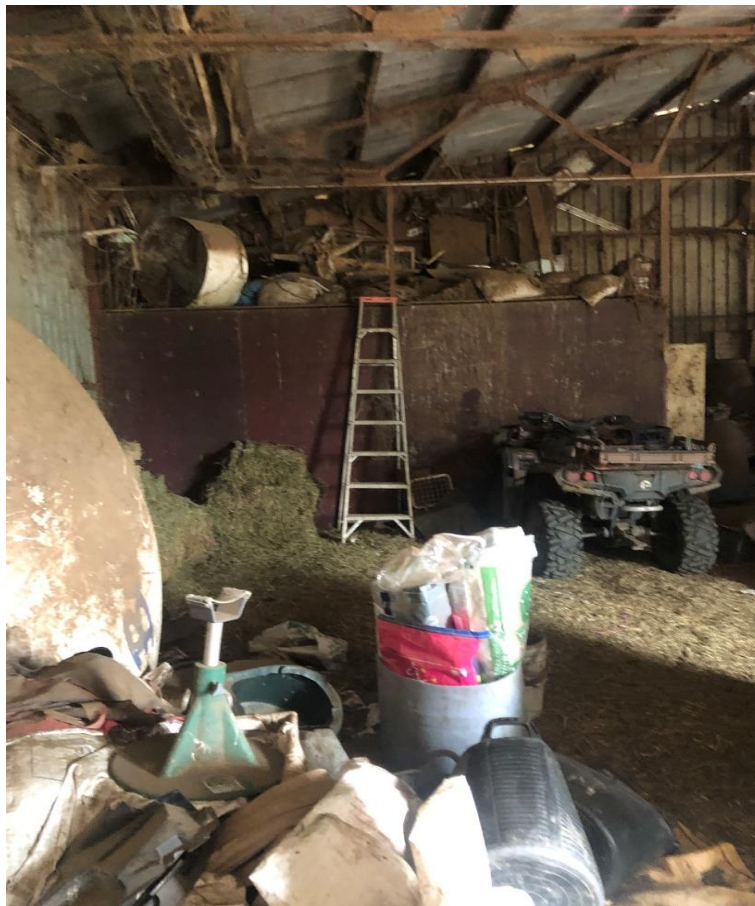
- To the south of the residential dwelling were stables, a storage shed (Shed 2), a carport and chicken coup. The stables, storage shed (Shed 2), carport and chicken coup were observed to have been constructed with timber and metal with an earth floor. Horses were observed in a number of the stables, with some vacant and/or used for storage. Various items were observed stored in Shed 2 and the disused stables. The items included: a grain mill, hay bales, two fridges used for storage of horse equipment, 205 L molasses drums, plastic buckets/crates, quad motorbikes, a tractor, metal piping and equipment, toolboxes, timber, gas bottles, horse feed, and small quantities (0.5 to 20L containers) of spray paints,

Photograph 8 - Shed 2 - hay bales, quad motorbike, plastic, metal etc

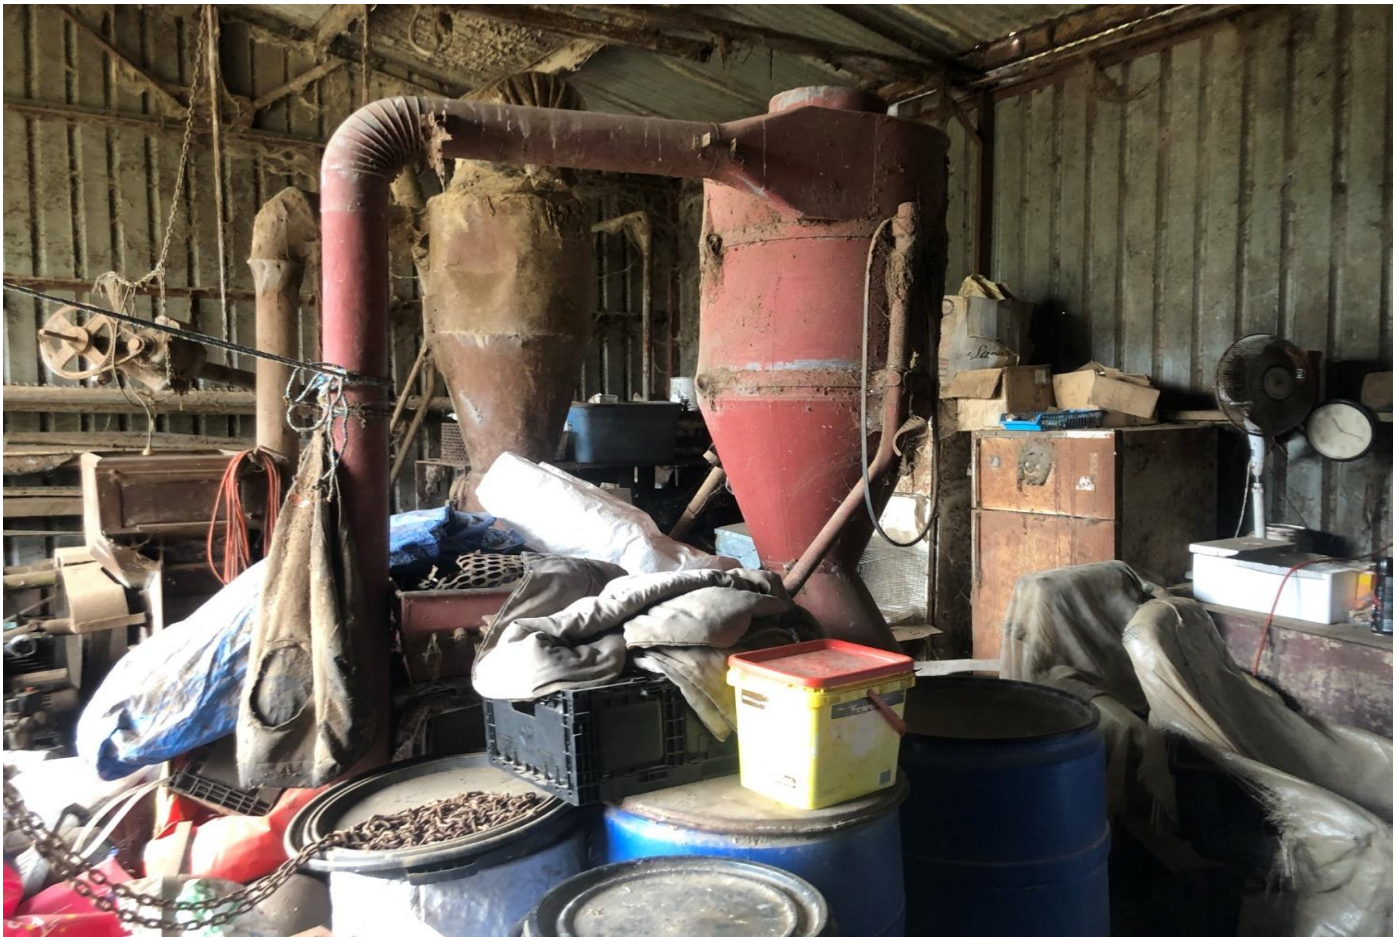
Photograph 9 - Shed 2 - grain mill, molasses drums, horse feed etc

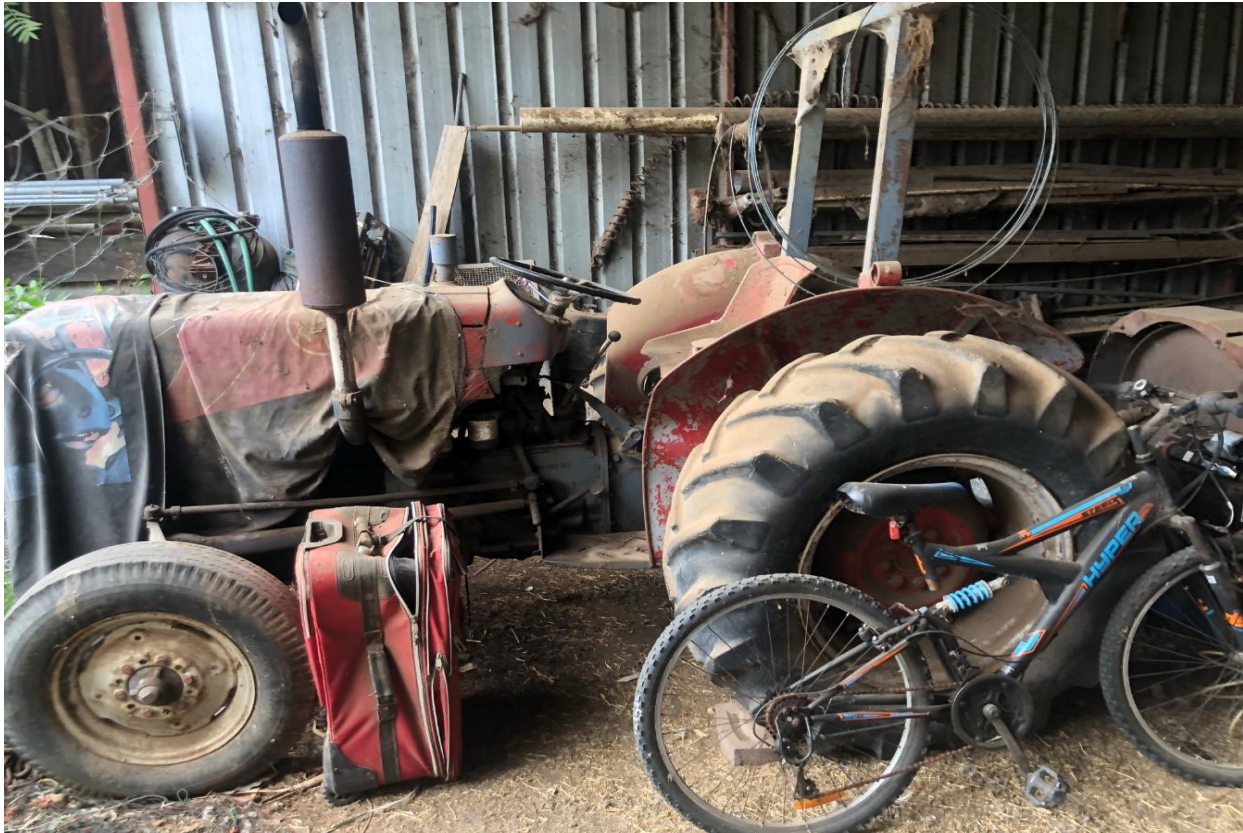
Photograph 10 - Shed 2 - tractor, metal

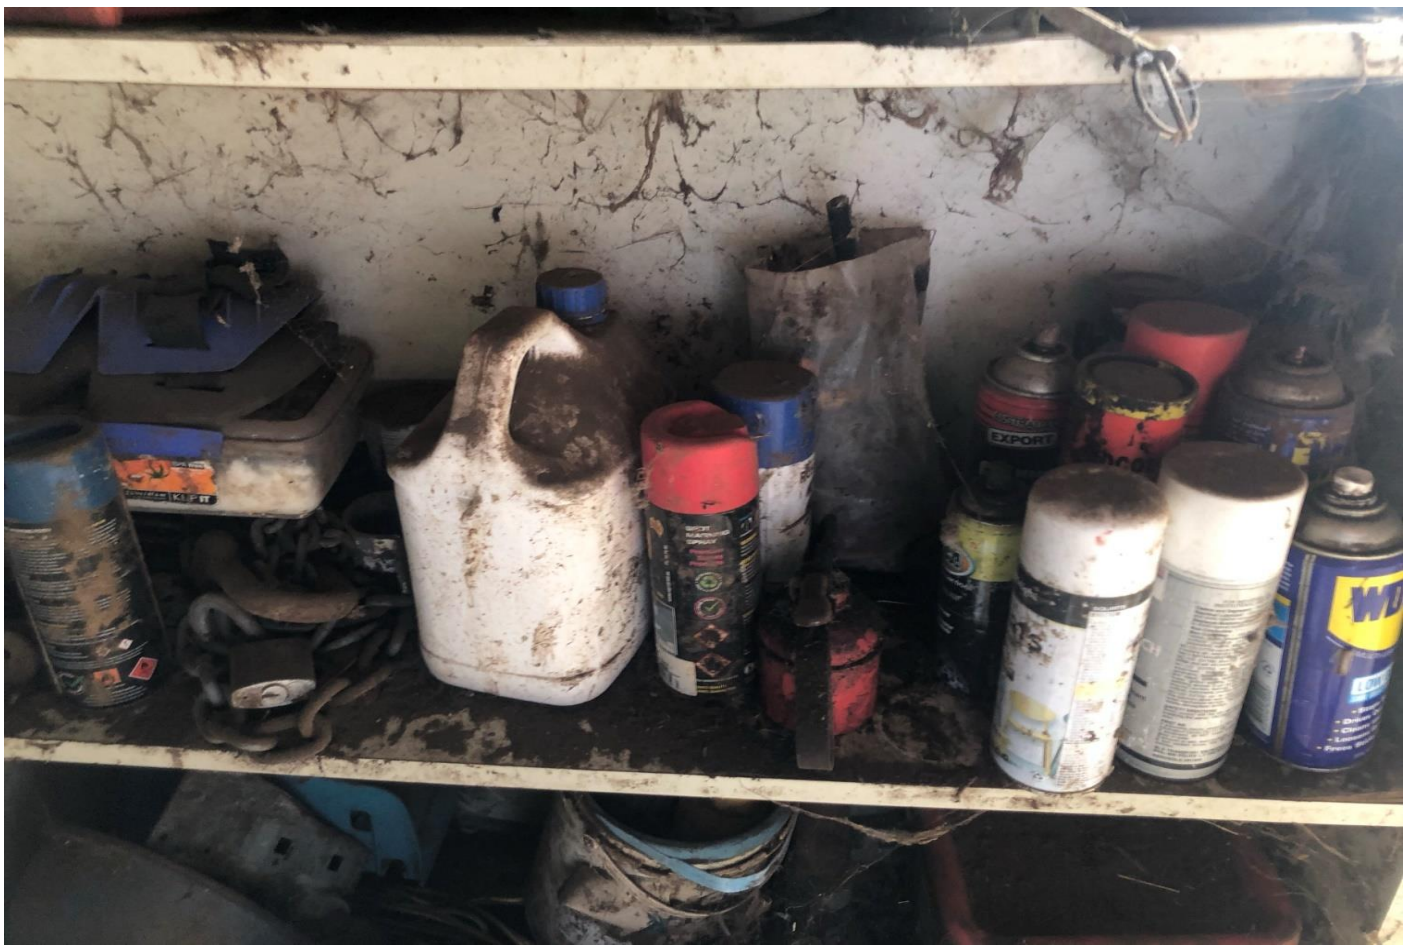
lubricants and oils stored on shelving, rolls of carpet (used as part of paddock fencing) and ladders. A walk behind loader, quad bike and various farm/household items including 205L metal drum, water piping, metal fencing and plough equipment was observed under the carport adjacent to the stables/Shed2 (see photographs 8 to 13);

Photograph 11 - Shed 2 - storage of small quantities of oils, lubricant etc

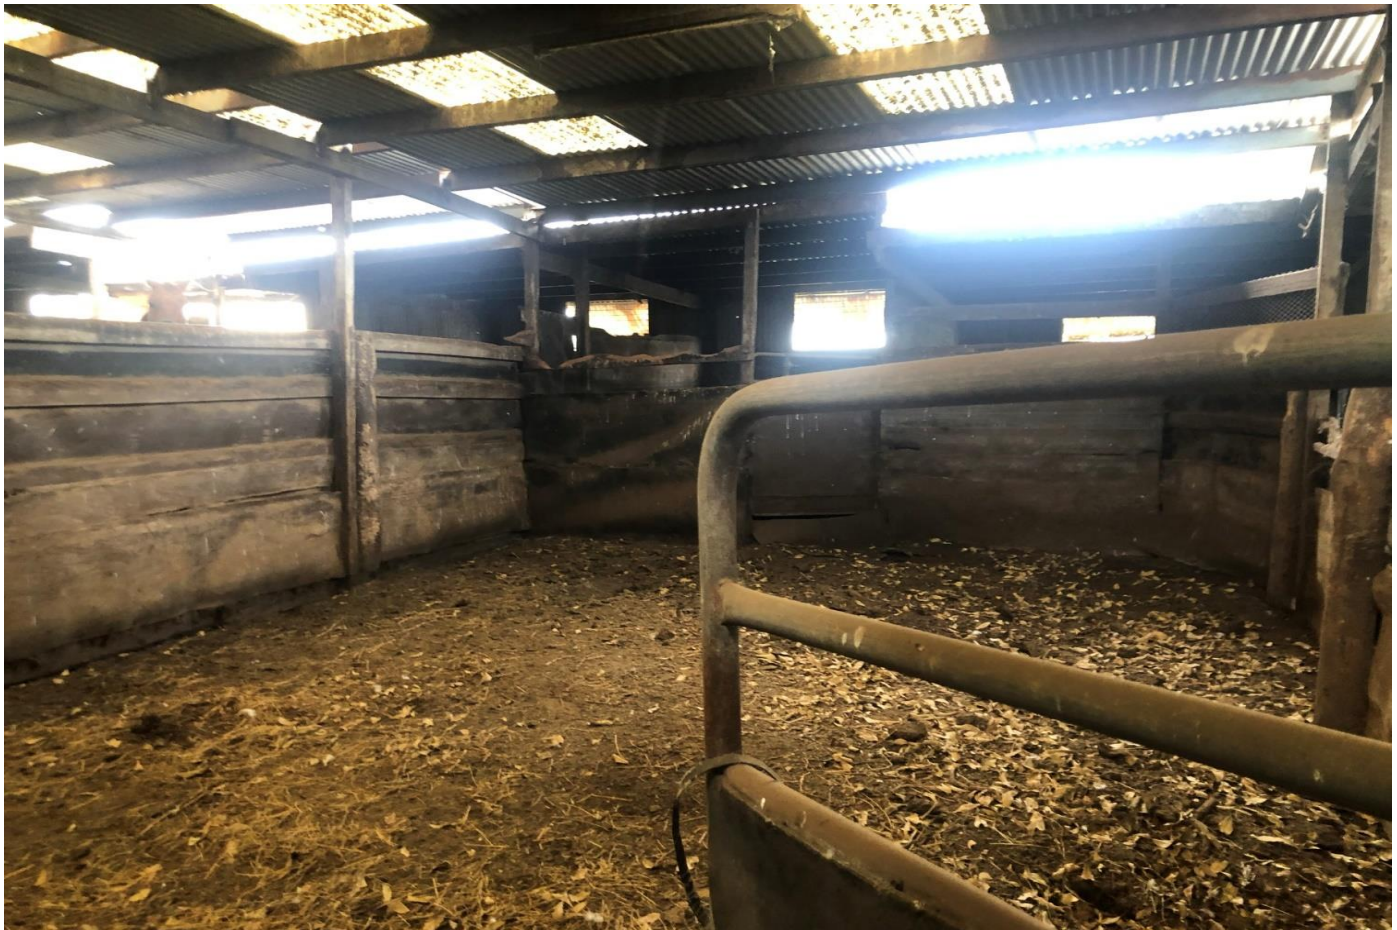
Photograph 12 - Empty horse stables

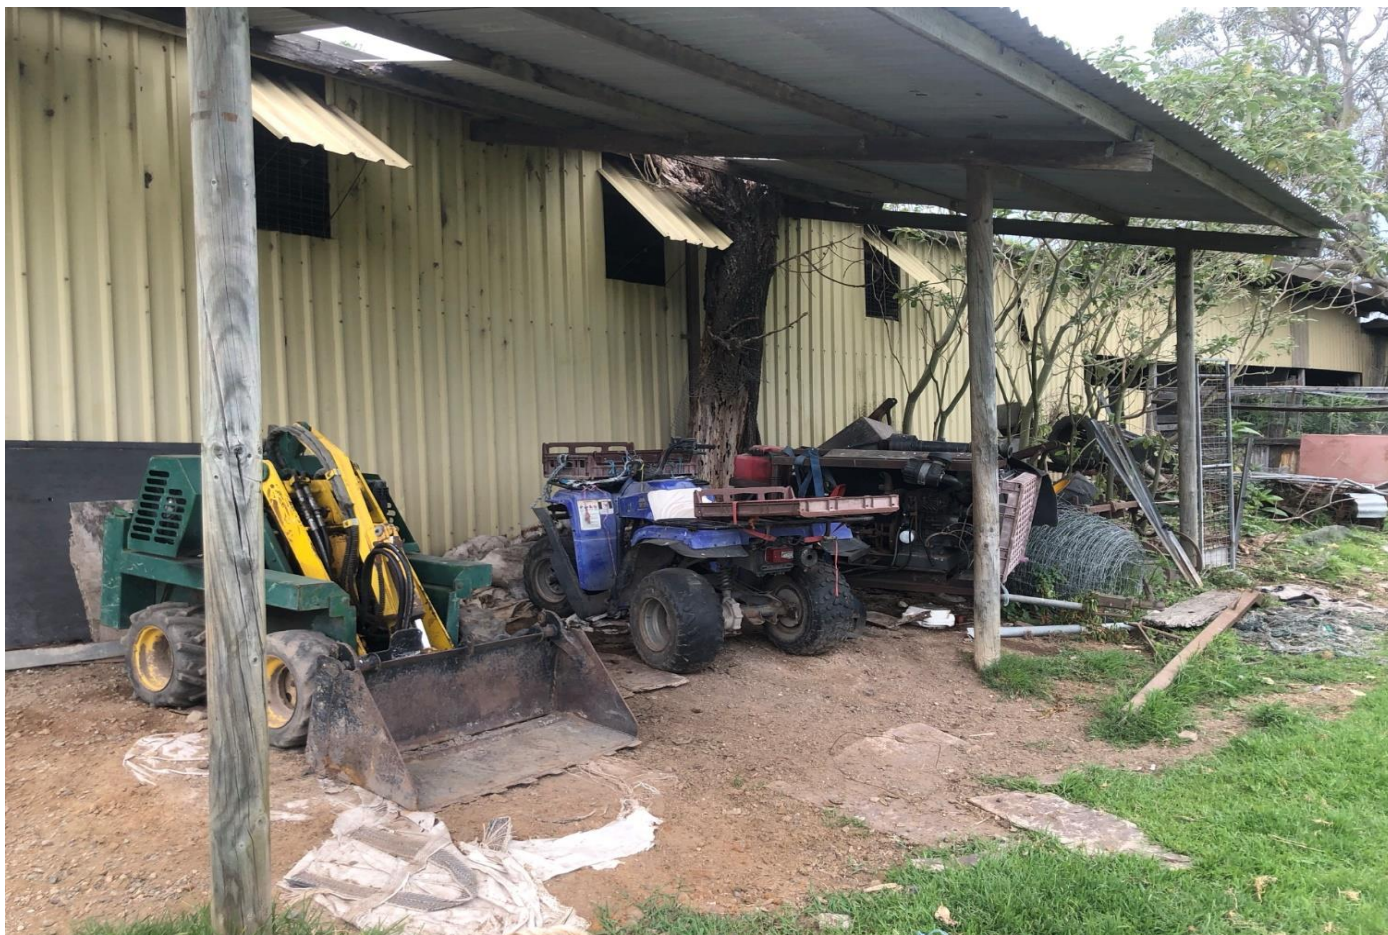
Photograph 13 - Carport, storage of equipment, chicken coup

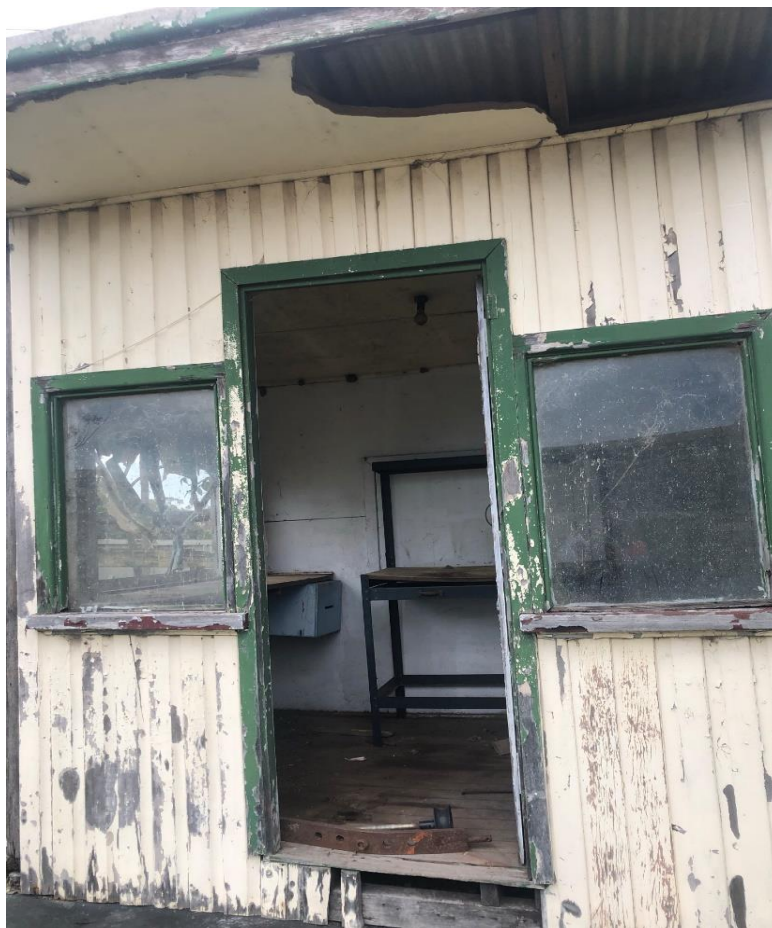
Photograph 15 - Former Racecourse building

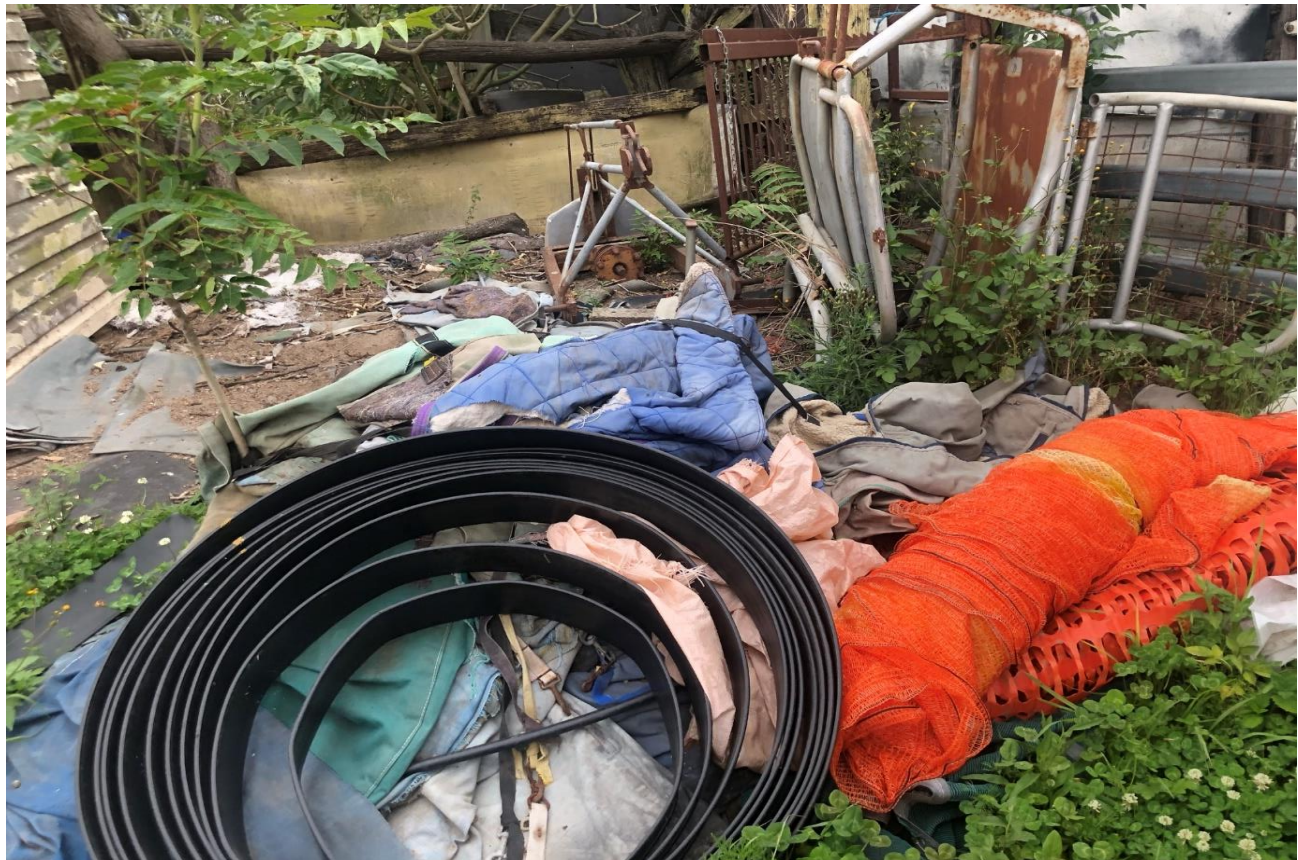
- Various items were observed stored to the south of the racecourse building including; horse rugs, plastic/poly piping, plastic and mesh hazard fencing, metal and carpet (see photograph 16);

Photograph 16 - Stored items, along eastern boundary of site

<p>2. Storage of equipment and waste materials on surface across the site</p> <ul style="list-style-type: none"> Stored wood, bricks and metal 	TRH, BTEX, PAH, metals, Asbestos (CoPCs dependent on waste type)	Medium to high	<ul style="list-style-type: none"> Top-down leaks/spills, flakes/fibres onto soil. Leaching of soil contaminants to surface water and groundwater. 	<ul style="list-style-type: none"> Aesthetics Underlying soils Surface water Groundwater 	<ul style="list-style-type: none"> Current site visitors Future construction workers & site users Soil biota/plants and transitory wildlife Offsite surface water – Four Mile Creek located 50m to 100m west of the site 	<ul style="list-style-type: none"> Direct dermal contact with contaminated soil and/or surface water Ingestion of contaminated soil and/or surface water Inhalation of asbestos fibres, or contaminated soil (as dust) Inhalation of petroleum hydrocarbon vapours Leaching of soil contaminants to surface water and/or groundwater Surface water and groundwater discharge to Four Mile Creek located 50m to 100m west of the site 	<ul style="list-style-type: none"> Potentially complete exposure pathway for current site visitors, future construction workers and site users Potentially complete exposure pathway for ecological receptors Potentially complete exposure pathway for surface water in Four Mile Creek. Likely incomplete exposure pathway to groundwater due to depth of groundwater (>3.0m bgs) and expected clay subsoils. 	Exposure pathway (excluding aesthetics) would be incomplete if soils are found to not be contaminated via sampling & analysis. Waste needs to be removed for aesthetics.
