Preliminary Contamination Assessment

349 McFarlanes Road,
Berry Park, NSW

NEW21P-0170-AA
17 November 2021

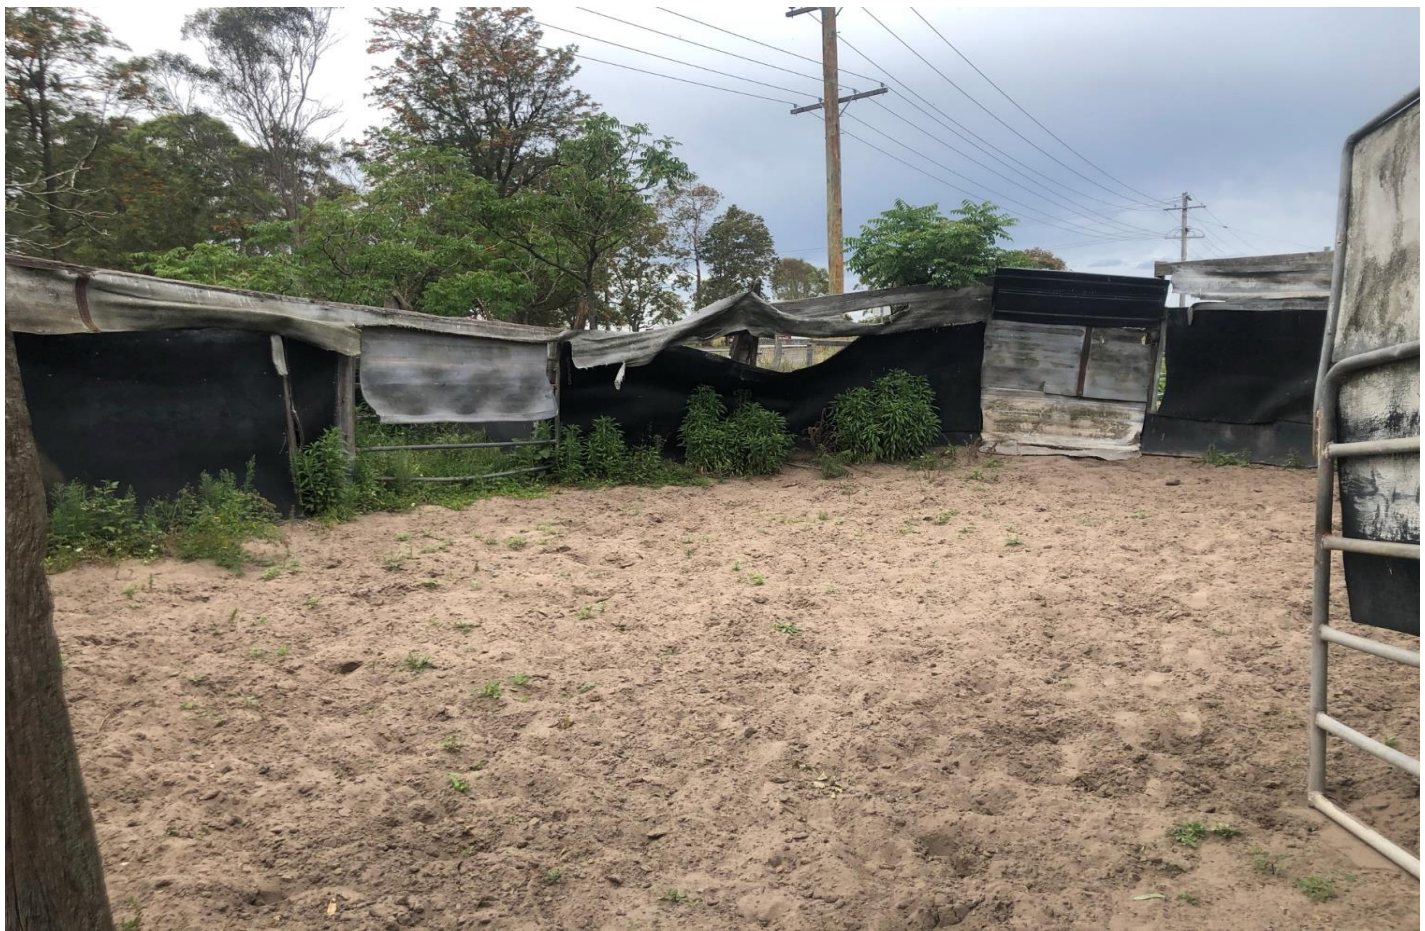
- To the south of the former racecourse building was a horse round house, used for horse training, and a former sand stockpiling area. The roundhouse was observed to have been constructed with metal and timber with rubber and carpet matting on the fence and a sand floor. The stockpiling area was constructed from metal and earth floor, used for the storage of imported sand for the horse round yard and stables (see photographs 17 and 18);

Photograph 17 - Horse Round House

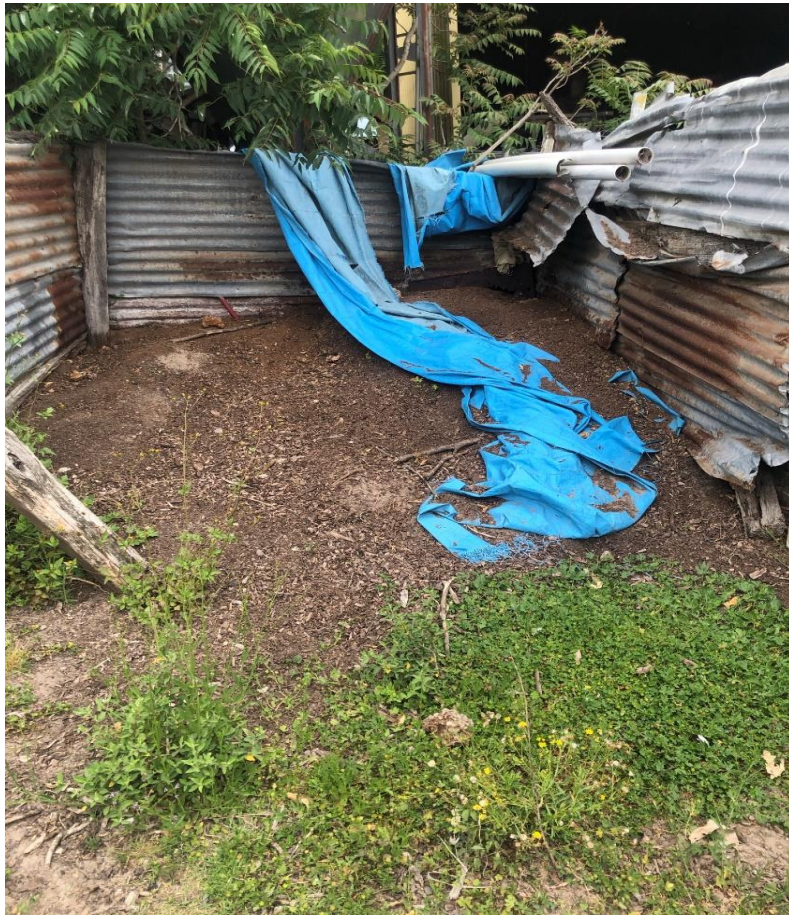
Photograph 18 - Former sand stockpiling area

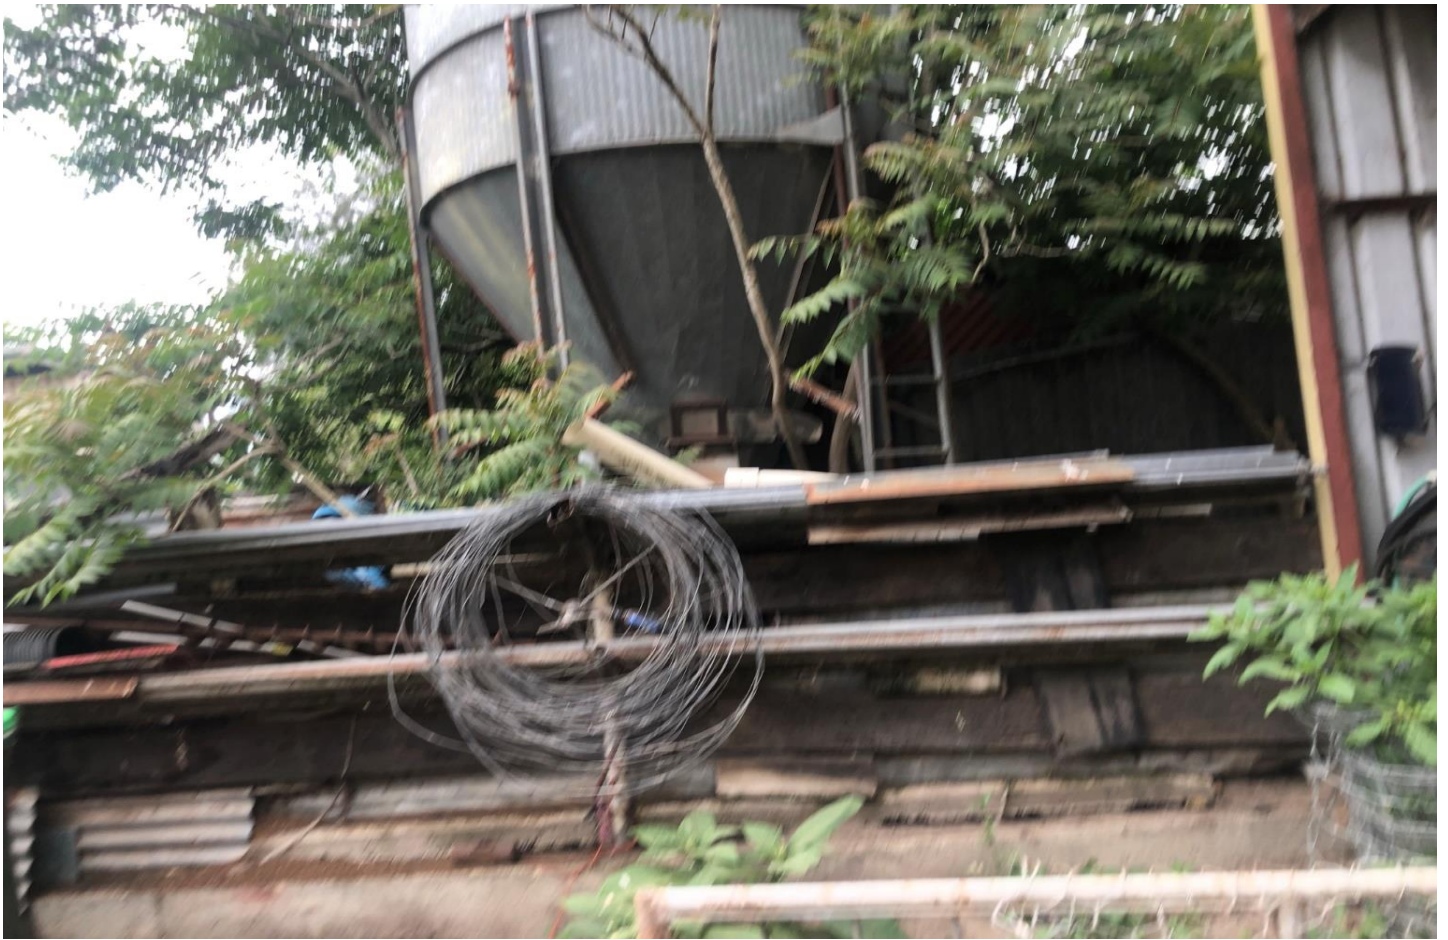
Photograph 19 - Metal grain silo

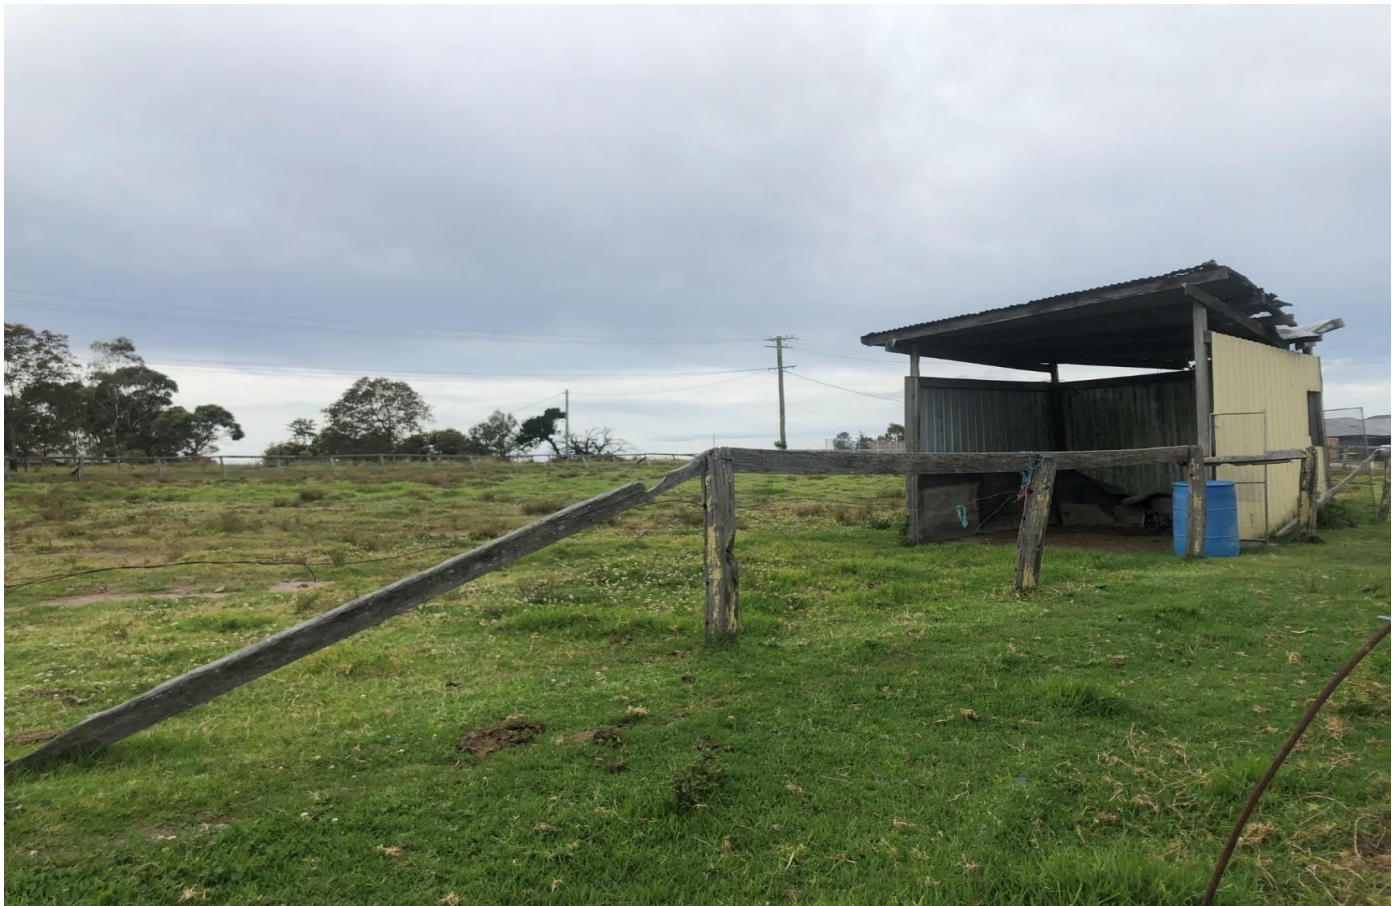
- A metal grain silo was observed to the south of the horse round house (see photograph 19);
- The central and southern portion of the site consisted of paddocks, two stock/sheep shelters. The paddock fencing was constructed from timber, wire and a painted carpet matting. The stock/sheep shelters were constructed with timber and metal sheeting. A stockpile of vegetation and timber was also observed in the south western portion of the site (see photographs 20 and 21);

Photograph 20 - Paddocks and Stock (sheep) shelter

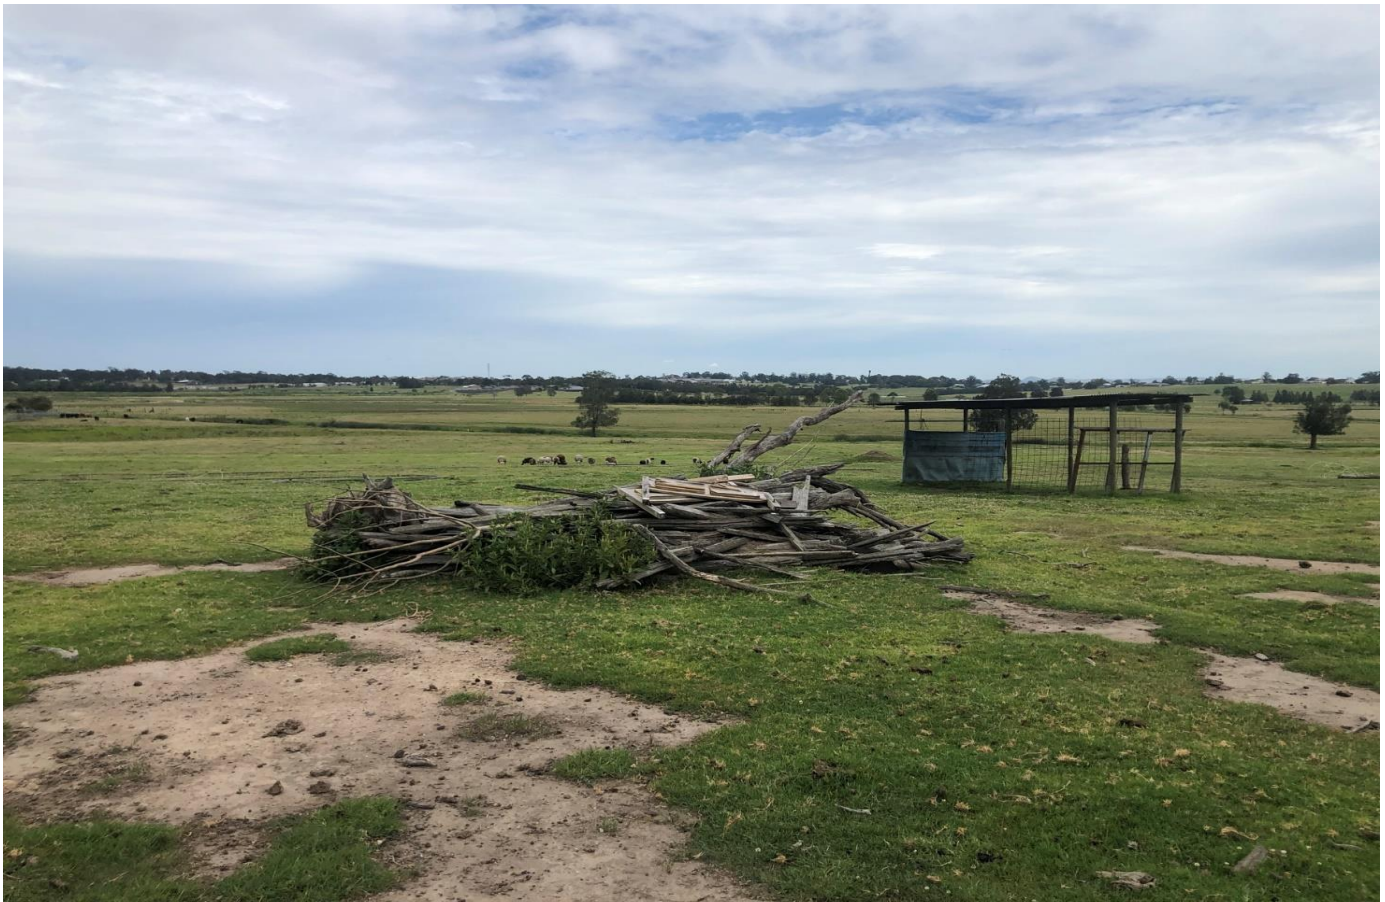
Photograph 21 - Stockpile of vegetation/timber and stock shelter

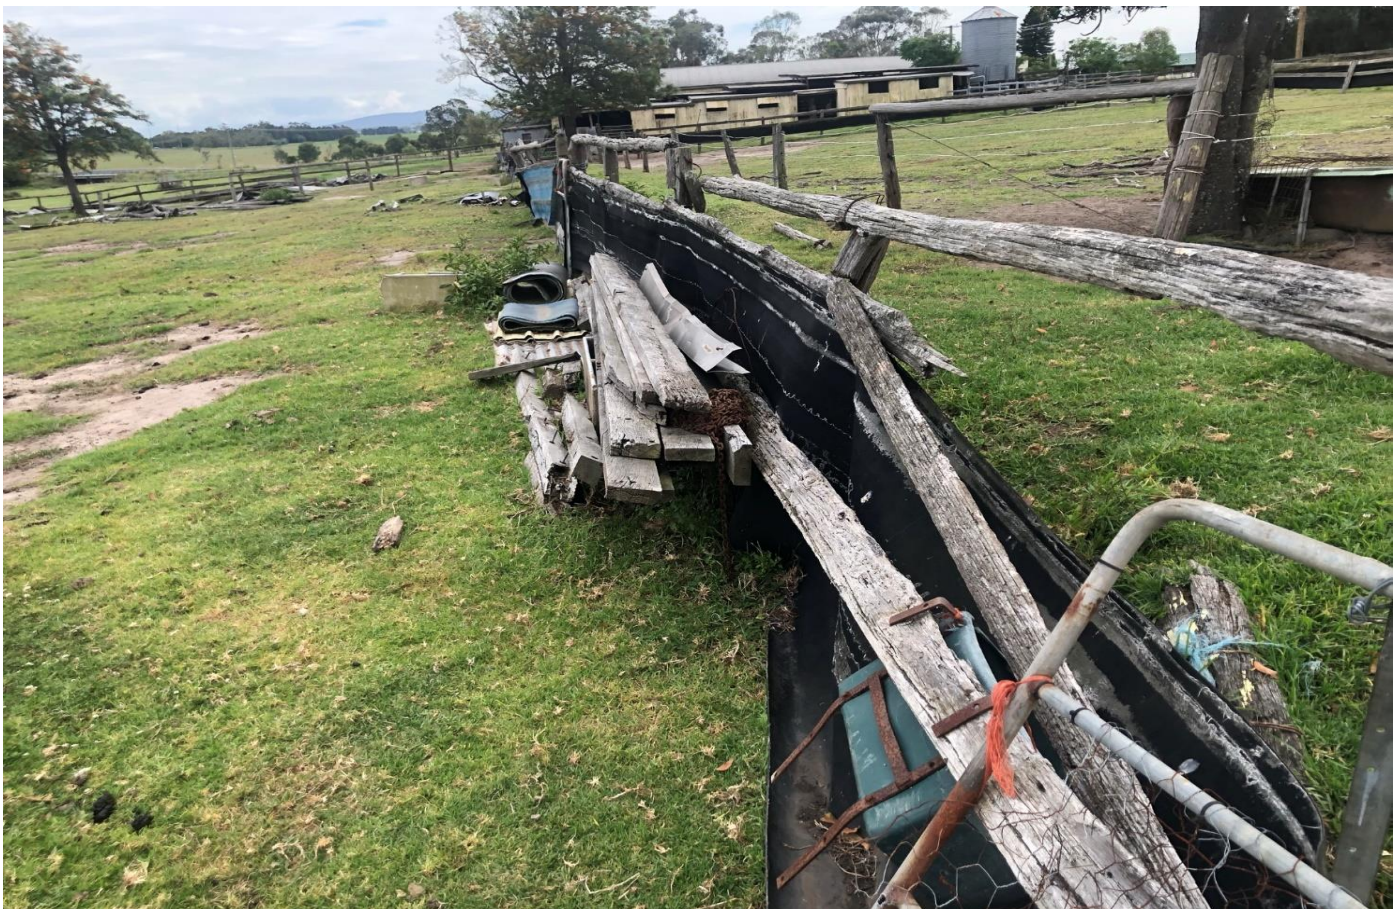
- Various items/equipment were observed stored around and within the paddocks including, timber, metal, carpet, plastic piping and bricks (see photographs 22 and 23); and

Photograph 22 - Timber, metal, carpet, plastic observed along paddocks in the southern portion of the site

<p>2. Storage of equipment and waste materials on surface across the site</p> <ul style="list-style-type: none"> Stored wood, bricks and metal 	TRH, BTEX, PAH, metals, Asbestos (CoPCs dependent on waste type)	Medium to high	<ul style="list-style-type: none"> Top-down leaks/spills, flakes/fibres onto soil. Leaching of soil contaminants to surface water and groundwater. 	<ul style="list-style-type: none"> Aesthetics Underlying soils Surface water Groundwater 	<ul style="list-style-type: none"> Current site visitors Future construction workers & site users Soil biota/plants and transitory wildlife Offsite surface water – Four Mile Creek located 50m to 100m west of the site 	<ul style="list-style-type: none"> Direct dermal contact with contaminated soil and/or surface water Ingestion of contaminated soil and/or surface water Inhalation of asbestos fibres, or contaminated soil (as dust) Inhalation of petroleum hydrocarbon vapours Leaching of soil contaminants to surface water and/or groundwater Surface water and groundwater discharge to Four Mile Creek located 50m to 100m west of the site 	<ul style="list-style-type: none"> Potentially complete exposure pathway for current site visitors, future construction workers and site users Potentially complete exposure pathway for ecological receptors Potentially complete exposure pathway for surface water in Four Mile Creek. Likely incomplete exposure pathway to groundwater due to depth of groundwater (>3.0m bgs) and expected clay subsoils. 	Exposure pathway (excluding aesthetics) would be incomplete if soils are found to not be contaminated via sampling & analysis. Waste needs to be removed for aesthetics.

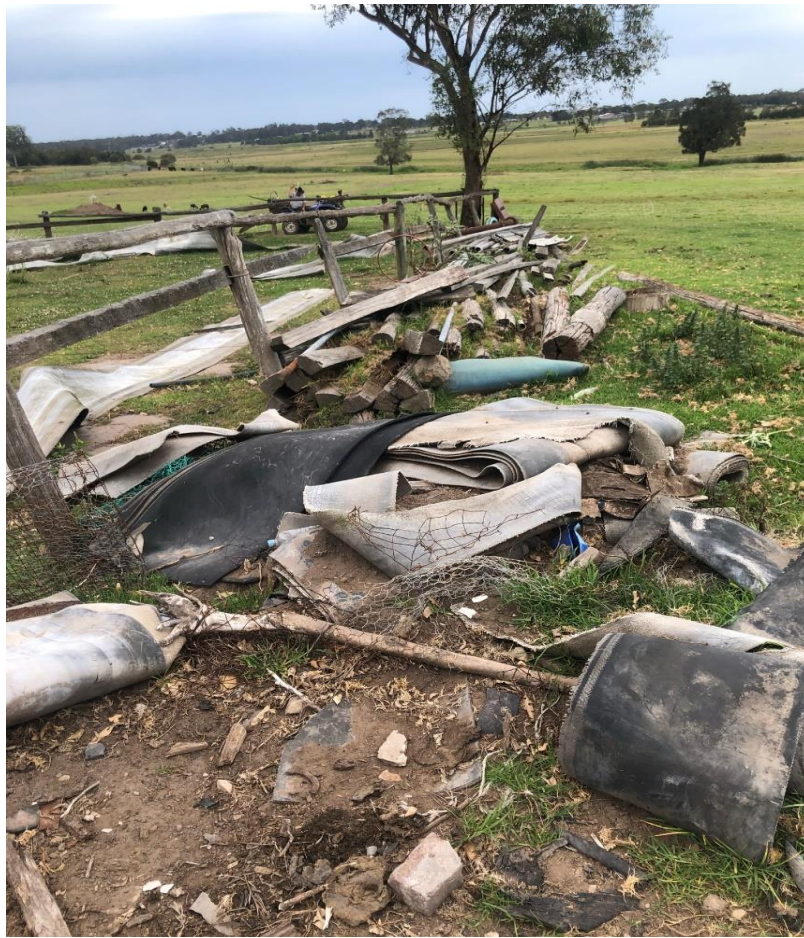
Photograph 23 - Timber, metal, carpet, plastic observed along paddocks in the central portion of the site

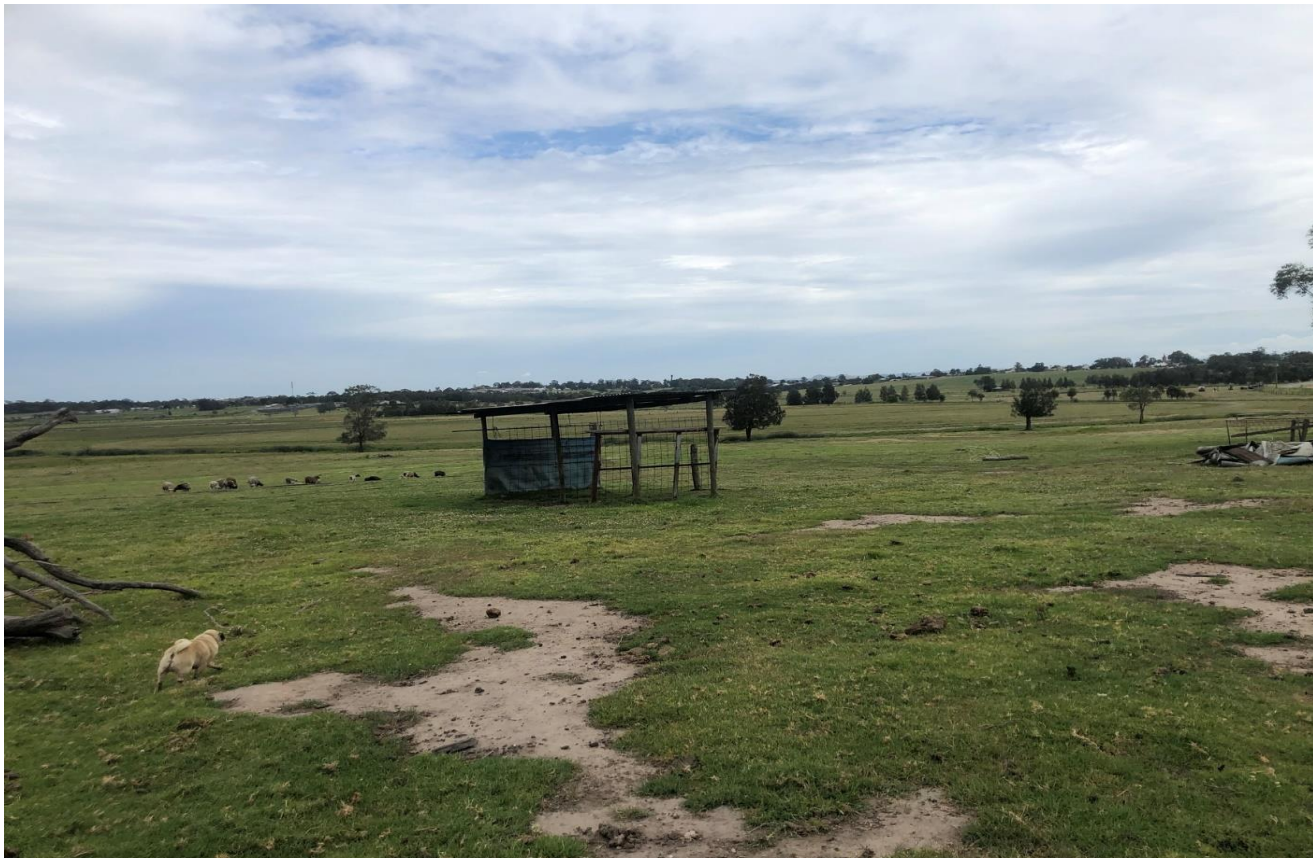
- Rock outcropping was observed in the central portion of the site (see photograph 24).

Photograph 24 - Residual soil and rock outcropping
