PRELIMINARY (ENVIRONMENTAL) SITE ASSESSMENT

5 HUNTINGDALE DRIVE
THORNTON, NSW

Lot 812 DP 1032401

Document – E21 090-A_5HuntingdaleDriveThornton_S1ESA.Rpt

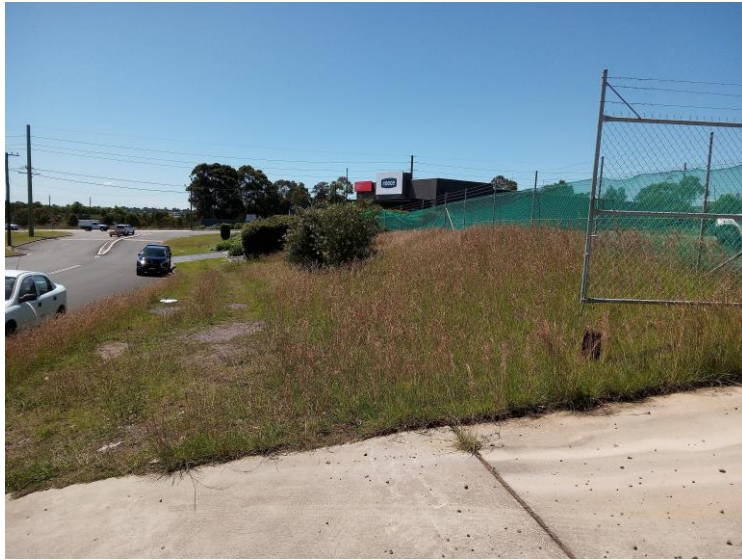
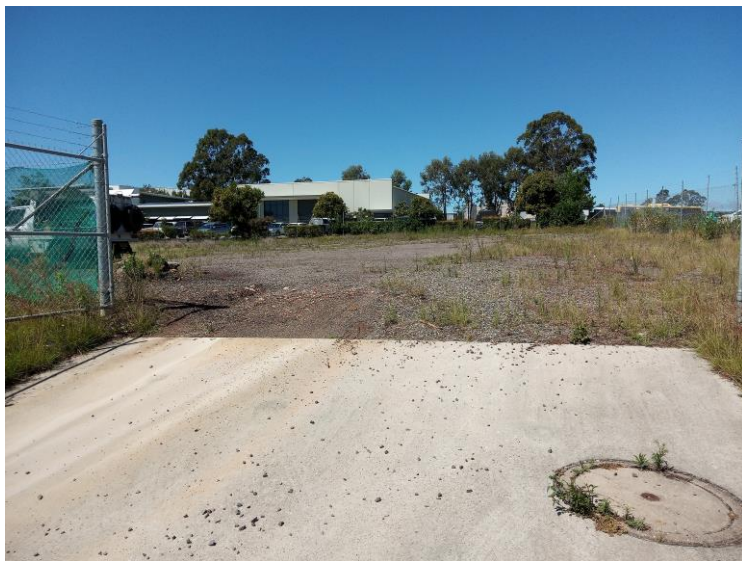
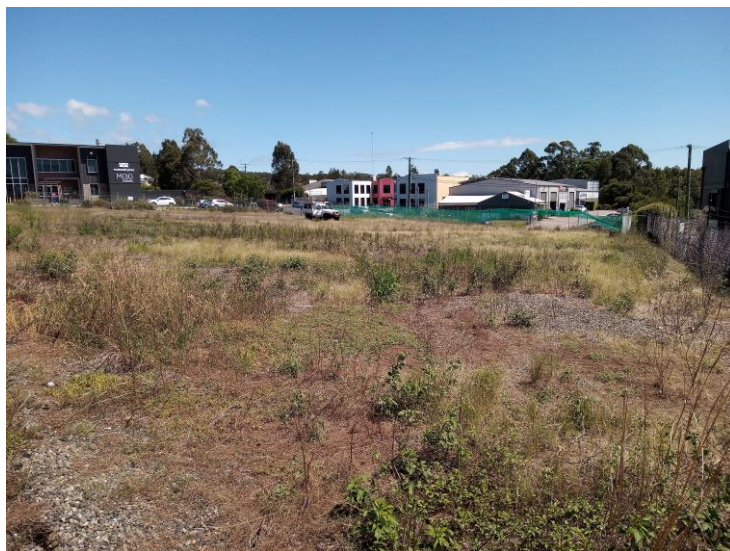
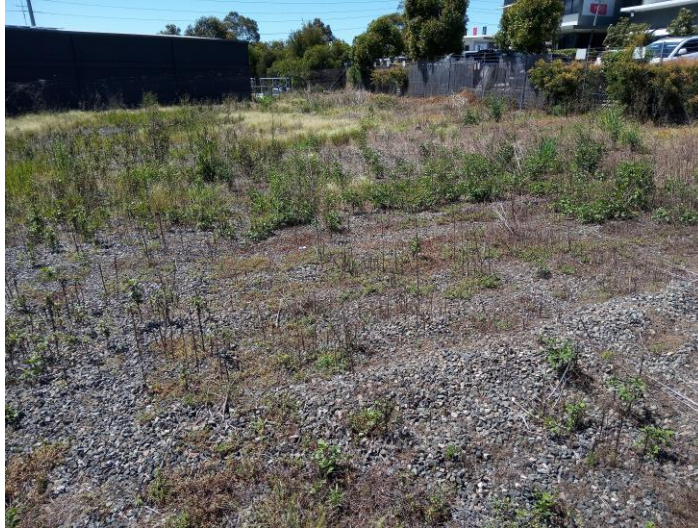
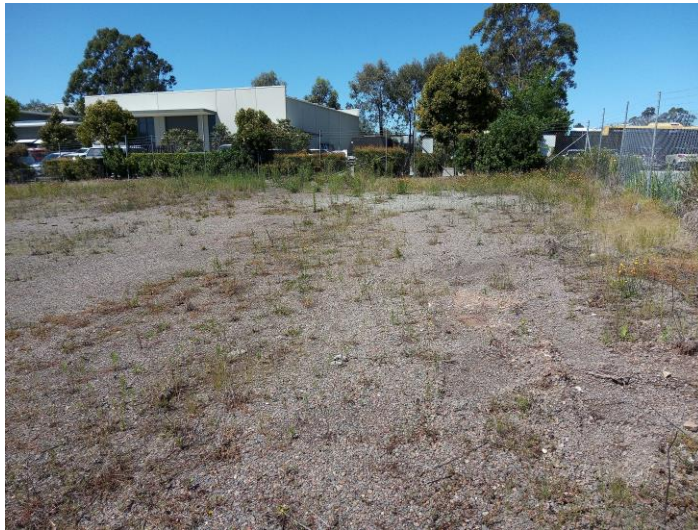
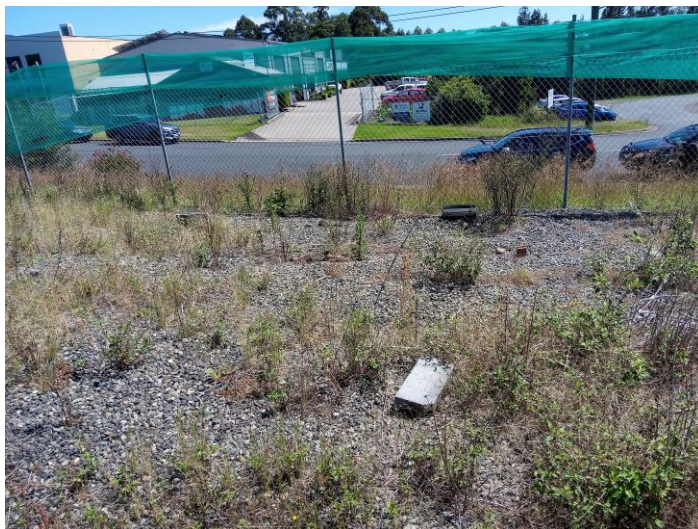
Existing developments were not observed on site during the site walkover as can be seen in the attached site photographs.

Small retaining structures were observed on the southern and western boundaries comprising upright kerb with structures greater than 600mm in height not noted.

Drums and other signs of chemical waste material were NOT noted over the main portion of site at the time of assessment. Odours were not noted at the time of assessment

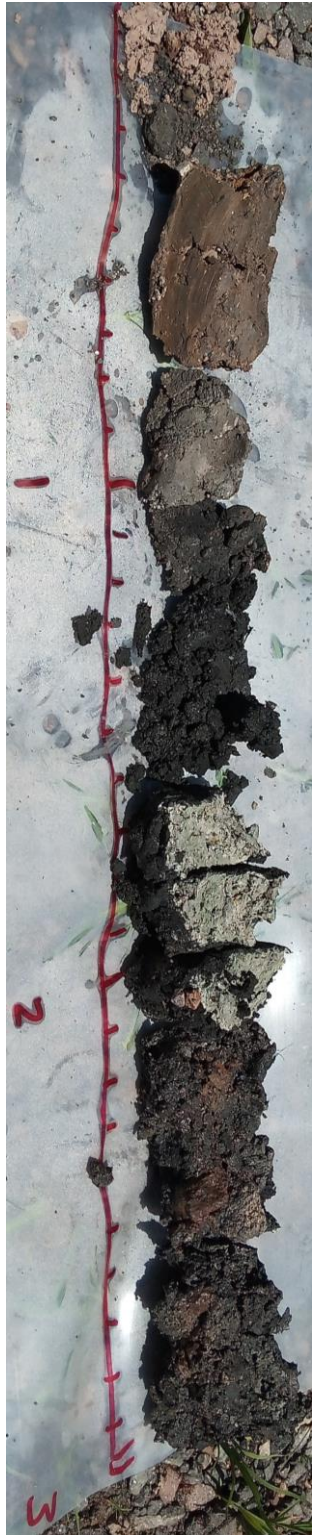
0.0 – 0.1	Sandy GRAVEL; fine to medium grained, grey, fine to med sand, moist, dense	FILL
0.1 – 0.2	Silty Sandy GRAVEL; fine grained, black, fine to med sand, low plasticity fines, moist, dense	FILL

0.2 – 0.7	CLAY; medium to high plasticity, orange and grey layers, moisture greater than the plastic limit, stiff becoming very stiff	FILL
0.7 - 1.4	Sandy CLAY; low to medium plasticity, black, fine grained sand, moisture greater than the plastic limit, stiff	FILL

1.4 – 1.8	Silty SAND; fine to medium grained, black, vegetation, moist	TOPSOIL
1.8 – 2.2	CLAY; medium to high plasticity, grey, moisture greater than the plastic limit, stiff becoming very stiff	RESIDUAL

2.2 – 3.0	Gravelly CLAY; low plasticity, dark grey, moisture greater than the plastic limit, stiff becoming very stiff	RESIDUAL
BH1 TERMINATED AT 3.0m (Limit of Investigation)		
GROUND WATER INFLOW NOT ENCOUNTERED

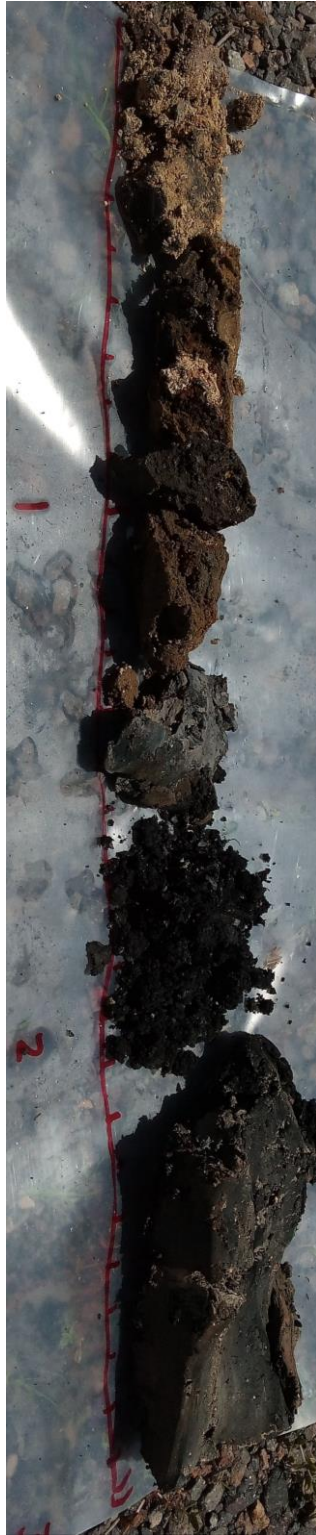
BH2

0.0 – 0.1	Sandy GRAVEL; fine to medium grained, grey, fine to med sand, moist, dense	FILL
0.1 – 0.4	Silty Sandy GRAVEL; fine grained, black, fine to med sand, low plasticity fines, moist, dense	FILL

0.4 – 1.6	CLAY; medium to high plasticity, orange and grey layers, moisture greater than the plastic limit, stiff becoming very stiff	FILL
1.6 – 1.8	Sandy CLAY; low to medium plasticity, black, fine grained sand, moisture greater than the plastic limit, stiff	FILL

1.8 – 2.2	Silty SAND; fine to medium grained, black, vegetation, moist	TOPSOIL
2.2 – 3.0	CLAY; medium to high plasticity, grey, moisture greater than the plastic limit, stiff becoming very stiff	RESIDUAL
<p>BH2 TERMINATED AT 3.0m (Limit of Investigation)</p> <p>GROUND WATER INFLOW NOT ENCOUNTERED</p>

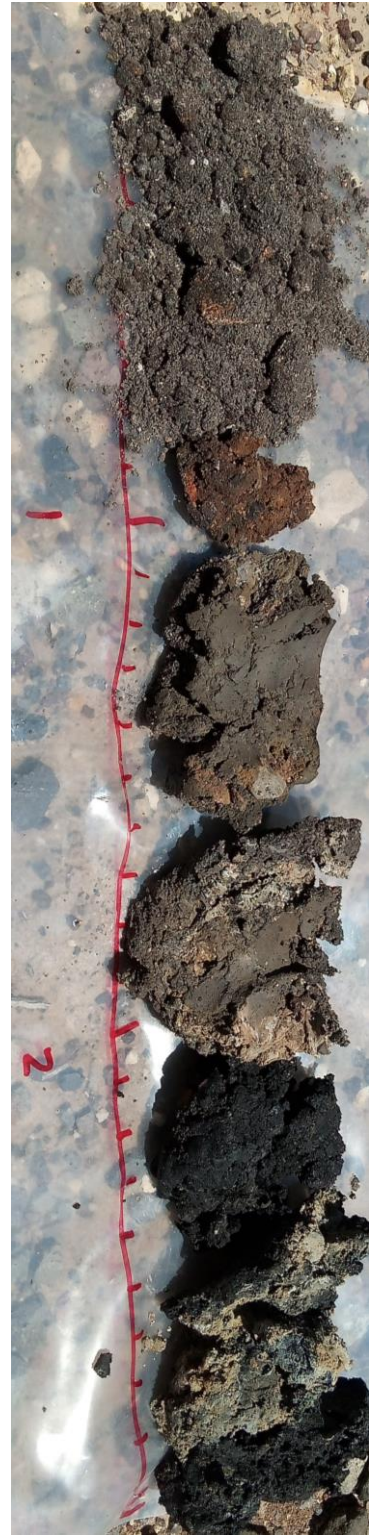
BH3

LOCATION:	5 HUNTINGDALE DV, THORNTON	
JOB NUMBER:	E21 090	
DATE:	11/11/2021	
MACHINE / LOGGED BY:	TRUCK RIG / DS	
BH - 3		
DEPTH (m BGL)	MATERIAL PROPERTIES	STRUCTURE AND ADDITIONAL OBSERVATIONS
0.0 – 0.8	Silty SAND; fine to medium grained, grey, fine to med sand, moist, dense	FILL
0.8 – 1.0	Gravelly CLAY; low to medium plasticity, orange, fine gravel. M>Wp	FILL
1.0 – 2.0	CLAY; medium to high plasticity, orange and grey layers, moisture greater than the plastic limit, stiff becoming very stiff	FILL
2.0 – 2.5	Silty SAND; fine to medium grained, black, vegetation, moist	TOPSOIL
2.5 – 3.0	CLAY; medium to high plasticity, grey, moisture greater than the plastic limit, stiff becoming very stiff	RESIDUAL
<p>BH3 TERMINATED AT 3.0m (Limit of Investigation)</p> <p>GROUND WATER INFLOW NOT ENCOUNTERED</p>

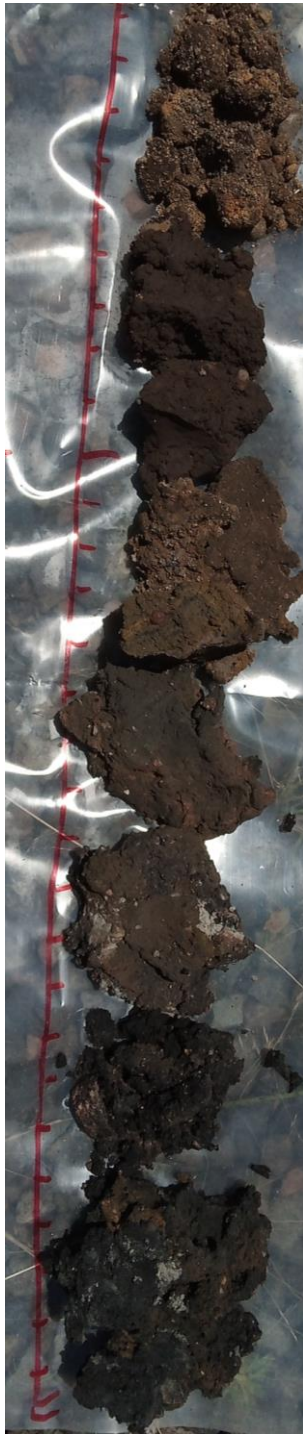
BH4

LOCATION:	5 HUNTINGDALE DV, THORNTON	
JOB NUMBER:	E21 090	
DATE:	11/11/2021	
MACHINE / LOGGED BY:	TRUCK RIG / DS	
BH - 4		
DEPTH (m BGL)	MATERIAL PROPERTIES	STRUCTURE AND ADDITIONAL OBSERVATIONS
0.0 – 0.4	Sandy CLAY; low to medium plasticity, orange and brown, fine to med sand, moist, dense	FILL
0.4 – 1.0	Sandy CLAY; low to medium plasticity, orange, fine sand, M>Wp	FILL
1.0 – 2.1	Gravelly CLAY; medium to high plasticity, orange and grey layers, moisture greater than the plastic limit, stiff becoming very stiff	FILL
2.1 – 2.5	Silty SAND; fine to medium grained, black, vegetation, moist	TOPSOIL
2.5 – 3.0	CLAY; medium to high plasticity, grey, moisture greater than the plastic limit, stiff becoming very stiff	RESIDUAL
<p>BH4 TERMINATED AT 3.0m (Limit of Investigation)</p> <p>GROUND WATER INFLOW NOT ENCOUNTERED</p>

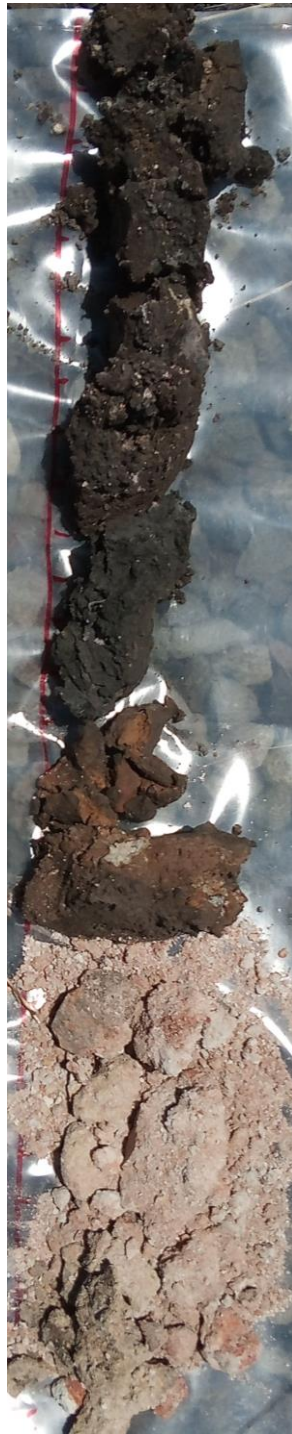
BH5

LOCATION:	5 HUNTINGDALE DV, THORNTON	
JOB NUMBER:	E21 090	
DATE:	11/11/2021	
MACHINE / LOGGED BY:	TRUCK RIG / DS	
BH - 5		
DEPTH (m BGL)	MATERIAL PROPERTIES	STRUCTURE AND ADDITIONAL OBSERVATIONS
0.0 – 0.5	Silty SAND; fine to medium grained, grey, fine to med sand, moist, dense	FILL
0.5 – 1.1	Gravelly CLAY; low to medium plasticity, orange, fine gravel. M>Wp	FILL
1.1 – 2.0	CLAY; medium to high plasticity, orange and grey layers, moisture greater than the plastic limit, stiff becoming very stiff	FILL
2.0 – 2.2	Silty SAND; fine to medium grained, black, vegetation, moist	TOPSOIL
2.2 – 3.0	CLAY; medium to high plasticity, grey, moisture greater than the plastic limit, stiff becoming very stiff	RESIDUAL
<p>BH5 TERMINATED AT 3.0m (Limit of Investigation)</p> <p>GROUND WATER INFLOW NOT ENCOUNTERED</p>

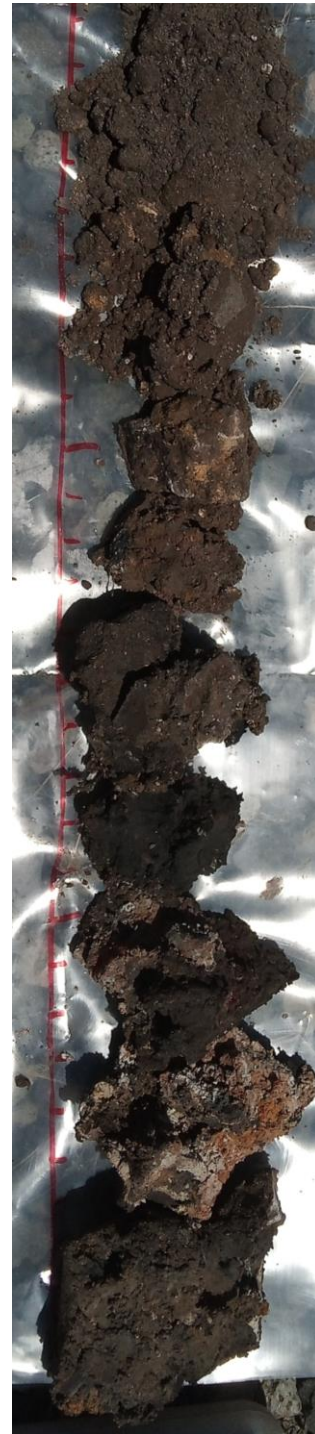
BH6

LOCATION:	5 HUNTINGDALE DV, THORNTON	
JOB NUMBER:	E21 090	
DATE:	11/11/2021	
MACHINE / LOGGED BY:	TRUCK RIG / DS	
BH - 6		
DEPTH (m BGL)	MATERIAL PROPERTIES	STRUCTURE AND ADDITIONAL OBSERVATIONS
0.0 – 0.5	Gravelly Clayey SAND; fine to medium grained, grey, fine to med sand, moist, dense	FILL
0.5 – 1.5	Gravelly CLAY; low to medium plasticity, orange, fine gravel. $M > W_p$	FILL
1.5 – 1.8	CLAY; medium to high plasticity, orange and grey layers, moisture greater than the plastic limit, stiff becoming very stiff	FILL
1.8 – 2.0	Silty SAND; fine to medium grained, black, vegetation, moist	TOPSOIL
2.0 – 3.0	CLAY; medium to high plasticity, grey, moisture greater than the plastic limit, stiff becoming very stiff	RESIDUAL
<p>BH6 TERMINATED AT 3.0m (Limit of Investigation)</p> <p>GROUND WATER INFLOW NOT ENCOUNTERED</p>

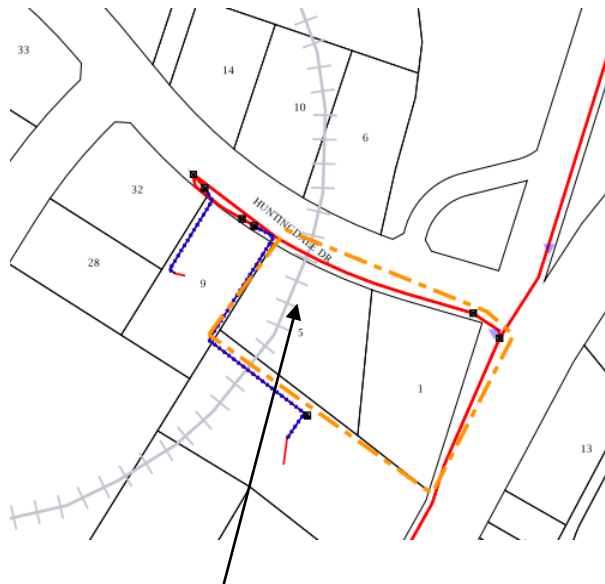
DBYD showing position of former rail line through site

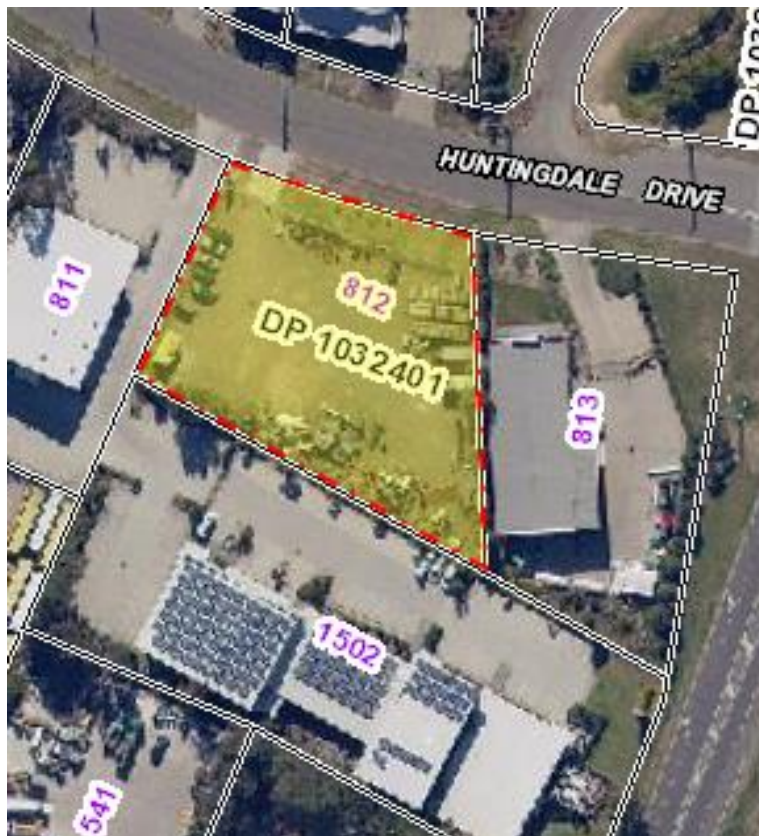
FIGURE 2 - SITE BOUNDARY

The site is located in the eastern portion of the commercial section of Thornton, on the southern side of Huntingdale Drive between Pipeclay Drive to the west and Thornton Road to the east as shown on the attached Figure 1 with Site Boundaries shown on the attached Figure 2.

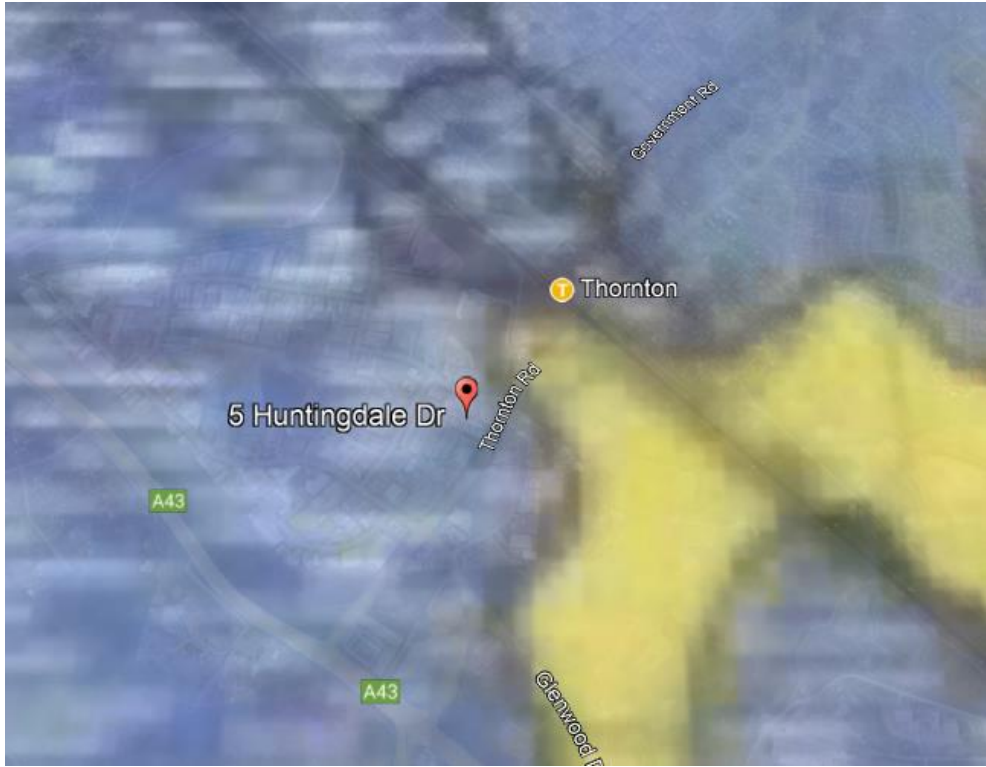
Figure 3 - Geology Map of Site (Residual BLUE and Alluvium YELLOW)
