Report on Preliminary Site Investigation (PSI)

Lot 2 DP 1286289, Louth Park, NSW

81022027-004.1

10 November 2022

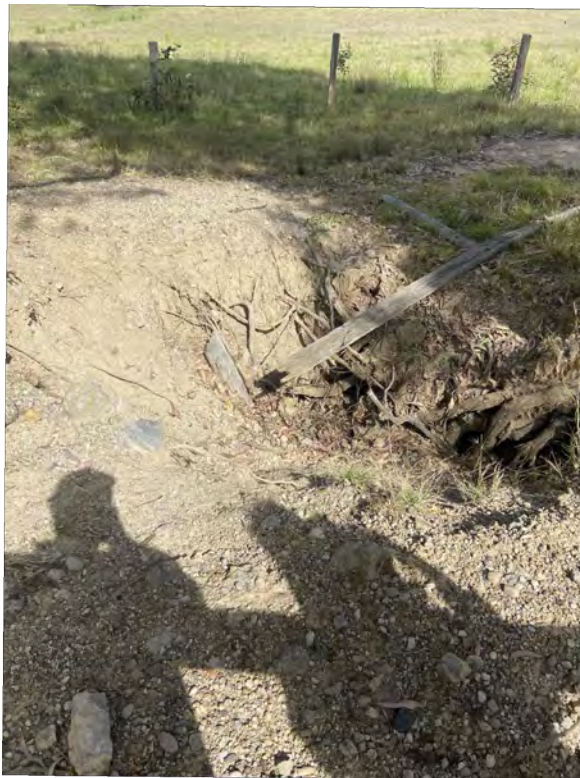
Photo 1: View of former mine shaft in the southwestern corner of the Site. Taken on 29/09/2022.

The extent of the filling is unknown, however is limited to the former adit and shaft. It should be noted that as part of the development both the adit and shaft are to be remediated, the adit by excavation and removal and the shaft by grouting and concrete capping. As a result, the filling excavated by the adit will be assessed both geotechnically and environmentally for its conclusion in Site works or removal from Site in accordance with relevant regulatory requirements.

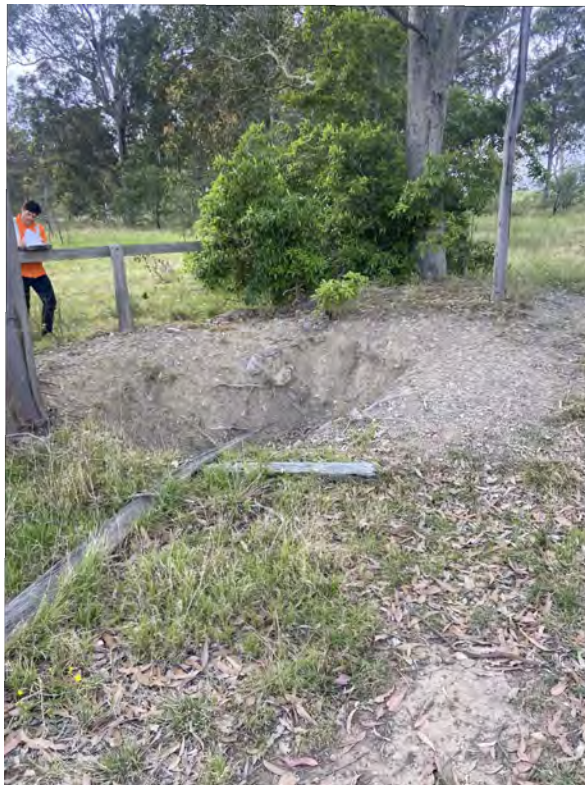
Photo 2: View facing south of former mine shaft in the southwestern corner of the site. Taken on 29.09.2022

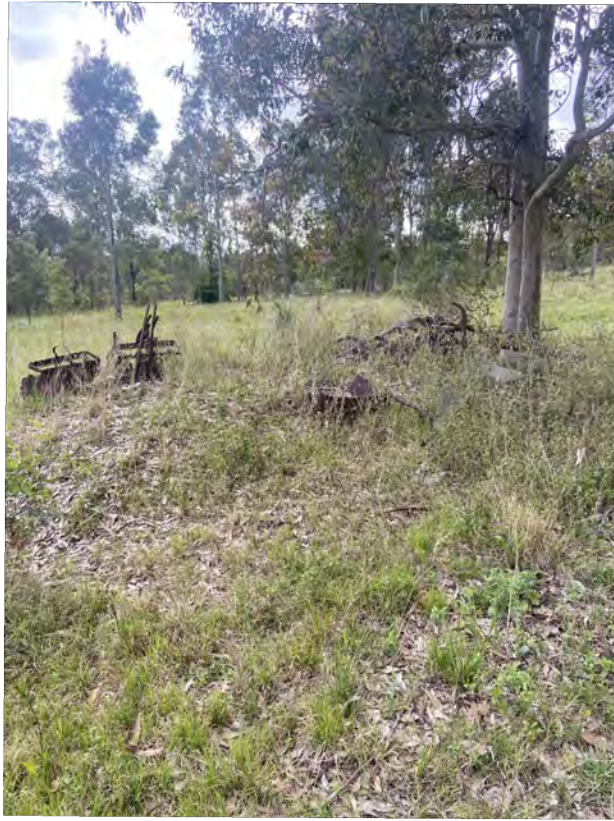
Photo 3: View of the stockpile and steel plough just north of the former mine shaft in the southwestern corner. Taken on the 29.09.2022.

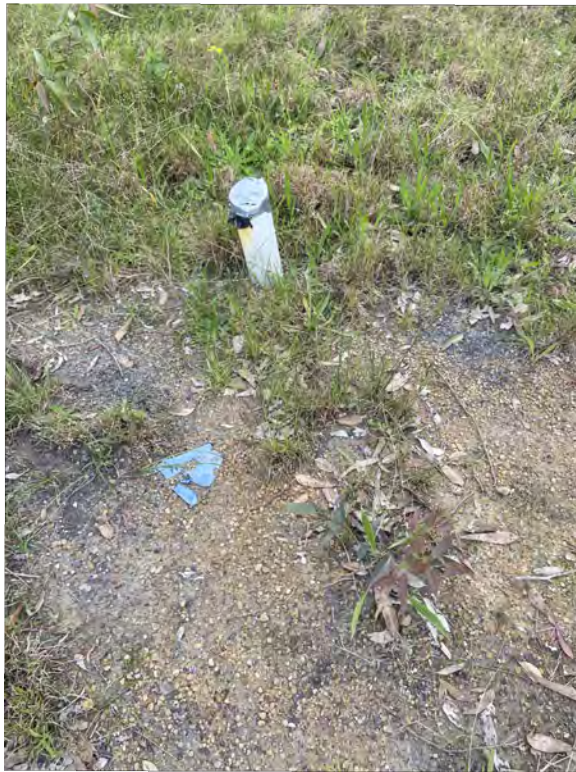
Photo 4: View of former PVC cased borehole in the southern portion of the Site, associated with previous investigation. Taken on 29.09.2022.

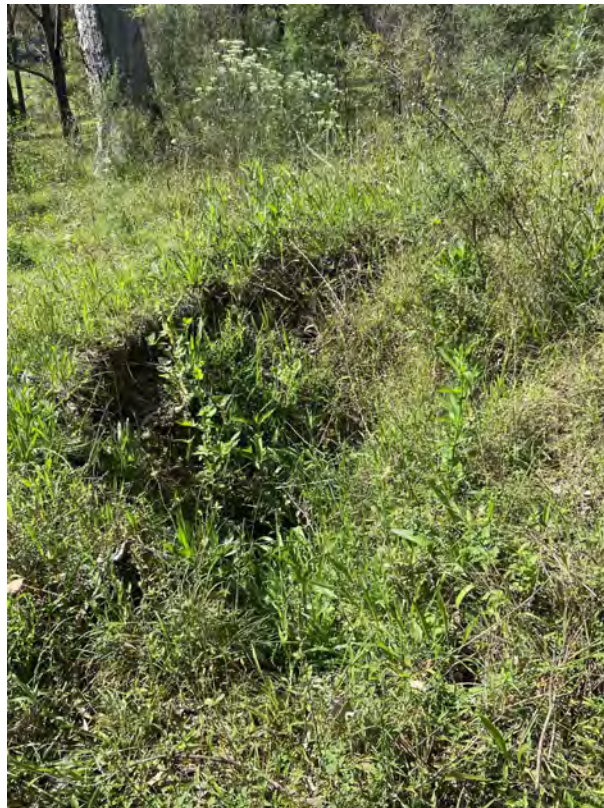
Photo 6: View of a depression in the ground associated with the former mine adit just beyond the eastern border of the site. Taken on the 29.09.2022

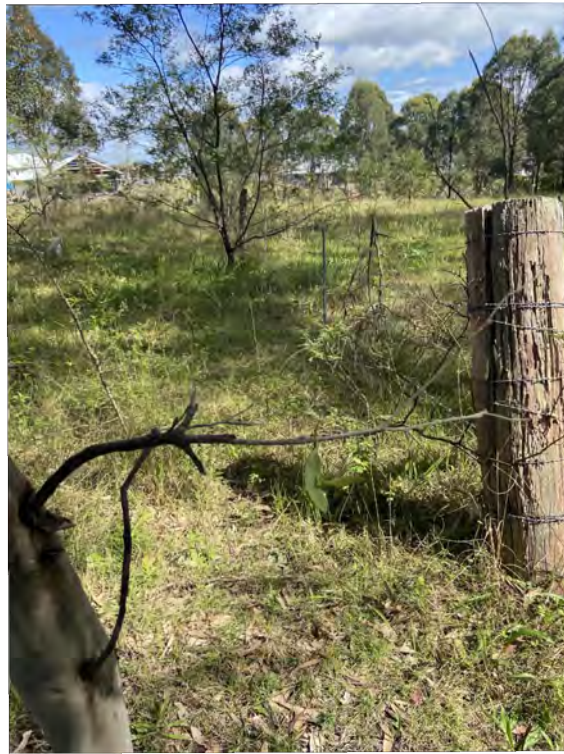
Photo 7: View of fenced area in the northern portion of the Site. Taken on the 29.09.2022

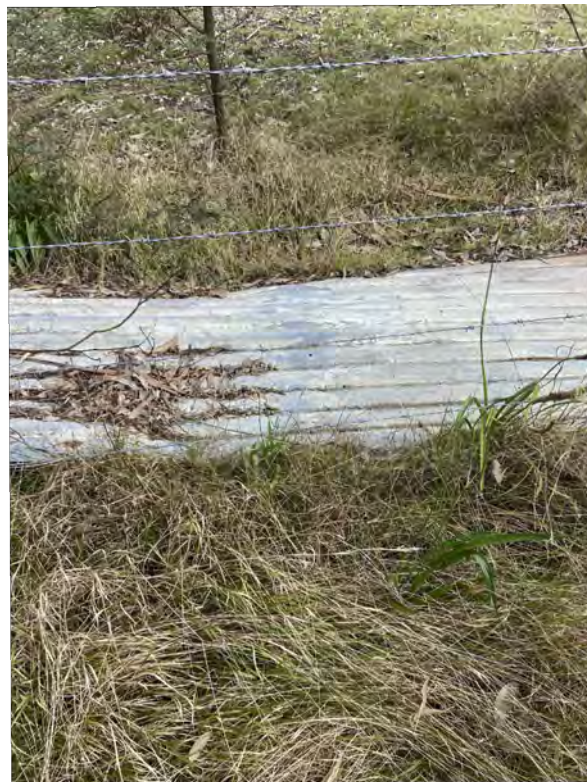
Photo 10: View of stored corrugated iron in the northern portion of the Site adjacent Dam. Taken 29.09.2022

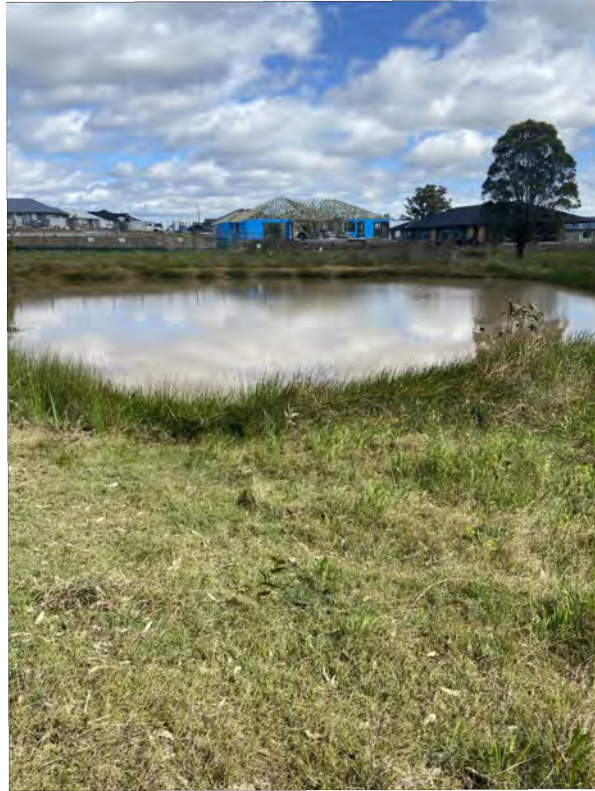
Photo 9: View of dam situated along the northern border of the Site. Taken on 29.09.2022

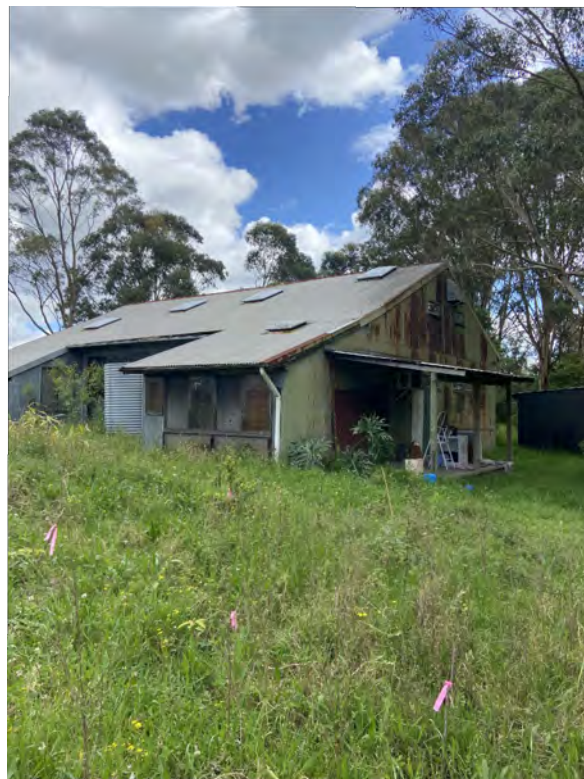
Photo 10: View of the structure just beyond the northern border of the Site. Taken on 29.09.2022

Potential asbestos in building materials	<ul style="list-style-type: none"> > No indications on Site. > There is potential bonded asbestos associated with the small shed immediately north of the Site.
Manufacturing, industrial or chemical processes and infrastructure	<ul style="list-style-type: none"> > The Site is underlain by underground mine working with a former mine adit and a fan shaft located on Site.
Fuel storage tanks (USTs/ASTs)	<ul style="list-style-type: none"> > Not observed.
Dangerous goods	<ul style="list-style-type: none"> > Not observed.
Presence of stockpiles, fly tipping or anthropogenic materials	<ul style="list-style-type: none"> > There were several stockpiles scattered throughout the Site, predominantly in proximity to the former shaft and former adit. Limited observations indicated the stockpiles contained soil materials with a portion of coal chitter. Minor concrete cobbles/boulders was noted in exposed fill in proximity to the former adit. > Isolated items of windblown construction waste noted on site associated with the residential construction west of the Site. > A range of aged agriculture tools including a plough noted in isolated locations across the Site.
