# PRELIMINARY SITE INVESTIGATION REPORT

**PROJECT:** 21-33 Owlpen Lane, Farley, NSW 2320

**DATE:** 05 July 2022

**REPORT NO:** NE1165

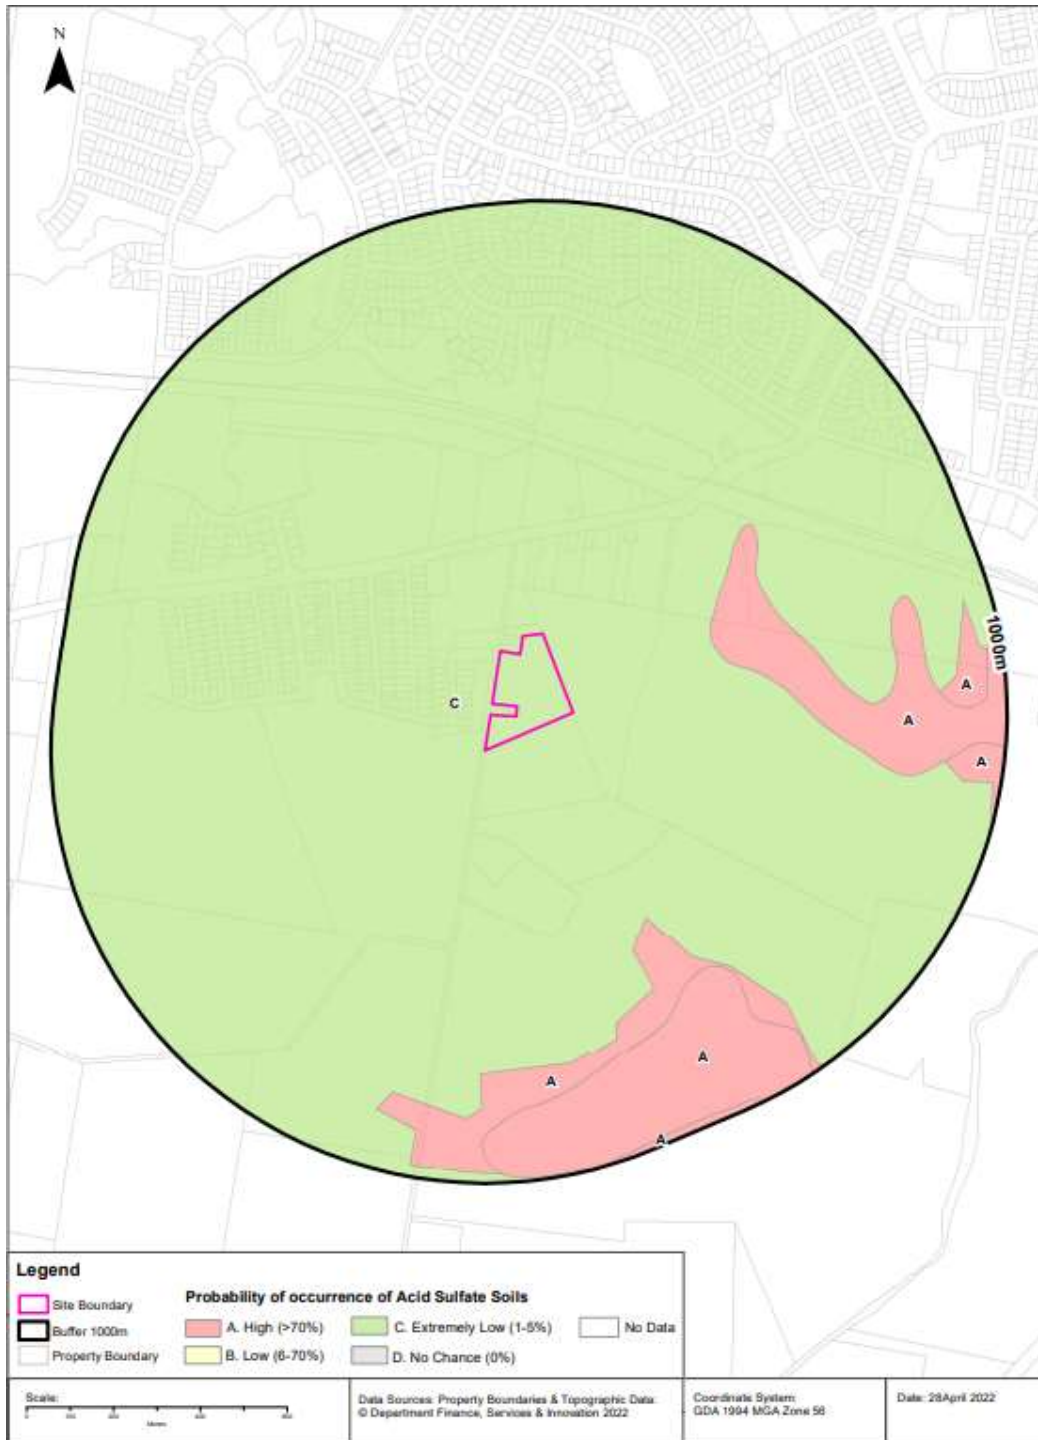
Figure 2. Probability of occurrence of Acid Sulfate Soils Map

The Department for Infrastructure, Planning and Natural Resources (DIPNR) Acid Sulphate Soils Risk Mapping (1997), Maitland Local Environmental Plan and the NSW Environmental Acid Sulphate Soil Risk Mapping eSPADE application indicates that the Site is not expected to be underlain by acid sulphate soils (Class 5 Acid Sulfate Soils). Class 5 Acid Sulfate Soils site is within 500 metres of adjacent Class 1, 2, 3, or 4 land that is below 5 metres AHD and by which the watertable is likely to be lowered below 1 metre AHD on adjacent Class 1, 2, 3 or 4 land, present an environmental risk (See Figure 2).

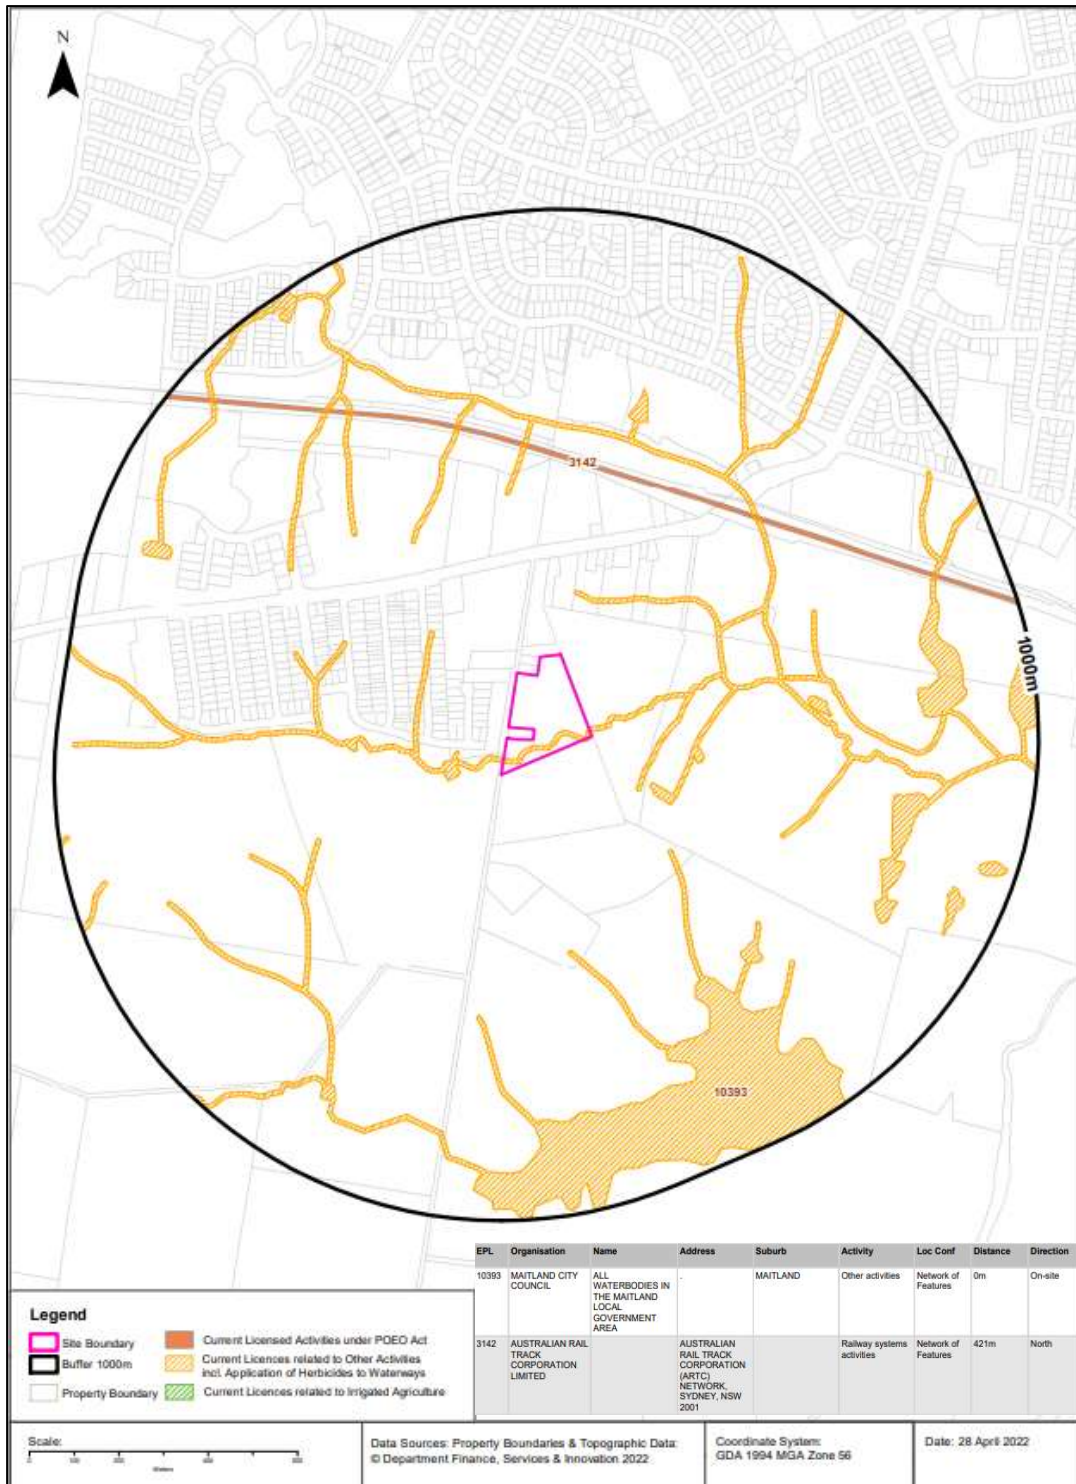
Figure 3. Licensed Activities under the POEO Act 1997 Map

A Licensed Activity under the POEO Act 1997 was identified onsite (#10393, ALL WATERBODIES IN THE MAITLAND LOCAL GOVERNMENT AREA. A second Licensed

Activity (#3142, AUSTRALIAN RAIL TRACK CORPORATION LIMITED) under the POEO Act 1997 was identified 421 m north from the site. (See Figure 3).

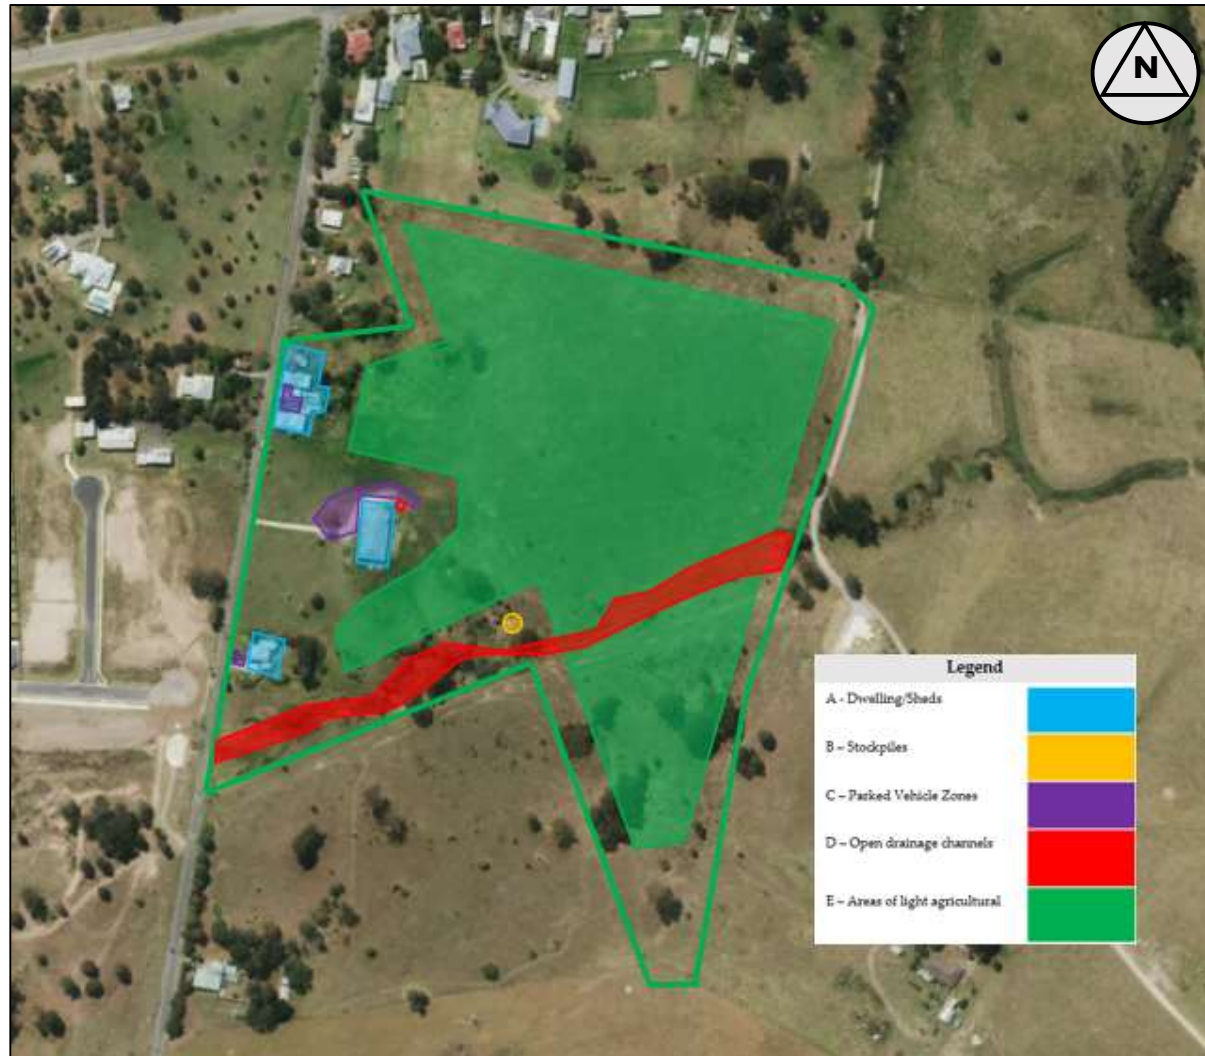
Figure 5: Areas of Environmental Concerns

- Contaminants from the contents of the garbage dump and parked vehicles may have leached, spilled or been distributed onto the underlying soil.
- Open drainage channels may cause environmental contamination to surrounding soil from upstream contaminants during heavy rainfall events.
- Areas of suspected agricultural usage, pesticides, heavy metals and TRHs

To address identified AECs, intrusive soil/water sampling regime is recommended to determine what, if any, remediation is required to render the site fit for residential use. A soil sampling plan is to be developed based on a judgemental or systematic sampling pattern and risk-based assessment.

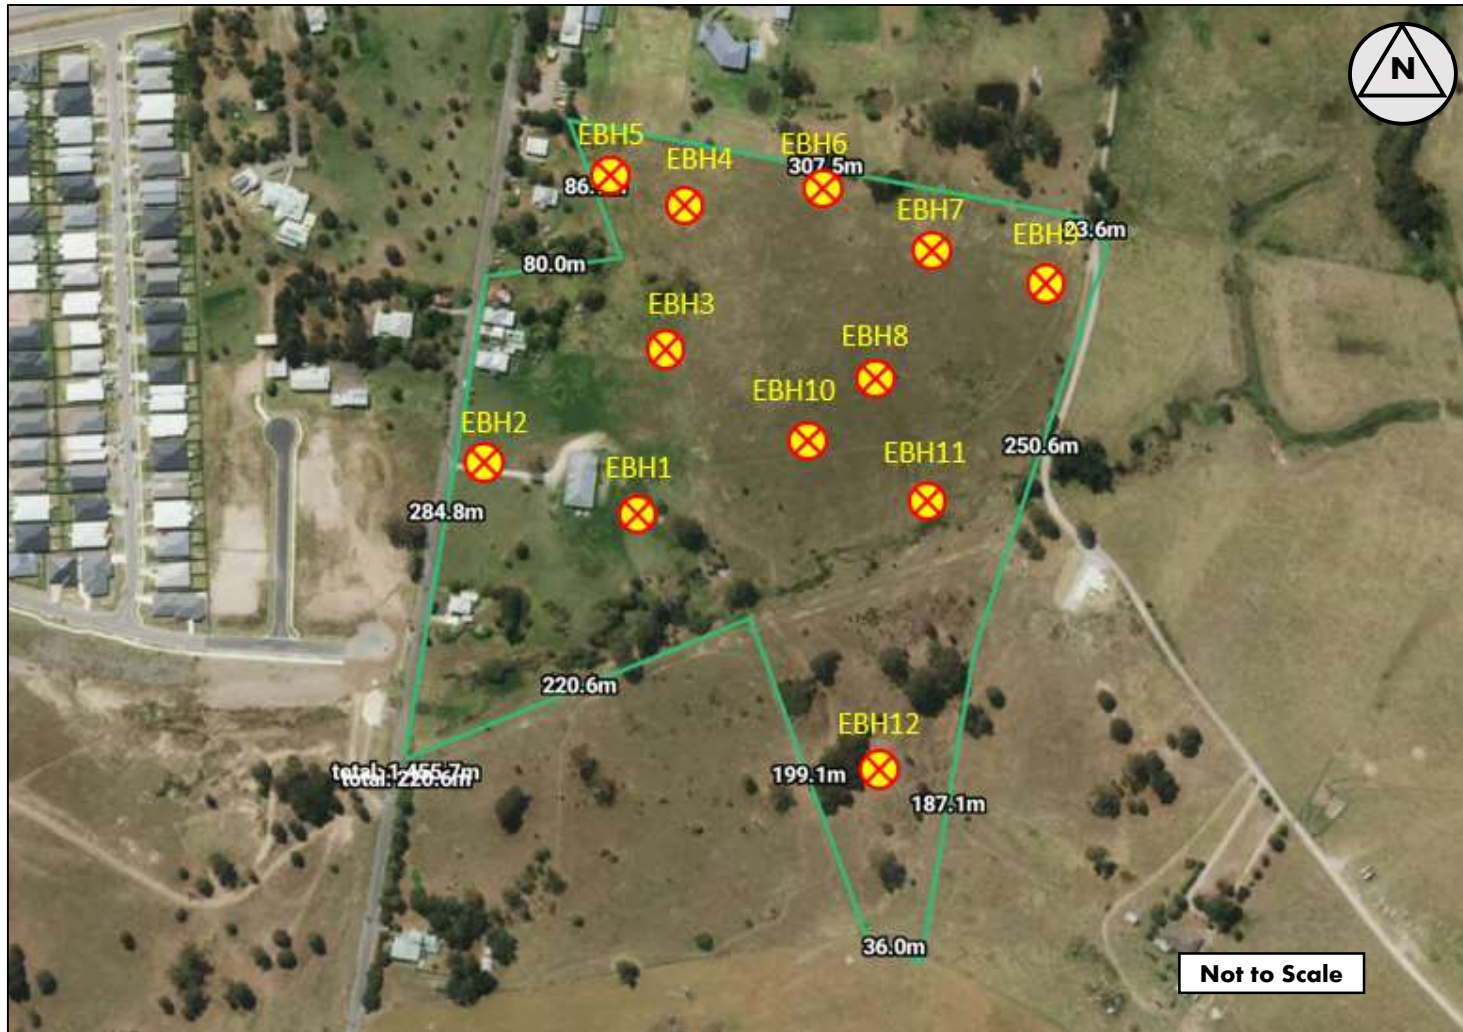
Figure 6: Environmental Soil Sampling Locations

Based on the fieldwork results, a topsoil/fill layer to a maximum depth of 1.0m, comprising of Silty Clay material, was observed in most boreholes.

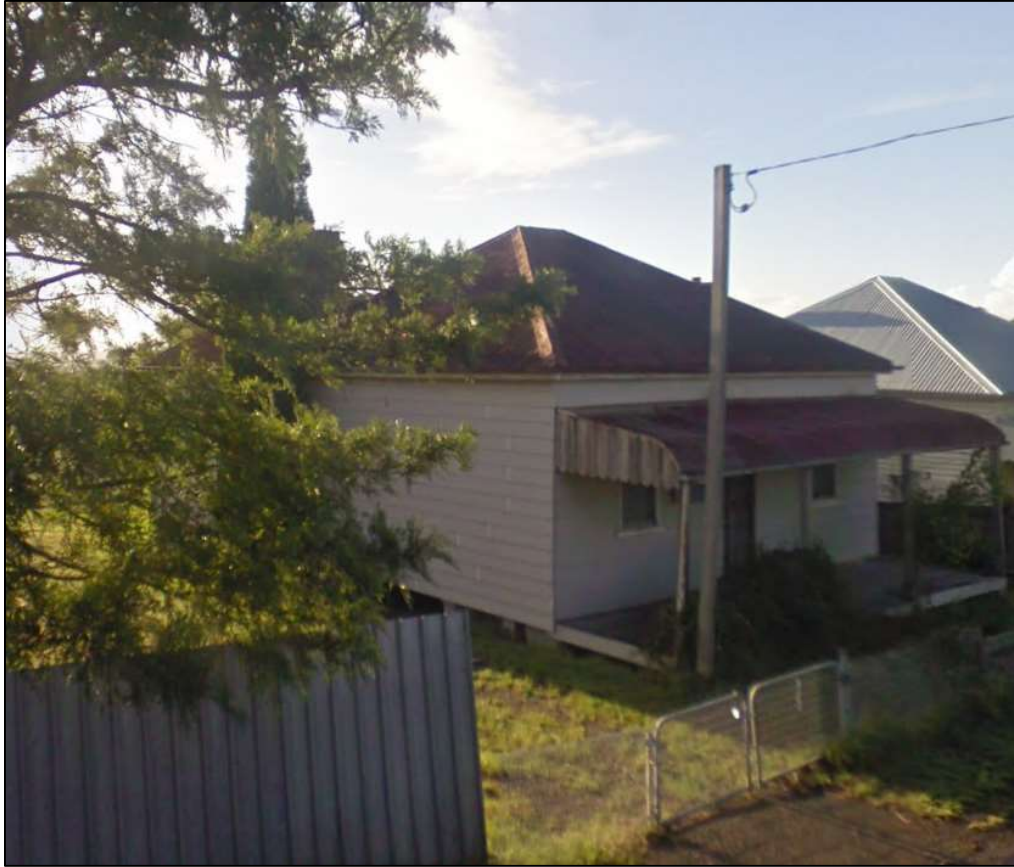
- There was a single-storey residential dwelling adjacent to Owlpen Lane. It was abandoned at the time of the investigation and not in good condition with damages in some parts.
- Broken, old cars were observed to park approximately 20 m away in the north side of the residential dwelling.
- An abandoned shed was present at approximately 40 m at the back of the residential dwelling.
- The remaining area was vacant, covered by grass and scattered trees.

**Photograph 1:** 21 Owlpen Lane, Farley, NSW 2320, viewed from the northwest of the dwelling.

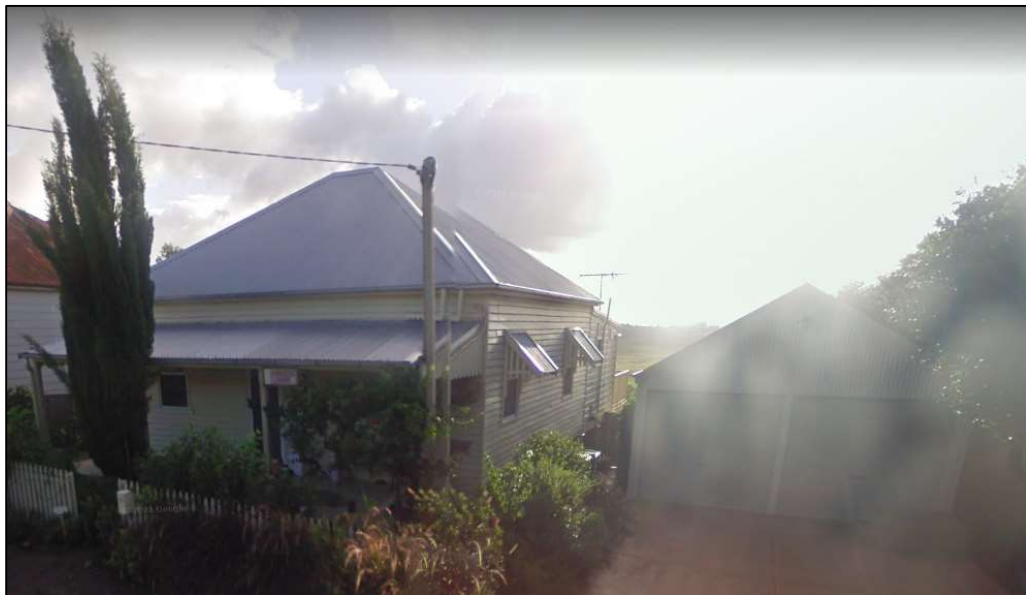
- There was a single-storey residential dwelling adjacent to Owlpen Lane.
- A garage was located in the south side of the dwelling.
- A swimming pool existed at the back of the garage.
- All structures at the site were in good condition during the site investigation.
- Cars were observed parking in the front of the garage.
- Grass and trees occupied approximately half of the lot.

**Photograph 2:** 23 Owlpen Lane, Farley, NSW 2320, viewed from the southwest of the dwelling.

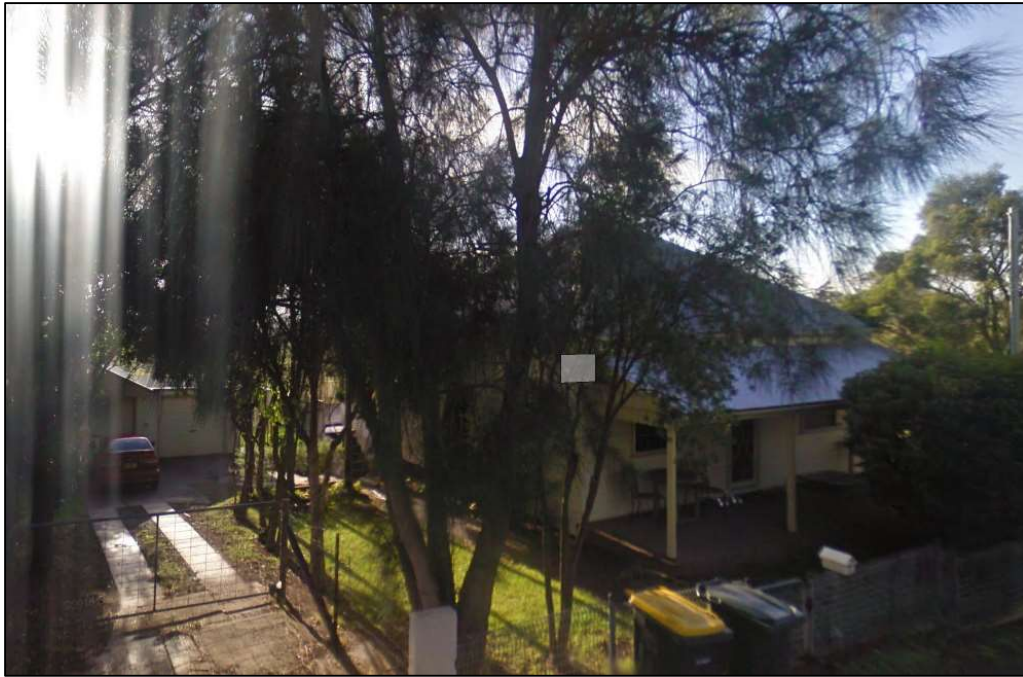
- There was a single-storey residential dwelling adjacent to Owlpen Lane.
- A garage and shed were located in the north side of the dwelling.
- A shed for animals was located in the south side of the dwelling.
- All structures at the site were in good condition during the site investigation.
- Cars were observed parking in the front of the garage.
- There was a playground at the back of the dwelling with a slide and trampoline.

**Photograph 3:** 25 Owlpen Lane, Farley, NSW 2320, viewed from the northwest of the dwelling.

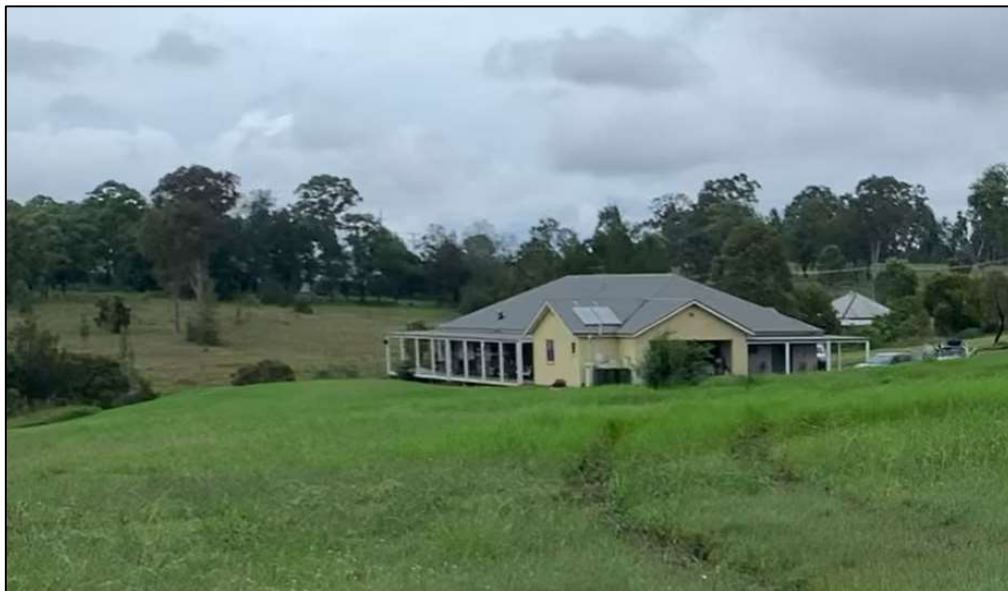
- There was a single-storey residential dwelling adjacent to Owlpen Lane.
- A garage and shed were located in the south side of the dwelling.
- All structures at the site were in good condition during the site investigation.
- Grass and trees occupied approximately a quarter of the lot.

**Photograph 4:** 33 Owlpen Lane, Farley, NSW 2320, viewed from the northeast of the dwelling.

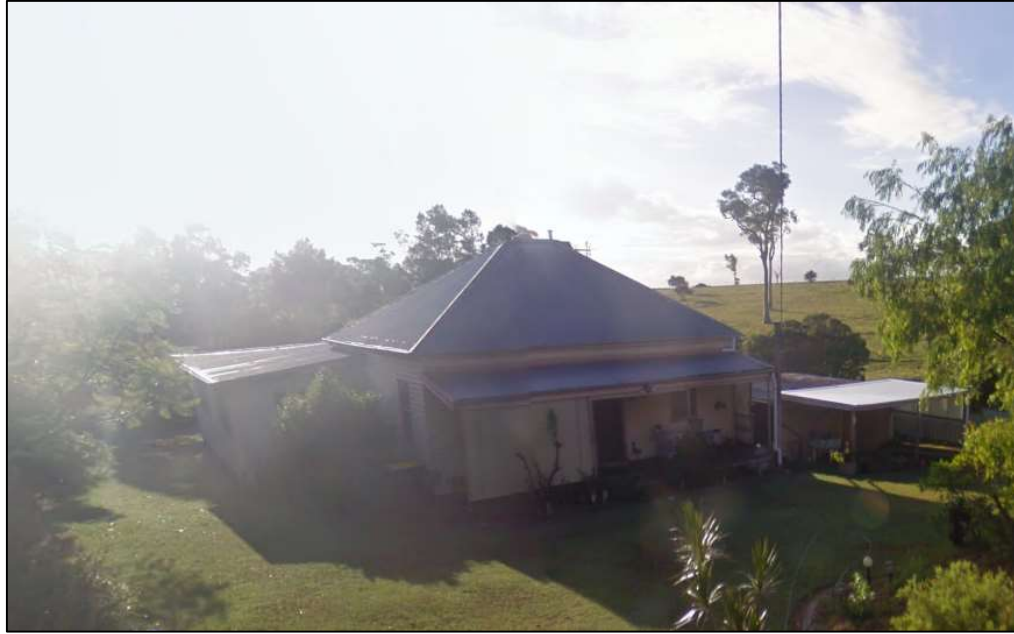
- Most site areas were vacant, covered by grass and scattered trees.
- A residential dwelling existed in the centre of the lot.
- An earth driveway connecting the residential dwelling to Owlpen Lane was noted.
- During the site investigation, cars were observed parking in the garage and beside the residential dwelling.
- Wastewater was observed to be discharged over the ground surface at the northeast corner of the dwelling.
- Two tanks for storing rainwater were observed in the north end of the dwelling.
- An open garbage stockpile was noted onsite at the east corner of the lot with construction and household wastes.
- All structures at the site were in good condition during the site investigation.

**Photograph 5:** 41 Owlpen Lane, Farley, NSW 2320, viewed from the northwest of the dwelling.
