Report on Preliminary Site Investigation

259 Windermere Road Windermere
NSW

81022070-001

7 October 2022

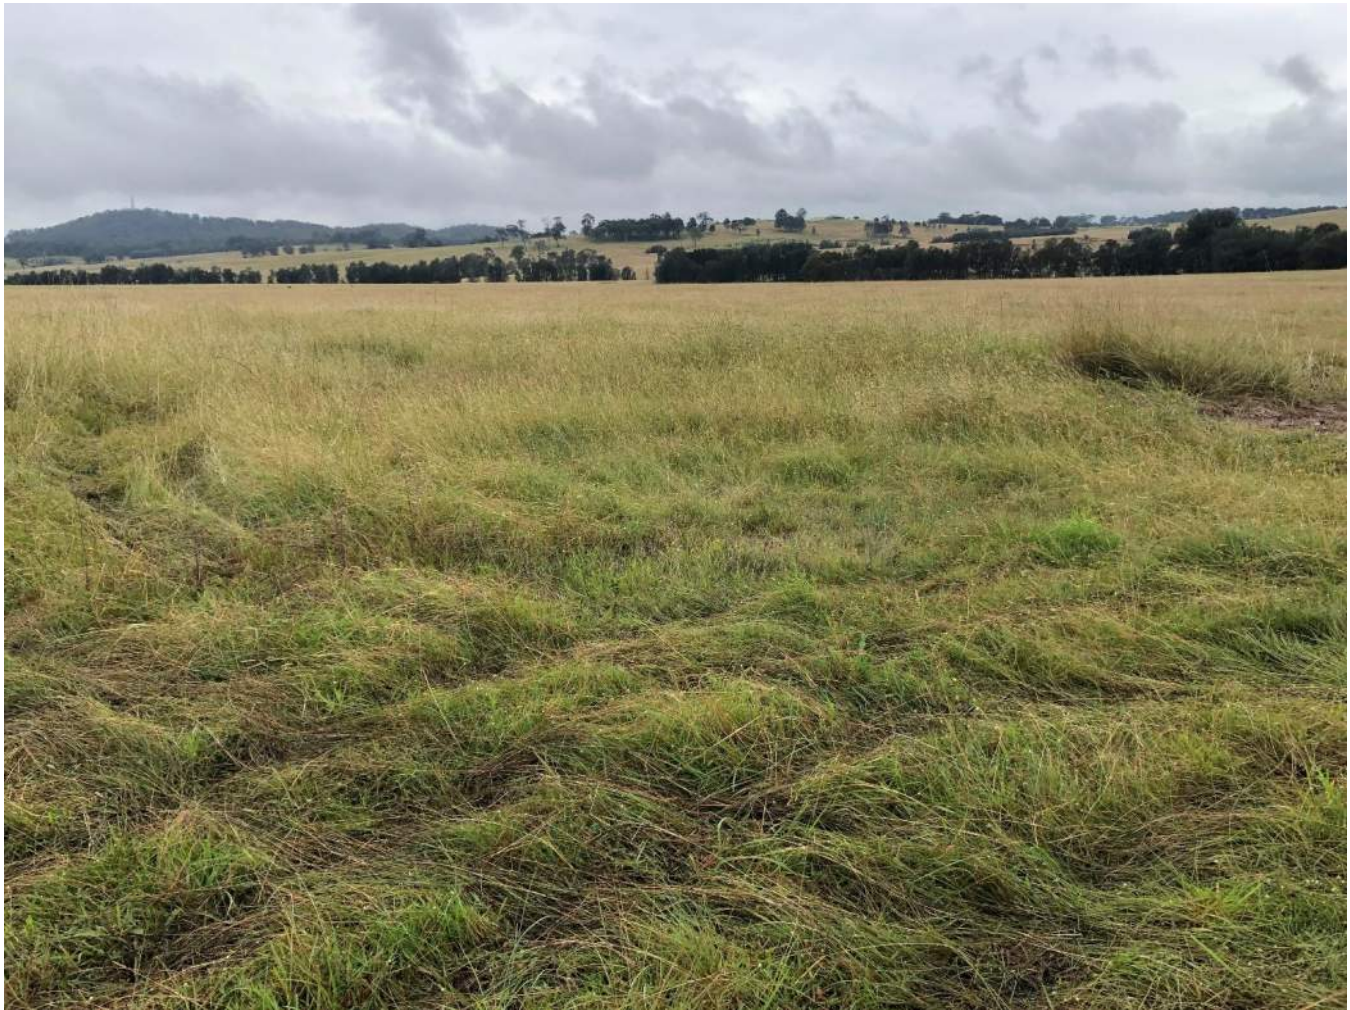
Photograph 1: Typical Site grass coverage.

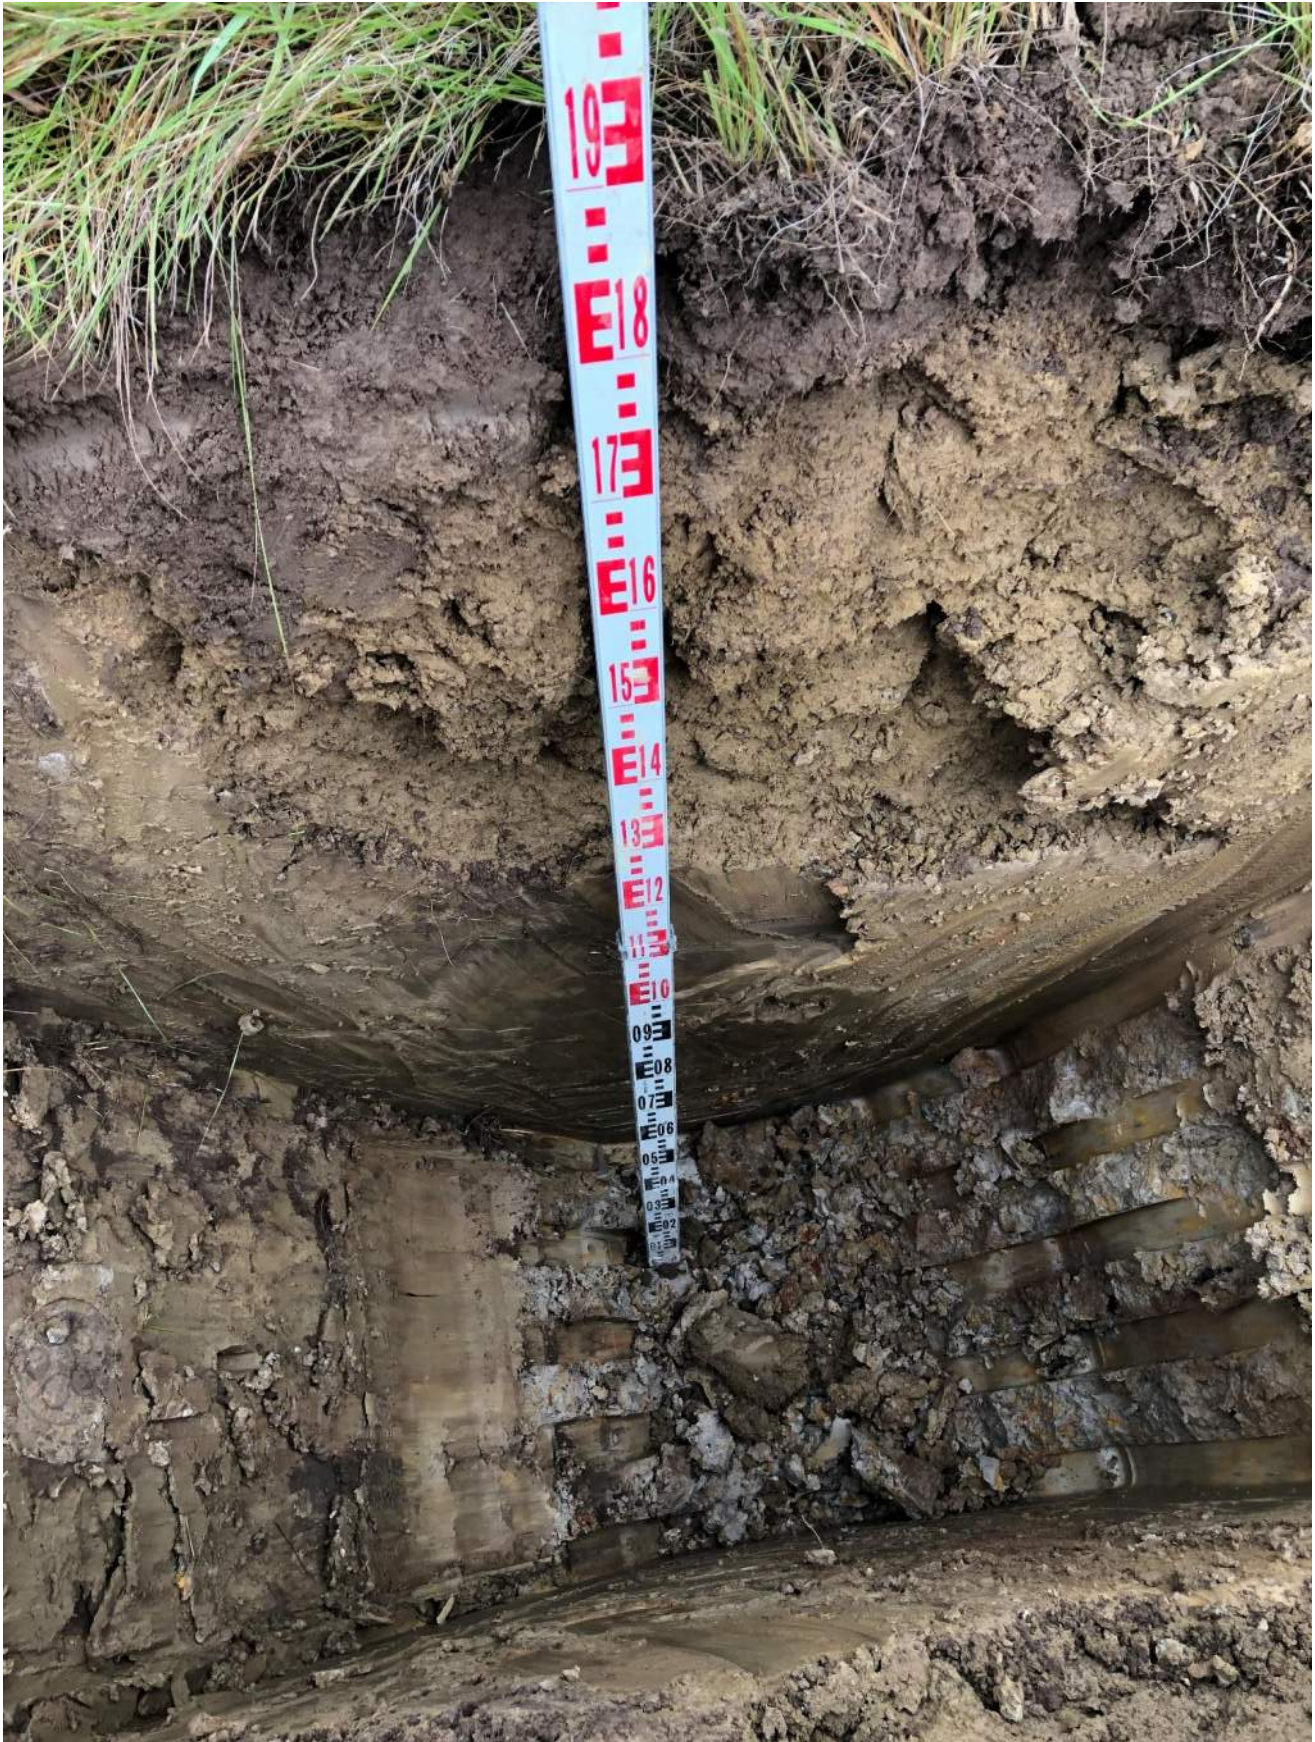
Photograph 2: Typical Site soils.

- > Colluvial soils comprising Clayey SAND/ Silty, Sandy CLAY and Gravelly, Sandy SILT were encountered in TP001, TP003-TP007, to depths in the range of 0.25–0.9 m BGL. The colluvial soils encountered ranged in plasticity from medium to high, with fine to coarse grained sand and traces of fine to coarse gravel. Granular colluvial soils were observed to wet, with cohesive soils of moisture content greater than plastic limit, and were of very loose to loose density and soft to firm consistency respectively.

- > Residual soils comprising Sandy/Silty CLAY were encountered in all test pits to depths ranging from 1.0 m to investigation limits of 2.0 m BGL. Residual clays were typically of medium to high plasticity and ranged from firm to hard consistency. Residual clays had observed moisture content ranging from equal to greater than plastic limit. Varying fractions of sand and gravel were encountered in the residual soils.

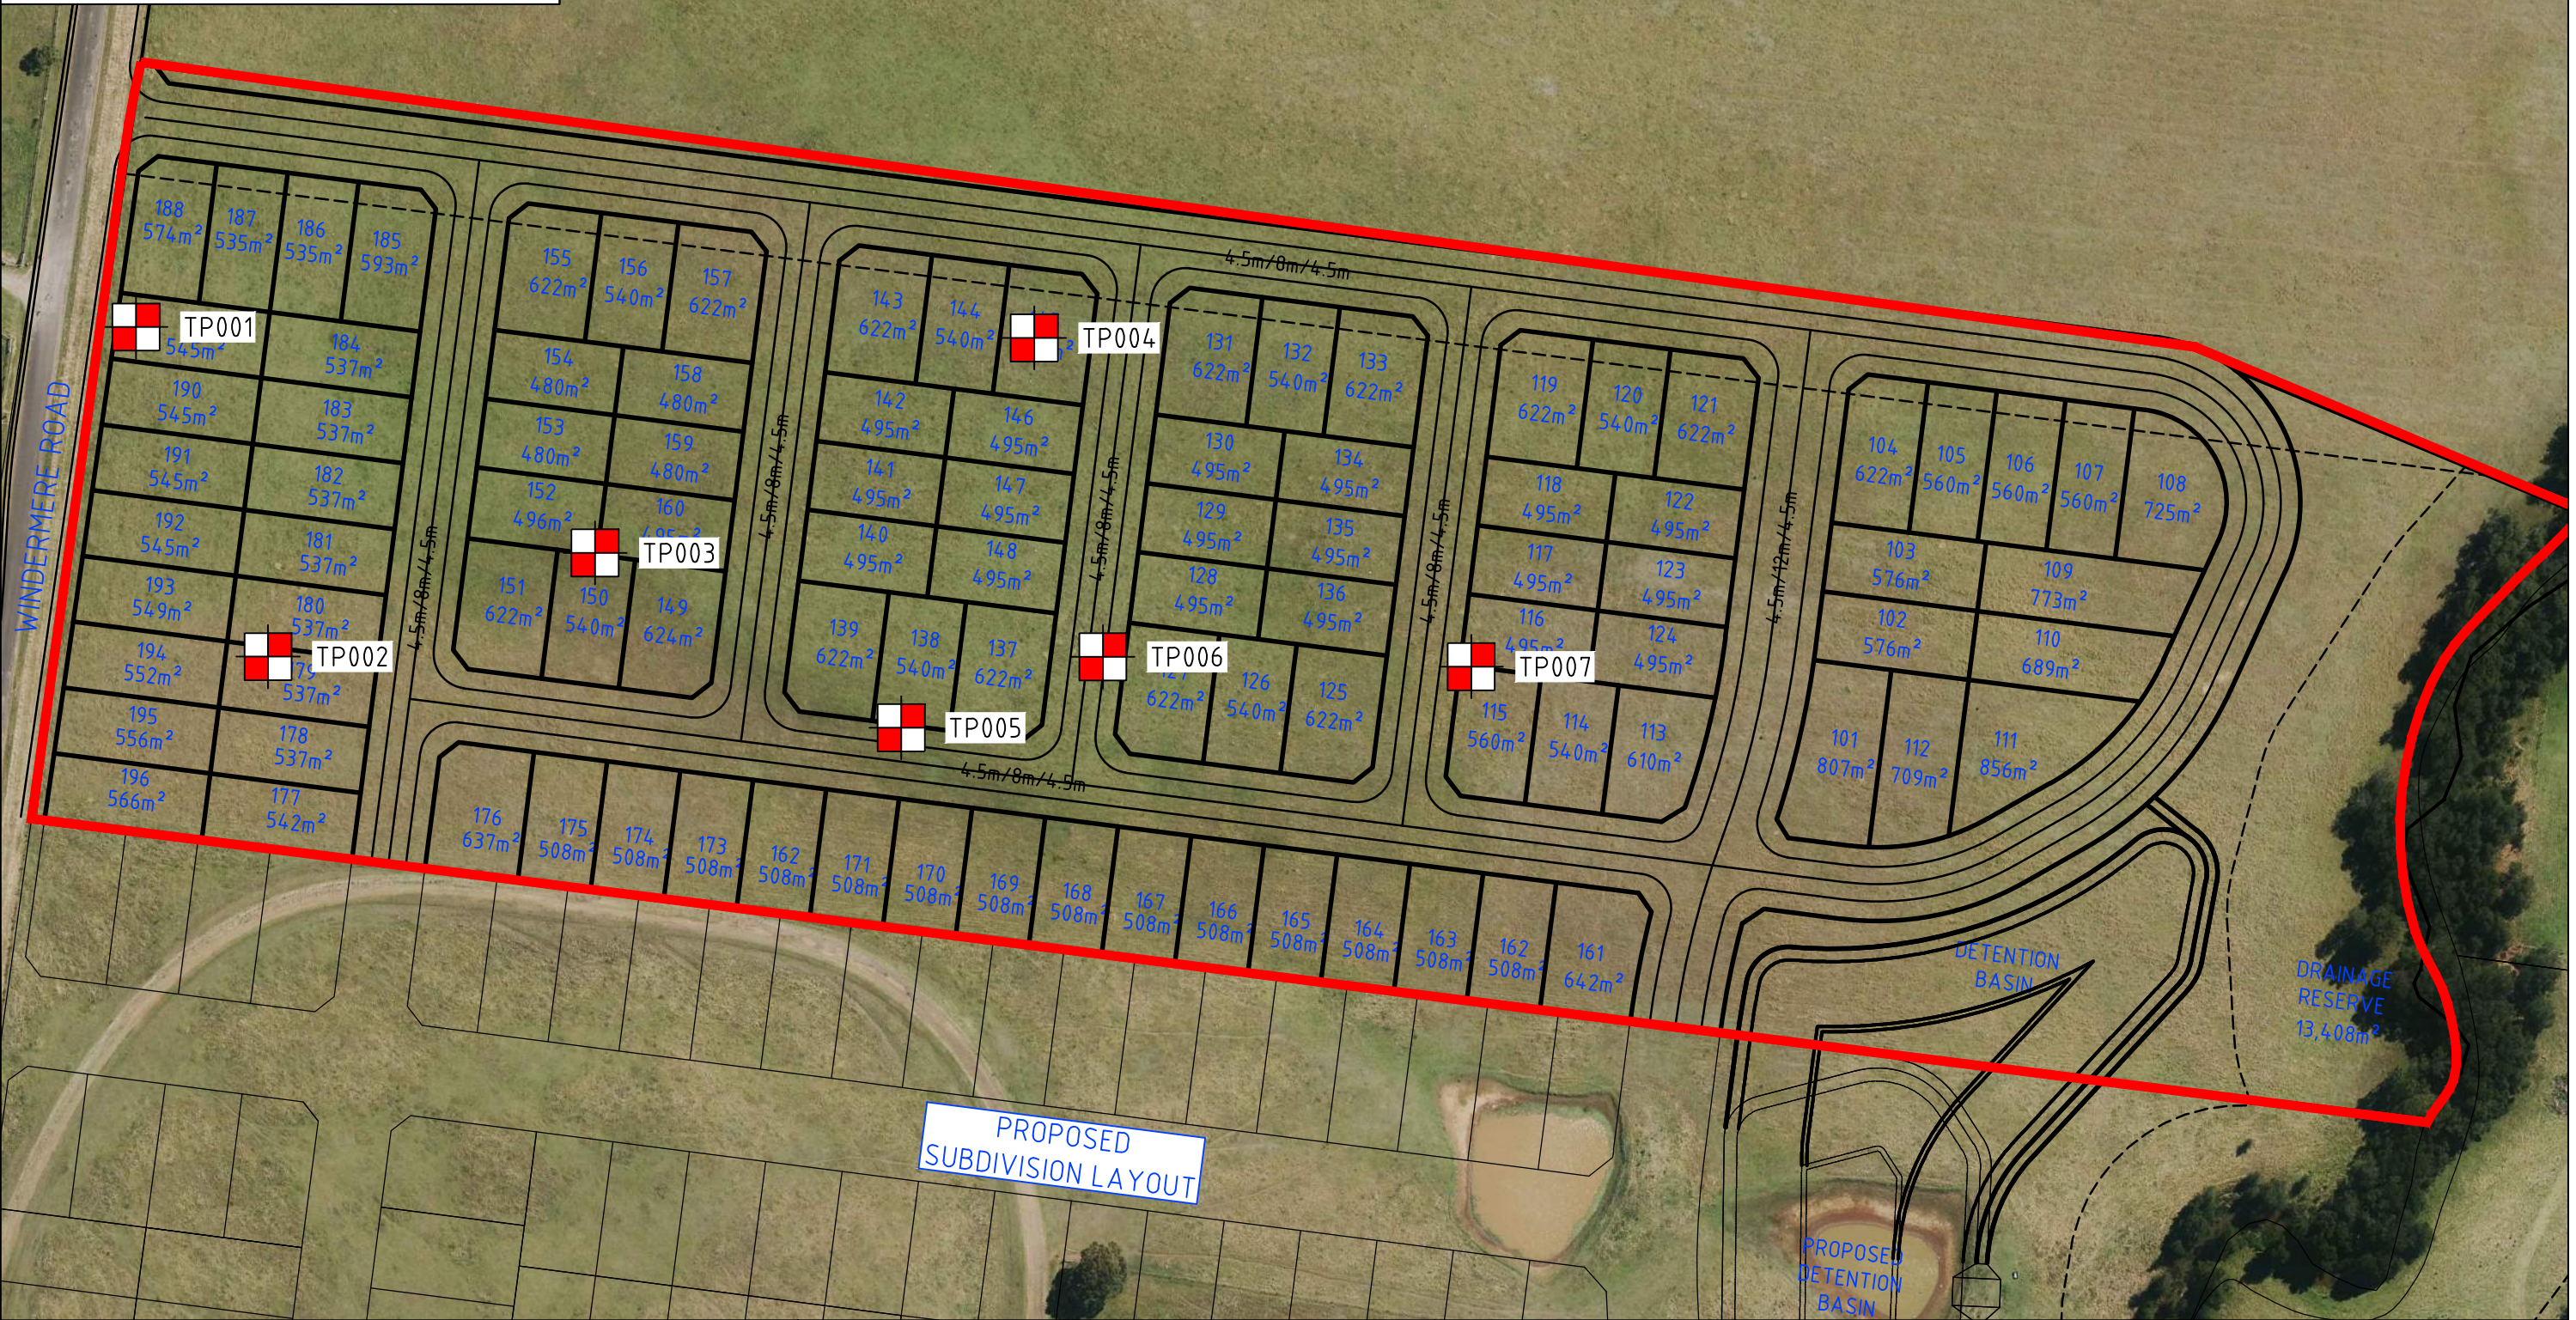
Approximate site assessment boundary.

The subsurface conditions encountered within the test pits are detailed on the attached test pit sheets attached in Appendix C, together with explanatory notes. Sample locations are shown on Figure 1 and 2 in Appendix A.

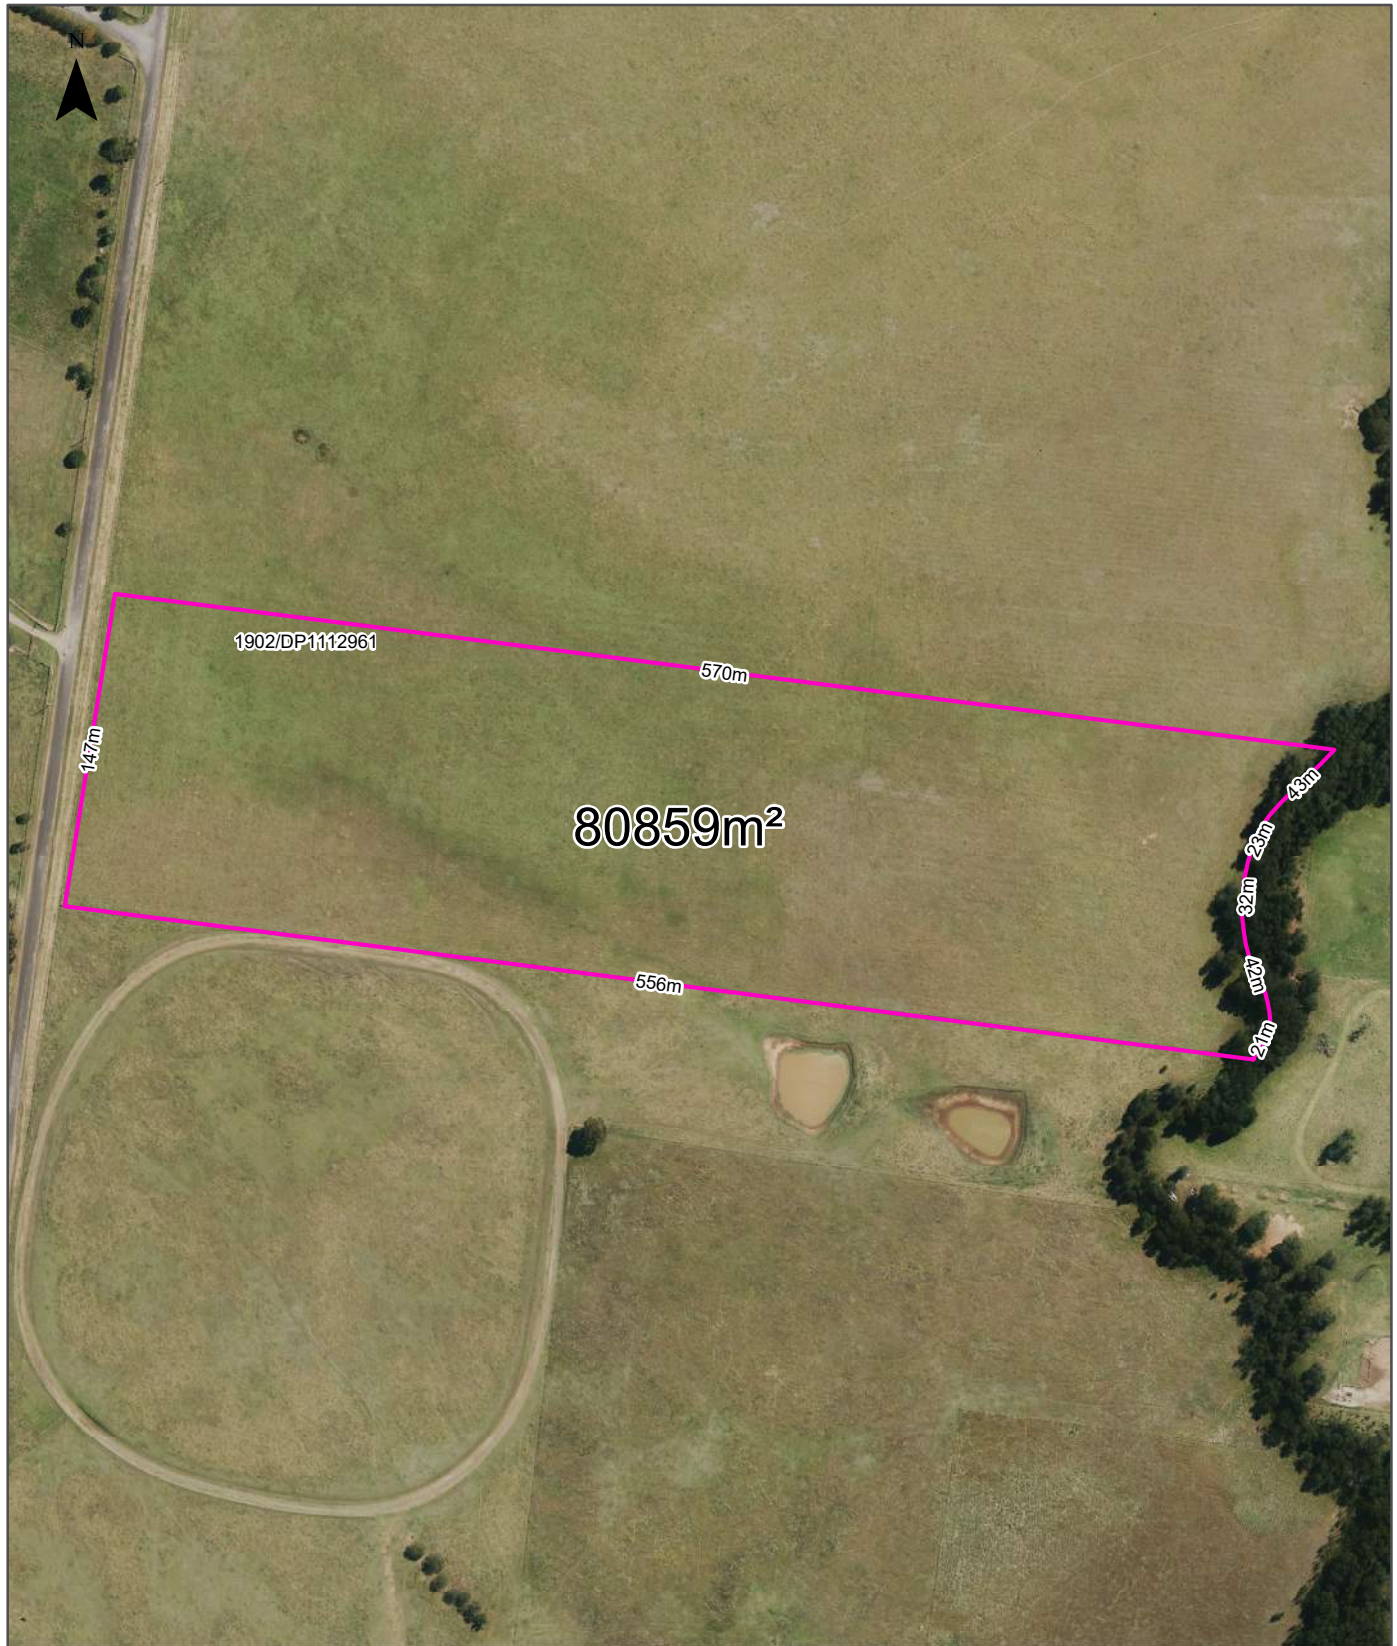
Site Diagram

Legend Site Boundary Internal Parcel Boundaries	Total Area: 80859m ² Total Perimeter: 1.44km	Scale:
	Disclaimers: Measurements are approximate only and may have been simplified or smaller lengths removed for readability. Parcels that make up a small percentage of the total site area have not been labelled for increased legibility.	Data Source Aerial Imagery: © Aerometrex Pty Ltd
		Date: 22 April 2022
