# PRELIMINARY SITE INVESTIGATION REPORT

**PROJECT:** 412 Cessnock Road, Gillieston Heights, NSW 2321

**CLIENT:** BATHLA GROUP

**REPORT No.:** NE1169

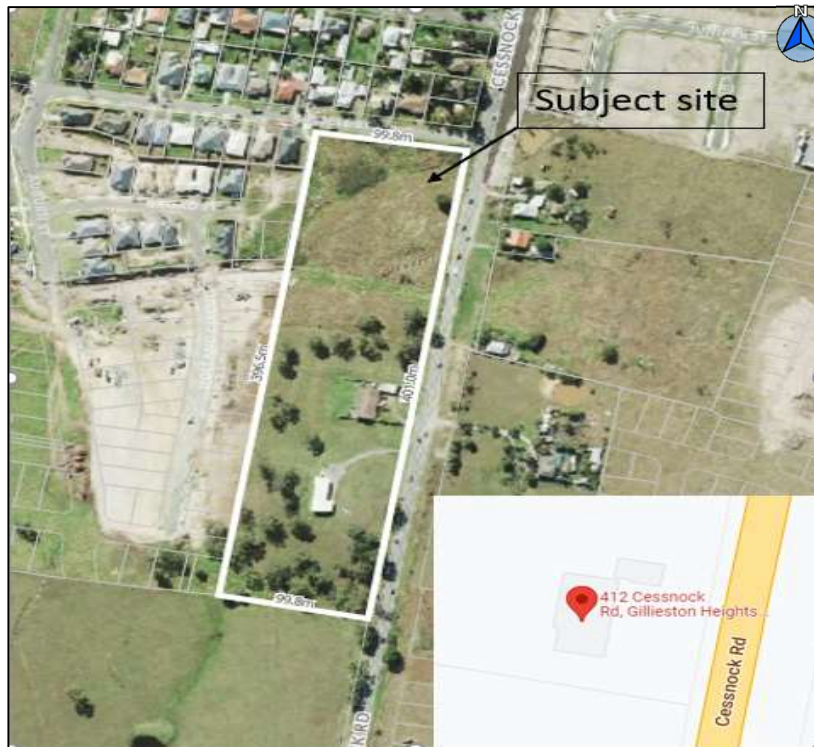
**Figure 1. Site Location Plan**

The site of investigation is located at 412 Cessnock Road, Gillieston Heights, NSW 2321, located at approximately 39 km (by road) of Newcastle, NSW. The site location and features are shown in Figure 1. The site has a rectangular shape and is relatively flat, with an area of approximately 39,604 m<sup>2</sup>. The site has a slope of approximately 8% downward from east to west.

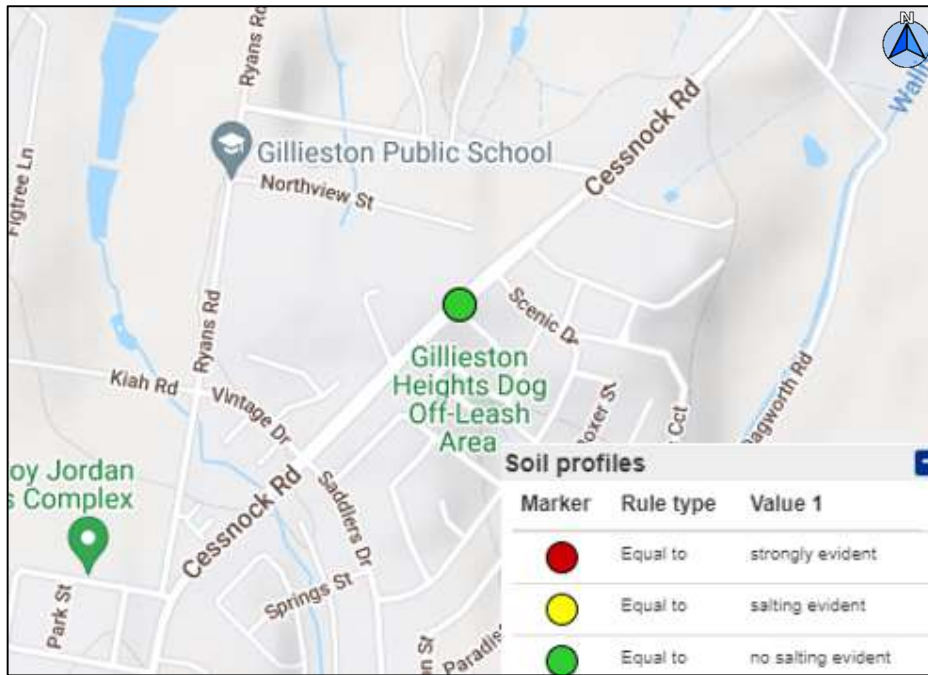
Figure 3. Salinity Potential Map

The eSPADE web app found at <https://www.environment.nsw.gov.au/eSpade2WebApp> indicated that the site is in an area with no salinity evidence (see Figure 3).

- ✓ Vegetation growth appeared healthy throughout the site.
- ✓ No water marks or salt crystals observed on the ground surface

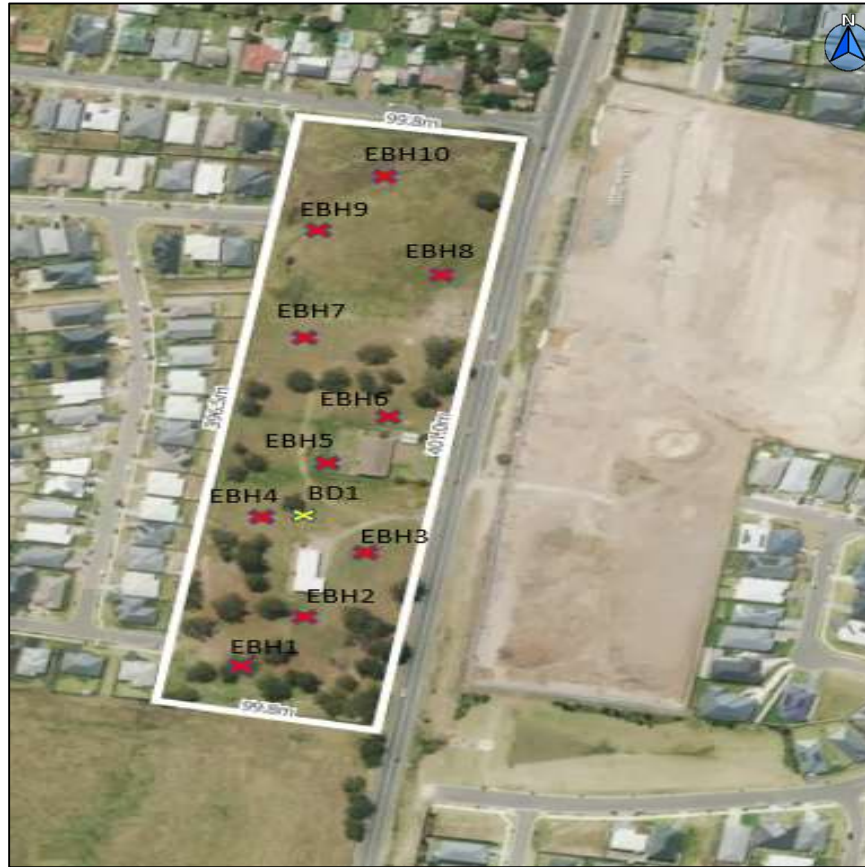
Figure 4. Sampling locations.

Fieldwork for this investigation was carried out on 13<sup>th</sup> April 2022 and included drilling of ten (10) boreholes. Borehole were drilled using a handheld auger up to the maximum depth of 0.3 m. The sampling locations are shown in Figure 4. Environmental soil samples were collected from the near surface and at lower depths up to 0.3m bgl and held for selected analysis.

During the sampling works a visual inspection was conducted for visible suspected asbestos containing materials (ACM), signs of contamination and odours. No visible ACM, contamination and odours were encountered on the site ground surfaces at the time of the inspection. The inspections for asbestos were undertaken in a systematic, back and forth fashion over the site to identify suspected ACM. No suspected ACM was encountered during the course of this investigation.

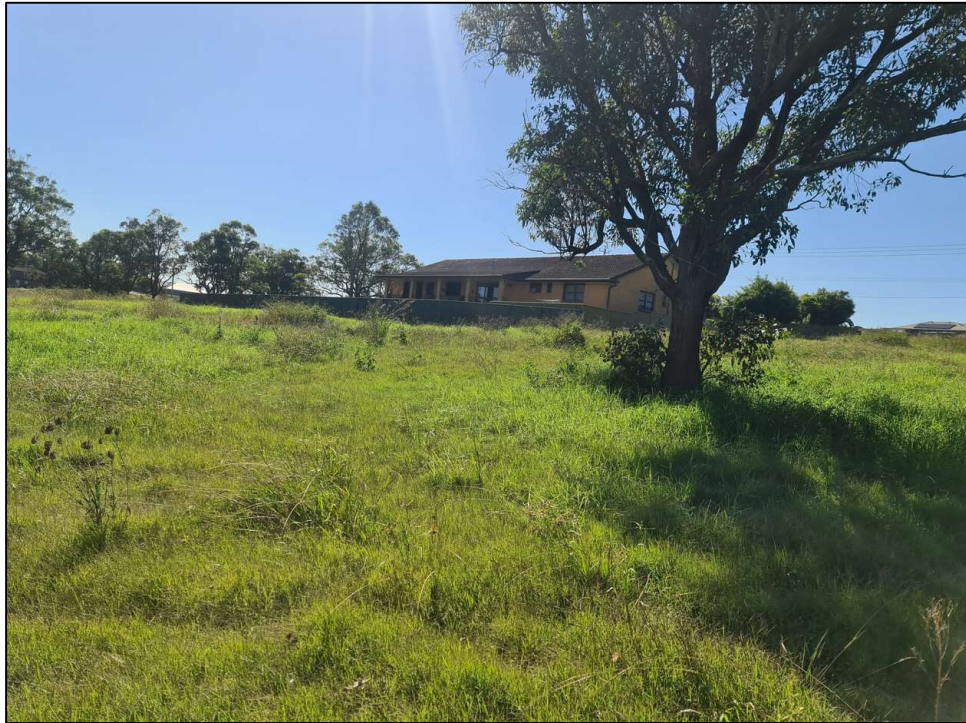
- One-storey residential dwelling constructed from brick veneer and appears to be in good condition, was located at the eastern central section of the site.
- One large shed made with Colourbond sheet metal and appears to be in good condition, was located in the southern section of the site. The large shed may serve as potential storage for fuel, chemicals, vehicles, generators, and equipment.
- Site consists of vacant grassed covered ground surfaces with sparsely populated mature trees across the site.
- The site has a slope of approximately 8% downward from east to west, the site appeared to drain to the west of the site.
- Vegetation onsite appeared to be healthy with no signs of 'vegetation die back'.
- No visible signs of contamination and associated odours were encountered during the investigation

**Photograph 1** – view of the site and dwelling from the south-west.

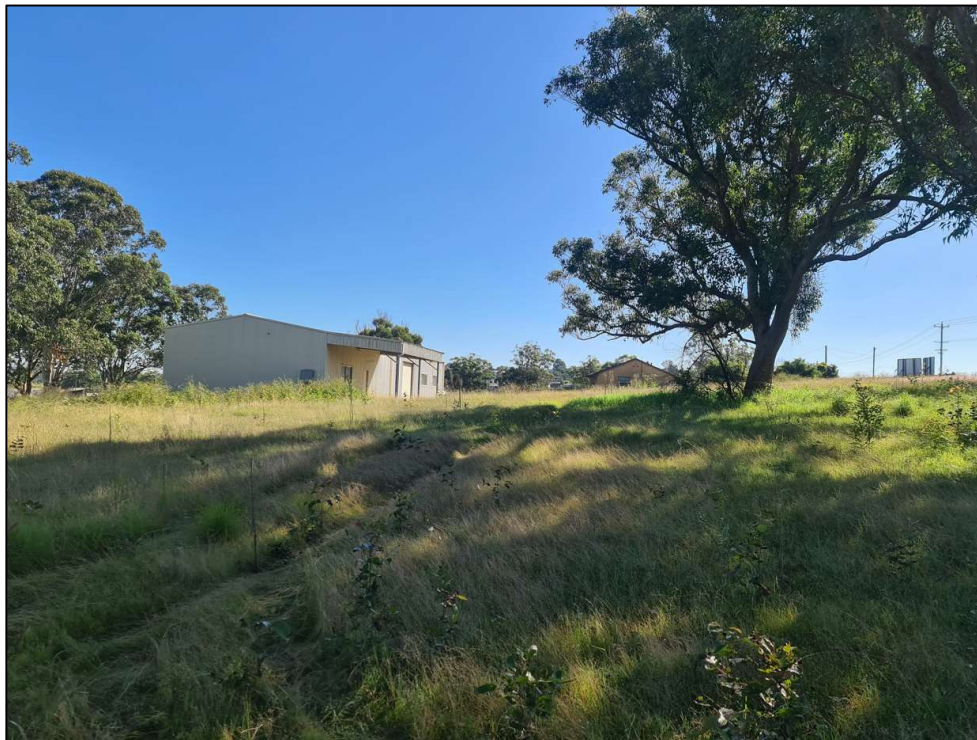
**Photograph 2** – view of the site and storage shed from the south.

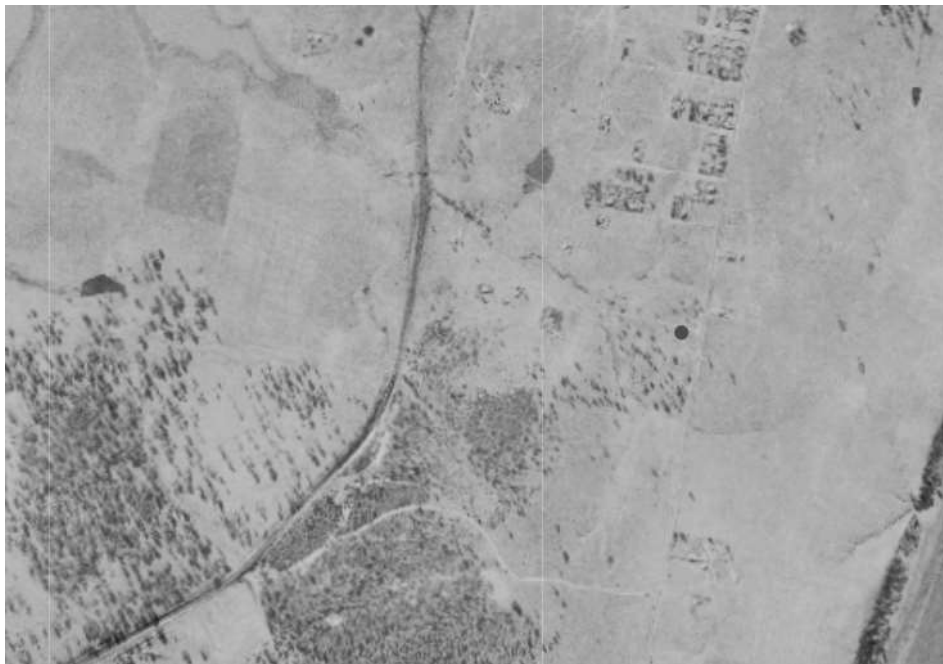
**Aerial Photo 1966**

<b>Year</b>	<b>Site Observations</b>	<b>Surrounding Area</b>
1944	The site is a vacant land covered by grass and scattered trees.	Vacant land covered by grass and scattered trees.
1954	No change from previous photograph	No change from previous photograph
1966	No change from previous photograph	Small residential dwellings located to the east
1974	No change from previous photograph	Small residential dwellings located to the east Market garden structures and dam located to the west
1984	A small residential/structure centrally located on the site Remaining site – grass exposed surfaces and multiple scattered trees	Agricultural use, dwellings and dam located to the east Dam located to the west
2007	A small residential/structure centrally located on the site Shed located in the southern section of the site Remaining site – grass exposed surfaces and multiple scattered trees	Residential development located adjacent north Agricultural use, dwellings and dam located to the east Market garden structures and dam located to the west

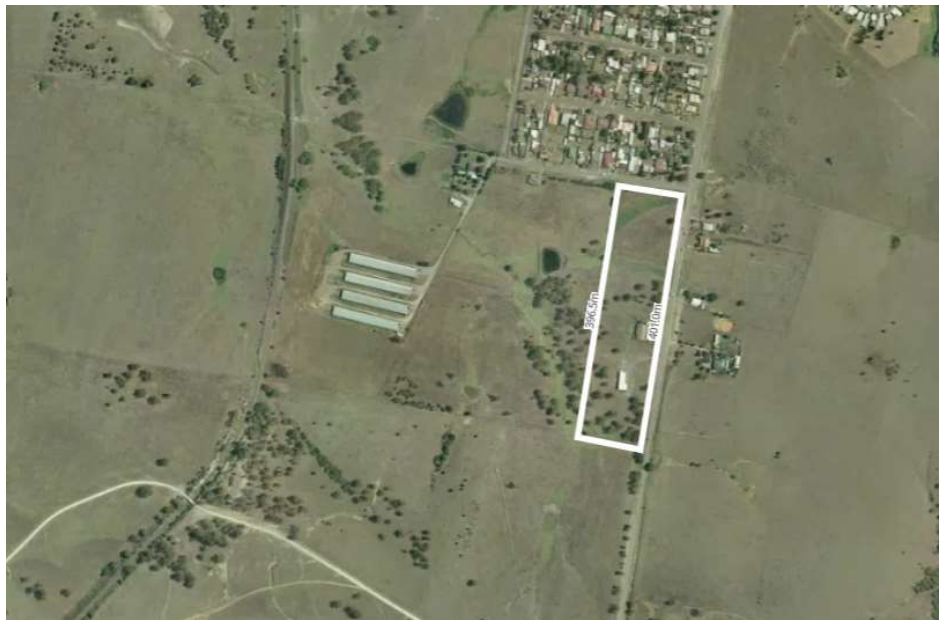
**Aerial Photo 2010**

2010	No change from previous photograph	No change from previous photograph
2015	No change from previous photograph	Residential development located adjacent north and north-west Earthworks located adjacent west Agricultural use, dwellings and dam located to the east Dam located to the west
2019	No change from previous photograph	Residential development located adjacent north and west Agricultural use, dwellings and dam located to the east Dam located to the west
2021	No change from previous photograph	Residential development located adjacent north and west Earthworks adjacent east Dam located to the west
